**PEACE REGION – SWAN HILLS  
GEOHAZARD RISK ASSESSMENT  
SITE INSPECTION FORM**

<b>SITE NUMBER</b> SH 11 (-3, -4)	<b>SITE NAME</b> Little Smoky SH11-3 Little Smoky SH11-4	<b>HIGHWAY &amp; KM</b> HWY 744:02	<b>PREVIOUS INSPECTION DATE</b> May 31, 2011	<b>INSPECTION DATE</b> July 5, 2012
<b>LEGAL DESCRIPTION</b> LSD 02-20-76-22 W5M	<b>NAD 83 COORDINATES</b> N6161152 E476601	<b>PREVIOUS RISK ASSESSMENT</b>		
		<b>PF: 9</b>	<b>CF: 2</b>	<b>TOTAL: 18</b>
		<b>CURRENT RISK ASSESSMENT</b>		
		<b>PF: 9</b>	<b>CF: 2</b>	<b>TOTAL: 18</b>

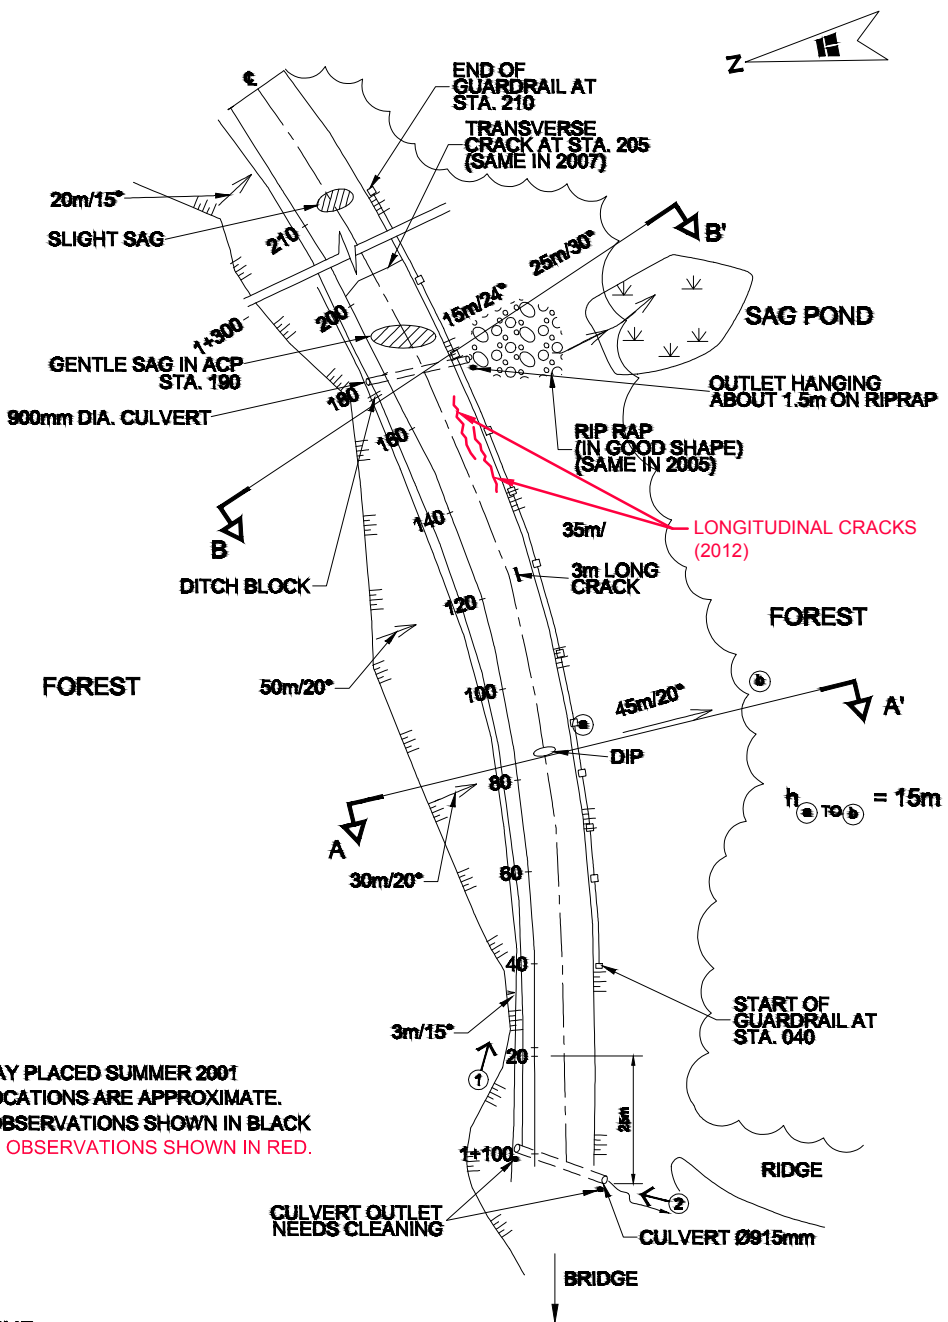
<b>PRIMARY SITE ISSUE:</b>  SH11-3 Pavement cracking and subsidence (undulations) of the highway. The site is part of a larger valley wall failure. The site is located on the southwest flank of a large valley wall block slide. A terrace (sag pond) is below the embankment and forms part of the benched valley wall.  SH11-4 Pavement cracking and subsidence (undulations) of the highway. The site is part of a larger valley wall failure. The site is located on the southwest flank of a large valley wall block slide. A terrace (sag pond) is below the embankment and forms part of the benched valley wall. The backslope ditch is wet with standing water. Movement at SH11-4 is considered to be more severe than at SH11-3.  Ongoing pavement repairs are required at both sites.  It is recommended that a lidar assessment of both sites be carried out to understand how the sites fit in with the larger valley wall failure. No remedial works are planned for the site. Re-routing the highway beyond the valley crest is considered to be one of the only approaches to prevent any further damage to the highway.  Note: Refer to previous inspection reports for further details

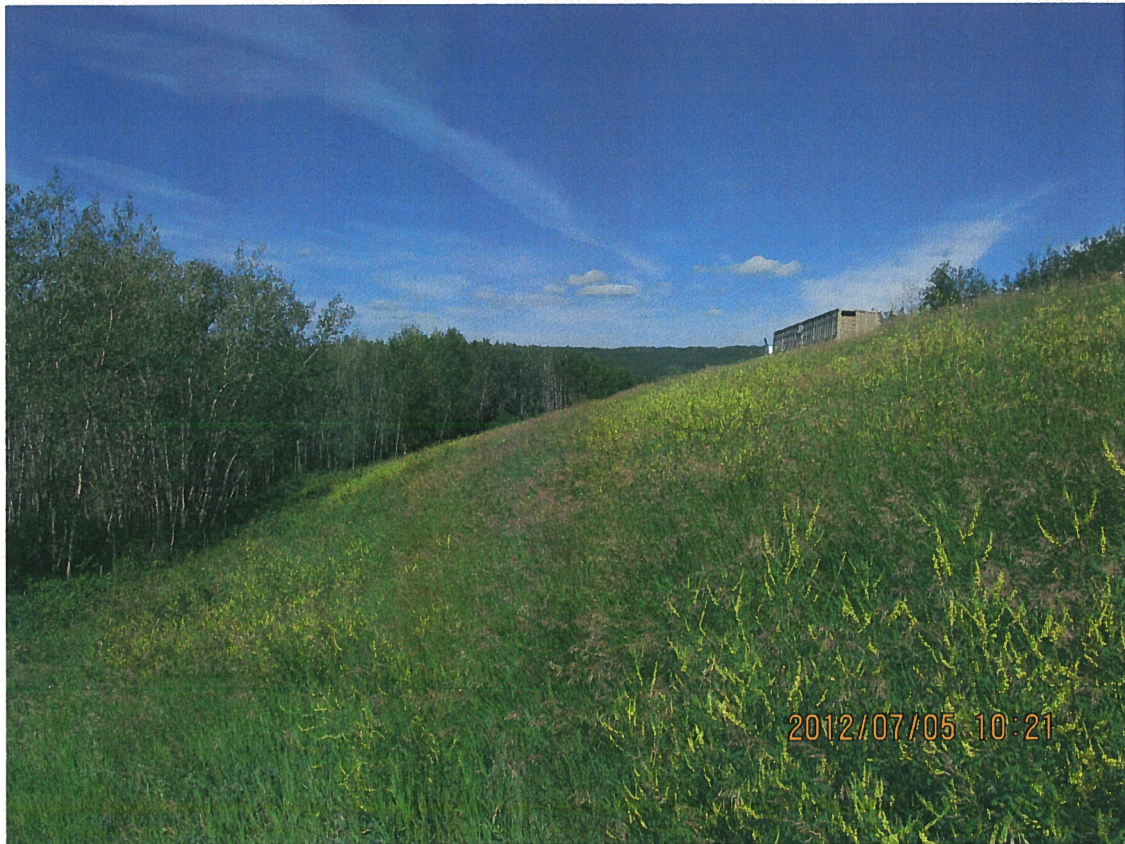
SH11-3 Photo 1. Site SH11-3 looking southwest at the road embankment slope (July 2012).

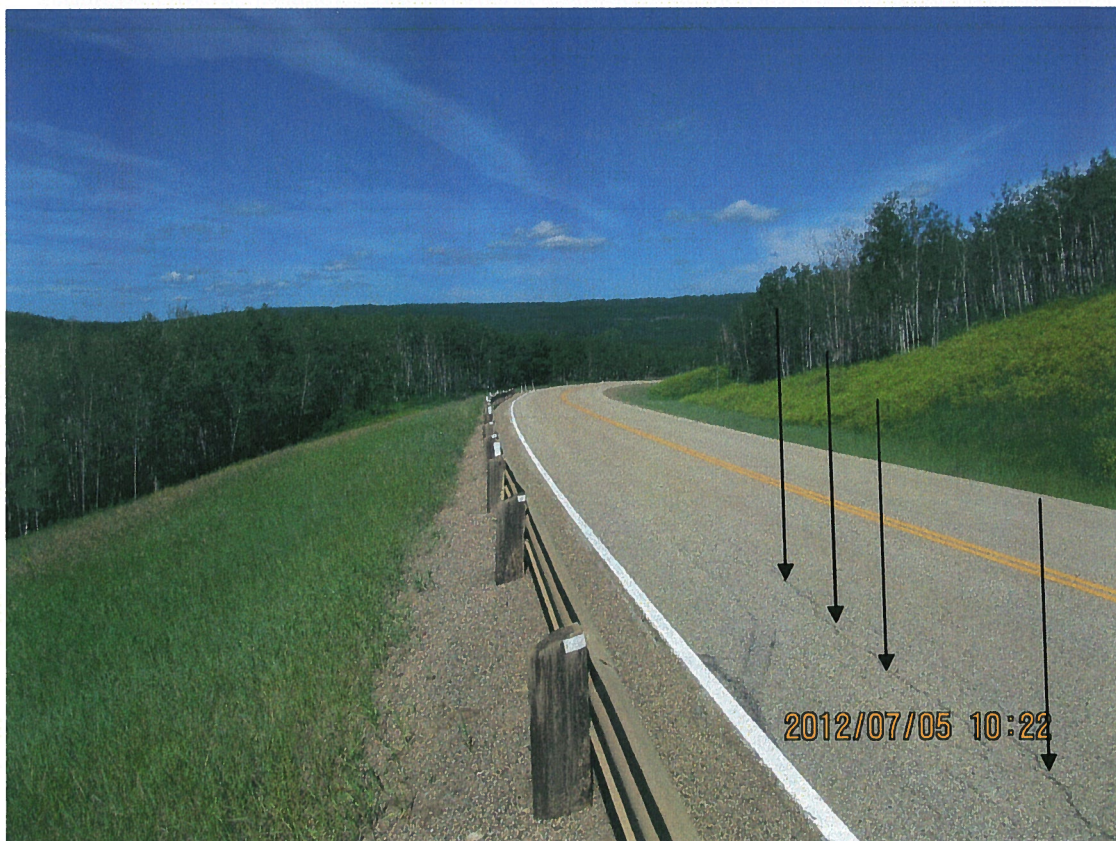
SH11-3 Photo 2. Looking southwest at the SH11-3 road surface. Note the cracking. The road surface undulates but is not visible in the image (July 2012).

Short term repairs of the road surface including, milling, patching, and crack filling should be carried out as required when distortion/settlement and cracking of pavement occurs. Records of maintenance should be kept for review.

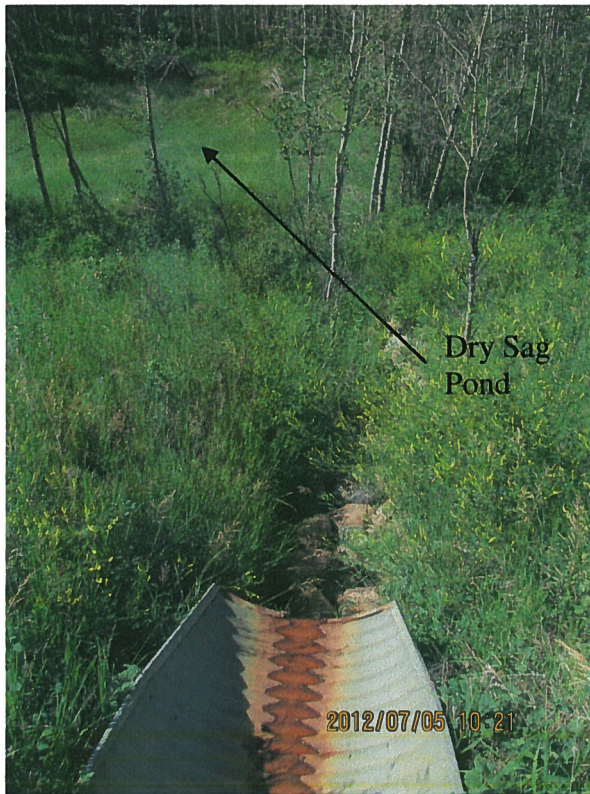
SH11-3 Photo 3. Looking southeast down the embankment from the highway at SH11-3. Note the sag pond at the bottom of the embankment (July 2012).

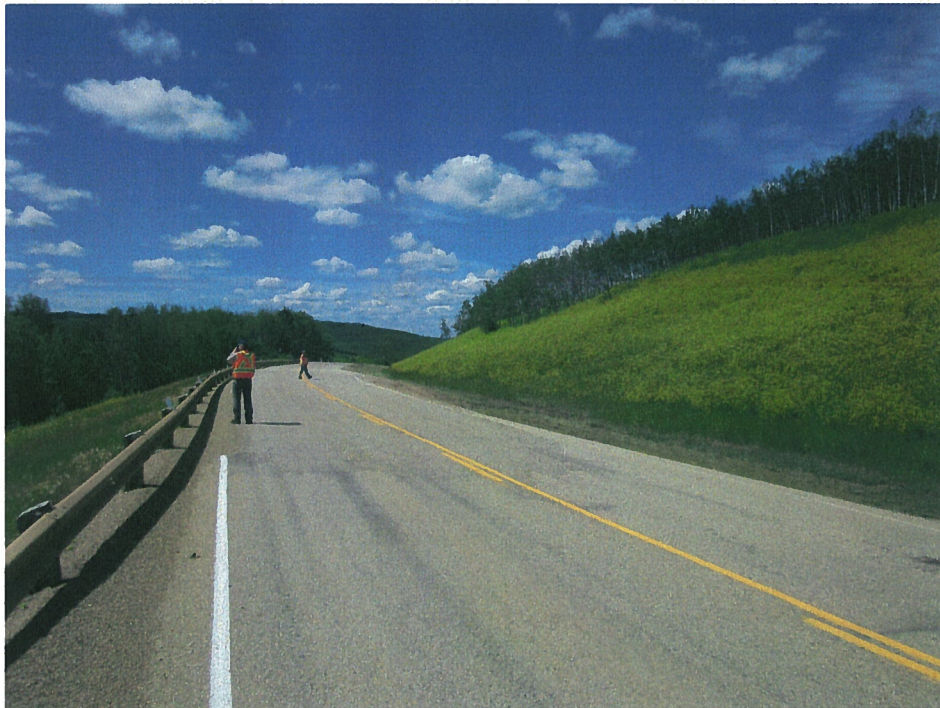
SH11-4 Photo 4. Looking downgrade at SH11-4 (July 2012).

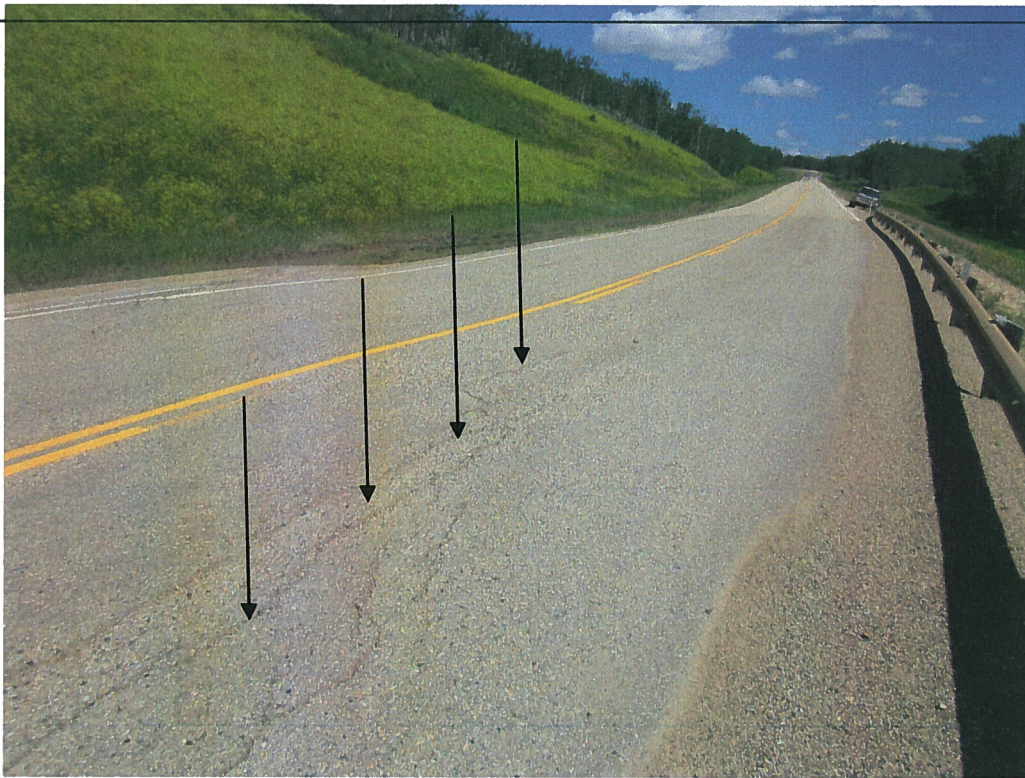
SH11-4 Photo 5. Looking upgrade at SH11-4. Note the undulations in the roadway and the cracking (July 2012).

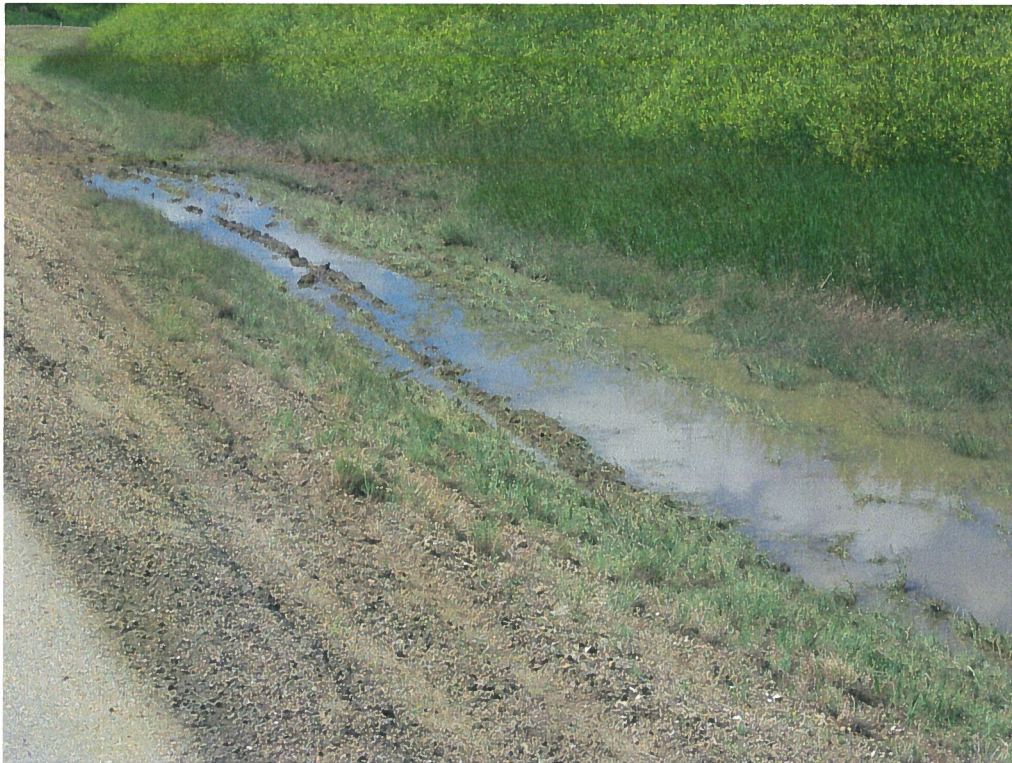
SH11-4 Photo 6. Looking at the wet backslope ditch at SH11-4 (July 2012).
