PEACE REGION – SWAN HILLS
GEOHAZARD RISK ASSESSMENT
SITE INSPECTION FORM

SITE NUMBER SH 11 (-3, -4)	SITE NAME Little Smoky SH11-3 Little Smoky SH11-4	HIGHWAY & KM HWY 744:02	PREVIOUS INSPECTION DATE July 5, 2012	INSPECTION DATE June 18, 2013
LEGAL DESCRIPTION LSD 02-20-76-22 W5M	NAD 83 COORDINATES N6161152 E476601	PREVIOUS RISK ASSESSMENT		
		PF: 9	CF: 2	TOTAL: 18
		CURRENT RISK ASSESSMENT		
		PF: 9	CF: 3	TOTAL: 27

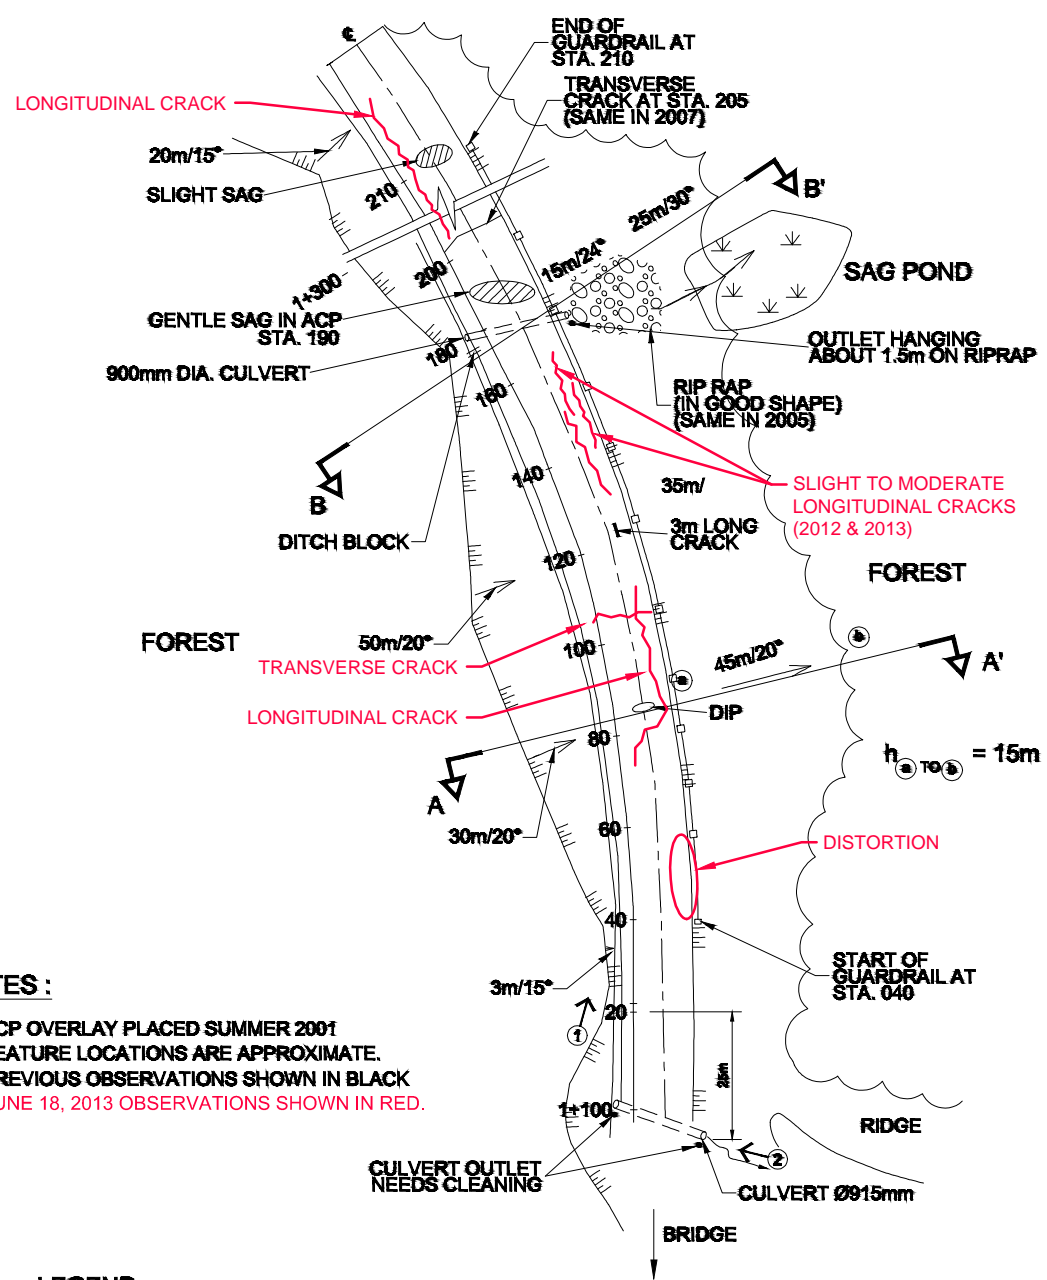
ITEM	CONDITION EXISTS		DESCRIPTION AND LOCATION	NOTICABLE CHANGE FROM LAST INSPECTION		
	YES	NO		YES	NO	See Comment
PAVEMENT DISTRESS	X		New cracking and distortion in the pavement were visible and shown on Figures 1 and 3.	X		
SLOPE MOVEMENT	X		The site is located on the southwest flank of a larger valley wall block failure		X	
EROSION		X			X	
SEEPAGE		X			X	
CULVERT DISTRESS		X			X

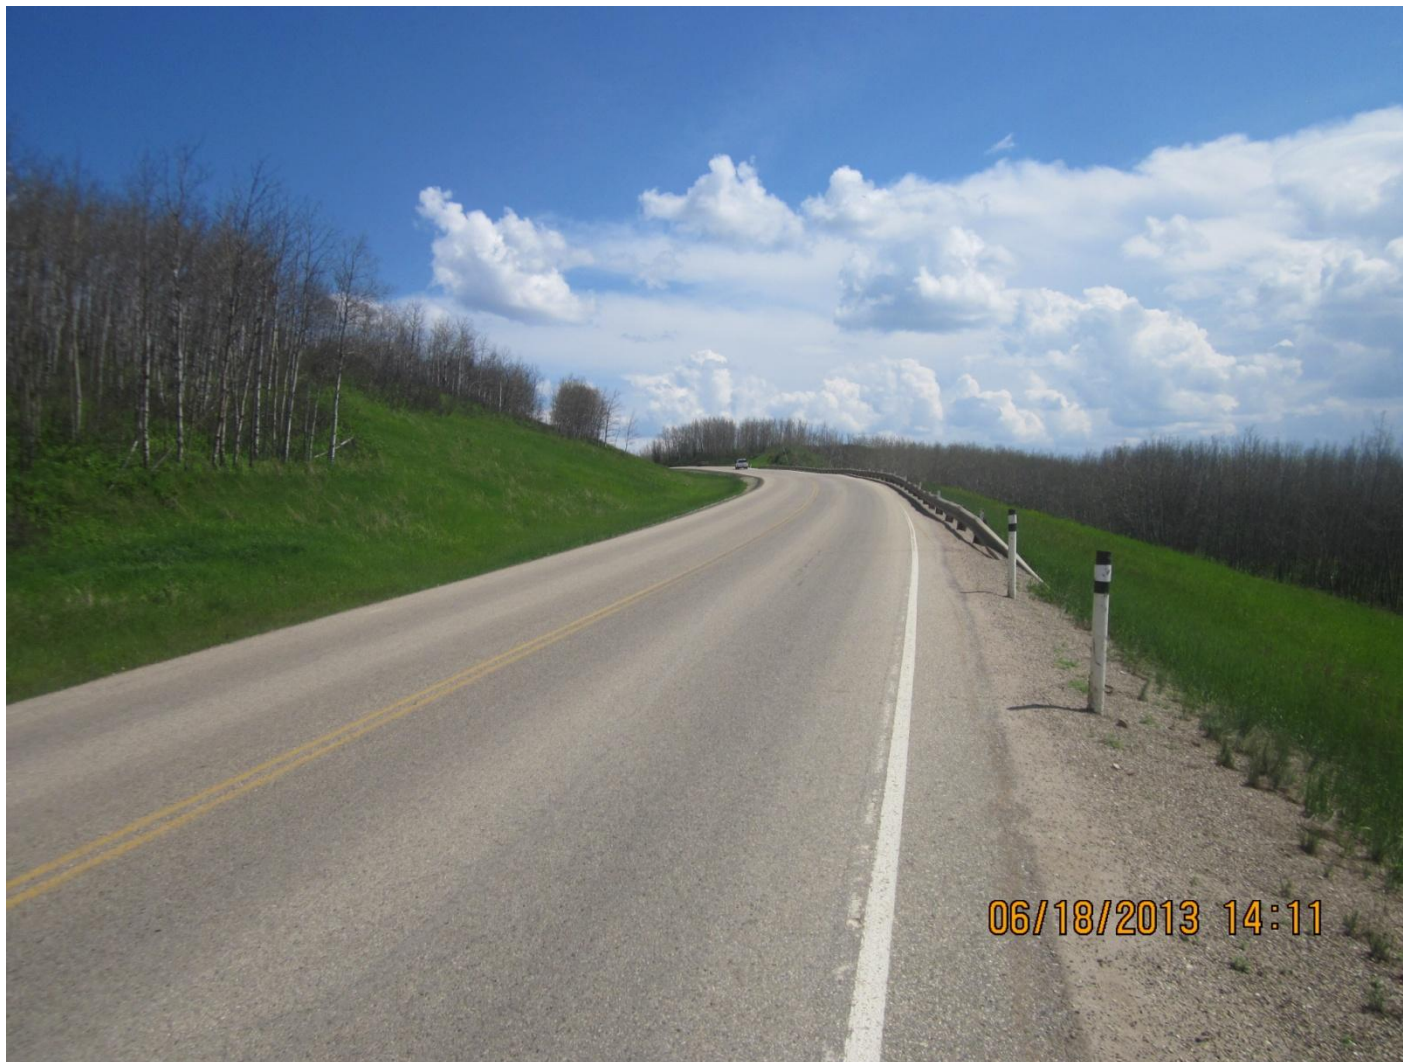
Photo 1: Looking upgrade to the east at the SH11-3 road surface

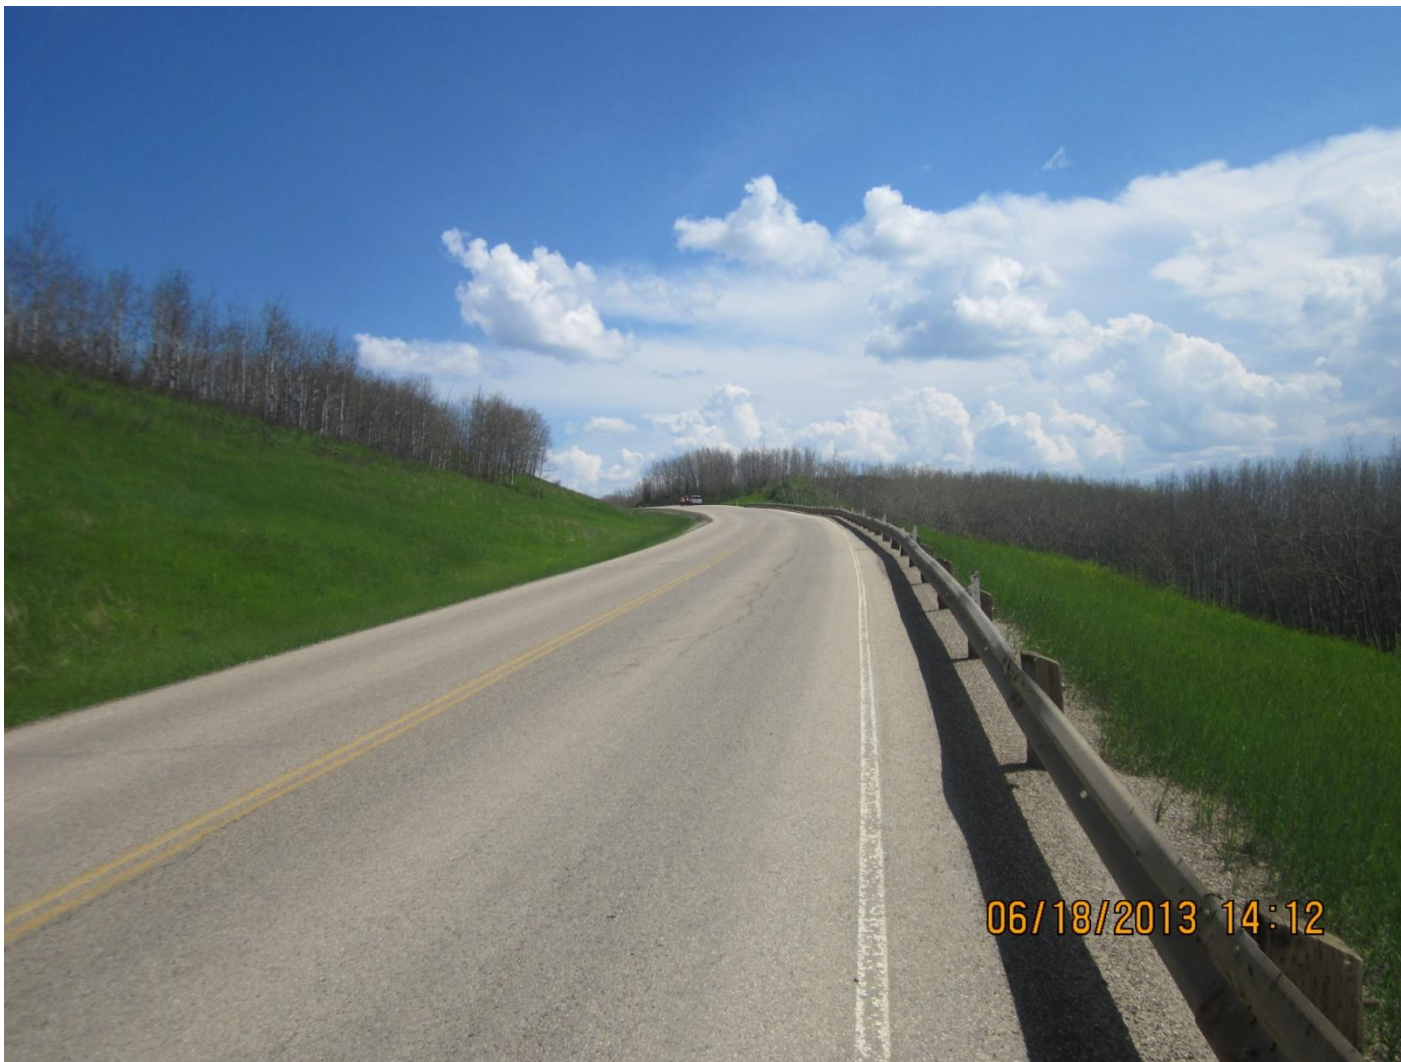
Photo 2: Looking upgrade to the east at the SH11-3 road surface. Note cracking (foreground) and distortion (background).

Short term repairs of the road surface including, milling, patching, and crack filling should be carried out as required when distortion/settlement and cracking of pavement occurs. Records of maintenance should be kept for review.

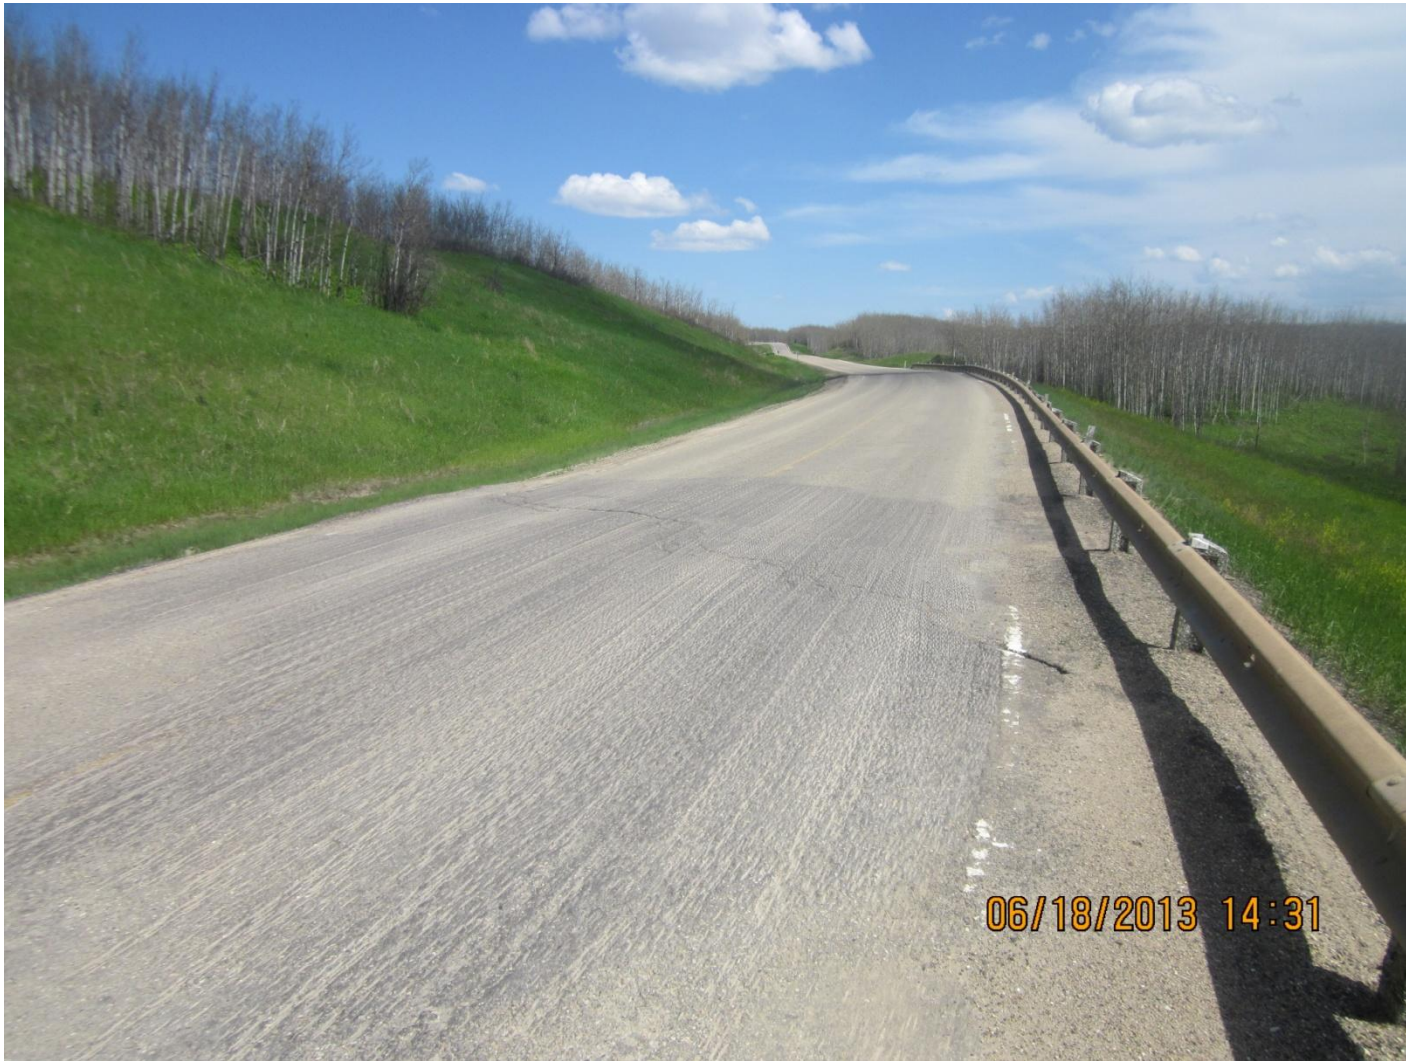
Photo 6: Looking upgrade to the west at the SH11-4 road surface. Note severe transverse crack and distortion of pavement in recently milled area.

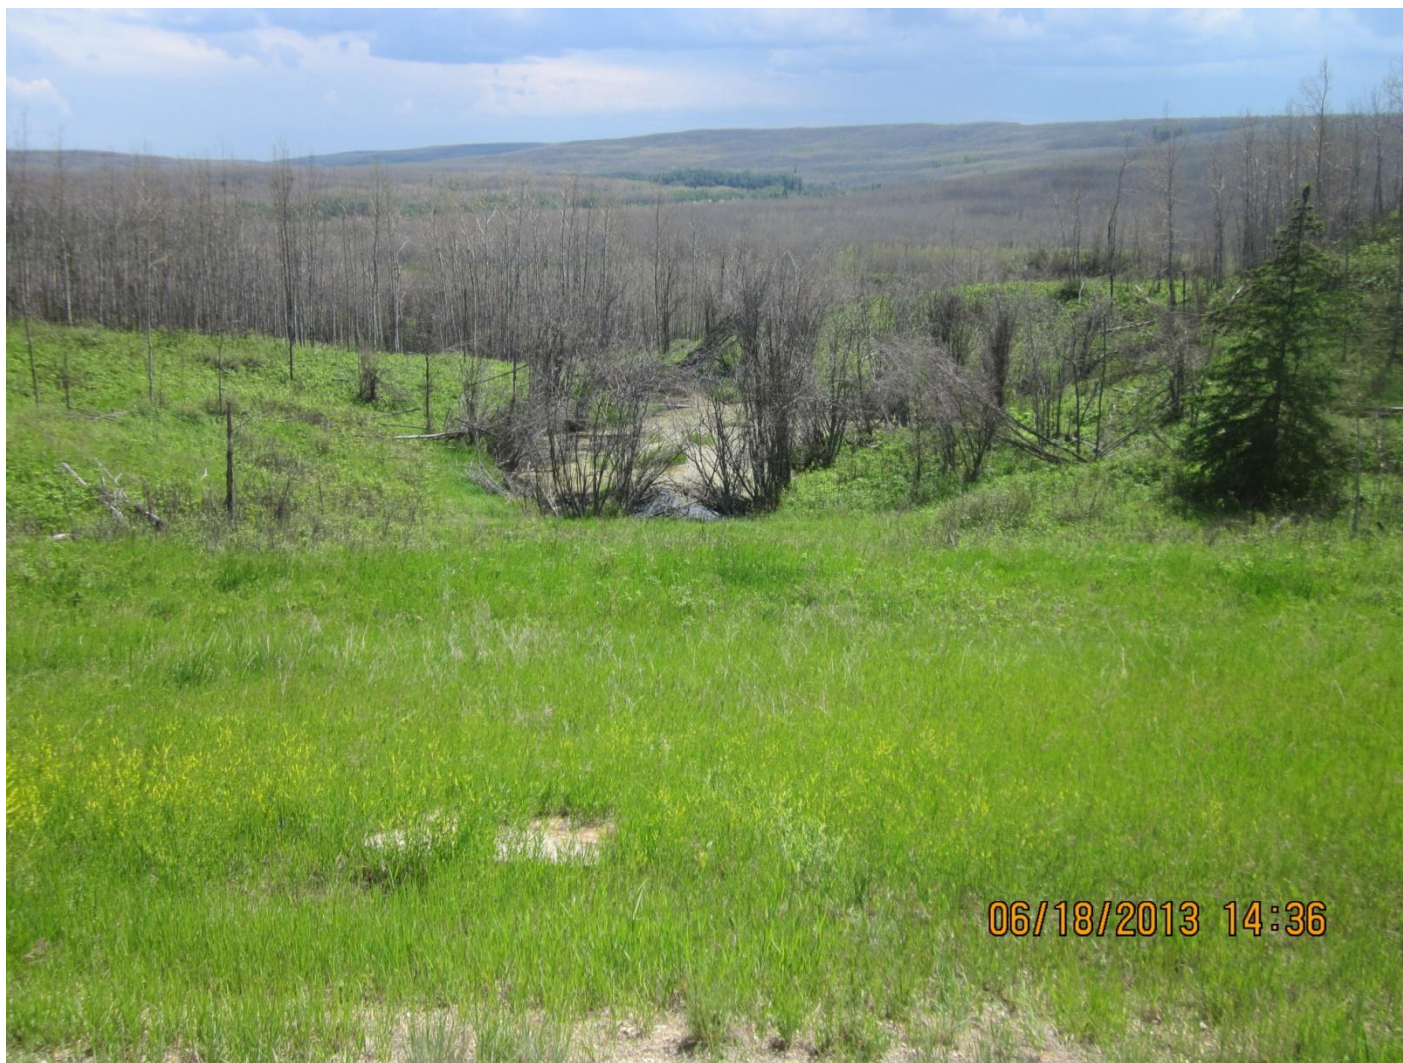
Photo 6: Looking downslope at sag pond from SH11-4.
