**PEACE REGION – SWAN HILLS
GEOHAZARD RISK ASSESSMENT
SITE INSPECTION FORM**

SITE NUMBER SH 11 (-3, -4)	SITE NAME Little Smoky SH11-3 Little Smoky SH11-4	HIGHWAY & KM HWY 744:02	PREVIOUS INSPECTION DATE May 31, 2011	INSPECTION DATE July 5, 2012
LEGAL DESCRIPTION LSD 02-20-76-22 W5M	NAD 83 COORDINATES N6161152 E476601	PREVIOUS RISK ASSESSMENT		
		PF: 9	CF: 2	TOTAL: 18
		CURRENT RISK ASSESSMENT		
		PF: 9	CF: 2	TOTAL: 18

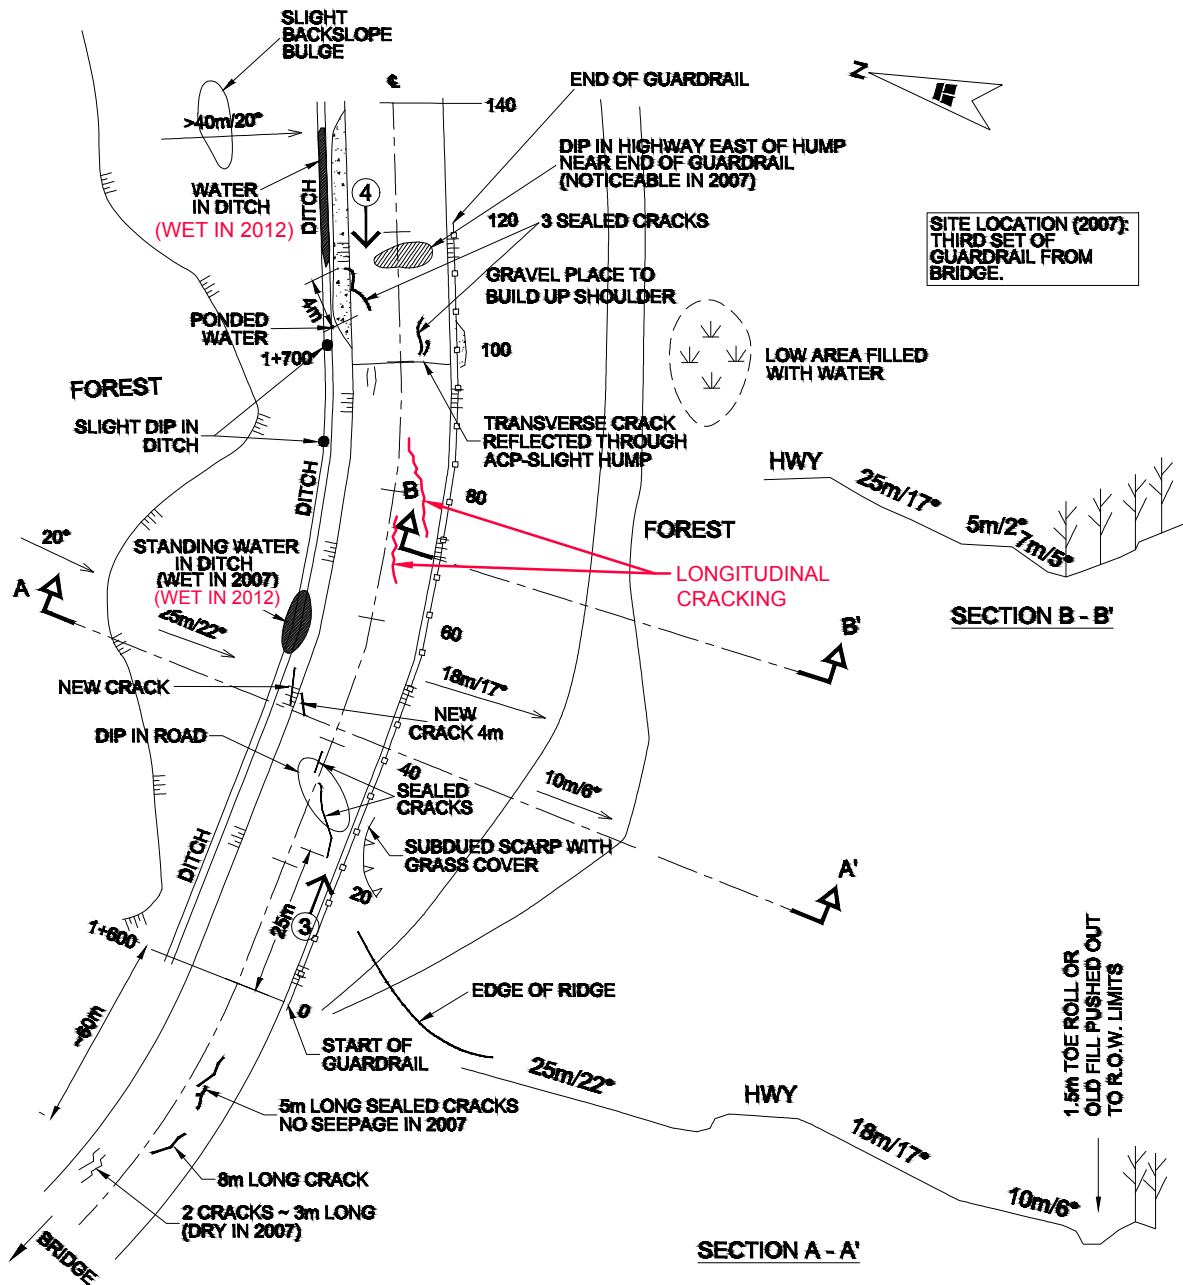
ITEM	CONDITION EXISTS		DESCRIPTION AND LOCATION	NOTICABLE CHANGE FROM LAST INSPECTION		
	YES	NO		YES	NO	See Comment
PAVEMENT DISTRESS	X		Cracking and subsidence (undulations) in the pavement are visible.			X
SLOPE MOVEMENT	X		The site is located on the southwest of a larger valley wall block failure			X
EROSION		X			X	
SEEPAGE		X			X	
CULVERT DISTRESS		X			X

Although pavement distress and slope movement was noted in the 2011 inspection, it could not be determined whether the extents and severity of the distress or movement were noticeably different from the last inspection.

SITE LOCATION (2007):
THIRD SET OF
GUARDRAIL FROM
BRIDGE.

Short term repairs of the road surface including, milling, patching, and crack filling should be carried out as required when distortion/settlement and cracking of pavement occurs. Records of maintenance should be kept for review.

Long term remediation of the site may include consideration for re-routing the highway to the valley crest. A re-route may be the only way to avoid the overall valley wall failure.
