PEACE REGION – SWAN HILLS
GEOHAZARD RISK ASSESSMENT
SITE INSPECTION FORM

SITE NUMBER SH 11 (-3, -4)	SITE NAME Little Smoky SH11-3 Little Smoky SH11-4	HIGHWAY & KM HWY 744:02	PREVIOUS INSPECTION DATE July 5, 2012	INSPECTION DATE June 18, 2013
LEGAL DESCRIPTION LSD 02-20-76-22 W5M	NAD 83 COORDINATES N6161152 E476601	PREVIOUS RISK ASSESSMENT		
		PF: 9	CF: 2	TOTAL: 18
		CURRENT RISK ASSESSMENT		
		PF: 9	CF: 3	TOTAL: 27

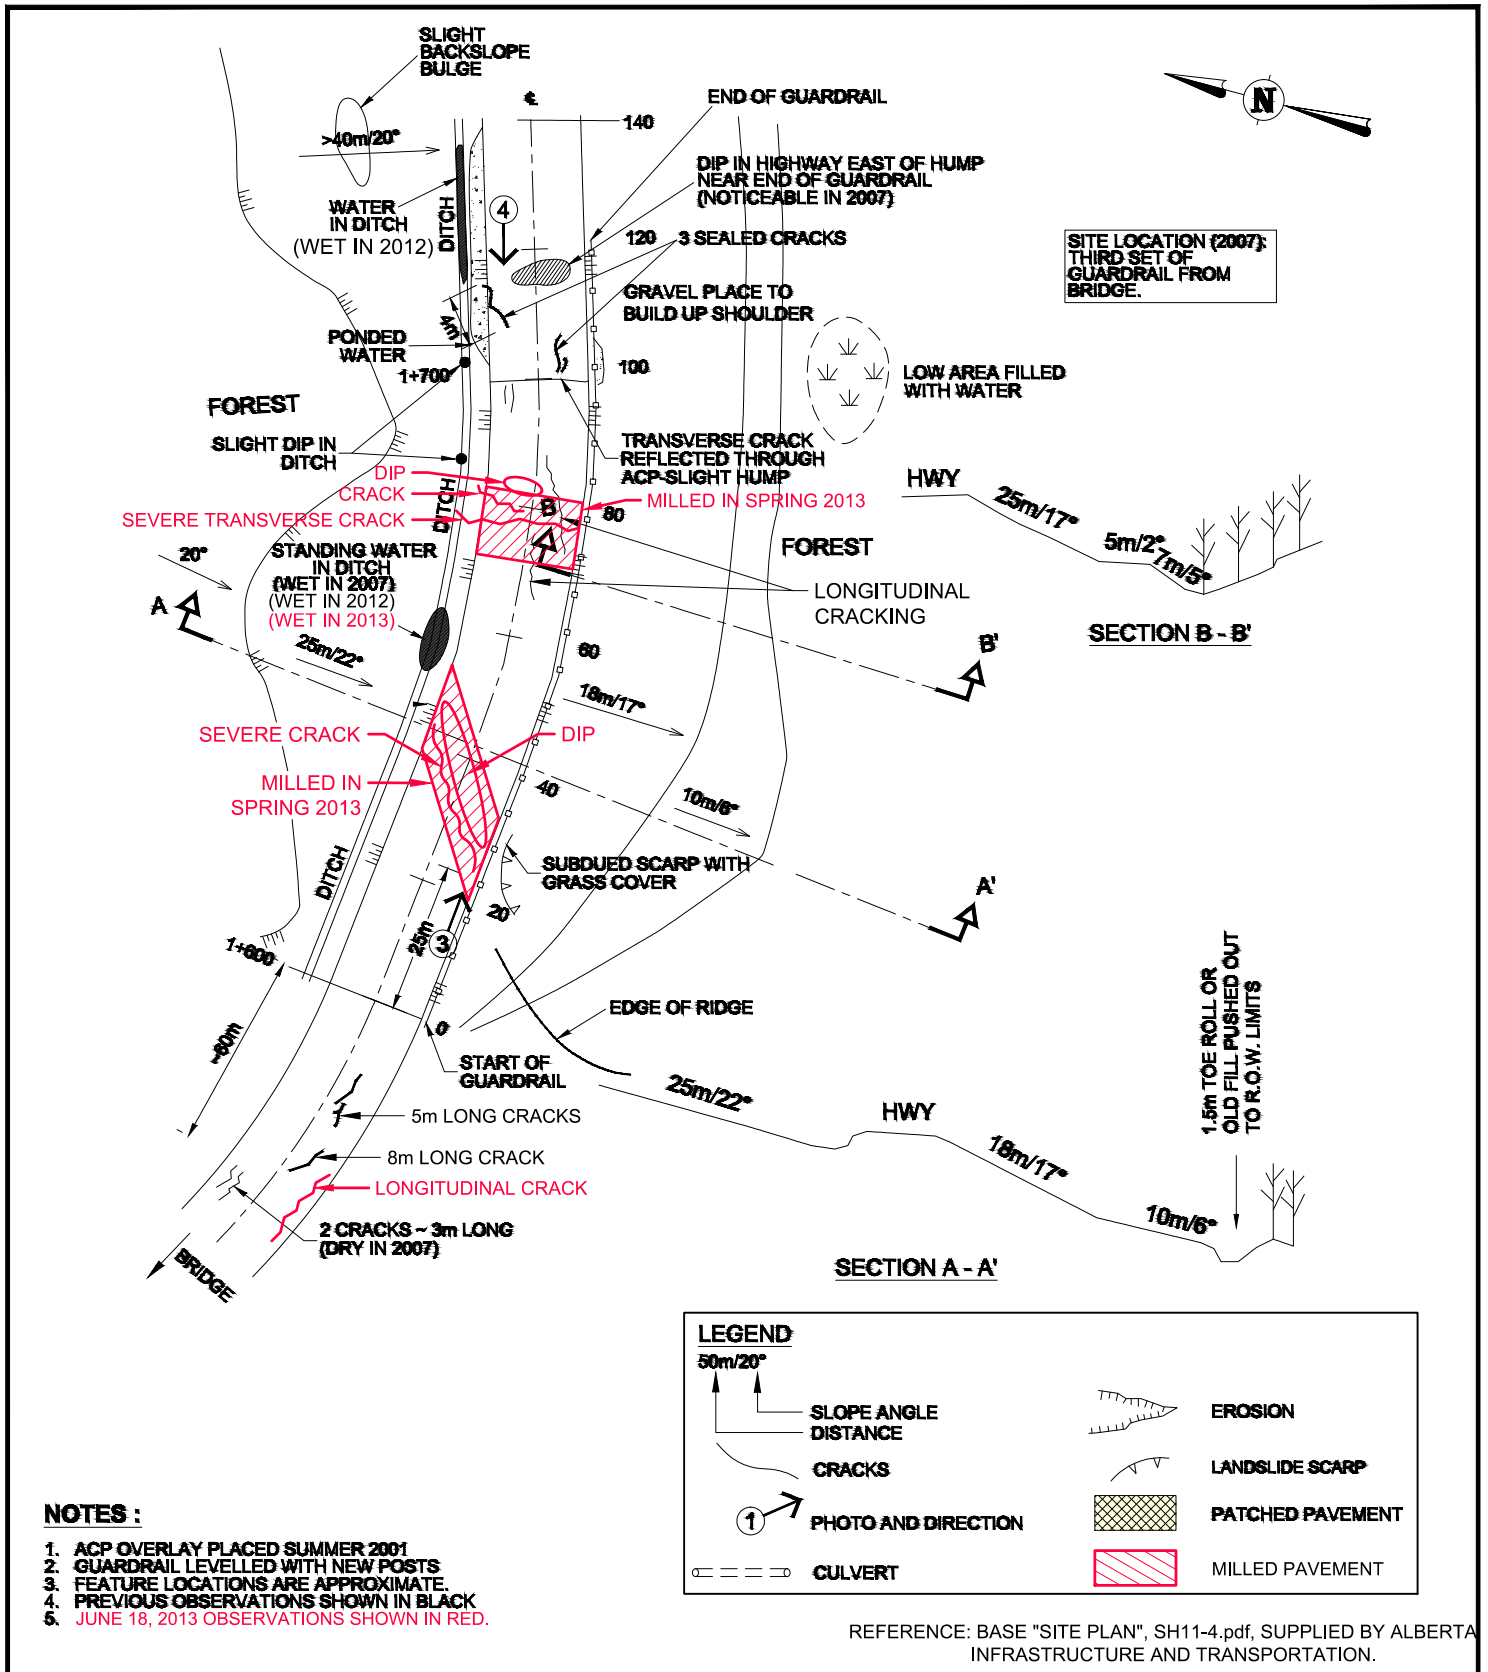
ITEM	CONDITION EXISTS		DESCRIPTION AND LOCATION	NOTICABLE CHANGE FROM LAST INSPECTION		
	YES	NO		YES	NO	See Comment
PAVEMENT DISTRESS	X		New cracking and distortion in the pavement were visible and shown on Figures 1 and 3.	X		
SLOPE MOVEMENT	X		The site is located on the southwest flank of a larger valley wall block failure		X	
EROSION		X			X	
SEEPAGE		X			X	
CULVERT DISTRESS		X			X

Short term repairs of the road surface including, milling, patching, and crack filling should be carried out as required when distortion/settlement and cracking of pavement occurs. Records of maintenance should be kept for review.

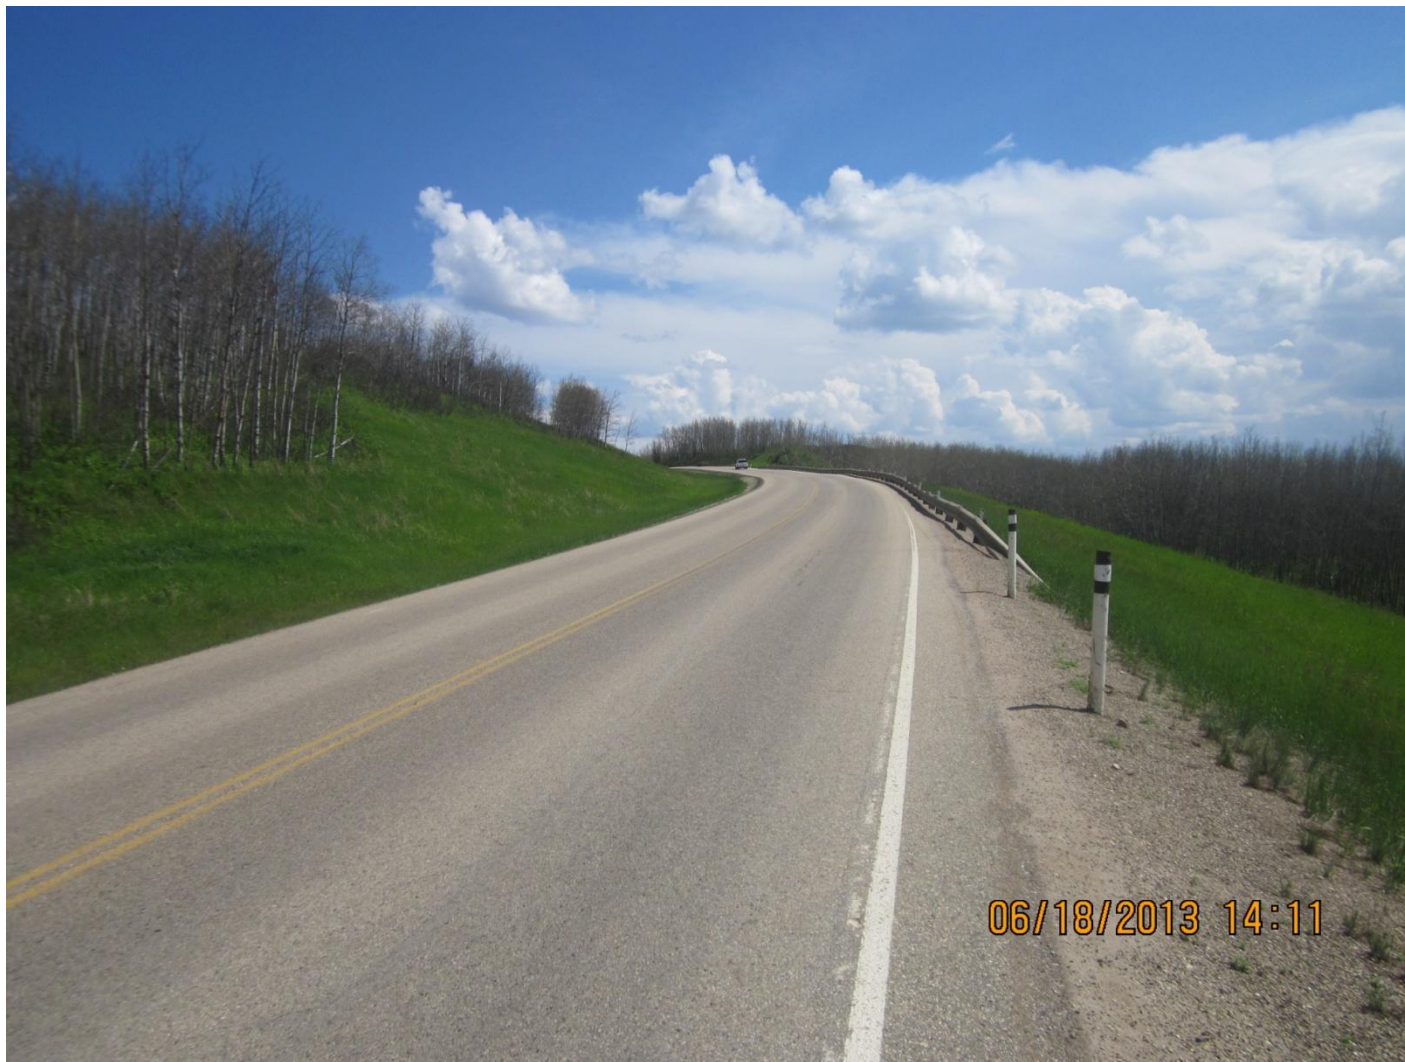
Photo 1: Looking upgrade to the east at the SH11-3 road surface

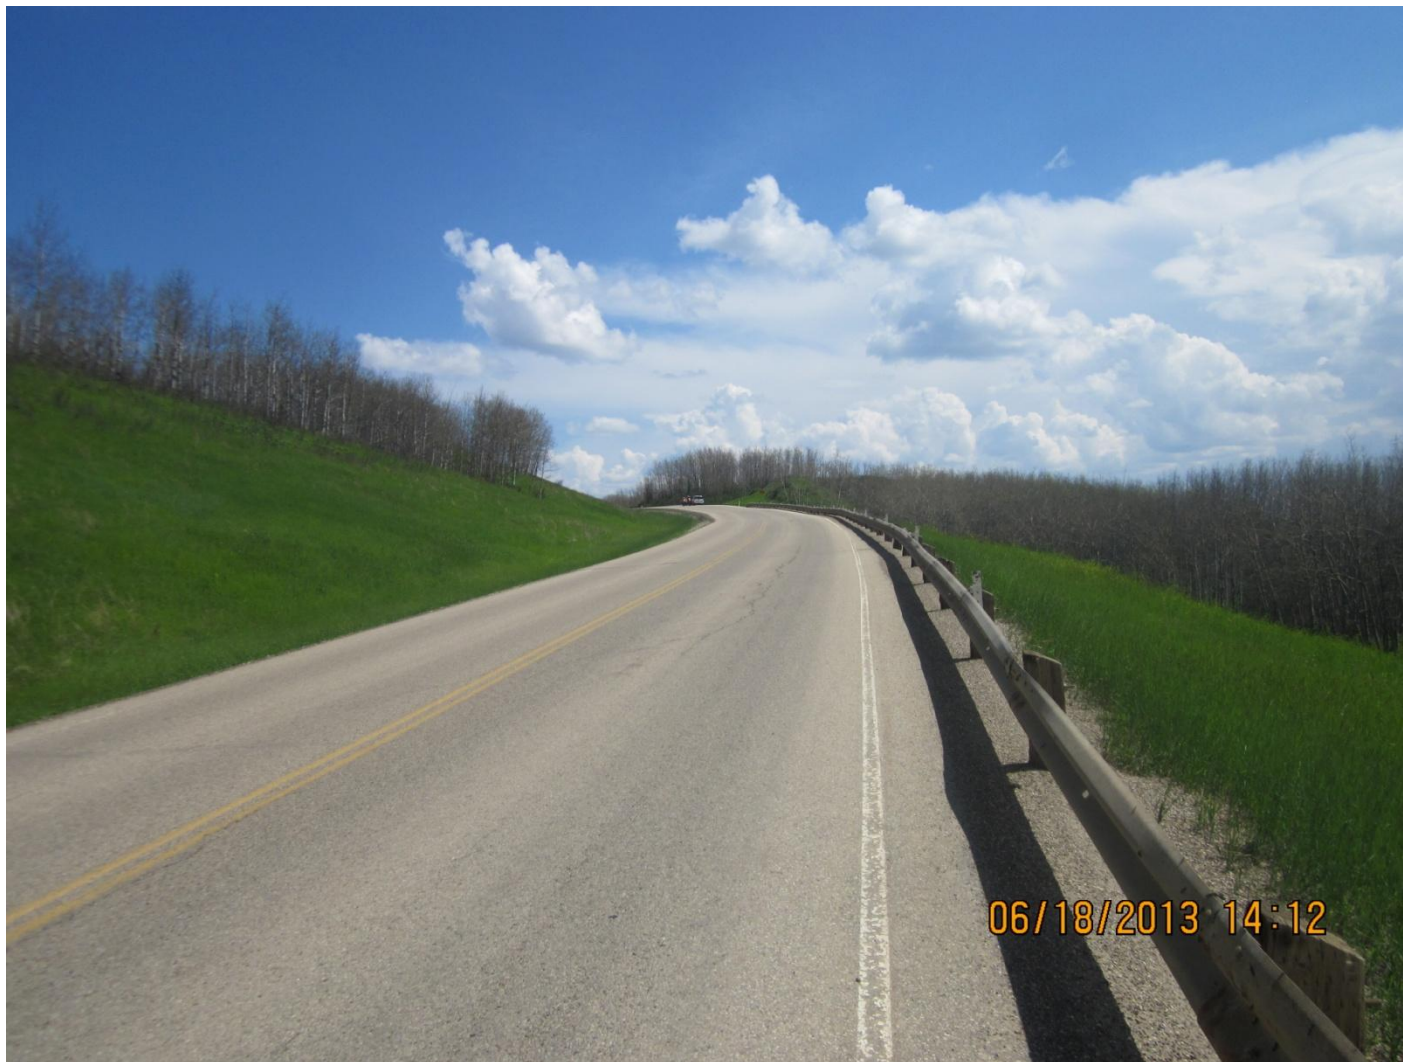
Photo 2: Looking upgrade to the east at the SH11-3 road surface. Note cracking (foreground) and distortion (background).

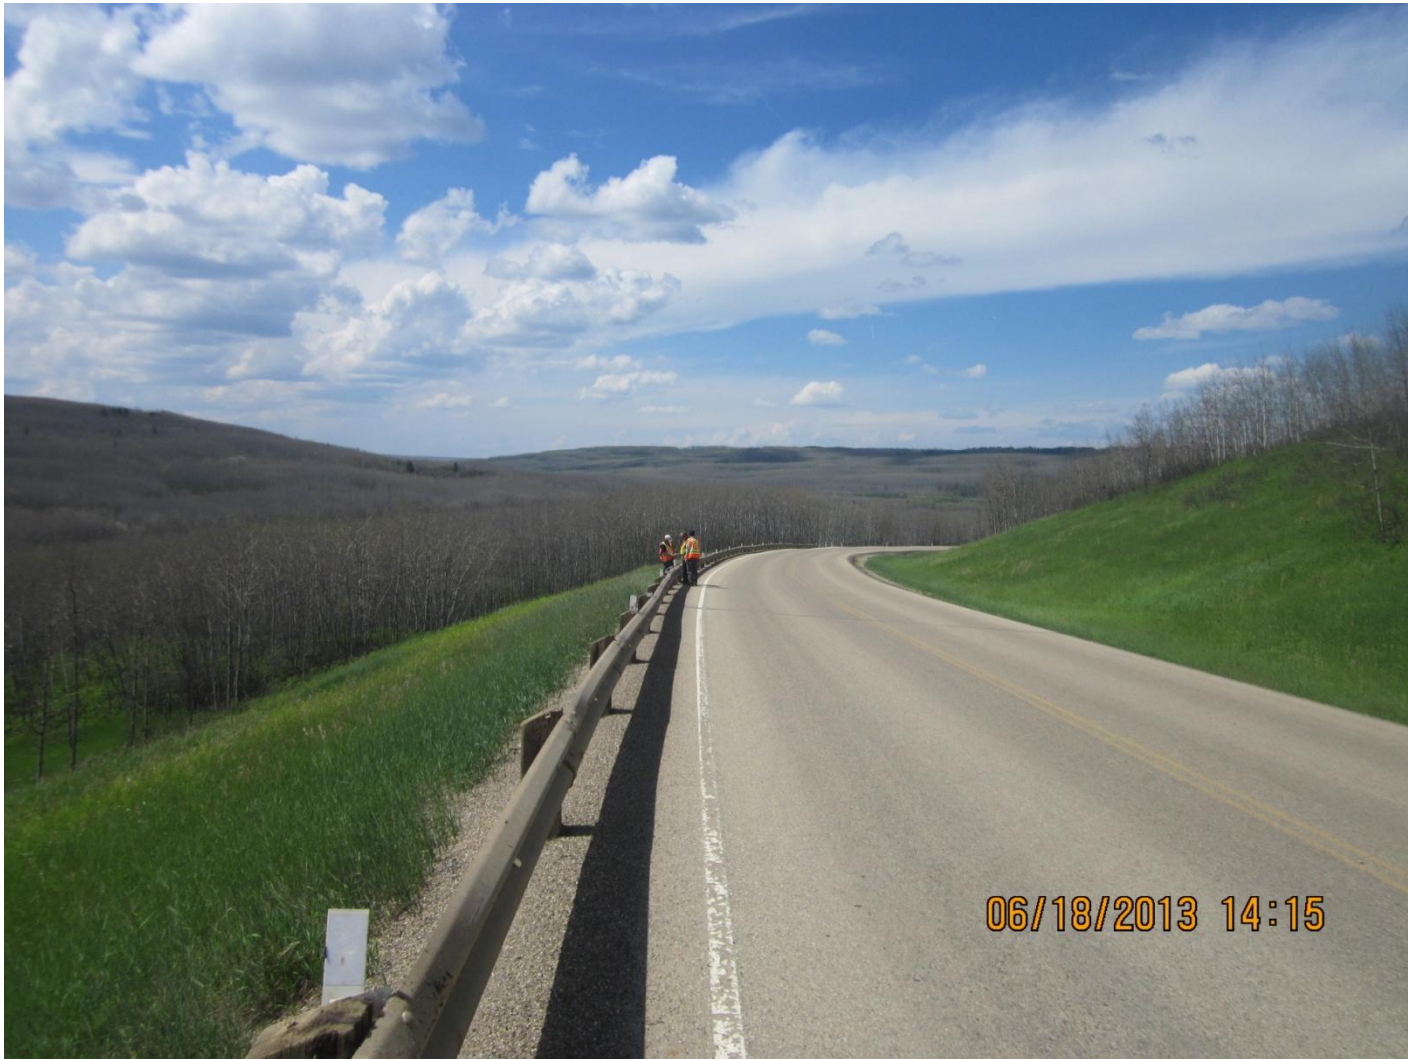
Photo 3: Looking downgrade to the west at the SH11-3 road surface. Note transverse cracking near centre of photo.

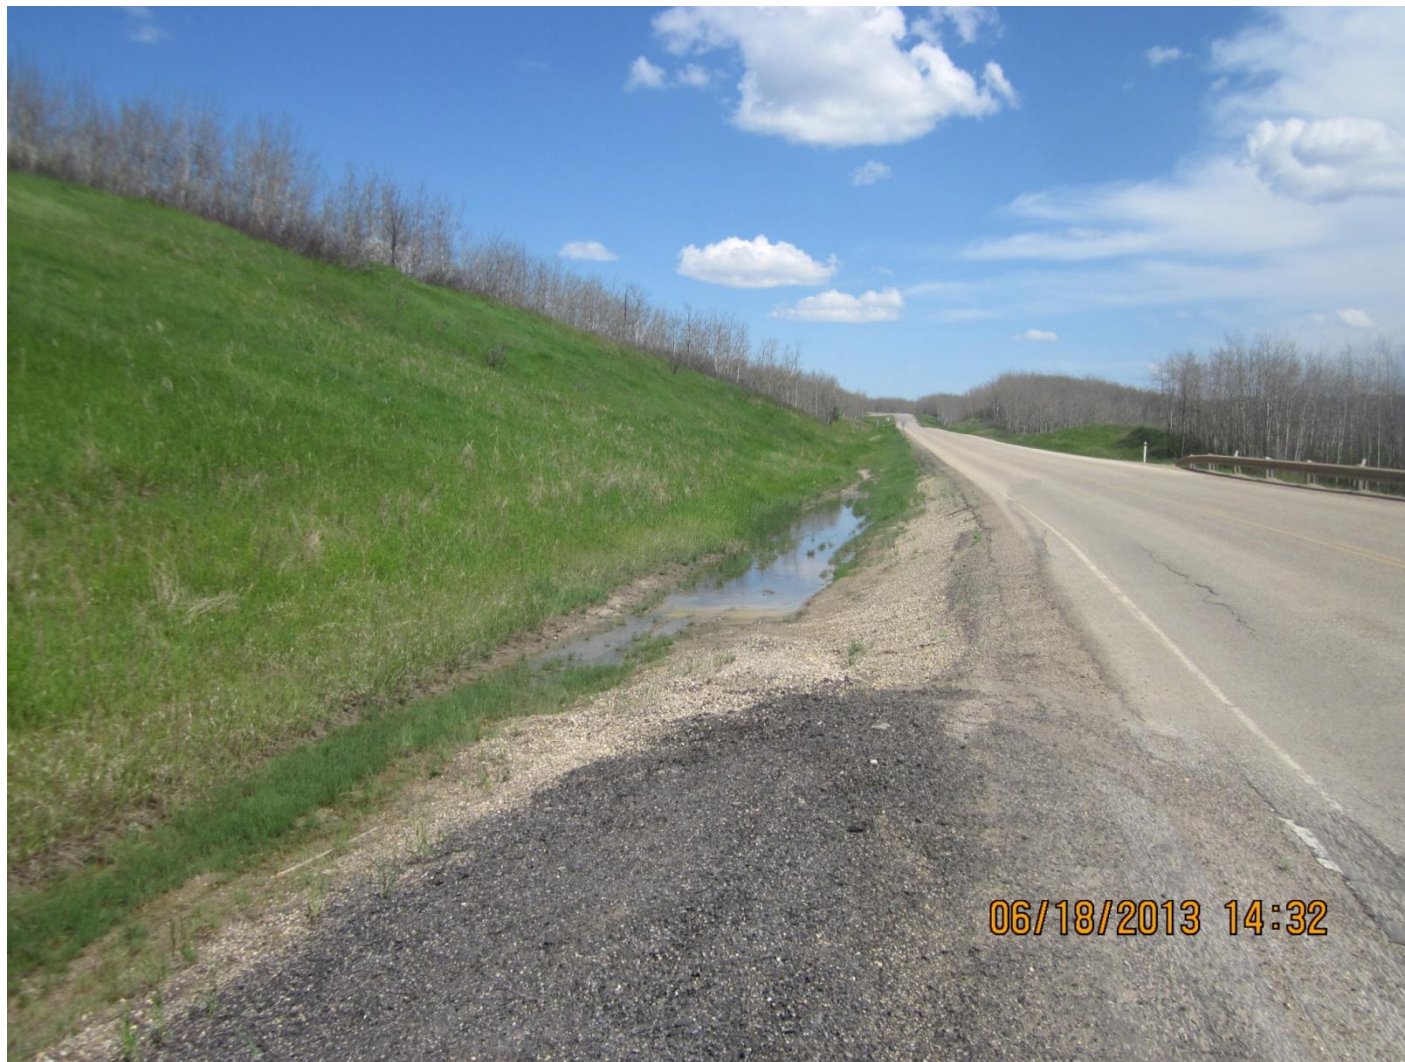
Photo 7: Wet backslope ditch at SH11-4.
