**ALBERTA TRANSPORTATION AND
ECONOMIC CORRIDORS
GEOHAZARD ASSESSMENT PROGRAM
PEACE REGION – SWAN HILLS
2024 INSPECTION**

Site Number	Location	Name	Hwy	km
SH012-8 SH012-9	Little Smoky River	Little Smoky River Valley, North Hill – Sites #8 and #9	744:02	19.70-19.83 19.83-20.0*
Legal Description		UTM Co-ordinates		
Site 8: SW21-76-22-W5M		11U E 477,815	N	6,161,486
Site 9: 21-76-22-W5		11U E 477,887	N	6,161,592

**SH012-8: HWY 744:02 LITTLE SMOKY RIVER VALLEY
 2024 SITE INSPECTION PLAN**

DWG No. 32121-SH012-8

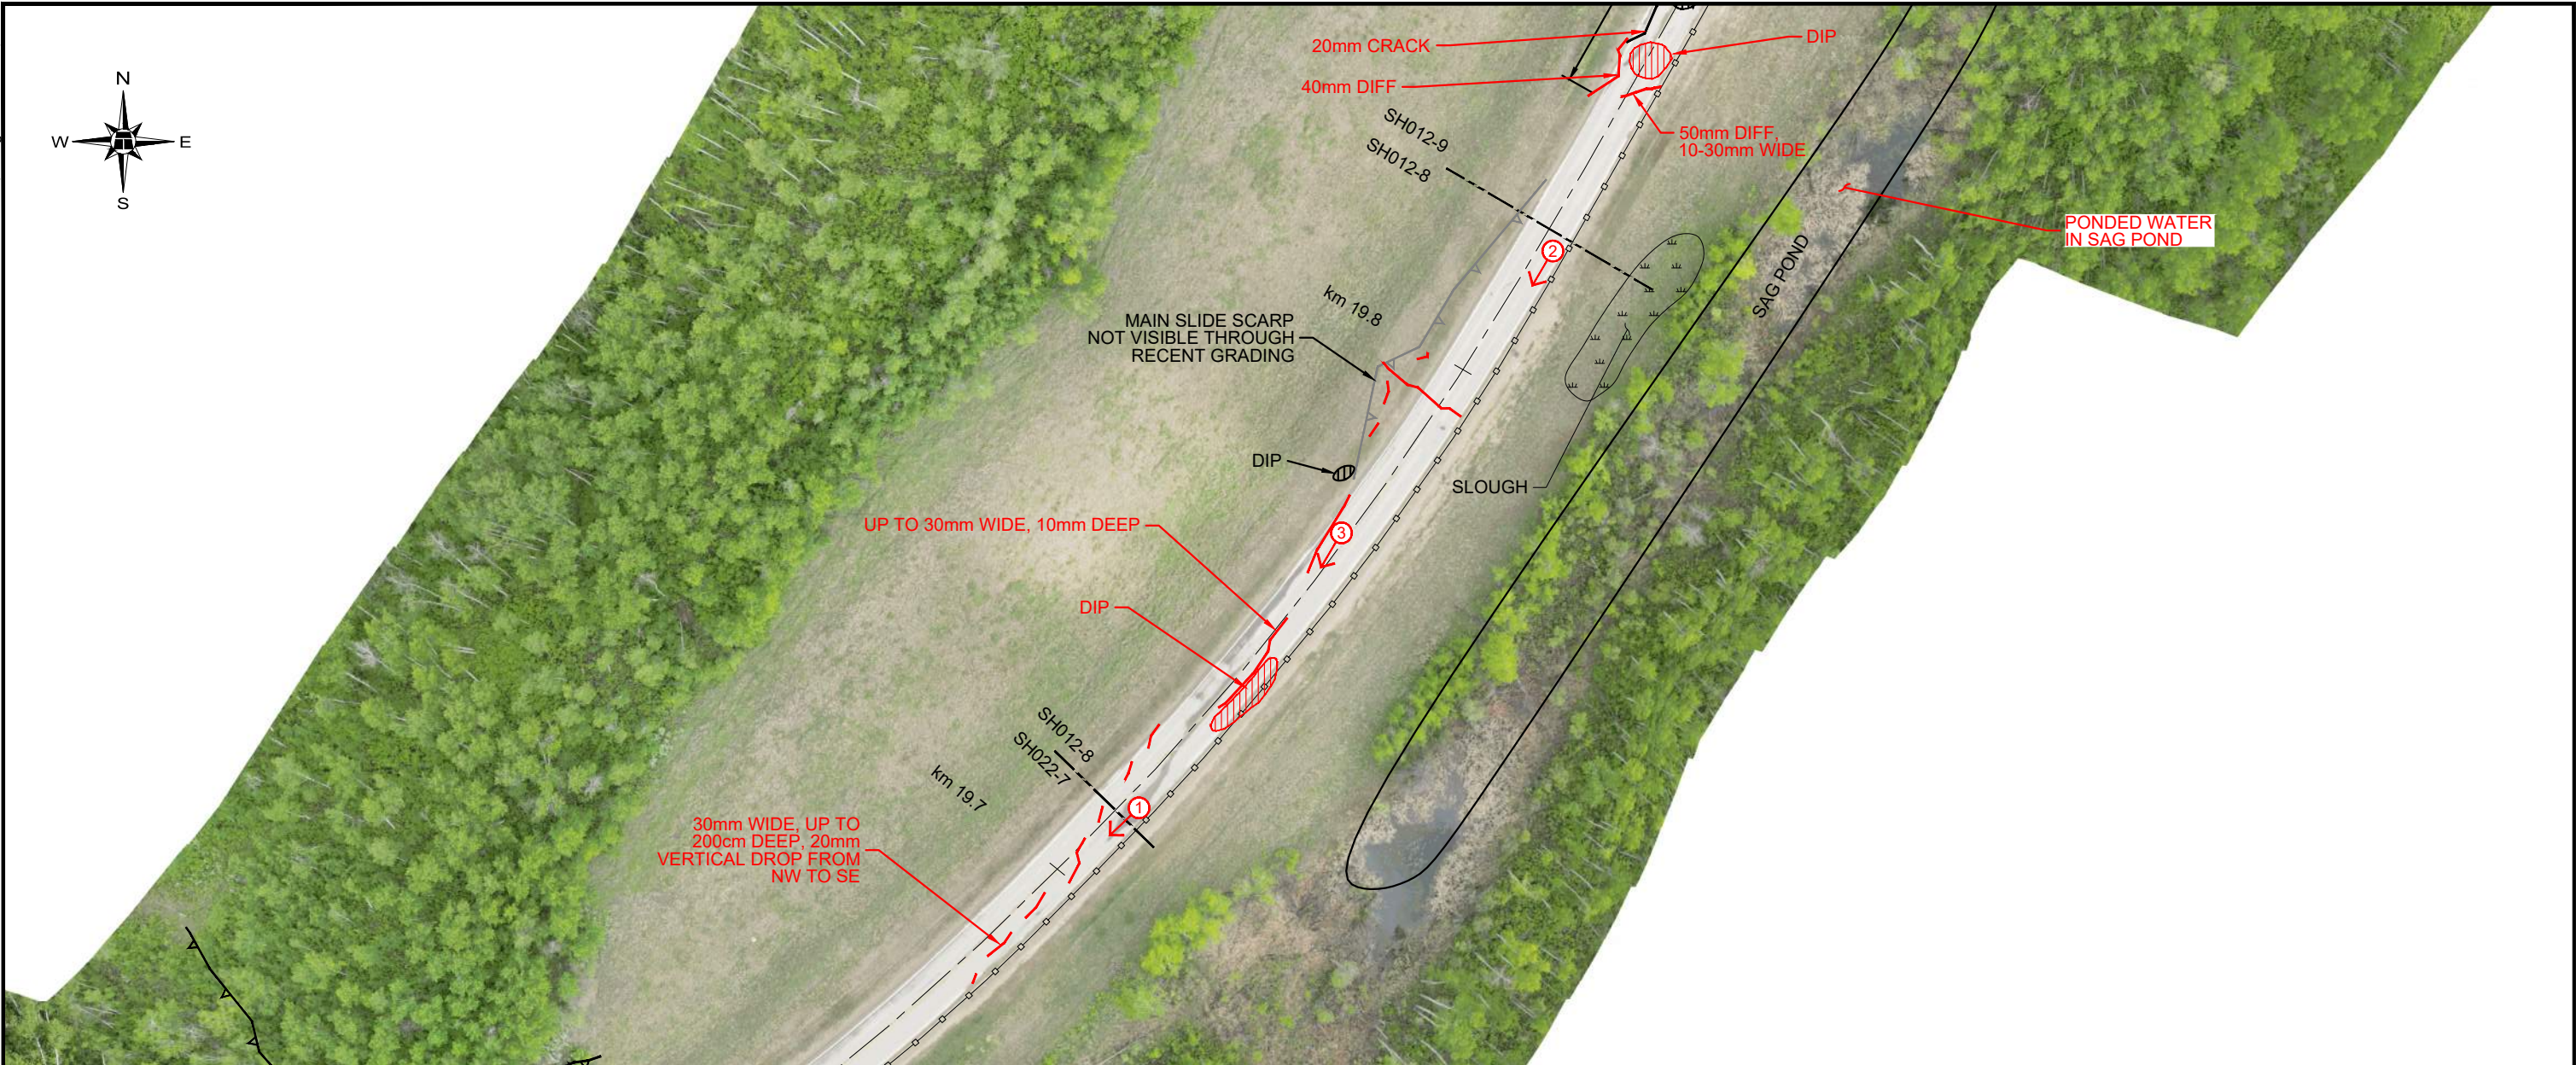
DETAILED SITE PLAN

Observations (Site 8):	Description	Worsened?
<input checked="" type="checkbox"/> Pavement Distress	Previous longitudinal and traverse cracks continue to reflect through the pavement.	<input checked="" type="checkbox"/>
<input checked="" type="checkbox"/> Slope Movement	Site is located on an active deep-seated landslide moving toward the Peavine Creek. Previously observed scarp not visible due to grading.	<input type="checkbox"/>
<input type="checkbox"/> Erosion		<input type="checkbox"/>
<input type="checkbox"/> Seepage		<input type="checkbox"/>
<input type="checkbox"/> Bridge/Culvert		<input type="checkbox"/>

<input type="checkbox"/> Other		<input type="checkbox"/>
Observations (Site 9):	Description	Worsened?
<input checked="" type="checkbox"/> Pavement Distress	Some of the previous longitudinal and traverse cracks have reflected through. There is surface distortion over the crack pattern.	<input checked="" type="checkbox"/>
<input checked="" type="checkbox"/> Slope Movement	Site is located on an active deep-seated landslide moving toward the Peavine Creek. This site crosses over a sag pond/graben with several dips in the highway.	<input type="checkbox"/>
<input checked="" type="checkbox"/> Erosion	Small gully in backslope.	<input type="checkbox"/>
<input type="checkbox"/> Seepage		<input type="checkbox"/>
<input checked="" type="checkbox"/> Bridge/Culvert	Culvert at km 19.93: Hanging outlet condition unchanged from 2022.	<input type="checkbox"/>
<input type="checkbox"/> Other		<input type="checkbox"/>

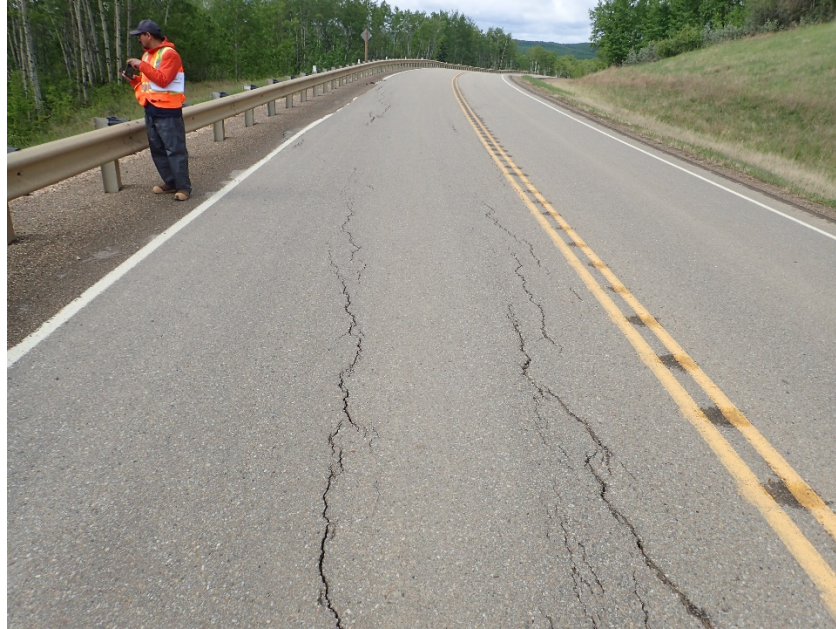
Photo 1, Site 8 – Looking southwest from Site SH012-8 towards Site SH012-7.

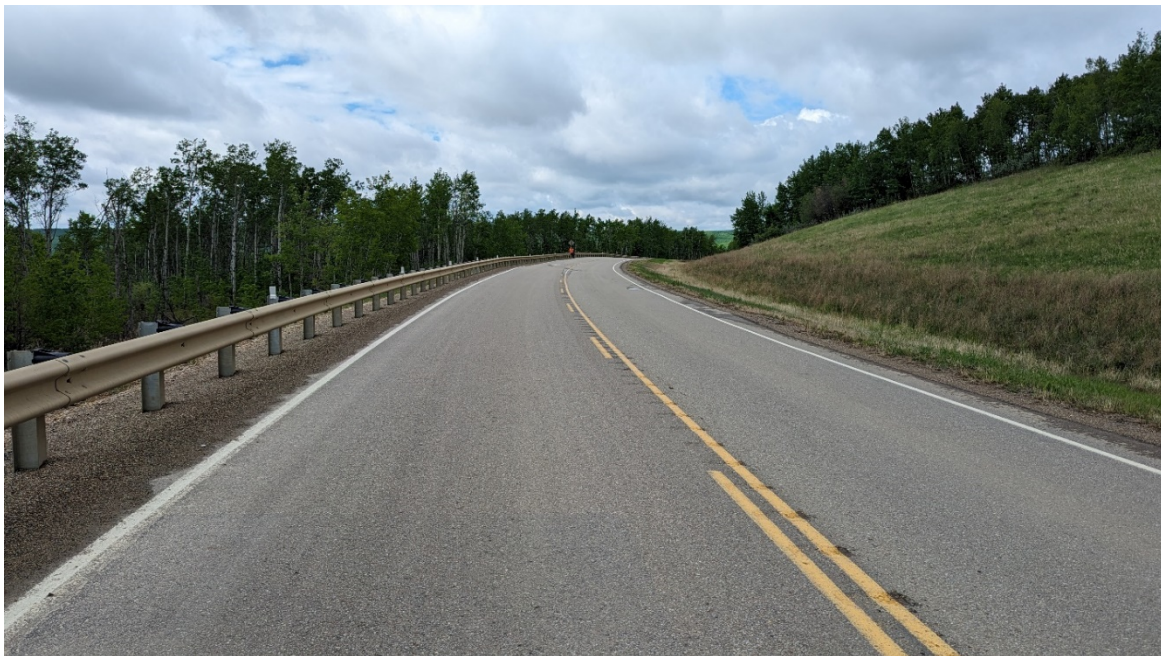
Photo 2, Site 8 – Looking southwest from the northeast end of Site SH012-8. Previous main scarp crack not clearly visible during inspection.

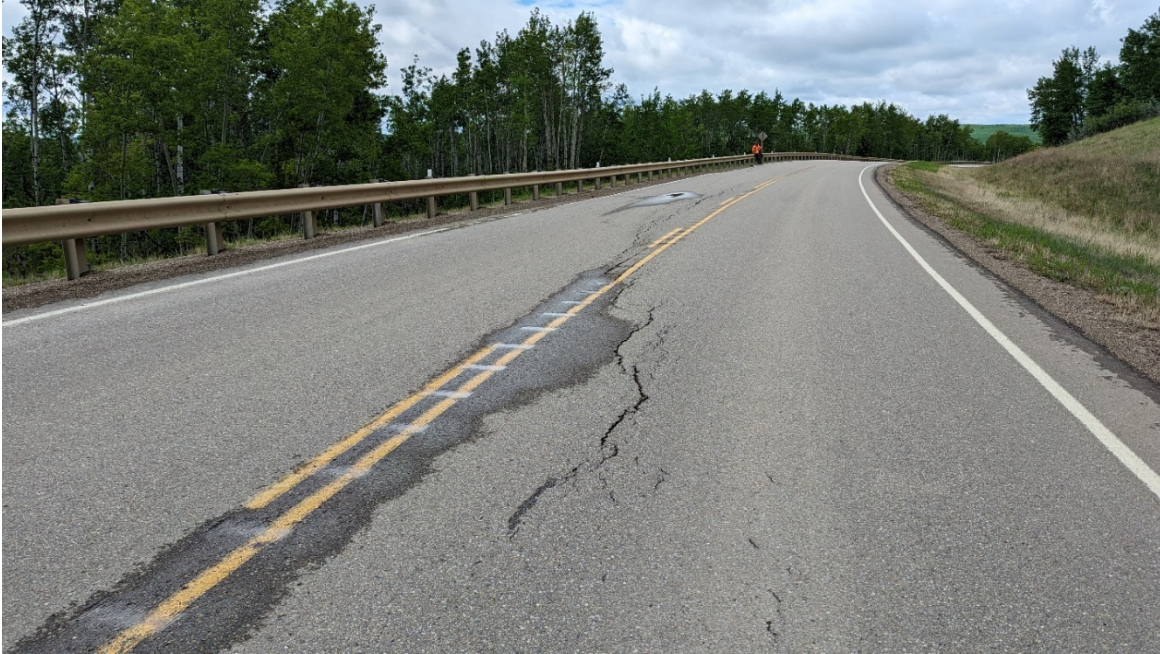
Photo 3, Site 8 – Looking southwest at crack crossing from the WBL towards the centerline and EBL.

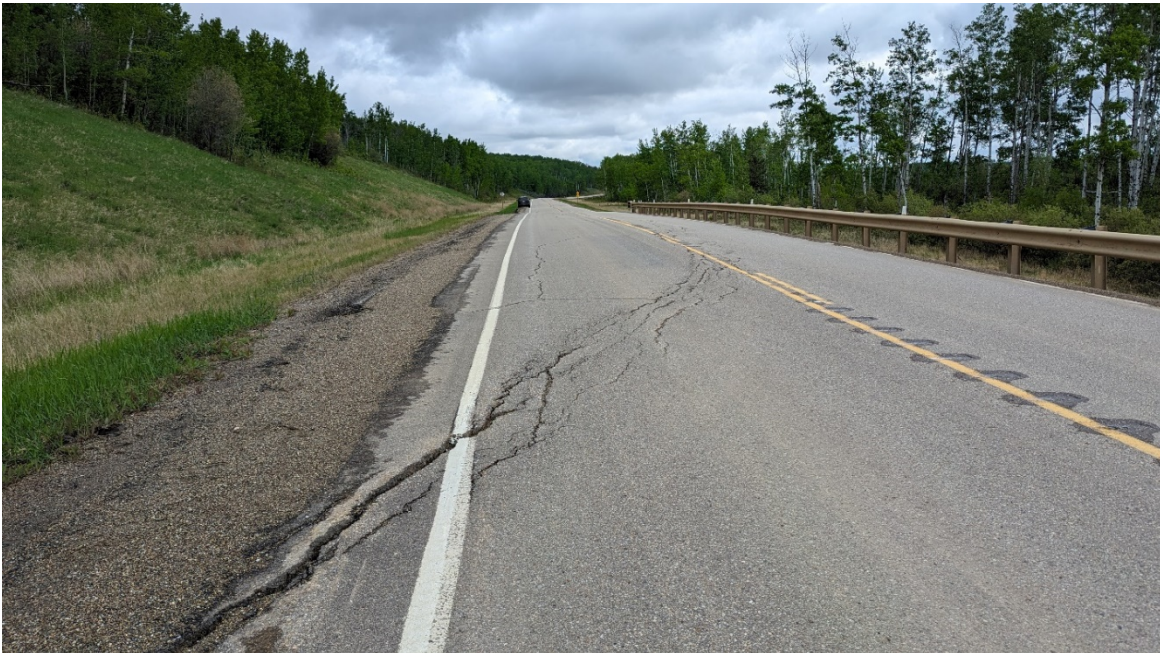
Photo 4, Site 9: Looking northeast at crack in highway surface over main slide scarp that has resurfaced.

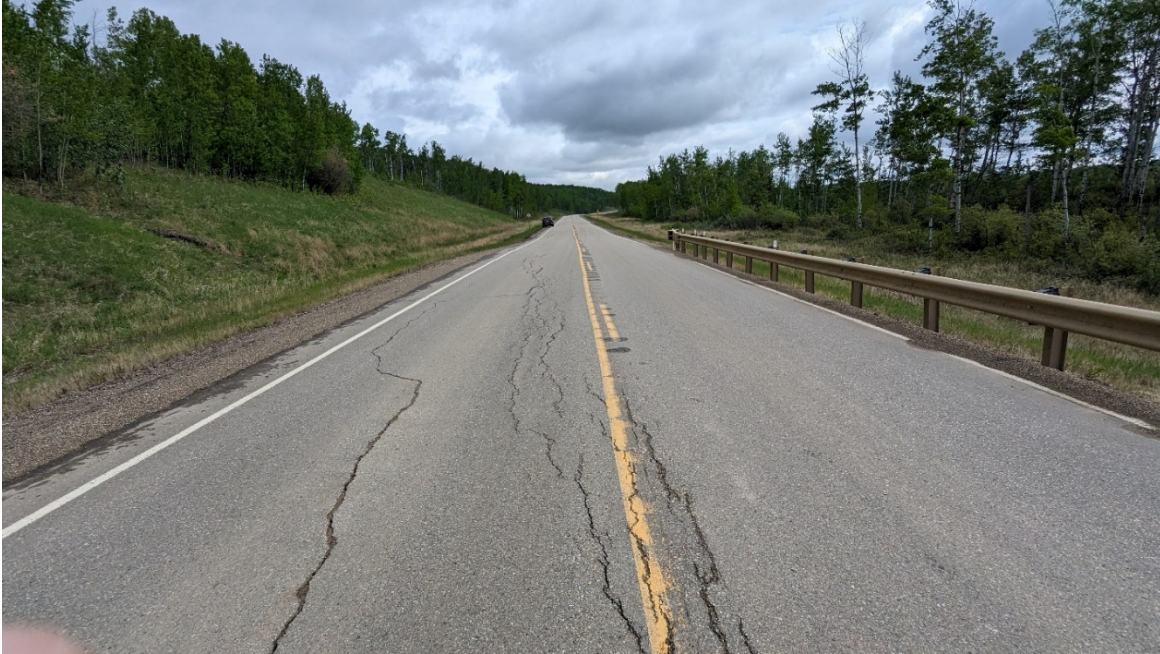
Photo 5, Site 9: Looking northeast at cracking near northeast end of site.

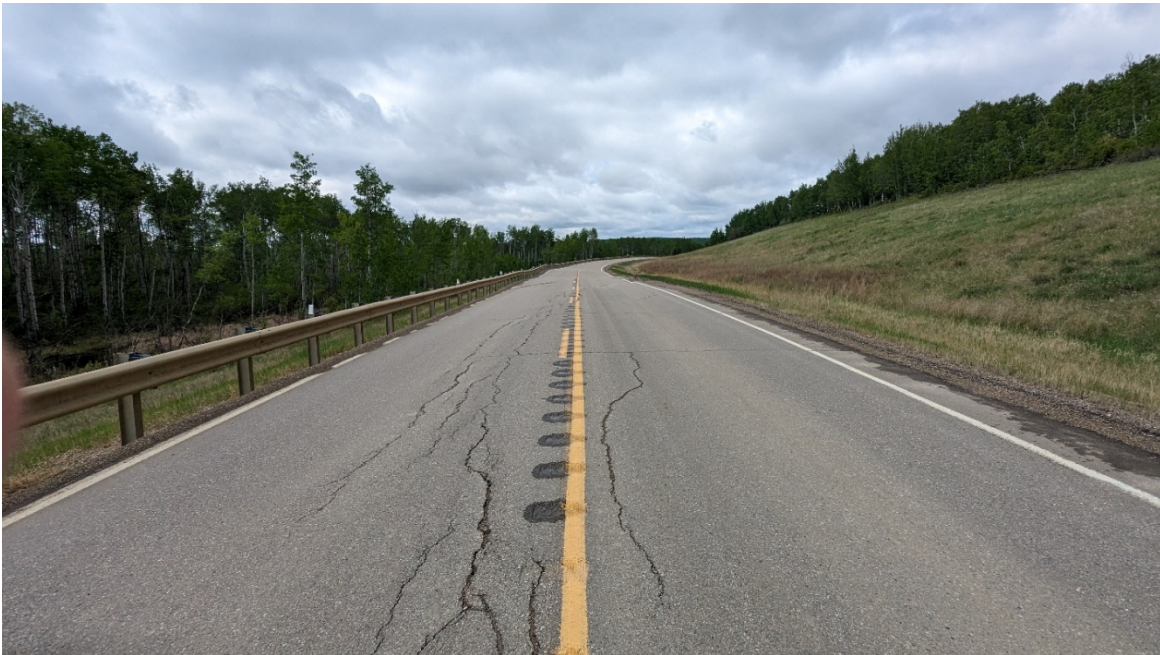
Photo 6, Site 9: Looking southwest at cracks along main slide scarp.
