**ALBERTA TRANSPORTATION AND
ECONOMIC CORRIDORS
GEOHAZARD ASSESSMENT PROGRAM
PEACE REGION – SWAN HILLS
2024 INSPECTION**

Site Number	Location	Name	Hwy	km
SH013-13	Little Smoky River	Little Smoky River Valley, North Hill – Site #13	744:02	21.36-21.49
Legal Description		UTM Co-ordinates		
SE28/SW27-76-22-W5M		11U E 478,608	N	6,162,922

SH013-13: HWY 744:02 LITTLE SMOKY RIVER VALLEY 2024 SITE INSPECTION PLAN

DWG No. 32121-SH013-13

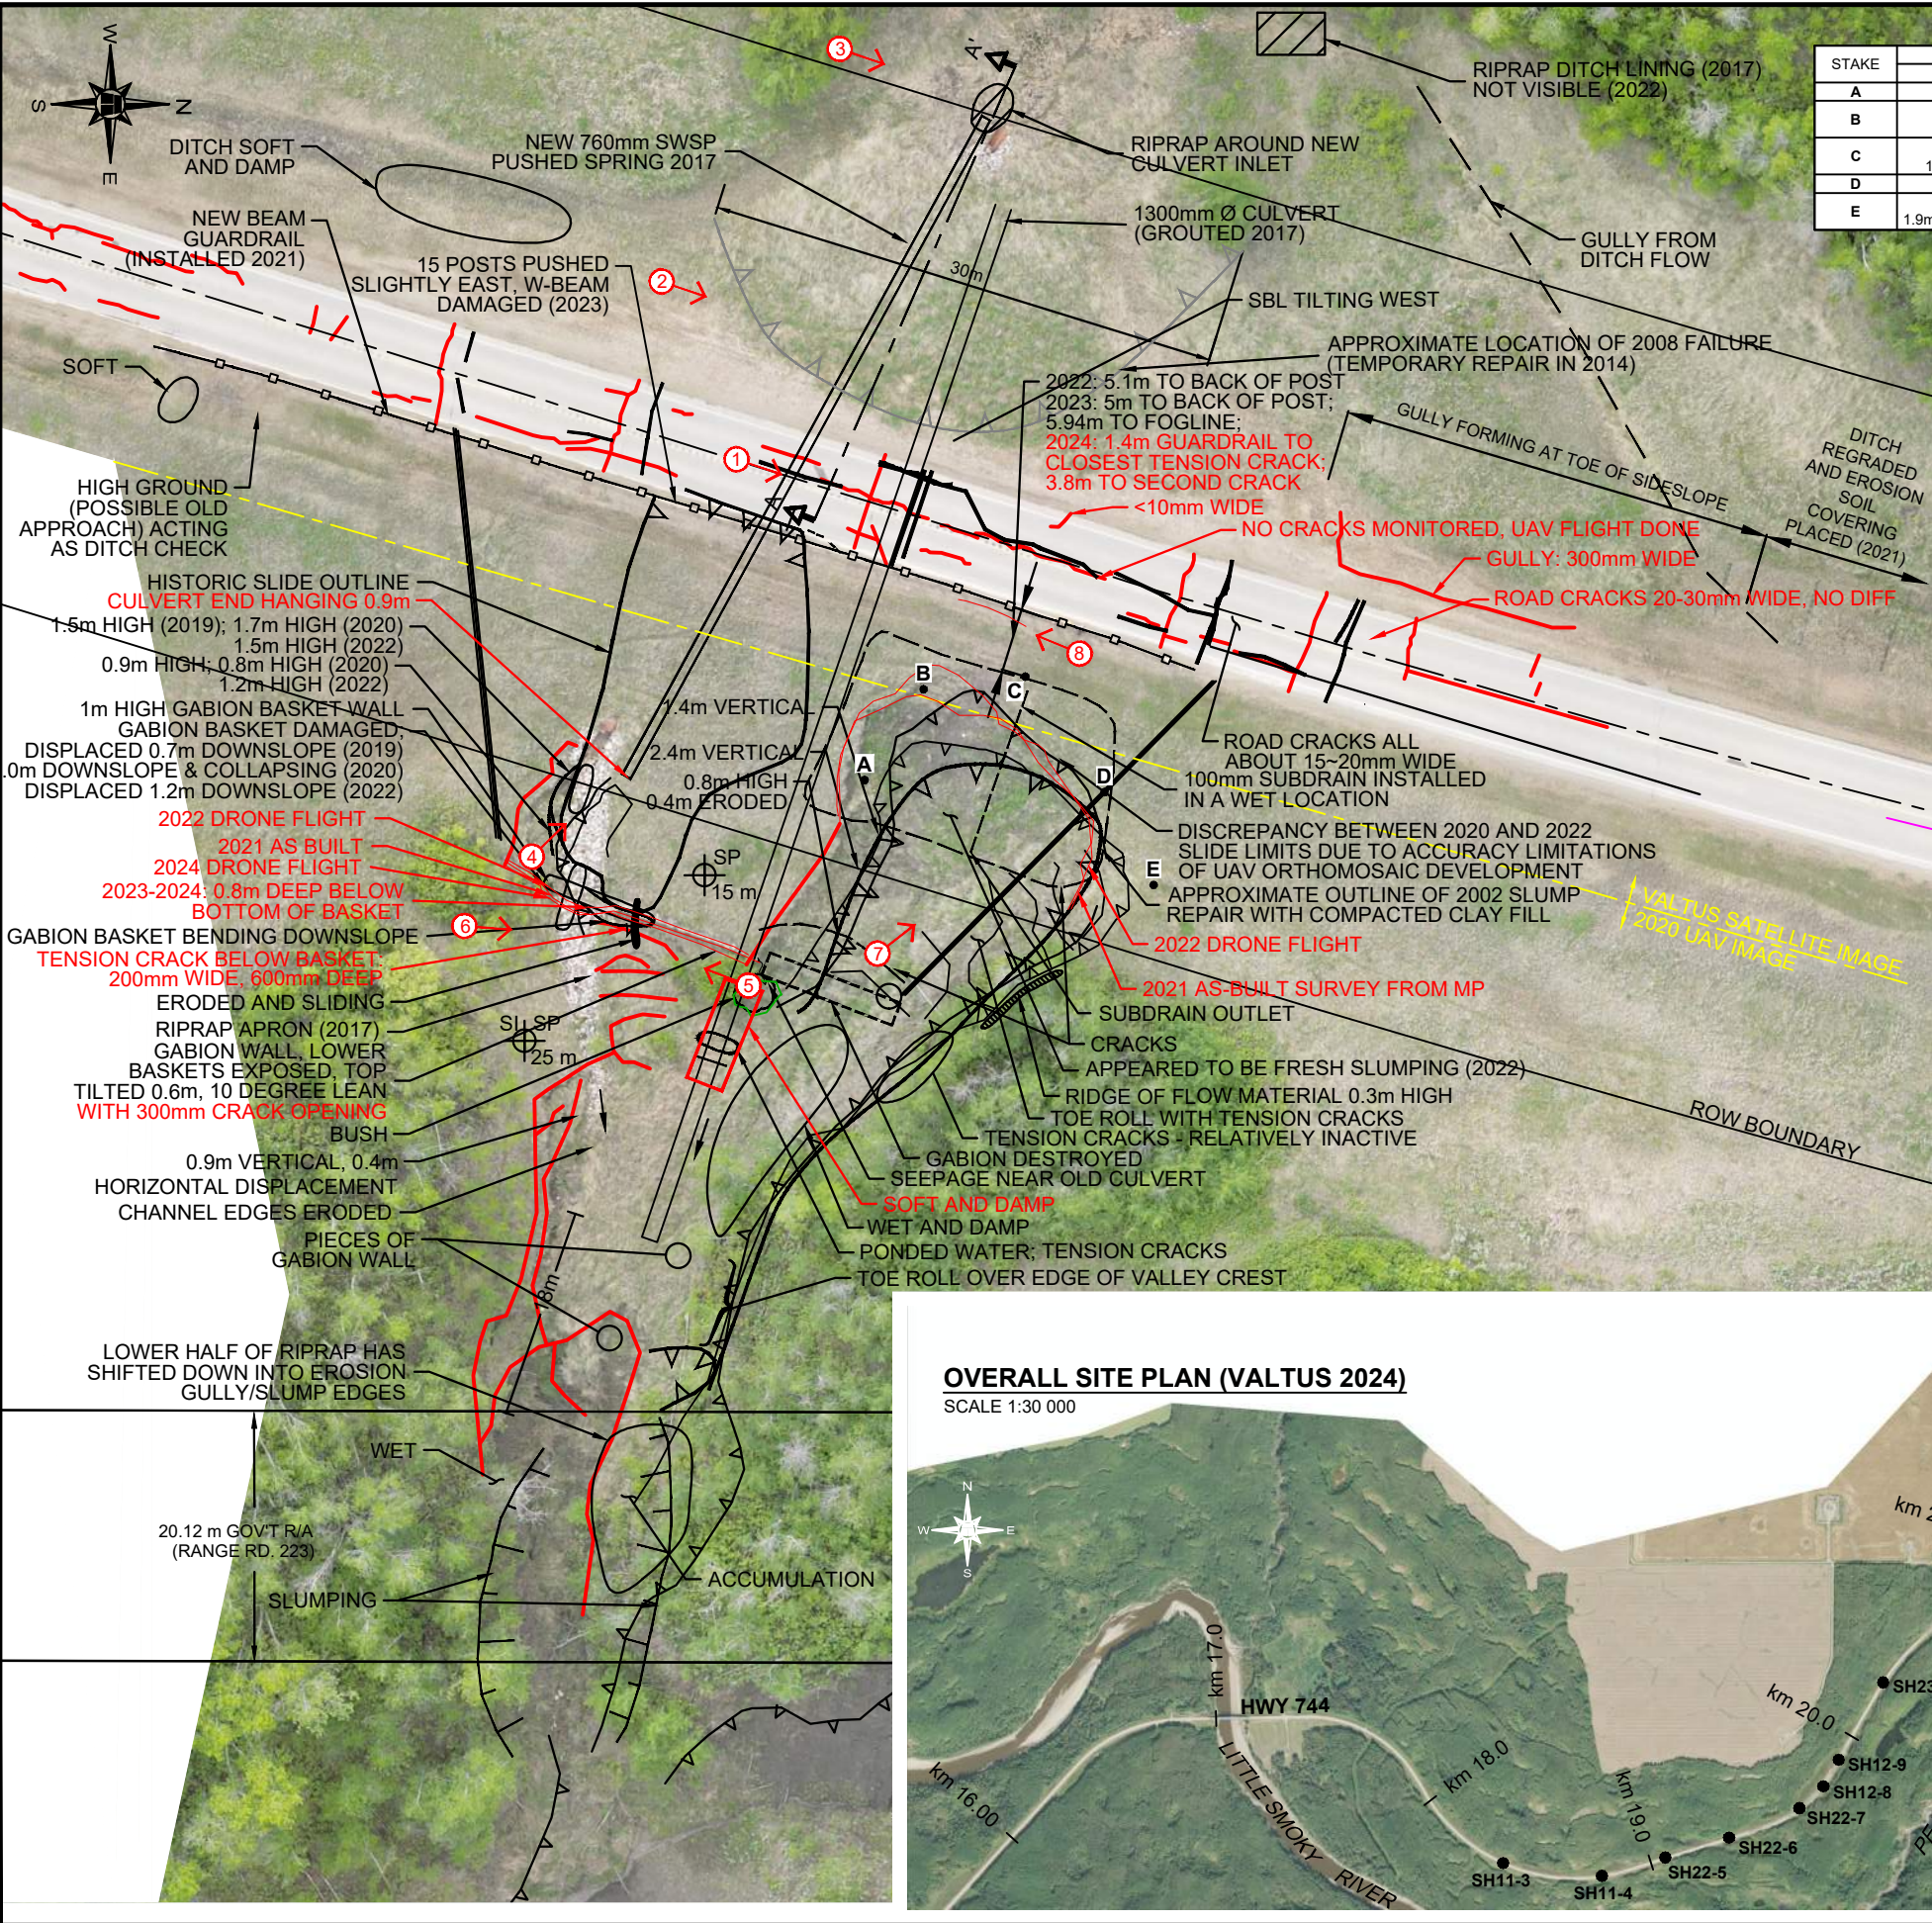
STAKE	SCARP (HEIGHT)				
	2019	2020	2022	2023	2023
A	3.1m (1.5m HIGH)	? (1.8m HIGH)*	1.8m (0.6m HIGH)	RESET: 2.0m (0.4m HIGH)	RESET: 1.8m (0.8m HIGH)
B	1.5m DOWNSLOPE 1.7m LATERAL	0.3m / 2.0m** (0.5m HIGH)	2.0m (0.2m HIGH)	2.0m (0.2m HIGH)	1.9m (0.25m HIGH)
C	1.3m 11.6m TO GUARDRAIL	0m / 2.0m**	2.0m (0.6m HIGH)	1.5m (0.4m HIGH)	1.4m (0.3m HIGH)
D	0.6m 0.6m TO CRACK	FELL / 2.0m**	1.3m (0.6m HIGH)	1.3m (0.6m HIGH)	1.3m (0.6m HIGH)
E	1.9m TO SCARP (0.5m HIGH)	1.9m TO SCARP (0.5m HIGH)	1.9m TO SCARP (0.5m HIGH)	(OPEN, 150mm WIDE, 200mm DEEP) 1.9 TO SCARP (0.5m HIGH)	RESET: 2.5m TO FIRST TENSION CRACK, 3.7m TO MAIN SCARP, 0.5m HIGH SCARP

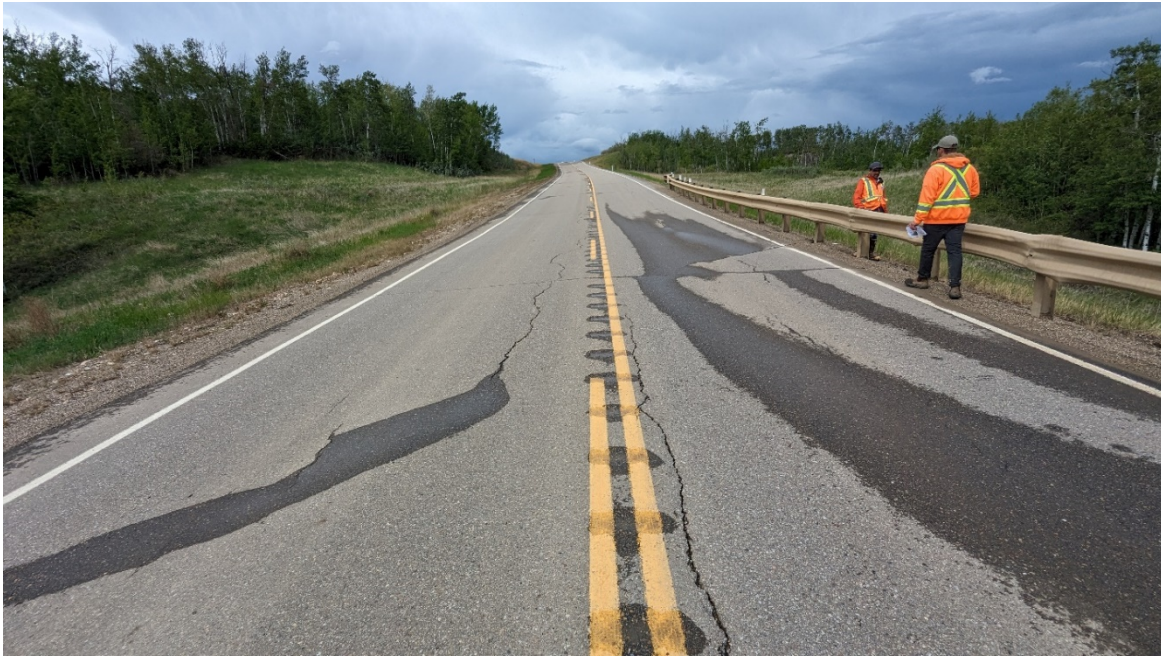
Cracks started to reflect through the pavement overlay in 2023 and 2024 due to the residual movements of the west embankment slide (buttress fill placed in 2017 during culvert installation).

Photo 1 – Looking north where the crack pattern is starting to reflect through the 2021 overlay.

- Road maintenance of milling and patching should continue as necessary to maintain a safe roadway surface. Cracks should be sealed to minimize the infiltration of rain fall and snow melt into the crack network.
- Routine observation of the site, particularly following periods of heavy precipitation, to ensure that the slide mass has not retrogressed closer to the highway.
- Preliminary engineering design should be undertaken so that there are developed options available for implementation should there be rapid deterioration of the site.

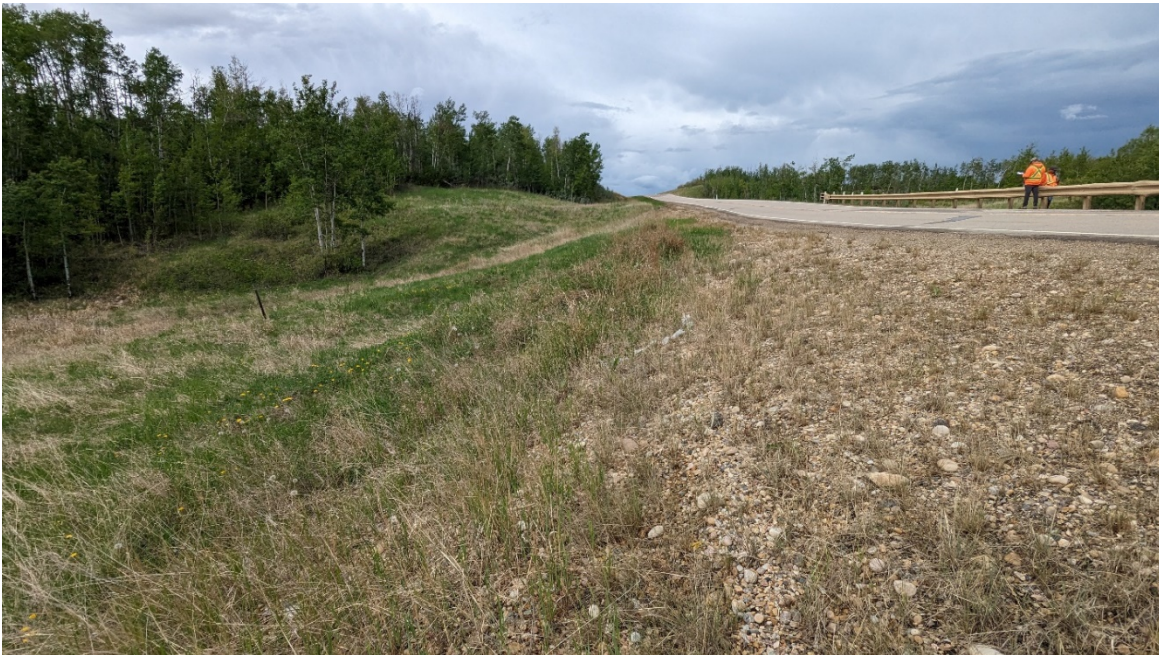
Photo 2 – Looking north at sideslope above culvert inlet.

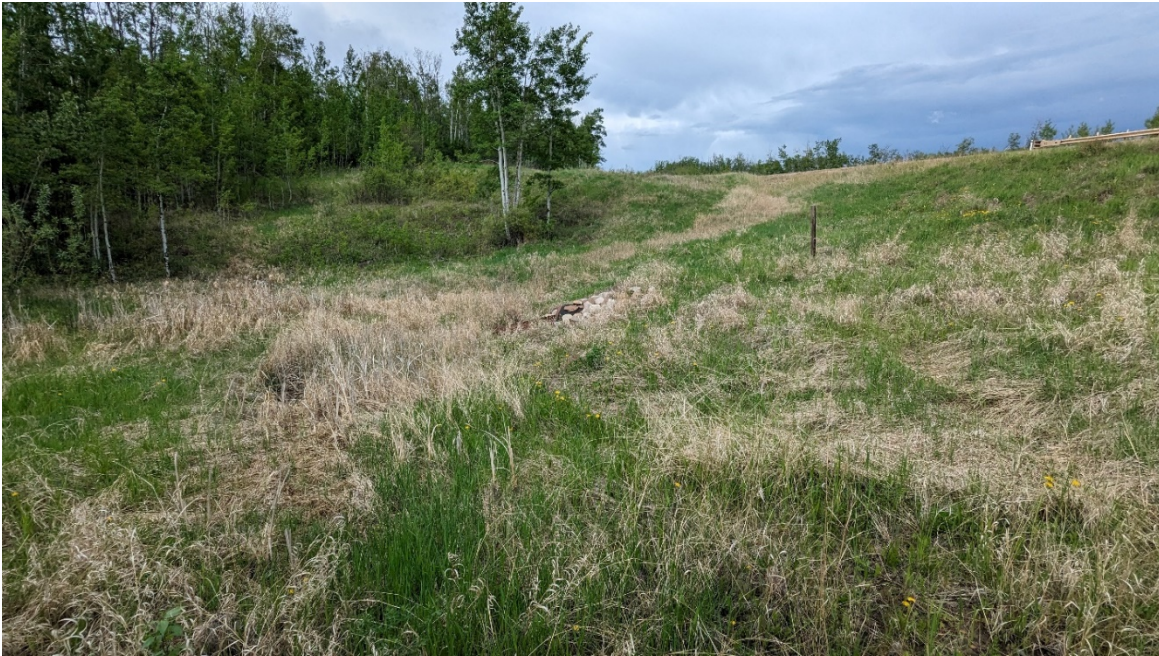
Photo 3: Looking north at culvert inlet.

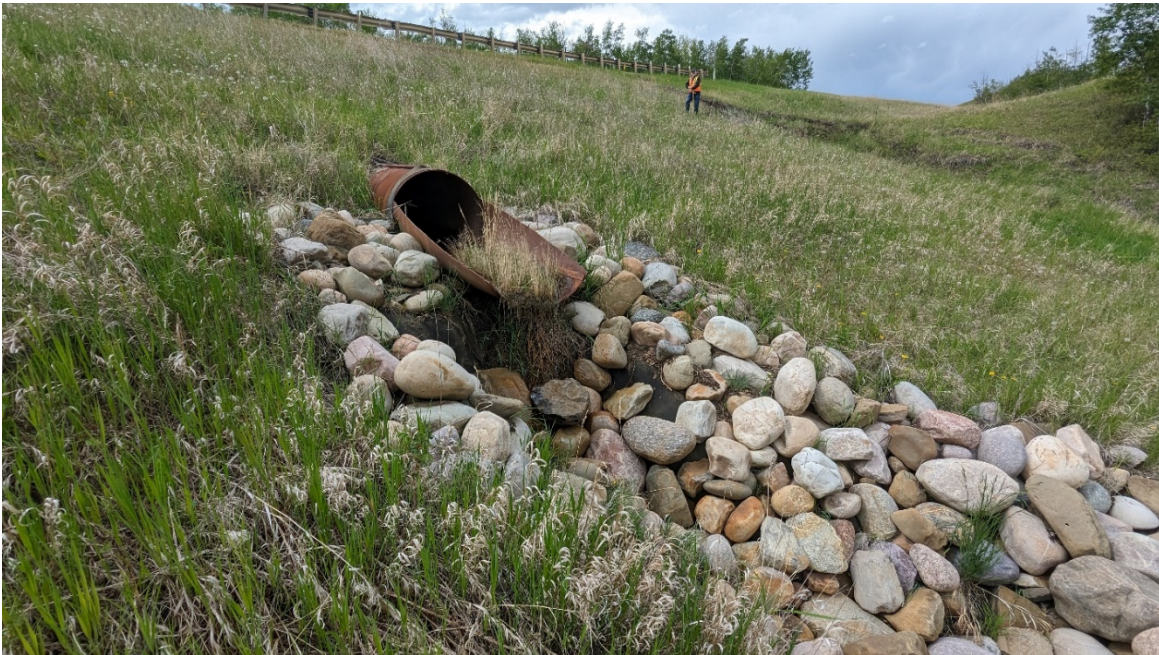
2024 observed deeper and wider slumps at and downstream of the culvert outlet and the culvert outlet was hanging.

Photo 4: Looking northwest at hanging culvert outlet. Erosion on left-hand side (south) is worse and may be part of a retrogressive tension crack from the slide further down the slope.

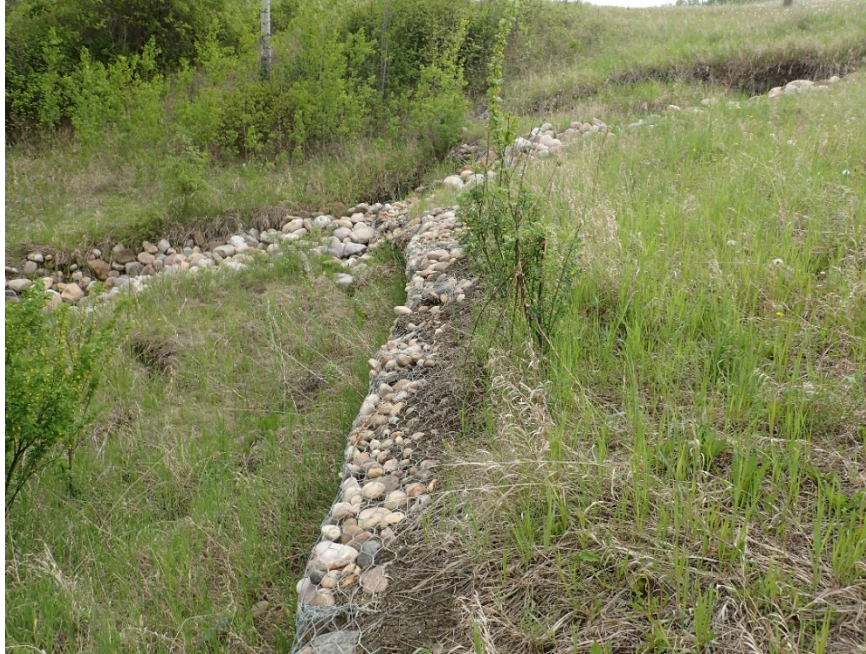
Heavy spring runoff in 2018 led to erosion and undermining of the riprap apron below the new culvert outlet particularly immediately below the outlet where the discharge flow impacted the top of the apron. There was also erosion, displacement of riprap, and damage to the gabion basket wall further down-channel. In Fall 2018, the north portion of the east embankment slope failed at the approximate location of the 2002 slump. By 2019, the scarp was approximately 20 m in width up to the north tree line and extended through the gabion wall removing the north half of it. The landslide head scarp was approximately 12 m from the east edge of the highway at the closest point. In 2020, the scarp had widened to 22 mm and was about 11 m from the east edge of the highway. Three of the five stakes (A to E as shown on the site plan) placed in 2019 to measure regression had to be relocated away from the encroaching scarp in 2023 and two of the stakes had to be relocated again in 2024. The rate of regression of the east landslide appears to have slowed down since 2020. However, tension cracks were observed 1.4 m and 3.8 m from the guardrail. This increased rate of movement may start to impact the guardrail and pavement.

Photo 5 – Looking south at gabion wall on downslope side of embankment. Note eroded south face of riprap apron from culvert outlet.

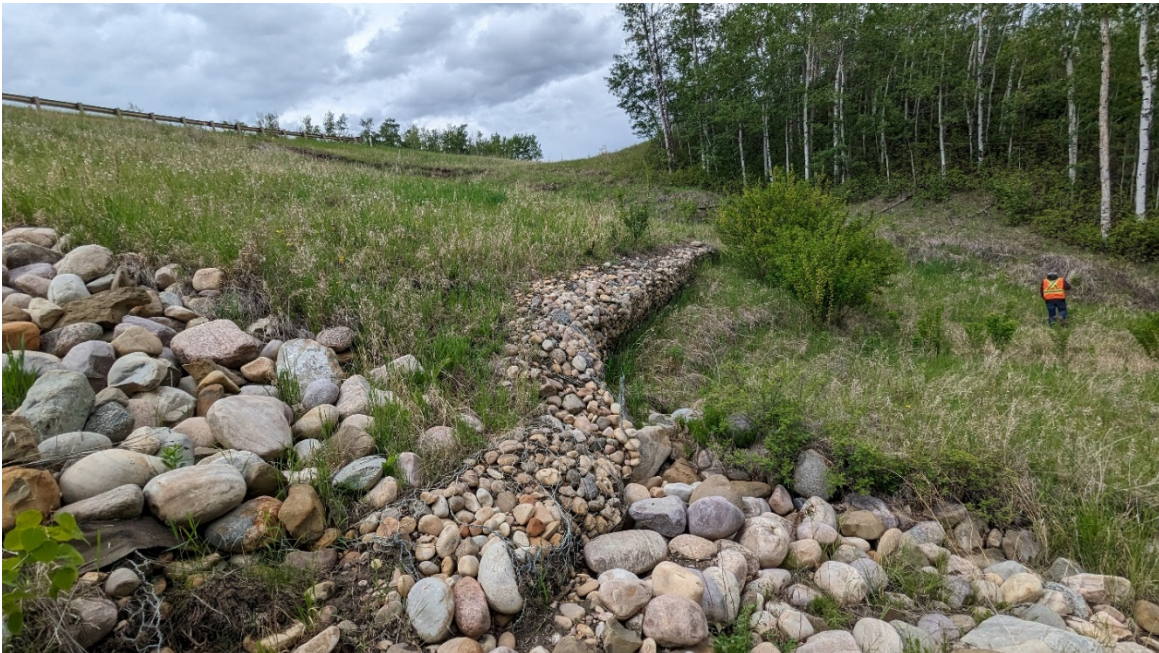
The south half of the gabion wall has displaced further and the retrogressive slumping below it is affecting the riprap apron including the erosion bowl forming below the culvert outlet. The inspection in 2023 and

Photo 6 – Looking north at the distorted gabion wall and riprap apron as well as slumping below the wall.

- The upper portion of the east sideslope could be repaired by excavating the failed material and rebuilding the slope with compacted common clay or granular fill while reinforcing the failing gabion wall with sheet piling or driven H piles to buy some time (maybe 5 years) before a realignment is completed.

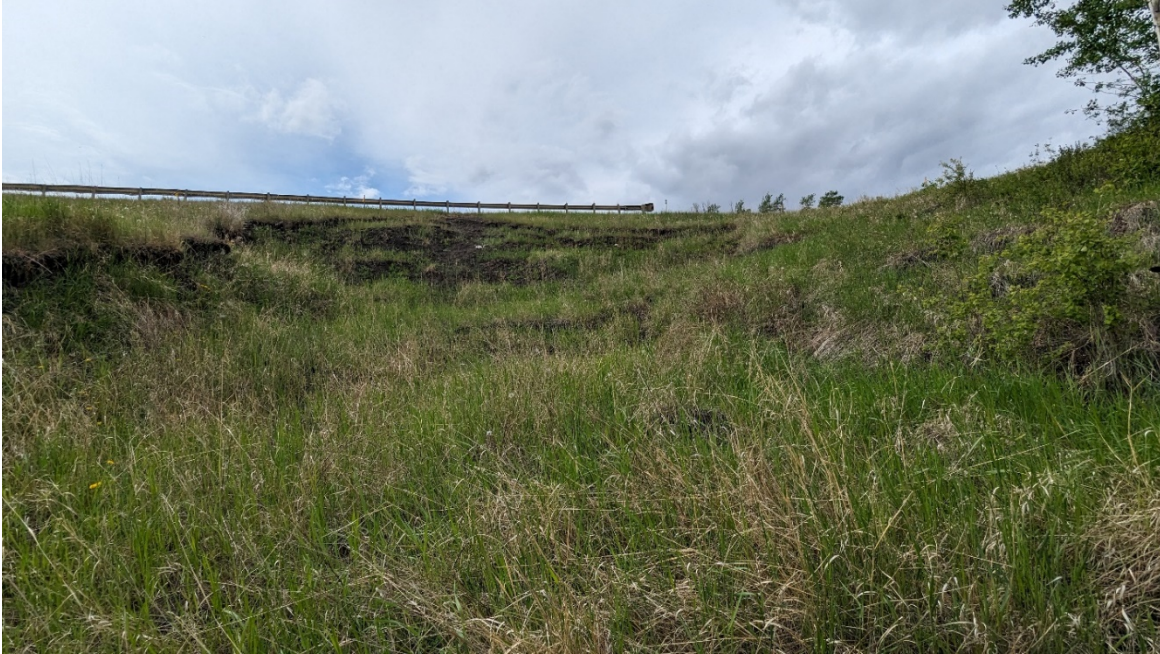
There is significant risk of failure of the east embankment due to the continued erosion of the gully and retrogression of the slide mass.

Photo 7 – Looking northwest at top of east embankment slide.

- A pile wall could be constructed across the narrower downslope end of the east sideslope near the outlet of the old culvert to buttress the slope. The slump in the east embankment could then be reconstructed with geogrid-reinforced fill after over-excavating the slide material.
- A surface pipe should be installed from the new culvert extending further east to where it meets the tributary coming down from Site #14.
- Although the upslope ditches were regraded and protected from erosion during the 2021 overlay, the gully from the ditch down toward the culvert inlet should also be shaped and protected from erosion to minimize eventual downcutting of the ditch and sediment accumulating at the culvert inlet.

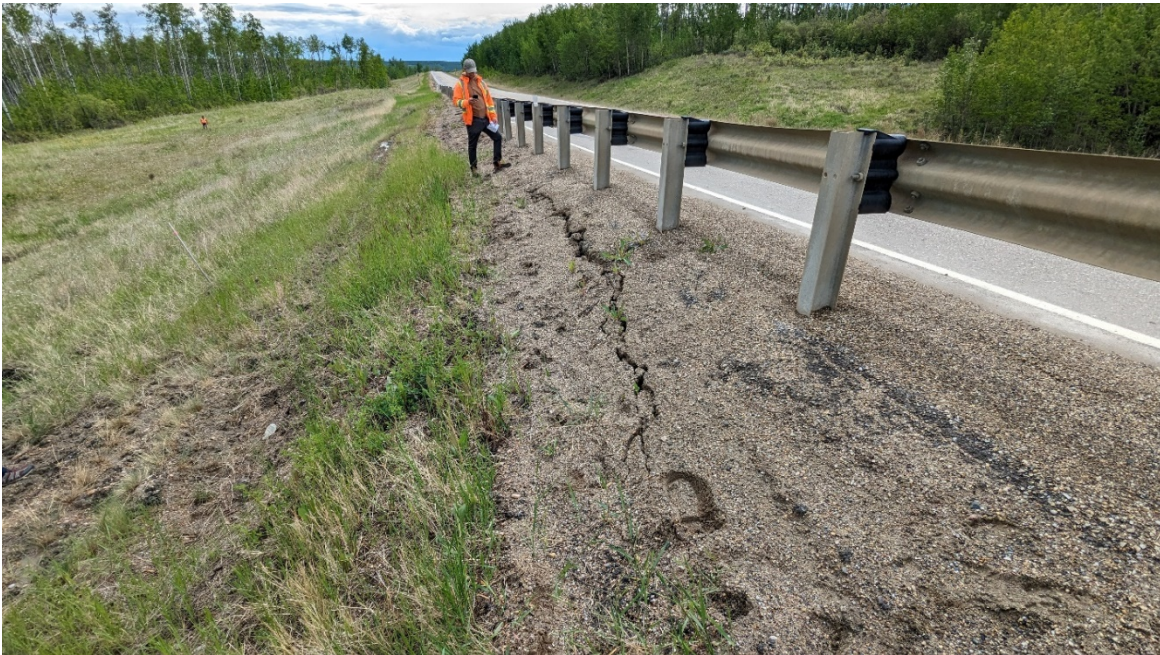
Photo 8 – Looking south at tension crack forming east and downslope of the guardrail.
