**ALBERTA TRANSPORTATION AND
ECONOMIC CORRIDORS
GEOHAZARD ASSESSMENT PROGRAM
PEACE REGION – SWAN HILLS
2024 INSPECTION**

Site Number	Location	Name	Hwy	km
SH013-14 SH013-15	Little Smoky River	Little Smoky River Valley, North Hill – Sites #14 & #15	744:02	21.61-21.80 21.55-21.61
Legal Description		UTM Co-ordinates		
Site 14: SE28/SW27-76-22-W5M		11U E 478,675	N	6,163,221
Site 15: SE28/SW27-76-22-W5M		11U E 478,647	N	6,163,070

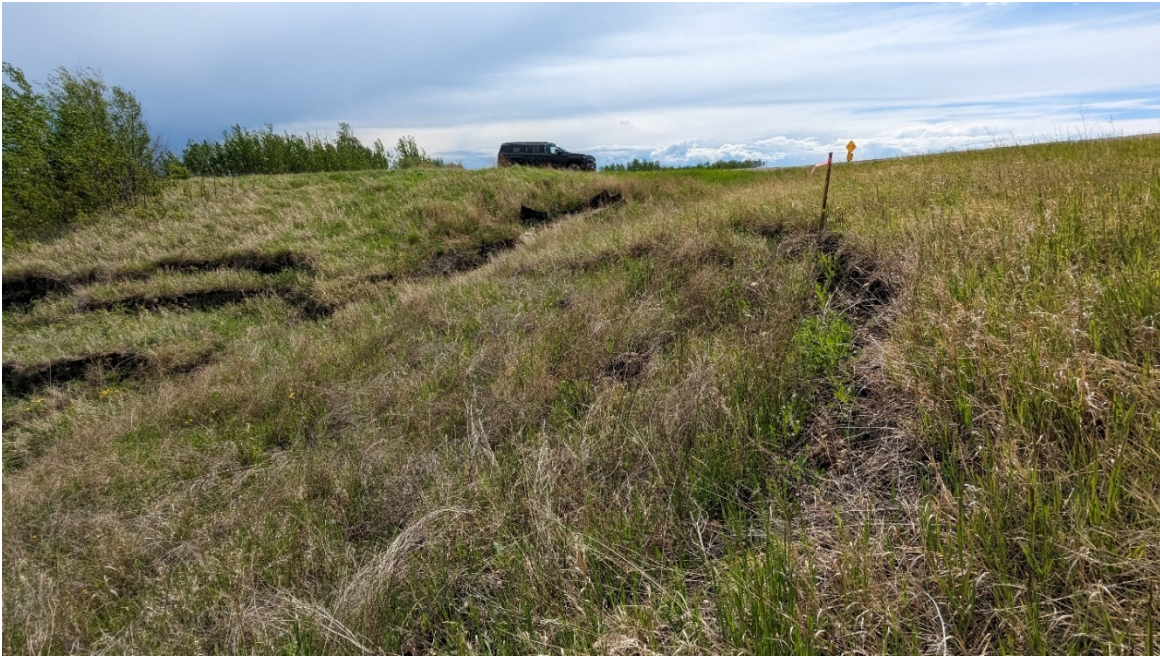
The highway is adjacent to a ravine that acts as an ephemeral tributary to the Peavine Creek. The channel flows to the south until it joins with the outflow from the culvert at Site 13 where it abruptly turns to the east and enters Peavine Creek. The ravine bed has aggressively downcut over the years with a mobile nick point (the start point of downcutting) that has exited the ravine and is now moving northward along the highway east ditch. Embankment slumping, related to the downcutting is extensive along the slopes of the ravine and is less than 20 m from the highway. There are two nick points, one moving along the east ditch and one moving westerly toward a centerline culvert. The westerly moving nick point is about 14 m from a culvert outlet. The erosion is fueled by overland flow carried by the highway east ditch, augmented by flow diverted from the west ditch through a centerline culvert. Heavy spring runoff and rain falls in 2019 and 2020 significantly increased the width and length of the erosion. Survey lathes were installed upstream of the nick points to monitor progression of the bank erosion and bed scour. The remaining lathe for was reset in 2019 and the offset from the crest of the slumping decreased from 4.95 m in 2019 to 1.3 m in 2022. Additional stakes were placed in 2023 to monitor the regression of the slide scarps including one near the south end of the roadside turnout. During the 2024 inspection, it appears that the slide scarp near the south end of the roadside turning is continuing to retrogress. The scarp north of the twin culverts is 7.5 m from the edge of the pavement. The erosion occurring in the highway ditch could be controlled with erosion control products; however, the downcutting along the tributary channel would require extensive works to reduce the erosion as this natural process will continue to extend as the grade of the tributary moves toward equilibrium conditions (geological time-scale process).

Photo 1, Site 14 – Looking southwest at slide scarp north of twin culverts that is retrogressing towards the highway.

- There are no practical medium-term options considered for Site 15.
- For Site 14 consideration could be given to the installation of a proper channel drop structure. The location of the drop structure could be downstream of the two nick points, and the channel bed between the nick points and the drop structure would be restored and armored. Preliminary engineering should be undertaken so that this remediation can be implemented quickly when required. A hydrotechnical assessment would be required to determine flow conditions for sizing of the drop structure(s).

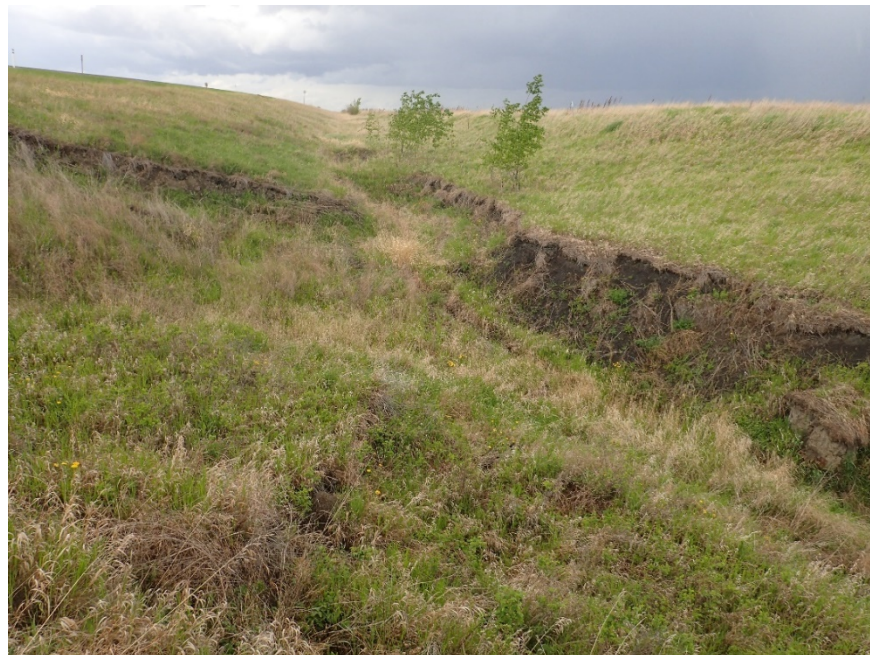
<input checked="" type="checkbox"/> Seepage	Ponded water observed in the east ditch.	<input checked="" type="checkbox"/>

Photo 2, Site 14 – Looking north along the east ditch.

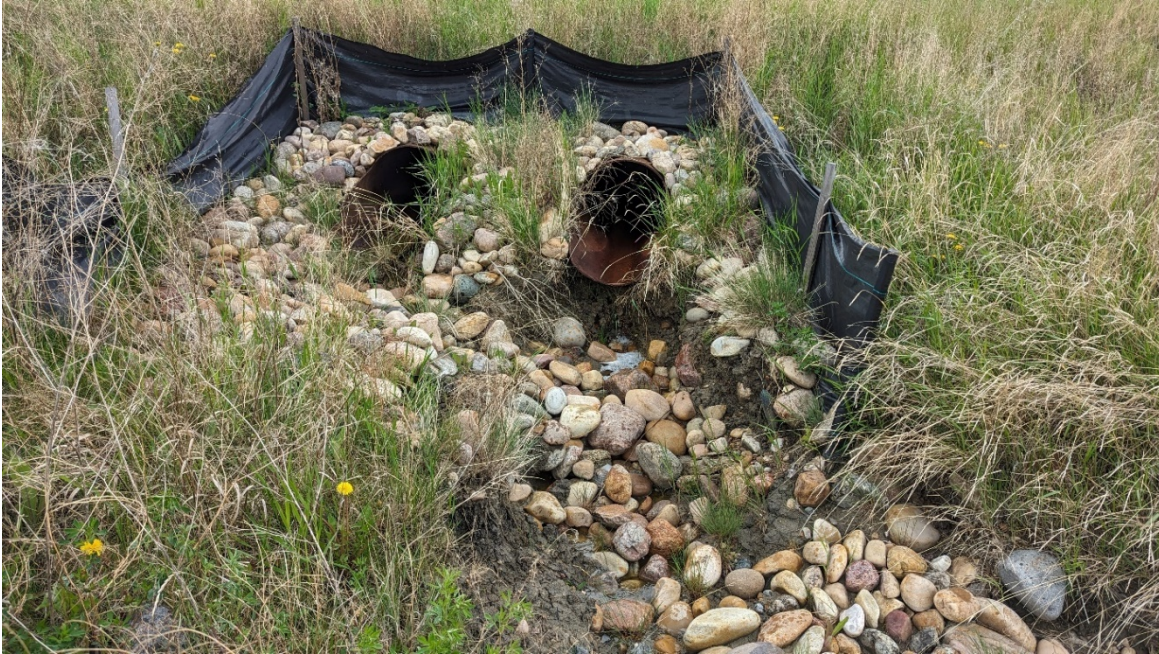
<input checked="" type="checkbox"/> Bridge/Culvert	Riprap apron at north pipe outlet collapsed with the riprap accumulating in the channel.	<input type="checkbox"/>
<input type="checkbox"/> Other		<input type="checkbox"/>
Observations (Site 15)	Description	Worsened?
<input checked="" type="checkbox"/> Pavement Distress	Previous longitudinal and traverse cracks have reflected through and extended. Main crack area had multiple coalescing cracks.	<input checked="" type="checkbox"/>
<input checked="" type="checkbox"/> Slope Movement	Site is located on the north flank of an active deep-seated landslide moving toward the Peavine Creek. There is also a slump at the top of the backslope. It is not definitively known where the slide crack intersects the highway on the south side of the slide mass.	<input checked="" type="checkbox"/>
<input checked="" type="checkbox"/> Erosion	Erosion control consisting of matting and GeoRidges installed in west ditch where gully was previously observed. Minor rills forming on portions of the sideslope and ditch. New gullies are developing upstream outside of the erosion control area.	<input type="checkbox"/>

Photo 3, Site 14 – Looking at outlets of SWSP twin culverts outlets. The riprap apron at the north SWSP had collapsed.

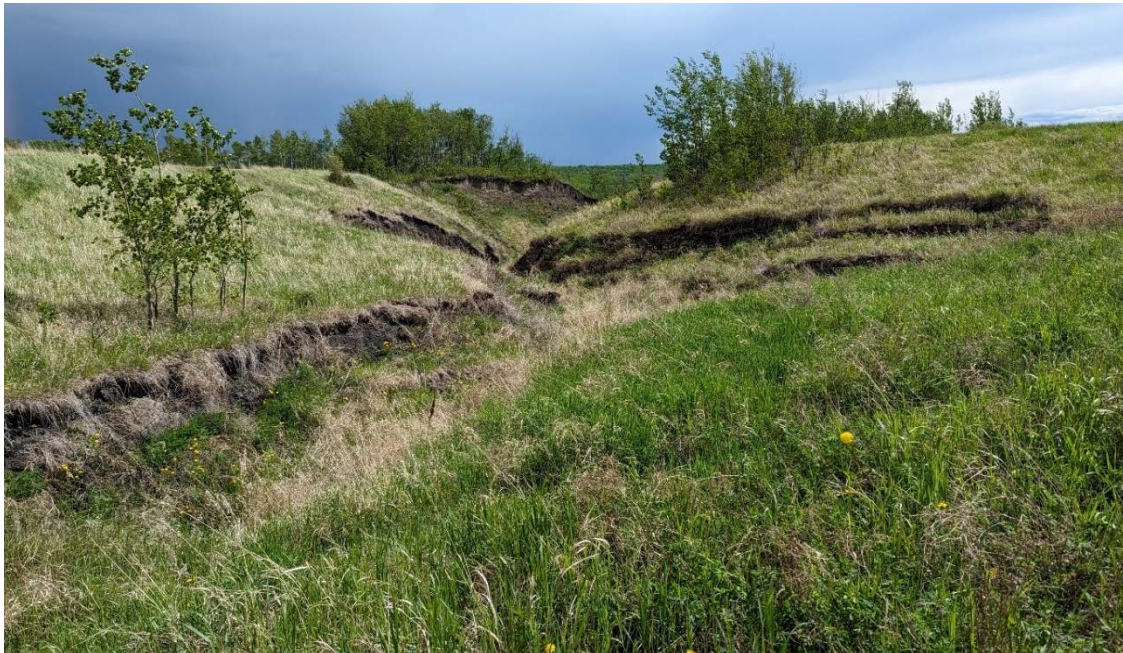
Photo 4, Site 14 – Looking south at slumping along the tributary channel.

- Road maintenance should continue as necessary to maintain a safe roadway surface and may consist of milling, patching, and crack sealing of the ACP.
- Riprap could be placed at the nick points to slow the rate of downcutting and scour retrogression.

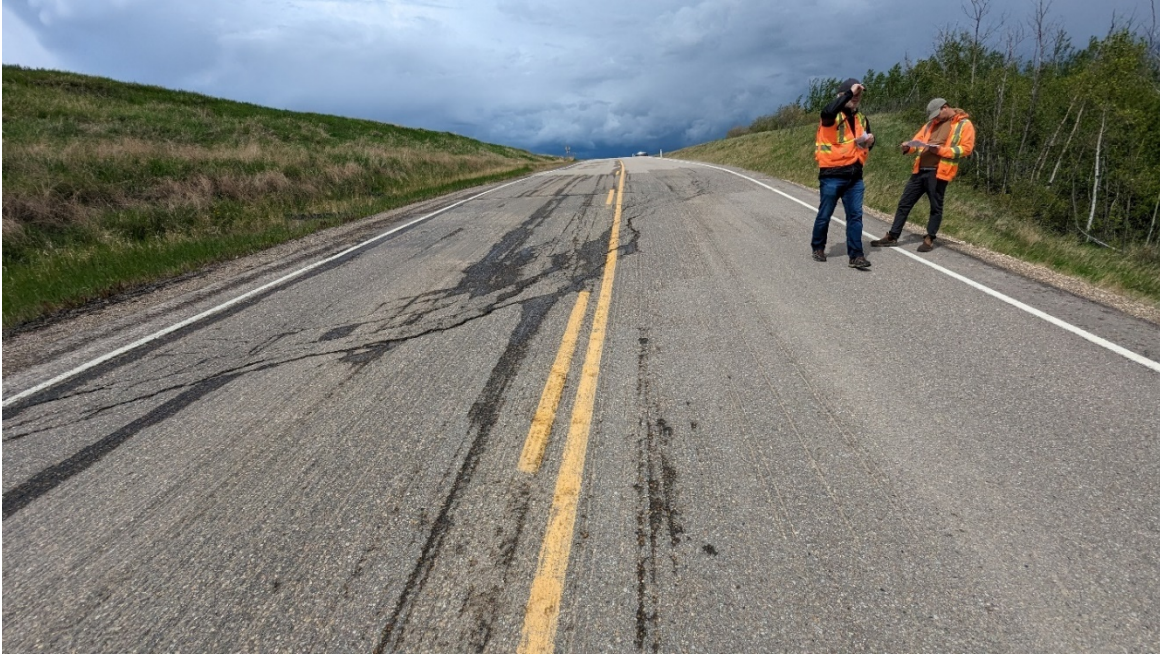
The overall valley movements have led to a diagonal crack across the highway at this location which likely represents the northern flank of the uppermost scarp of the deep-seated, retrogressive movements in the valley. The dip in the highway surface on the downslope side of the crack was removed with the

highway overlay in 2021. The main crack pattern has become re-established after the overlay including some differential across the cracks. Increased crack width was observed in 2023; however, the vertical difference was reduced as the main crack area had been recently milled. During the 2024 inspections, the main crack area had multiple coalescing cracks, and the cracks continued to widen. The cracks were infilled with sand and gravel. There is some erosion located downslope (east) of the highway and shallower scarp which may both be contributing to the movement at the highway. There is also a backslope slump that has formed about 1 m from the valley crest which may be the result of cut slope angle rather than the overall valley movement.

Photo 5, Site 15 – Looking north at diagonal crack intersecting the highway that was recently milled.

- It is understood that, at this time, the only long-term remediation option under consideration is realignment of the entire north hill section of Highway 744 and this study is currently being undertaken by CIMA+. Realignment is likely the only practical option to deal with Site 15 issues.
- Additional ravine channel bed stabilization could be undertaken to protect the highway from erosion induced ravine slope instabilities, and from lateral migration of the channel bed. This might consist of armouring the channel bed with heavy rip rap and inclusion of a series of drop structures and stilling ponds.

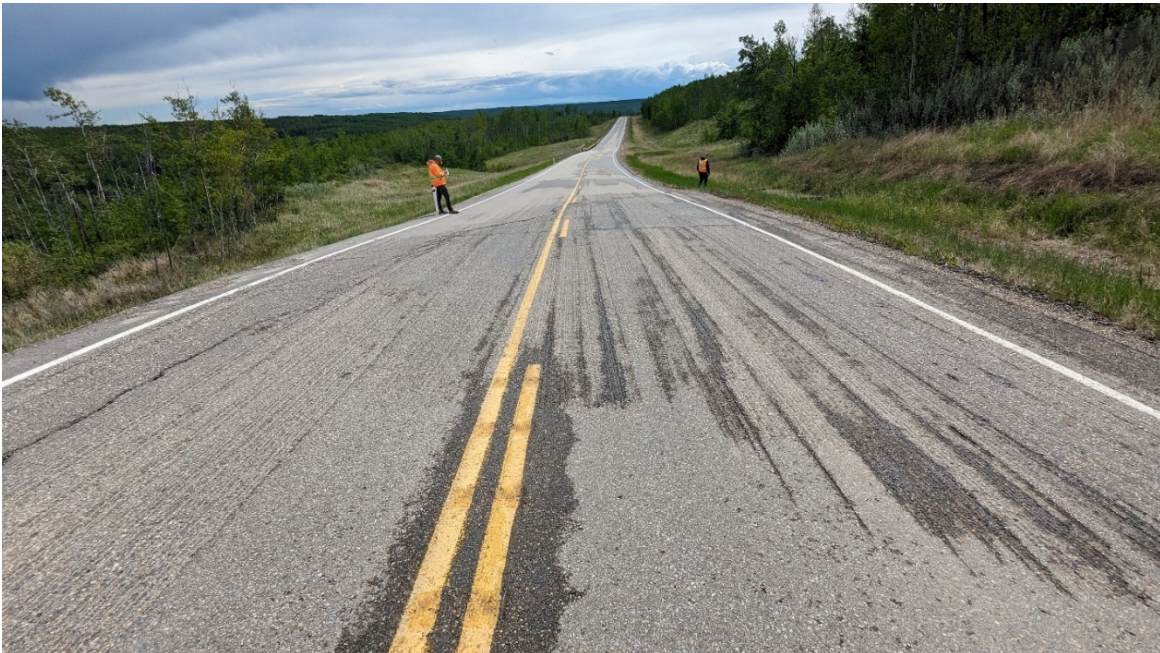
Photo 6, Site 15 – Looking south at the main crack and milled section of road.

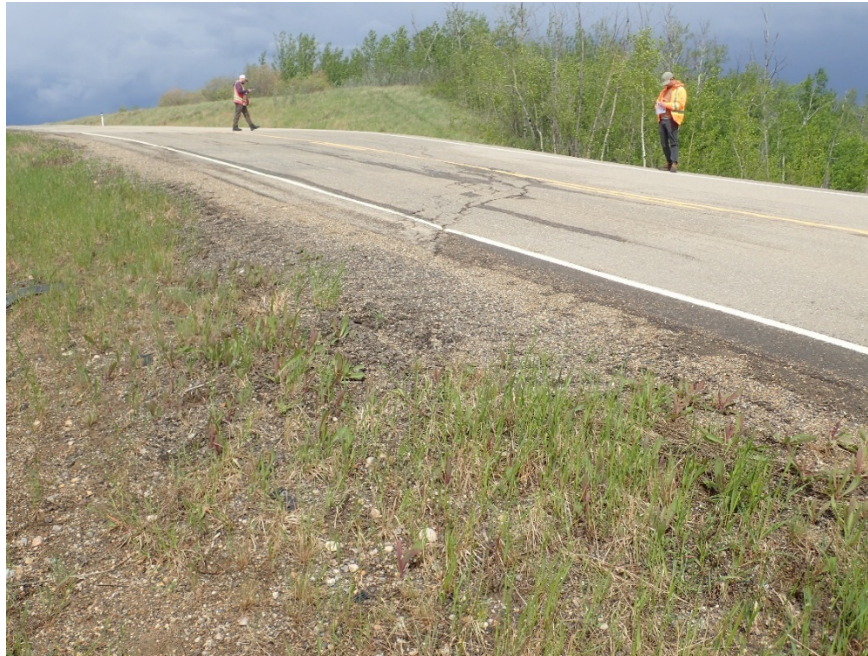
Photo 7, Site 15 – Looking northeast where scarp from road extends southwest into the treeline

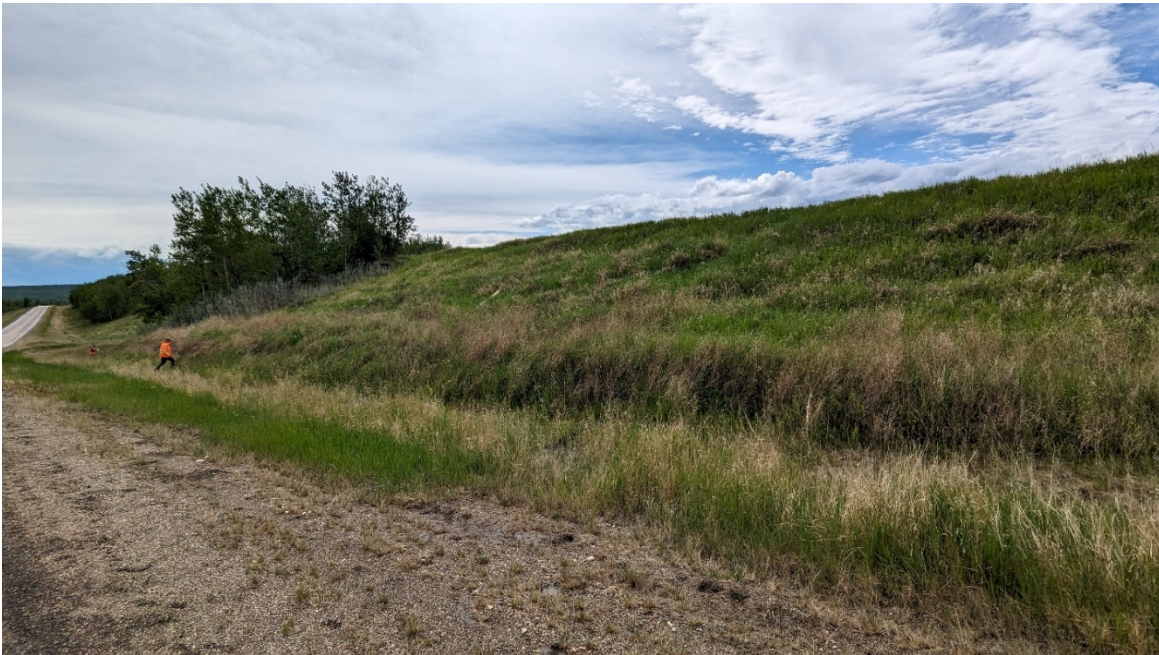
Photo 8, Site 15 – Looking southwest at backslope slump at valley crest.

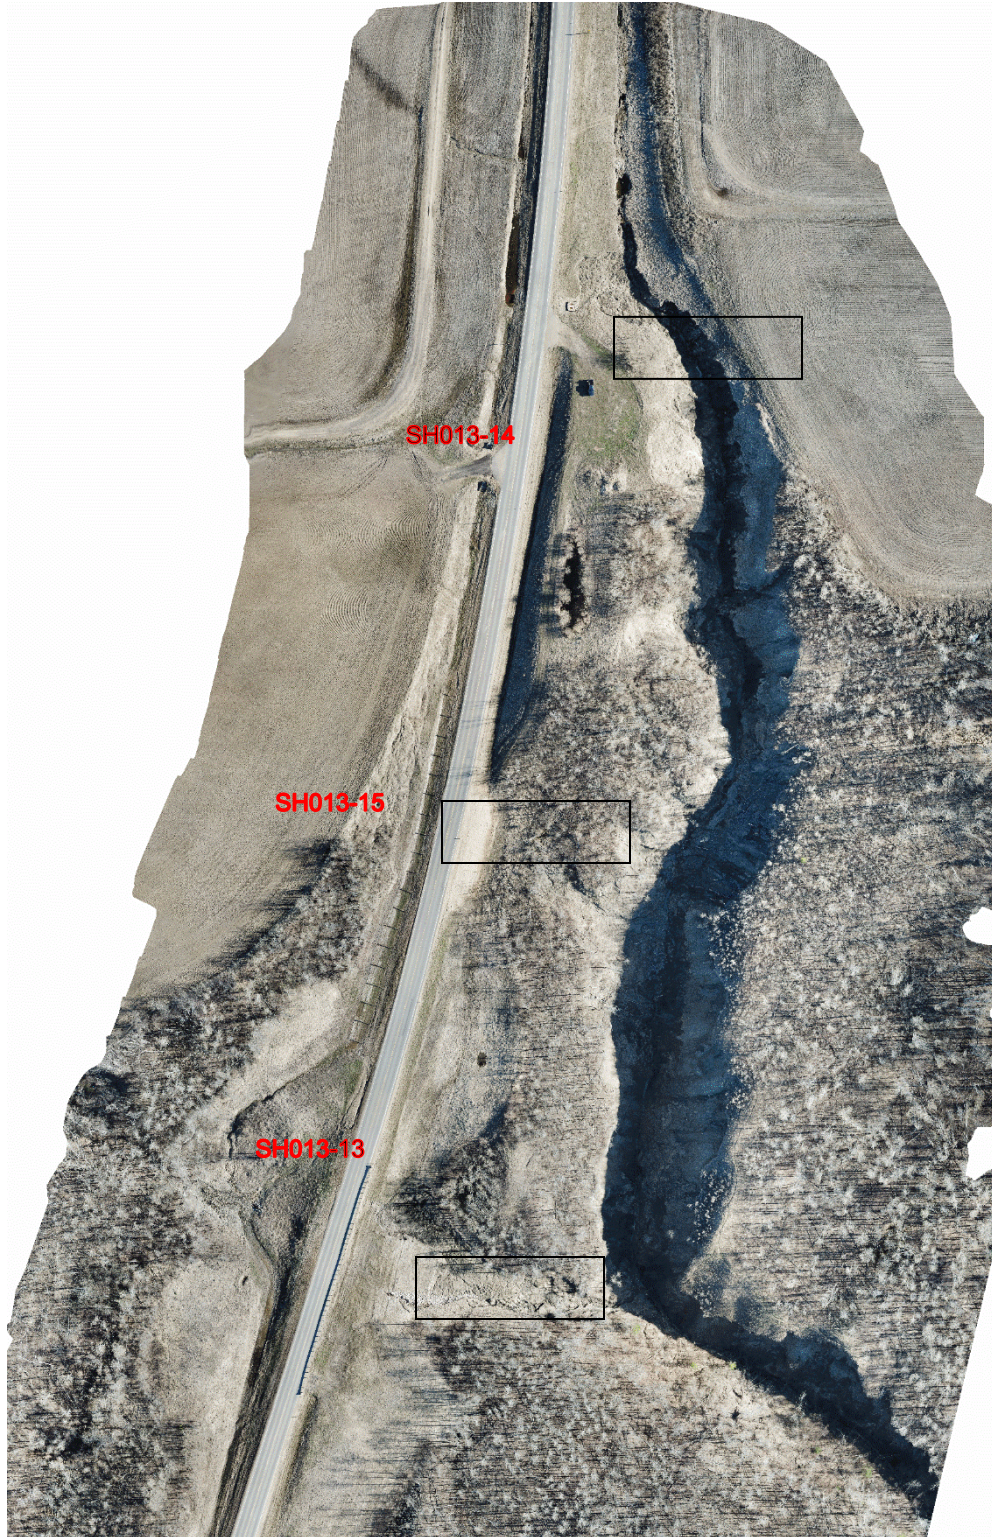
2022 UAV orthomosaic of the erosion gully at SH013-13, SH013-14, and SH013-15 locations.
