**ALBERTA TRANSPORTATION AND ECONOMIC  
CORRIDORS  
GEOHAZARD ASSESSMENT PROGRAM  
PEACE REGION – SWAN HILLS  
2024 INSPECTION**

Site Number	Location	Name	Hwy	km
SH022-5 SH022-6	Little Smoky River	Little Smoky River Valley, North Hill – Sites #5 and #6	744:02	19.00-19.14 19.20-19.53
<b>Legal Description</b>		<b>UTM Co-ordinates</b>		
Site 5: SW21-76-22-W5M		11U E 477,204	N	6,161,204
Site 6: SW21-76-22-W5M		11U E 477,479	N	6,161,291

**SH022-5: HWY 744:02 LITTLE SMOKY RIVER VALLEY  
2024 SITE INSPECTION PLAN**

**SH022-6: HWY 744:02 LITTLE SMOKY RIVER VALLEY  
2024 SITE INSPECTION PLAN**

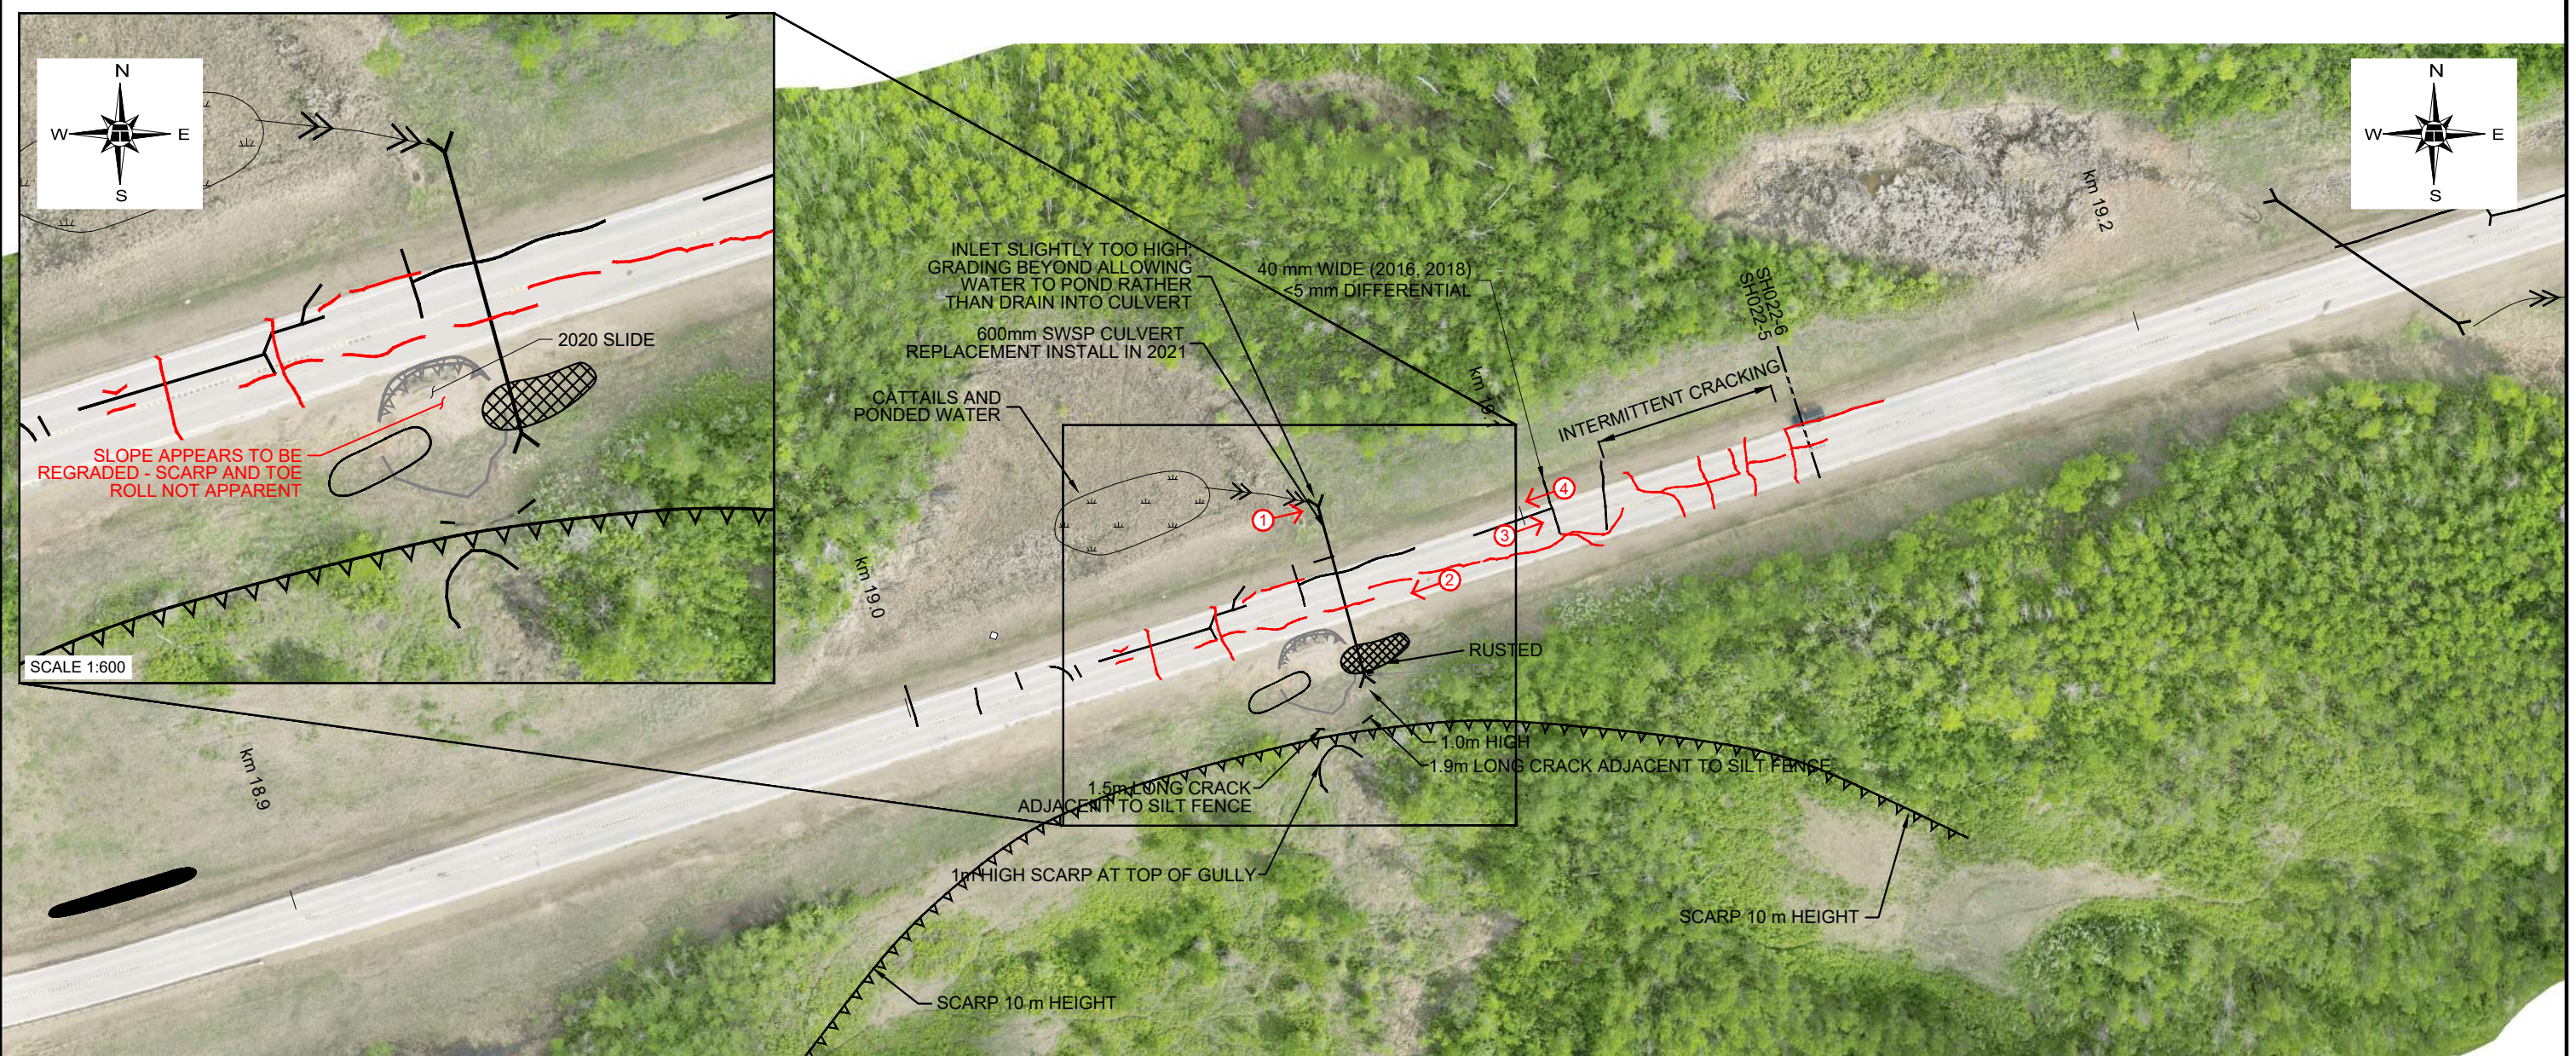
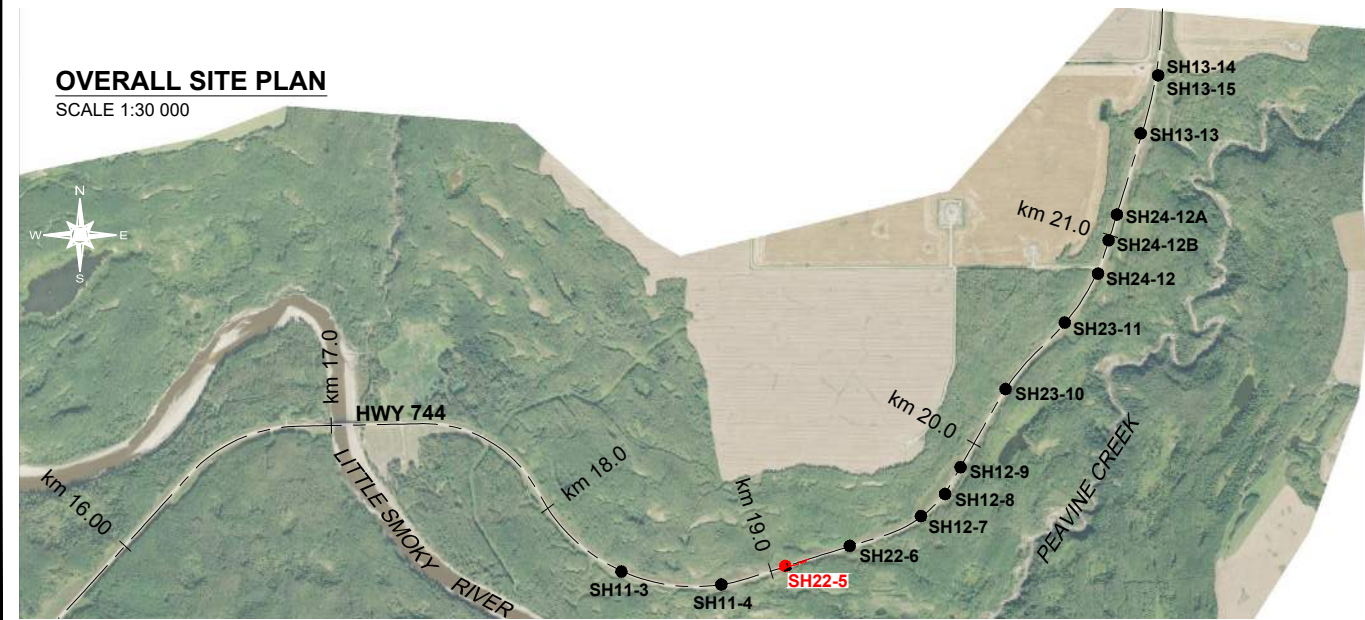
**DWG No. 32121-SH022-5**

Cracks continue to re-appear on the road surface after the highway was overlaid in 2021. Given the overall valley condition, continued creep movement is expected which may manifest as increased crack lengths, widths, and height differential as well as vertical pavement distortion. The scarp and toe roll noted in 2019 at km 19.06 were obscured by grading activities on the slope and around the culvert outlet. The culvert outlet was cleared of obstruction.

- Preliminary engineering should be undertaken for short-term repair of the 2020 slide at km 19.07. Consideration should be given to replacing and extending the culvert at this location at the same time to ensure that the discharge is controlled (elephant trunk down to sag pond). It is anticipated that a local excavation and replacement with geo-grid reinforced gravel will be the simplest solution; the potential for the lower slide at km 19.06 to retrogress into the highway at this location should also be considered in the design.

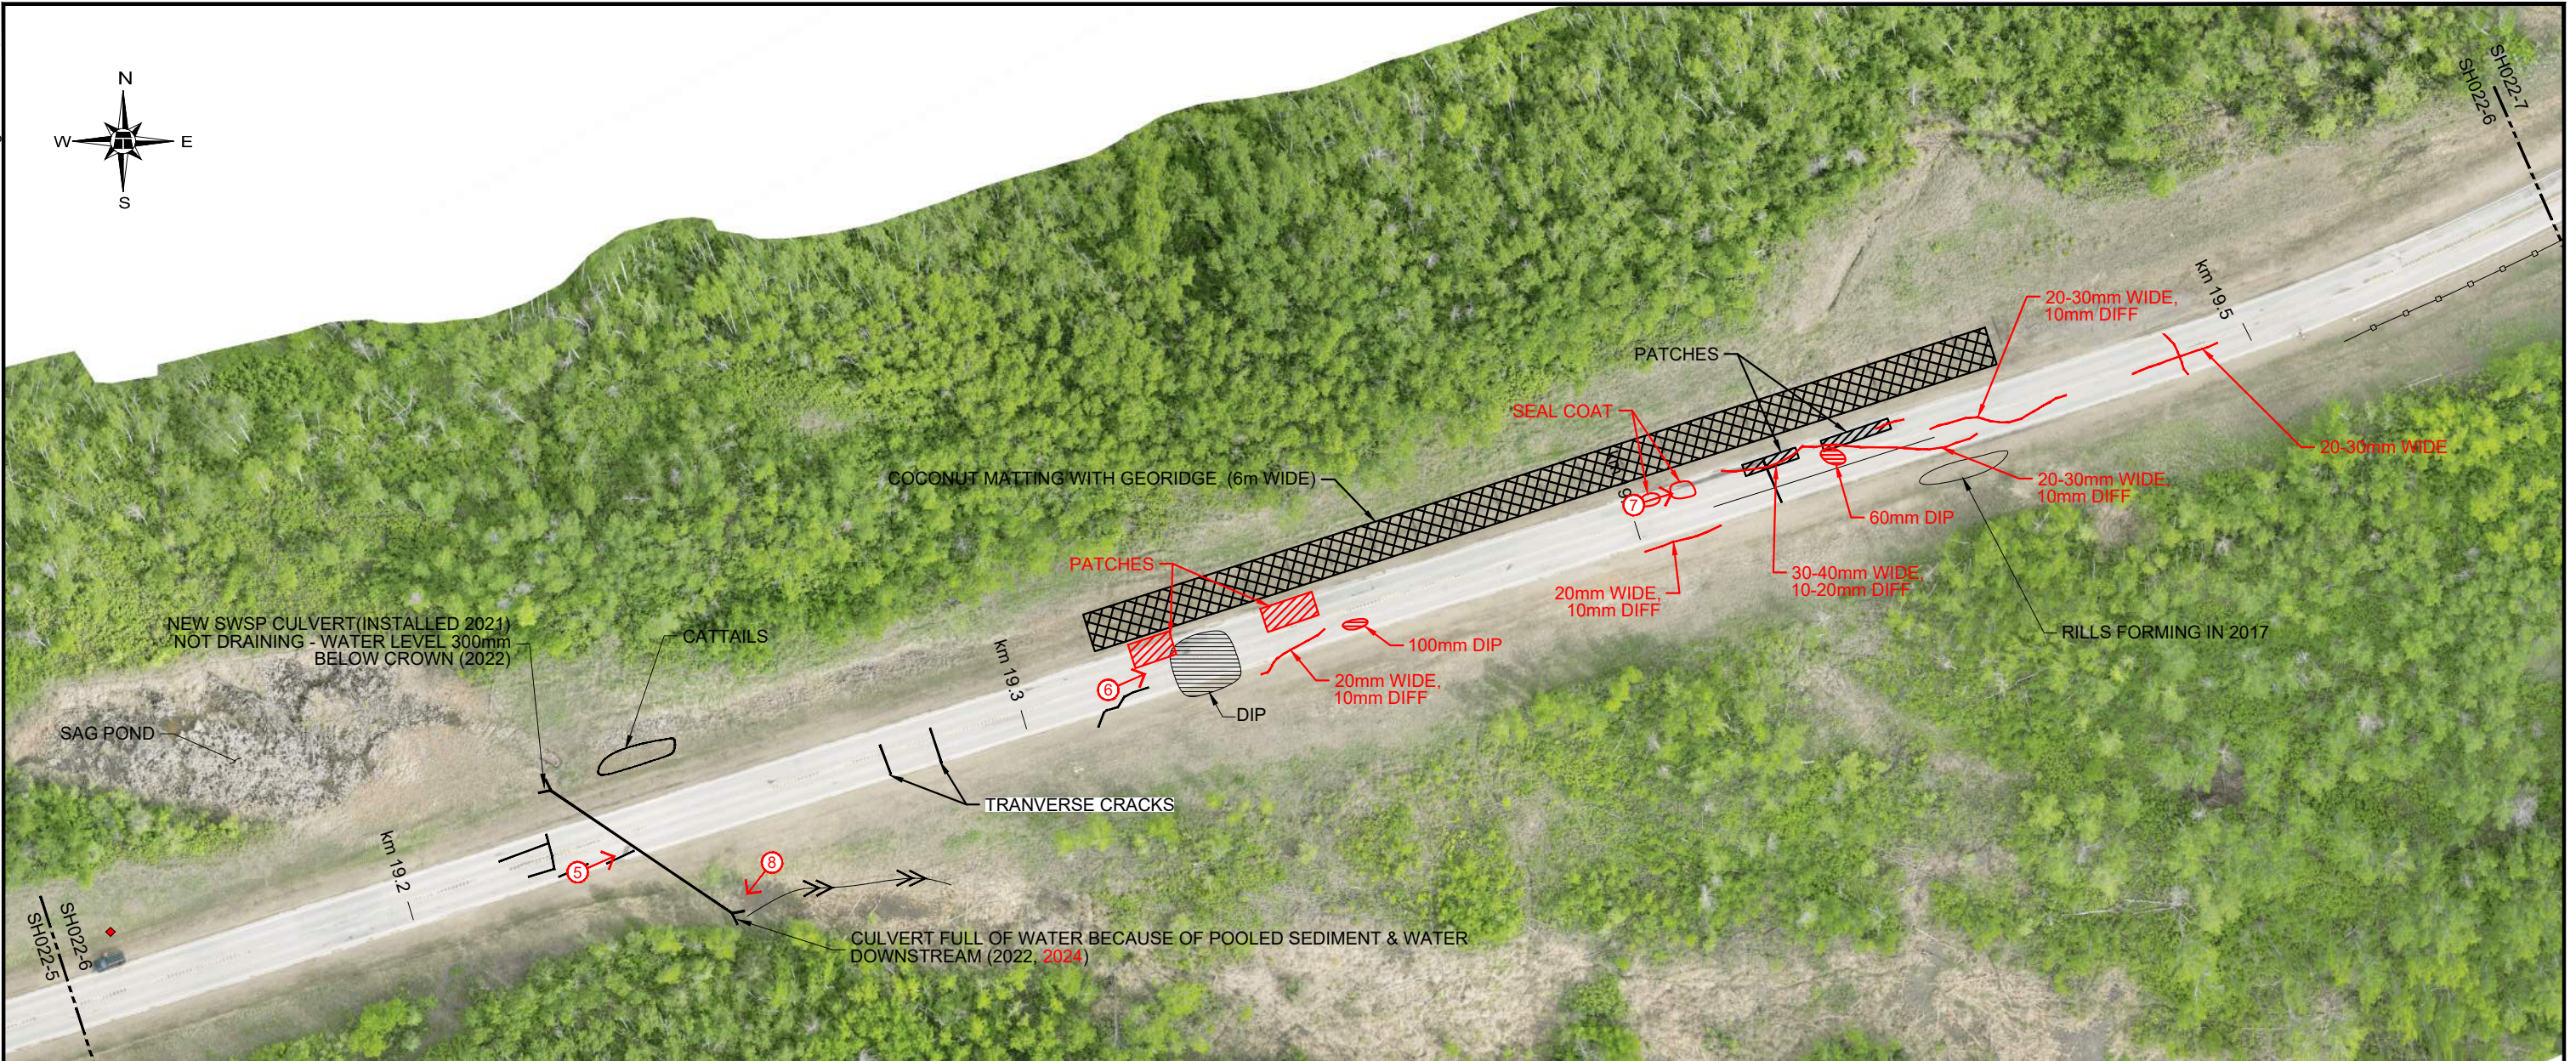
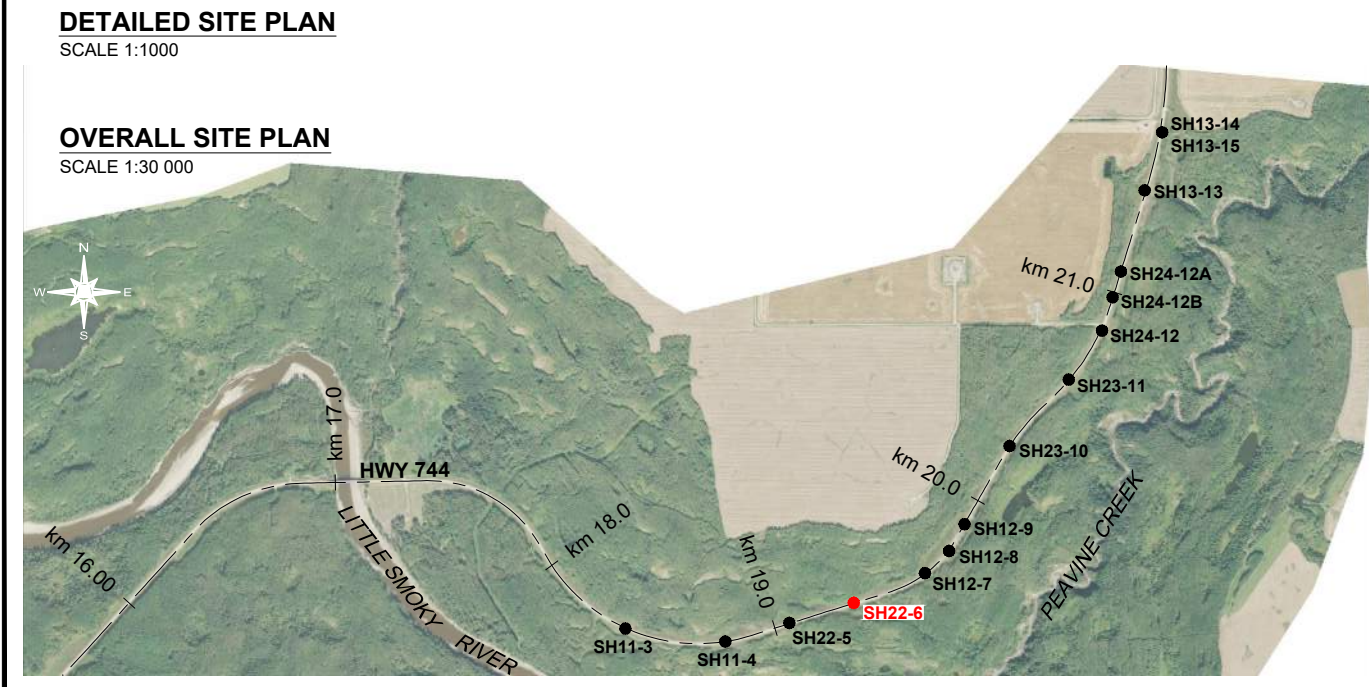
**DWG No. 32121-SH022-6**

Cracks continue to re-appear on the road surface after the highway was overlaid in 2021. Given the overall valley condition, continued creep movement is expected which may manifest as increased crack lengths, widths, and height differential as well as vertical pavement distortion. From the 2022 inspections, the previously observed erosion feature at km 19.40 was repaired with a portion of the north ditch regraded and erosion controls measures installed including matting and GeoRidges. The portion of the north ditch that doesn't have the erosion control measures in place has cattails present, indicating poor drainage over a portion of the ditch. The smooth wall steel pipe culvert installed in 2021 that replaced the old culvert is not draining; pooled water was observed at the inlet and outlet during the 2022 and 2024 inspections.

- The grading at the culvert outlet at km 19.23 (Site 6) should be re-evaluated to determine if the water can be drained away from the outlet to limit ponding and infiltration.

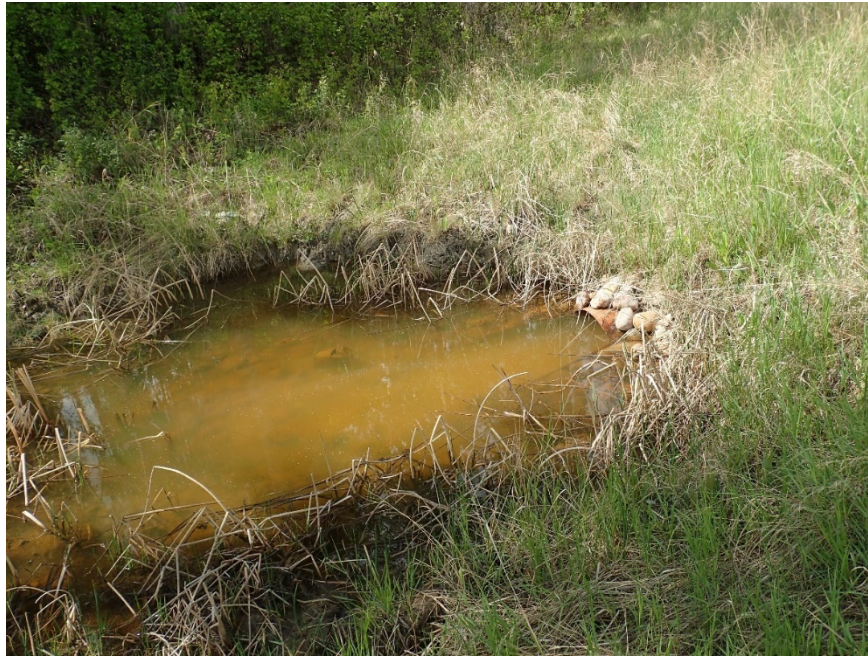
<input checked="" type="checkbox"/> Bridge/Culvert	Culvert at km 19.07: inlet is partially blocked and too high.	<input checked="" type="checkbox"/>
<input type="checkbox"/> Other		<input type="checkbox"/>
<b>Observations (Site 6):</b>	<b>Description</b>	<b>Worsened?</b>
<input checked="" type="checkbox"/> Pavement Distress	Some of the previous longitudinal and traverse cracks have reflected through.	<input checked="" type="checkbox"/>
<input checked="" type="checkbox"/> Slope Movement	Site is located on an active deep-seated landslide moving toward the Little Smoky River. This site crosses over a sag pond/graben.	<input checked="" type="checkbox"/>
<input checked="" type="checkbox"/> Erosion	The ditch was lined with erosion control products during the 2021 overlay.	<input type="checkbox"/>
<input type="checkbox"/> Seepage		<input type="checkbox"/>
<input checked="" type="checkbox"/> Bridge/Culvert	SWSP culvert installed at km 19.23 is not draining. Pondered water observed at inlet and outlet.	<input checked="" type="checkbox"/>

**Photo 1, Site 5 – Looking northeast at ponded water at culvert inlet at km 19.07.**

- Although the culvert at km 19.07 (Site 5) was just installed in 2021, it should be replaced as the inlet is too high to adequately drain the upslope sag pond and limit infiltration as shown in Photo 1.

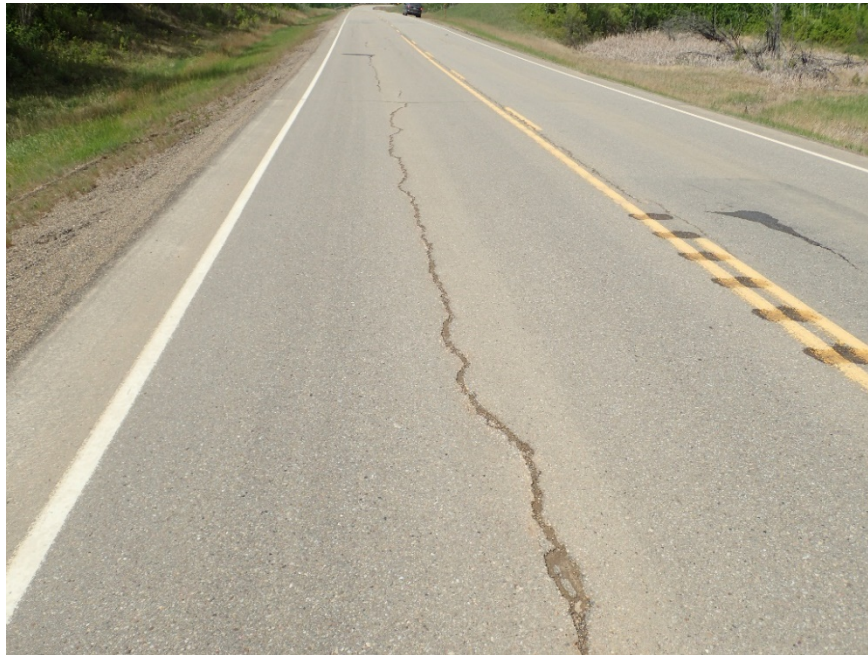
**Photo 2, Site 5 – Looking west at crack pattern on the eastbound lane.**

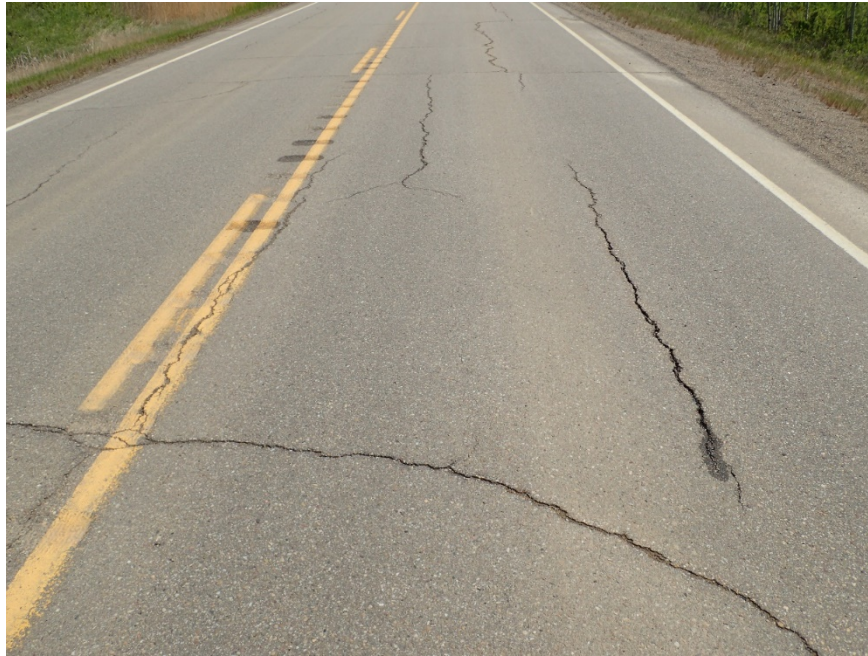
**Photo 3, Site 5 – Looking northeast at intermittent cracking between km 19.10 to km 19.13.**

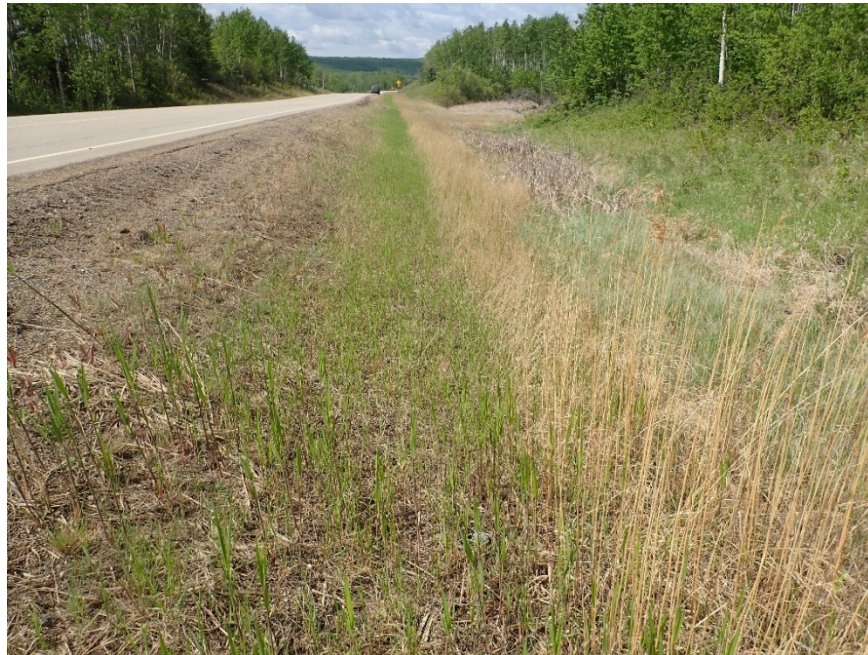
**Photo 4, Site 5 – Looking southwest along the north ditch.**

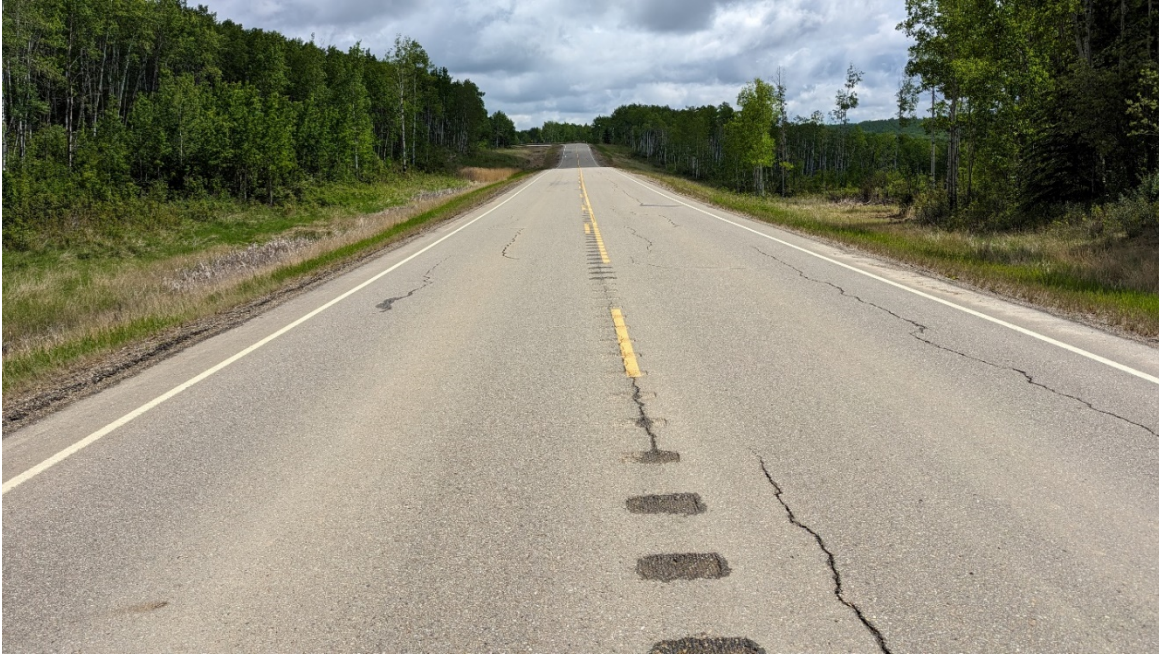
**Photo 5, Site 6 – Looking northeast at cracks on the road south of the culvert.**

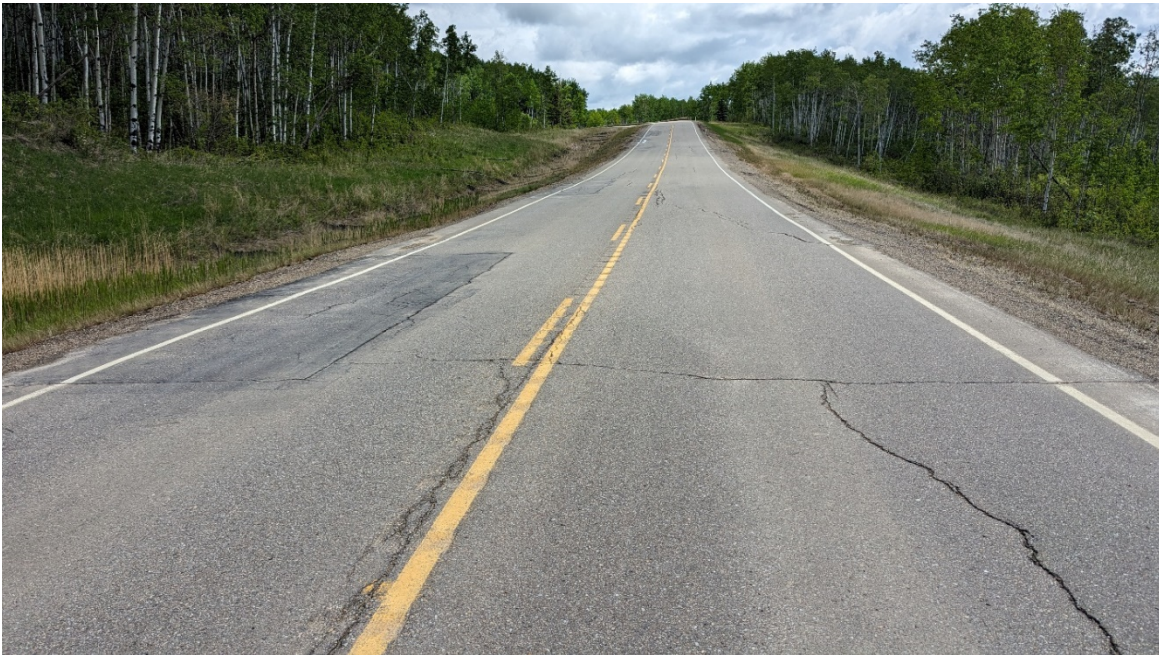
**Photo 6, Site 6 – Looking northeast near km 19.3. Dip noted on eastbound lane and recent patches observed on westbound lane.**

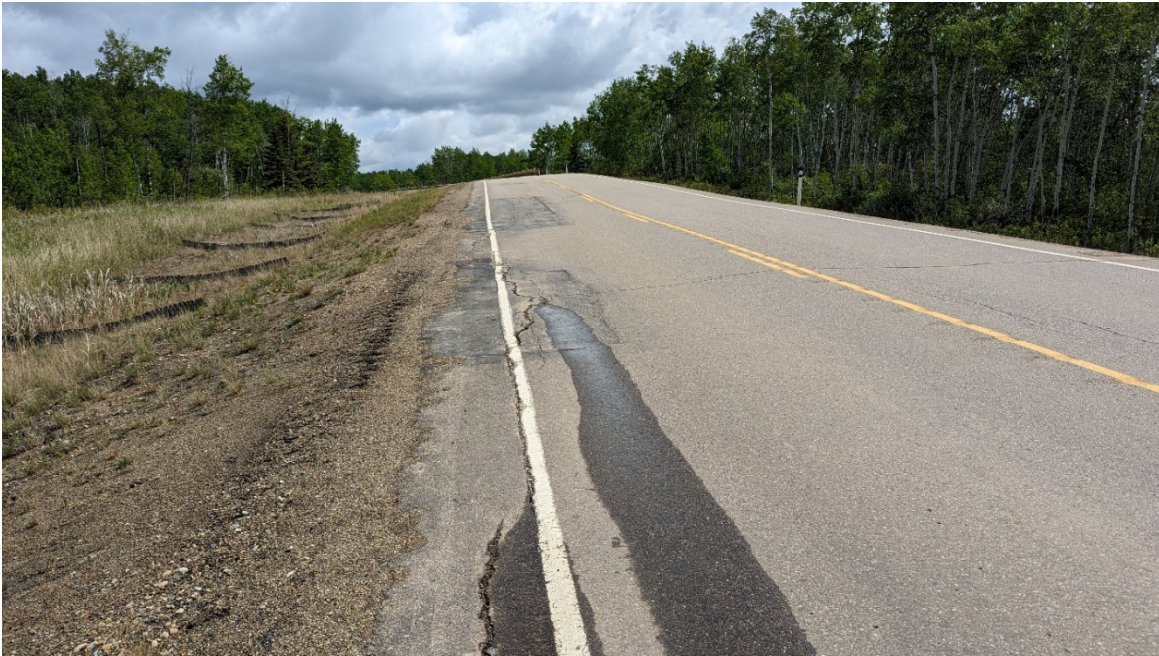
**Photo 7, Site 6 – Looking northeast at matting and GeoRidges installed in the north ditch. Cracking observed through patches along the fog line.**

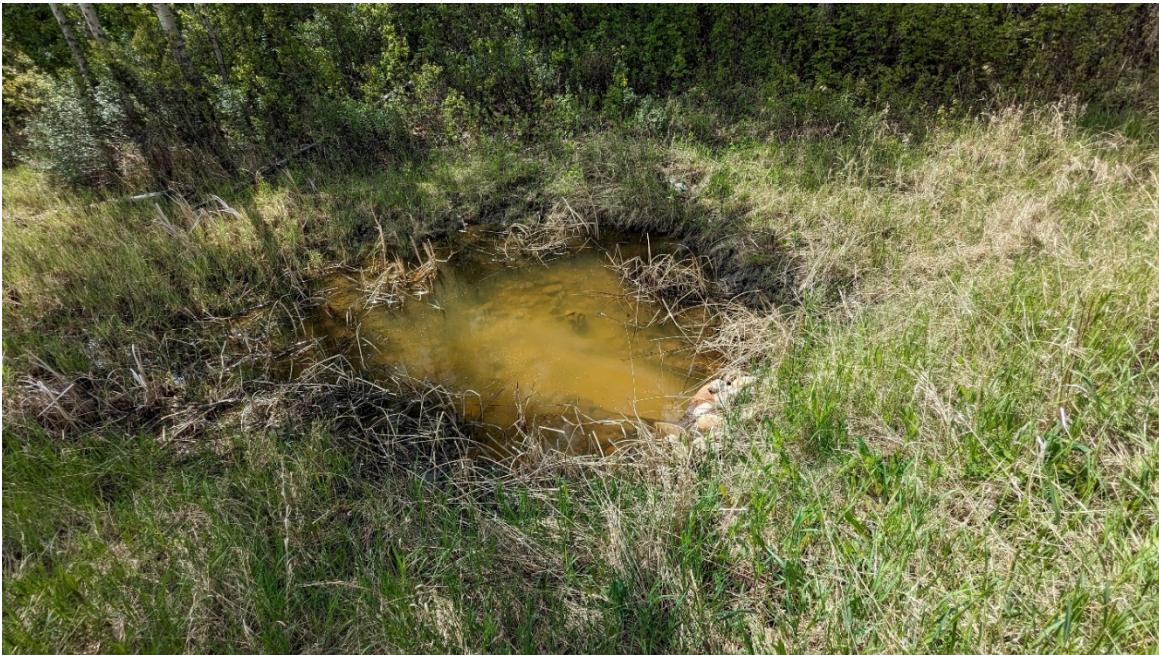
**Photo 8, Site 6 – Looking southwest at culvert outlet that has pooled water because it is not draining.**
