**ALBERTA TRANSPORTATION AND
ECONOMIC CORRIDORS
GEOHAZARD ASSESSMENT PROGRAM
PEACE REGION – SWAN HILLS
2024 INSPECTION**

Site Number	Location	Name	Hwy	km
SH022-7	Little Smoky River	Little Smoky River Valley, North Hill – Site #7	744:02	19.58-19.71*
Legal Description		UTM Co-ordinates		
SW21-76-22-W5M		11U E 477,732	N	6,161,398

**SH022-7: HWY 744:02 LITTLE SMOKY RIVER VALLEY
 2024 SITE INSPECTION PLAN**

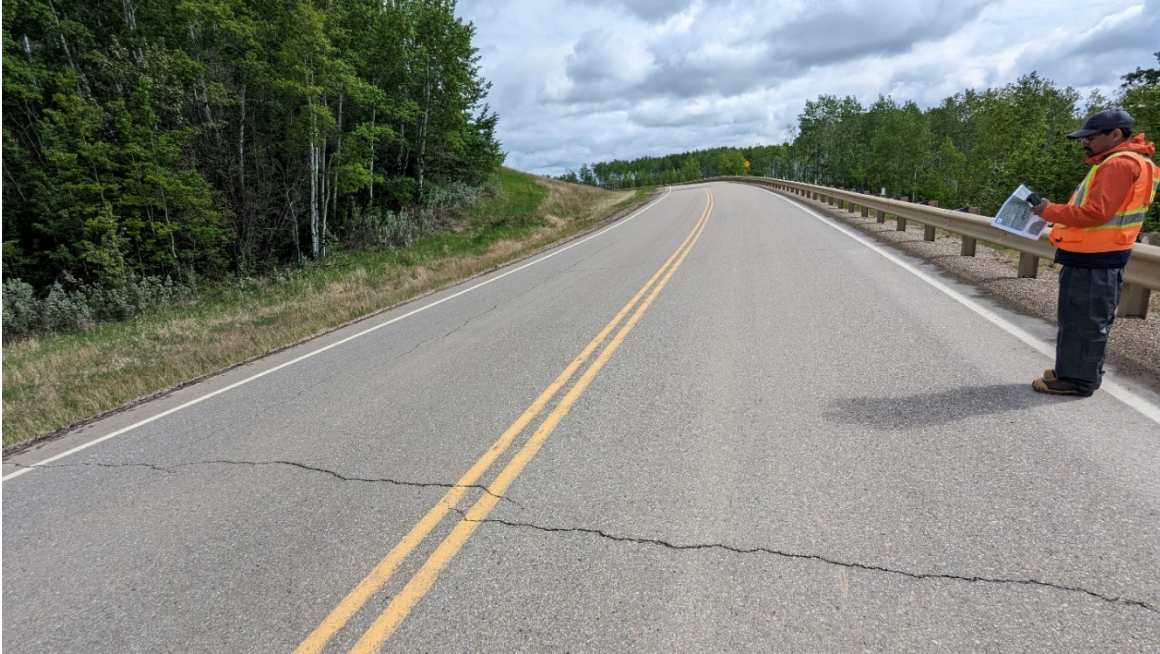
Photo 1 – Looking east from west end of site.

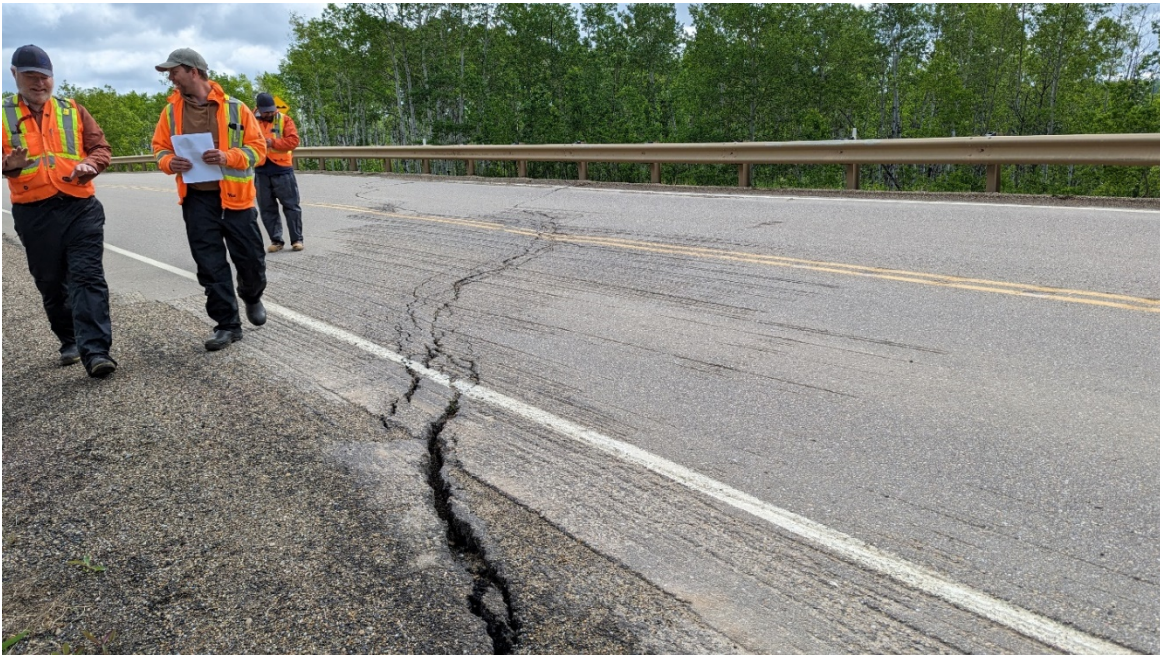
Site #7 intersects a major scarp which parallels the highway resulting in significant pavement distortions and requires frequent patching and milling to maintain a safe driving surface. The 2021 highway overlay removed most of the previously observed pavement distortions. As of the 2022 Geohazard inspection, some of the previously observed longitudinal and traverse cracks have started to reflect through. The highway embankment sideslopes were regraded to promote better drainage at the site. During the 2024 inspections, the cracks continued to spread. The main scarp that crosses the highway near km 19.62 shows cracks that have widened and exhibit vertical displacement. There was dip adjacent to the cracks that was milled. The previously observed slide scarp in the backslope has resurfaced.

Photo 2 – Looking at cracks merging together and widening where main scarp crosses highway.

- Road maintenance activities such as milling and patching should continue as necessary to maintain a safe roadway surface. Crack sealing of the ACP should be done to limit rain fall and snow melt entering the crack network.

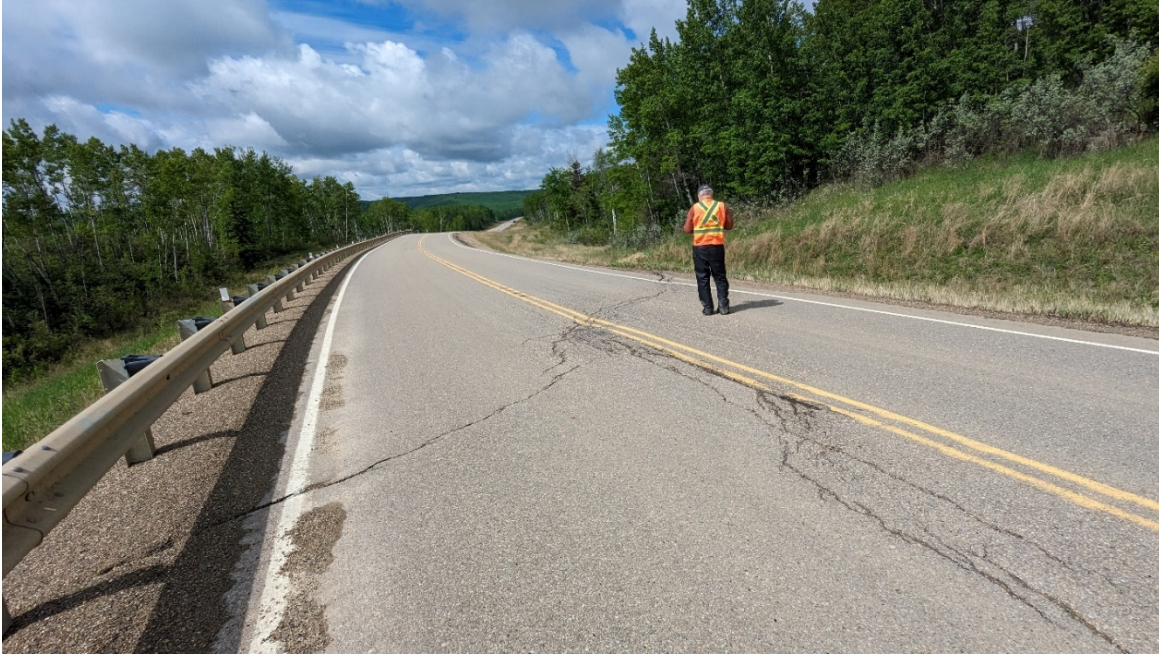
Photo 3 – Looking west at parallel cracks merging together at the centerline.

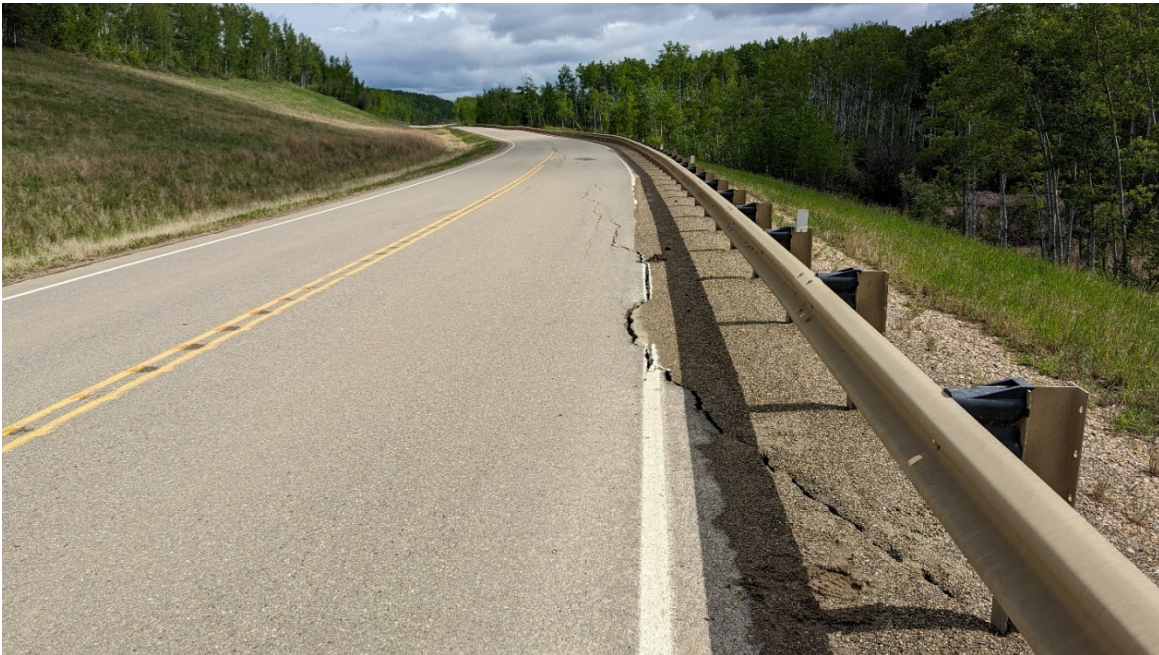
Photo 4– Looking east towards Site #8 where cracks were observed near the guardrail.
