**ALBERTA TRANSPORTATION
GEOHAZARD ASSESSMENT PROGRAM
PEACE REGION – SWAN HILLS
2020 INSPECTION**

Site Number	Location	Name	Hwy	km
SH022-5 SH022-6	Little Smoky River	Little Smoky River Valley, North Hill – Sites #5 and #6	744:02	19.00-19.14 19.20-19.53
Legal Description		UTM Co-ordinates		
Site 5: SW21-76-22-W5M		11U E 477,204	N	6,161,204
Site 6: SW21-76-22-W5M		11U E 477,479	N	6,161,291

Date	PF	CF	Total
Previous Inspection:	11-Jun-2019	9	3	Site 5: 27
		9	3	Site 6: 27
Current Inspection:	2-June-2020	11	3	Site 5: 33
		9	3	Site 6: 27
Road AADT:	240	Year:		2020
Inspected By:	Rocky Wang, TRANS		Ken Froese, Thurber	
Report Attachments:	<input checked="" type="checkbox"/> Photographs			
	<input checked="" type="checkbox"/> Plans		<input checked="" type="checkbox"/> Maintenance Items

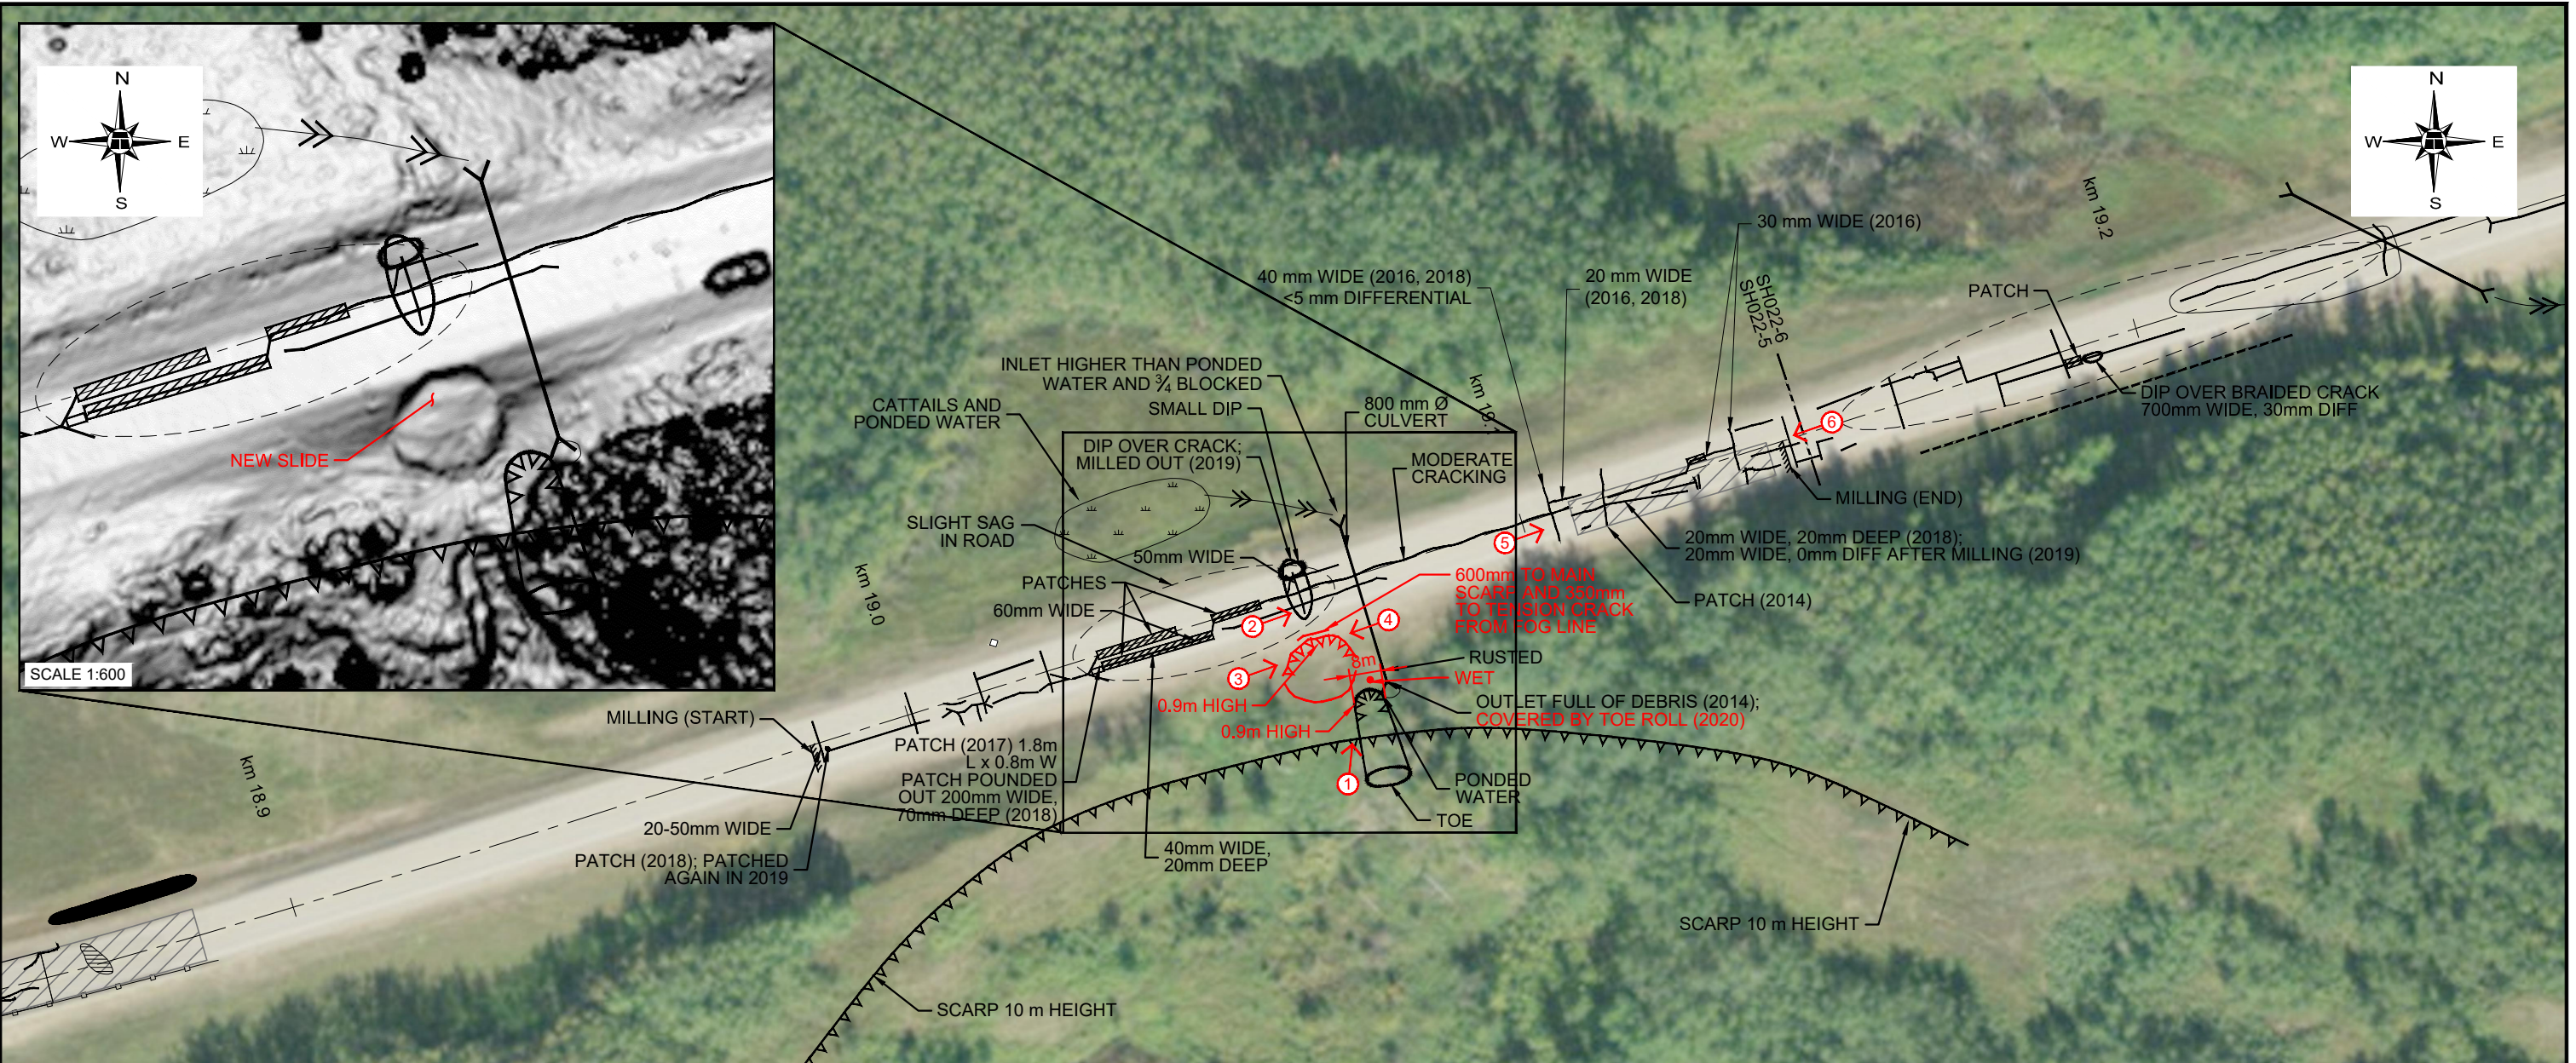
DWG No. 13355-SH022-5

**SH022-5: HWY 744:02 LITTLE SMOKY RIVER VALLEY
2019 SITE INSPECTION PLAN**

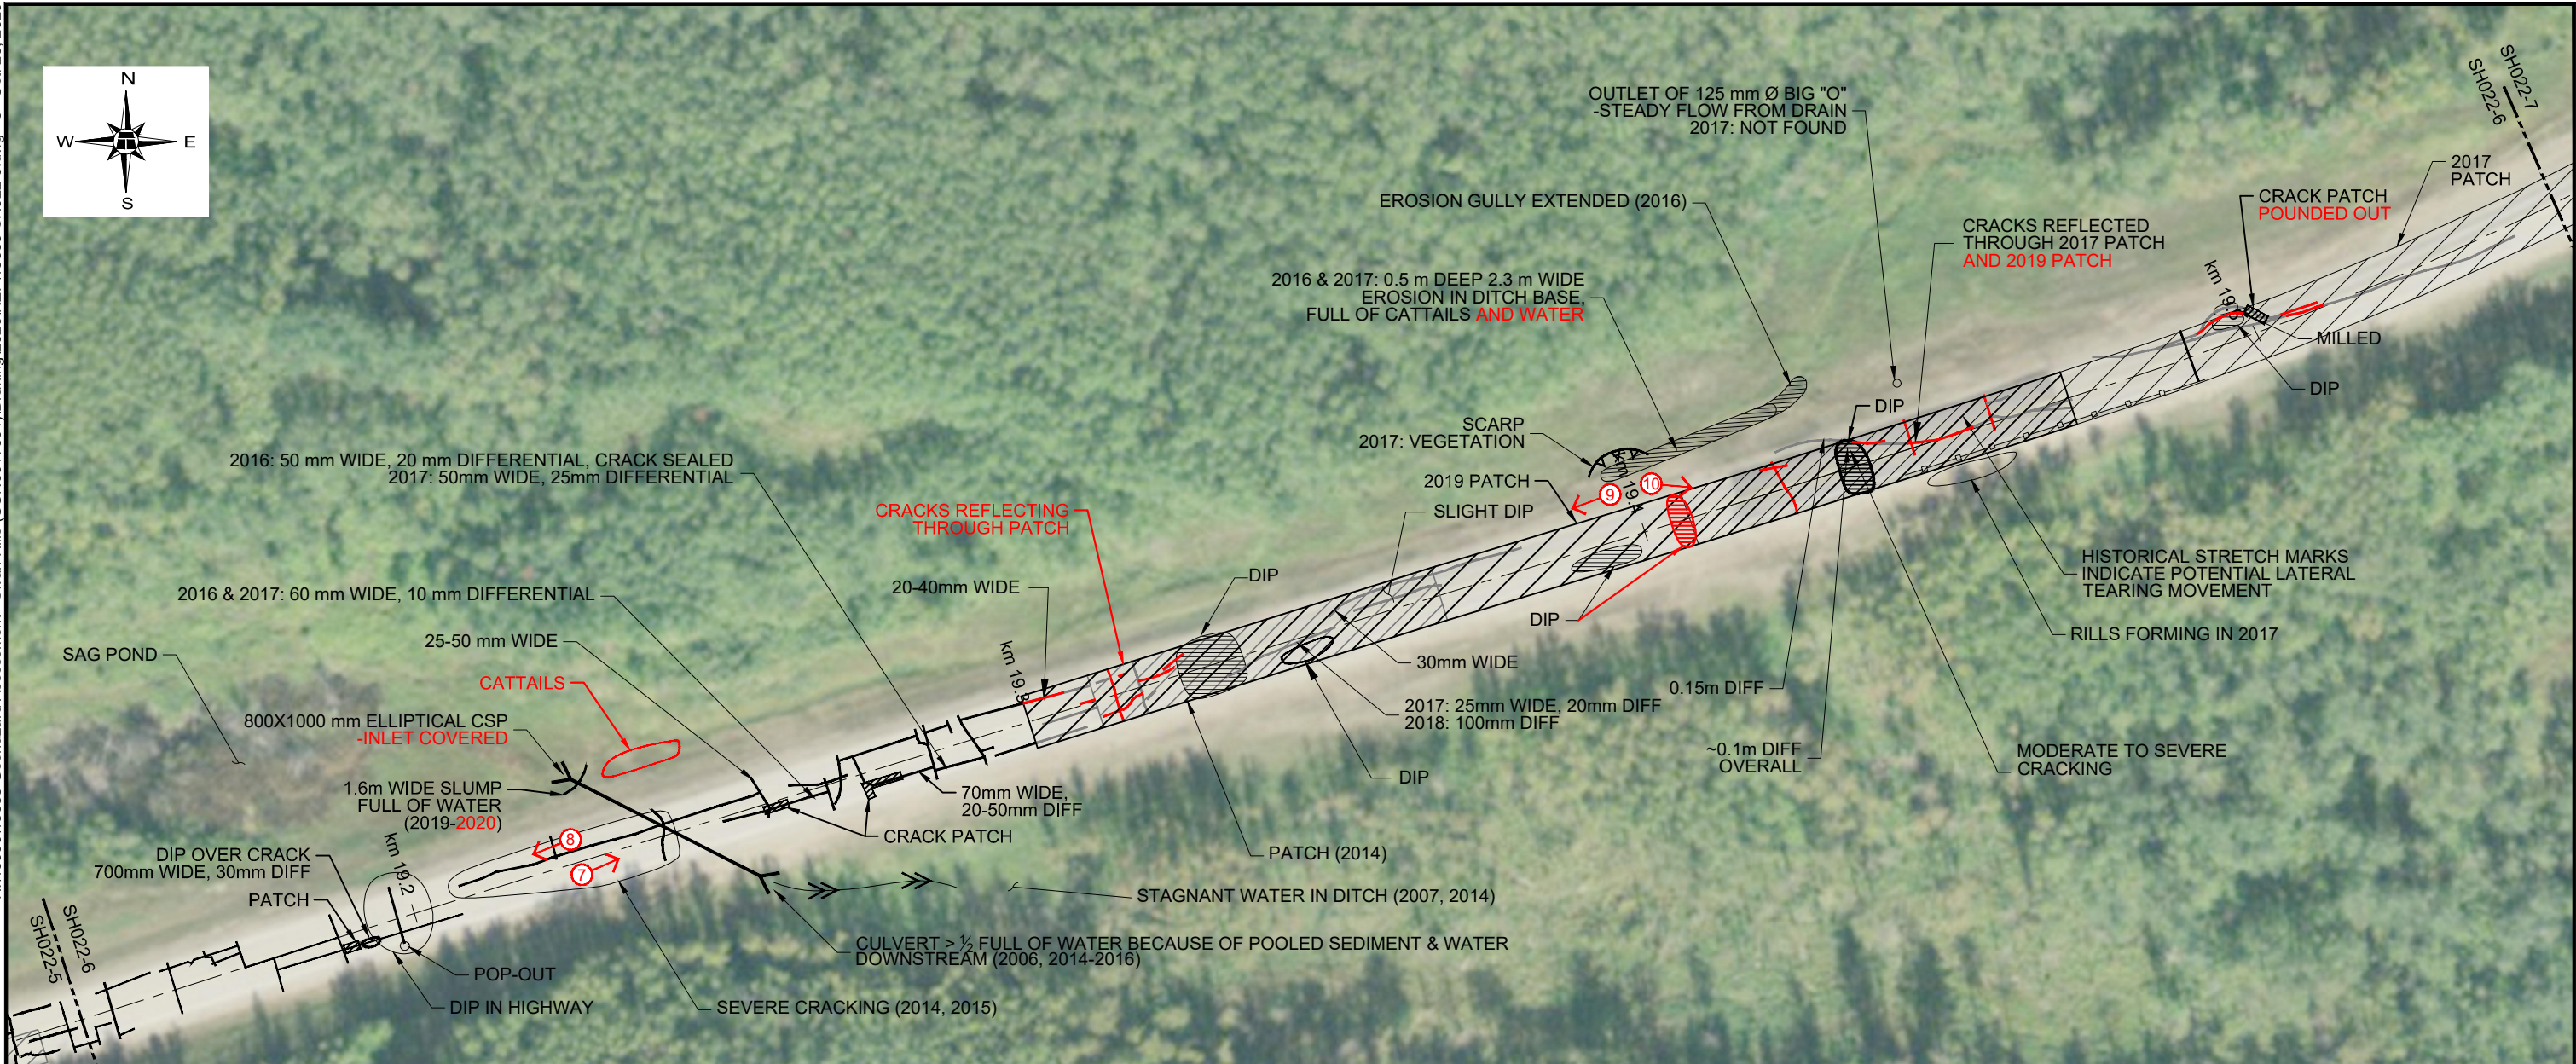
DWG No. 13355-SH022-6

**SH022-6: HWY 744:02 LITTLE SMOKY RIVER VALLEY
2020 SITE INSPECTION PLAN**

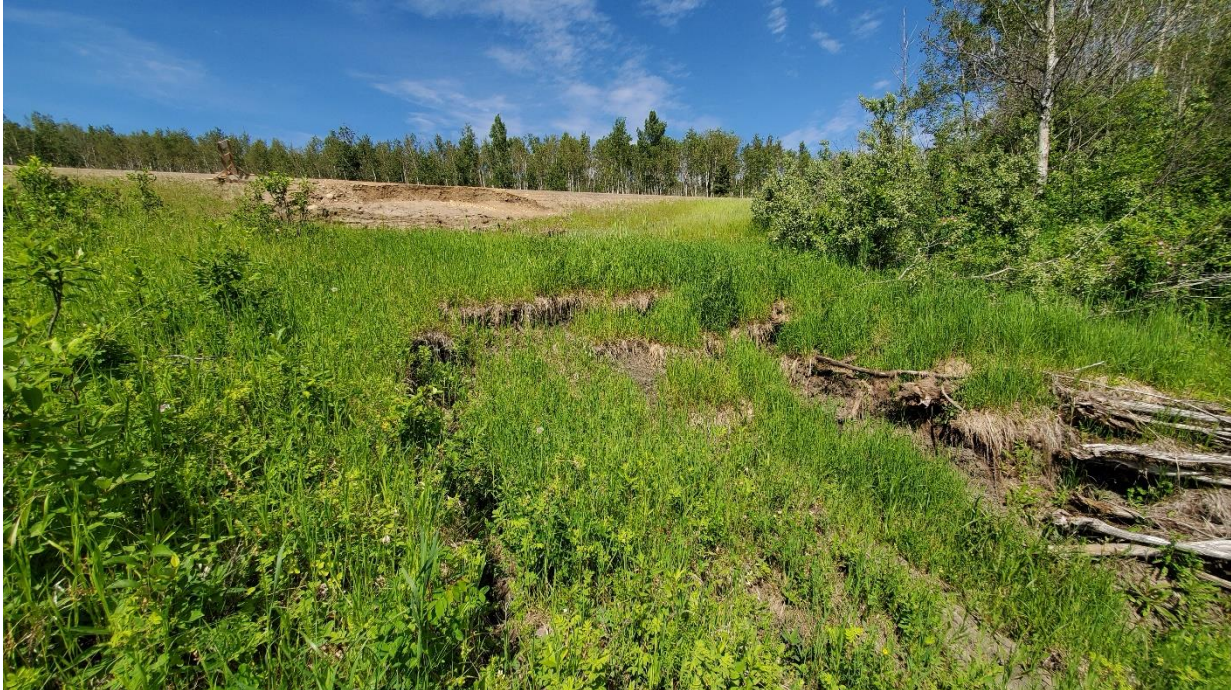
Photo 1, Site 5 (June 24, 2020) – Looking north at slump that has formed at the north edge of the deep landslide depression adjacent to the highway at about km 19.06.

- Preliminary engineering should be undertaken for short-term repair of the new slide at km 19.07. Consideration should be given to replacing the culvert at this location at the same time to ensure that the discharge is controlled (elephant trunk down to sag pond). It is anticipated that a local excavation and replacement with geo-grid reinforced gravel will be the simplest solution; the potential for the lower slide at km 19.06 to retrogress into the highway at this location should also be considered in the design.
- Culvert inlet and outlet at km 19.07 (Site 5) should be cleaned out and consideration given to replacing the culvert at a lower elevation to better drain the upslope sag pond and limit infiltration.
- Culvert inlet and outlet at km 19.23 (Site 6) should be cleaned out.
- Erosion gully at km 19.4 (Site 6) could be regraded and lined with erosion-resistant material(s).

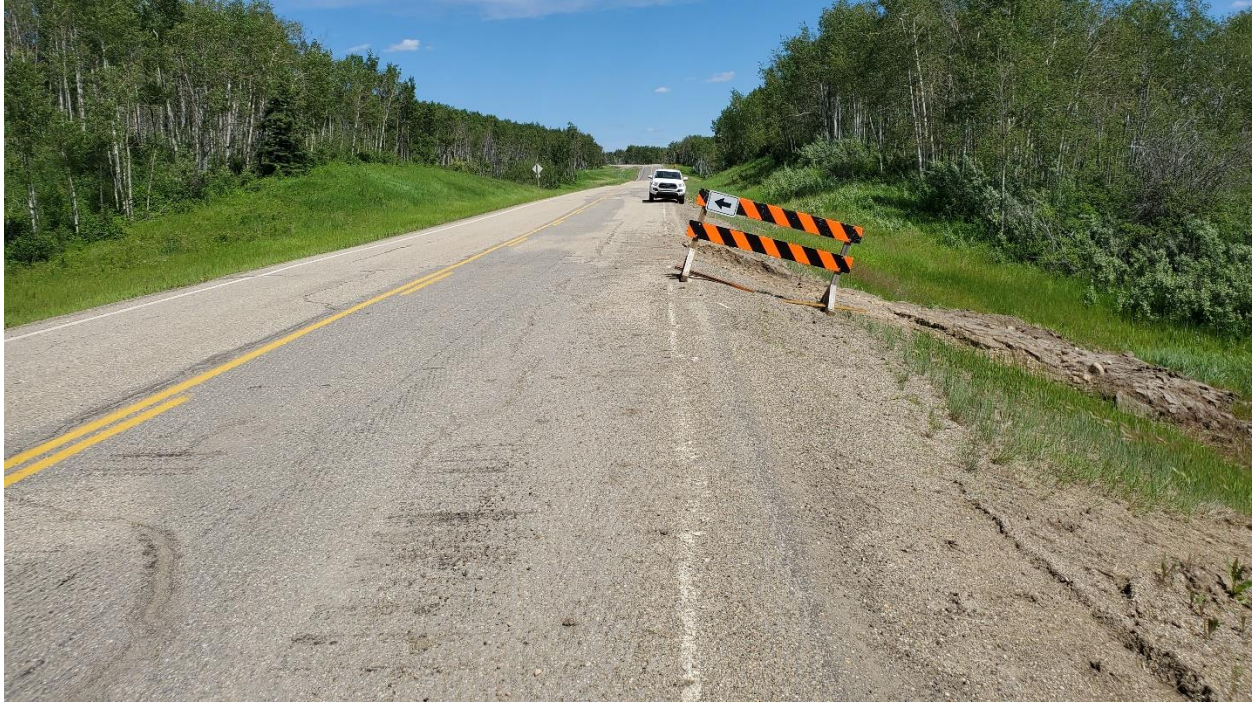
Photo 2, Site 5 (June 24, 2020): Looking east at partially-repaired slide on right shoulder.

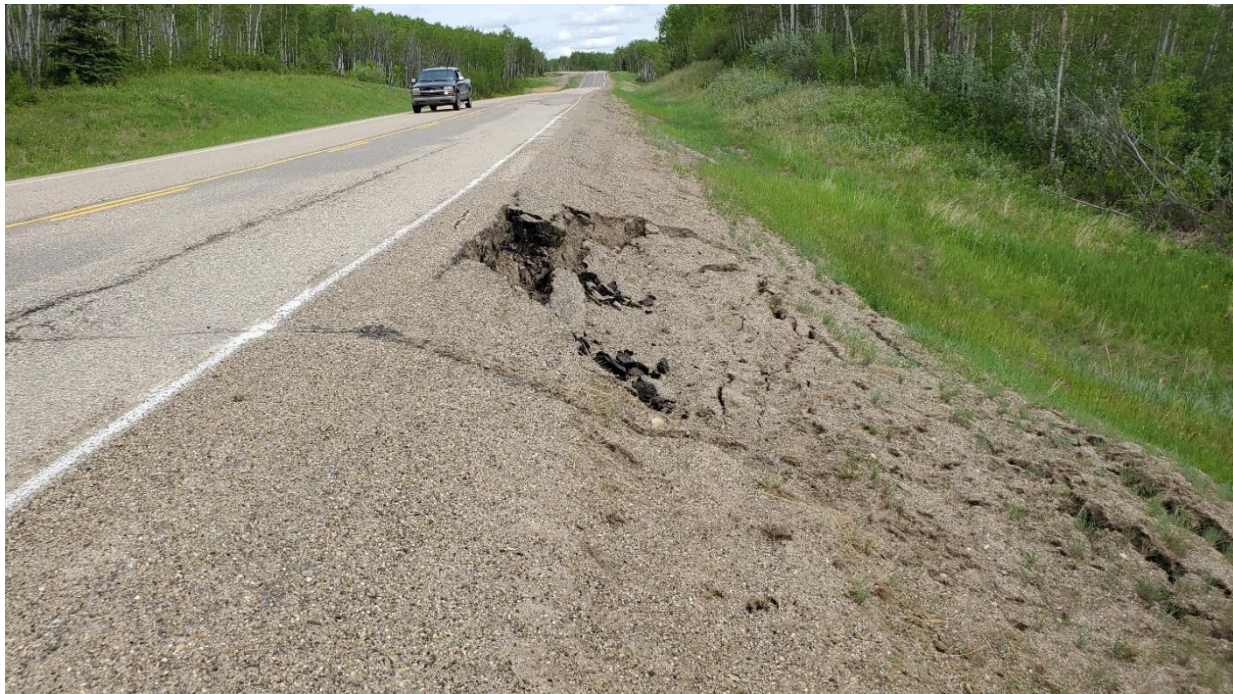
<input type="checkbox"/> Seepage		<input type="checkbox"/>
<input checked="" type="checkbox"/> Bridge/Culvert Distress	Culvert at km 19.07: inlet is partially blocked and too high and outlet was obstructed in by new slide in 2020.	<input checked="" type="checkbox"/>
<input type="checkbox"/> Other		<input type="checkbox"/>
Observations (Site 6):	Description	Worsened?
<input checked="" type="checkbox"/> Pavement Distress	Numerous longitudinal and traverse cracks are present which have continued to increase each year. Cracks have reflected through 2019 patching.	<input checked="" type="checkbox"/>
<input checked="" type="checkbox"/> Slope Movement	Site is located on an active deep-seated landslide moving toward the Little Smoky River. This site crosses over a sag pond/graben.	<input checked="" type="checkbox"/>
<input checked="" type="checkbox"/> Erosion	An erosion gully is present at km 19.40. There is a small scarp on the north side at the west end of the gully.	<input type="checkbox"/>

Photo 3: Looking east at new slump on shoulder that has blocked the culvert outlet (km 19.07).

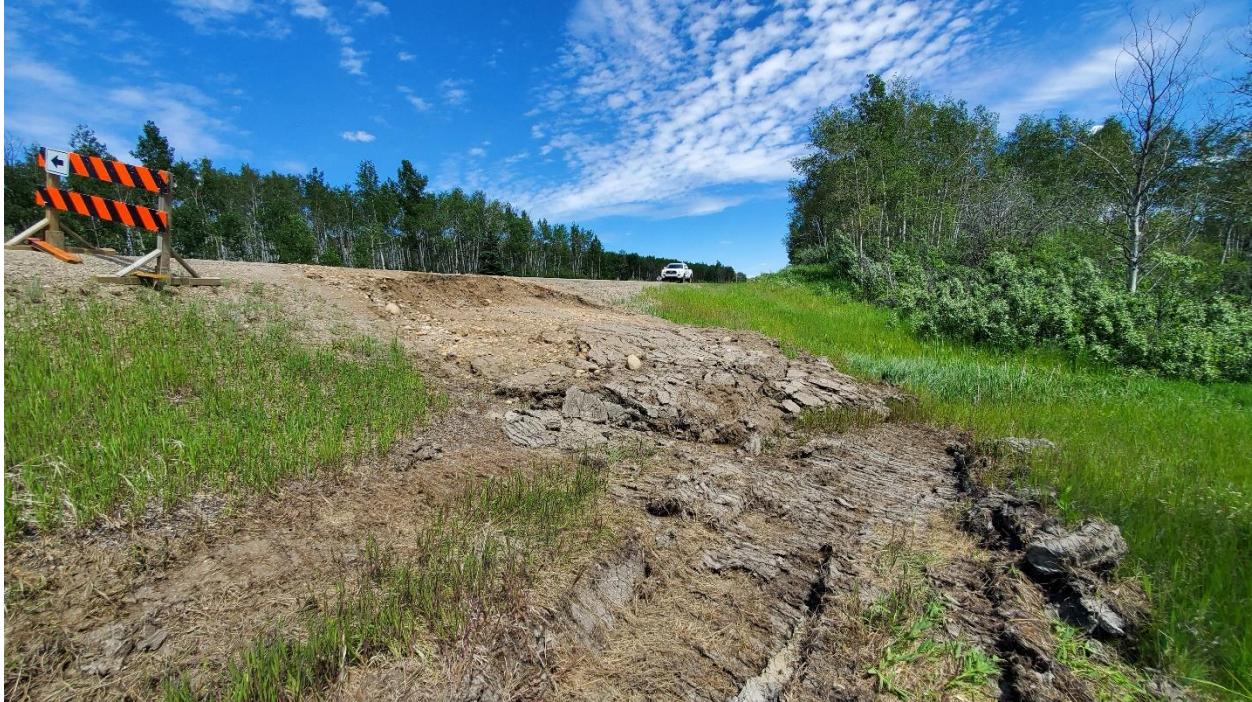
Photo 3, Site 5 (June 24, 2020): Emergency fill placed on the shoulder has also slumped.

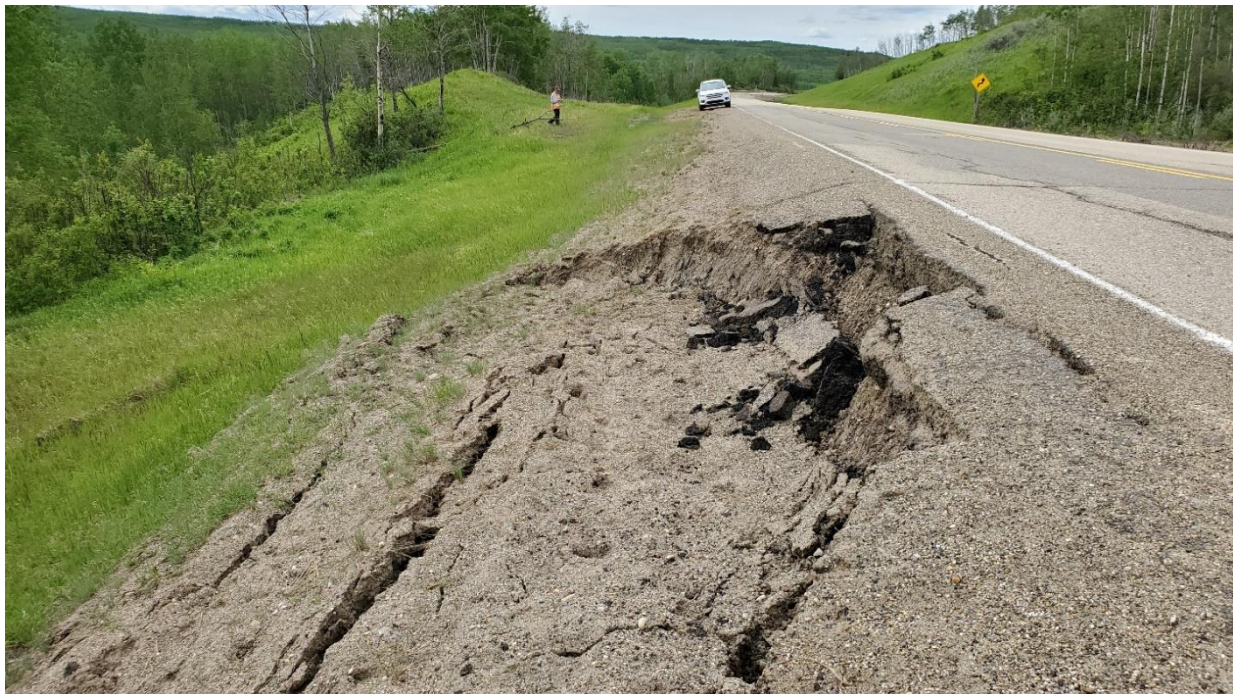
Photo 4, Site 5: Looking west at new slide over the culvert outlet at km 19.07.

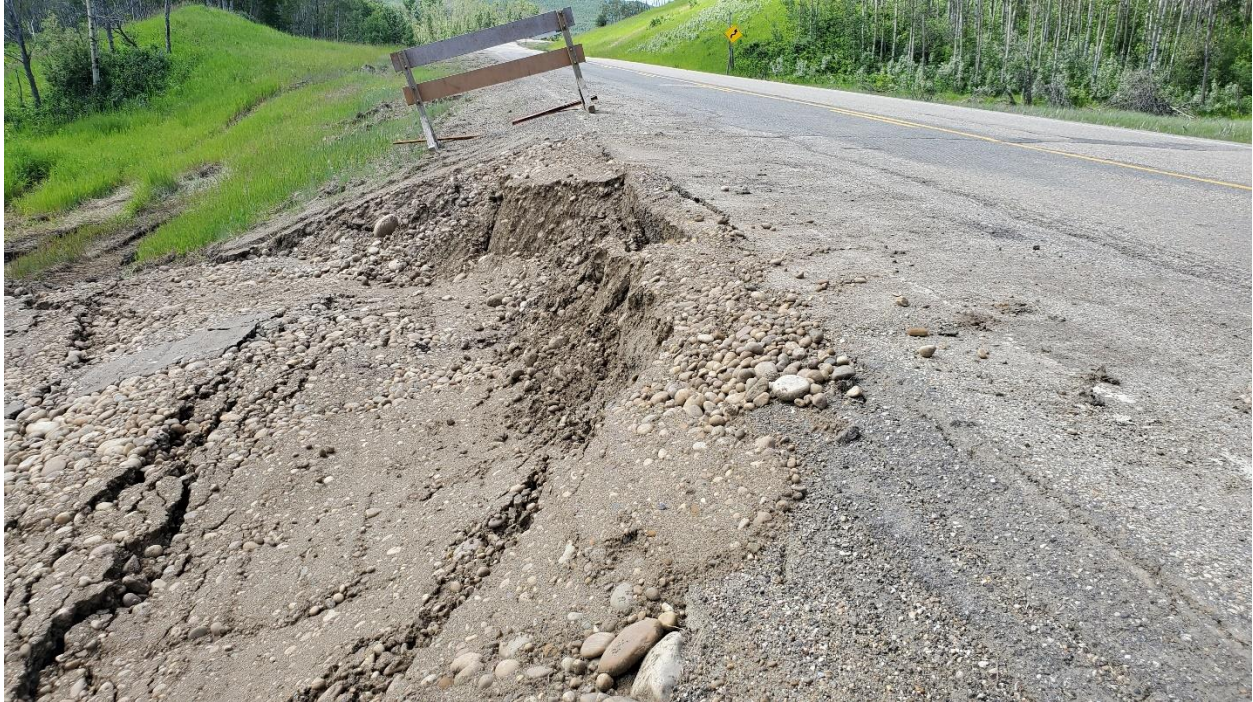
Photo 4, Site 5 (June 24, 2020): Looking west after emergency fill placement.

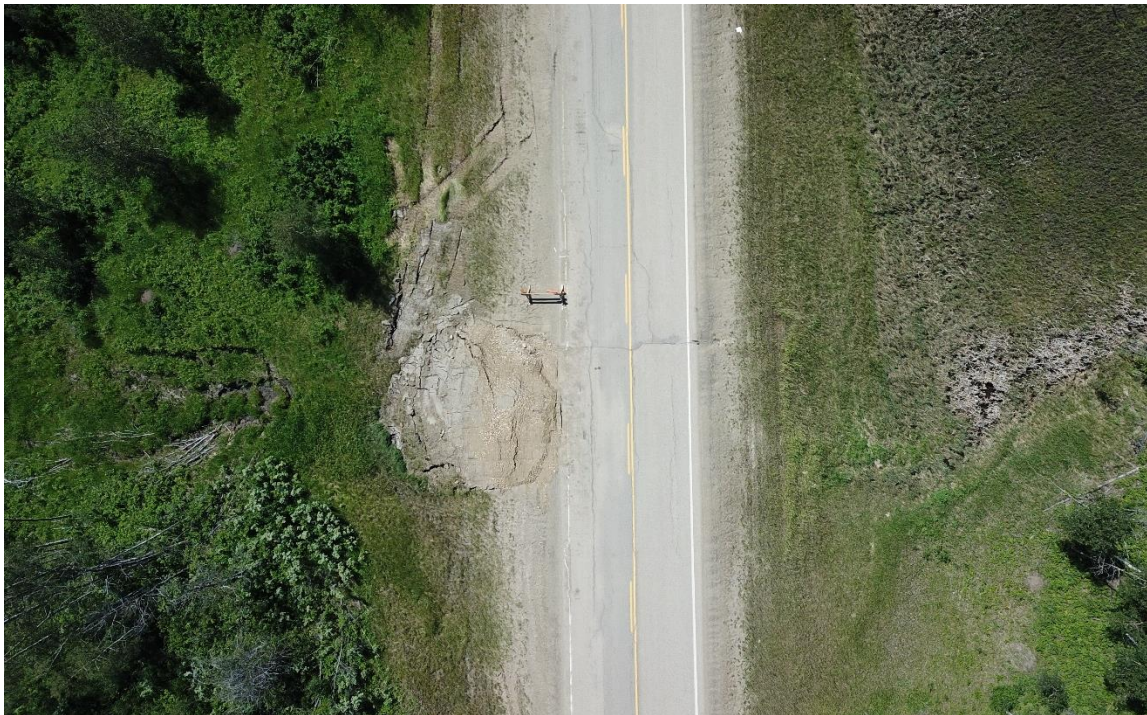
UAV, Site #5 (June 24, 2020): Showing attempted repair and continued retrogression

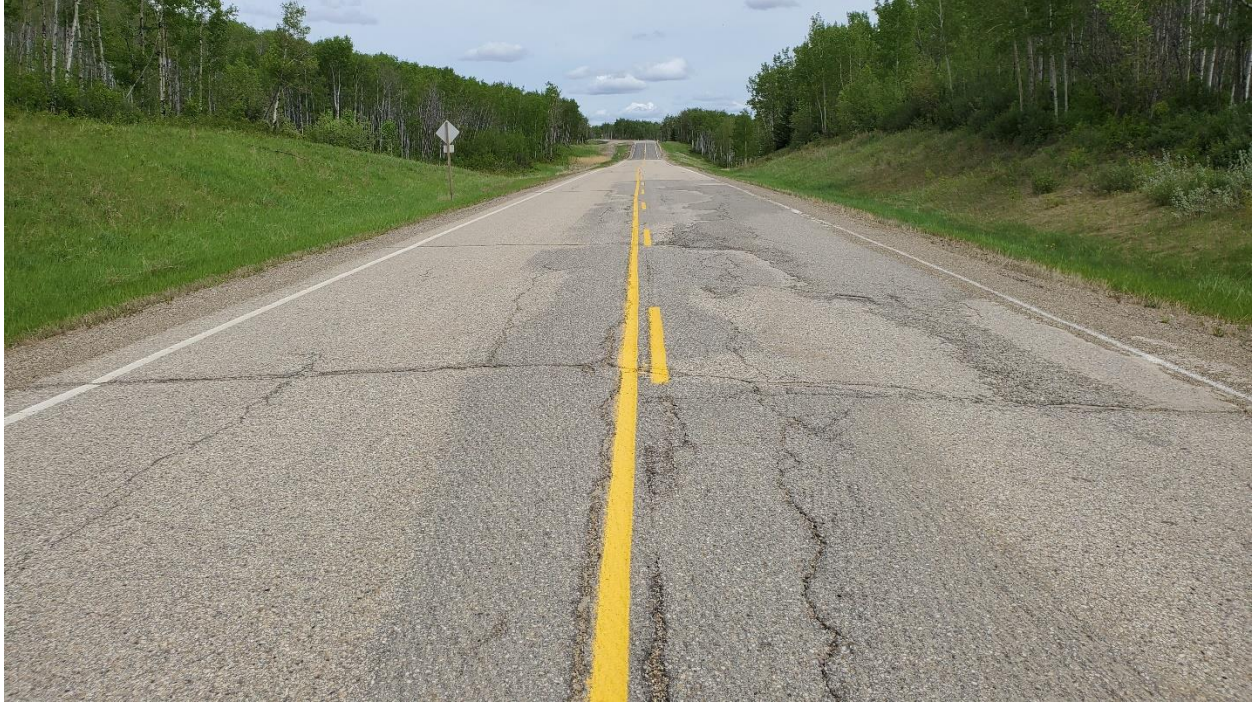
Photo 5, Site 5 – Looking northeast at partially-milled patch between km 19.10 to km 19.13.

- Road maintenance should continue as necessary to maintain a safe roadway surface and may consist of milling, patching, and crack sealing of the ACP.

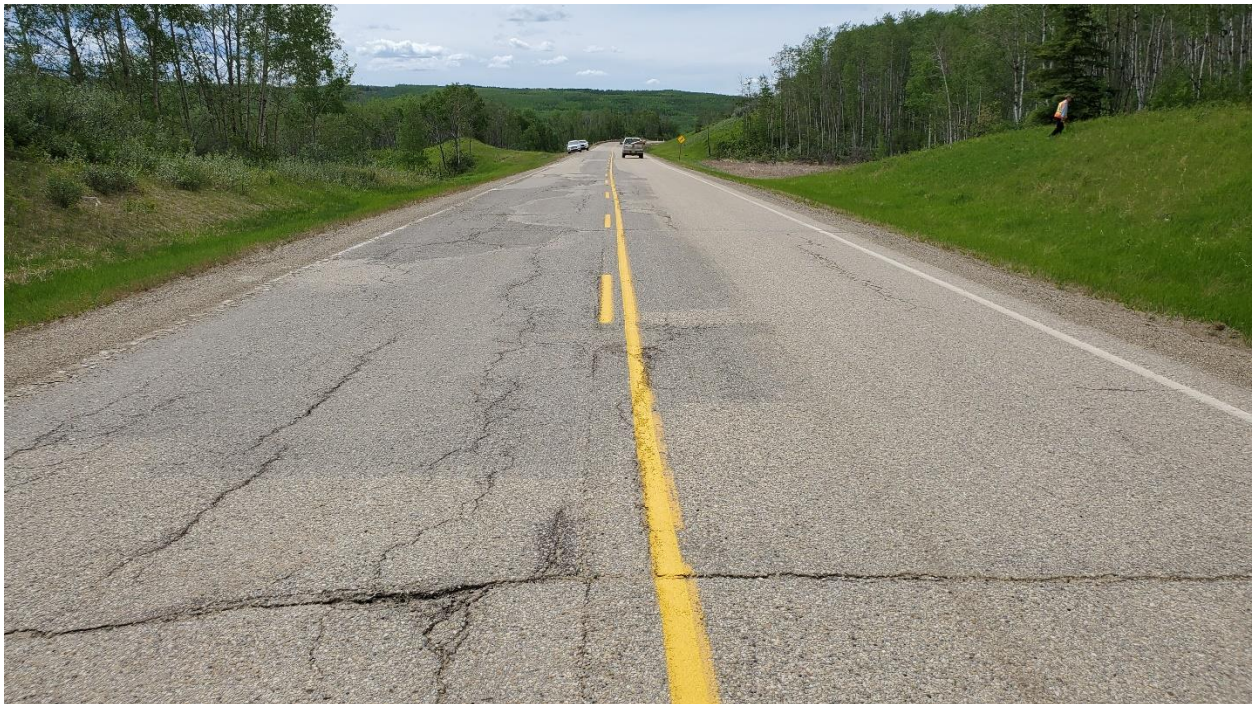
Photo 6, Site 5 – Looking southwest at milled patch between km 19.10 to km 19.13.

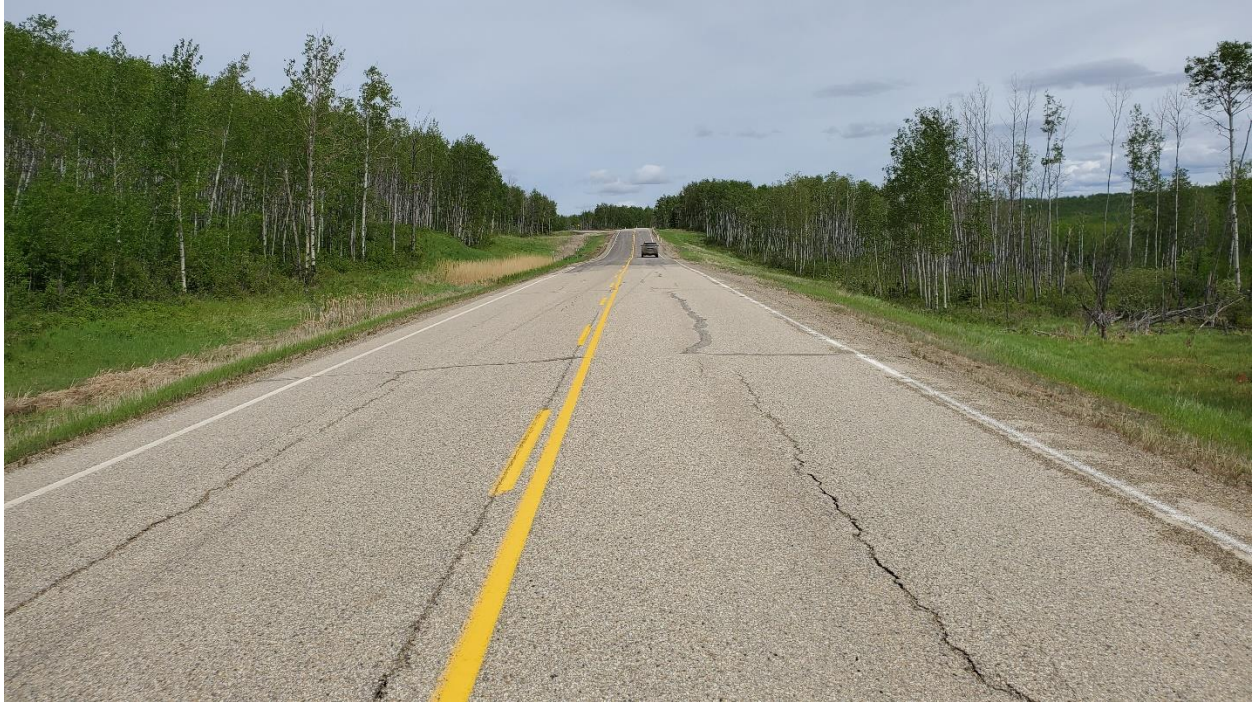
Photo 7, Site 6 – Looking northeast at 2019 patch at km 19.3. There is a noticeable dip about 20 m to 30 m east of the start of the patch.

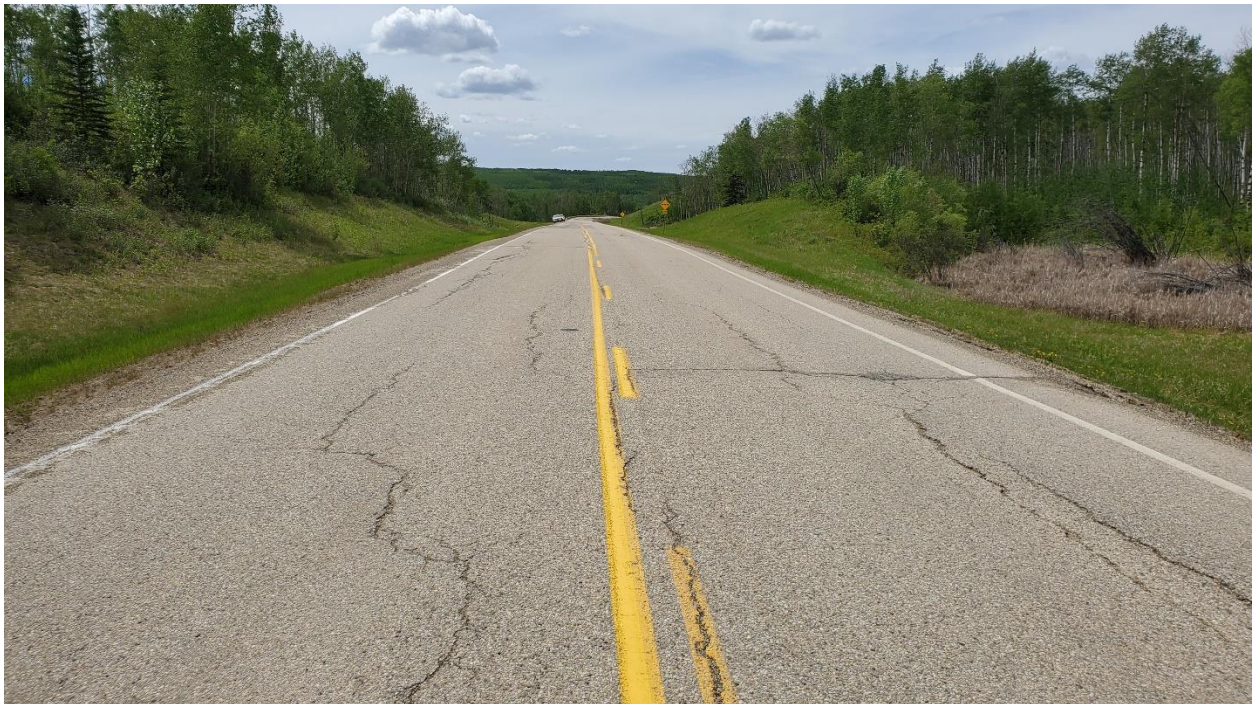
Photo 8, Site 6 – Looking west at west end of Site #6 toward Site #5.

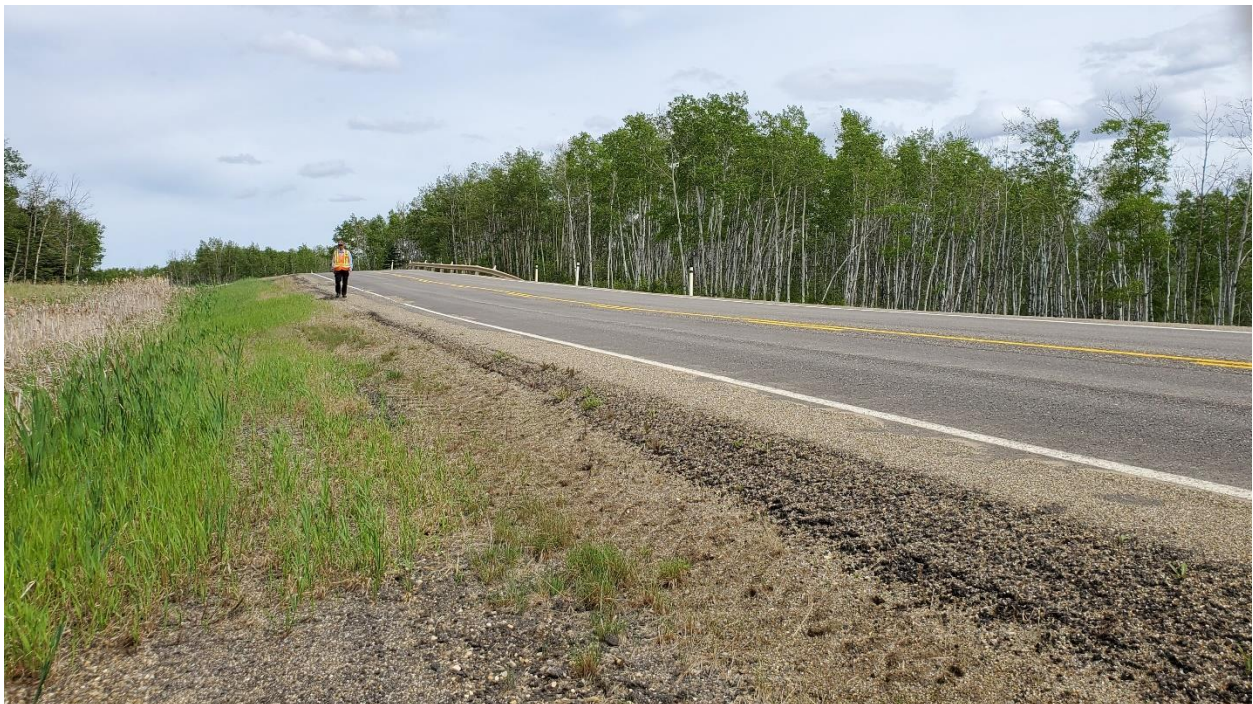
Photo 10, Site 6 – Looking east at 2019 patch near east end of site.
