**GEOHAZARD RISK MANAGEMENT PROGRAM (CON0022164)
PEACE REGION (PEACE RIVER DISTRICT)**

**SECTION D CALLOUT REPORT
SITE SH022-5: HWY 744:02 km 19.00 – 19.14**

**SH022-5: HWY 744:02 LITTLE SMOKY RIVER VALLEY
2021 CALLOUT**

DWG No.32121-SH022-CALLOUT-1

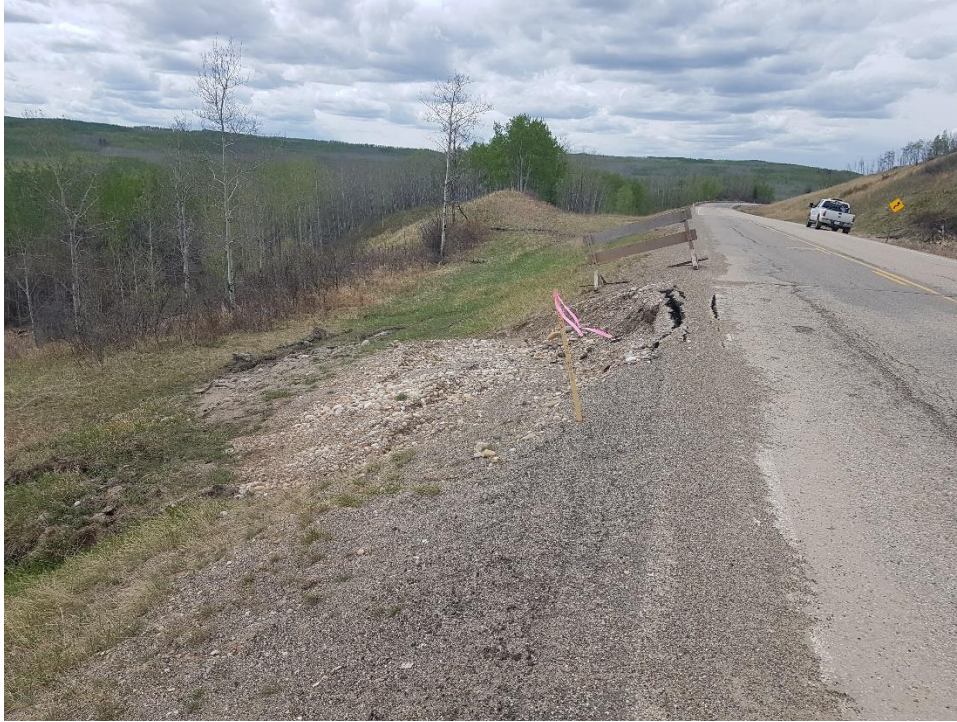
- There was a 50 mm overlay with Mix Type M1 (PG 52-34). No vertical profile adjustment was made at this site.
- Pavement width through the site was 8.3 m.
- As per the May 2021 photo (see attachments), the slide had not been repaired before the overlay work took place and the contractor was directed to not repair it, only install the culvert.

Photo 1 (McIntosh Perry, May 16, 2021) - Looking east at slump with stake at new culvert outlet.

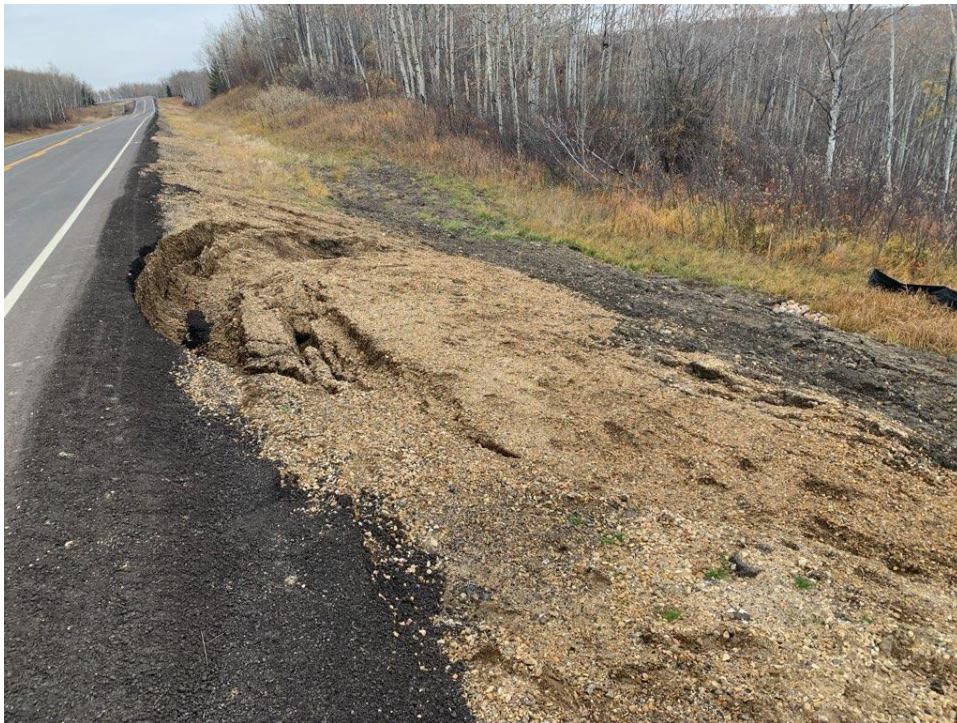
Photo 2 (MCI, Oct. 13) – Looking west at crest of slump

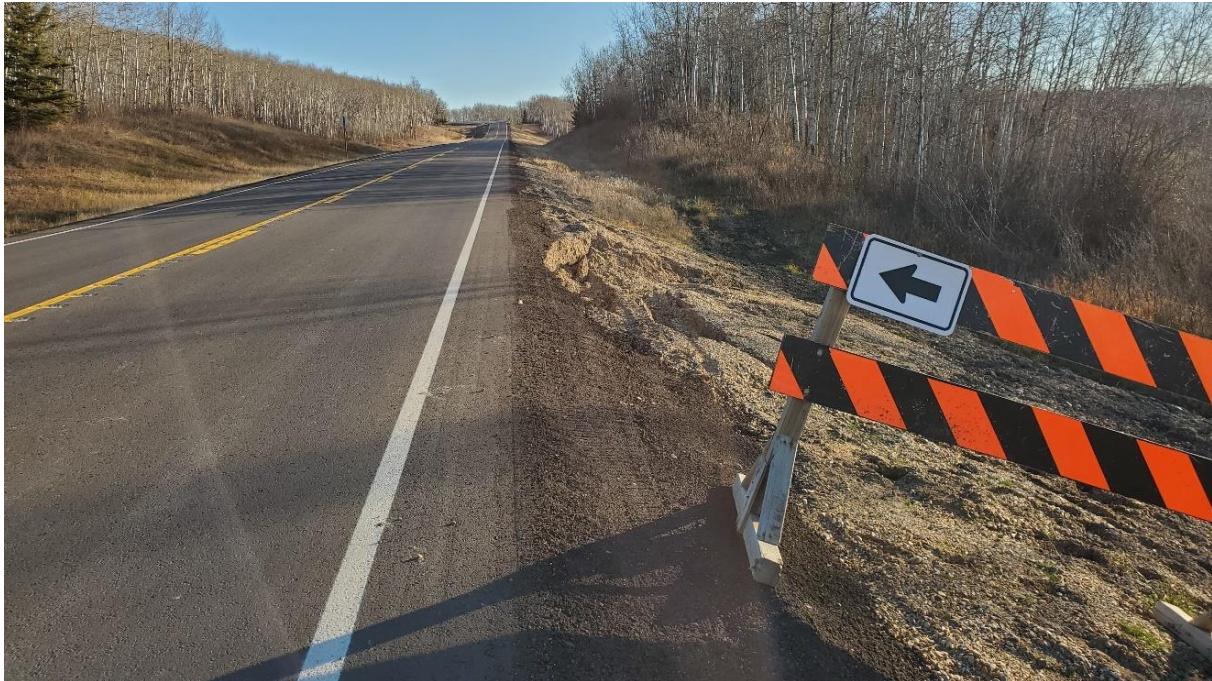
At the time of the call-out inspection, the slump had dropped noticeably since the October 21 photos provided by the MCI: the scarp was between 0.9 m and 1.2 m high and as close as 0.9 m to the fog line. The location is almost the same as in 2020. The embankment is about 4 m high at this location. The 11 m wide scarp had about 5 m intercepting the new asphalt shoulder. There was a narrow graben at the bottom of the backscarp about 0.5 m lower than the top of the slumped surface. The toe roll at the bottom of the approximately 4 m-high embankment was between 0.9 m and 1.3 m in height. The overall width of the slide is about 13 m and is 12 m in length (measured from scarp to edge of toe roll). Sideslopes adjacent to the slumped area where on the order of 20° or 2.7H:1V. The outlet of the culvert was not obstructed by toe roll.

Photo 3 (Oct. 28) – Looking west at crest of slump

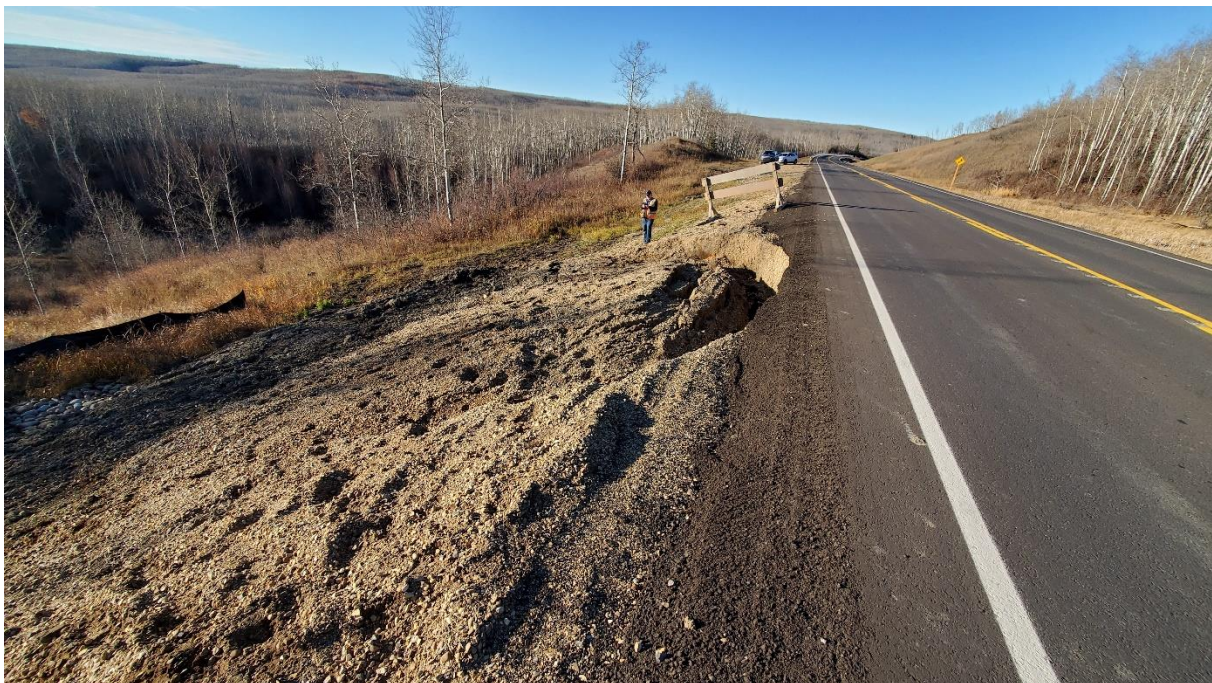
Photo 4 (Oct. 28) – Looking east at slump.

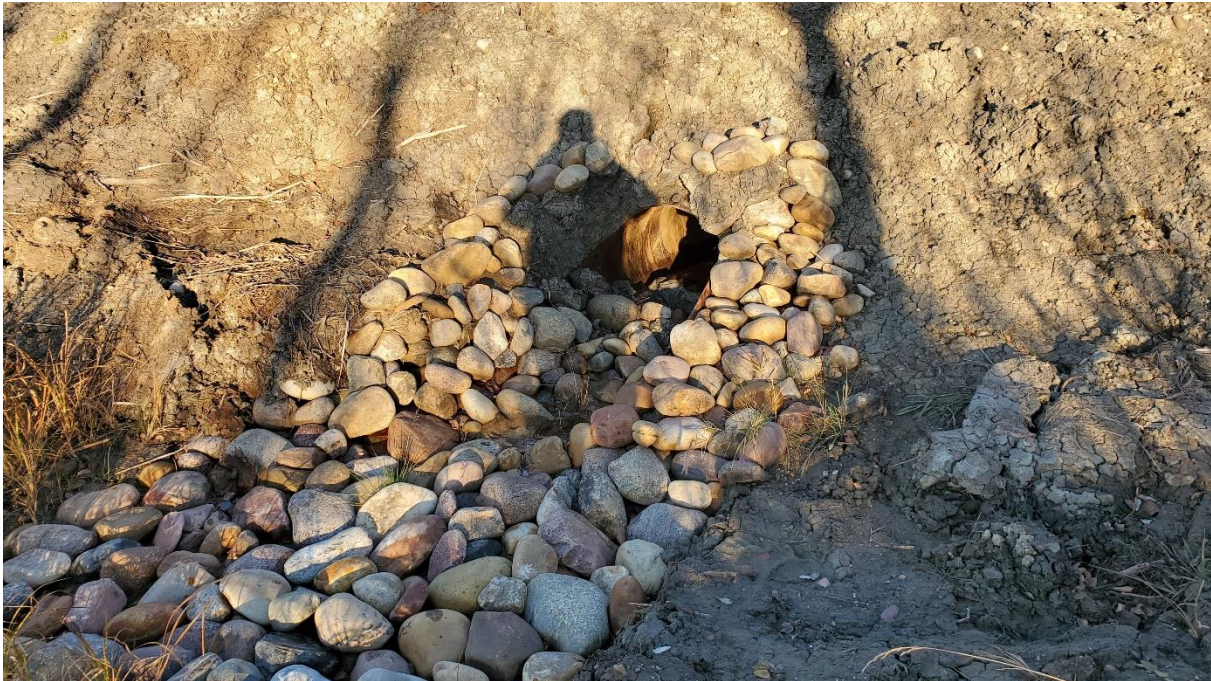
There was some minor seepage noted in the lower half of the west portion of scarp where the gravel was wetter. Seepage was also observed along the sideslope at the base of the gravel on both the west and east sides of the slide. The culvert outlet was still exposed although the new riprap was somewhat disturbed. At the inlet, it was noted that minor material excavated during installation had been pulled away to the north essentially damming the flow into the culvert.

Photo 5 (Oct. 28) – Toe roll around culvert outlet

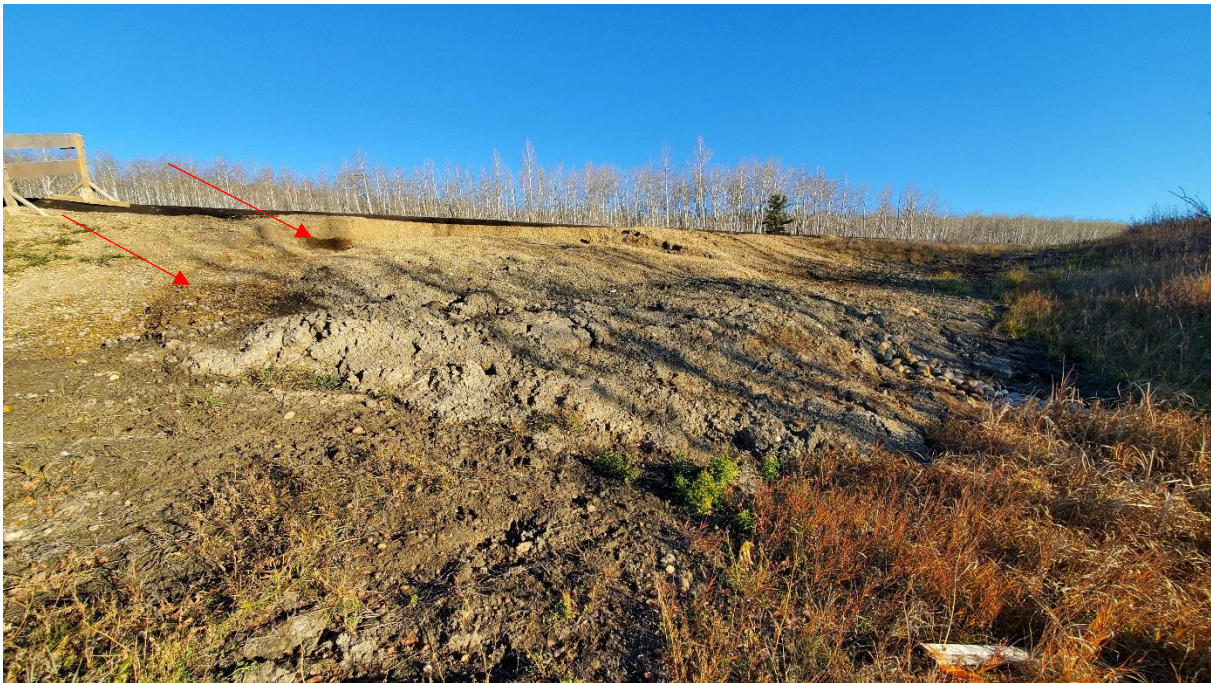
Photo 6 (Oct. 28) – Looking northwest at slump. Seepage marked by arrows.

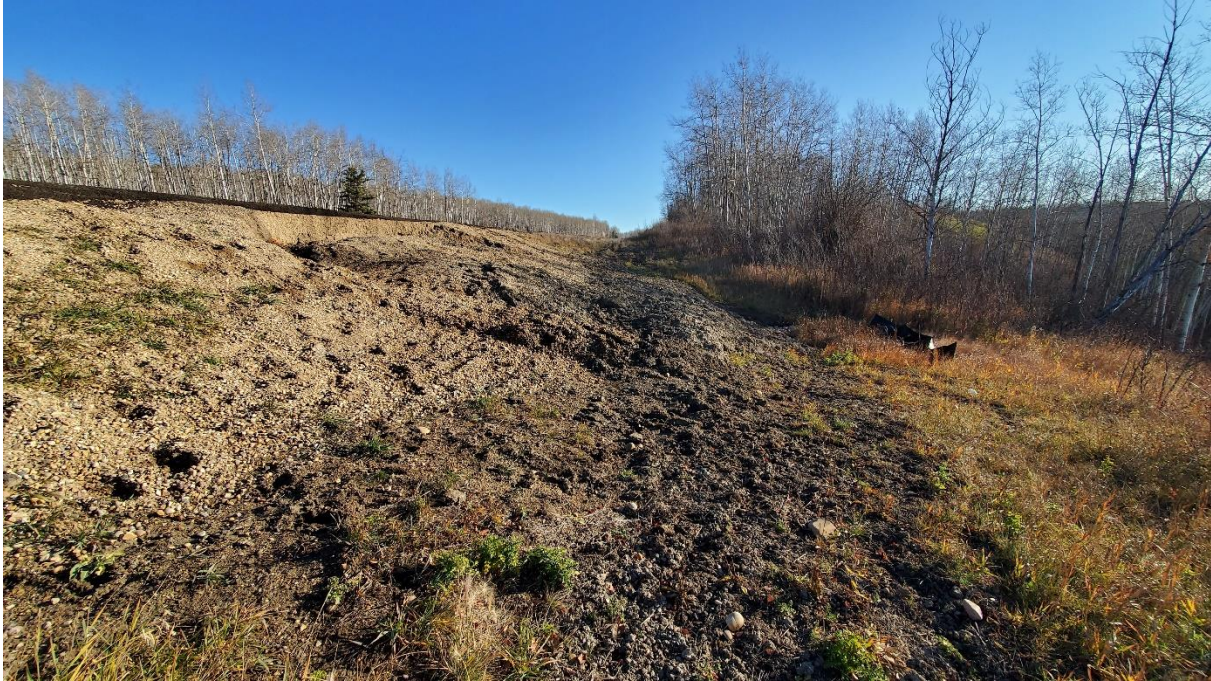
Photo 7 (Oct. 28) – Looking west at profile of the slide.

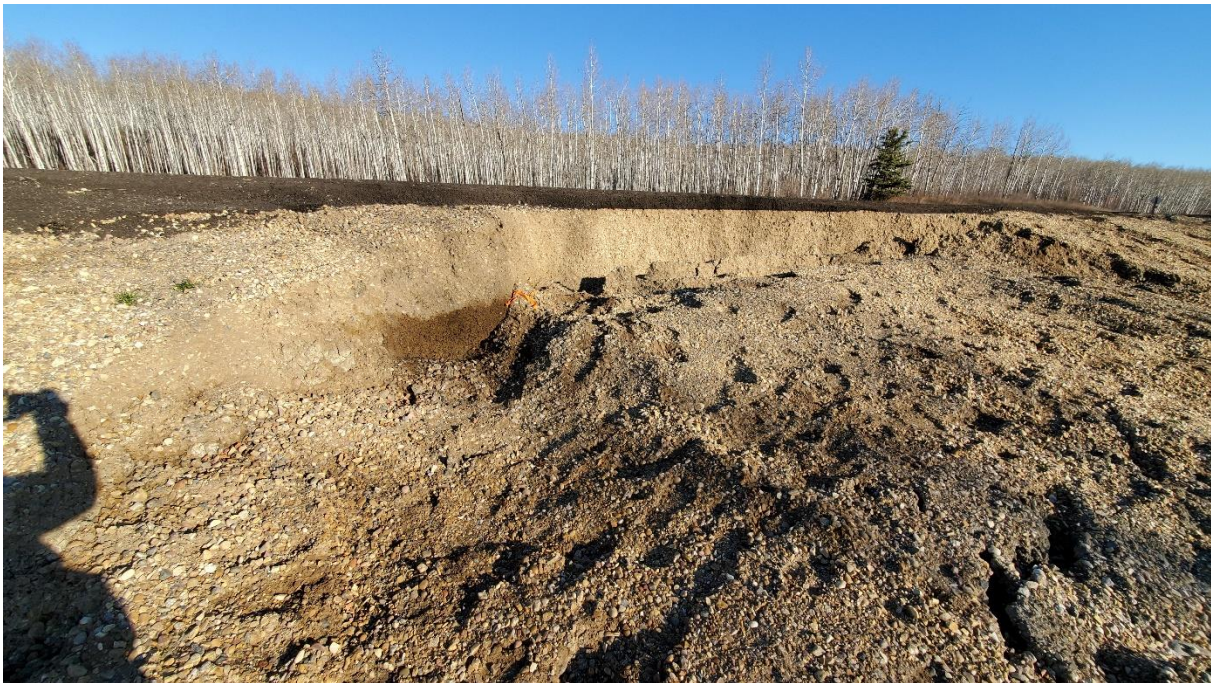
Based on the absence of significant disturbance at the inlet, it is assumed the culvert was bored through the highway from the outlet. Thus, a portion of the slumped area will have been excavated for the equipment to install the culvert. It was observed that the gravel and fill at the surface of the slump were relatively soft and loose.

Photo 8 (Oct. 28) – Closer view of the scarp. Note the seepage on the left hand side and the depth of the footprints in the loose material.

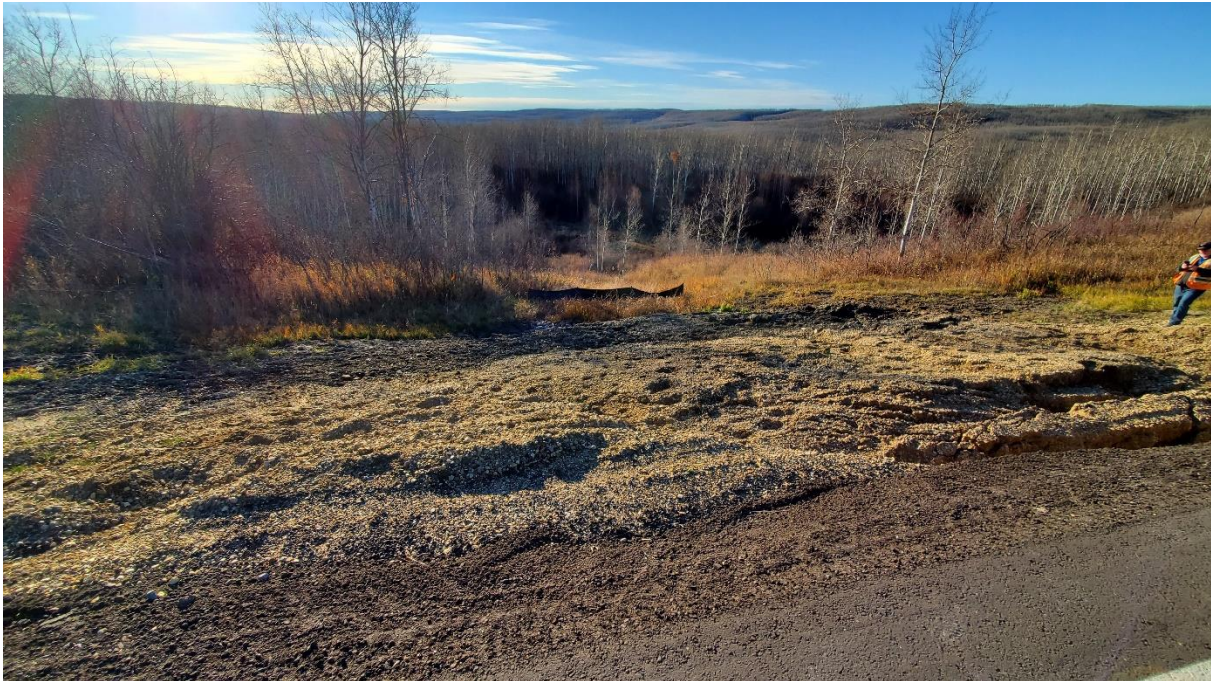
There was a silt fence installed during construction at the top of this feature presumably to intercept sediment from the culvert flow. The fence is 5.7 m long. On either side of the fence, there were cracks, and it was not apparent if they were the result of a cut for installing the silt fence or if the silt fence had been installed into a tension crack. This crack extended 1.5 m further west and 1.9 m further east of the silt fence. The silt fence is about 2.6 m to the north of the scarp at the top of the gully.

Photo 9 (Oct. 28) – Looking south down the slump towards the silt fence at the top of the gully to the sag pond below.

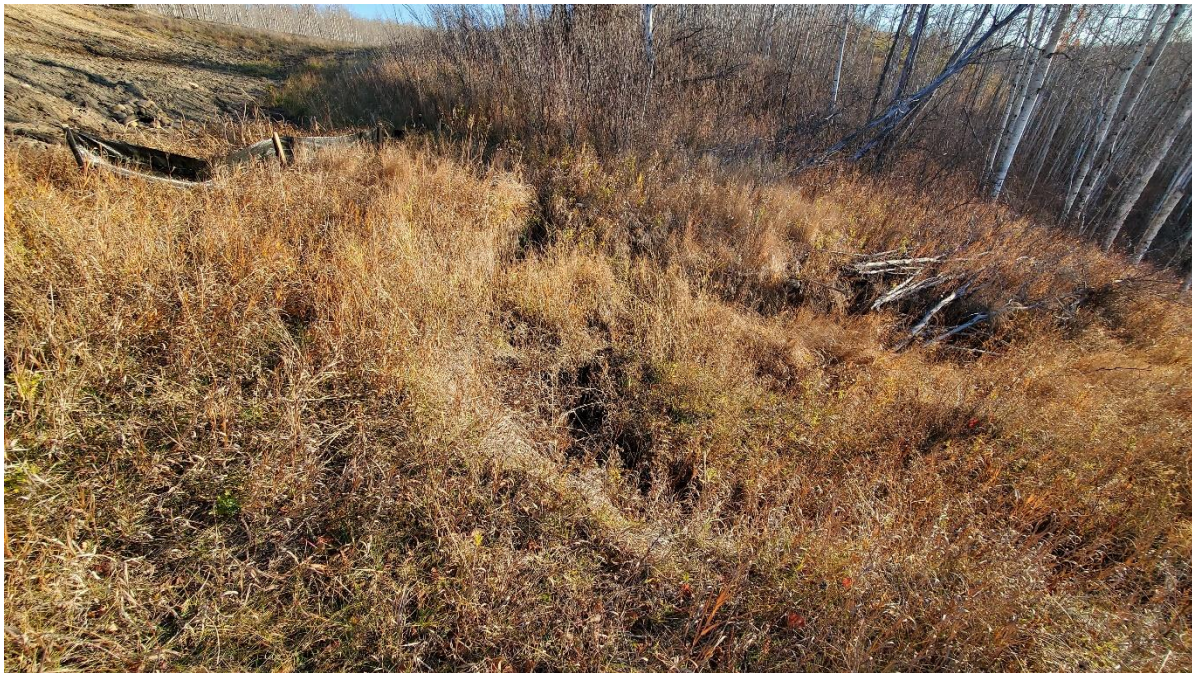
There is a retrogressive scarp about 5 m in width located further downslope and just west of the culvert outlet that was likely triggered by erosion. It was first observed in 2019 and is located at the top of a gully leading down to a sag pond. There was concern that this feature would retrogress

Photo 10 (Oct. 28) – Crest of the slump at the top of the gully.

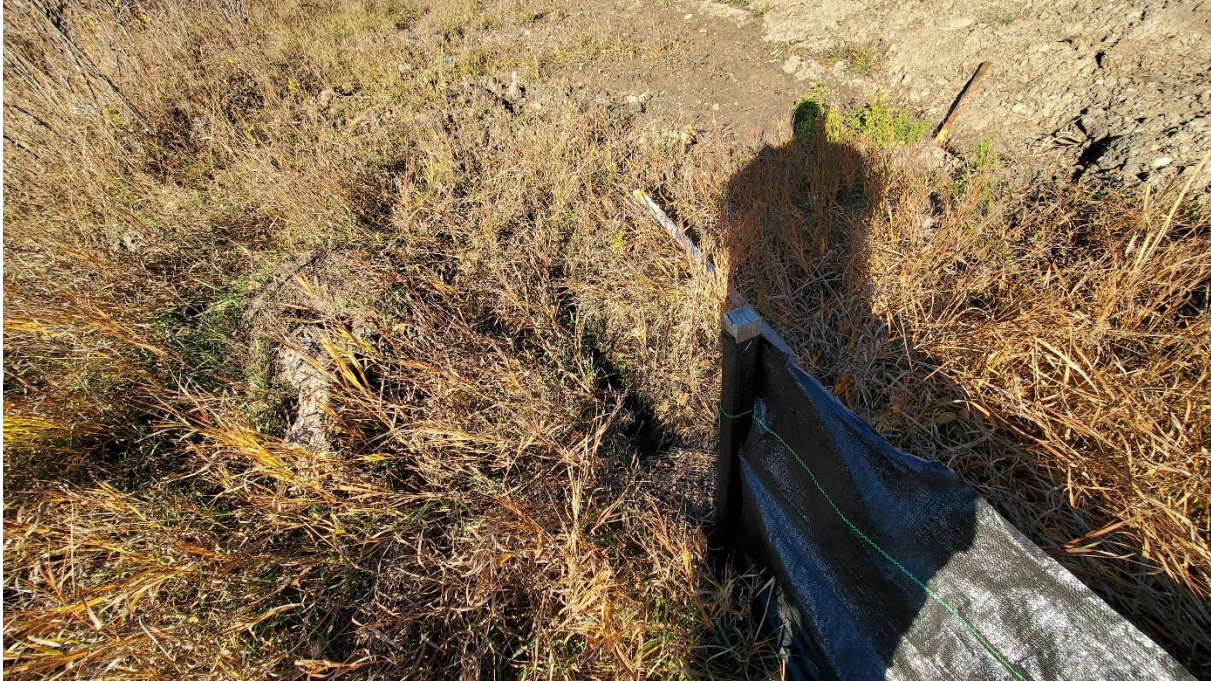
Photo 11 (Oct. 28) – Crack or trench on the west side of the silt fence. Also, note the soft, wet area toward the top of the photo.

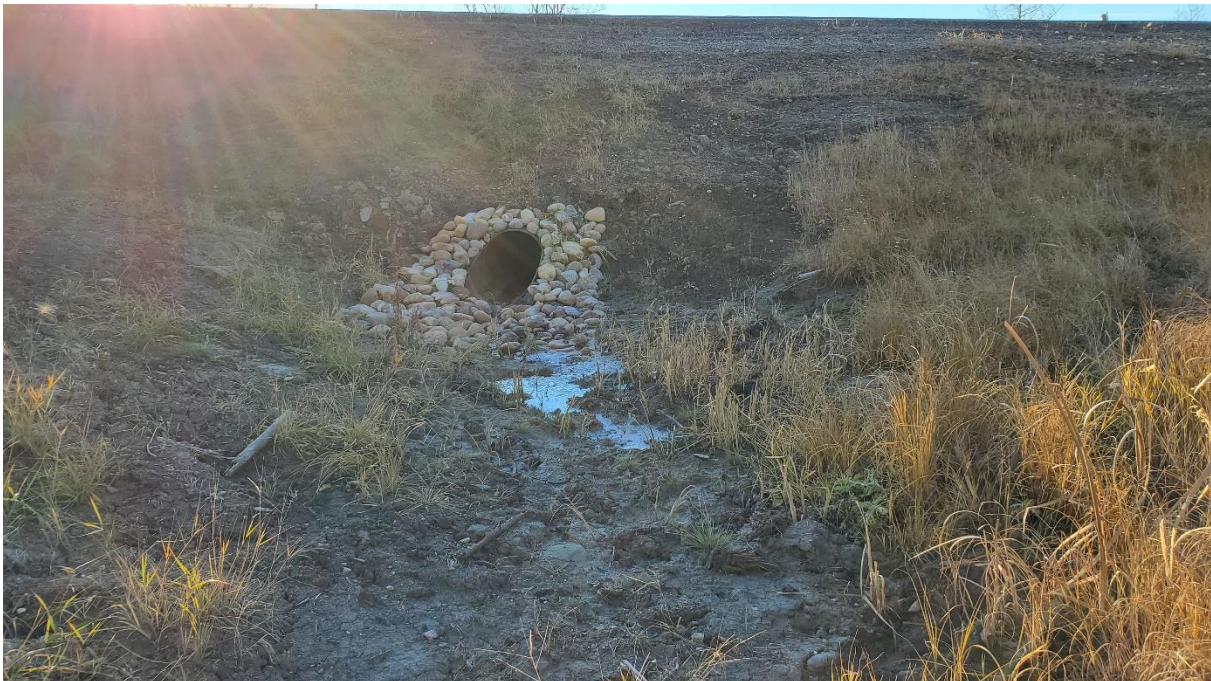
Photo 12 (Oct. 28) – New culvert inlet. Note that inlet seems a bit high.

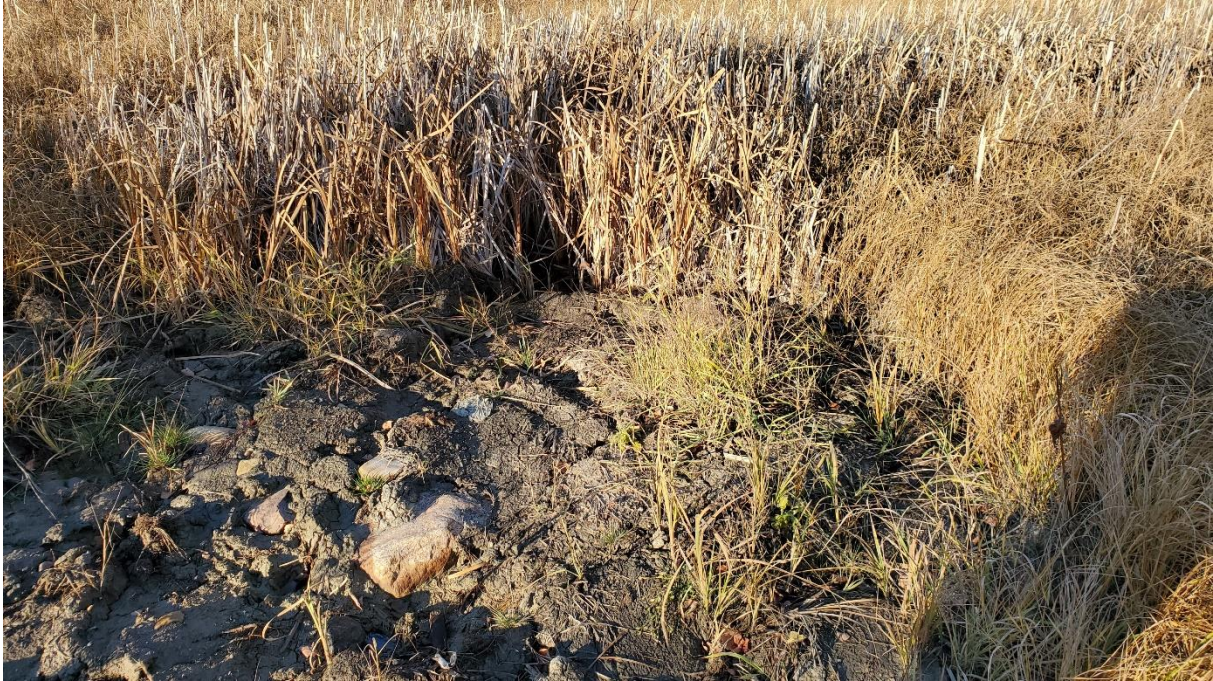
Photo 13 (Oct. 28) – Mound of material upstream/upslope of the culvert inlet blocking drainage from the slough.

- The excavation should extend at least 1 m beyond the edges of the slumped material including into the roadway surface.
- A temporary excavation cut face of 1H:1V is acceptable for this low-height embankment.
- Pit-run gravel is suitable for backfill except for the granular base course portion of the pavement surfacing.
- Non-woven geotextile should be placed along the base and three sides of the excavation.
- Three layers of uniaxial geogrid should be placed within the gravel: one at about 150 mm above the base, one at the 1/3 height, and one at the 2/3 height. The geogrid layers should extend from the back and sides of the excavation to the face of the fill.
- The material that is blocking drainage near the inlet of the culvert should be smoothed out to allow the ditch to drain freely into the culvert.

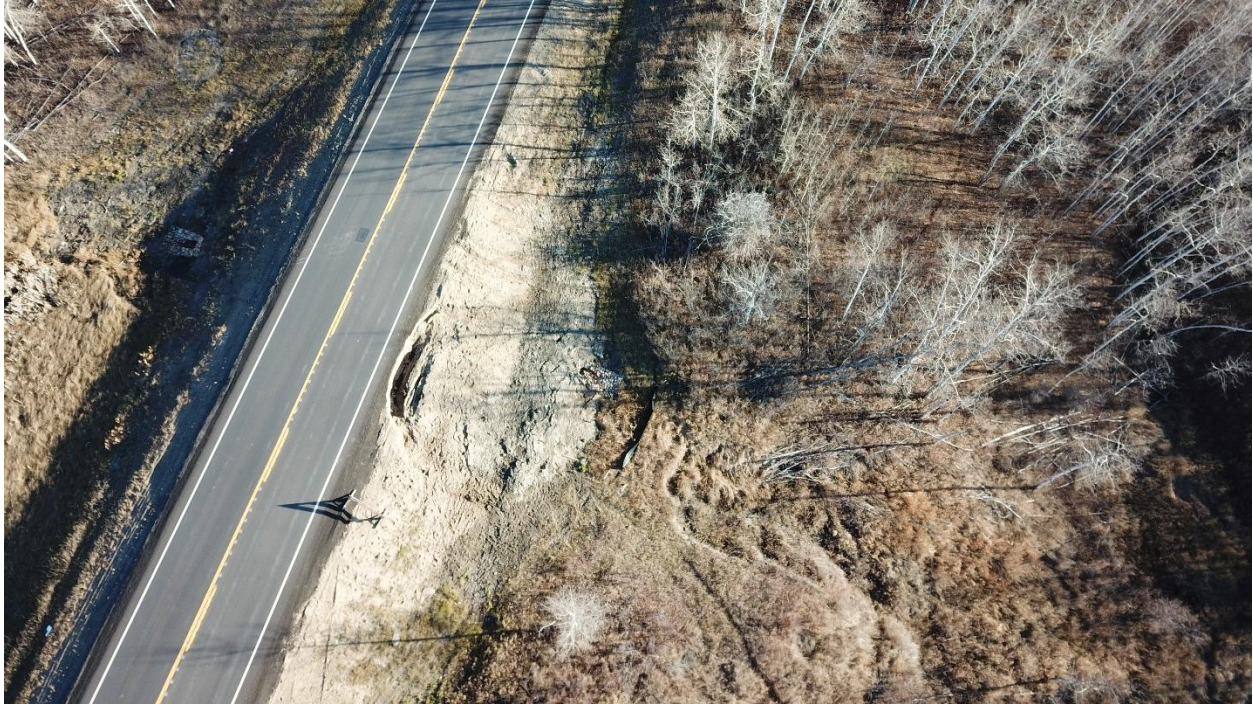
October 28, 2021 - UAV Photo of slide and new culvert. Sag pond is to the right.

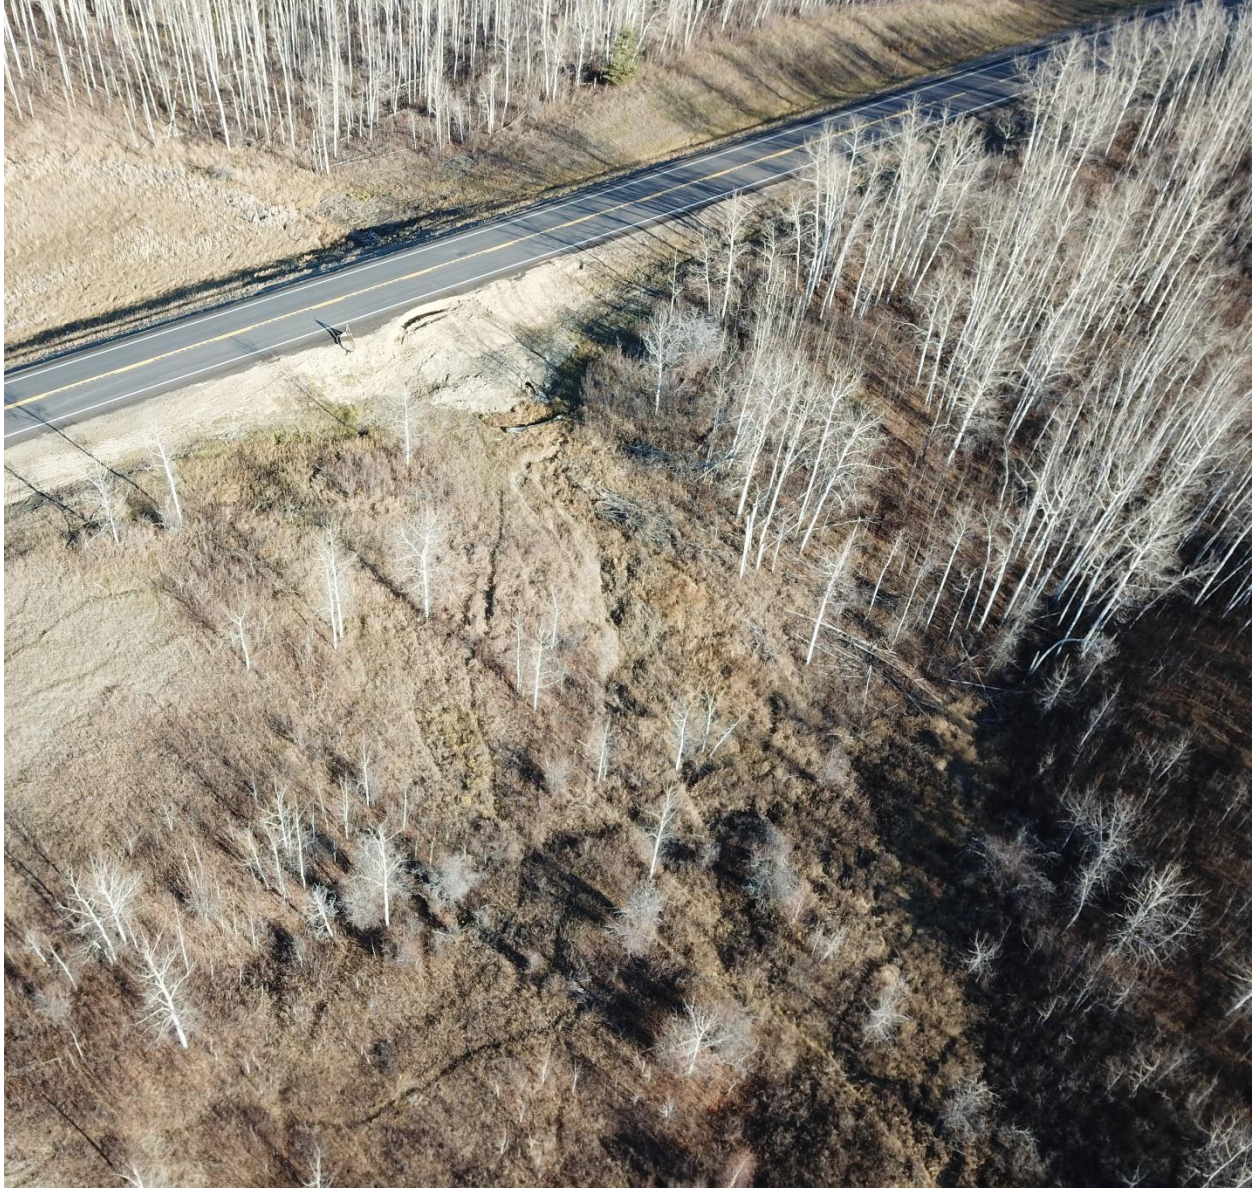
October 28, 2021 - UAV Oblique Photo of slump, gully, and sag pond.

A potential longer term issue at this site is that water from the culvert drains onto the unstable area further downslope. The risk of this instability retrogressing close to the road could be reduced if the flow from the SWSP could be directed via a riprap lined ditch into the bush further away from the downslope instability. This might add another \$15,000 to the cost.
