**ALBERTA TRANSPORTATION
GEOHAZARD ASSESSMENT PROGRAM
PEACE REGION – SWAN HILLS
2022 INSPECTION**

Site Number	Location	Name	Hwy	km
SH022-5 SH022-6	Little Smoky River	Little Smoky River Valley, North Hill – Sites #5 and #6	744:02	19.00-19.14 19.20-19.53
Legal Description		UTM Co-ordinates		
Site 5: SW21-76-22-W5M		11U E 477,204	N	6,161,204
Site 6: SW21-76-22-W5M		11U E 477,479	N	6,161,291

**SH022-5: HWY 744:02 LITTLE SMOKY RIVER VALLEY
2022 SITE INSPECTION PLAN**

**SH022-6: HWY 744:02 LITTLE SMOKY RIVER VALLEY
2022 SITE INSPECTION PLAN**

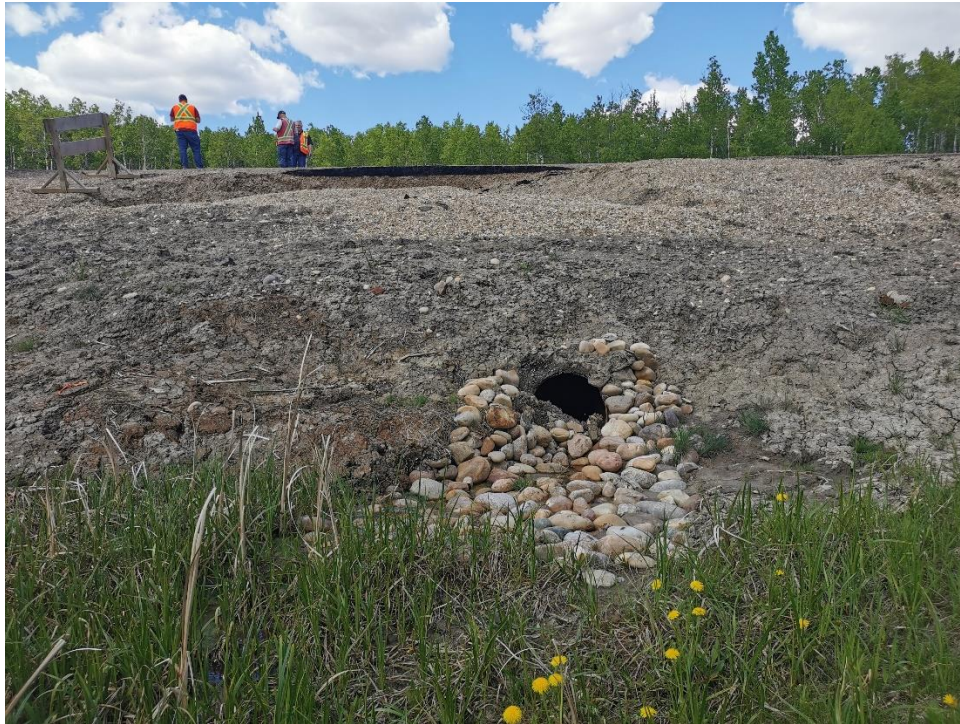
Observations (Site 5):	Description	Worsened?	
<input checked="" type="checkbox"/> Pavement Distress	Site was recently overlaid. Some of the previous longitudinal and traverse cracks have reflected through.	<input checked="" type="checkbox"/>	
<input checked="" type="checkbox"/> Slope Movement	Site is located on an active deep-seated landslide moving toward the Little Smoky River. There is a significant scarp located about 20 m downslope from the pavement edge at km 19.06.	<input checked="" type="checkbox"/>

Photo 1, Site 5 – Looking north at slump that has formed at the north edge of the deep landslide depression adjacent to the highway at about km 19.06. Culvert outlet partially blocked with debris.

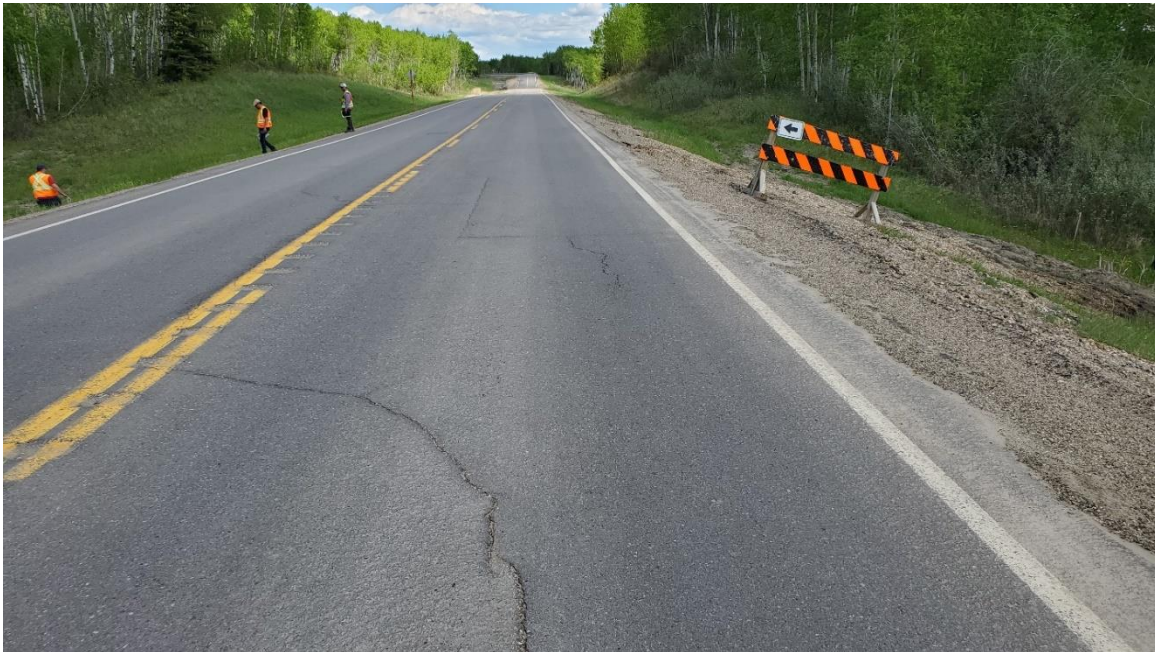
Photo 2, Site 5 – Looking east at crack pattern and slide at edge of right shoulder.

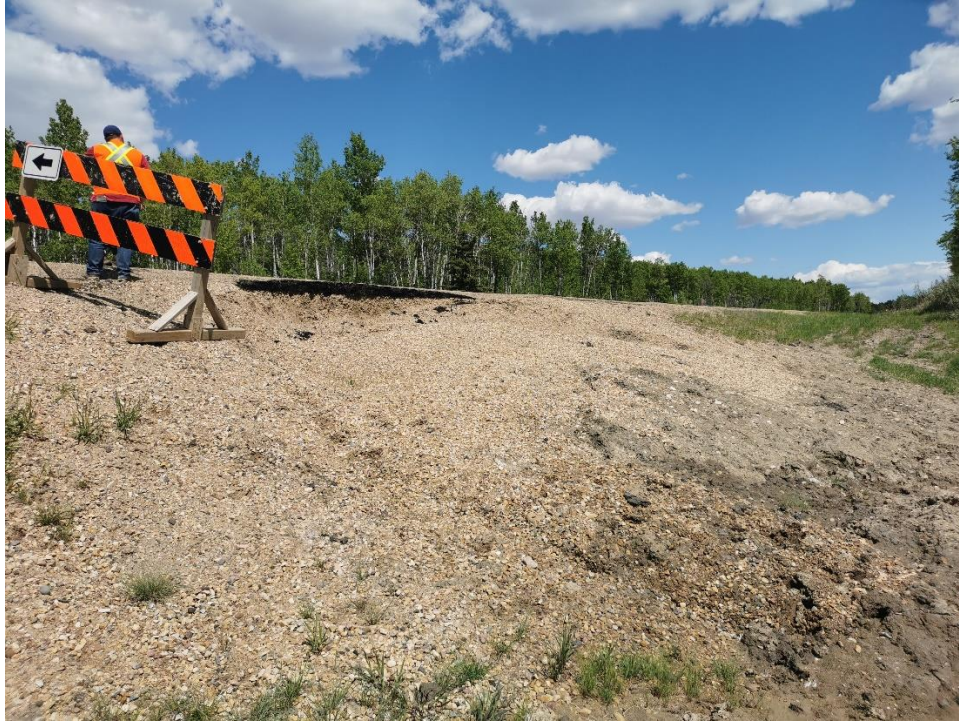
Photo 3: Looking east at the fill placed over the 2020 slump during the highway overlay in 2021.

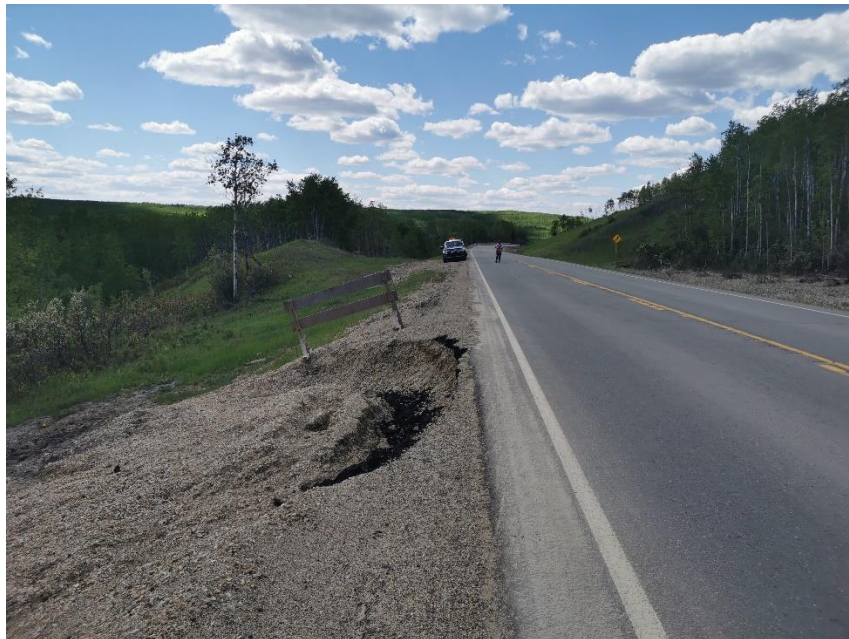
A new slide formed at the edge of pavement in 2020 at km 19.07 and continues to move.	
<input type="checkbox"/> Erosion		<input type="checkbox"/>
<input type="checkbox"/> Seepage		<input type="checkbox"/>
<input checked="" type="checkbox"/> Bridge/Culvert Distress	Culvert at km 19.07: inlet is partially blocked and too high and outlet is partly obstructed by slide debris.	<input checked="" type="checkbox"/>
<input type="checkbox"/> Other		<input type="checkbox"/>
Observations (Site 6):	Description	Worsened?
<input checked="" type="checkbox"/> Pavement Distress	Site was recently overlaid. Some of the previous longitudinal and traverse cracks have reflected through.	<input checked="" type="checkbox"/>
<input checked="" type="checkbox"/> Slope Movement	Site is located on an active deep-seated landslide moving toward the Little Smoky River. This site crosses over a sag pond/graben.	<input checked="" type="checkbox"/>

Photo 4, Site 5: Looking west at slide over the culvert outlet at km 19.07.

- Preliminary engineering should be undertaken for short-term repair of the 2020 slide at km 19.07. Consideration should be given to replacing and extending the culvert at this location at the same time to ensure that the discharge is controlled (elephant trunk down to sag pond). It is anticipated that a local excavation and replacement with geo-grid reinforced gravel will be the simplest solution; the potential for the lower slide at km 19.06 to retrogress into the highway at this location should also be considered in the design.
- Although the culvert at km 19.07 (Site 5) was just installed, it should be replaced as the inlet is too high to adequately drain the upslope sag pond and limit infiltration.
- The grading at the culvert outlet at km 19.23 (Site 6) should be re-evaluated to determine if the water can be drained away from the outlet to limit ponding and infiltration.

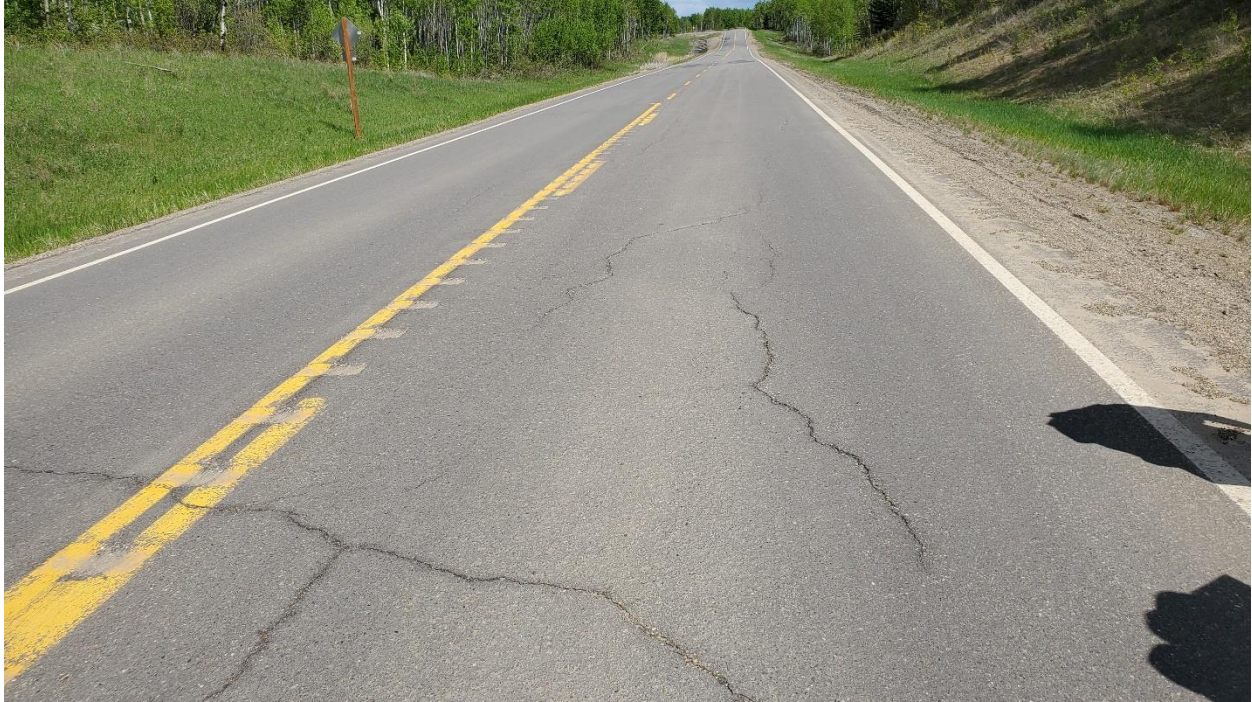
Photo 5, Site 5 – Looking northeast at intermittent cracking between km 19.10 to km 19.13.

- Road maintenance should continue as necessary to maintain a safe roadway surface and may consist of milling, patching, and crack sealing of the ACP.

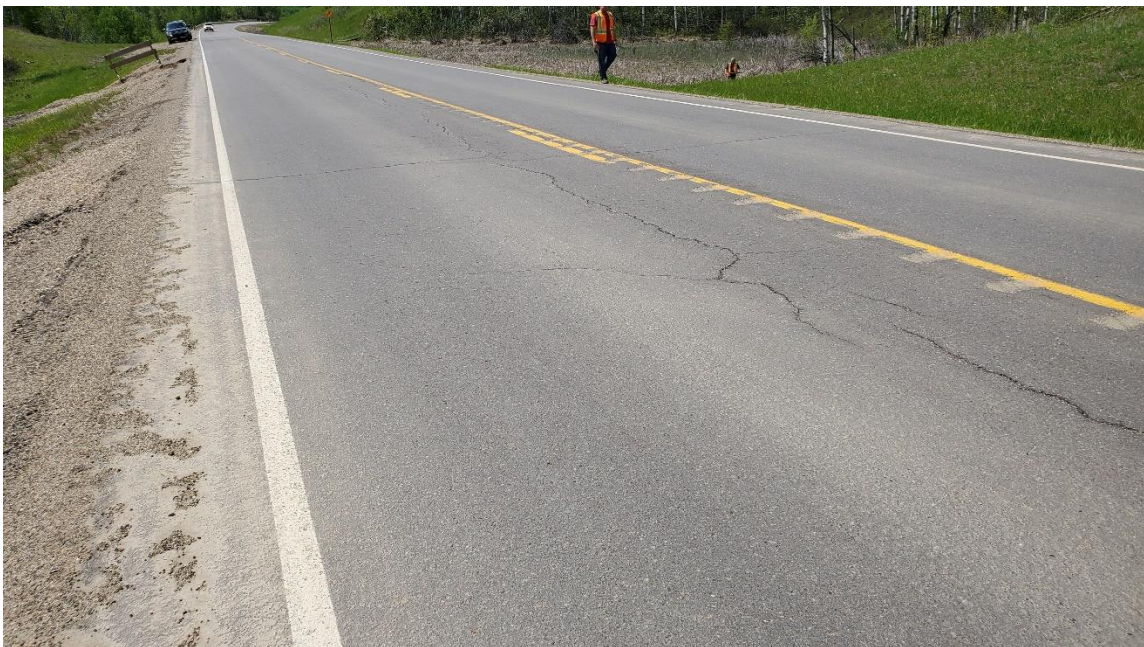
Photo 6, Site 5 – Looking southwest at intermittent cracking between km 19.10 to km 19.13.

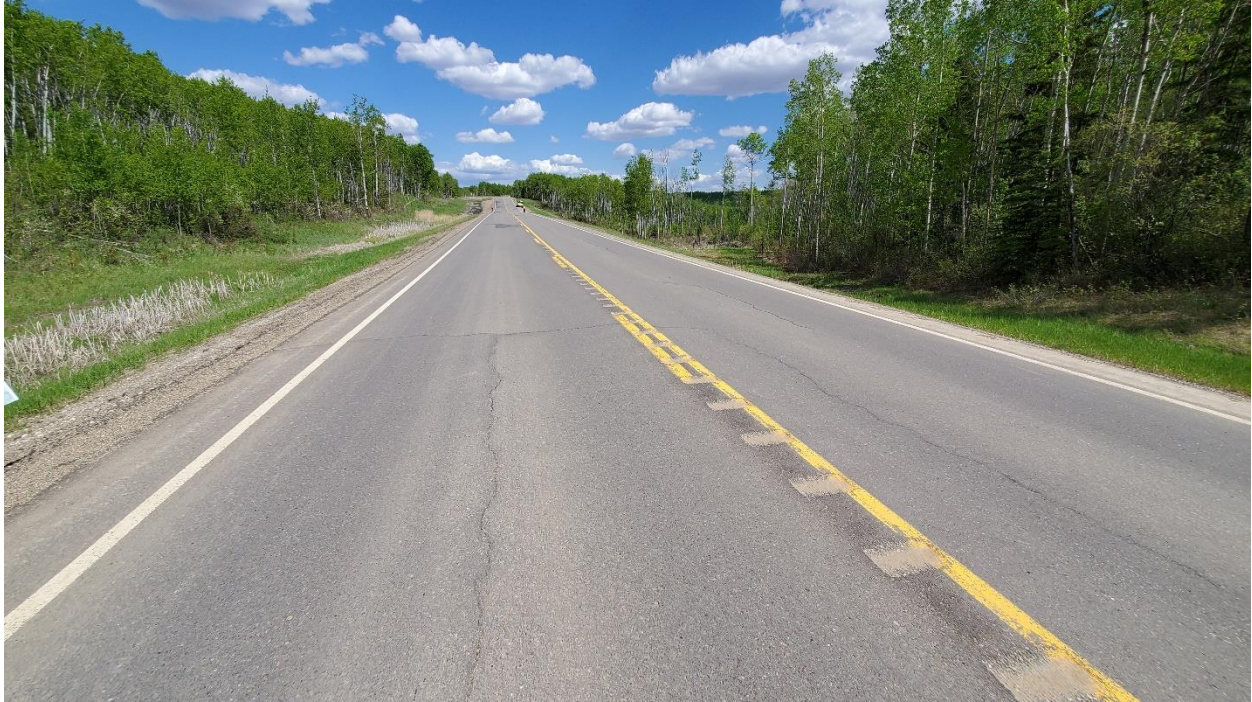
Photo 7, Site 6 – Looking northeast at cracks on the road south of the culvert.

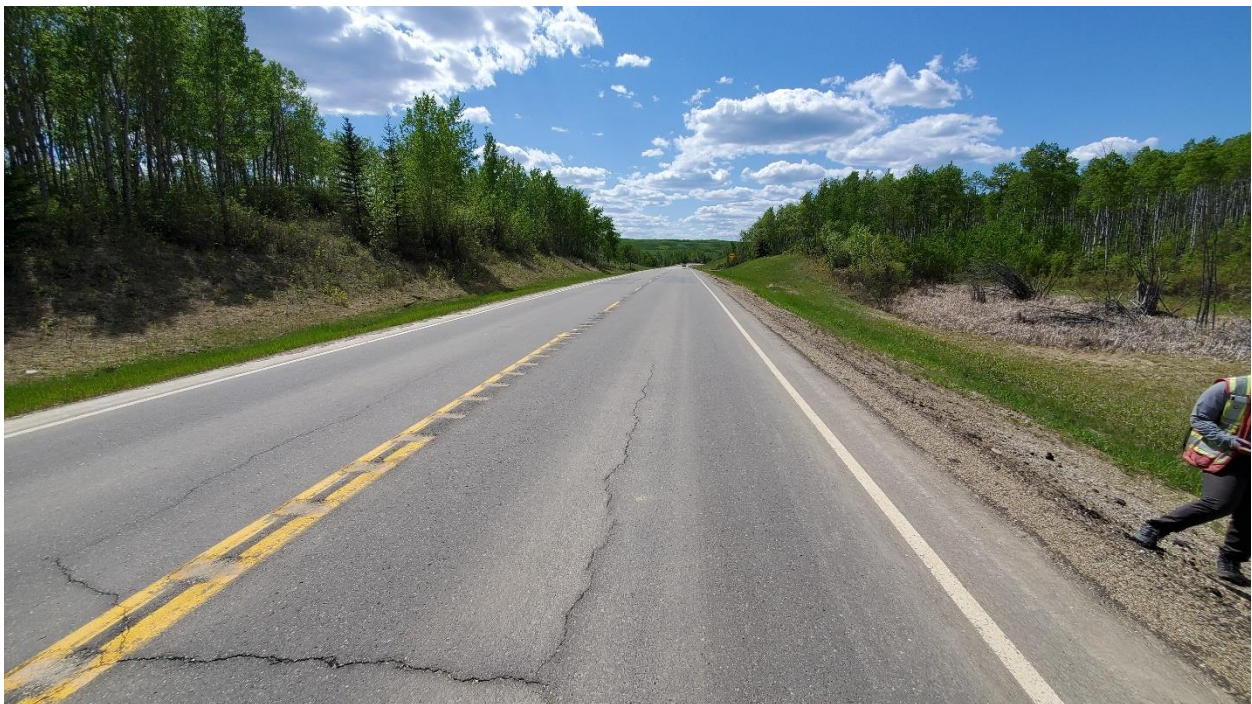
Photo 8, Site 6 – Looking west at west end of Site #6 toward Site #5.

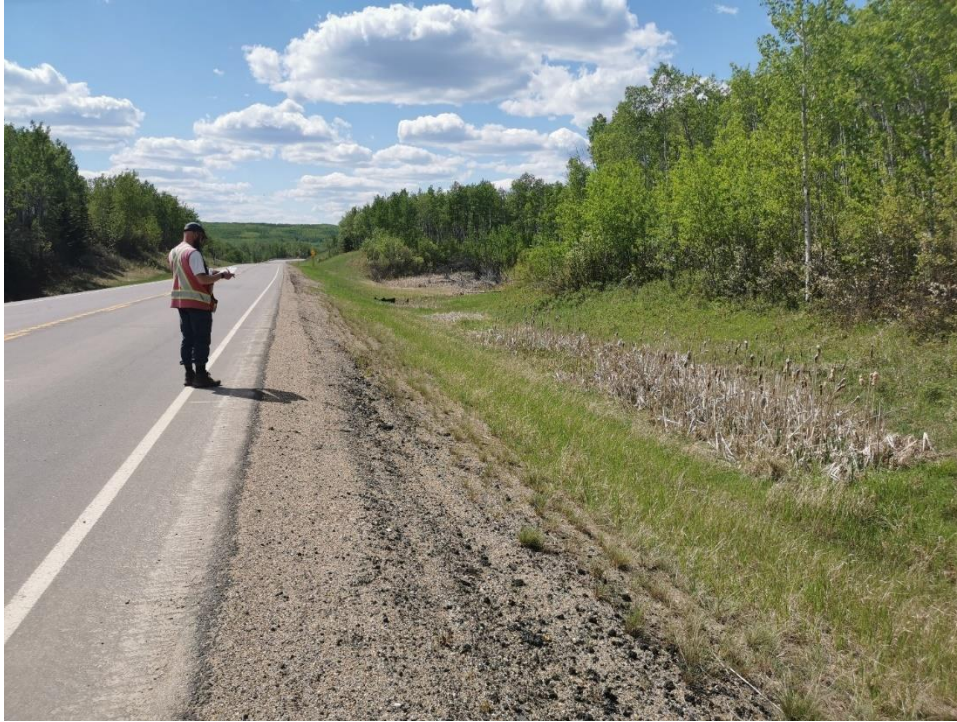
Photo 9, Site 6 – Looking west at cattails in gully at km 19.3.

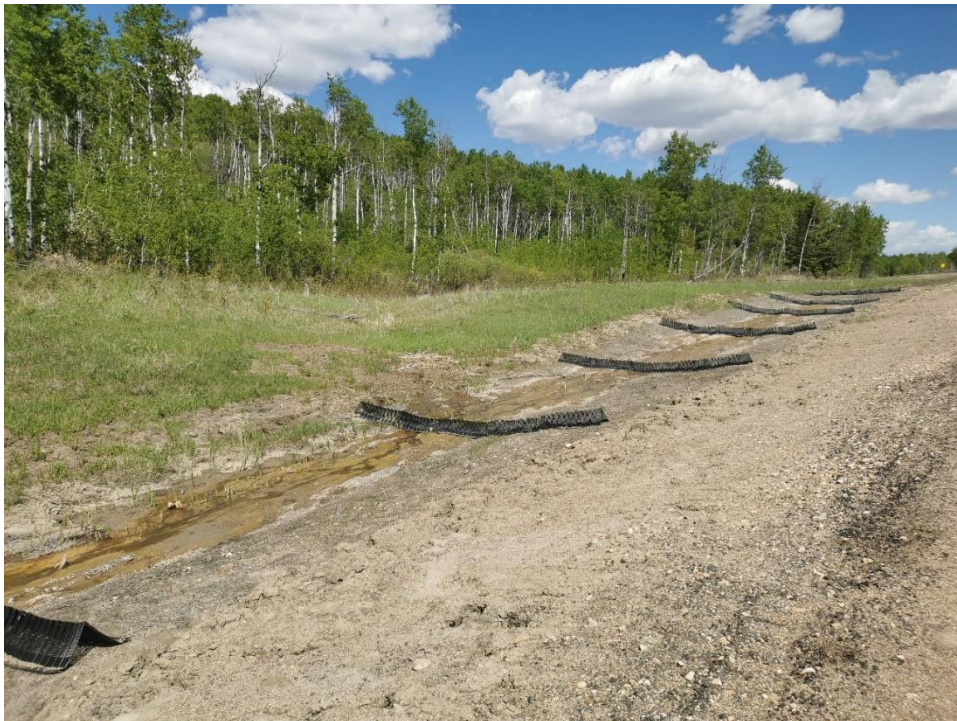
<input checked="" type="checkbox"/> Erosion	An erosion gully is present at km 19.40. The ditch was lined with erosion control products during the 2021 overlay.	<input type="checkbox"/>
<input type="checkbox"/> Seepage		<input type="checkbox"/>
<input checked="" type="checkbox"/> Bridge/Culvert Distress	New SWSP culvert installed at km 19.23 is not draining. Ponded water observed at inlet and outlet.	<input checked="" type="checkbox"/>
<input type="checkbox"/> Other		<input type="checkbox"/>
Instrumentation: None.		
Assessment:		
<p>The overall valley slope is moving as several separate slide blocks in response to the toe erosion and downcutting of two different rivers resulting in numerous scarps, sag ponds, and differential movement zones going in slightly different directions. The highway intersects the scarps of these blocks at several locations resulting in an uneven highway surface and cracking.</p> <p>Site 5: Cracks have started to re-appear on the road surface after the highway was overlaid last year (2021). Given the overall valley condition, continued creep movement is expected which may manifest as increased crack lengths, widths, and height differential as well as vertical pavement distortion. The retrogressive scarp about 5 m in width located at km 19.06, just beyond the culvert outlet at km 19.07, was likely triggered by erosion, had widened somewhat in 2020 but did not appear to have advanced closer to the highway as was also observed in the 2022 inspection. However, the 2020 slide in the highway embankment has become re-established after the grading work completed in 2021 and is now 0.75 m from the fog line. The toe roll was partially obstructed the culvert outlet.</p> <p>Site 6: Cracks have started to re-appear on the road surface after the highway was overlaid last year (2021). Given the overall valley condition, continued creep movement is expected which may manifest as increased crack lengths, widths, and height differential as well as vertical pavement distortion. The erosion feature at km 19.40 was repaired with a portion of the north ditch regraded and erosion controls measures installed including matting and GeoRidges. The portion of the north ditch that doesn't have the erosion control measures in place has cattails present, indicating poor drainage over a portion of the ditch. The new smooth wall steel pipe culvert that replaced the old culvert is not draining as pooled water was observed at the inlet and outlet.</p>

Photo 10, Site 6 – Looking northeast at matting and Georidges installed in the upslope ditch.

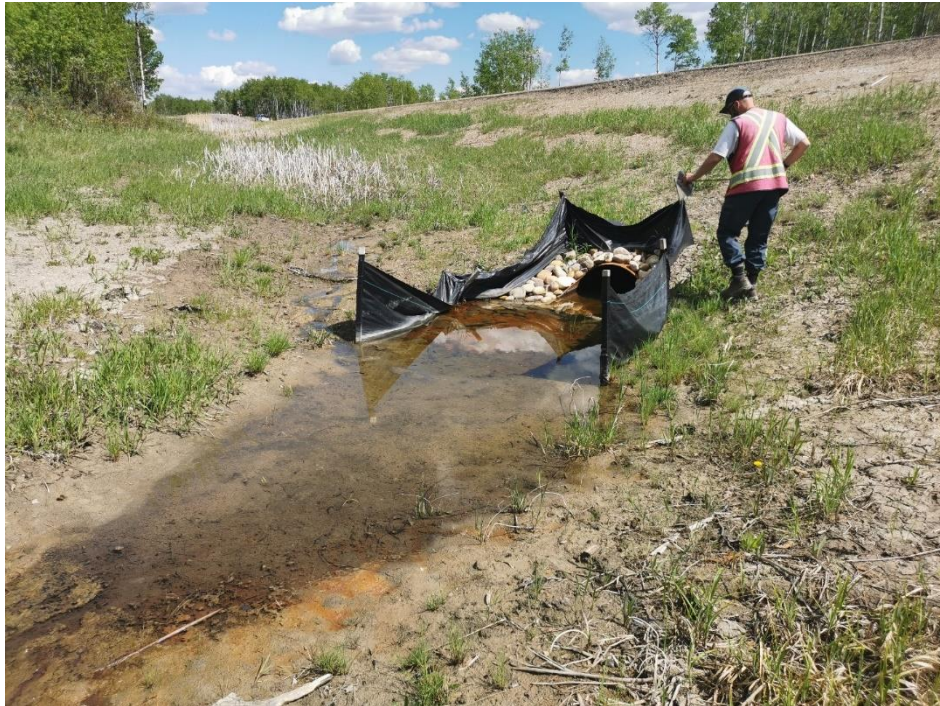
Photo 11, Site 6 – Looking southeast at inlet of new culvert that has pooled water because it is not draining.

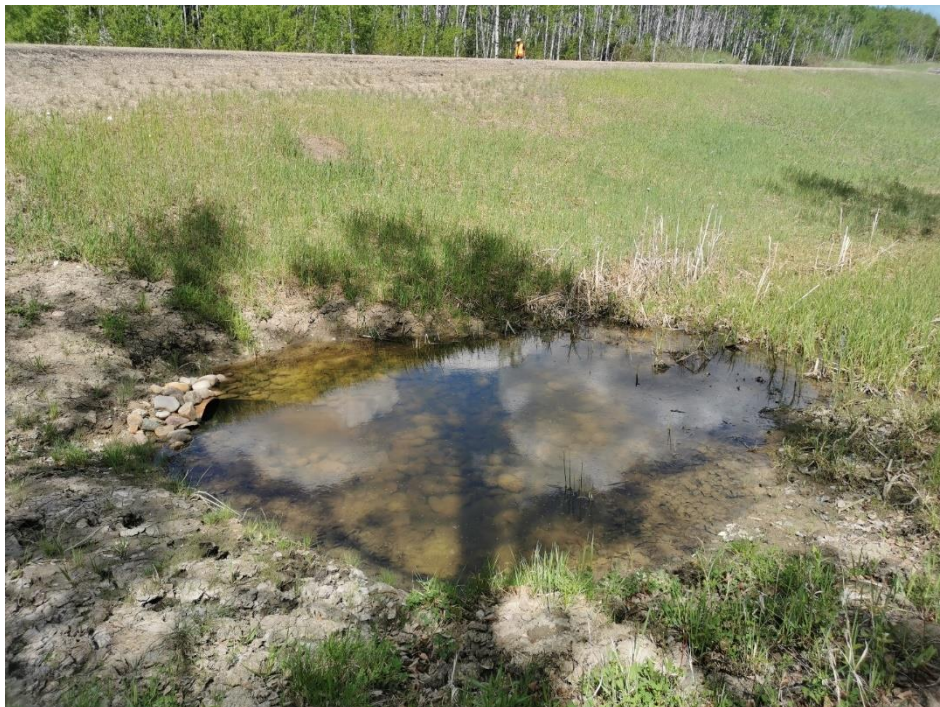
Photo 12, Site 6 – Looking northeast at new culvert outlet that has pooled water because it is not draining.
