**ALBERTA TRANSPORTATION
GEOHAZARD ASSESSMENT PROGRAM
PEACE REGION – SWAN HILLS
2020 INSPECTION**

Site Number	Location	Name	Hwy	km
SH022-5 SH022-6	Little Smoky River	Little Smoky River Valley, North Hill – Sites #5 and #6	744:02	19.00-19.14 19.20-19.53
Legal Description		UTM Co-ordinates		
Site 5: SW21-76-22-W5M		11U E 477,204	N	6,161,204
Site 6: SW21-76-22-W5M		11U E 477,479	N	6,161,291

**SH022-5: HWY 744:02 LITTLE SMOKY RIVER VALLEY
2019 SITE INSPECTION PLAN**

**SH022-6: HWY 744:02 LITTLE SMOKY RIVER VALLEY
2020 SITE INSPECTION PLAN**

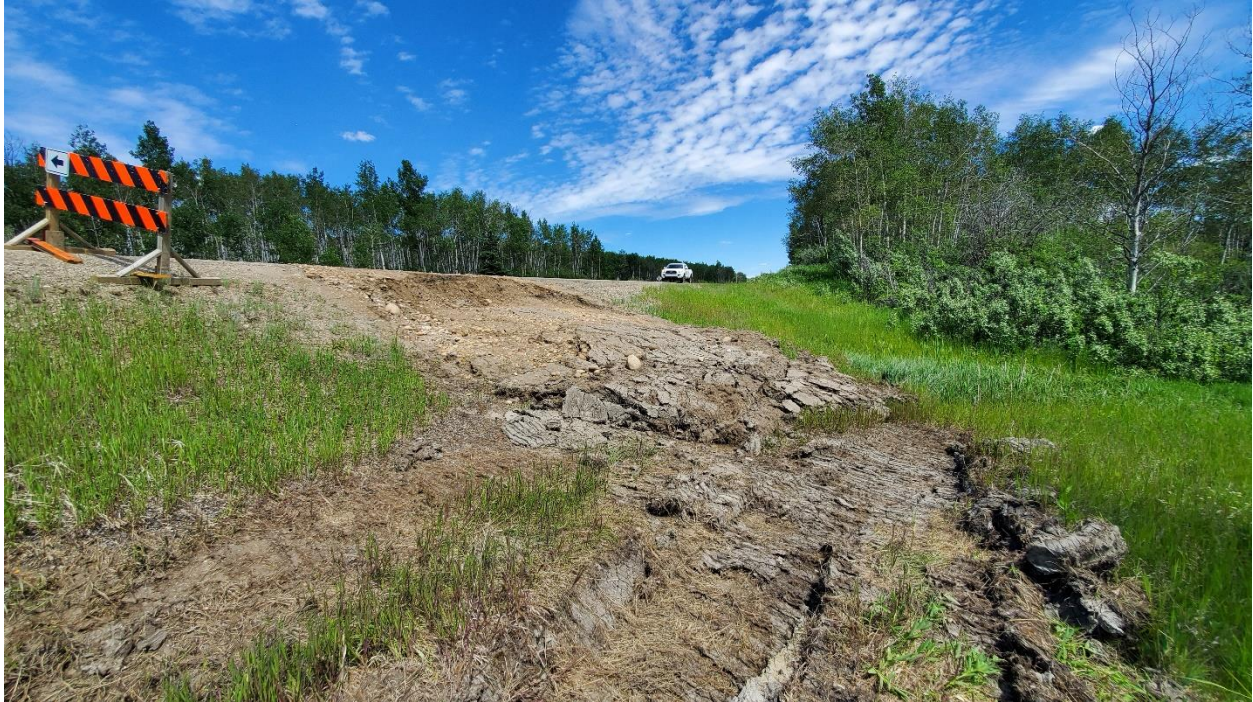
Photo 3, Site 5 (June 24, 2020): Emergency fill placed on the shoulder has also slumped.

- Preliminary engineering should be undertaken for short-term repair of the new slide at km 19.07. Consideration should be given to replacing the culvert at this location at the same time to ensure that the discharge is controlled (elephant trunk down to sag pond). It is anticipated that a local excavation and replacement with geo-grid reinforced gravel will be the simplest solution; the potential for the lower slide at km 19.06 to retrogress into the highway at this location should also be considered in the design.
- Culvert inlet and outlet at km 19.07 (Site 5) should be cleaned out and consideration given to replacing the culvert at a lower elevation to better drain the upslope sag pond and limit infiltration.
- Culvert inlet and outlet at km 19.23 (Site 6) should be cleaned out.
- Erosion gully at km 19.4 (Site 6) could be regraded and lined with erosion-resistant material(s).

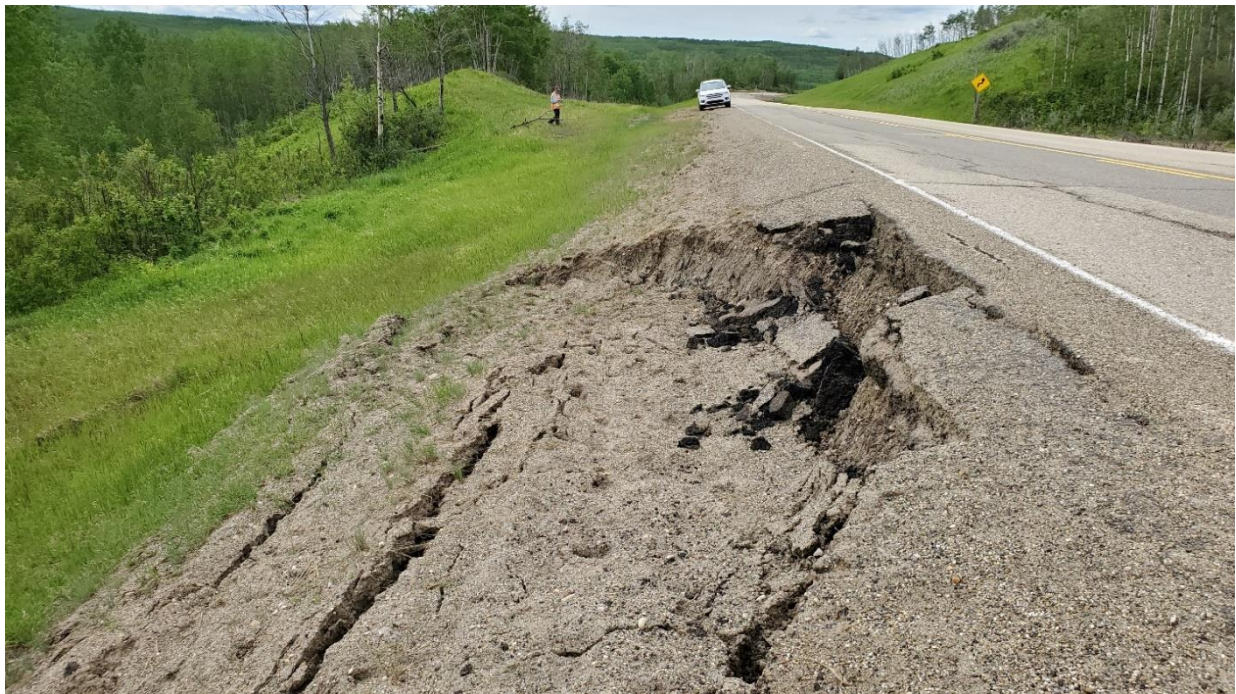
Photo 4, Site 5: Looking west at new slide over the culvert outlet at km 19.07.

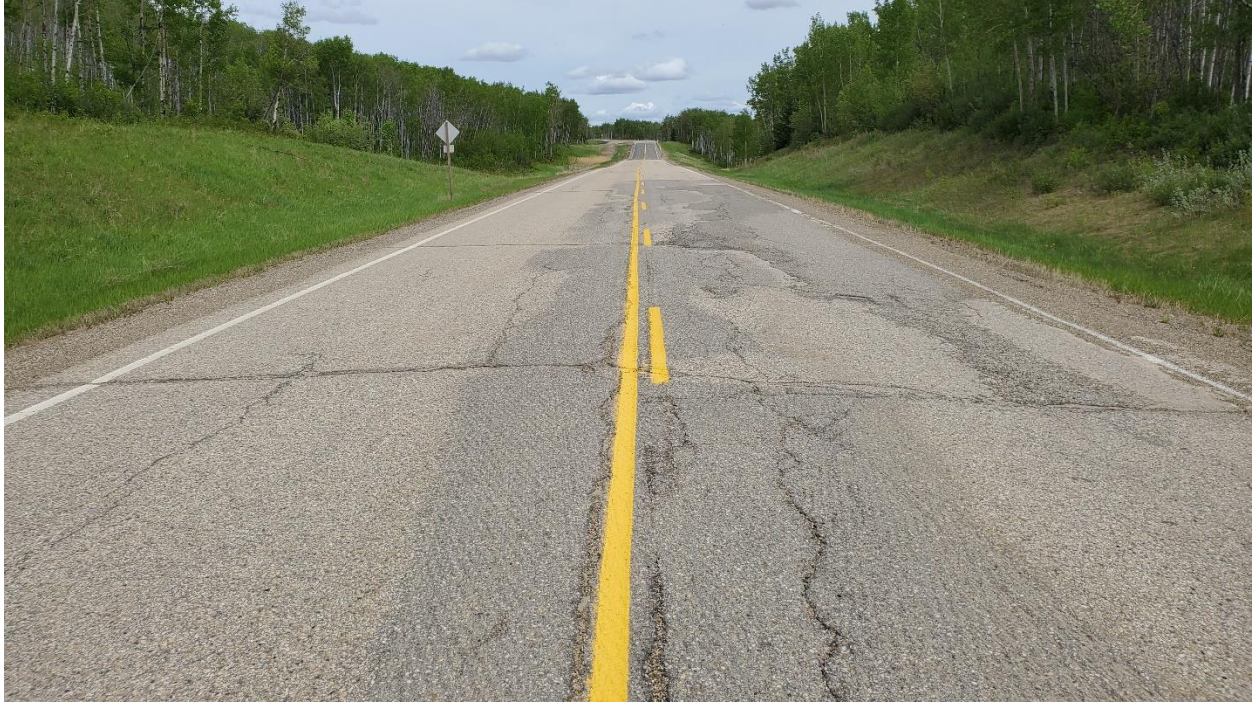
Photo 5, Site 5 – Looking northeast at partially-milled patch between km 19.10 to km 19.13.
