**ALBERTA TRANSPORTATION  
GEOHAZARD ASSESSMENT PROGRAM  
PEACE REGION – SWAN HILLS  
2020 INSPECTION**

Site Number	Location	Name	Hwy	km
SH022-7	Little Smoky River	Little Smoky River Valley, North Hill – Site #7	744:02	19-58-19.70*
<b>Legal Description</b>		<b>UTM Co-ordinates</b>		
SW21-76-22-W5M		11U E 477,732	N	6,161,398

**SH022-7: HWY 744:02 LITTLE SMOKY RIVER VALLEY  
2020 SITE INSPECTION PLAN**

DWG No. 13355-SH022-7

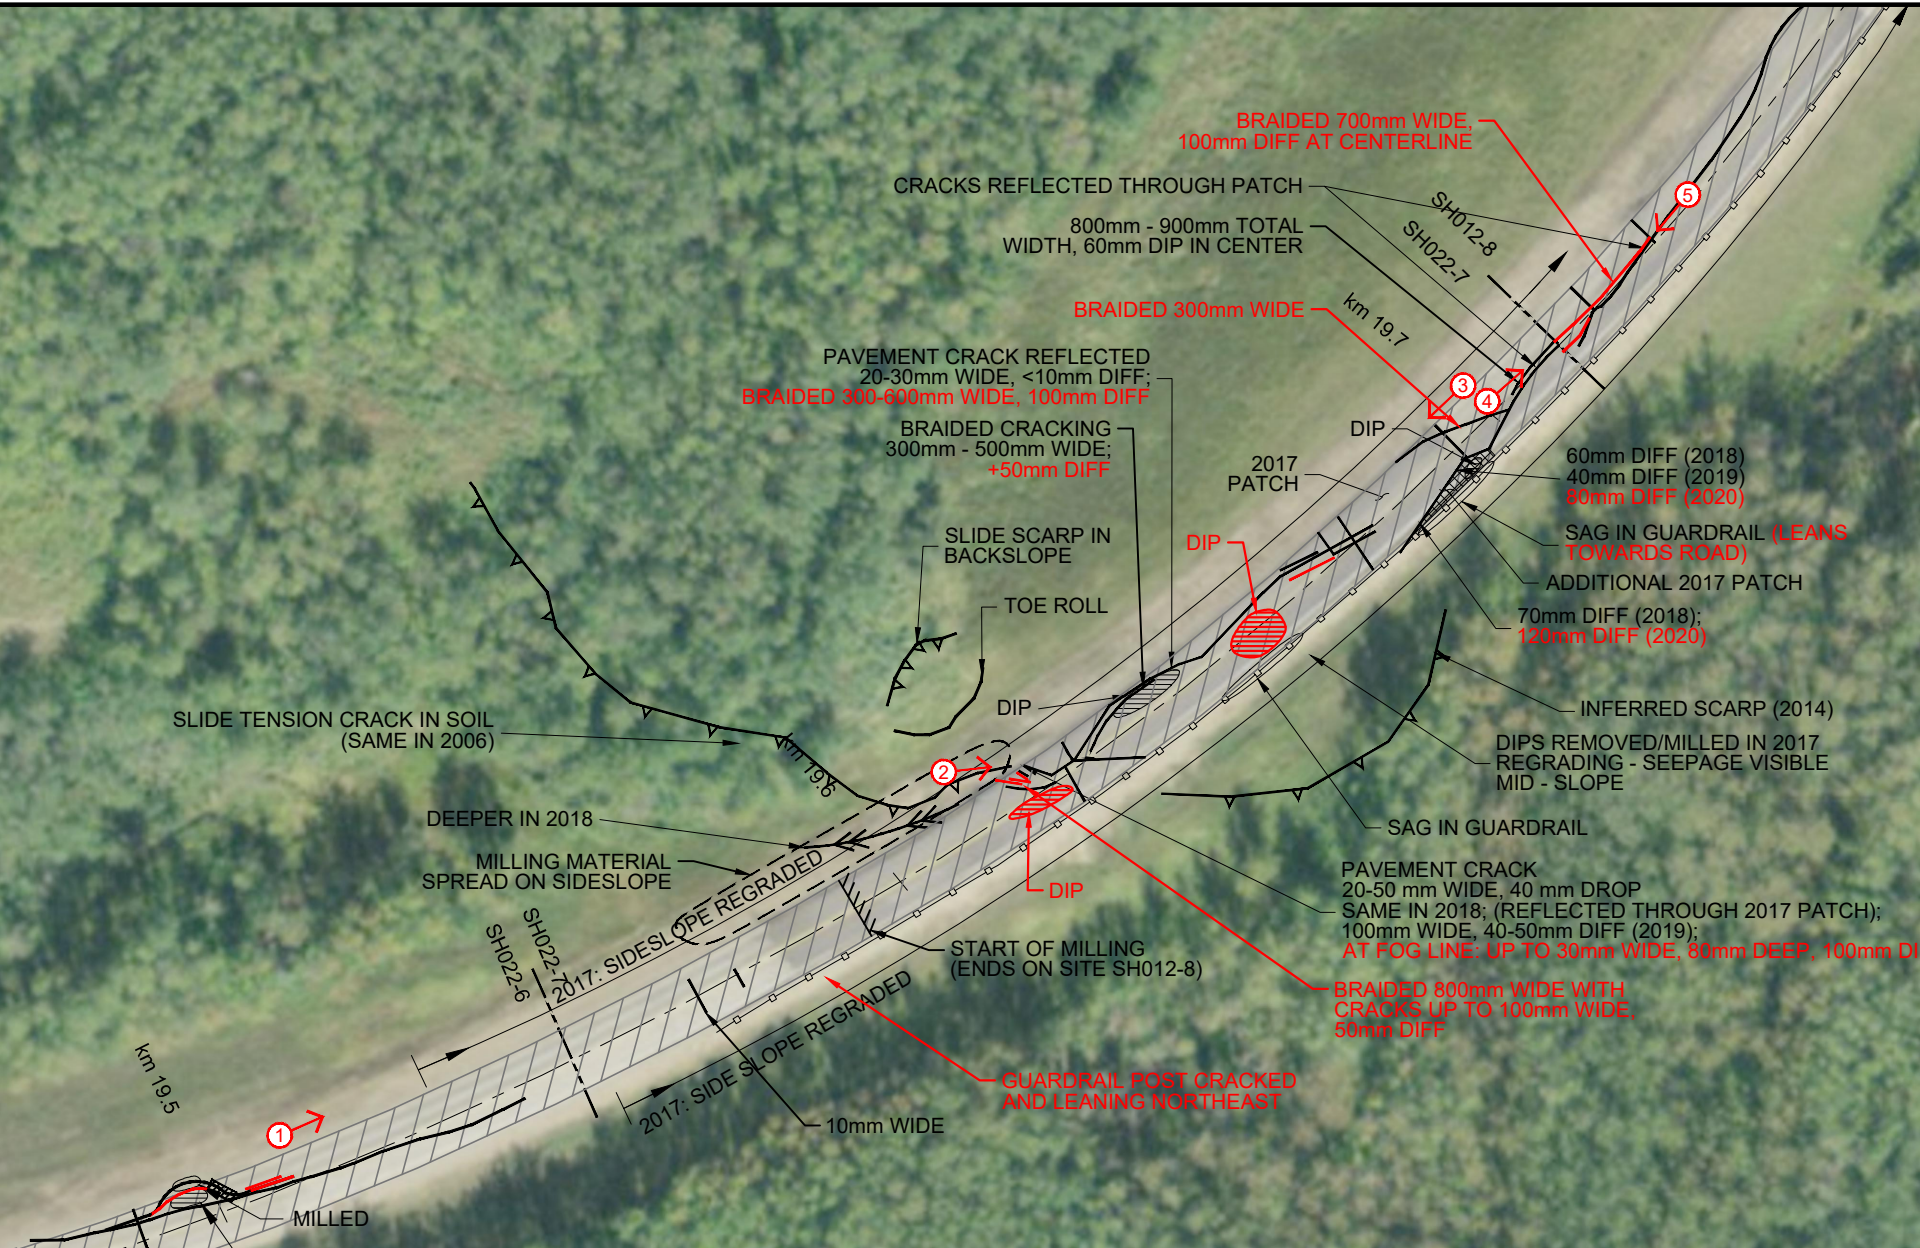
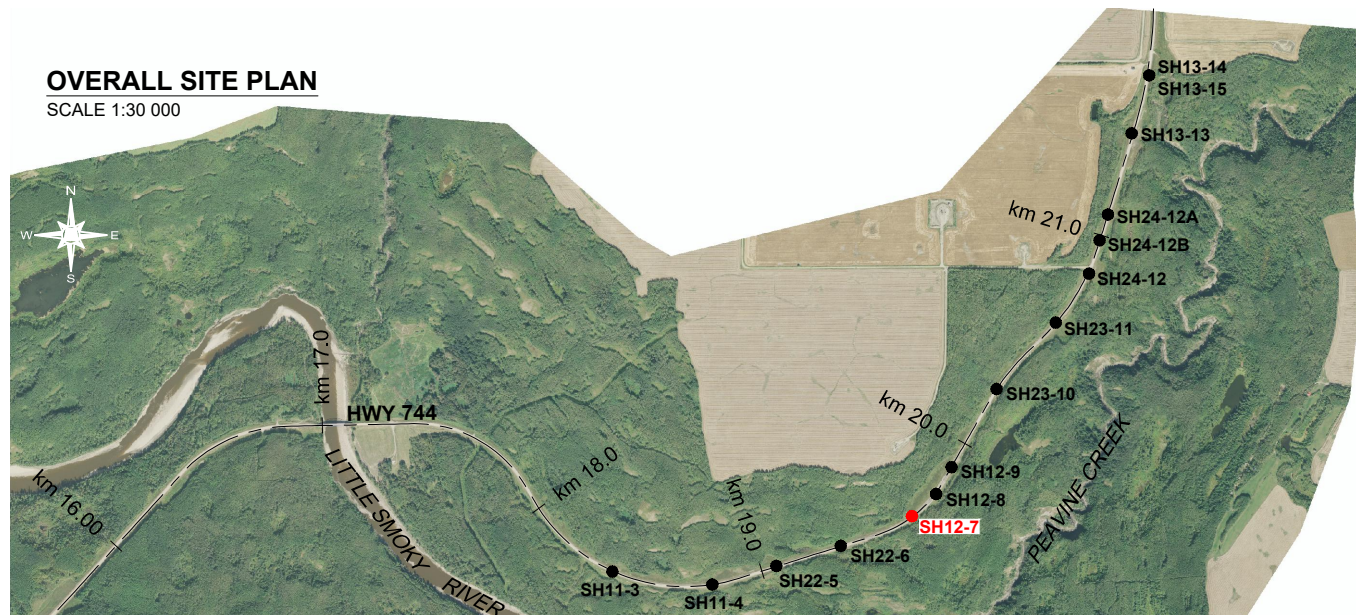
Site #7 intersects a major scarp which parallels the highway resulting in significant pavement distortions and requires frequent patching and milling to maintain a safe driving surface. This site is more active than Sites #5 and #6. The major scarp crack had reflected through the 2017 patch in less than a year., The differential heights had been reduced in 2019 due to the recent milling but have been re-established. More undulation of the driving surface was observed in 2020.

- Road maintenance should continue as necessary to maintain a safe roadway surface and may consist of milling, patching, and crack sealing of the ACP.

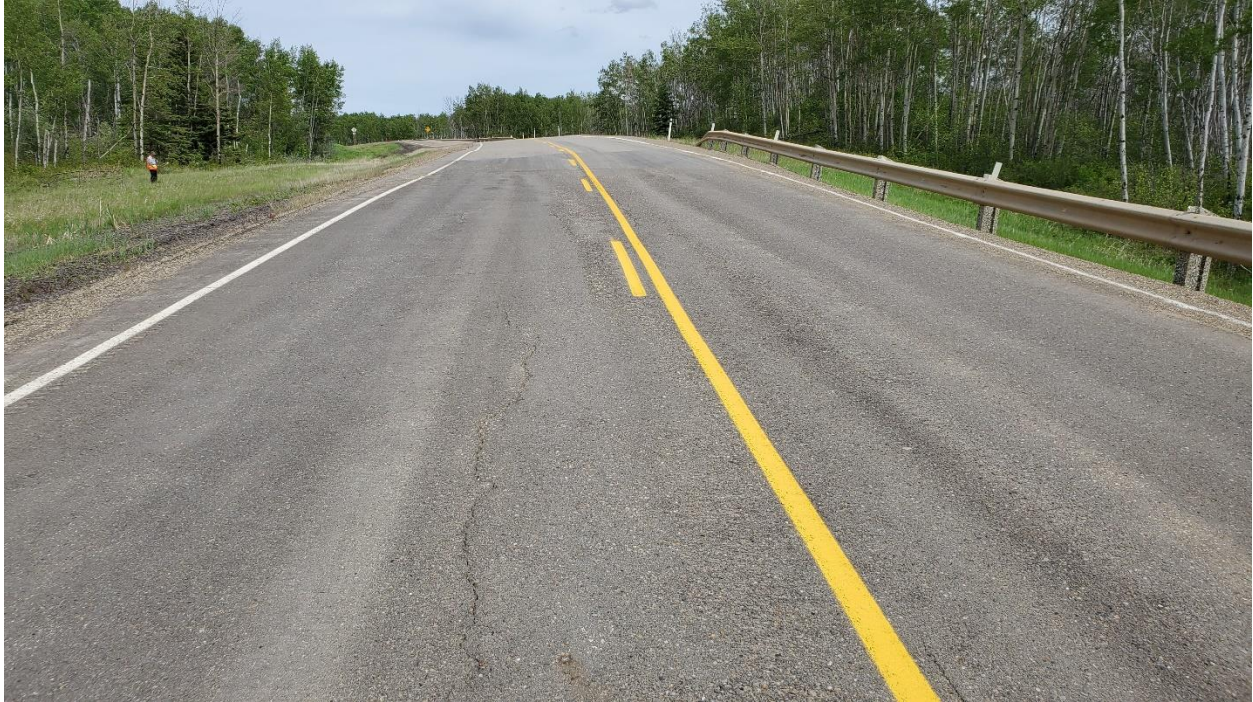
Photo 1 – Looking east from west end of site.

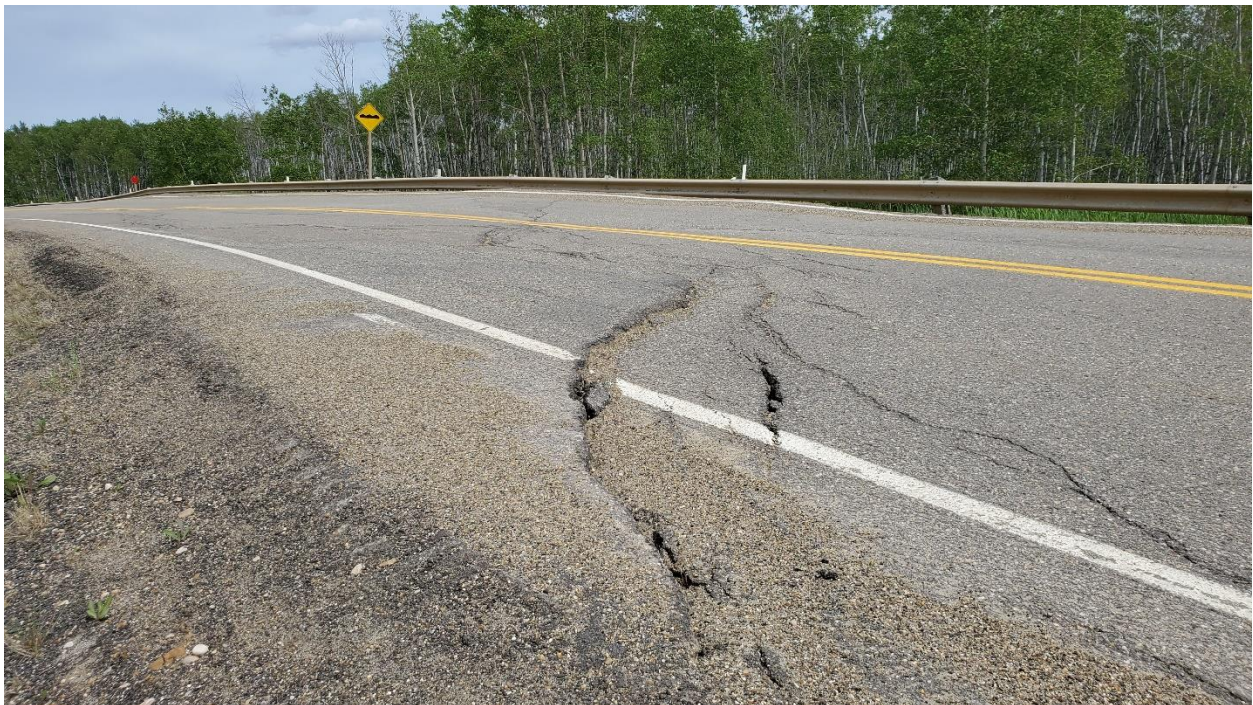
Photo 2 – Looking up-chainage at cracks and milling where main scarp crosses highway.

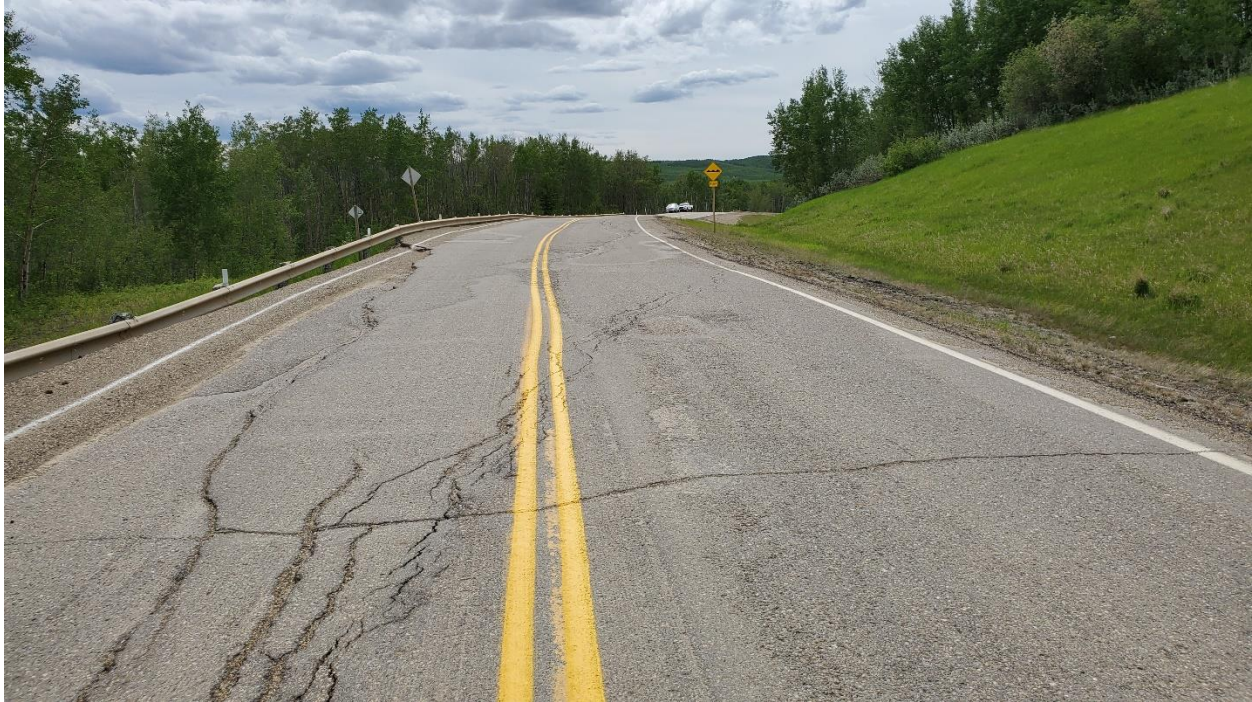
Photo 3 – Looking down chainage at main scarp crack along highway surface.

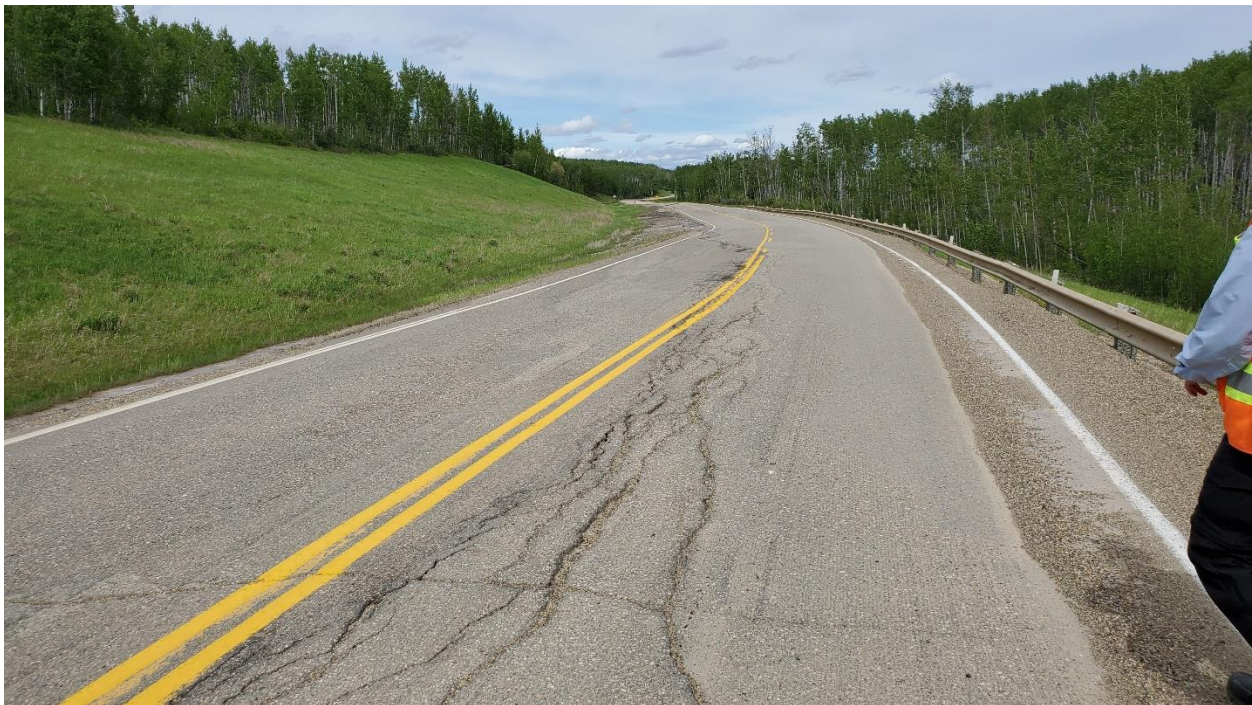
Photo 4 – Looking up-chainage at milling over main scarp crack.

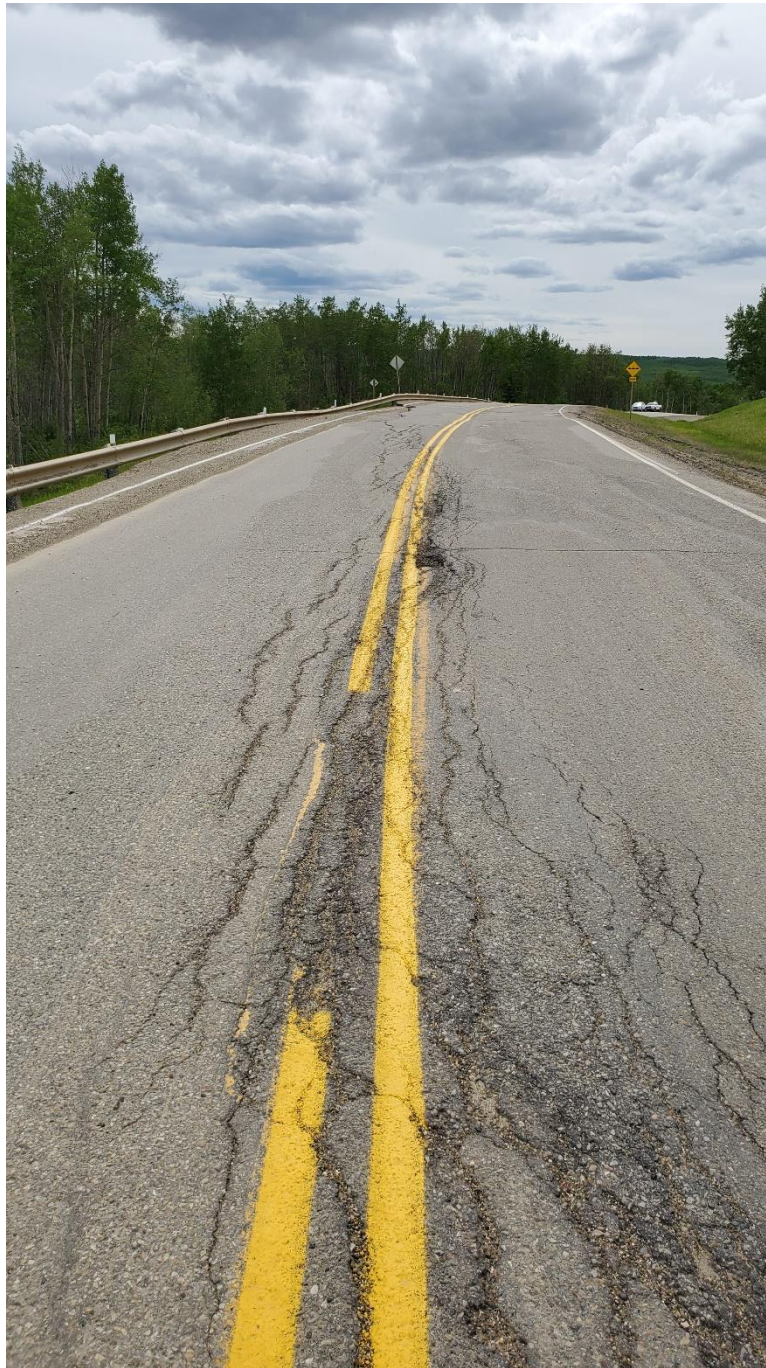
Photo 5 – Looking down-chainage at patch near east end of Site #7 (back towards Photo #6).  
Note growing width of crack pattern.
