**ALBERTA TRANSPORTATION  
GEOHAZARD ASSESSMENT PROGRAM  
PEACE REGION – SWAN HILLS  
2022 INSPECTION**

Site Number	Location	Name	Hwy	km
SH022-7	Little Smoky River	Little Smoky River Valley, North Hill – Site #7	744:02	19.58-19.71*
Legal Description		UTM Co-ordinates		
SW21-76-22-W5M		11U E 477,732	N	6,161,398

**SH022-7: HWY 744:02 LITTLE SMOKY RIVER VALLEY  
2022 SITE INSPECTION PLAN**

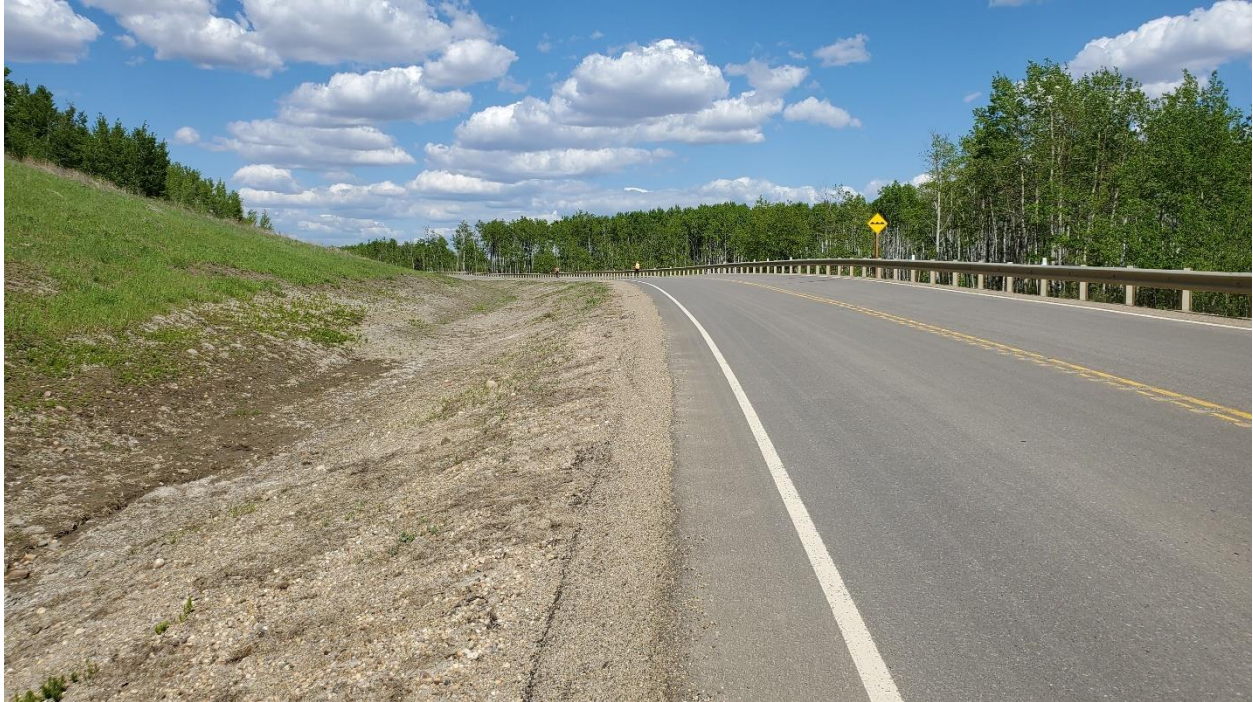
Photo 1 – Looking east from west end of site.

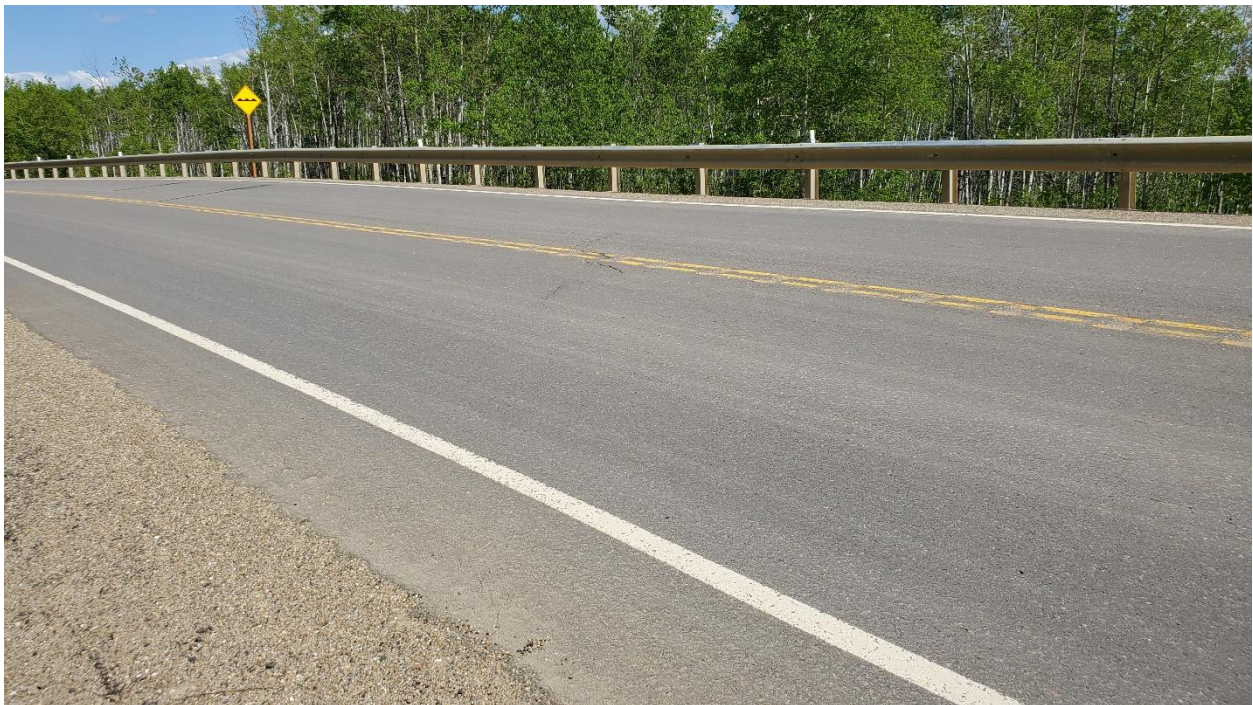
Site #7 intersects a major scarp which parallels the highway resulting in significant pavement distortions and requires frequent patching and milling to maintain a safe driving surface. The 2021 highway overlay removed most of the previously observed pavement distortions. As of the 2022 Geohazard inspection, it appears that this site is less active than Sites #5 and #6. The sideslopes were regraded to promote better drainage at the site.

Photo 2 – Looking up-chainage at cracks starting to resurface where main scarp crosses highway.

- Road maintenance should continue as necessary to maintain a safe roadway surface and may consist of milling, patching, and crack sealing of the ACP.

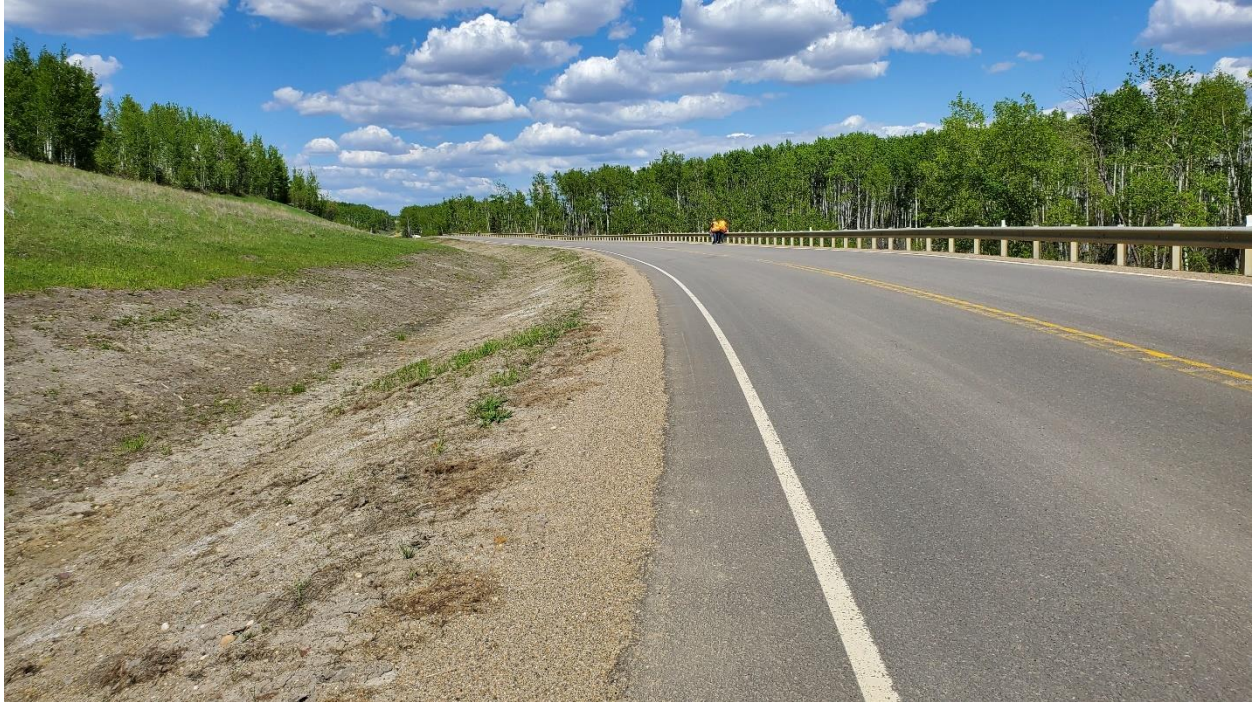
Photo 3 – Looking up-chainage where overlay has covered previously-observed cracks.

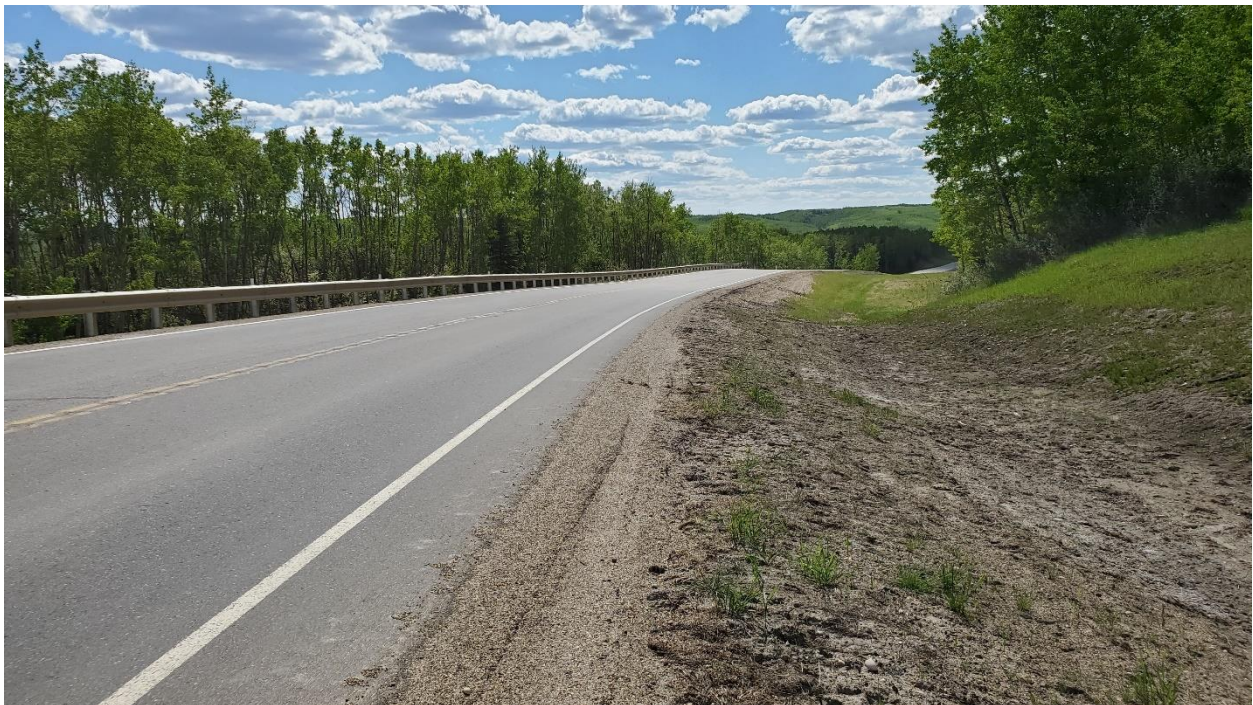
Photo 4– Looking west near east end of Site #7.
