**ALBERTA TRANSPORTATION AND
ECONOMIC CORRIDORS
GEOHAZARD ASSESSMENT PROGRAM
PEACE REGION – SWAN HILLS
2024 INSPECTION**

Site Number	Location	Name	Hwy	km
SH023-10	Little Smoky River	Little Smoky River Valley, North Hill – Site #10	744:02	20.20-20.40
Legal Description		UTM Co-ordinates		
NE21-76-22-W5M		11U E 478,074	N	6,161,918

**SH023-10: HWY 744:02 LITTLE SMOKY RIVER VALLEY
2024 SITE INSPECTION PLAN**

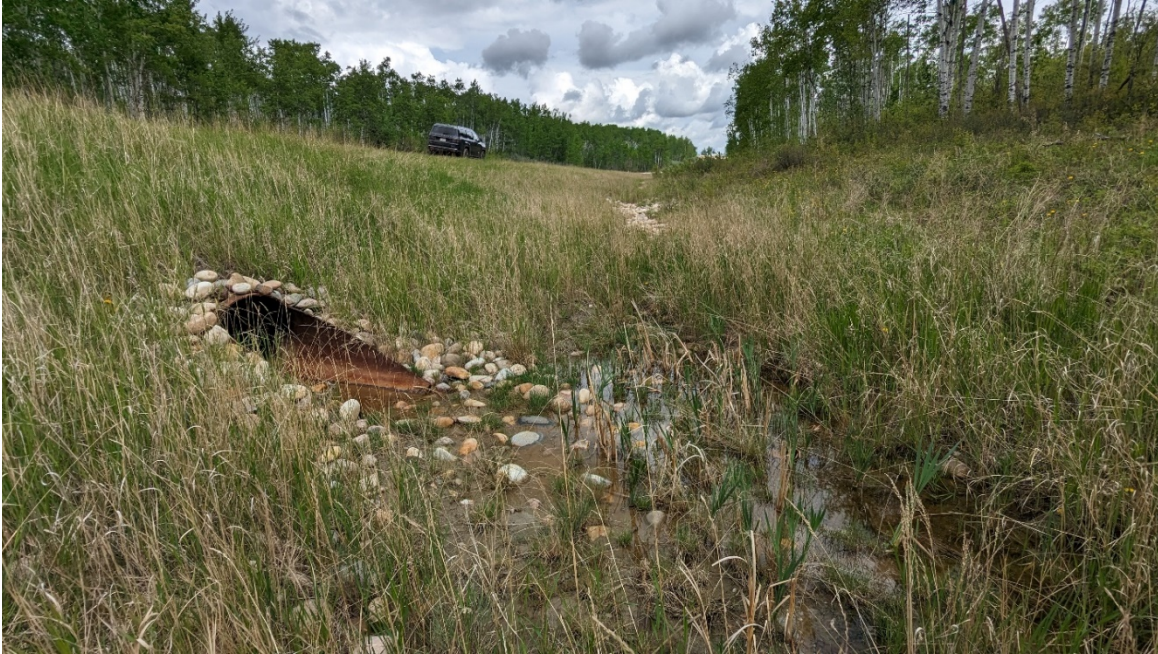
Photo 1 – Looking northeast along downslope ditch.

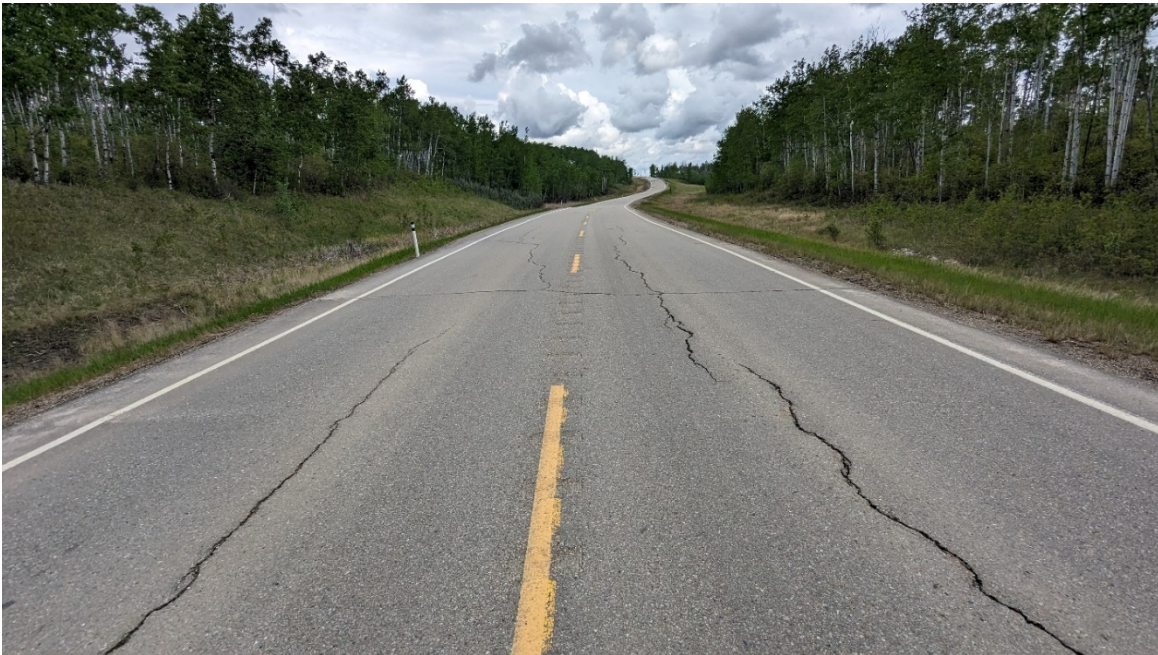
Although this Site #10 is located on the unstable valley slope with a significant sag pond located below the site, landslide movements have not been consistently observable at this site with most cracking being transverse or longitudinal. There is a noticeable dip in the highway profile which could also be related to soft subgrade soils given the historically wet upslope ditch. Previously observed vertical distortions and angled cracks were not present during the 2022 inspection since the highway was overlaid in 2021. Continued reflection of the previous crack pattern was observed during the 2024 inspection.

Photo 2 – Looking northeast at cracking that is continuing to surface around km 20.26 (just northeast of the culvert).

- Road maintenance should continue as necessary to maintain a safe roadway surface and may consist of ACP milling, patching, and crack sealing.

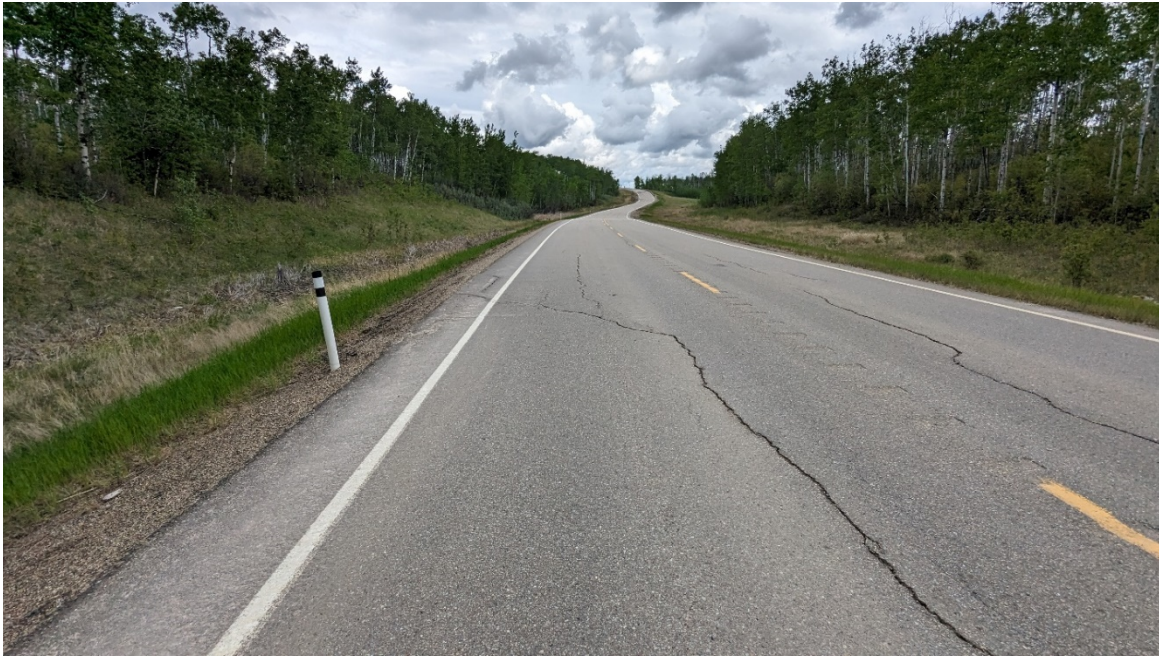
Photo 3 – Looking northeast at potential scarp crack northeast of Photo 3.

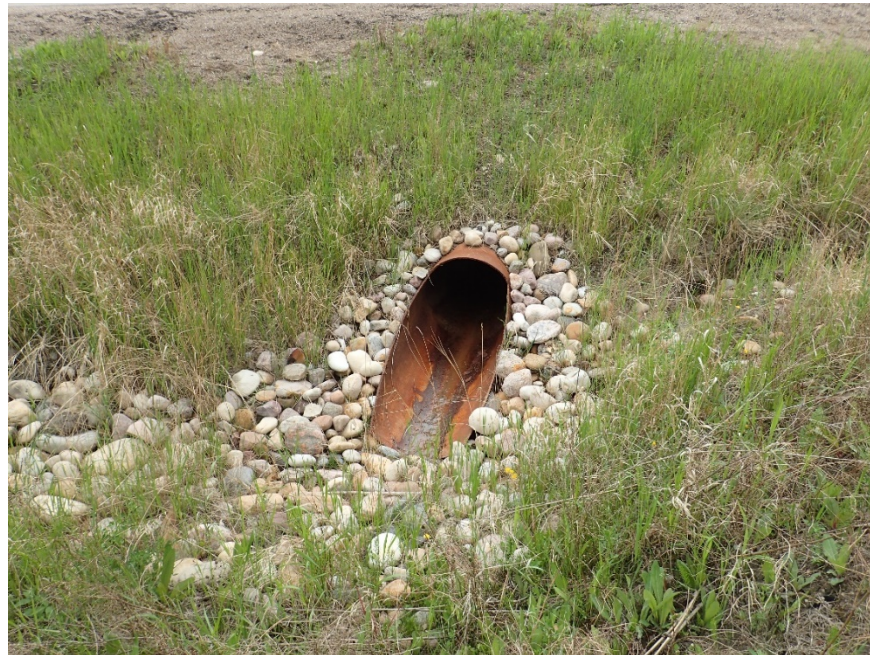
Photo 4 – Looking at inlet of culvert at km 20.22. Note minor rill on the right-hand side of the photo.

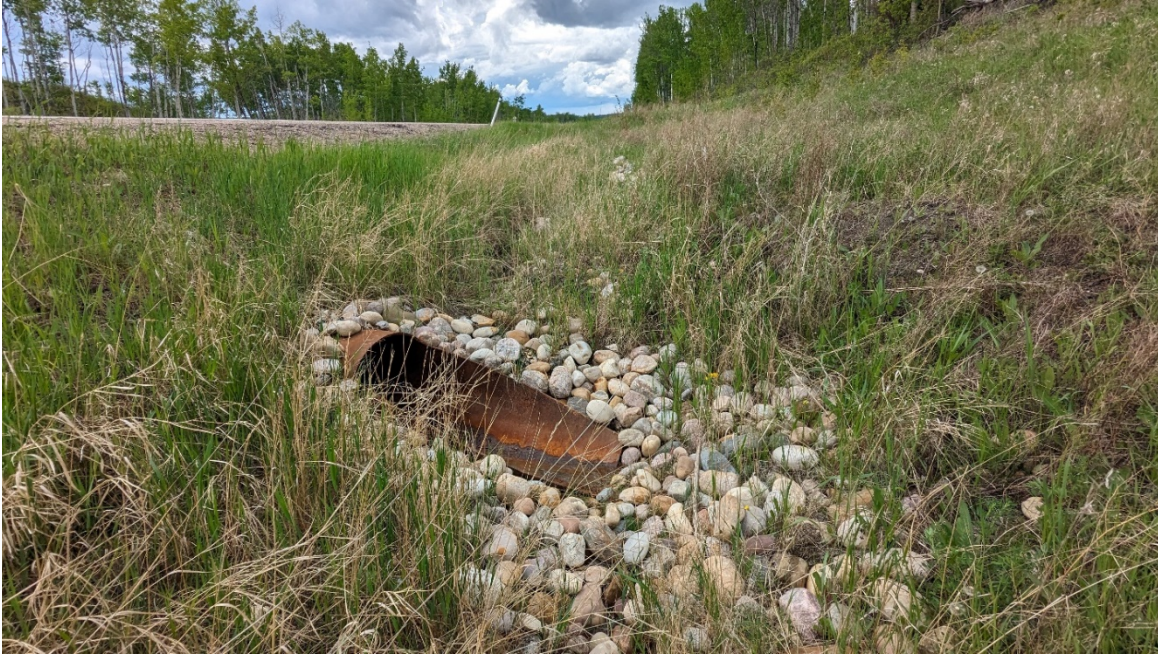
Historically, there has also been problems with erosion of the ditches following high precipitation events. The erosion gully forming away from the highway below the riprap apron had noticeably deteriorated since 2018. SWSP culverts were installed in 2021 at km 20.22 and at km 20.38. Culvert at km 20.38 is 50 percent full and ponded water was observed at the outlet. Standing water was observed in the east ditch which is an indication of poor drainage at the site.

Photo 5: Erosion adjacent to km 20.22 culvert inlet (right side of Photo 5).

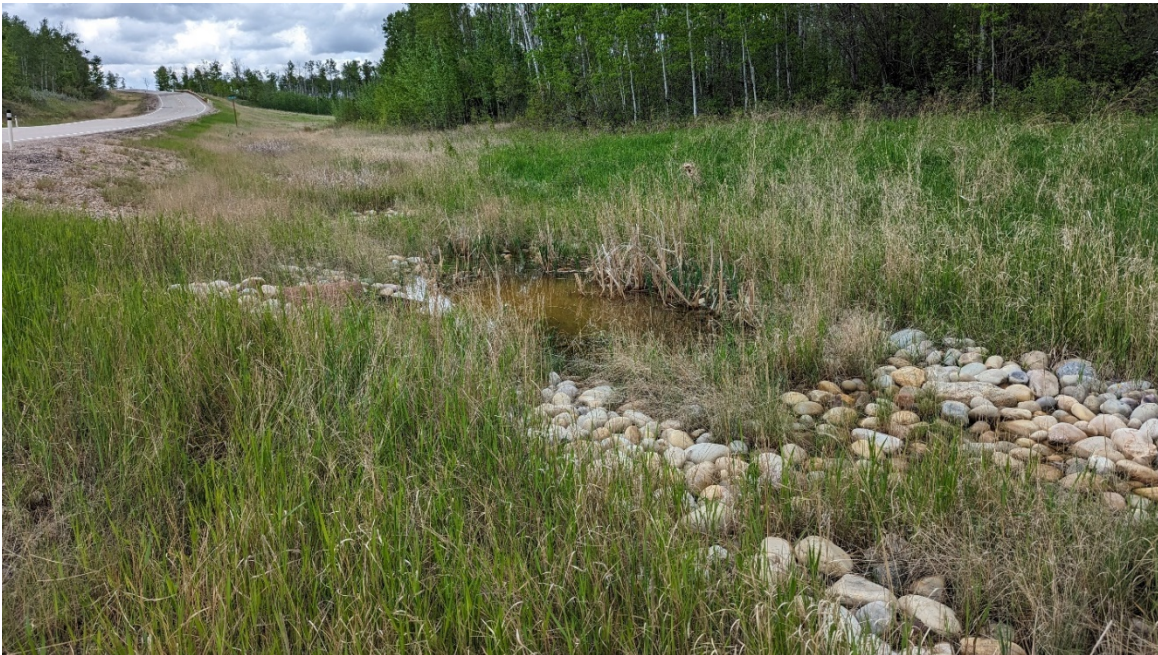
Photo 6: Ponding water in reggraded downslope ditch at the km 20.38 culvert outlet.

- Minor regrading could be carried out to allow drainage of the ponded water at the north culvert and standing water observed in the east ditch.

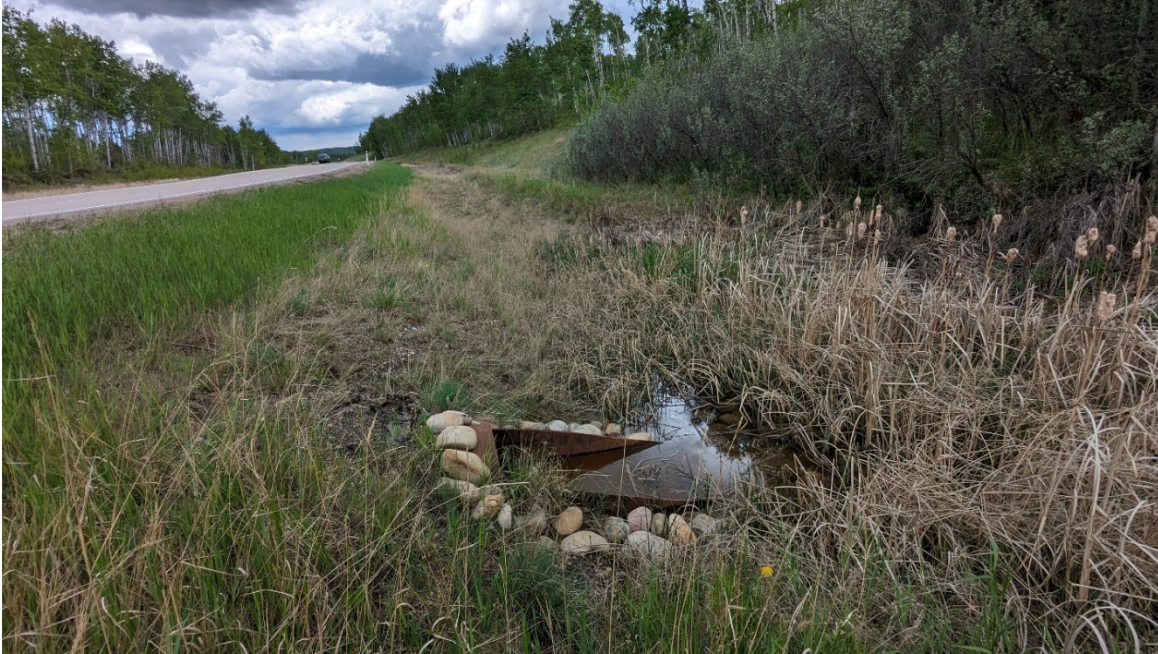
Photo 7: Poor drainage and ponding water at the km 20.38 culvert inlet.
