**ALBERTA TRANSPORTATION AND  
ECONOMIC CORRIDORS  
GEOHAZARD ASSESSMENT PROGRAM  
PEACE REGION – SWAN HILLS  
2024 INSPECTION**

Site Number	Location	Name	Hwy	km
SH023-11	Little Smoky River	Little Smoky River Valley, North Hill – Site #11	744:02	20.46-20.79
Legal Description		UTM Co-ordinates		
NE21-76-22-W5M		11U E 478,317	N	6,162,188

**SH023-11: HWY 744:02 LITTLE SMOKY RIVER VALLEY  
2024 SITE INSPECTION PLAN**

DWG No. 32121-SH023-11

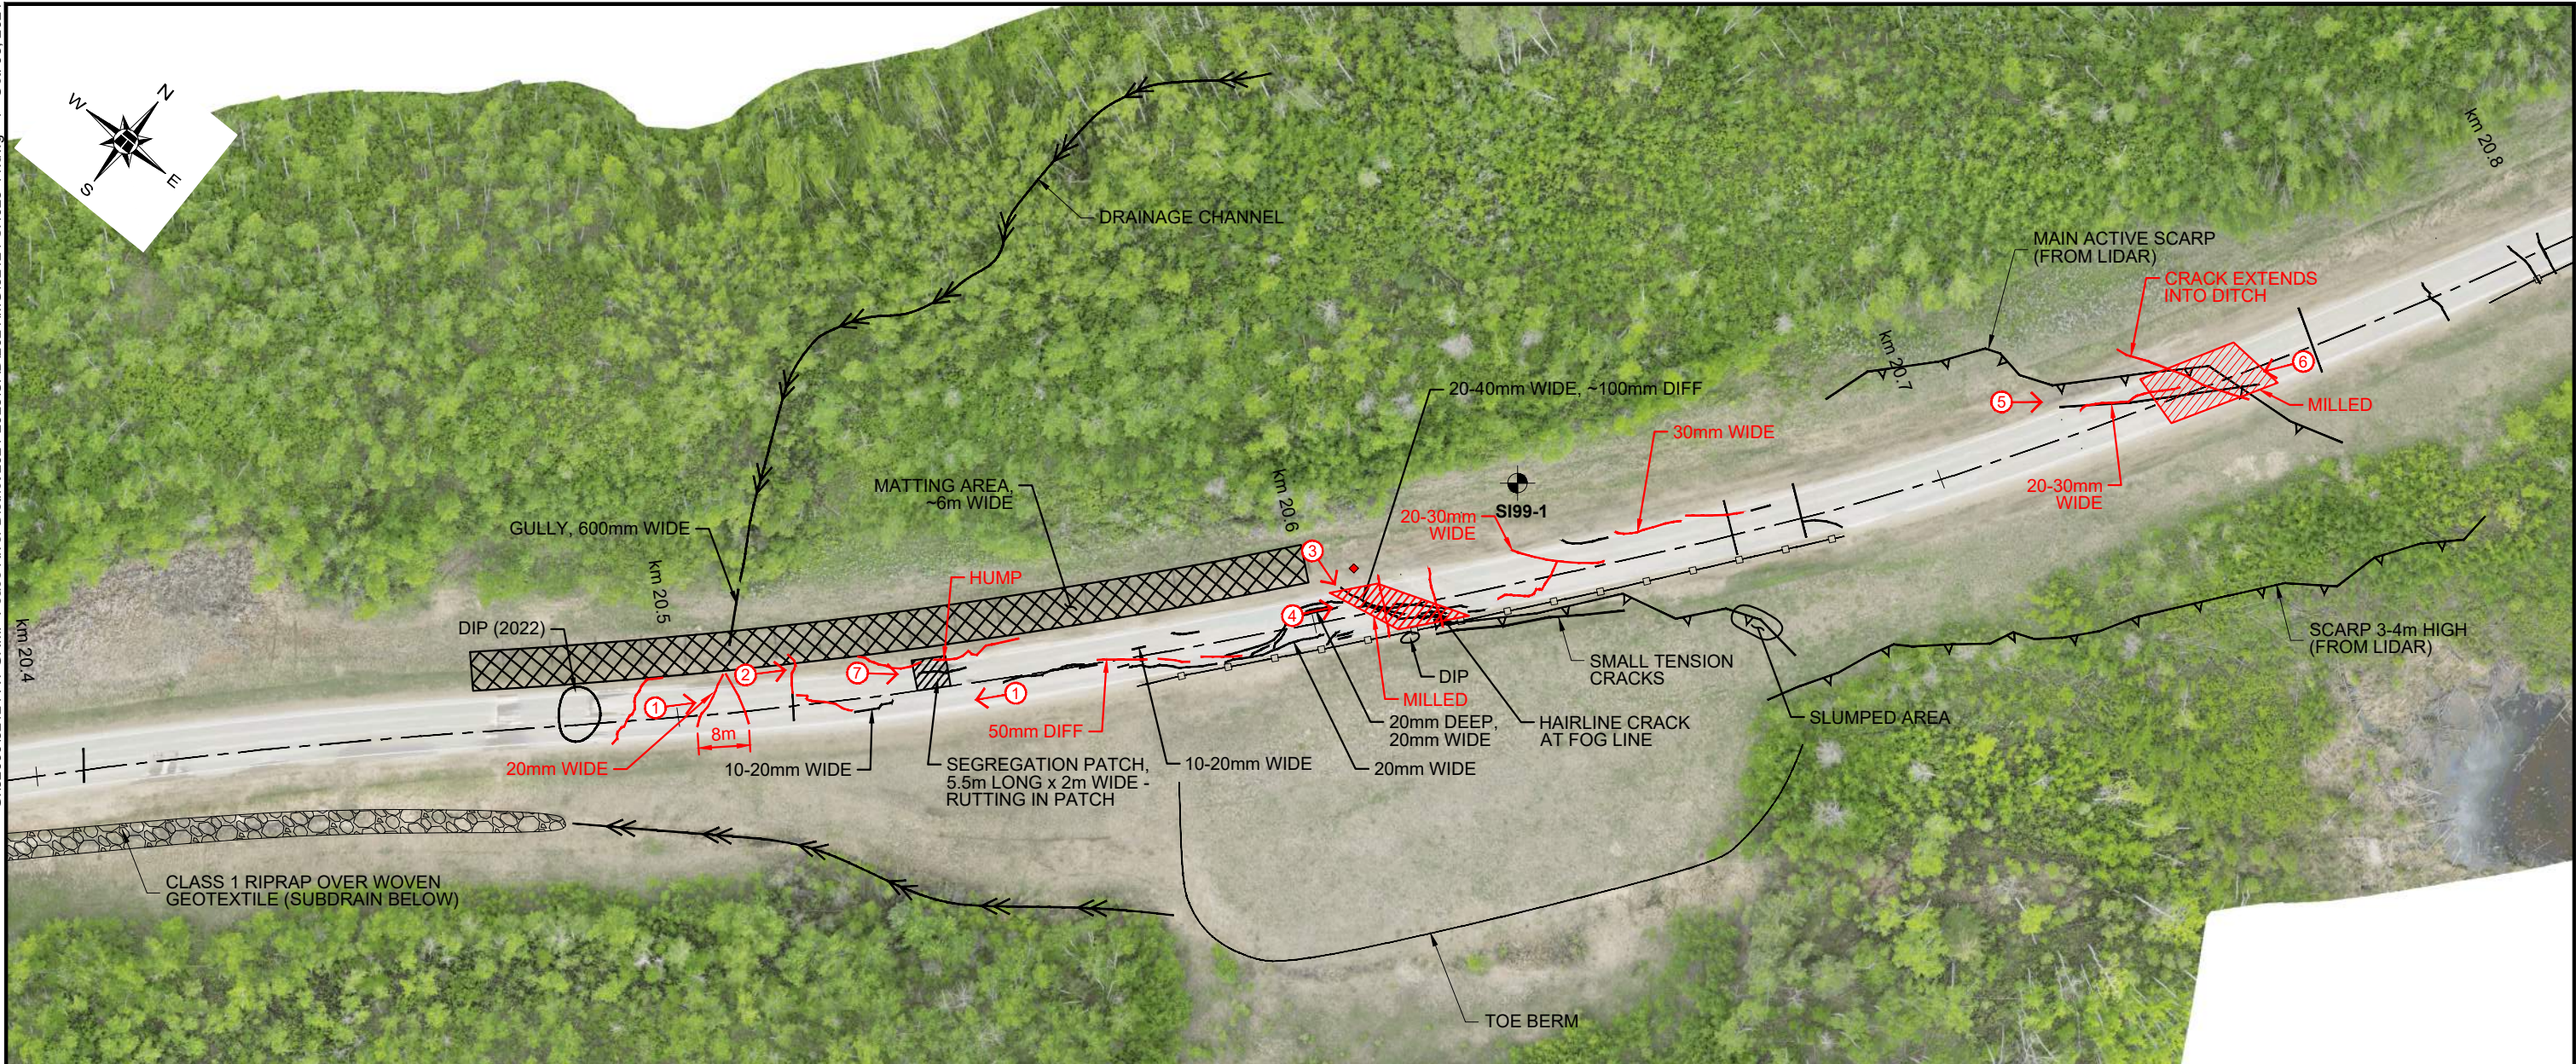
Site #11 is located on an active scarp with significant vertical deformation that affects the highway. Two significant scarp cracks were identified crossing the highway surface and could also be traced in the adjacent ditches (although obscured by regrading done in 2019 and 2021). The ditches were regraded and removed previously observed erosion gullies. Erosion control measures including matting and GeoRidges were installed in a portion of the upslope ditch. Since the highway overlay in 2021, the two main scarp cracks have become re-established. The south of the two sets of scarp cracks has greater deformation since the observed cracks were wider and deeper. There was less deformation at the north scarp crack; however, there is a significant 4 m high scarp located downslope in the trees (identified from LiDAR topography). During the 2024 inspection, extension of existing cracks was observed, with some faint new cracks reflecting from previous cracks. Most of the cracks were infilled with sand.

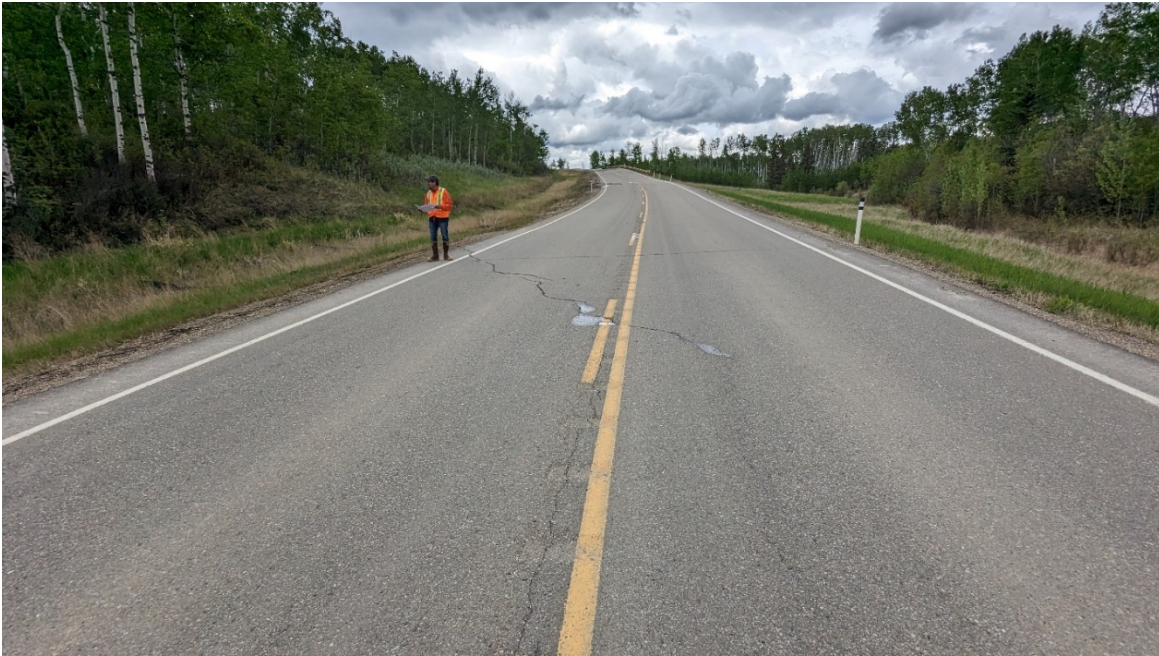
**Photo 1 – Looking northeast from the southwest end of Site 11.**

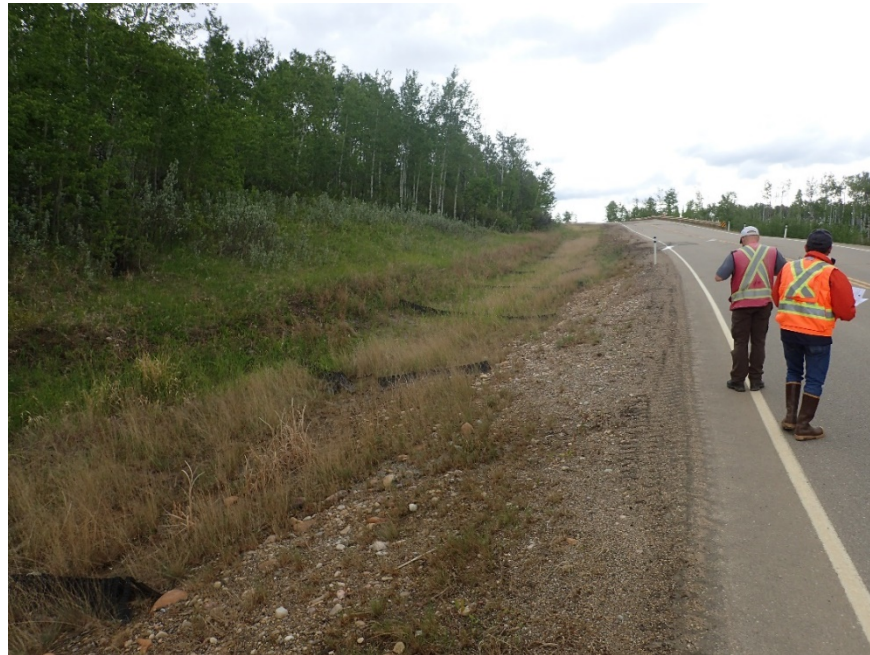
**Photo 2 – Looking east at south end of site at installed erosion control measures where previously observed significant gully was regraded.**

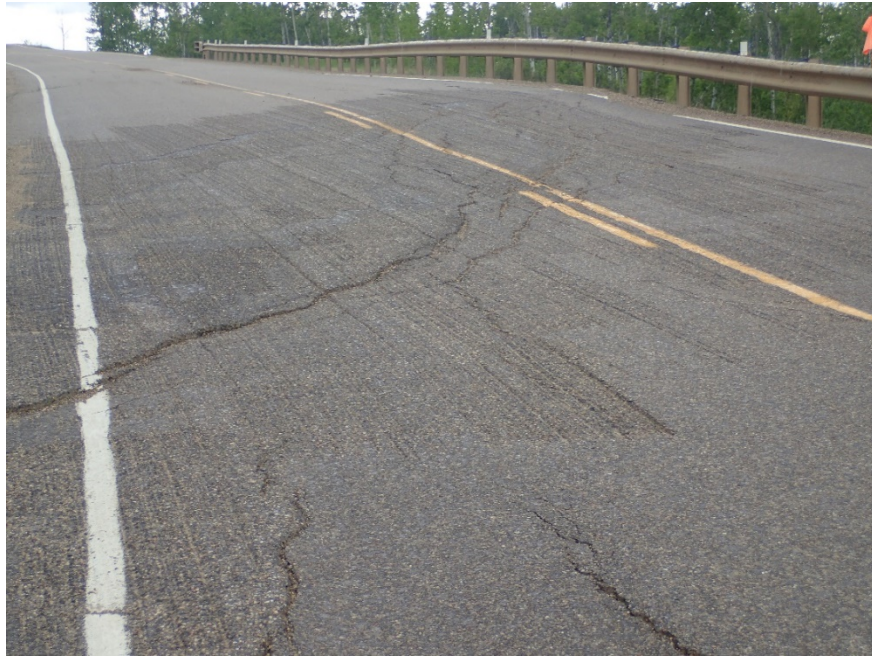
Photo 3 – Looking east at south scarp crack crossing highway (see Photo #4).

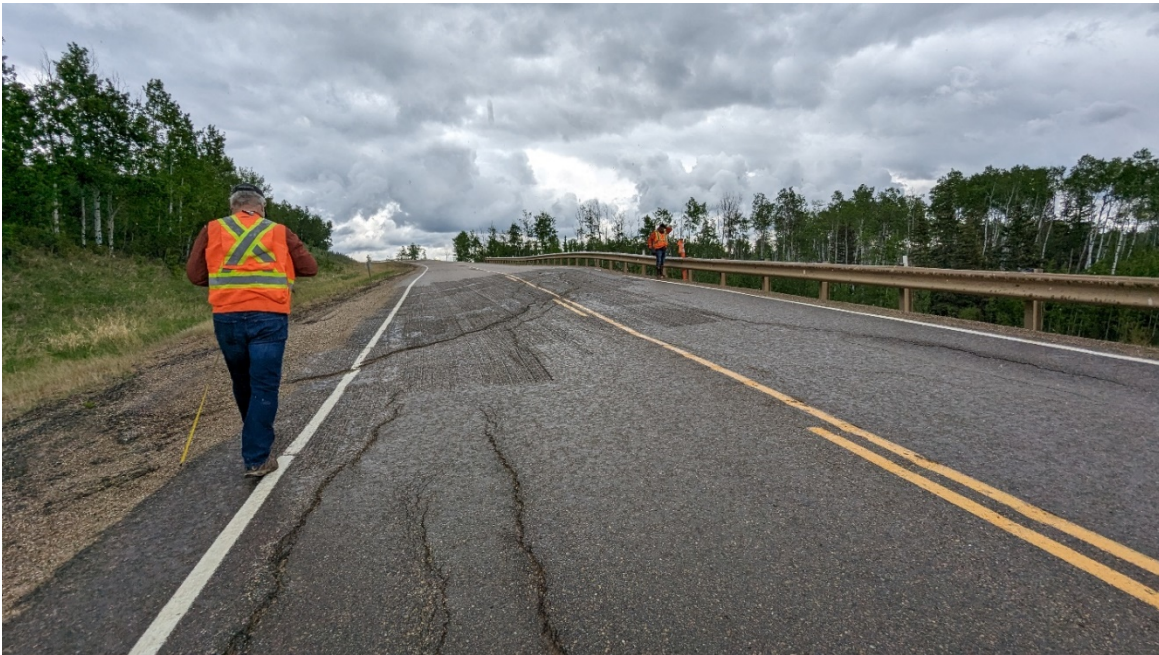
Photo 4: Looking northeast where south scarp crack crosses the highway at the central portion of Site 11.

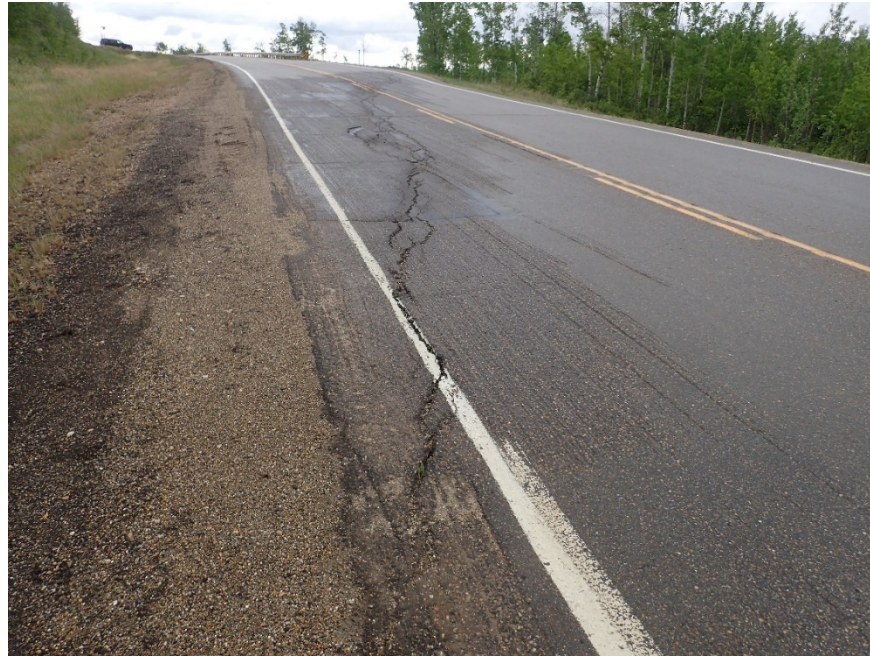
**Photo 5 – Looking northeast at north scarp crack.**

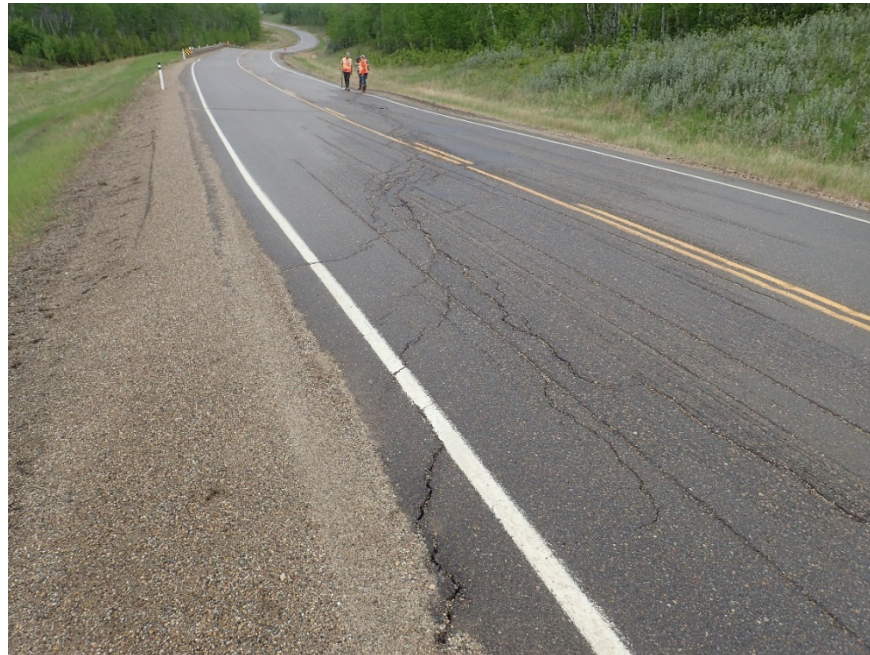
**Photo 6 – Looking southwest at north scarp crack.**

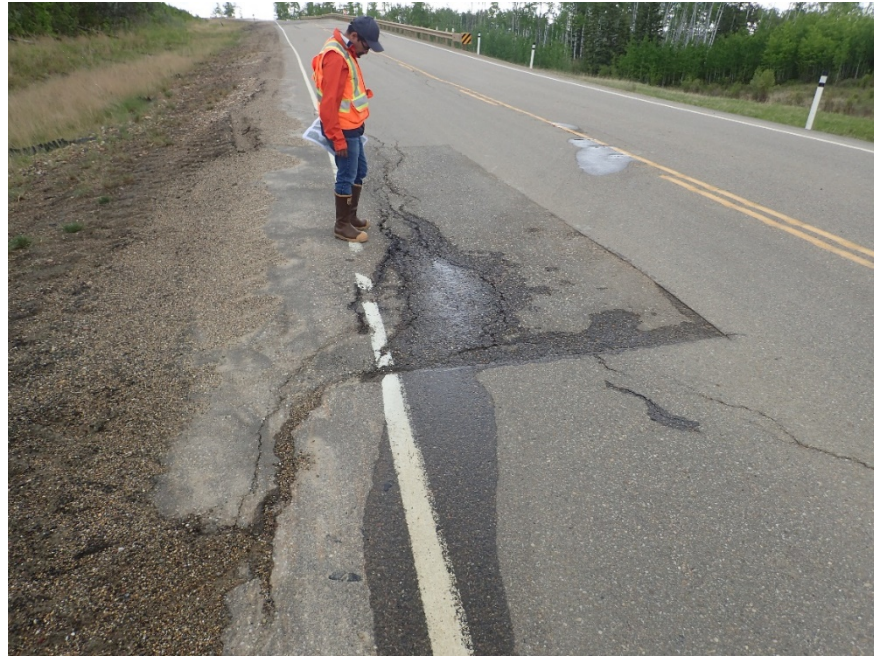
<b>Observations:</b>	<b>Description</b>	<b>Worsened?</b>
<input checked="" type="checkbox"/> Pavement Distress	Some of the previous longitudinal and traverse cracks have reflected through. Existing cracks have extended. Rutting was observed in a patch located in the outer wheel path of the SBL. Cracks were infilled with sand.	<input checked="" type="checkbox"/>
<input checked="" type="checkbox"/> Slope Movement	Site is located on an active deep-seated landslide moving toward the Peavine Creek. There is continuing vertical deformation of the pavement.	<input checked="" type="checkbox"/>
<input checked="" type="checkbox"/> Erosion	Upslope ditch was regraded and erosion control measures installed.	<input type="checkbox"/>
<input type="checkbox"/> Seepage		<input type="checkbox"/>
<input type="checkbox"/> Bridge/Culvert		<input type="checkbox"/>

**Photo 7: Scarp crack and rutting in a patch located in the SBL.**

- Road maintenance such as milling and patching should continue as necessary to maintain as safe roadway surface. Minor embankment grading may be required to maintain safe sideslope conditions. Guardrail height adjustment may be required. Cracks within the ACP should be sealed to limit infiltration of rain fall and snow melt into the crack network.
