THURBER ENGINEERING LTD.

July 21, 2003

File: 15-16-166

**PEACE RIVER (SWAN HILLS) REGION LANDSLIDE ASSESSMENT
Hwy 744:02 SLIDES (SH10, 11, 12 AND 13)
2003 ANNUAL INSPECTION REPORT**

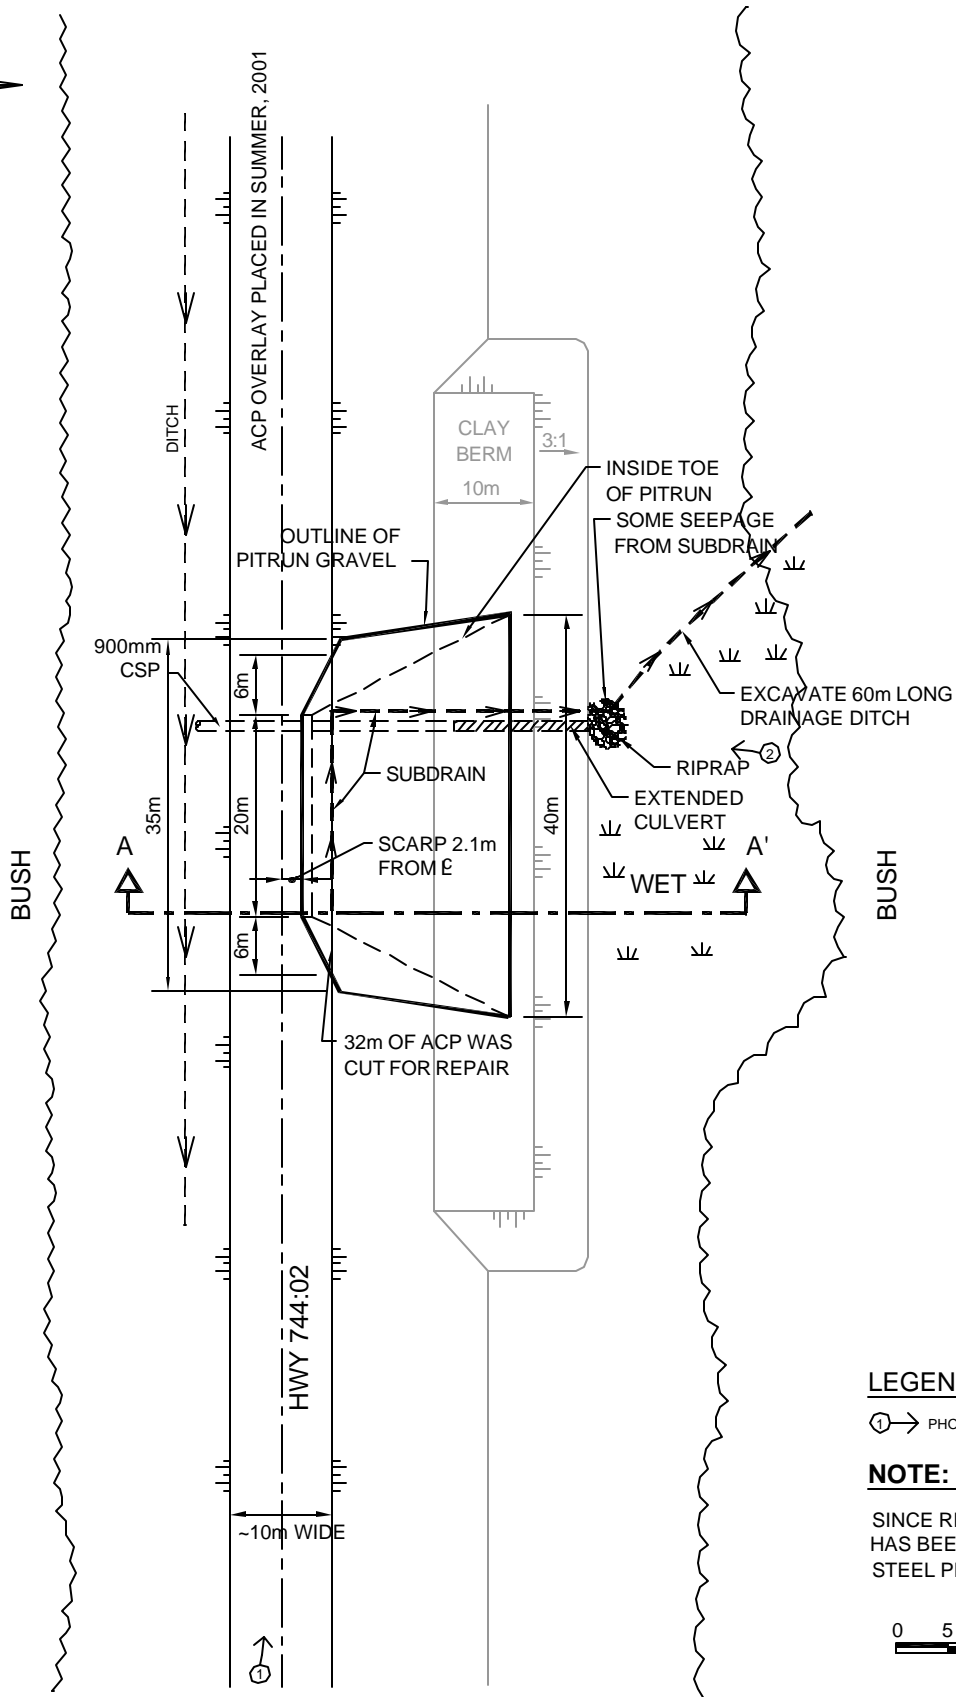
SH744:02 LITTLE SMOKY RIVER VALLEY (SH13)
SITE #12A SKETCH PLAN (JUNE 3, 2003)

#12A (SH13)	km 21.2 (4 km northeast of the bridge)	10 m	5 m		12 upper slope 18 lower slope, 14.5 overall	- some seepage was observed from the new subdrain - The top of the d/s slope was wet and soft - Since repair the culvert has been lined with a smooth steel culvert, 762 mm in outside diameter	13	4	52	This slide area was remediated in July, 2002 by subexcavating the slide area, installing a subdrain inside the excavation, reconstructing the slope with imported pit run gravel, using the excavated clay to construct a toe berm and repairing and extending the culvert. The work was carried out by the maintenance contractor on an hourly basis supervised by one of Thurber's technologists. A summary of the slide repairs will be presented in a construction summary report in the near future <u>Long Term:</u> - major highway re-alignment

SINCE REPAIR, THE NEW CULVERT HAS BEEN LINED WITH A SMOOTH STEEL PIPE (762mm OD)

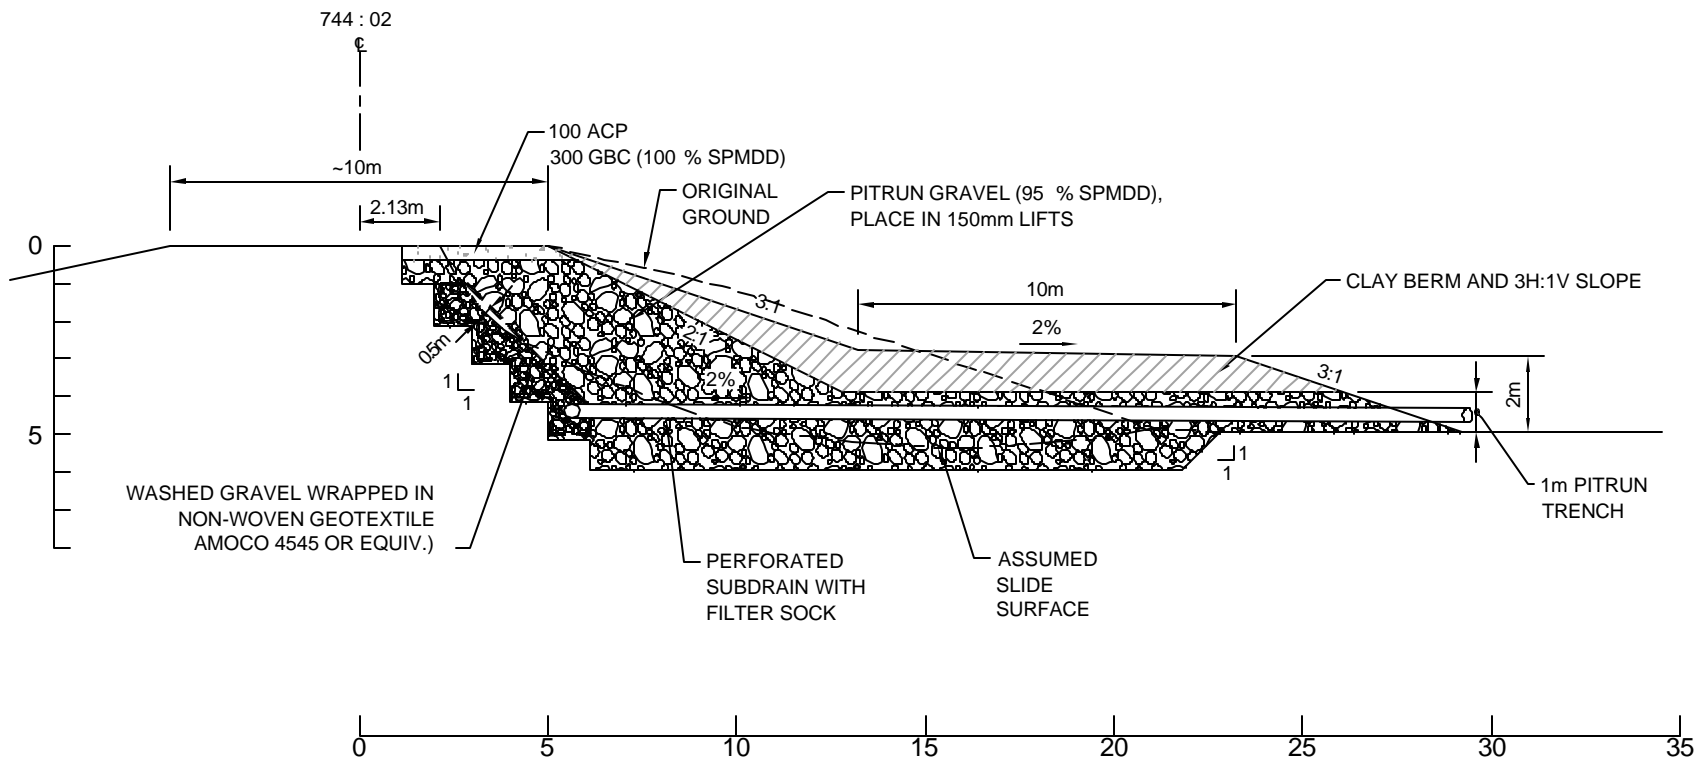
SH744:02 LITTLE SMOKY RIVER VALLEY (SH13)
SITE #12A CROSS-SECTION A - A' (JUNE 3, 2003)

NOTE: REMEDIAL MEASURES CARRIED OUT ON JULY, 2002

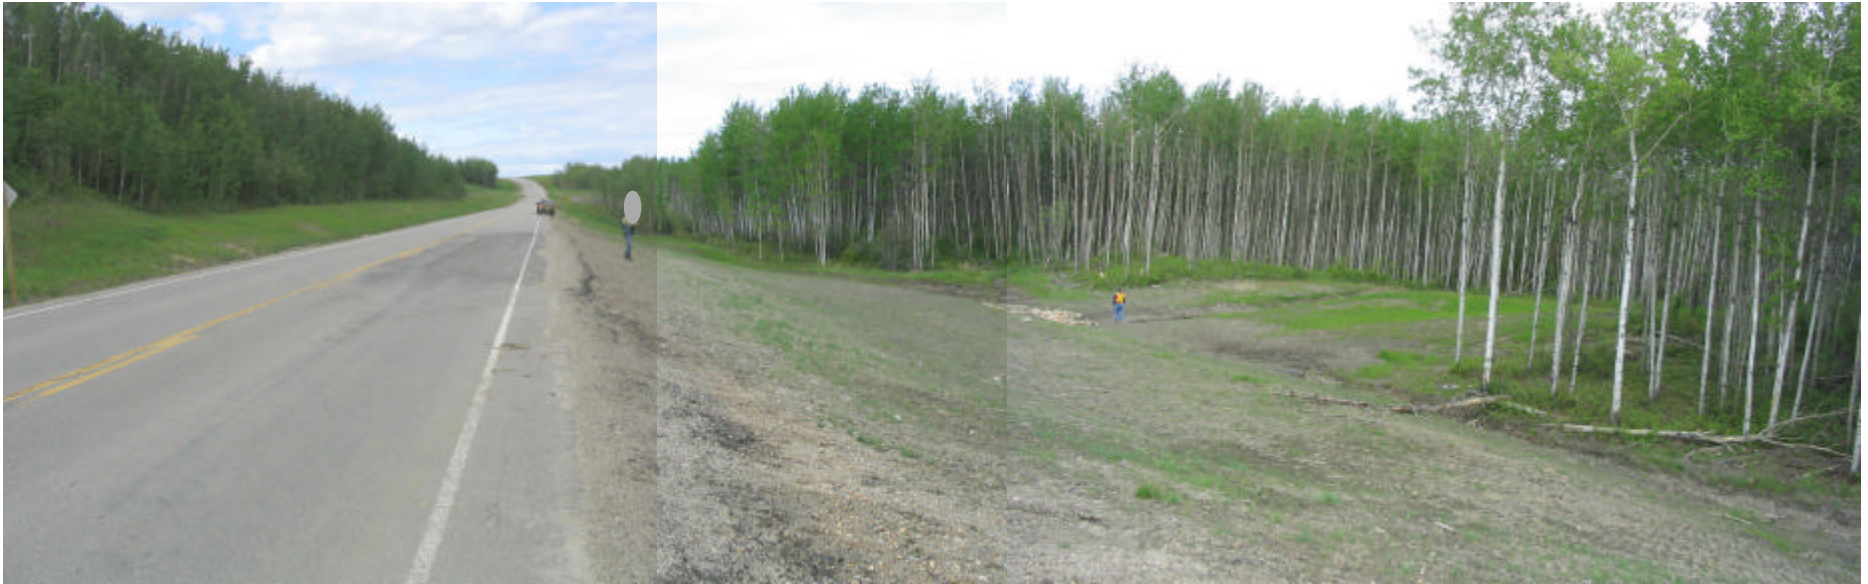
PHOTO 1 LOOKING NORTH TO NORTHEAST AT RECENTLY REPAIRED SITE

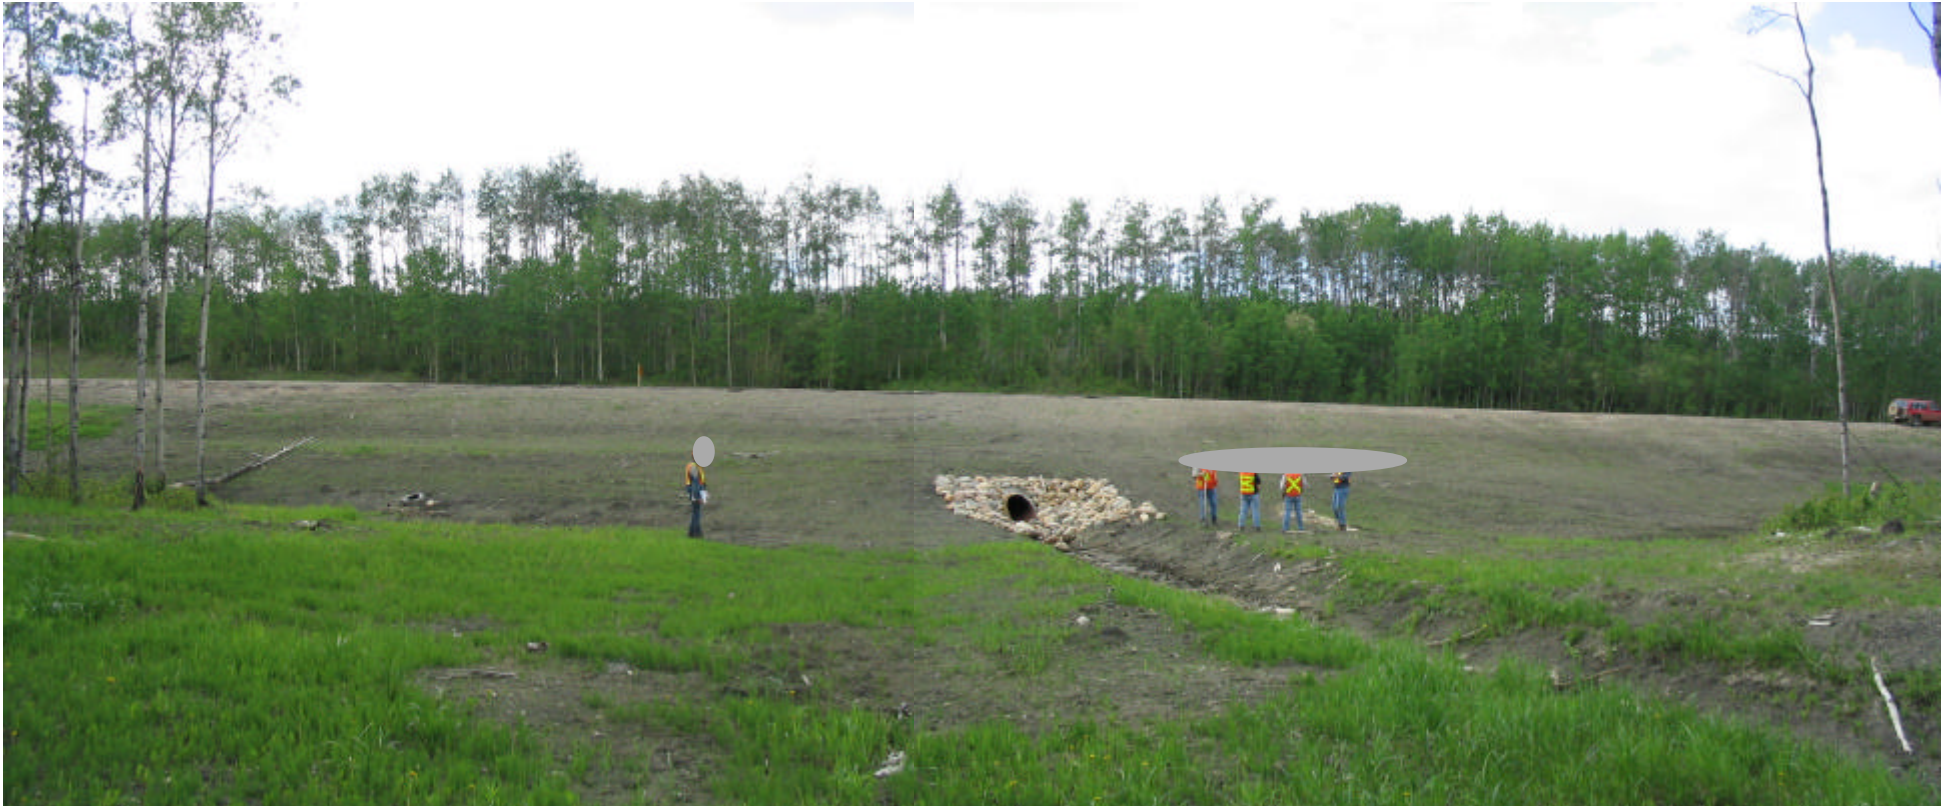
PHOTO 2 LOOKING WEST AT CULVERT
OUTLET AND RECENT REPAIR
