**THURBER ENGINEERING LTD.**

October 7, 2004

File: 15-16-191

**PEACE RIVER (SWAN HILLS) REGION GEOHAZARD ASSESSMENT  
Hwy 744:02 SLIDES (SH10, 11, 12 AND 13)  
2004 ANNUAL INSPECTION REPORT**

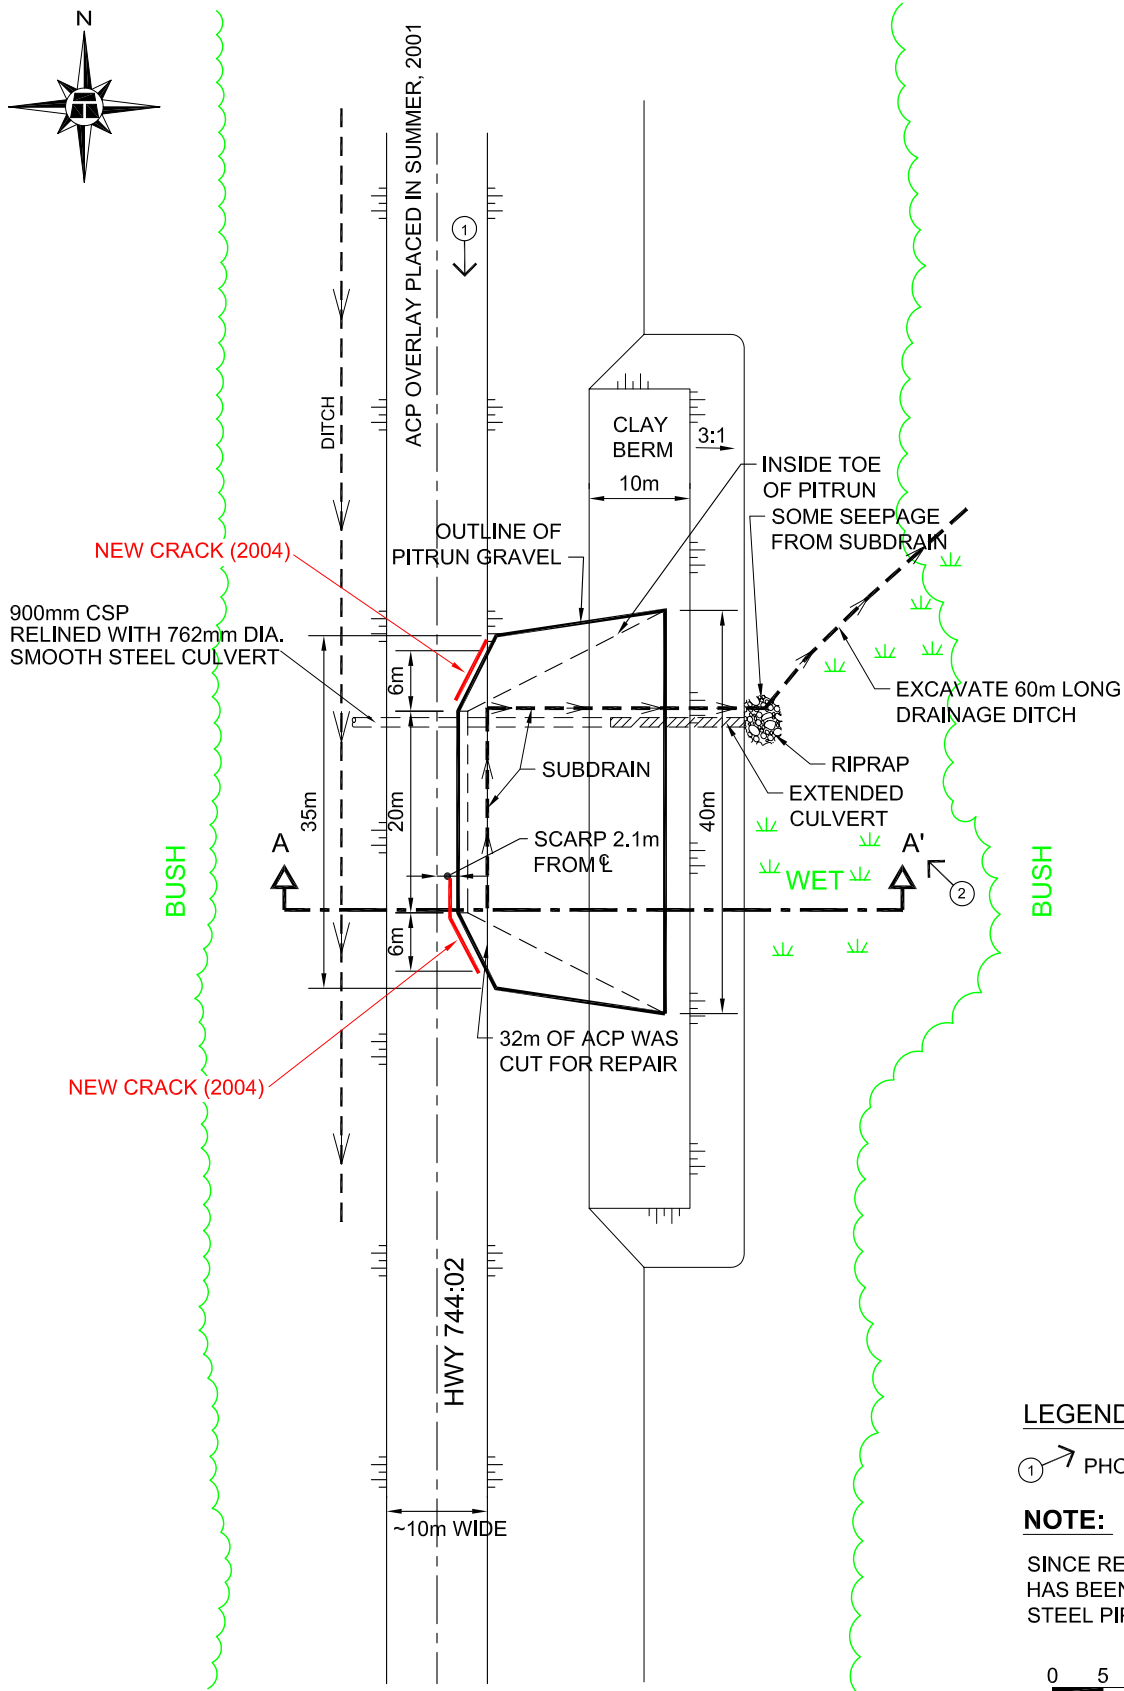
**FIGURE SH13-SITE #12A**  
 HWY 744:02 LITTLE SMOKY RIVER VALLEY  
 SKETCH PLAN (JUNE 9, 2004)

#12A (SH13)	km 21.2 (4 km northeast of the bridge)	10 m	5 m		12 upper slope 18 lower slope, 14.5 overall	<ul style="list-style-type: none"> <li>- No significant changes observed, the 2002 repairs appear to be performing well</li> <li>- new cracks were observed along the sawcut edges of the patch installed during the 2002 repairs</li> <li>- no seepage was observed from the subdrain</li> </ul>	4	4	15	<p>This slide area was remediated in July, 2002 by subexcavating the slide area, installing a subdrain inside the excavation, reconstructing the slope with imported pit run gravel, using the excavated clay to construct a toe berm and repairing and extending the culvert. Since repair the culvert has been lined with a smooth steel culvert, 762 mm diameter. A construction summary report of the slide repairs was prepared dated October 14, 2003.</p> <p><u>Short Term</u></p> <ul style="list-style-type: none"> <li>- visually monitor.</li> </ul> <p><u>Long Term:</u></p> <ul style="list-style-type: none"> <li>- major highway re-alignment</li> </ul>

SINCE REPAIR, THE NEW CULVERT HAS BEEN LINED WITH A SMOOTH STEEL PIPE (762mm OD)

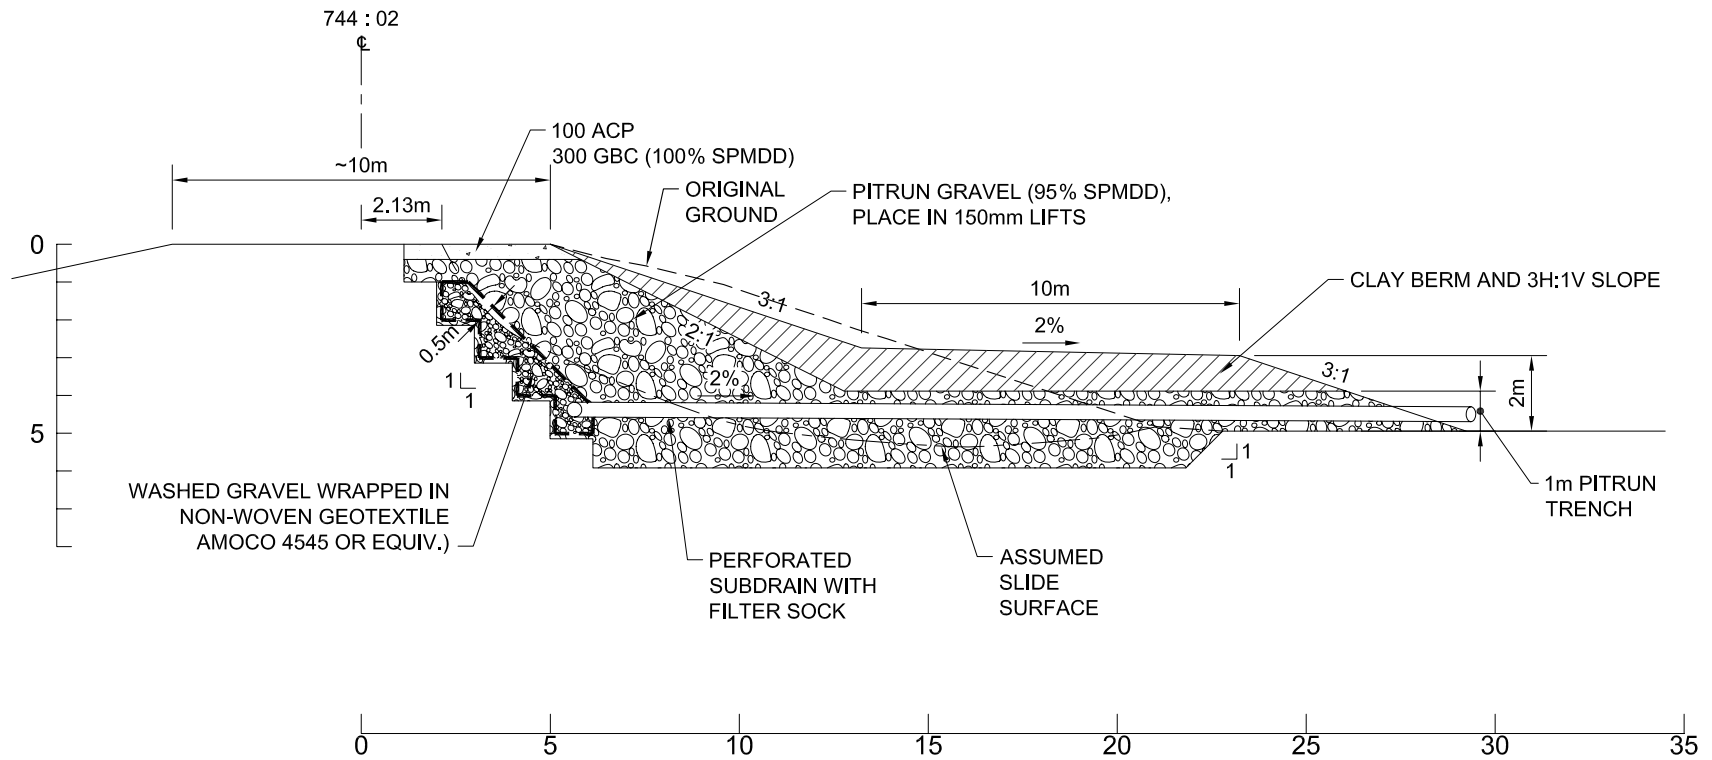
**FIGURE SH13-SITE #12A**  
 HWY 744:02 LITTLE SMOKY RIVER VALLEY  
 CROSS-SECTION A - A' (JUNE 3, 2003)

NOTE: REMEDIAL MEASURES CARRIED OUT ON JULY, 2002

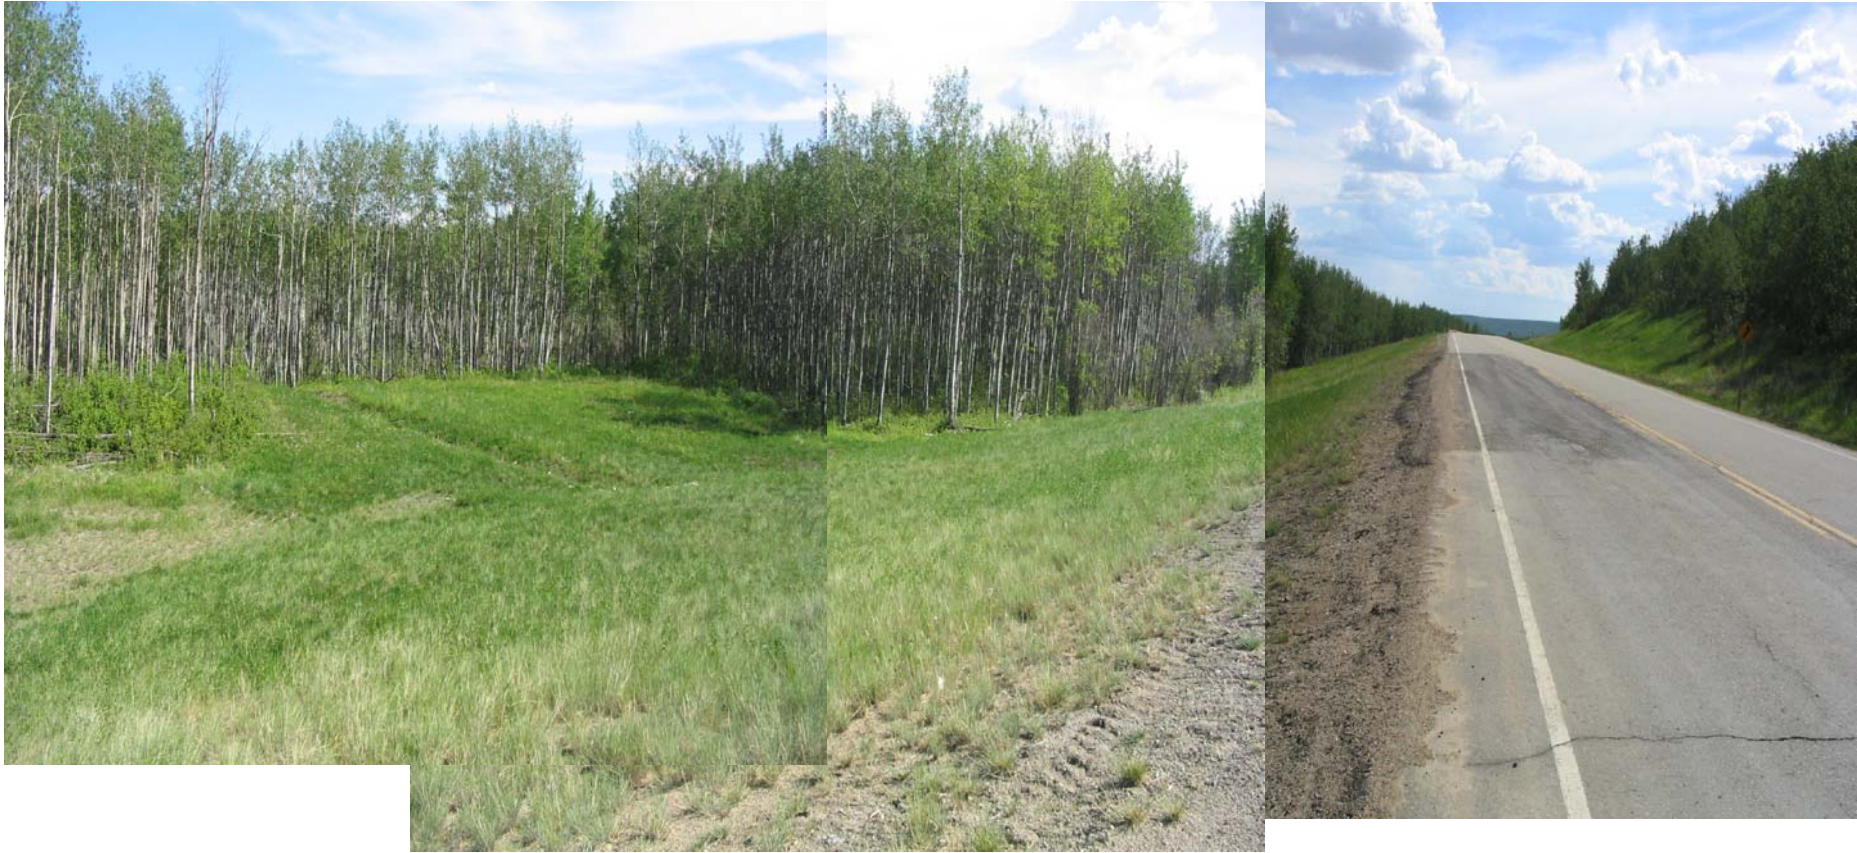
PHOTO #1 : LOOKING SOUTH TO SOUTHEAST AT SITE

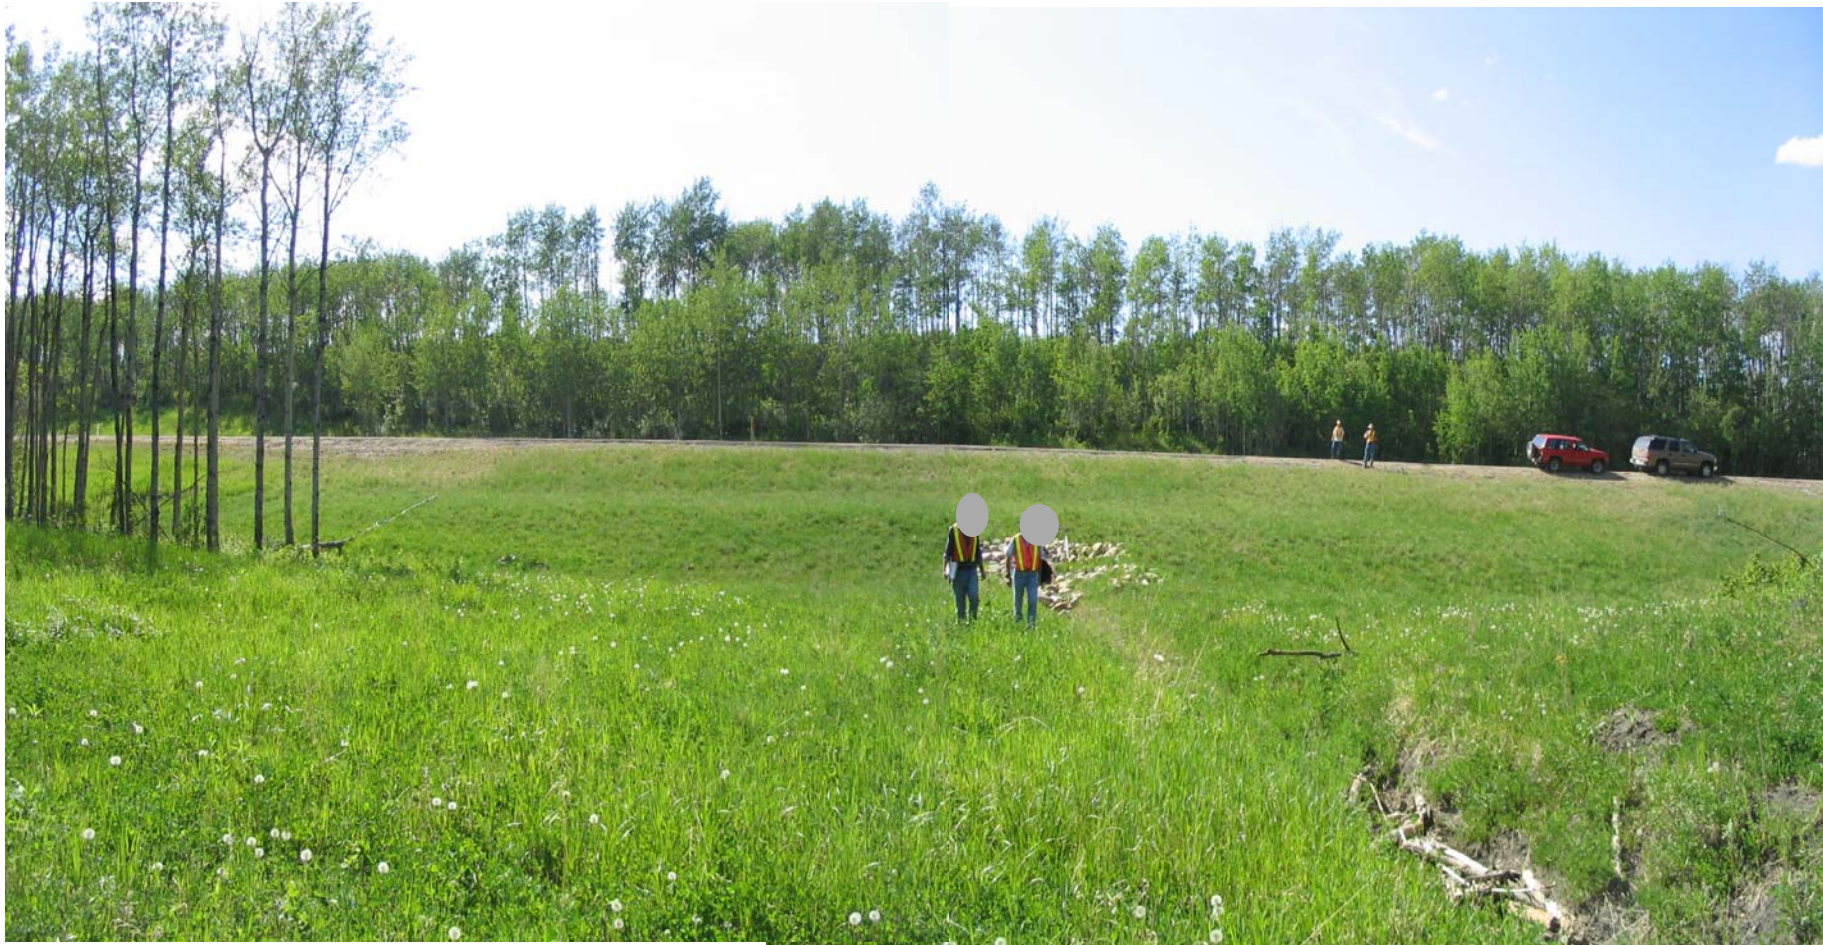
PHOTO #2 : LOOKING NORTHWEST AT CULVERT OUTLET.  
NOTE : GOOD VEGETATION GROWTH SINCE LAST YEAR OVER REPAIRED AREA.
