**ALBERTA TRANSPORTATION AND
ECONOMIC CORRIDORS
GEOHAZARD ASSESSMENT PROGRAM
PEACE REGION (PEACE RIVER DISTRICT)
2024 INSPECTION**

Site Number	Location	Name	Hwy	km
PH012	Judah Hill	Heart River Slides	744:04	57.114
Legal Description		UTM Co-ordinates (NAD 83)		
SE¼ 20-083-21 W5M		11V E 483284	N 6229209

Date	PF	CF	Total
Previous Inspection:	May 17, 2023	15	2	30 (Slide Risk Rating)
Current Inspection:	May 28, 2024	15	2	30 (Slide Risk Rating)
Road WAADT:	630	Year:		2023
Inspected By:	Don Proudfoot, Tyler Clay, Cole Szakacs (Thurber). Rocky Wang, Robert Senior (TEC)			
Report Attachments:	<input checked="" type="checkbox"/> Photographs <input checked="" type="checkbox"/> Plans <input type="checkbox"/> Maintenance

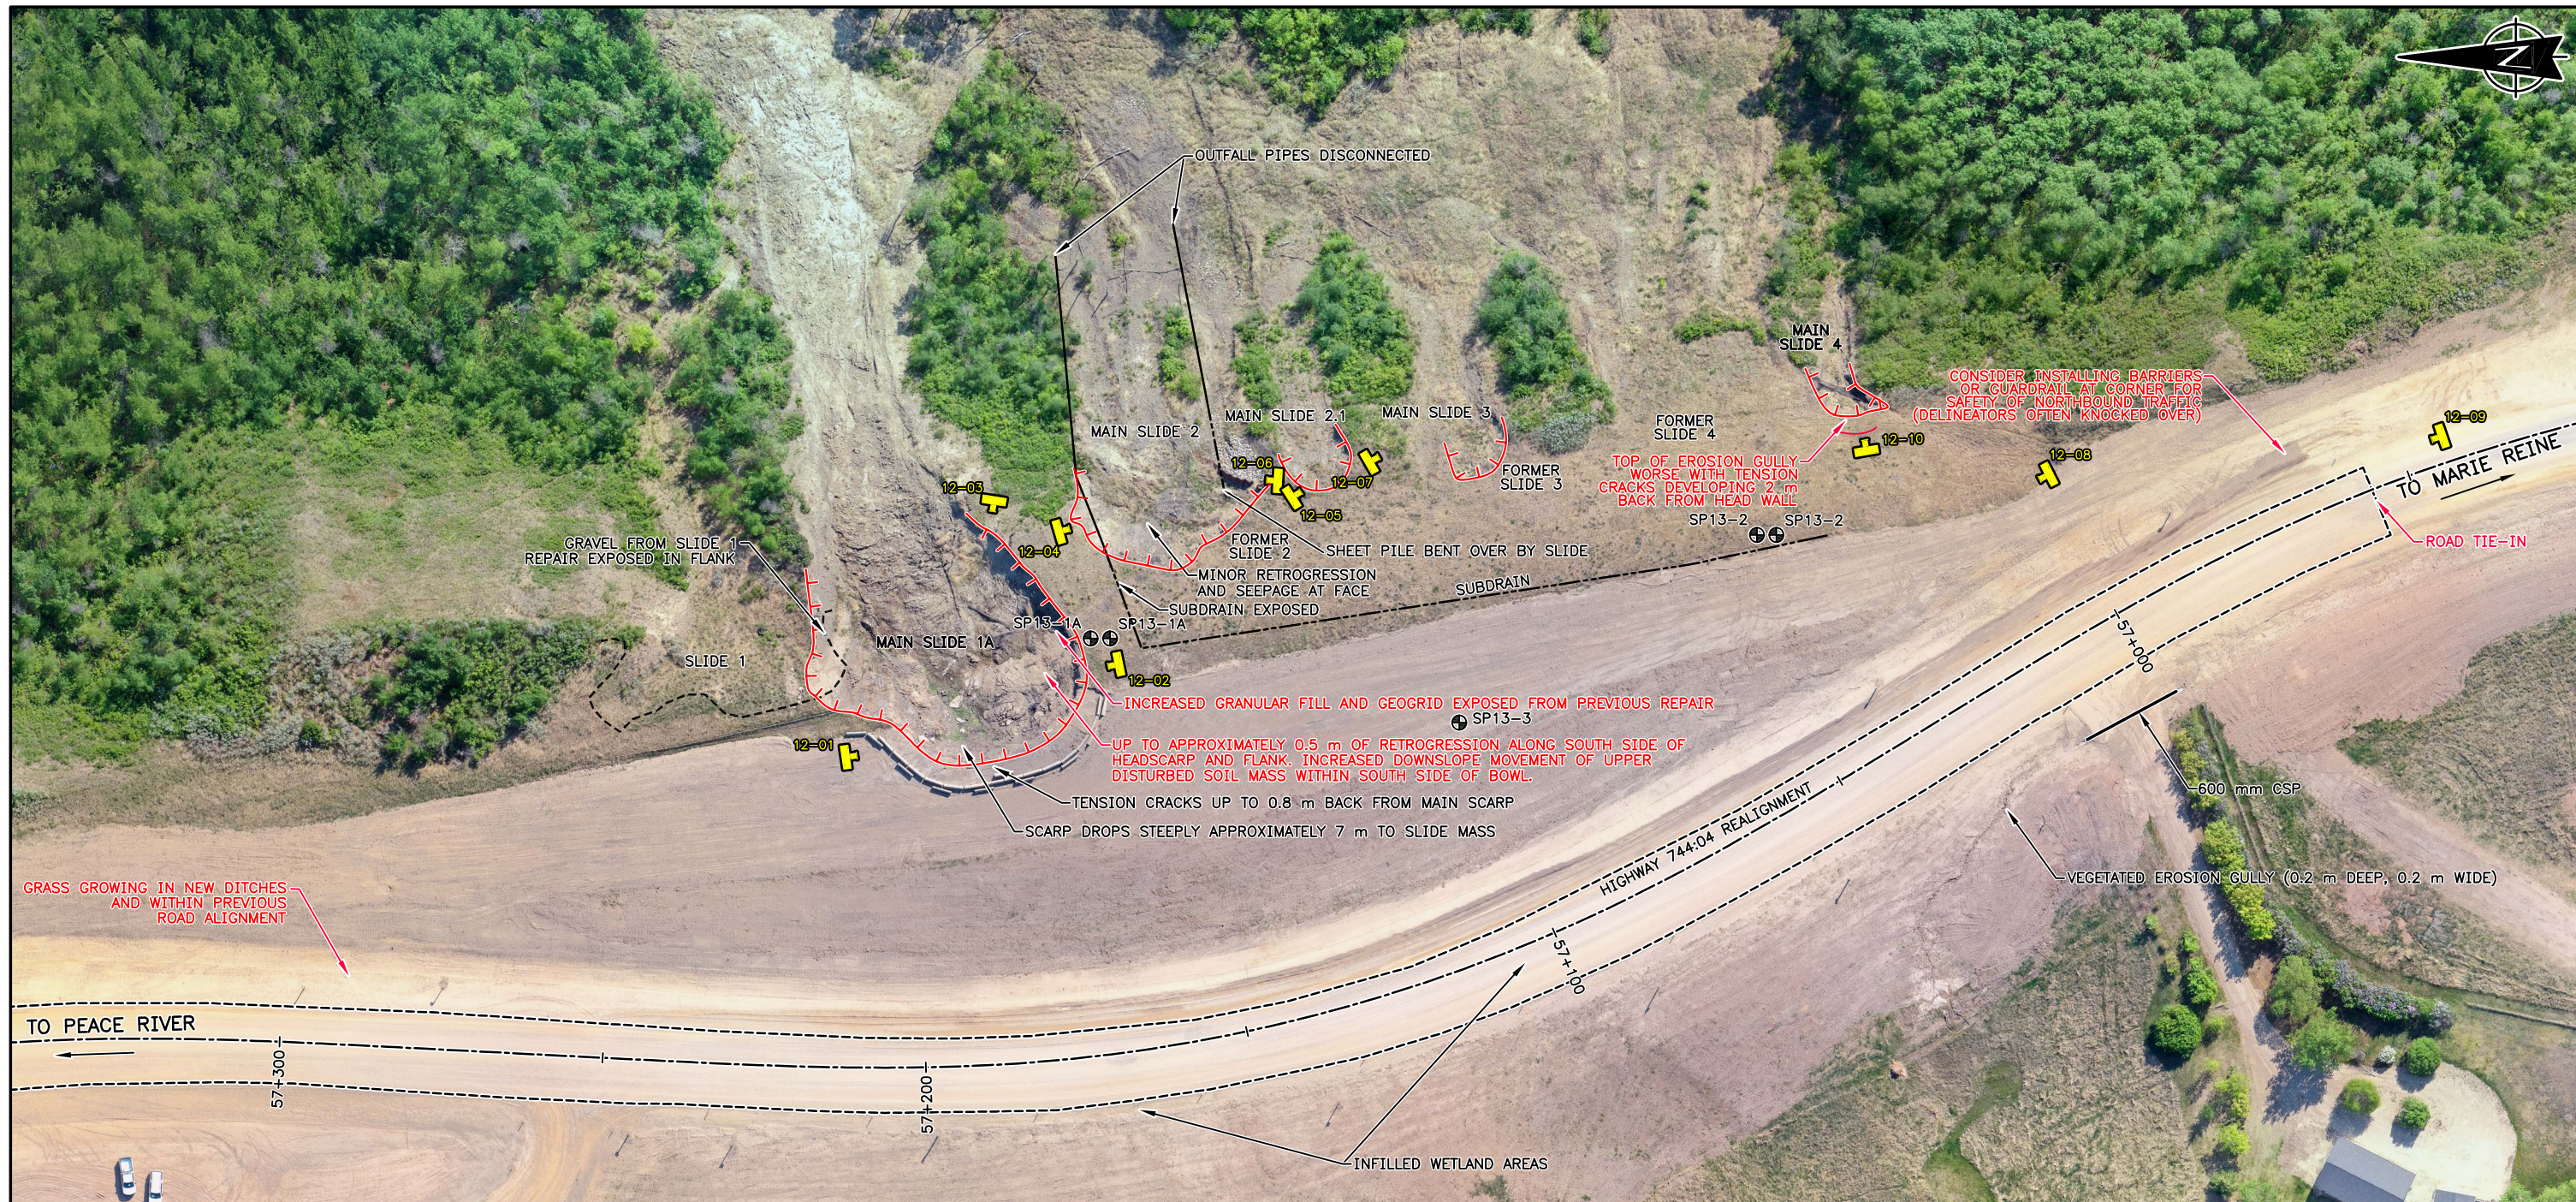
FIGURE PH012-1-1

A combination of weathering, heavy precipitation, and active seepage beneath the old highway embankment fill, which was built through a slough, and surface water drainage in the ditch appears to have caused the retrogression of Slides 2, 3 and 4 before they were repaired. The previous repair at Slide 1 continues to perform well. No new cracking noted on the slope above these slide areas has been observed to date.

The main scarp of Main Slide 1A (formed between Slide 1 and the former Slide 2) continues to retrogress but at a reduced rate since the large increment of movement that occurred in September 2020. The rate of retrogression will be highly dependent on groundwater and precipitation conditions. Signs of active seepage have been noted at the exposed scarp face and appear to be a driving factor in the loss of soil strength and rapid retrogression. The current offset from the main scarp and toe of the new gravel realignment embankment is approximately 35 m and therefore the consequence factor for this site has been reduced. However, if nothing is done to curb the rate of the Slide 1A retrogression, it is expected to encroach into the plateau area and might eventually become a threat to the new gravel alignment. The rate of retrogression towards the new realignment could be significantly reduced by buttressing or reinforcing the vertical scarp face.

The sheet pile wall has been compromised from slope movements and is deflected and ineffective at its north end. Ongoing slide movement and loss of material upslope from the wall due to earth flows are expected in the following years. Loss of material here and further south of the sheetpile wall could begin to undermine the upslope repairs above former slides 2 and 3.

Scour in seepage zones in the till underlying the 2014-2015 repair from Contract CON0015153 continue to develop resulting in shallow earth flows on the colluvium slope below the locations of the former slides 2, 3 and 4.

Thurber has previously recommended that the backscarp of the Main Slide 1A area be cut back at the top and buttressed at the bottom with a gravel wedge to reduce the rate of scarp retrogression. It is recommended to cut a ramp down the SE corner of the slide and clear out the base of the slide bowl of disturbed material. The removed slide material should be placed at the low lying borrow pit area SW of the site to avoid water ponding. The upper third of the main scarp should be excavated and a wedge of gravel backfill should be placed against the lower two thirds of the scarp (TEL can provide design drawings). (\$300k-500k)

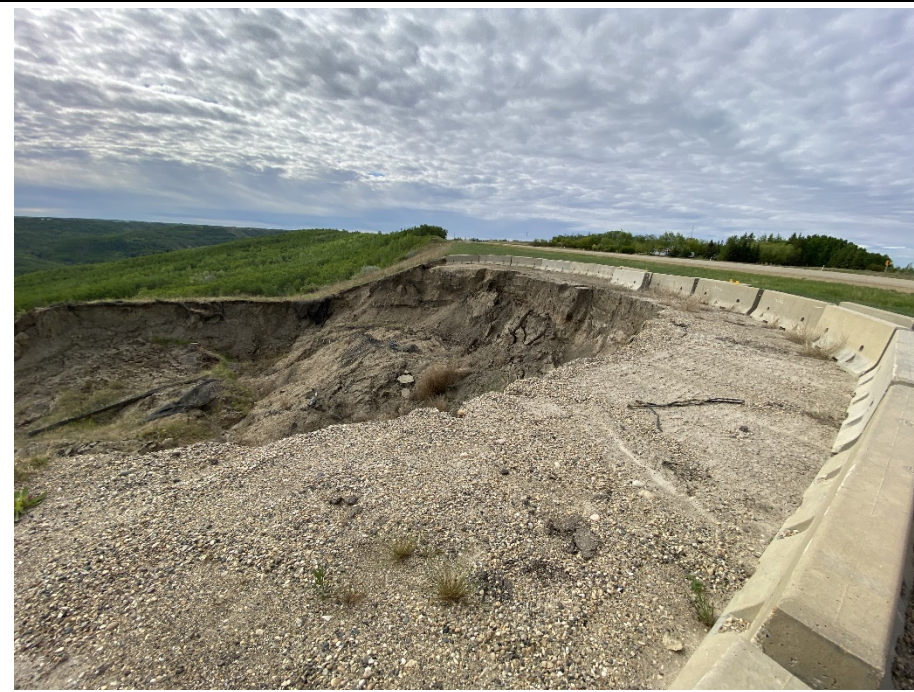
Photo 12-01.
Looking south from north side of Main Slide 1A. There is ongoing retrogression and erosion primarily within the southern half of the main scarp and south flank. Tension cracks were observed 0.8 m behind the main scarp. Main scarp offset from the edge if the gravel realignment is approximately 35 m (unchanged from 2023).

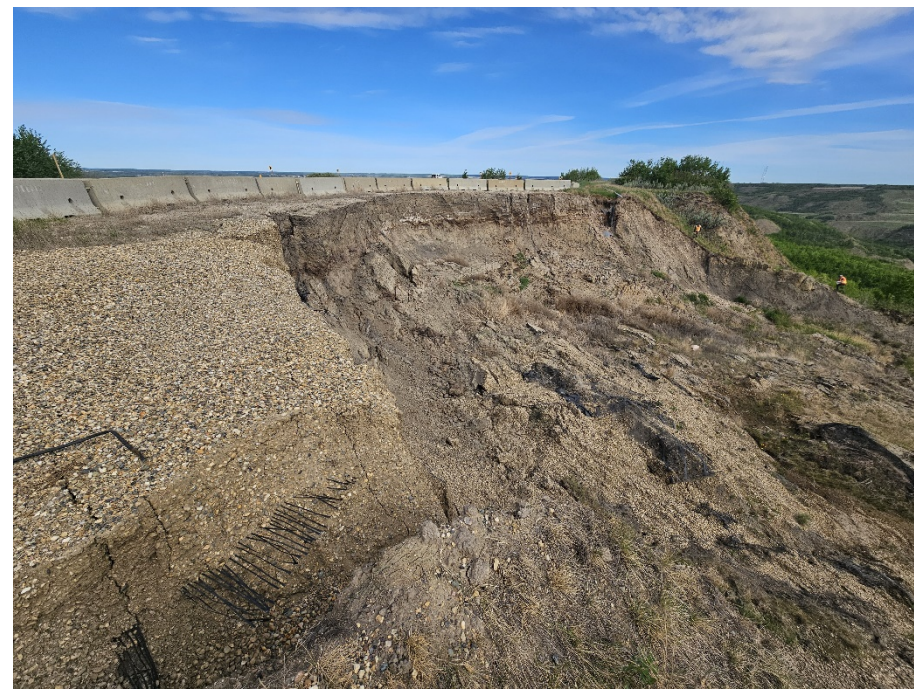
Photo 12-02.
Looking north towards the main scarp of Main Slide 1A. Disturbed slide mass within the upper slide bowl appeared to have increased downslope movement relative to the 2023 condition. Note dark seepage horizon visible in the main scarp and white mineral buildup.

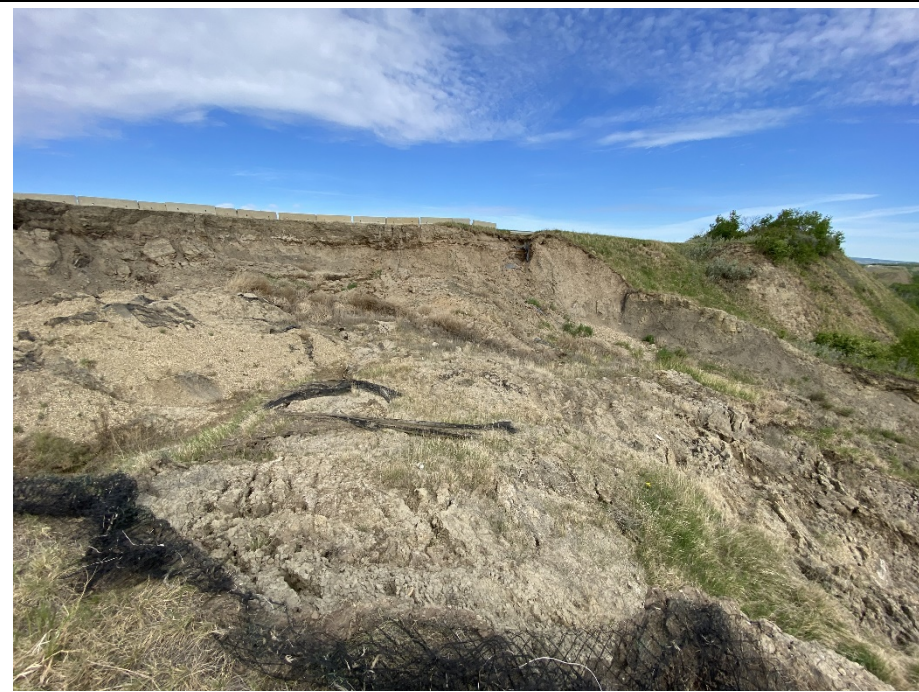
Photo 12-03.
Looking upslope towards the west at the main scarp and slide runout area of Main Slide 1A from the lower south flank.

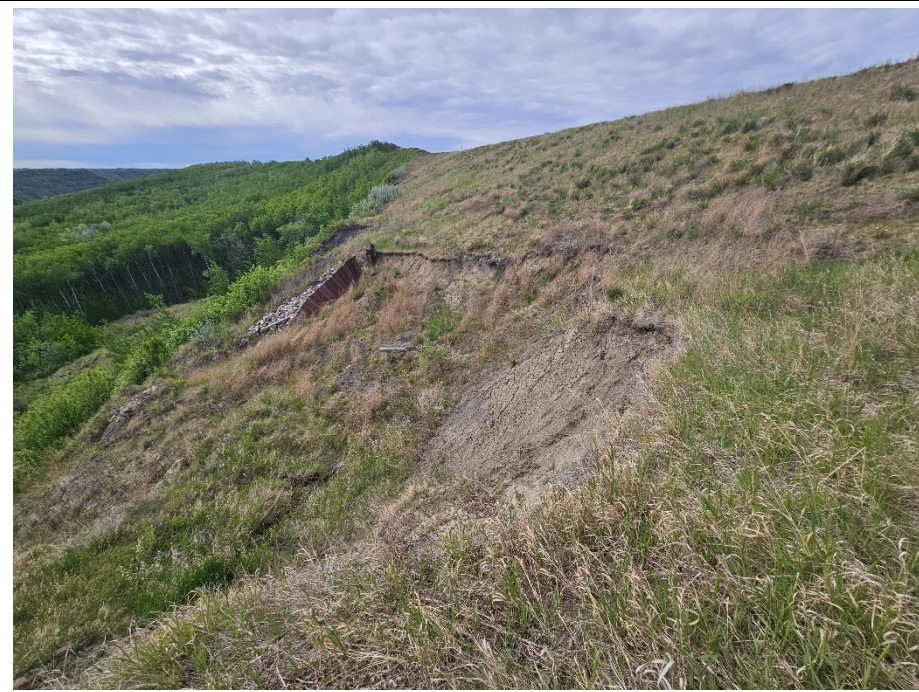
Photo 12-04.
Looking south at Main Slide 2 and 2.1 from the north end of Heart River Landslide repair excavation (Former Slide 2). Ongoing downslope movement and minor scarp erosion but no major retrogression / expansion of the scarp relative to the 2023 condition.

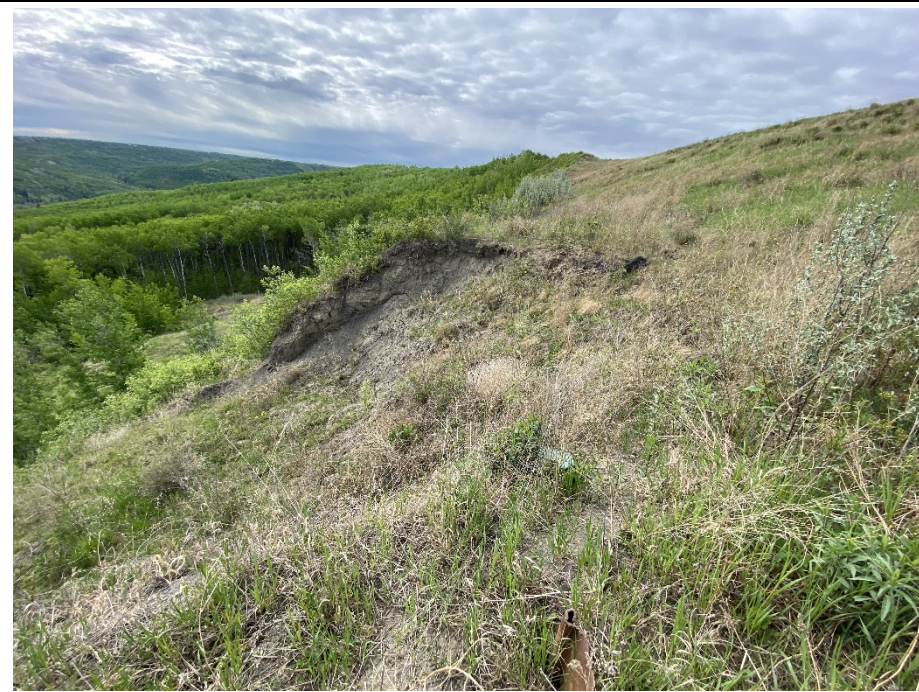
Photo 12-05.
Looking south at Main Slide 2.1 south of the sheet pile wall. No major retrogression of the scarp at this location since 2023.

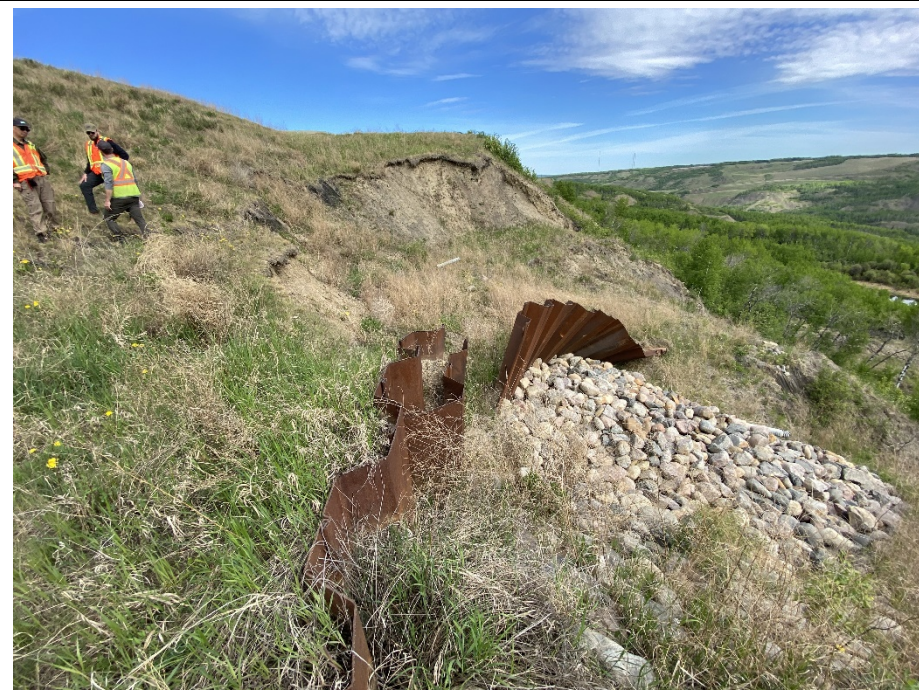
Photo 12-06.
Looking north at the former Slide 2 area with ongoing downslope slide movement and erosion of the upper scarp. No major changes observed since 2023. Deflection of the sheet piles appears similar to the 2023 condition.

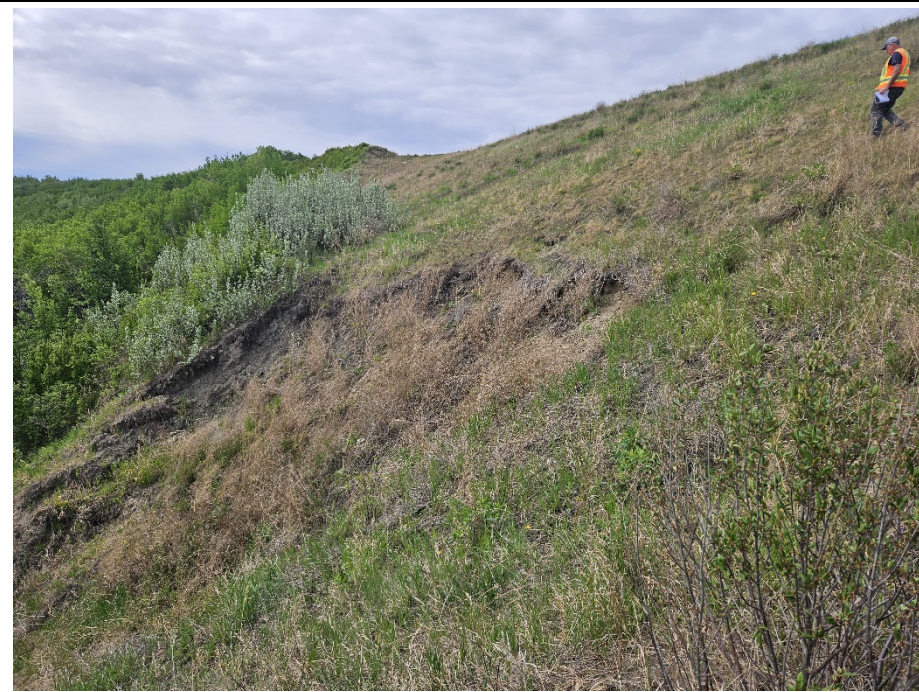
Photo 12-07. Looking south at earth flow at Main Slide 3. No significant retrogression or expansion of the main scarp since 2023.

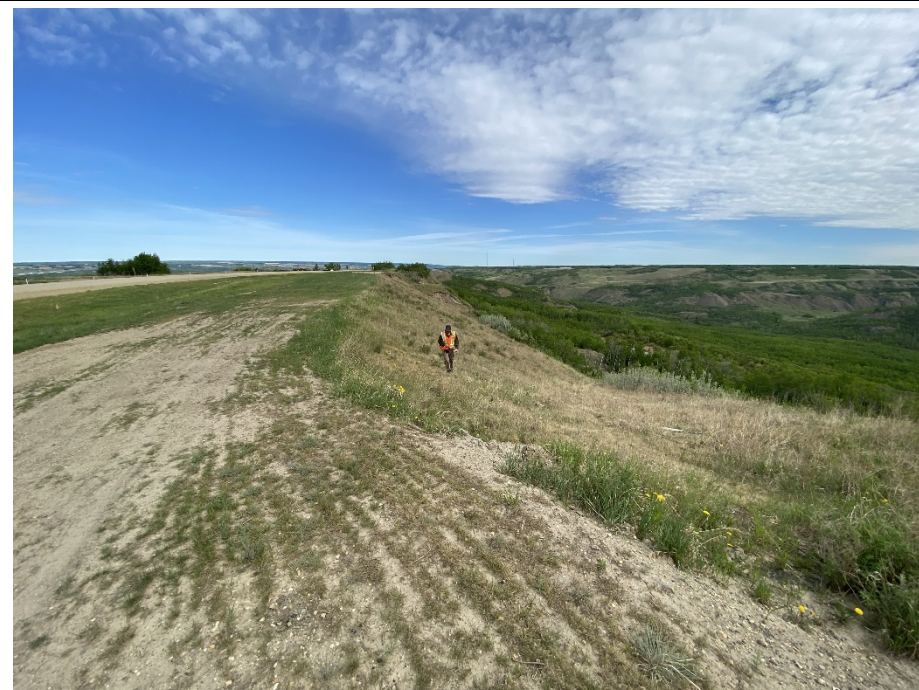
Photo 12-08. Looking north from south end of the former Slide 4 repair area. Overall repairs from 2014 are performing well. Overall slope is well vegetated and with no visible indications of new slide development within the granular backfill slope. Old highway alignment has grass development.

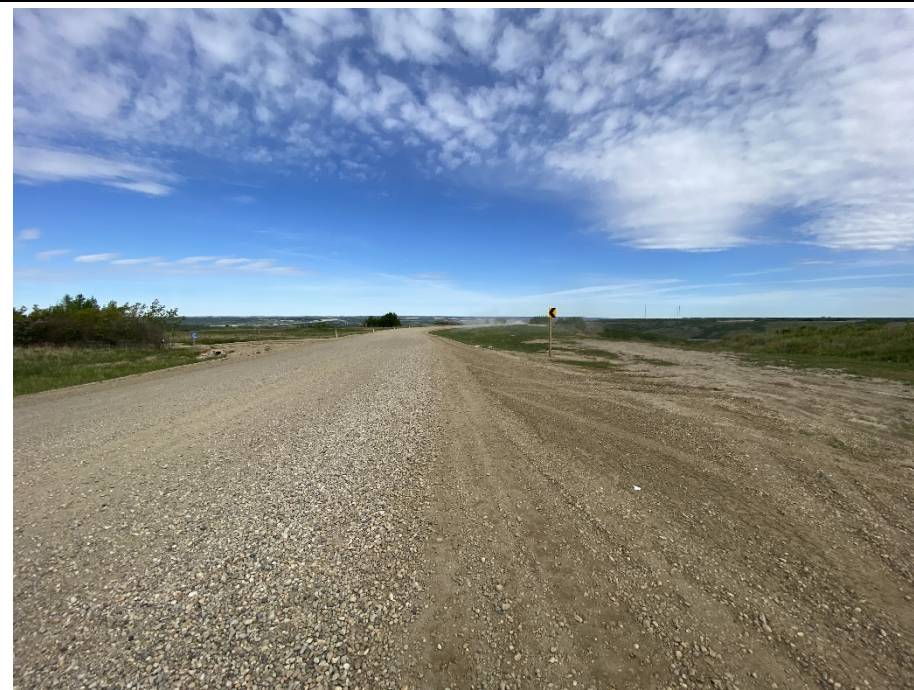
realignment near KM 56+000 to 57+000 (corner delineators are currently installed). (Photo 12-09)		
--	--	--	--

Photo 12-09. Standing within the gravel realignment looking north from the south end of the site. Barriers or a guardrail should be considered at the road bend here (KM 56+000 to 57+000) for northbound traffic to reduce potential for drivers to maintain a course into the old alignment.

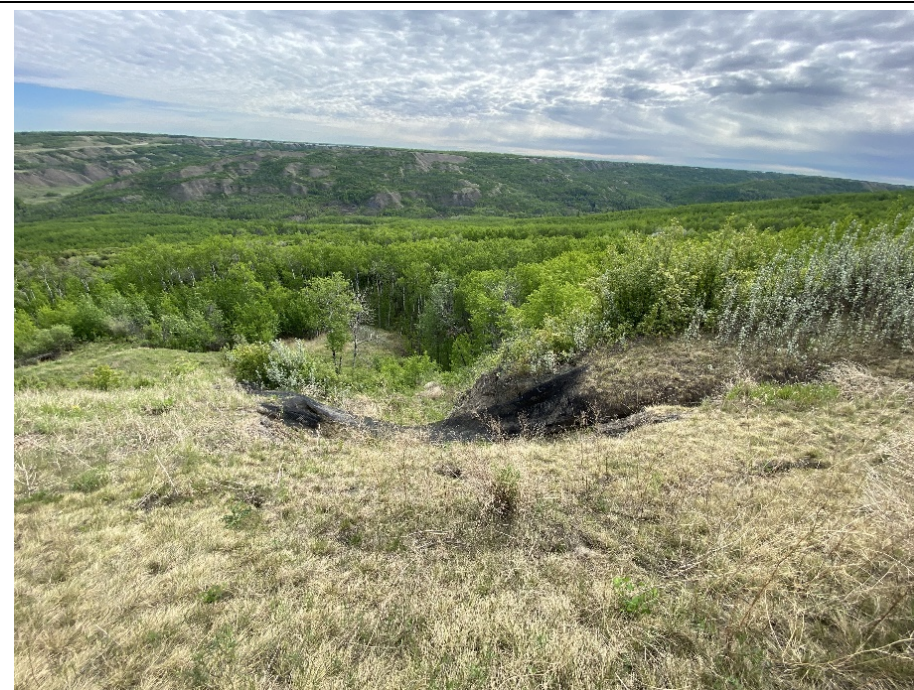
Photo12- 10. Active gully erosion within the top of Main Slide 4. Erosion damage at the gully headwall appeared worse relative to the 2023 condition and a new tension crack had developed 2 m upslope from the gully headwall.
