**ALBERTA TRANSPORTATION AND
ECONOMIC CORRIDORS
GEOHAZARD ASSESSMENT PROGRAM
PEACE REGION (PEACE RIVER DISTRICT)
2024 INSPECTION**

| Site Number | Location | Name | Hwy | km |
|---|---|---|---|---|
| PH030 | Judah Hill | Lookout Slides | 744:04 | 57.43 |

**PH030 LOOKOUT SLIDES
2024 SITE INSPECTION PLAN**

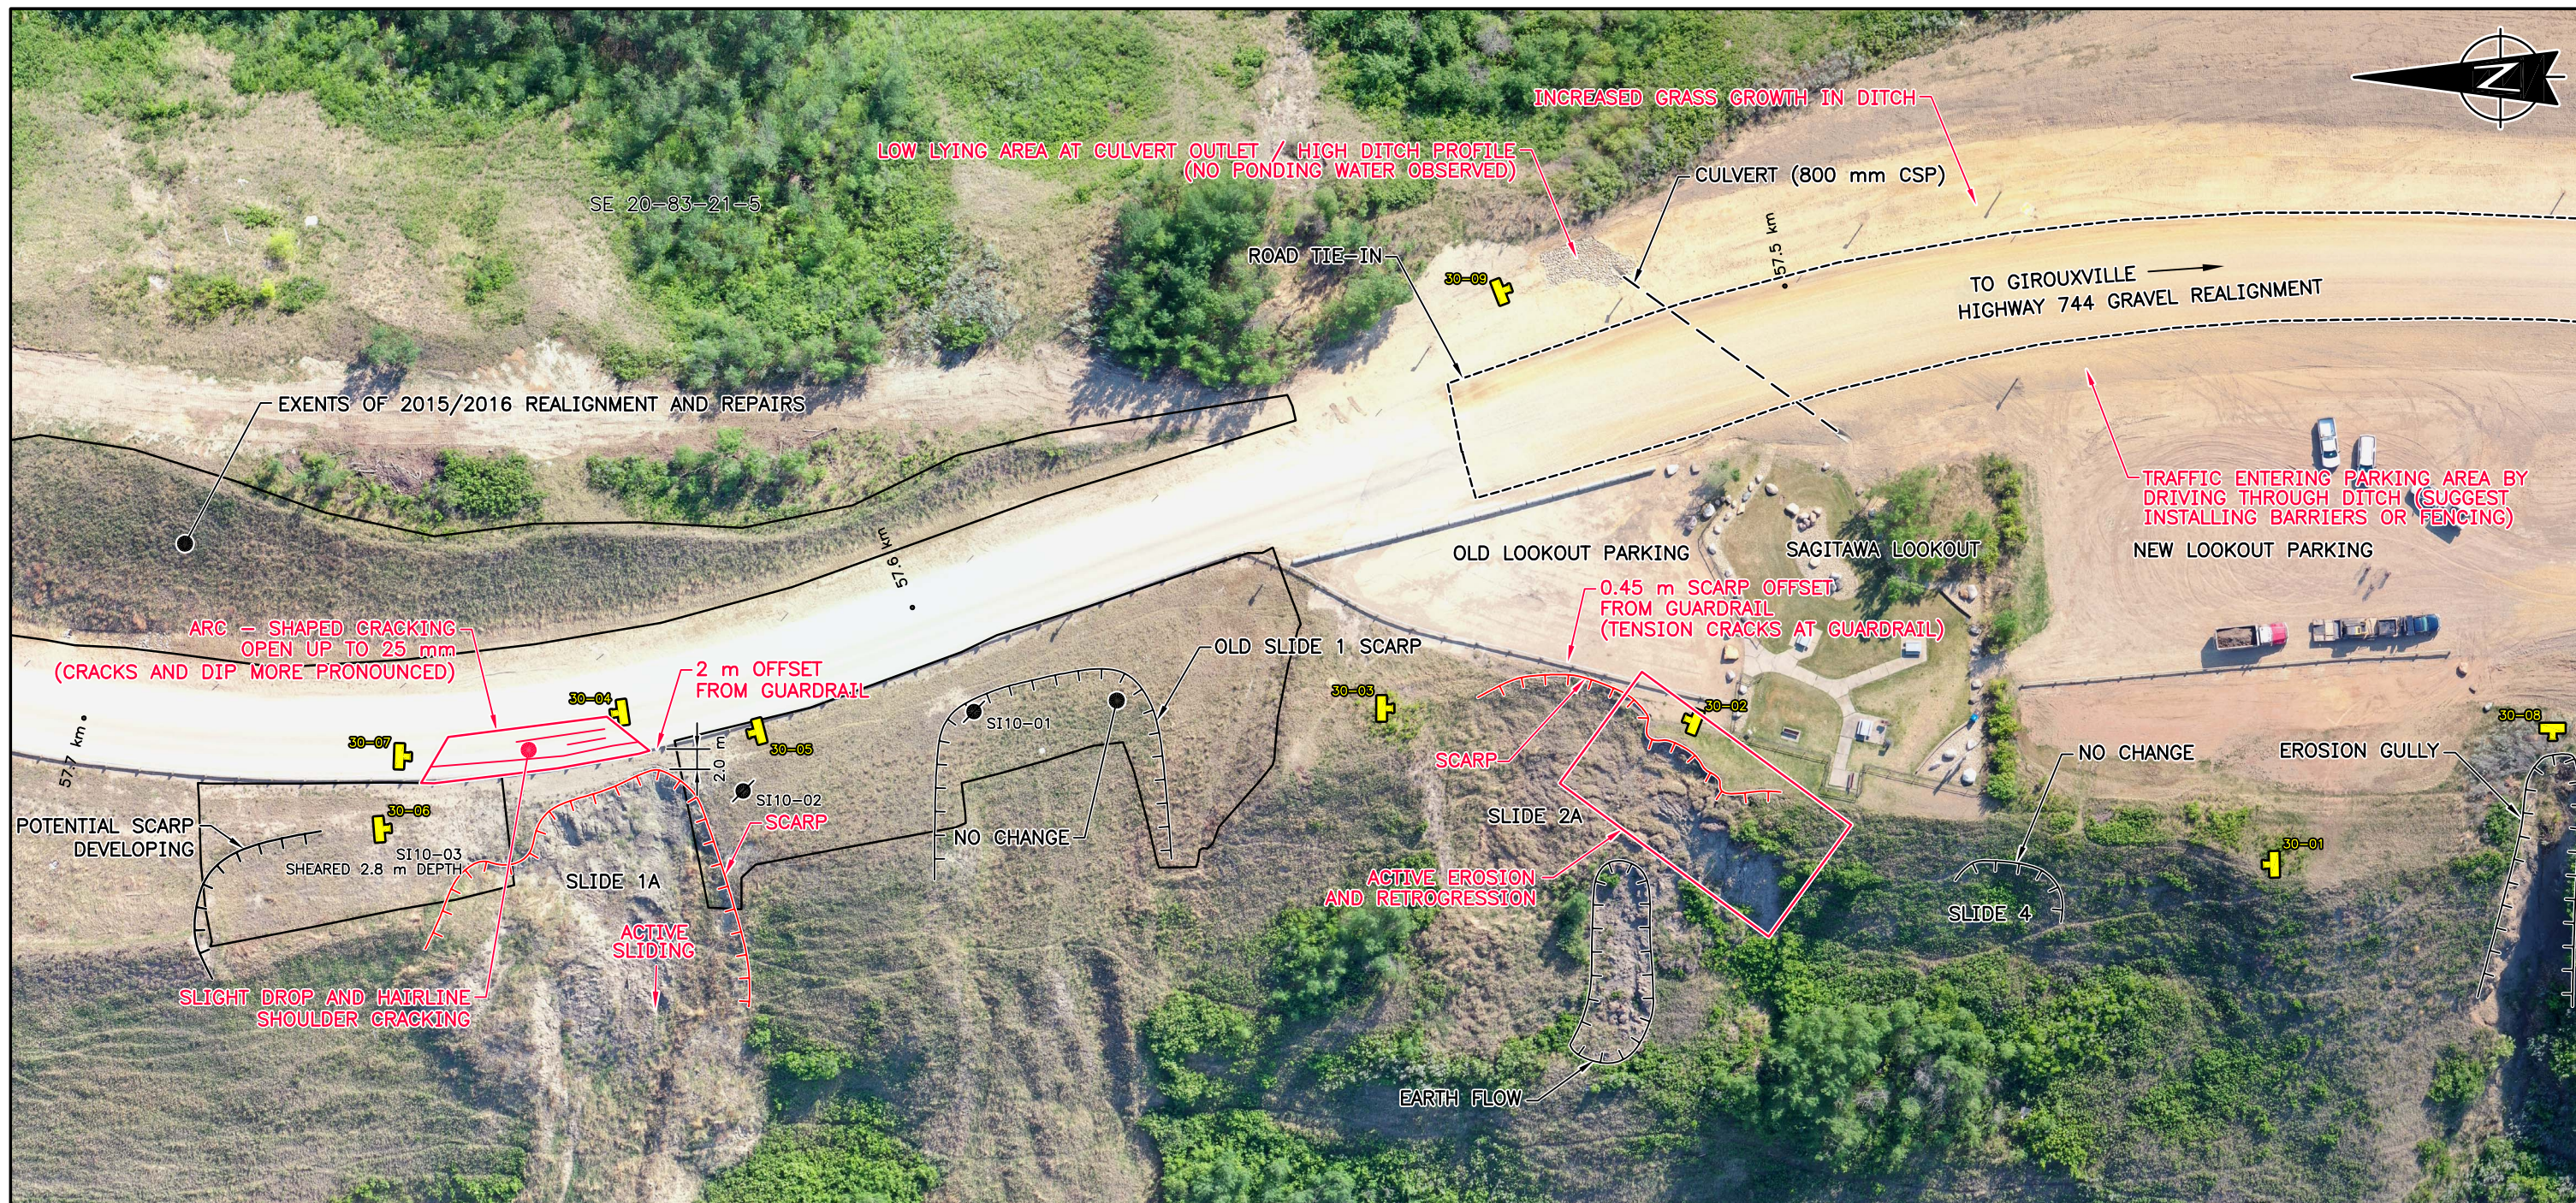
FIGURE PH030-1-1

The existing slides occurred on steep slopes (36° to 38°) and are similar in appearance to the Heart River slides. The previous repairs at Slide 1 (shredded tire fill wedge) appear to be effective, although there may be some ongoing movement in the backscarp causing minor pavement distress.

There is continuing slide activity in Slide 2A (formerly Slides 2 and 3) and in Slide 1A located in the newly regraded highway sideslope below the SBL at km 57.65. This movement could be in response to natural groundwater drainage and seepage locations. Retrogression of the main scarps at these slides has generally been slow with larger increments that could be linked to seasonal affects.

At Slide 1A (km 57.65), the visible main scarp continues to retrogress towards the SBL and is only offset 2 m from the guardrail. Based on the arc-shaped cracking pattern within the pavement upslope from this slide area, a slide plane appears to have developed beneath the highway, and it encompasses the SBL and an increasing part of the NBL. Although the movements within the road have been relatively small to date, a large increment of movement within this slide block could negatively impact both lanes of the driving surface. The operating SI near this area (SI10-2) appears to be outside of the main movement zone; however, a trend of accelerating movement rates has been observed at approximately 6 m depth. The largest movement rate (~12 mm/yr) was recorded at SI10-2 since initialization during the Fall 2024 readings. This could reflect progressive loss of toe support below the highway at km 57.65, resulting in the observed pavement damage.

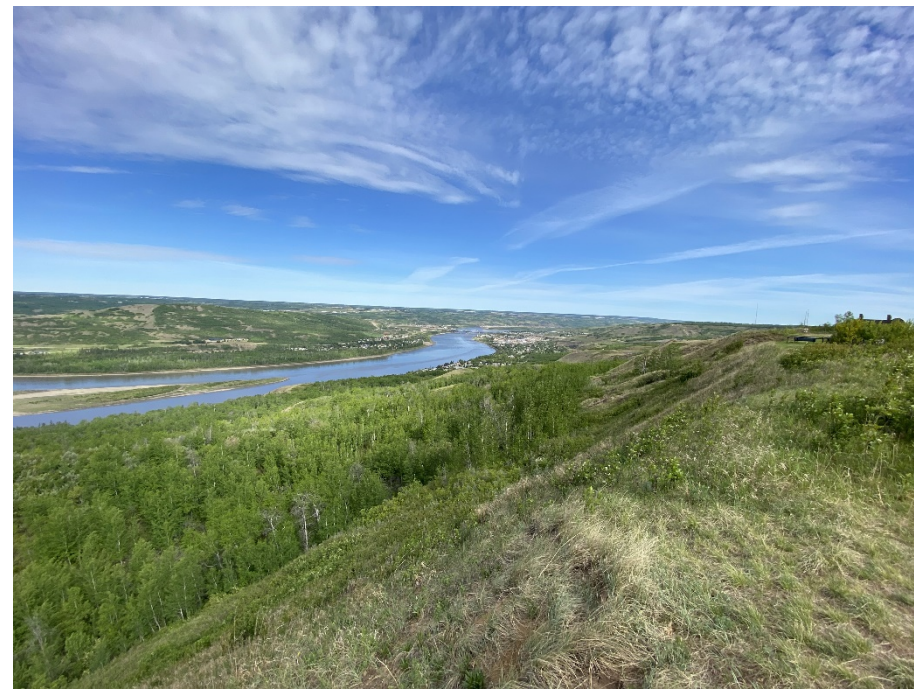
| <input checked="" type="checkbox"/> Slope Movement | <p>No changes have been observed at Slide 4 over the last several years. (Photo 30-1)</p> <p>Increased retrogression and flank expansion within the southern end of Slide 2A. Slide 2A main scarp offset 0.45 m from the guardrail (unchanged from 2023) and upper slide area was well vegetated. Tension cracks behind the main scarp now extend below the guardrail. (Photos 30-2 and 30-3)</p> <p>The main scarp of Slide 1A (km 57.65) appears to be actively moving with increased downdrop, and erosion along the exposed scarp faces but no significant retrogression since 2023. Main scarp is offset a minimum of 2.0 m from the guardrail, unchanged from the 2023 condition. (Photos 30-5 and 30-6)</p> | <input checked="" type="checkbox"/> | <input type="checkbox"/> |

Photo 30-01.
Looking north towards the Slide 4 area from the south end of the site. No change to the slide in this area has been observed over the last several years and it is well vegetated.

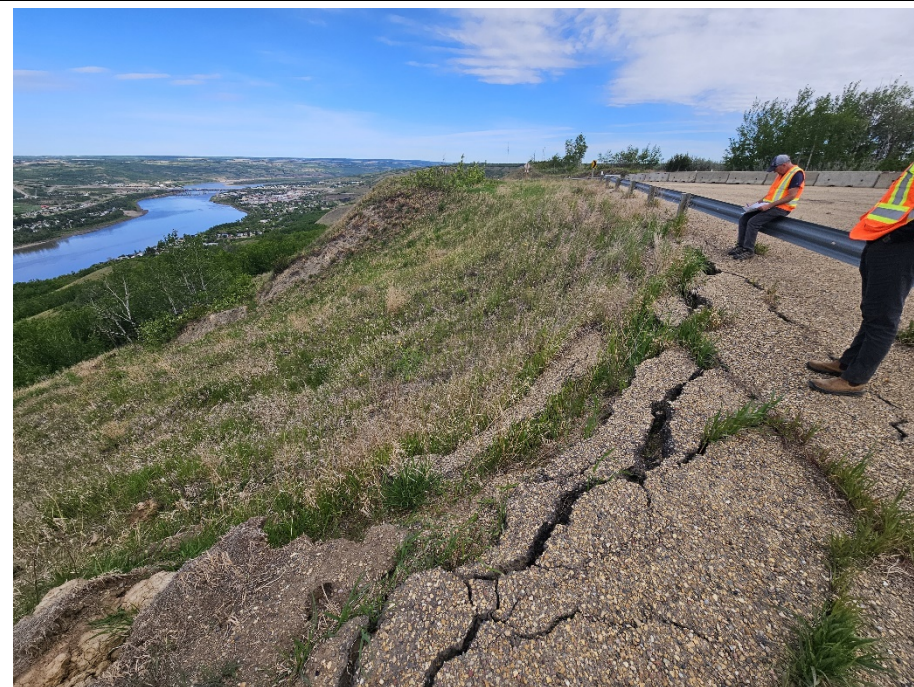
Photo 30-02.
Looking north along backscarp of Slide 2A (previously Slides 2 and 3) which has a minimum offset of 0.45 m from the parking lot guardrail. Some localized main scarp retrogression at south end, flank erosion and additional pavement cracking since 2023. Tension cracks are now at the guardrail.

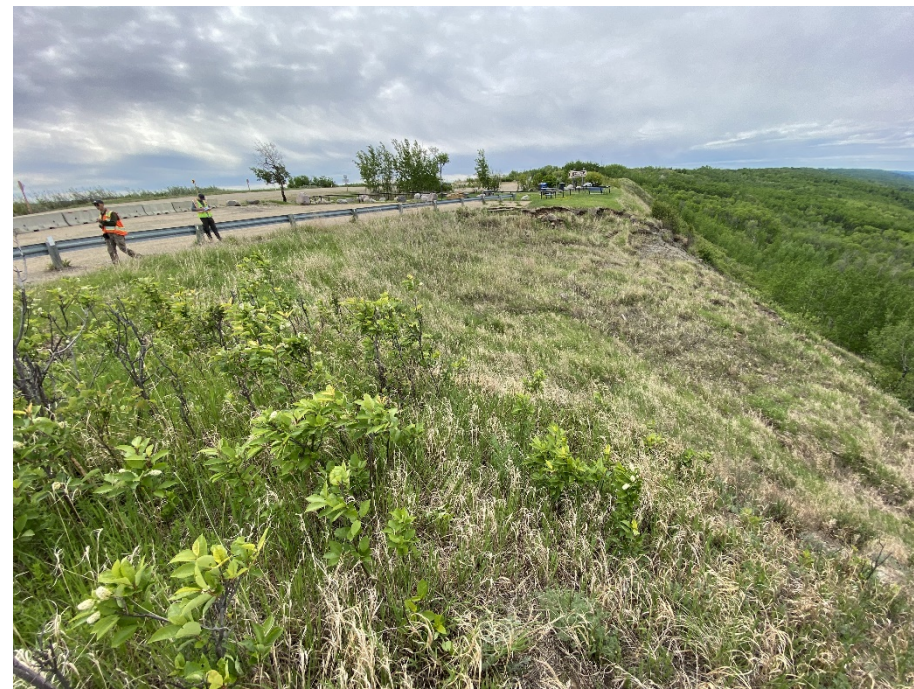
Photo 30-03.
Looking south towards the upper part of Slide 2A. South flank had most activity since 2023 within increased erosion and minor retrogression. Ongoing movements occurring further downslope, primarily involving shallow earth flows.

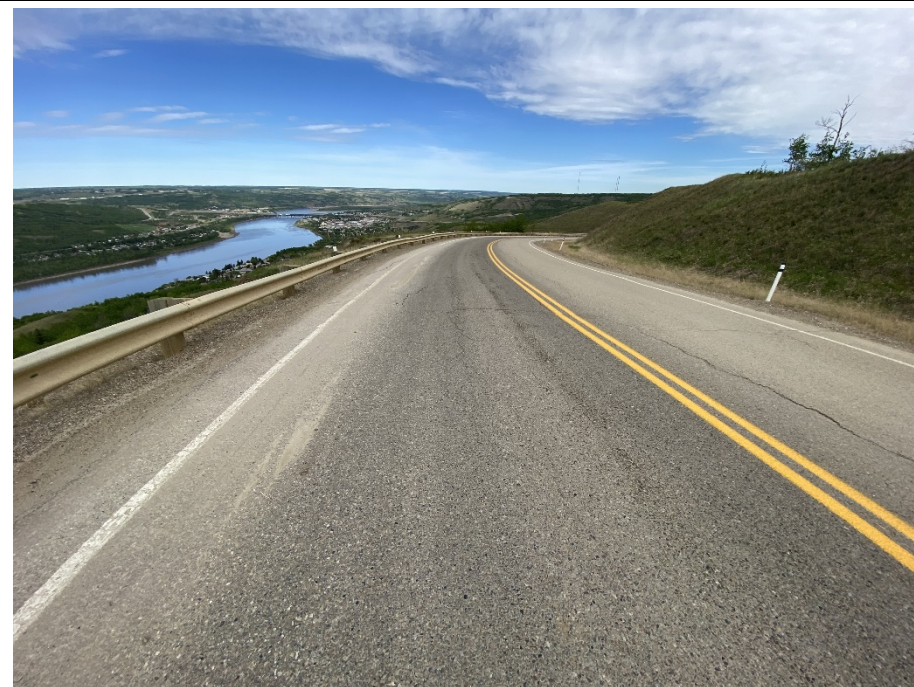
| Primary Site Issue: | <p>Several old slides on the steep slope west of the Sagitawa Lookout and north on Hwy 744:04.</p> <p>Highway was closed from May 2013 to January 2014, due to the occurrence of the Sunshine Landslide further north. Highway section through the area was realigned as part of Contract CON0015153 in 2015/2016 due to a landslide located near SI10-3 that retrogressed into the SBL in June 2015. A temporary detour had to be built in the NBL ditch and the traffic was re-instated on the current alignment in mid-November 2015. Failures in the sideslope are retrogressing toward the re-aligned road north of the Lookout slide.</p> | | |
|--|---|---|---|
| <input checked="" type="checkbox"/> Pavement | Longitudinal arc-shaped cracking that extends just past the centreline into the NBL occurring upslope from the extents of Slide 1A (km 57.65). The cracks are open up to 40 mm at the north end and there is a more pronounced dip relative to the 2023 condition. Hairline shoulder cracks are occurring within the slide area. Increased cracking was extending into the NBL. (Photos 30-4 and 30-7). | <input checked="" type="checkbox"/> | <input type="checkbox"/> |

Photo 30-04.
Looking north along the SBL of Hwy 744:04 near km 57.65 at south end of 2015 realignment. Transverse cracks have formed joining the previous longitudinal crack in the NBL to form arc-shaped crack within the downslope extents of Slide 1A. Cracks have extended into the NBL.

- Movement at Slide 1A (57.65) is expected to continue to move and retrogress toward the new highway alignment. In the short-term, if the southbound lane was lost an emergency repair would likely involve a realignment into the hillside and conversion to gravel. (\$350k – \$500k)
- Sub-excavation of the Slide 1A mass and replacement with light weight fill could be considered as a shorter-term, cost-effective solution. (\$500k - \$750k)

- Long-term option for Slide 1A would likely involve a tied-back pile wall. The wall will need to be in the order of 35 m to 40 m wide with two rows of tie-back anchors. (\$1.5M - \$3M)

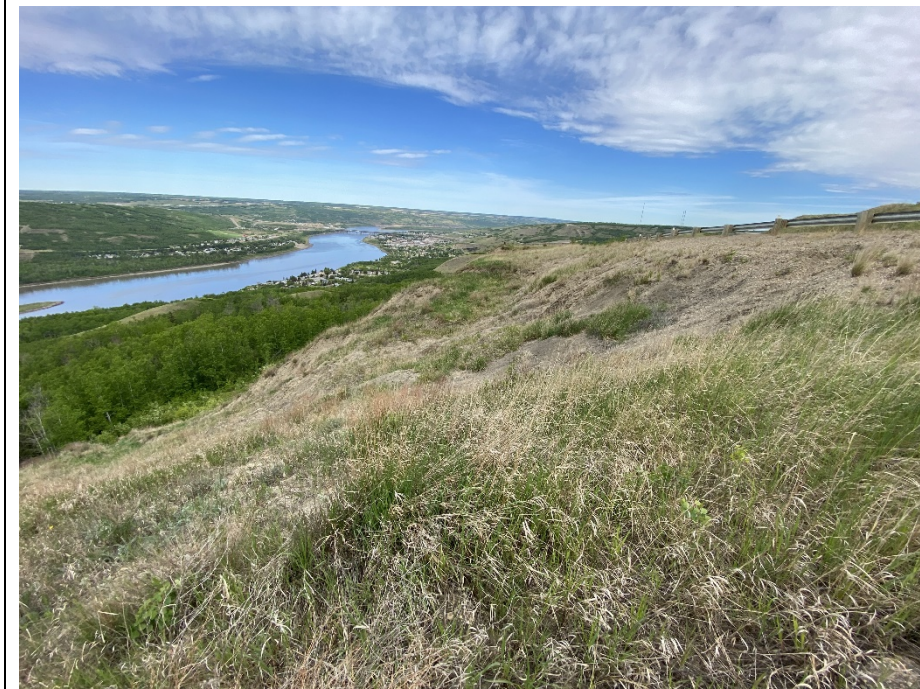
Photo 30-05.
Looking north from downslope of the SBL of Hwy 744:04 near km 57.63. Increased down drop within the disturbed slide mass of Slide 1A. Main scarp had minor retrogression since 2023 and is offset a minimum of 2.0 m from the guardrail (unchanged from 2023).

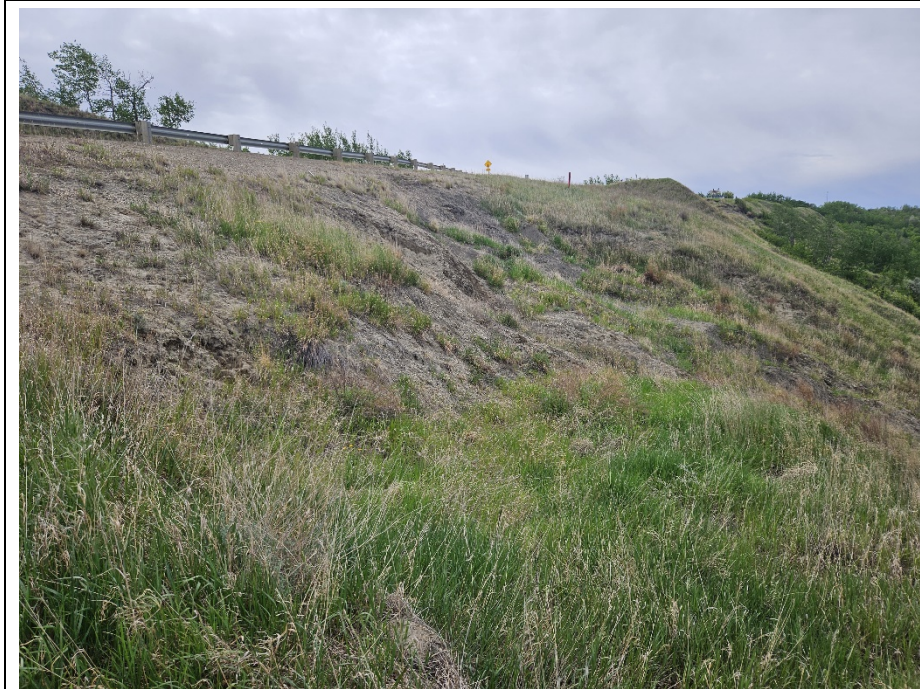
Photo 30-06.
Looking south at Slide1A (near KM 57.65). Ongoing downslope movement and erosion at the main scarp and south flank; however, no major change from the 2023 condition.

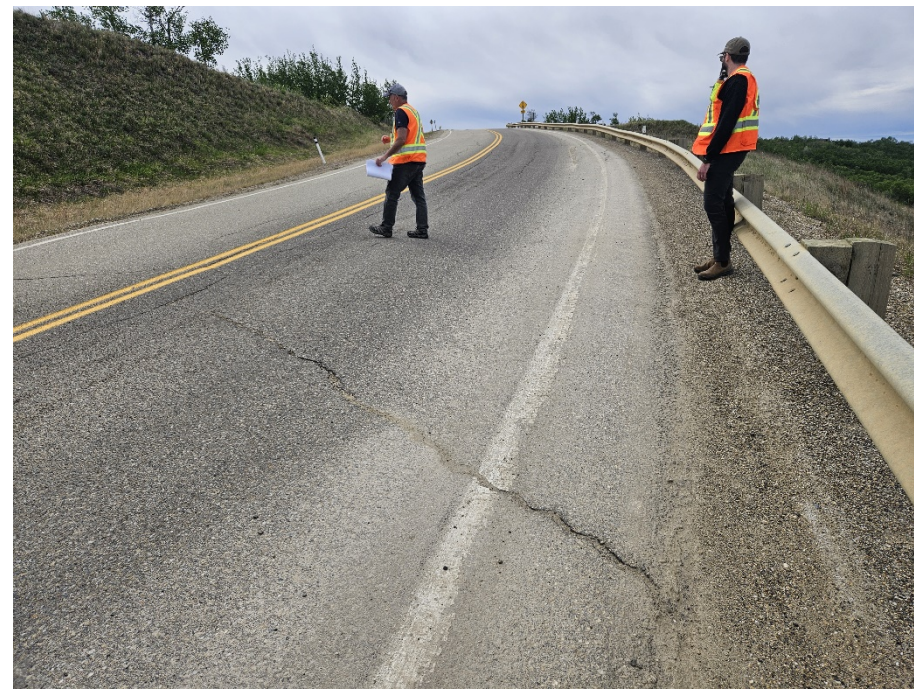
Photo 30-07.
Looking south along SBL of Hwy 744:04 at km 57.68. Arc-shaped cracking more prominent in SBL within the downslope extents of Slide 1A. Dip was more pronounced relative to the 2023 condition and cracks have started to extend into NBL.

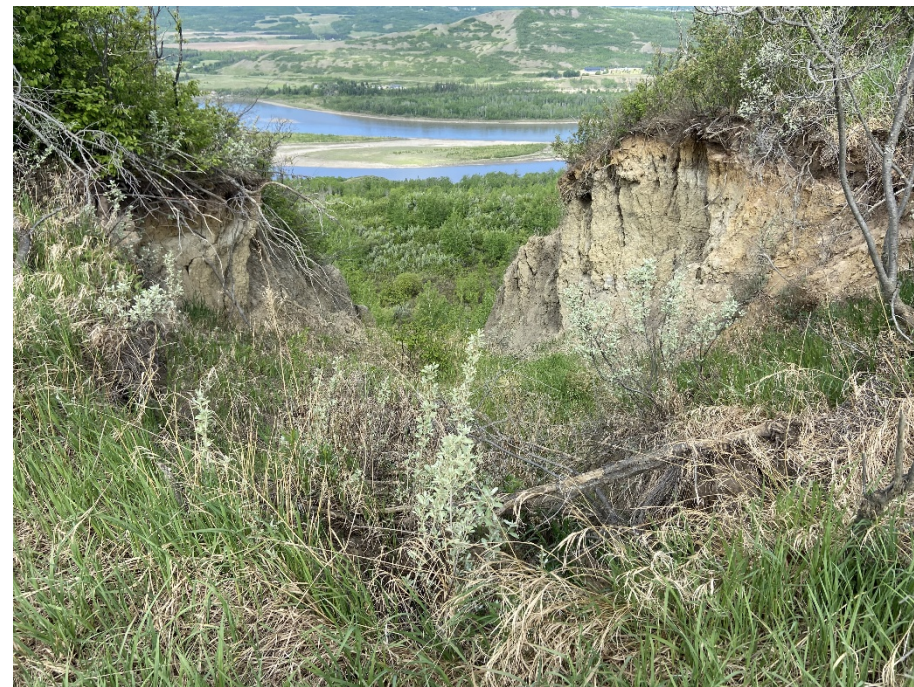
| <input checked="" type="checkbox"/> Erosion | <p>Erosion gully approximately 50 m south of Slide 4 at the southern end of the site has actively eroding flank walls but no retrogression of the headwall (Photo 30-8).</p> <p>Traffic is entering the new lookout parking area (km 57.45) by driving through the ditch on the west side of the new alignment which could limit grass growth and exacerbate any development of future ditch erosion.</p> | <input type="checkbox"/> | <input checked="" type="checkbox"/> |

Photo 30-08.
Looking at the top of an erosion gully located at the southern edge of the site, approximately 50 m south of the Slide 4 area. Gully is offset approximately 50 m west of the new highway realignment. No headwall retrogression since 2023.

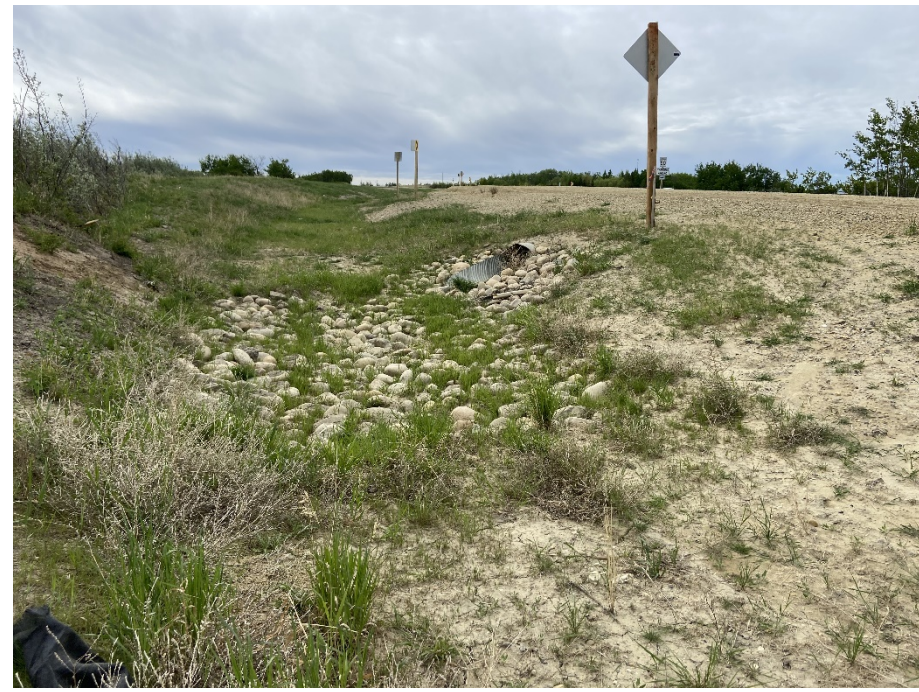
| <input checked="" type="checkbox"/> Other | <p>Potential ponding area due to high ditch profile from realignment construction downstream of new culvert outlet (km 57.52. No ponding was observed in 2024.</p> | <input type="checkbox"/> | <input checked="" type="checkbox"/> |

Photo 30-09.
Looking south along the east ditch of the new gravel realignment and new culvert outlet (km 57.52). There is a low spot within the ditch that should be fixed by regrading for an approximately 20 m section north of the outlet to prevent ponding. No ponding was observed in 2024.

- The ditches on either side of the new gravel alignment should have topsoil placed, seeded and TRM installed. The east ditch profile should be lowered a bit to avoid ponding for an approximately 20 m length north of the ditch outlet at the new culvert near km 57.52.
- Install barriers or fencing on the east side of the new lookout parking area to prevent traffic driving across ditch.
