**ALBERTA TRANSPORTATION AND
ECONOMIC CORRIDORS GRMP
PEACE REGION – (PEACE RIVER DISTRICT)
INSTRUMENTATION MONITORING - FALL 2024**

Site Number	Location	Name	Hwy	km
PH031	HWY 744:04 C1 57.7	Michelin Slide- Judah Hill	744:04	Km 57.7
Legal Description:		UTM Co-ordinates		
9-20-83-21 W5		11U E 483125.92	N	6229725.01

Current Monitoring:	21-Sep-2024	Previous Monitoring	22-May-2024
Instruments Read By:	Mr. Niraj Regmi, G.I.T and Mr. Nixson Mationg, of Thurber

**ALBERTA TRANSPORTATION AND ECONOMIC CORRIDORS
PEACE REGION (PEACE RIVER DISTRICT)
INSTRUMENTATION MONITORING FIELD SUMMARY (PH031)
FALL 2024**

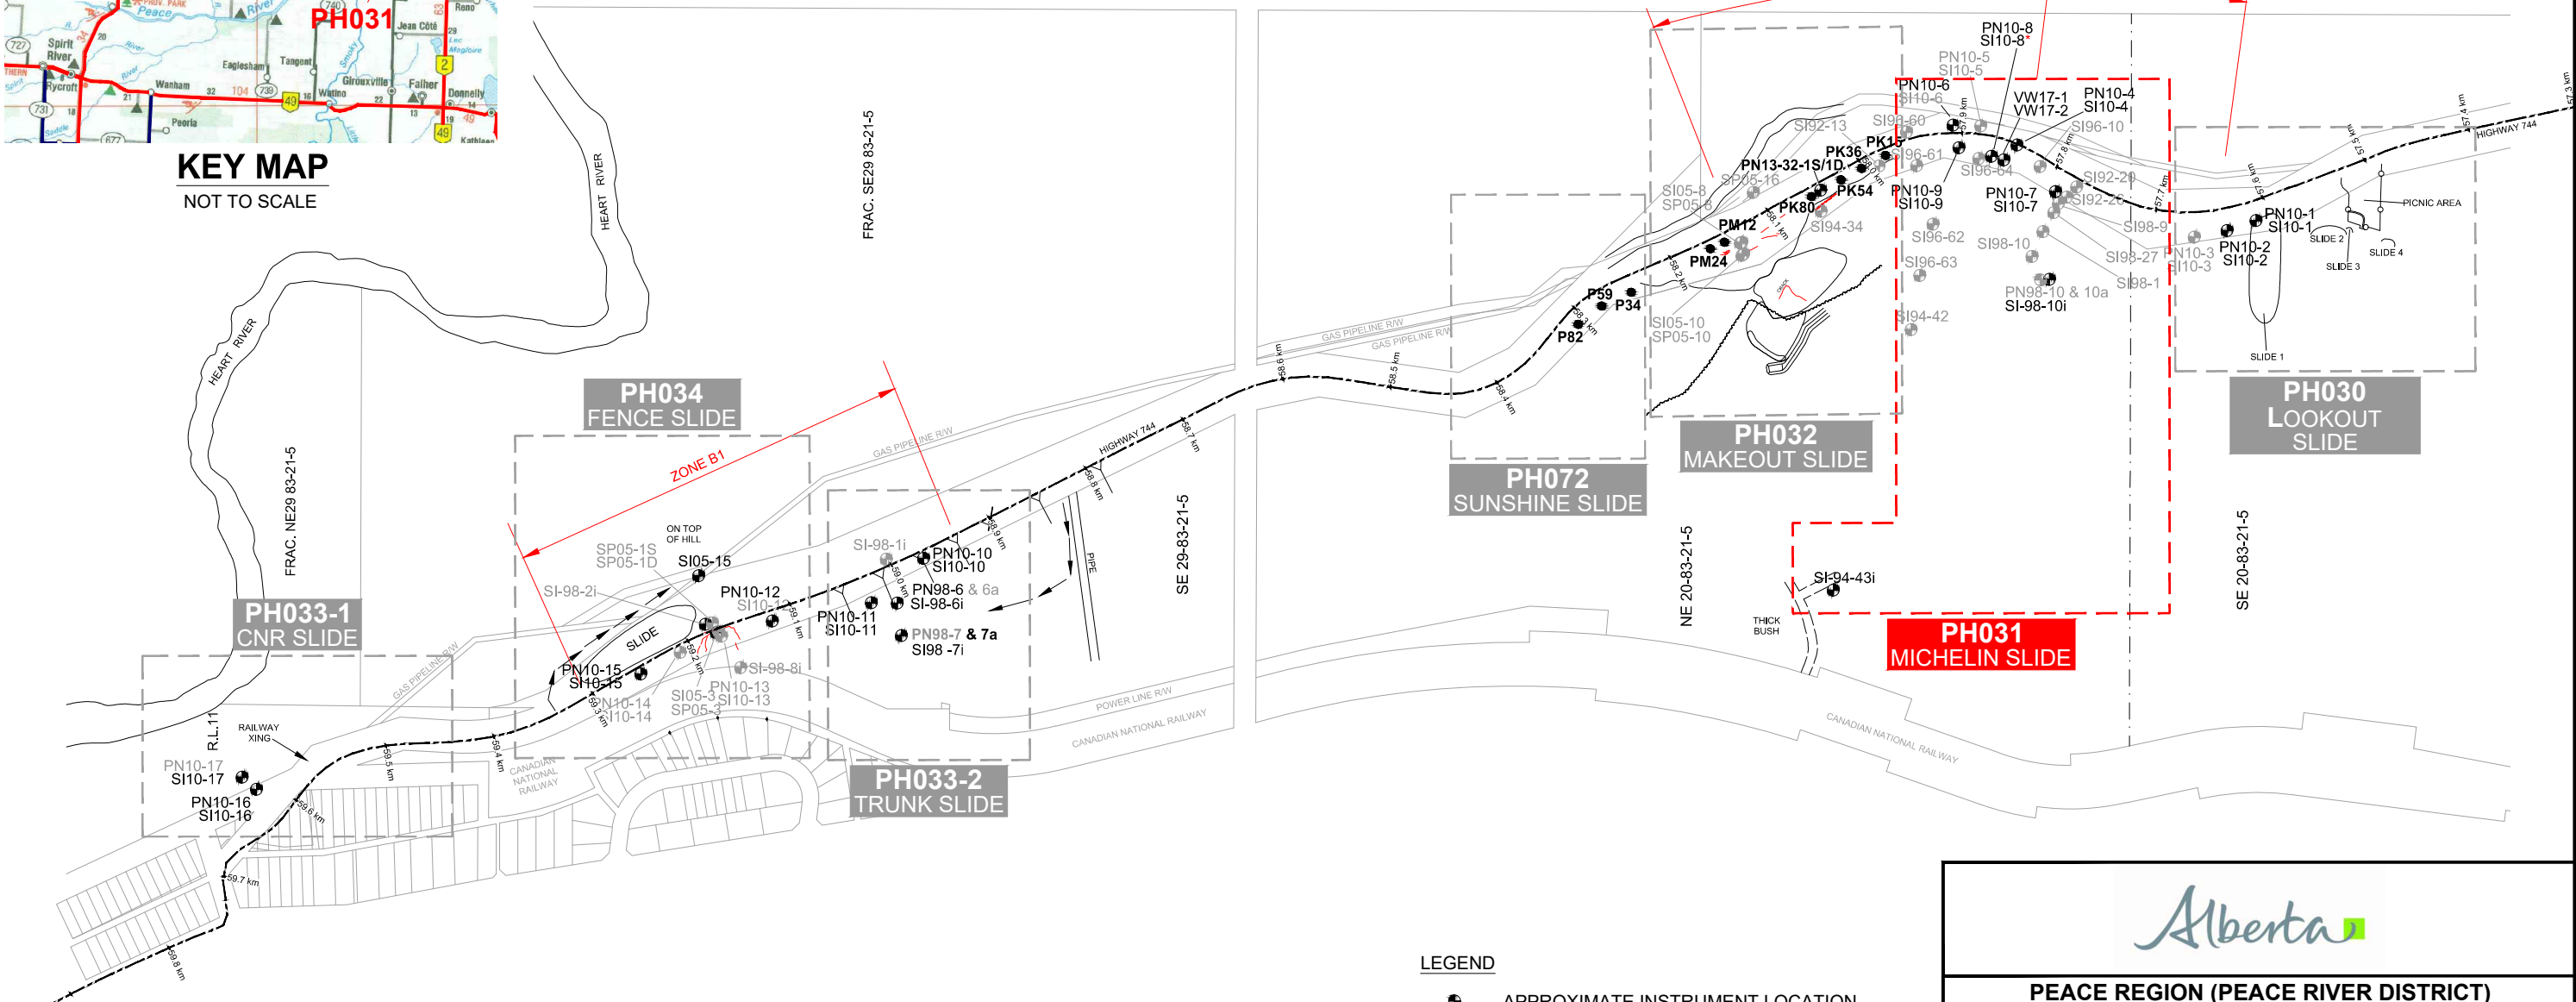
PH031: HWY 744:04 - JUDAH HILL (MICHELIN SLIDE) INSTRUMENT LOCATIONS

NOTE:
* A SHAPE ACCELEROMETER ARRAY (SAA) WAS INSTALLED INSIDE THE SI10-08 CASING IN DECEMBER 2014.

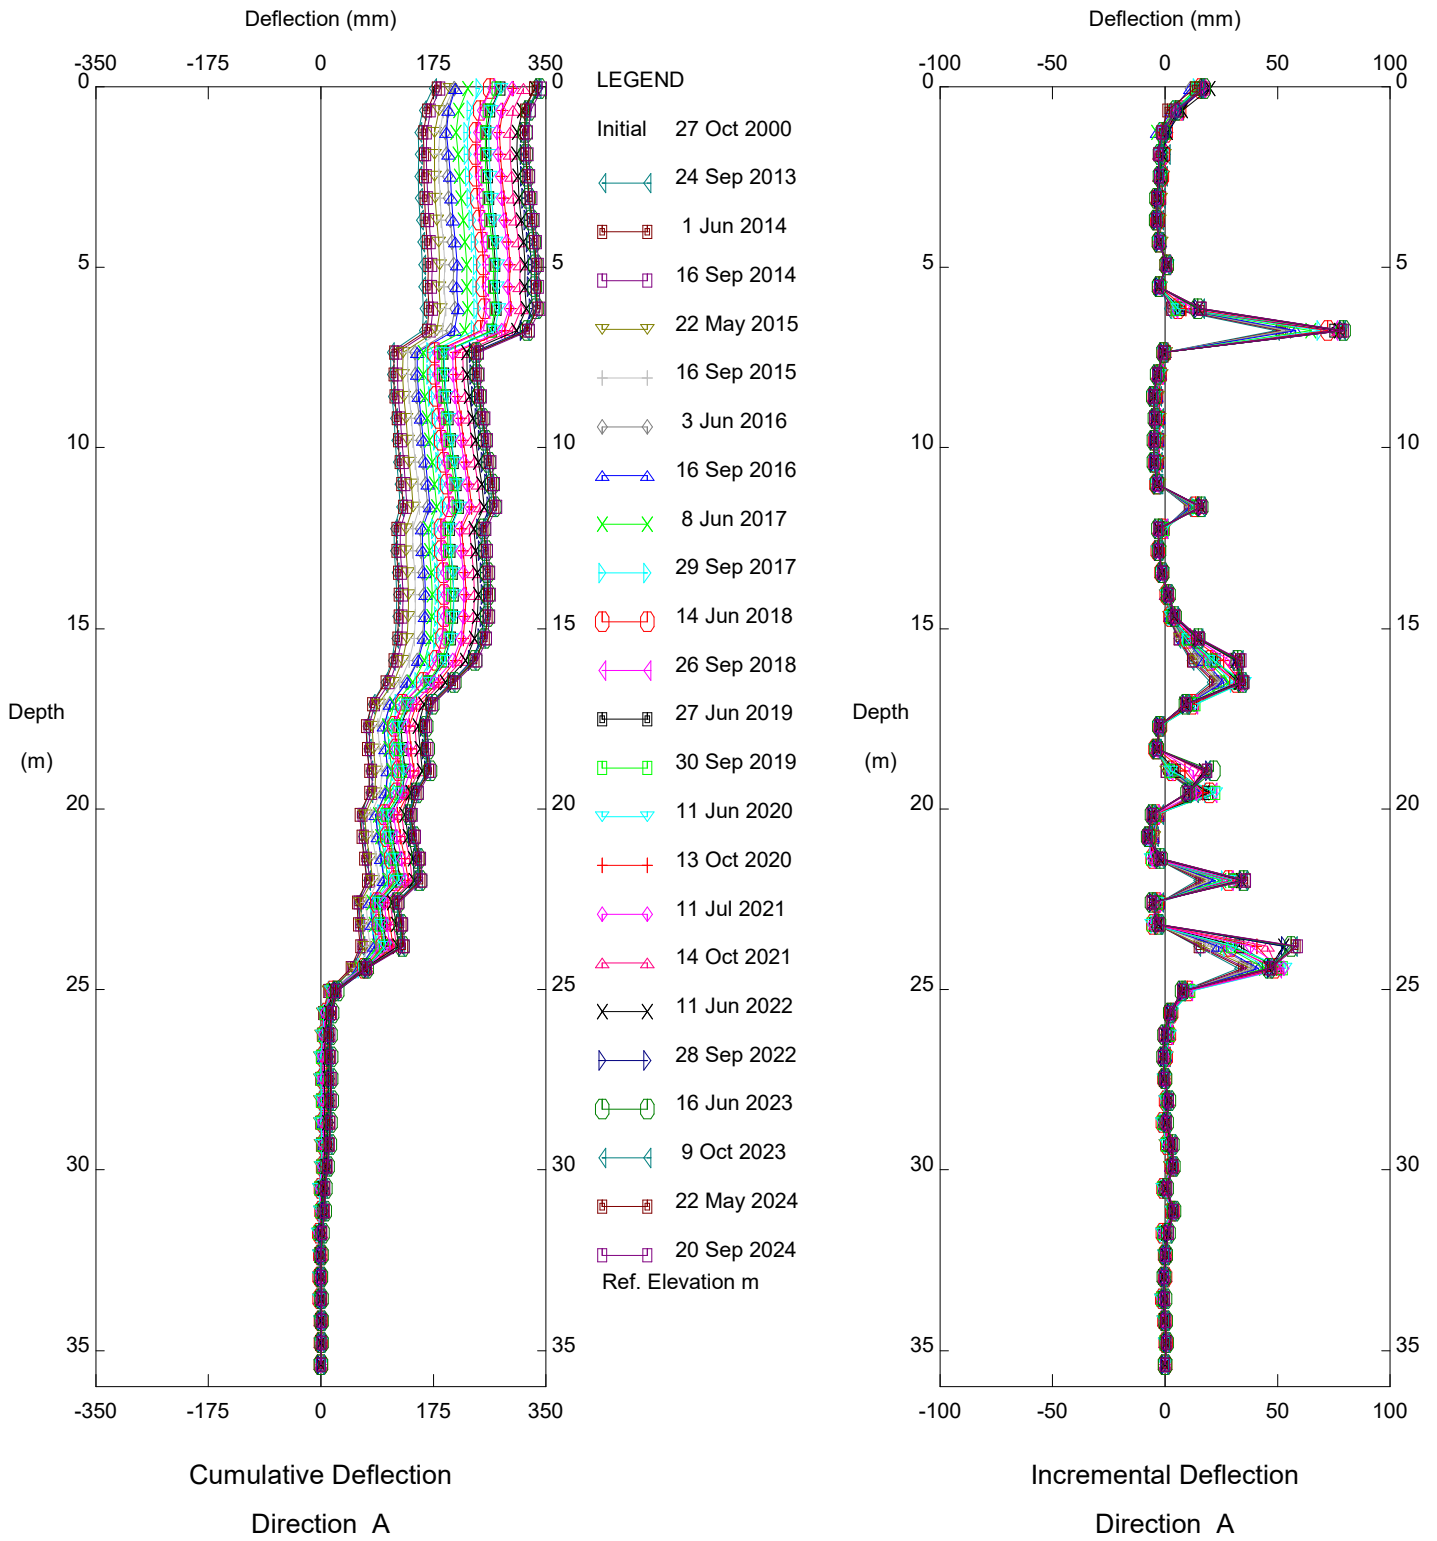
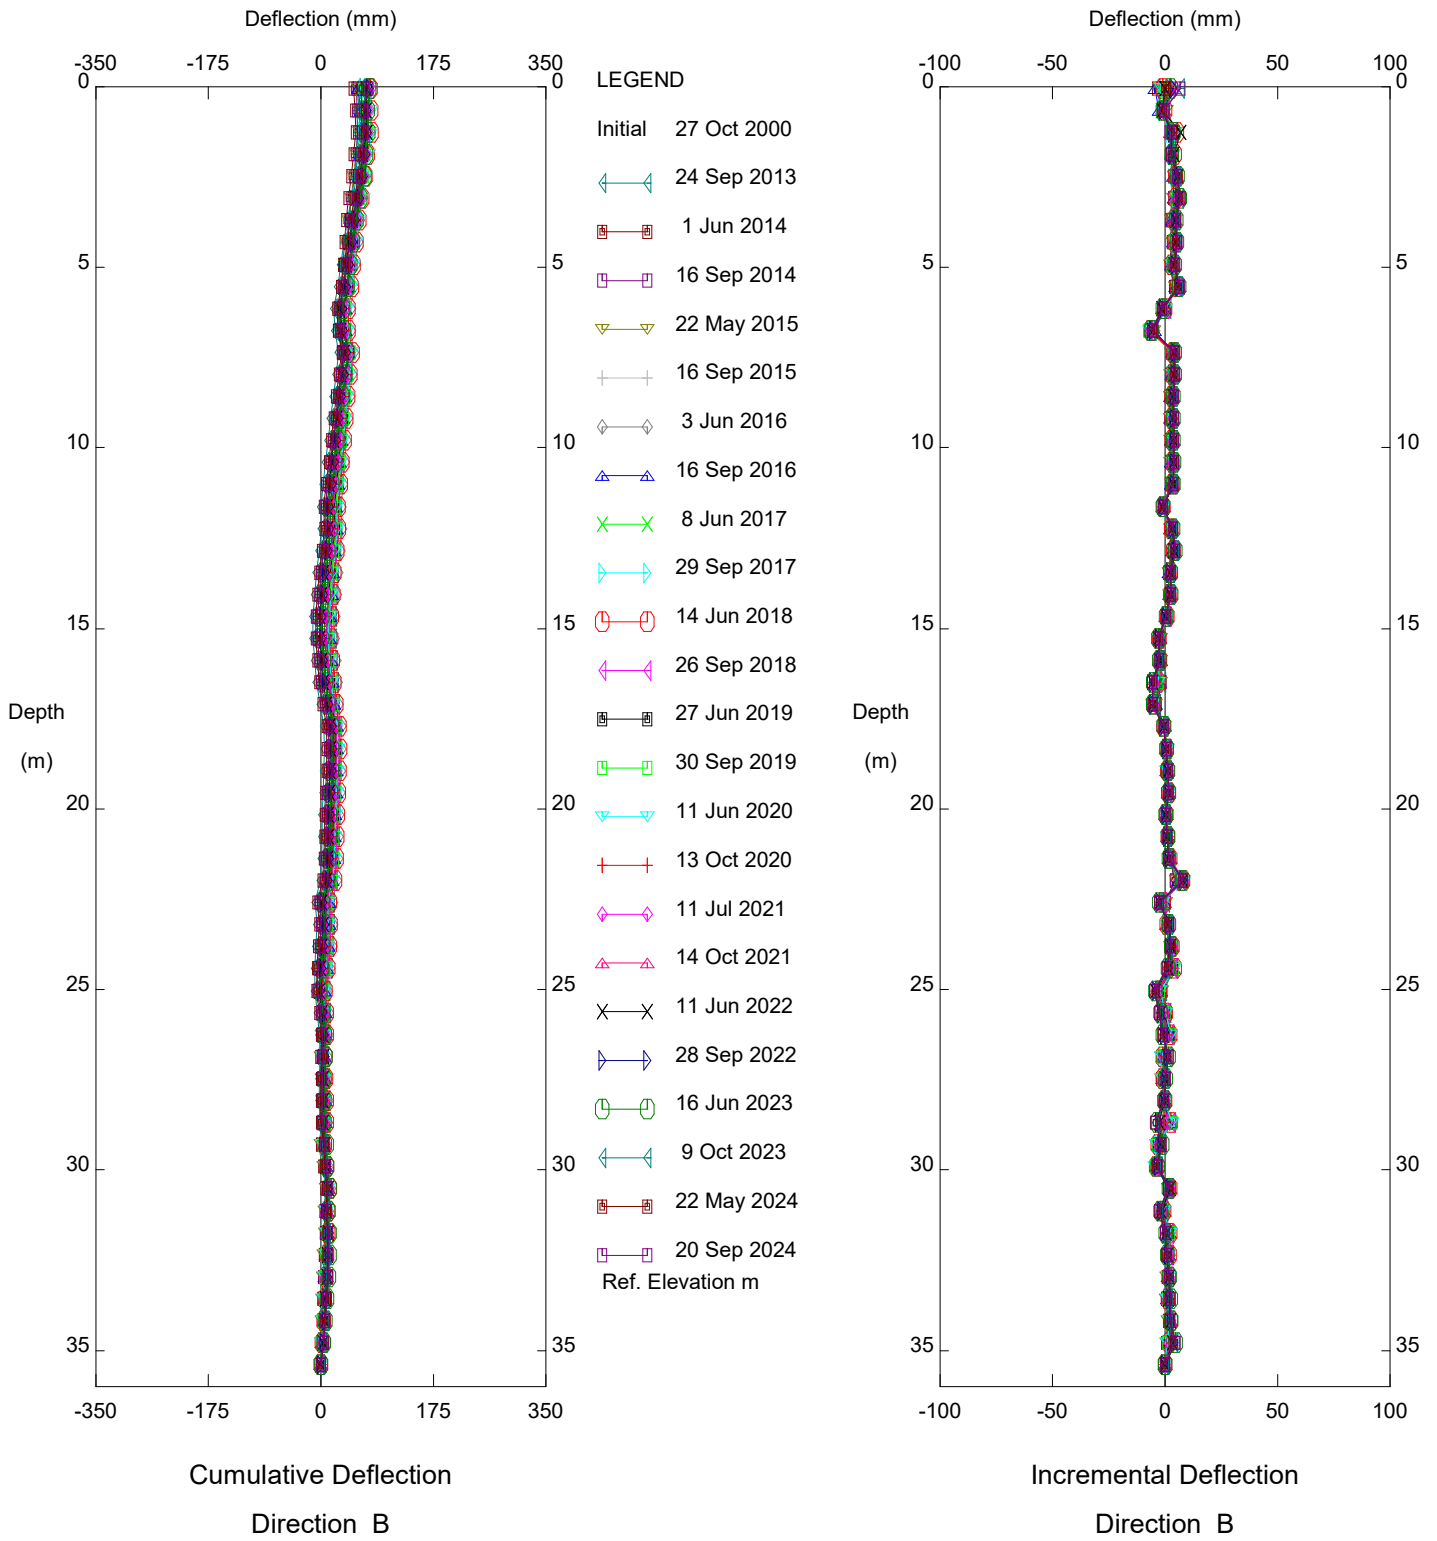
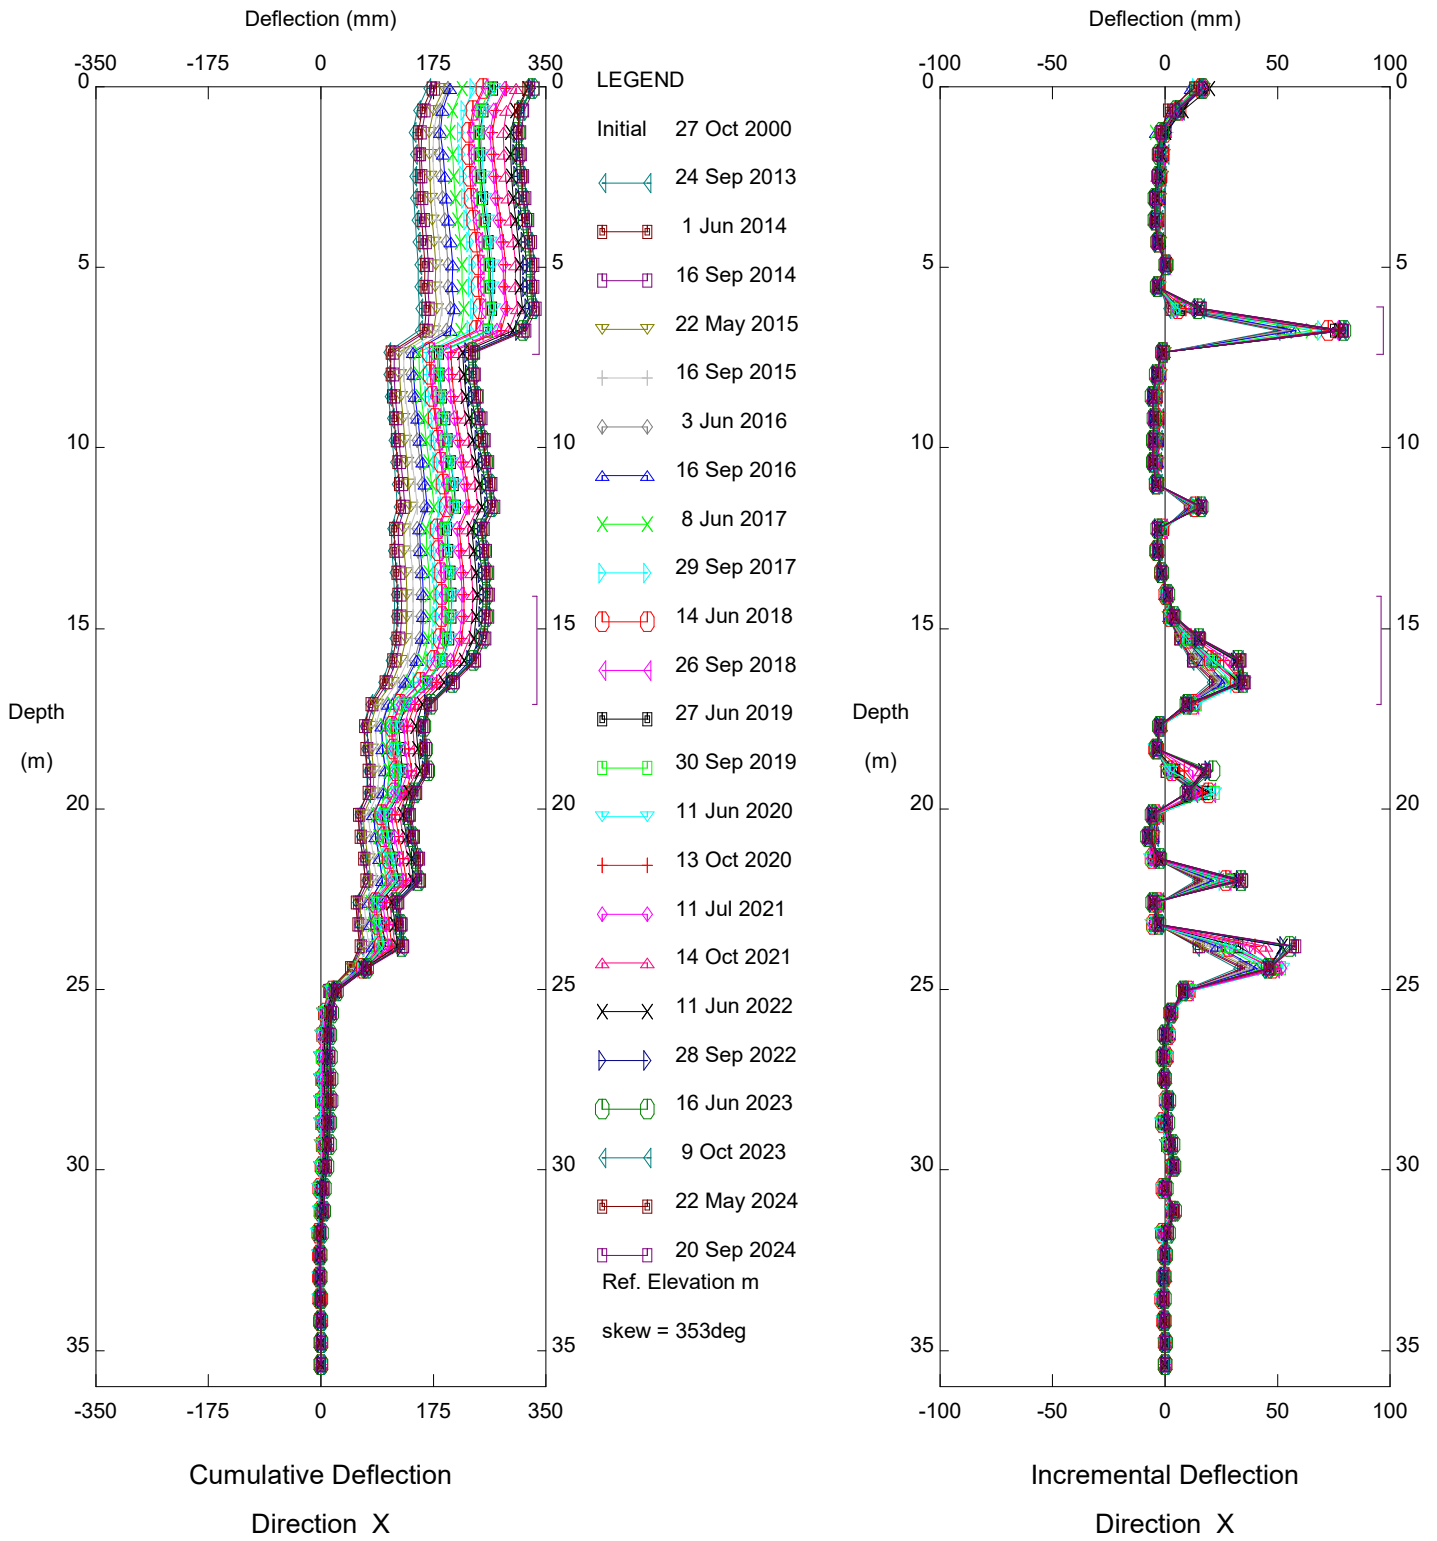
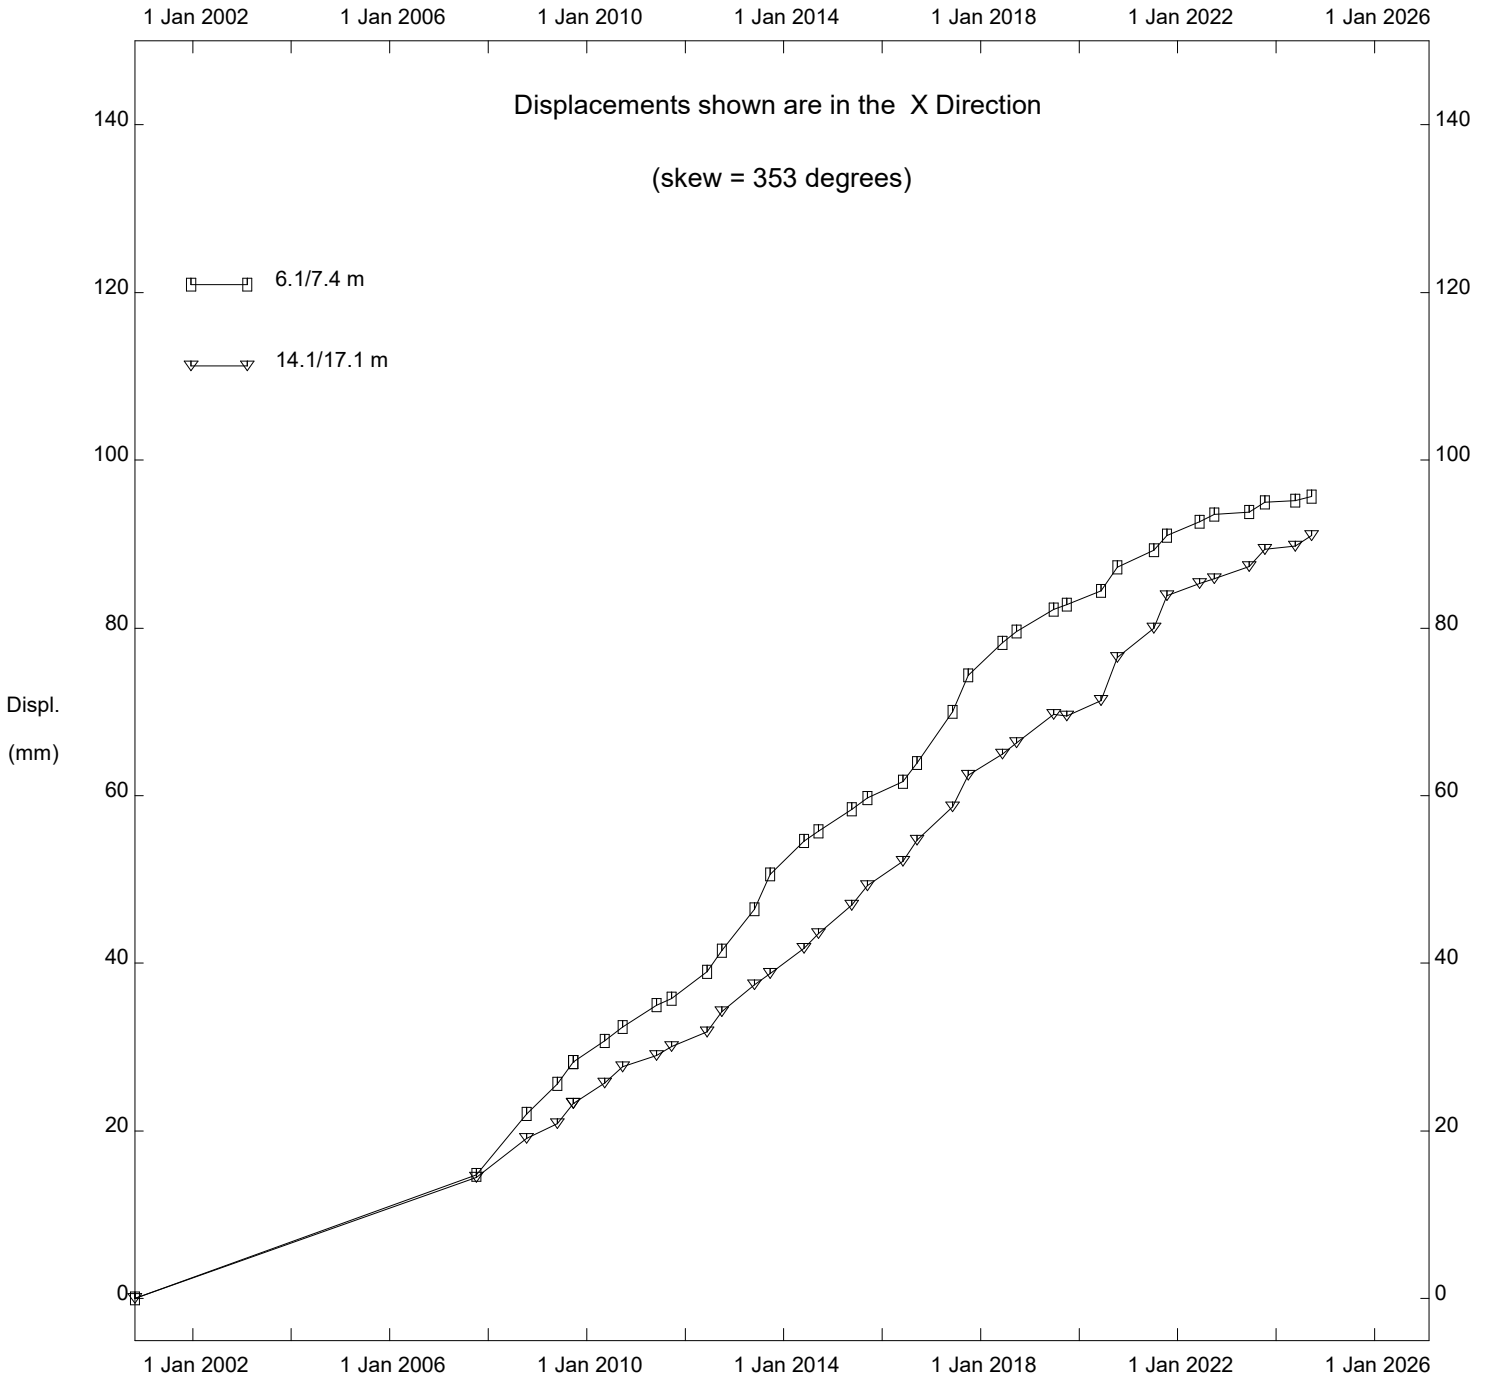
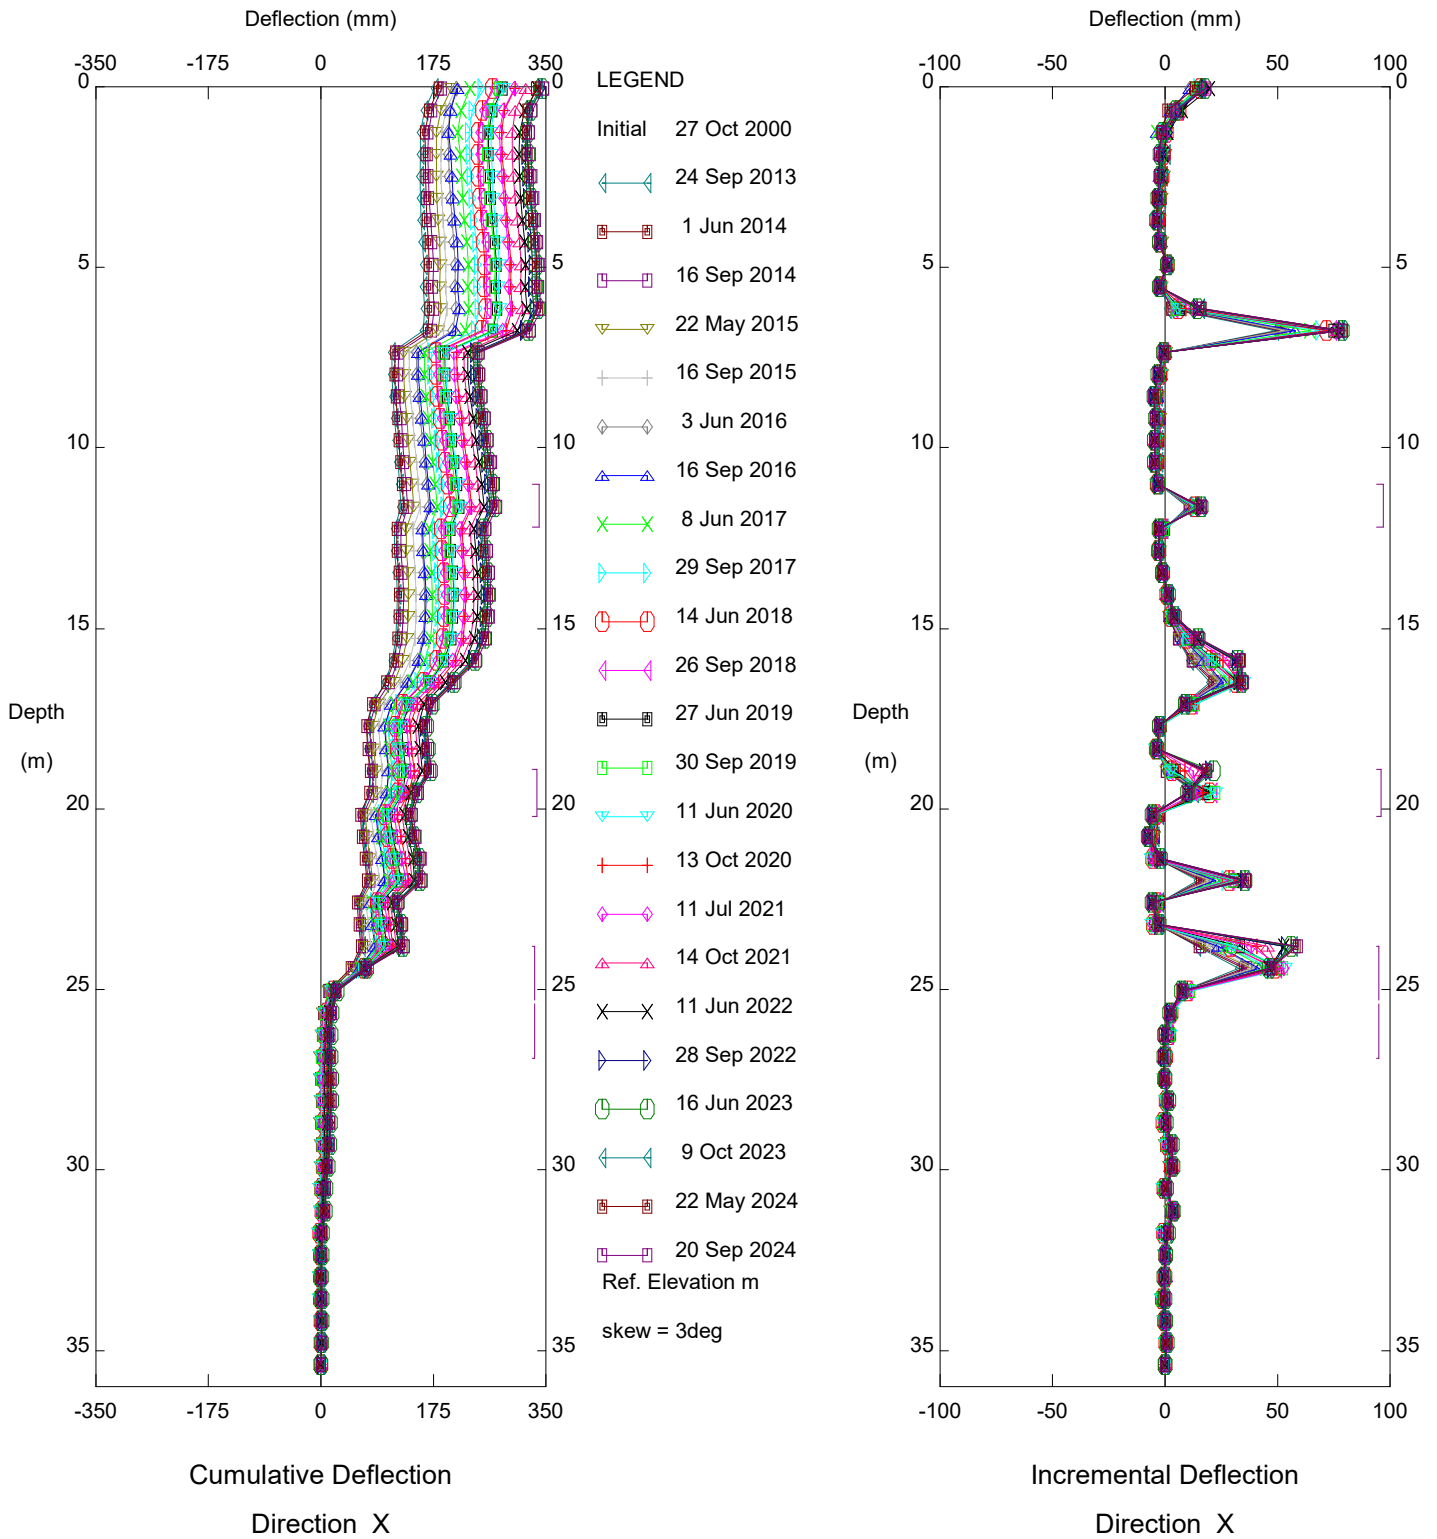
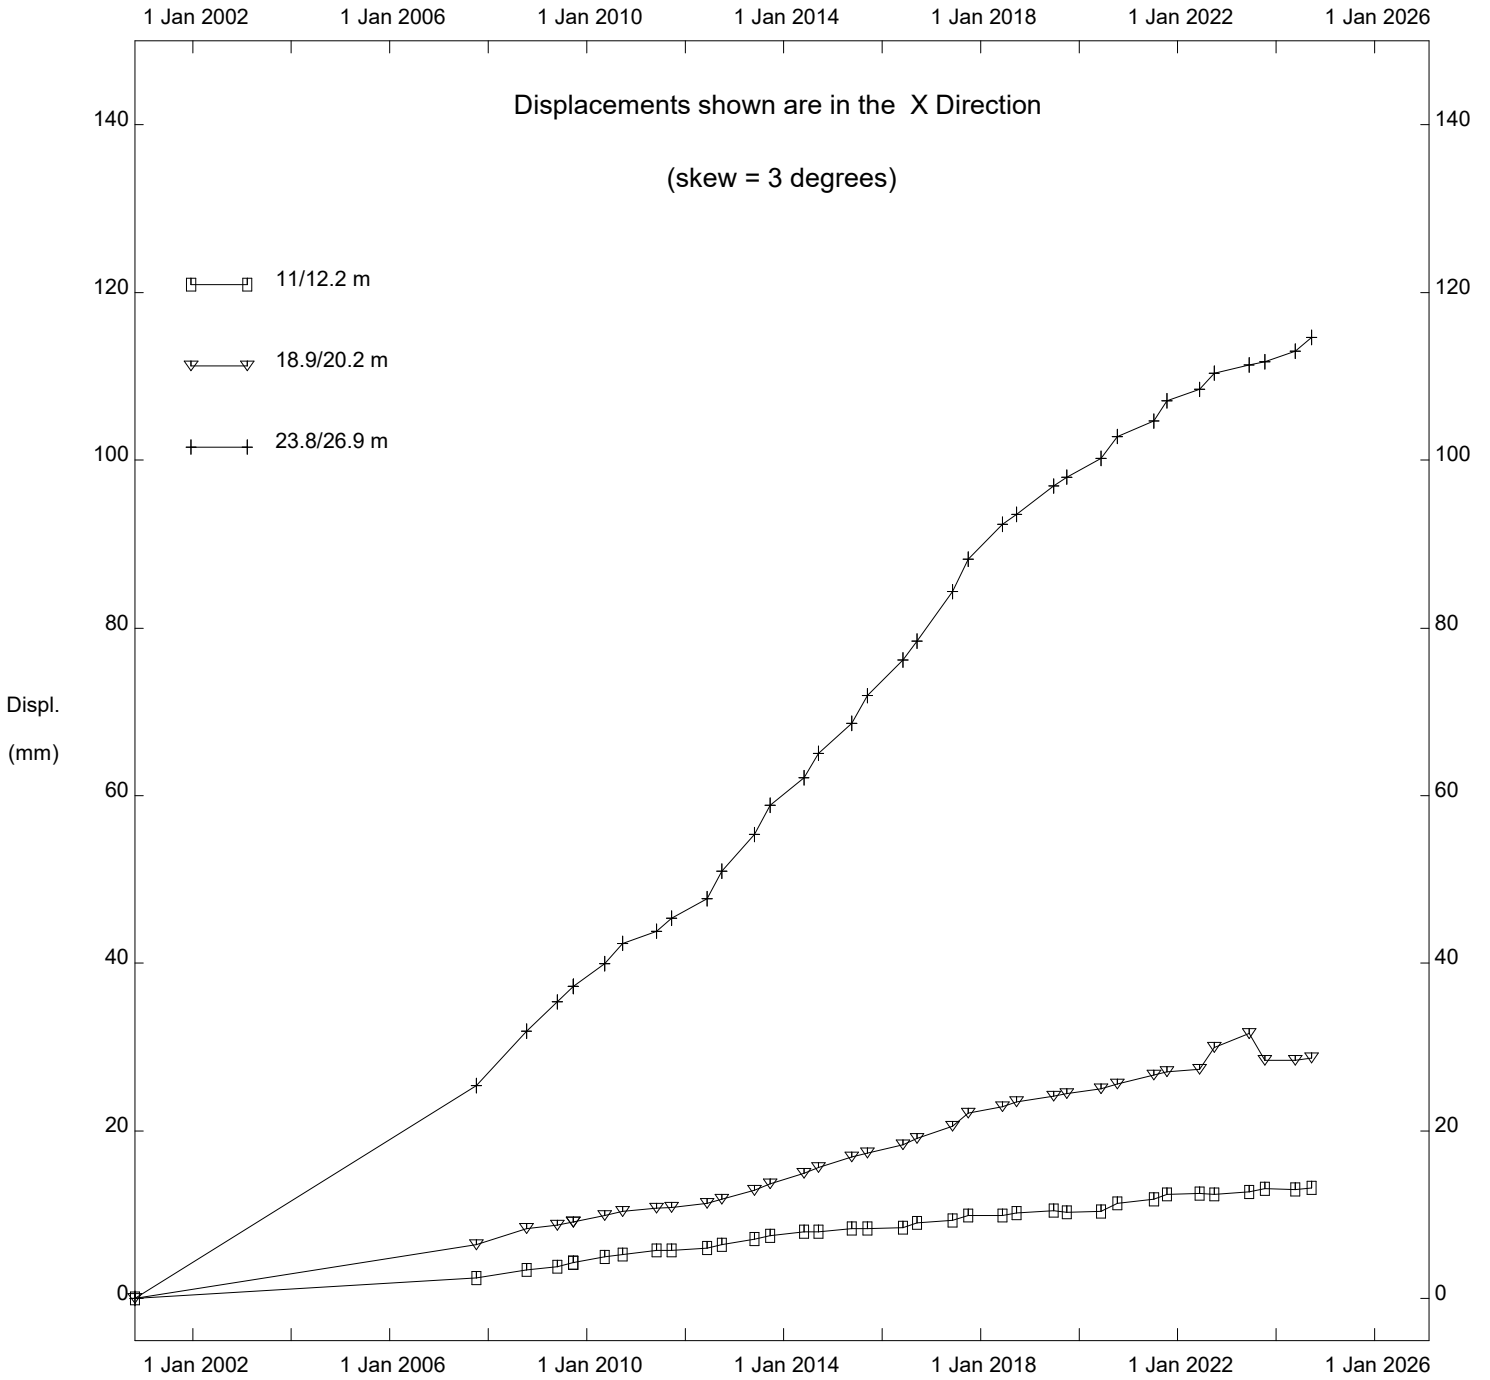
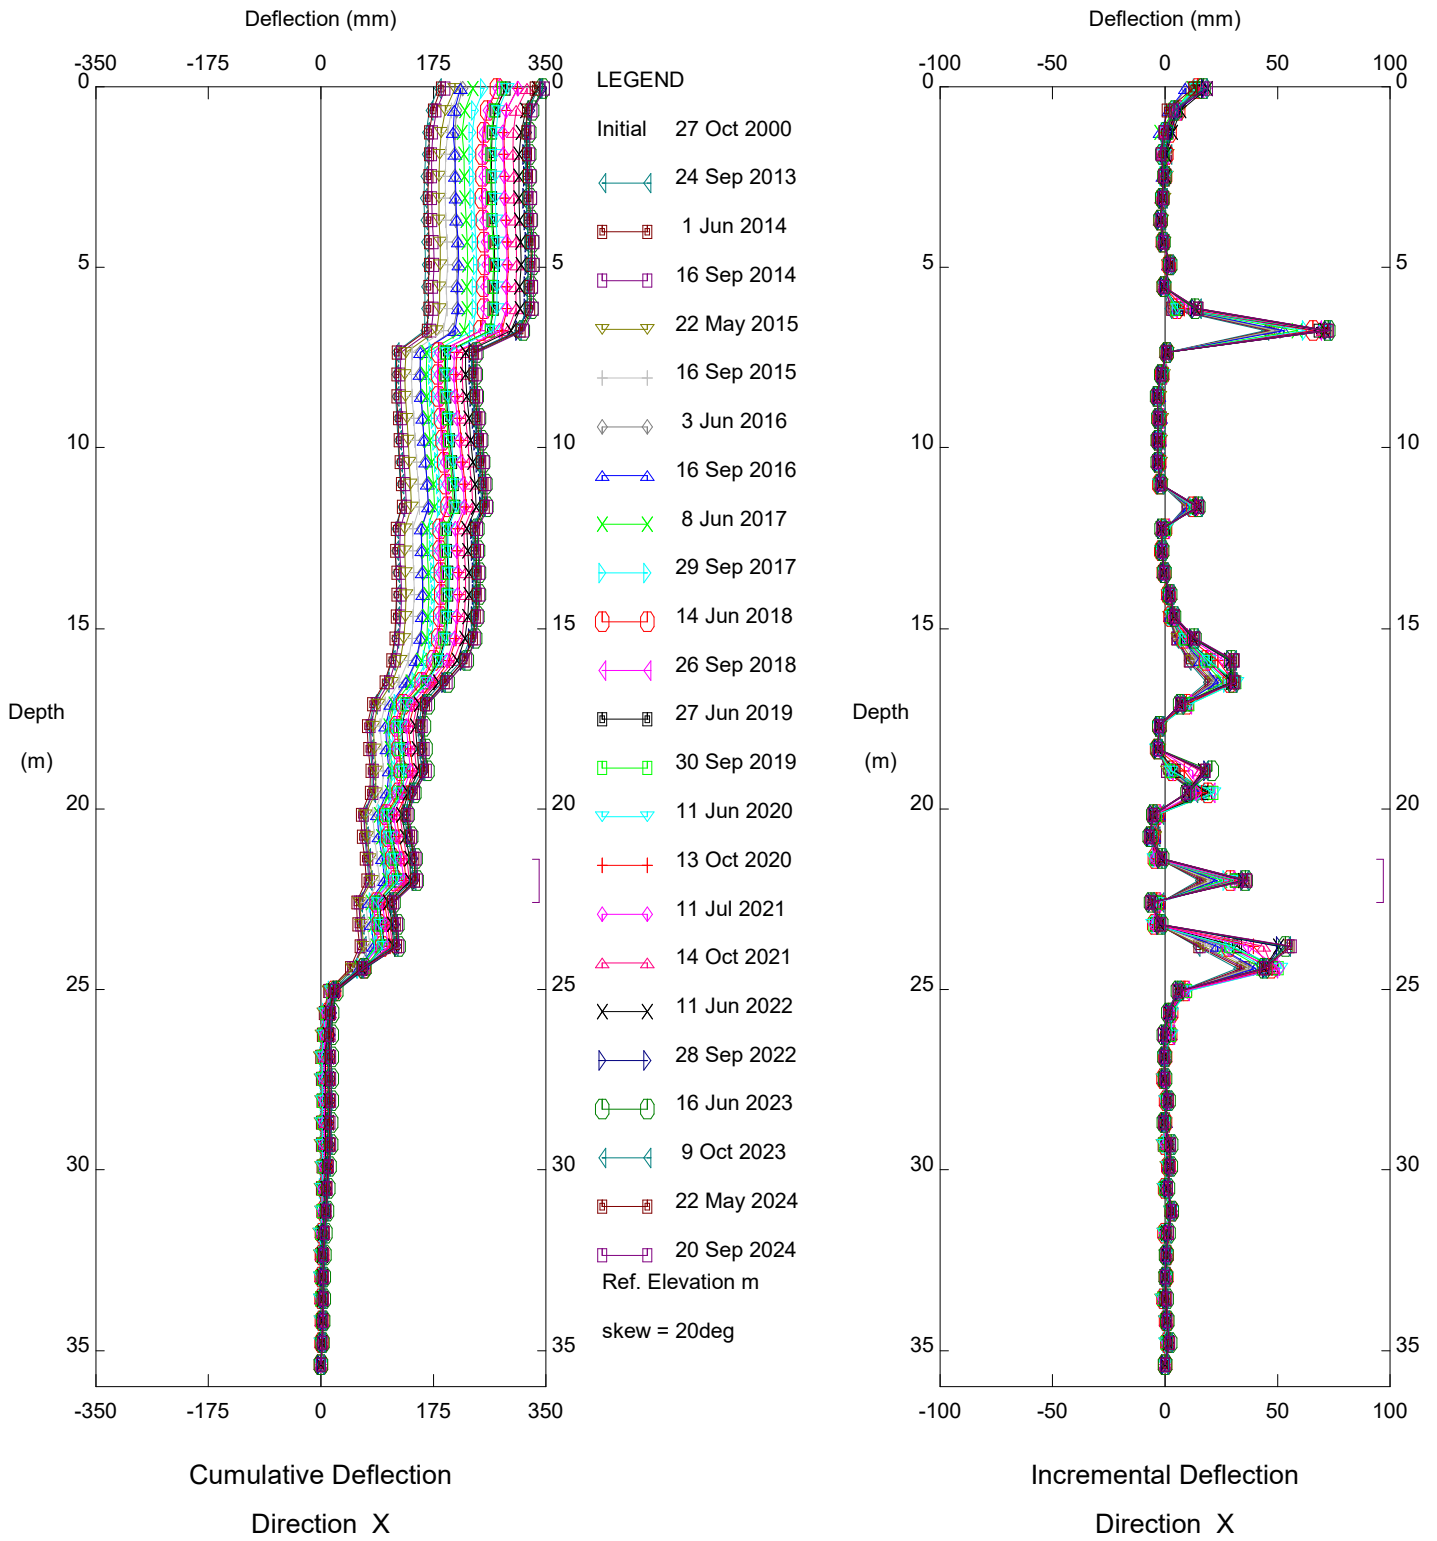
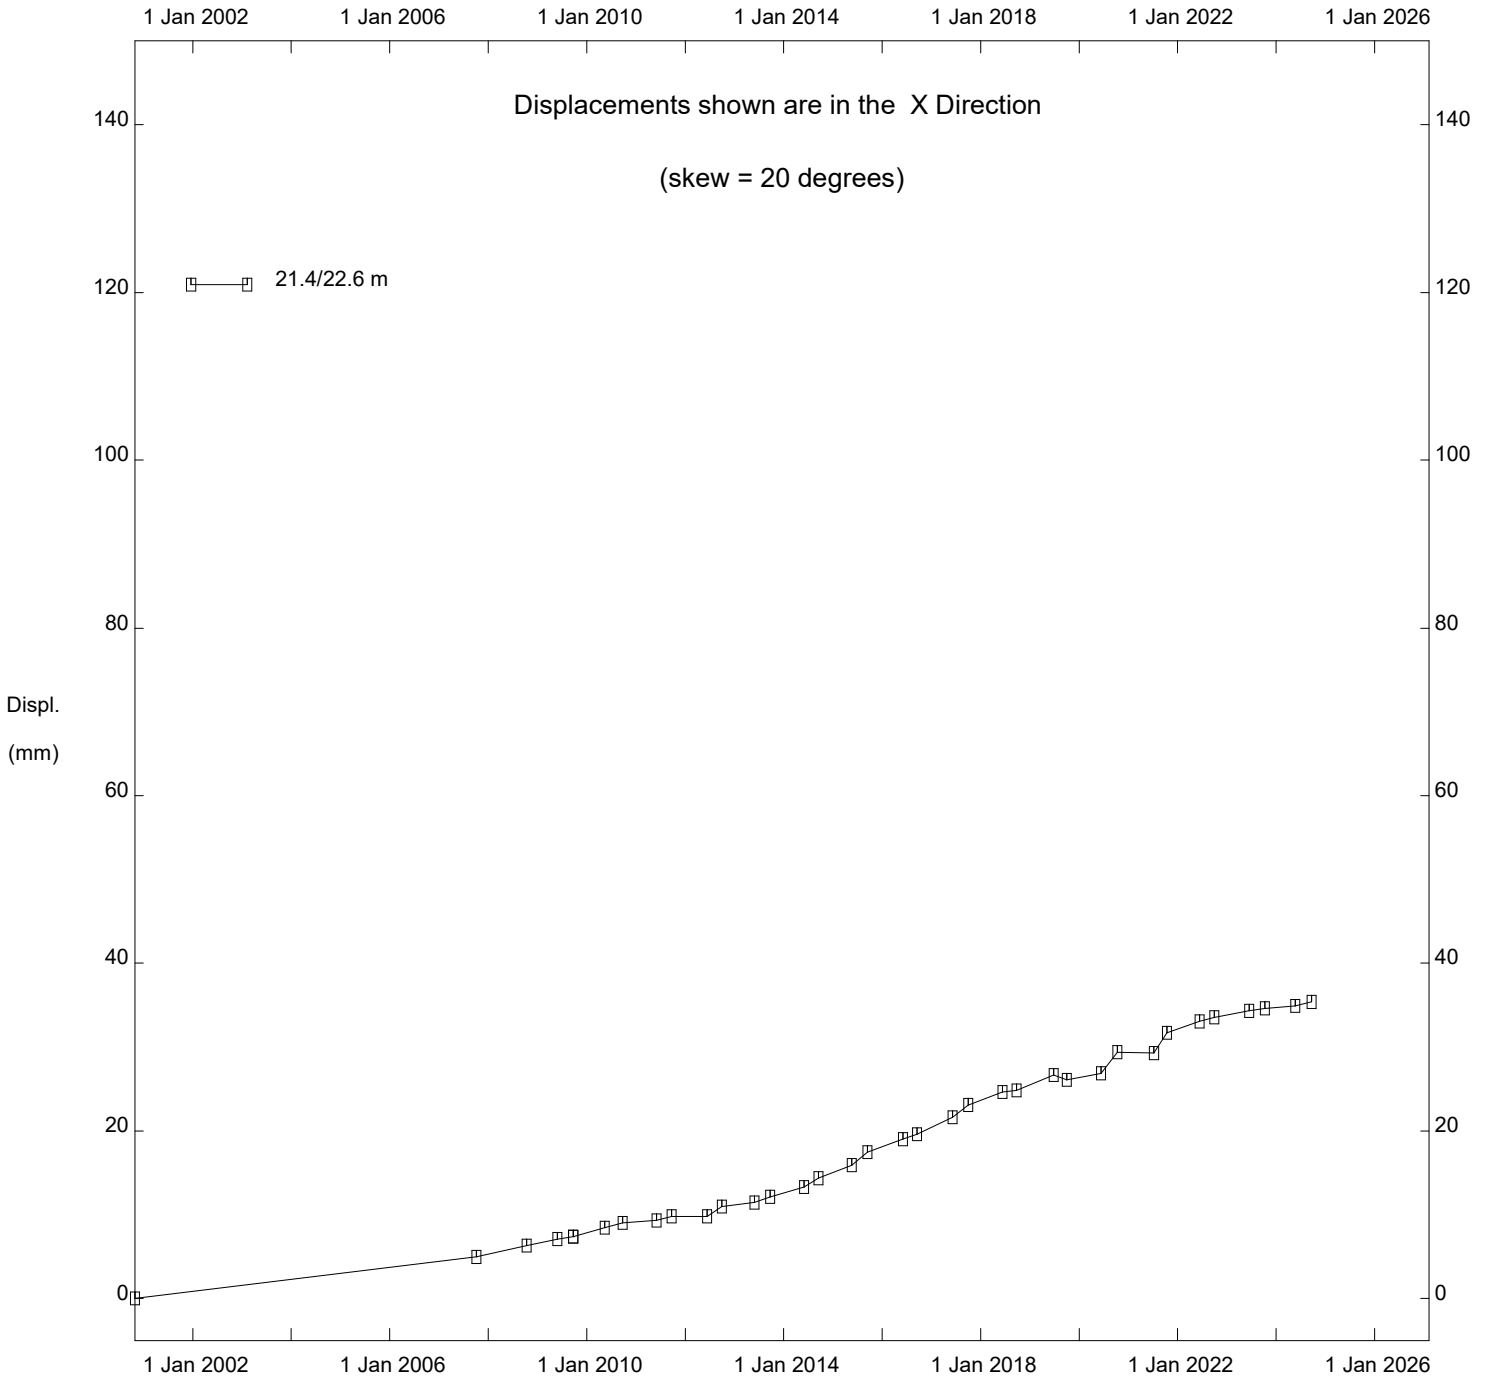
HWY 744:04 - STA. 57+700 to 58+000, Inclinometer SI98-10i

Zones of New Movement:	None
Interpretation of Monitoring Results:	<p>Slope inclinometer SI98-10i, located beyond the toe of Michelin slide showed small incremental movements along six distinct shear planes, since the spring of 2024 readings. The multitude of distinct movement zones speaks to the complexity of ongoing valley wall deformations along Judah Hill. Since the slope indicator was installed in October 2000 the sum of the movements over all these zones is 378.5 mm. The movement rates in these zones has typically ranged between 1 mm/yr and 5 mm/yr with median rate below 3 mm/yr.</p> <p>The movement rates showed small changes (less than 2 mm/yr) since the previous readings in the spring of 2024 with the exception an approximately 3 mm/yr increase in movement rate measured in the zones over 14.1 m to 17.7 m (3.7 mm/yr) depth and over 23.2 m to 26.9 m (4.7 mm/yr) depth .</p> <p>Slope inclinometer SI10-4 is located close to the highway and has one well defined movement zone at 6 m depth in a clay strata, and several subtle movement zones lower down in clay and clay till layers. A rate of movement of 3.2 mm/yr was measured over 5.7 m to 6.9 m depth</p>

<p>and a rate of movement of 1.6 mm/yr over 11.8 m to 17.9 m depth since the spring of 2024 readings. Average movement rates in both zones has typically been below 1.5 mm/yr and cumulative measurement movement is less than 15 mm. The last three datasets show a potential acceleration trend in the 6 m depth movement zone. The movement is in the direction of the active landslide in the Heart River valley slope, directly opposite from the Michelin Slide direction.</p> <p>SI10-7 showed three zones of movement. In the upper clay fill a movement rate of 1.5 mm/yr was measured over 1.9 m to 6.8 m depth; near a sand/clay transition a movement rate of 0.3 mm/yr was measured over 8.6 m to 9.8 m depth, and; in a lower clay layer 0.5 mm/yr was measured, over 14.1 m to 15.9 m depth, all since the spring of 2024 readings.</p> <p>As the datalogger battery was dead, no new readings could be downloaded for SAA10-8. The spring 2024 SI plots are included for SAA10-8.</p> <p>SI10-9 showed one distinct zone of movement and several more subtle movement zones. In the upper clay no discernible movement was measured over 6.5 m to 7.7 m. The more distinct movement zone was between 11.9 and 14.4 m in a sand layer, where a movement rate of 1.5 mm/yr was measured since the spring of 2024 readings.</p> <p>Pneumatic piezometers PN10-4 showed no change in groundwater level since the spring of 2024 readings. PN10-6, PN10-7, PN10-8, and PN10-9 showed increases in groundwater levels of 0.78 m, 0.63 m, 0.85 m, and 0.43 m, respectively, since the spring of 2024 readings. The groundwater levels of 7.53 m and 8.79 m measured in PN10-6 and PN10-7, respectively, were the highest measured since the instruments were initialized.</p>
