**ALBERTA TRANSPORTATION AND
ECONOMIC CORRIDORS
GEOHAZARD ASSESSMENT PROGRAM
PEACE REGION (PEACE RIVER DISTRICT)
2024 INSPECTION**

Site Number	Location	Name	Hwy	km
PH031	Judah Hill	Michelin Slides	744:04	57.664
Legal Description		UTM Co-ordinates (NAD 83)		
NE¼ 20-083-21 W5M		11V E 483226	N 6229678

Date	PF	CF	Total
Previous Inspection:	May 17, 2023	13	7	91 (Slide Risk Rating)
Current Inspection:	May 28, 2024	13	7	91 (Slide Risk Rating)
Road WAADT:	840		Year:	2023
Inspected By:	Tyler Clay, Cole Szakacs (Thurber). Rocky Wang, Robert Senior (TEC)			
Report Attachments:	<input checked="" type="checkbox"/> Photographs <input checked="" type="checkbox"/> Plans <input type="checkbox"/> Maintenance

**PH031-1 MICHELIN SLIDES
2024 SITE INSPECTION PLAN**

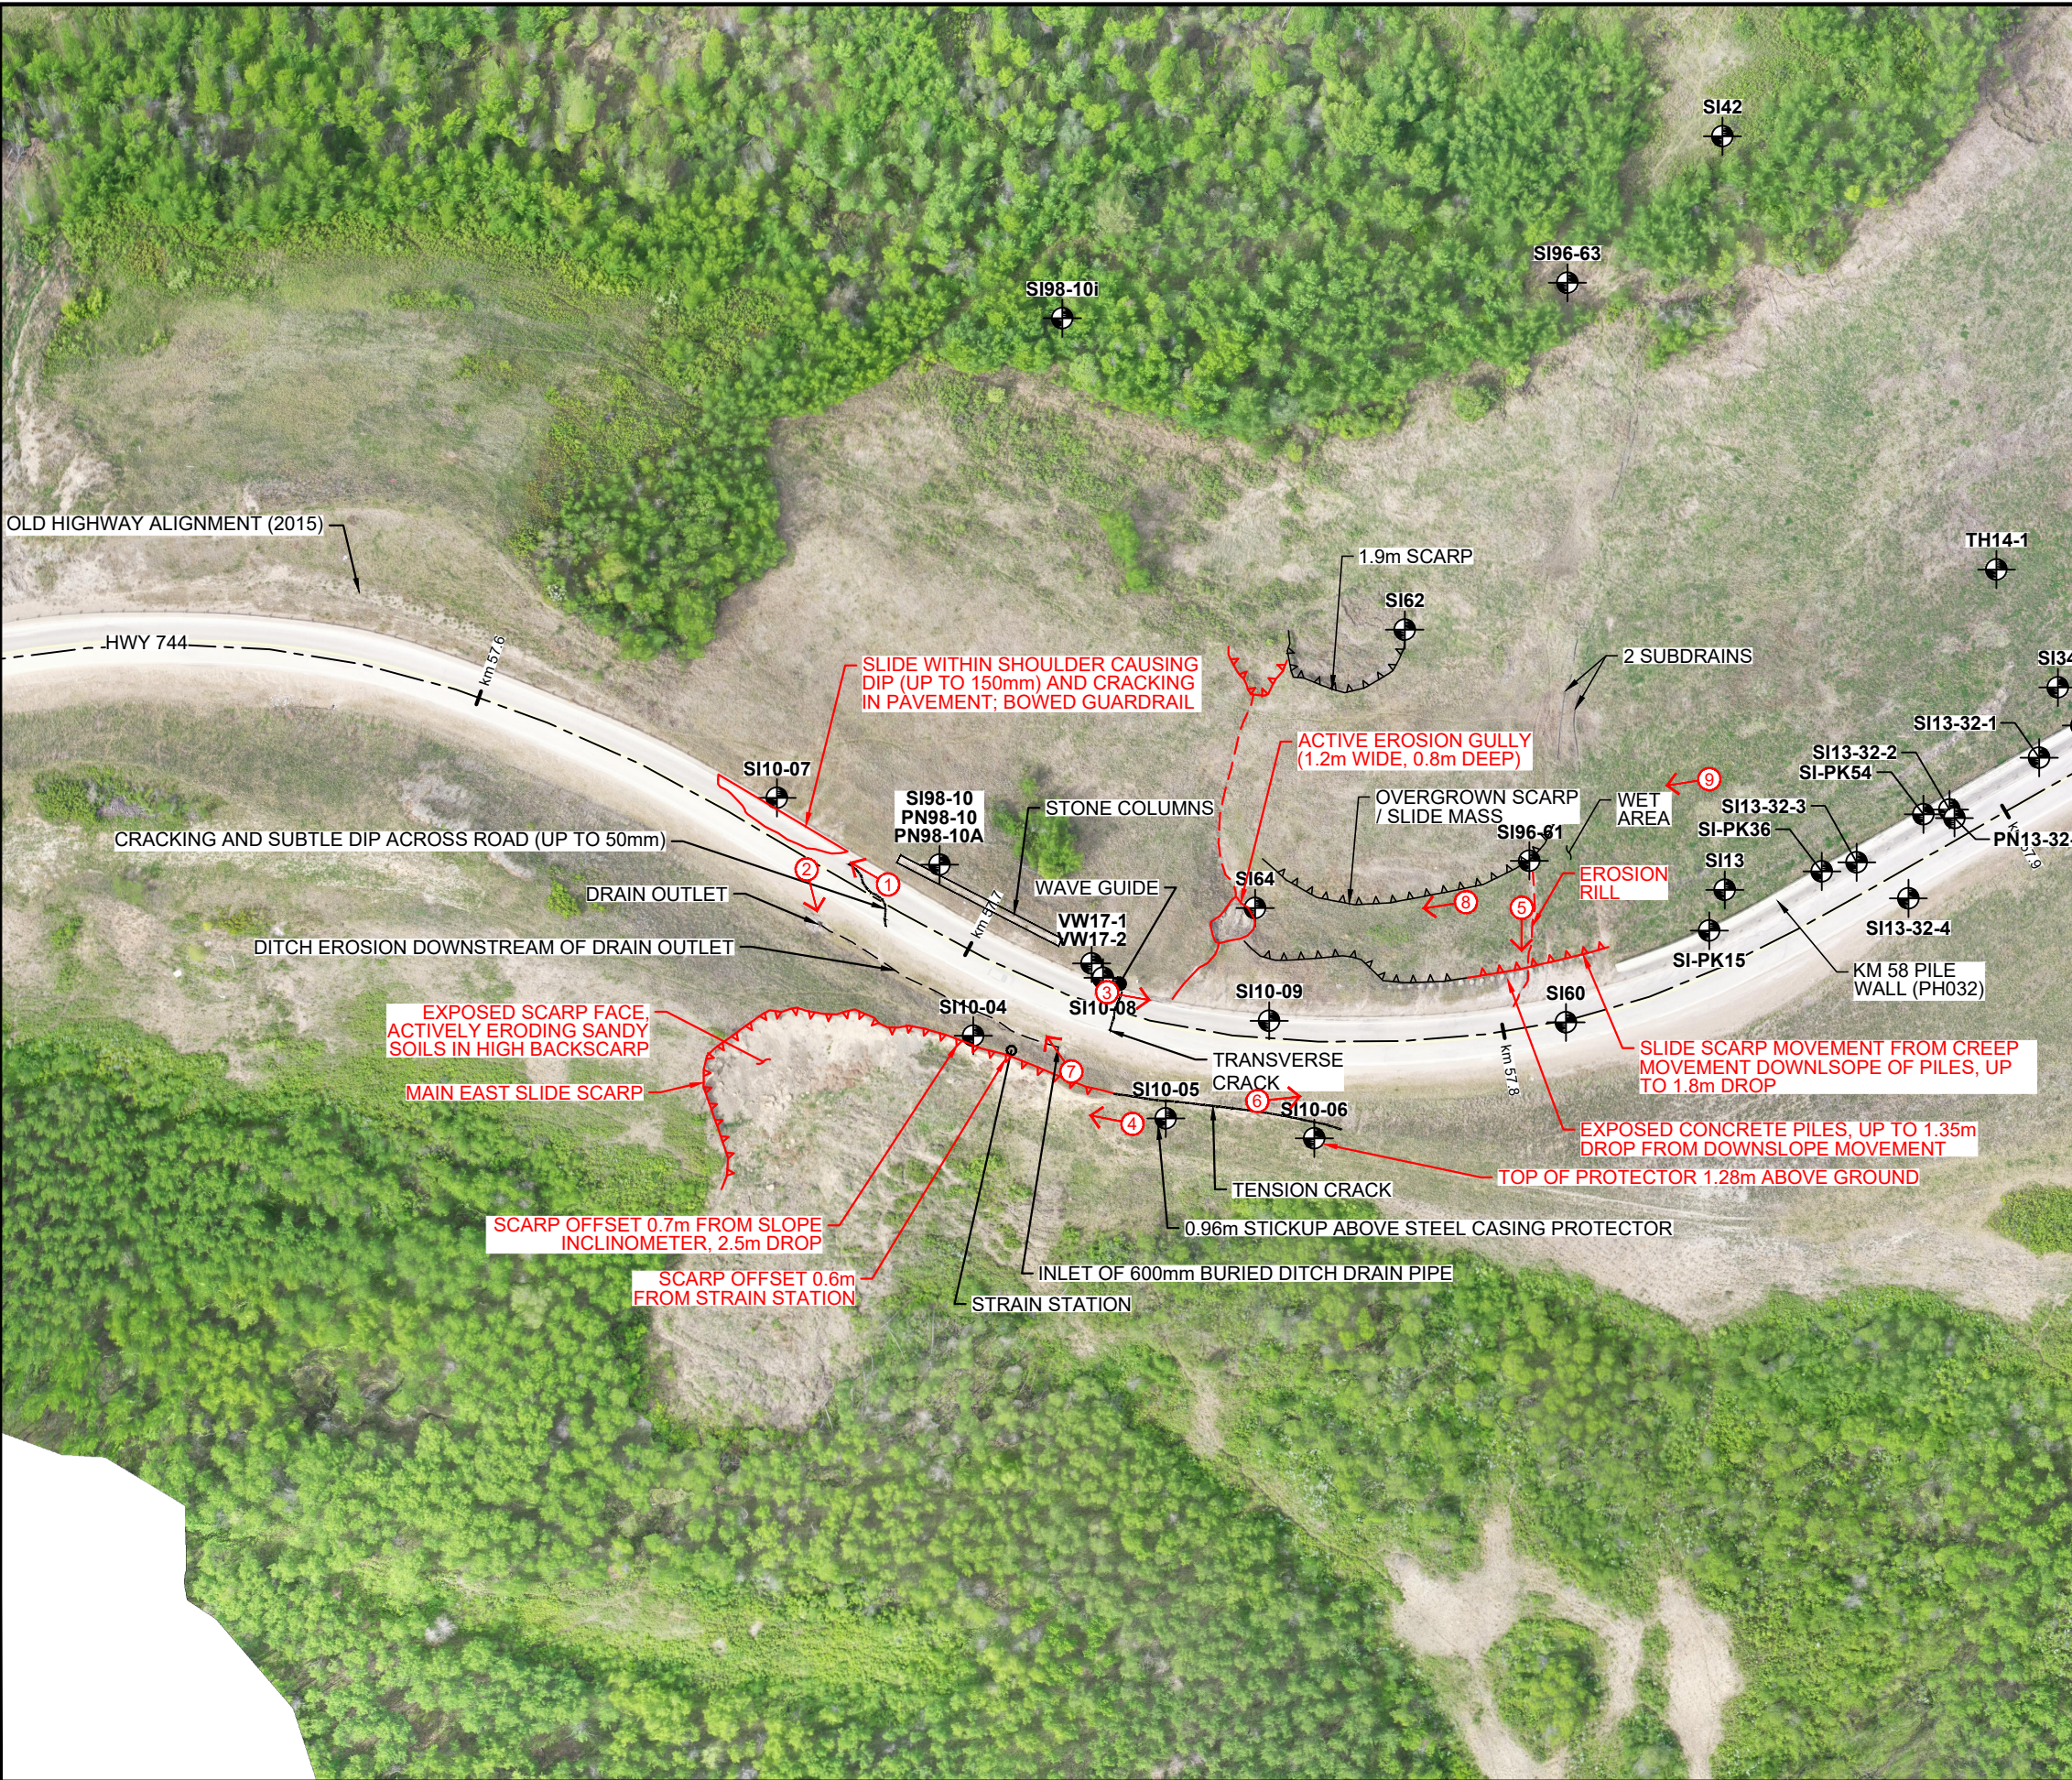
Continued landslide creep near the km 57.8 repair is expected to be ongoing however damage to the highway has not significantly worsened. Minor erosion damage is occurring in localized areas.

Slope movement in the area west of the highway between the Michelin and Makeout landslides is ongoing at similar or slightly reduced rates that have been measured and observed in the past. Water being shed off the road on the inside of the bend may be contributing to the problem. Cracking and slope movement downslope of the pile wall is ongoing at similar or slightly reduced rates. The existing pile wall is still providing some support to the highway. The instruments on the west side of the highway show ongoing movement at rates previously observed or slightly reduced.

Intermittent movement and active erosion within the backscarp of the slide that is moving toward the Heart River indicates that the road is at risk from both eastward and westward movement. No accelerating movement trends were measured at S10-4 indicating a slide plane has not retrogressed further towards the highway beyond the visible scarp. As first mentioned in 2012, there is no room to move the road at this location and because of the severity and rapidity of movement, design for a pair of tied-together retaining walls should be conducted to limit the extent of work required.

- Long-term repair using ~ 230 m of tied back retaining walls. Approximately 80 m would be required on the Heart River side and 150 m on the Peace River side, extending south from the km 58 wall. (\$13M - \$15M)

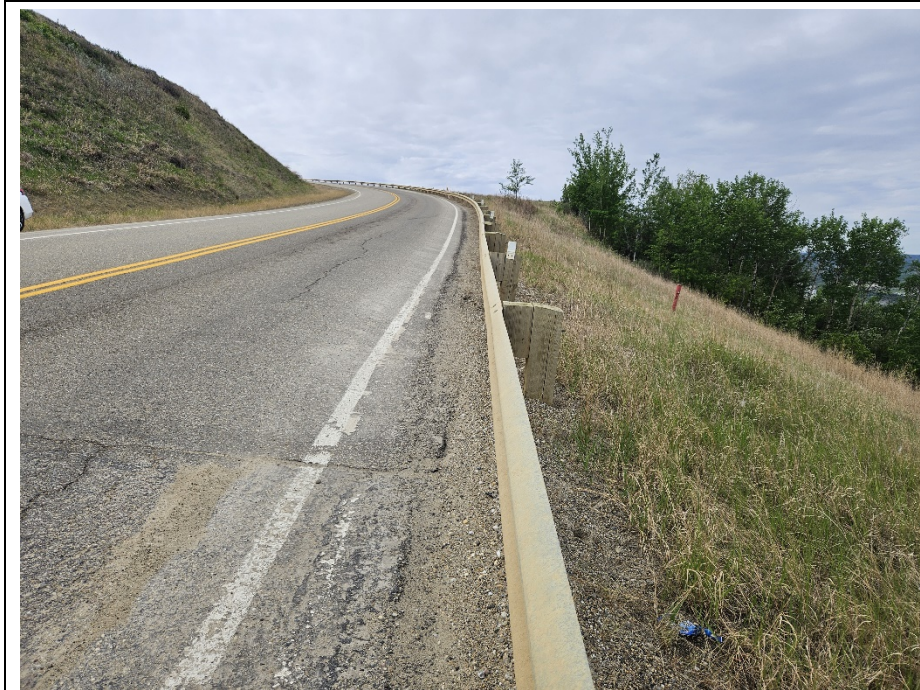
Photo 1.
Looking southwest along the centerline of Hwy 744:04 at km 57.65 near the north end of the 2014-2015 realignment. Cracks have not significantly expanded but localized settlement (estimated up to 150 mm) is more apparent at the shoulder relative to the 2023 condition.

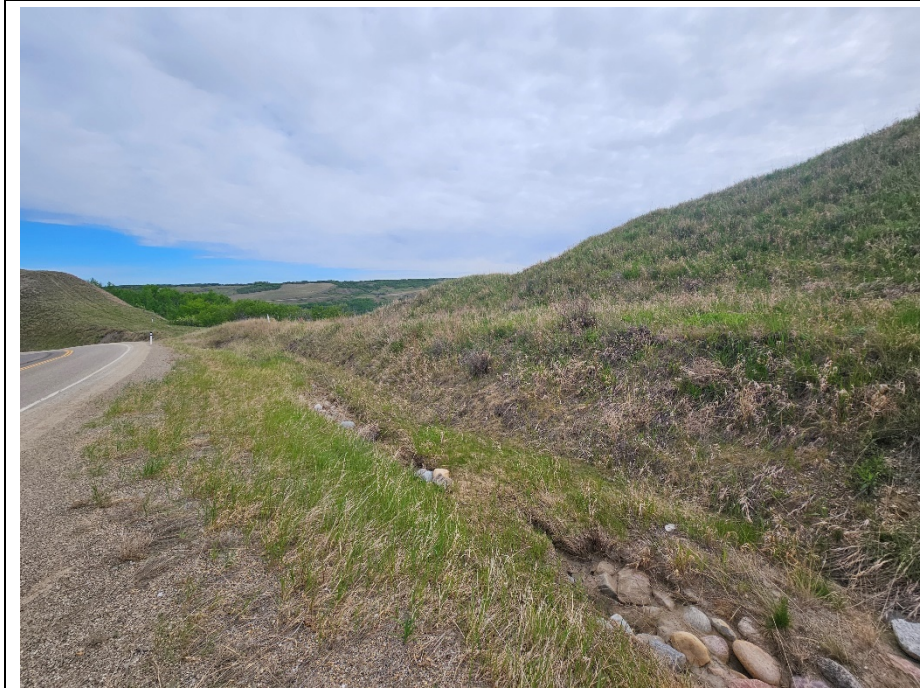
Photo 2.
Looking northeast along the east ditch near km 57.65 where there is ongoing ditch erosion that has become slightly worse since 2023.

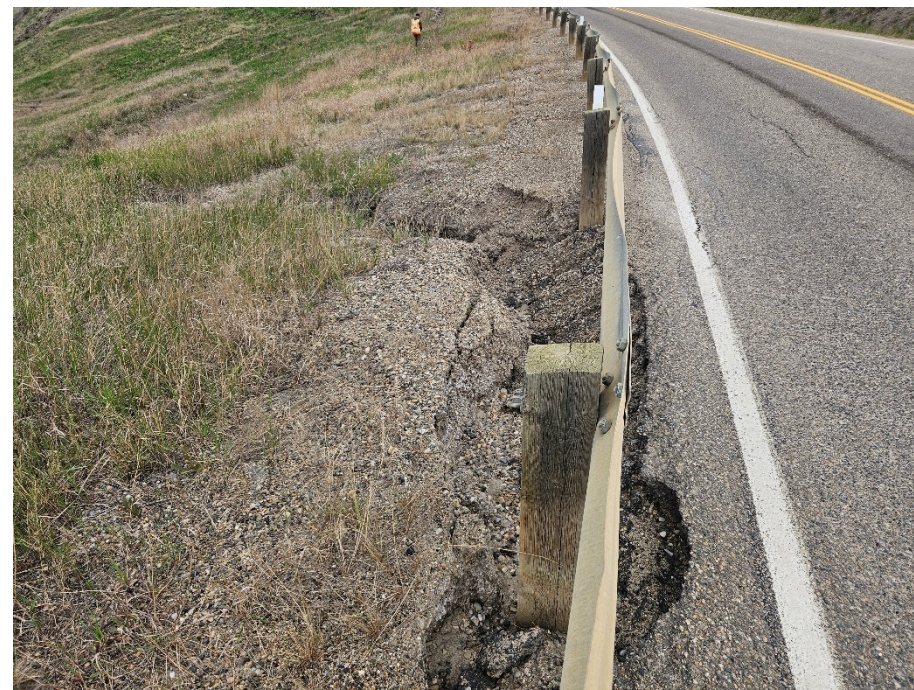
Photo 3.
Looking north at gully erosion on the west side of the highway near km 57.75. The gully is up to 1.2 m wide and 0.8 m deep and is slightly worse from the 2023 condition.

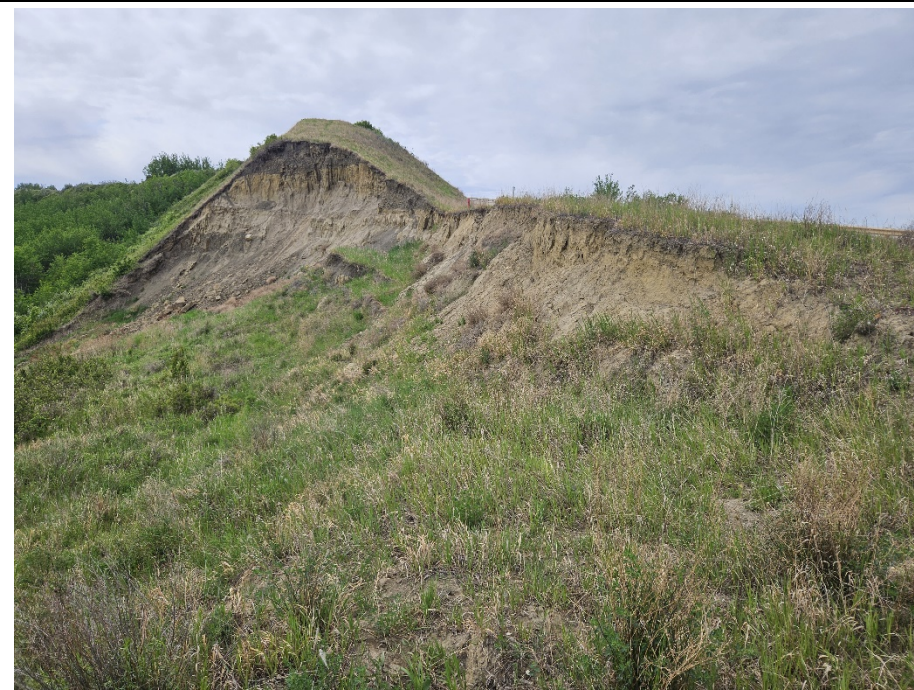
Photo 4.
Looking south along the landslide backscarp at the top of the Heart River valley on Hwy 744:04 at km 57.85. There was a slightly larger buildup of soil at the base of the vertical scarp, indicative of ongoing erosion but no major lateral expansion or retrogression towards the highway since 2023.

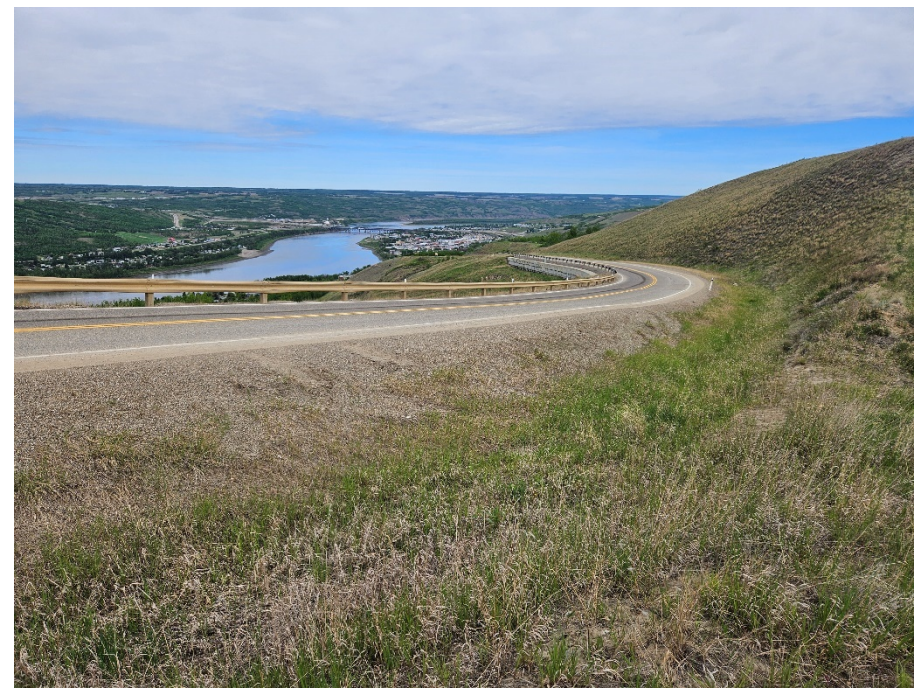
Photo 6.
Looking north along the east side of Hwy 744:04 at km 57.8 and upslope of the landslide movement towards the Heart River. No new cracks were apparent in the pavement or ditch area upslope from the backscarp.

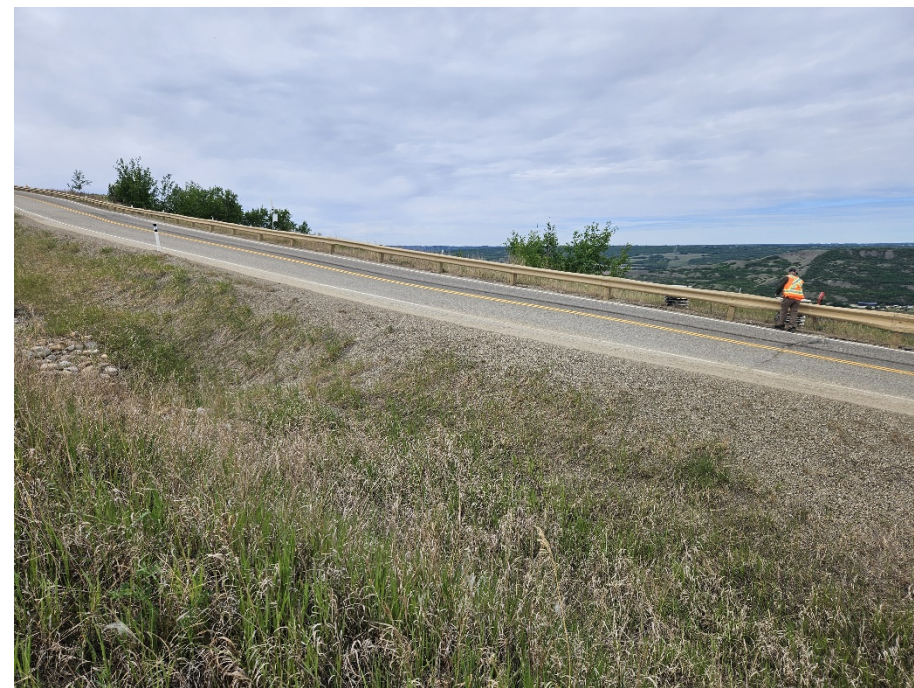
Photo 7.
Looking southwest along Hwy 744:04 from km 57.85 at the crack and dip across the road. No significant visible change from the conditions observed in 2023.

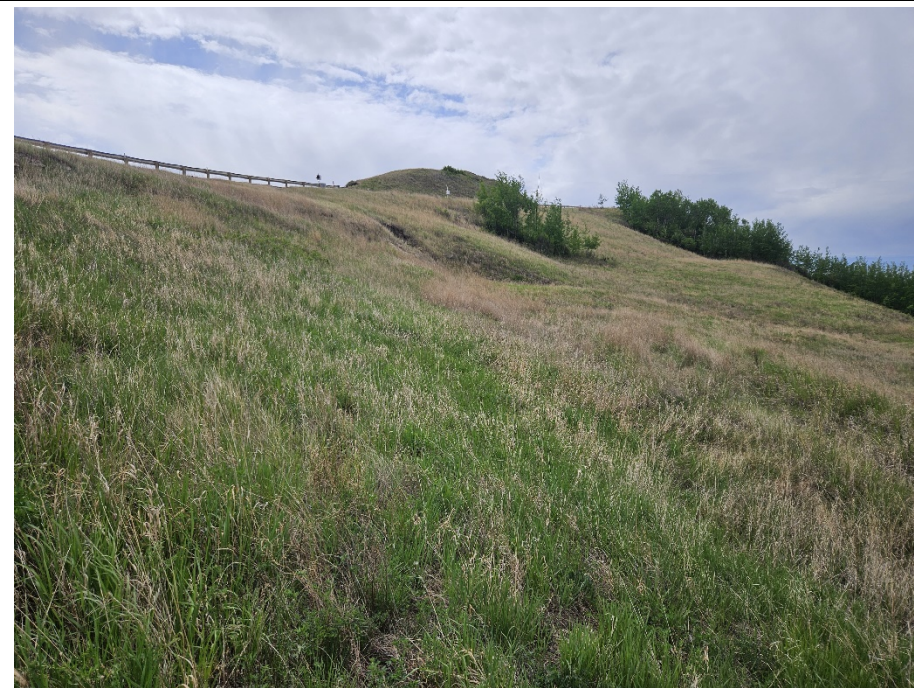
Photo 8.
Looking south near km 57.8 along the west side slope of the below the highway with active gully erosion and old, vegetated slide scarps. No major visible difference in the slide terrain within the upper slope relative to the 2023 condition.

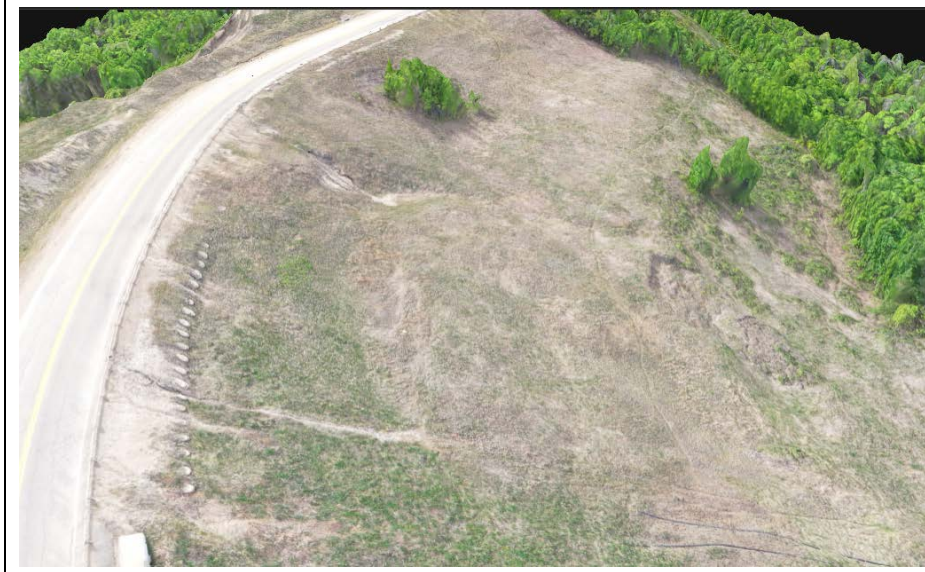
Photo 9.
Screen capture from the 2023 drone photogrammetry model looking south towards the west slope below the highway near km 57.85. Recent slide activity is most apparent within the earth flows in the lower slope.
