Site Number	Location	Name	Hwy	km
PH031	HWY 744:04 C1 57.7	Michelin Slide- Judah Hill	744:04	Km 57.7
Legal Description:		UTM Co-ordinates		
9-20-83-21 W5		11U E 483125.92	N	6229725.01

**ALBERTA TRANSPORTATION AND ECONOMIC CORRIDORS GRMP (CON0022164)
PEACE REGION (PEACE RIVER DISTRICT)
INSTRUMENTATION MONITORING RESULTS**

SPRING 2024

SITE PH031: HWY 744:04, JUDAH HILL (MICHELIN SLIDE)

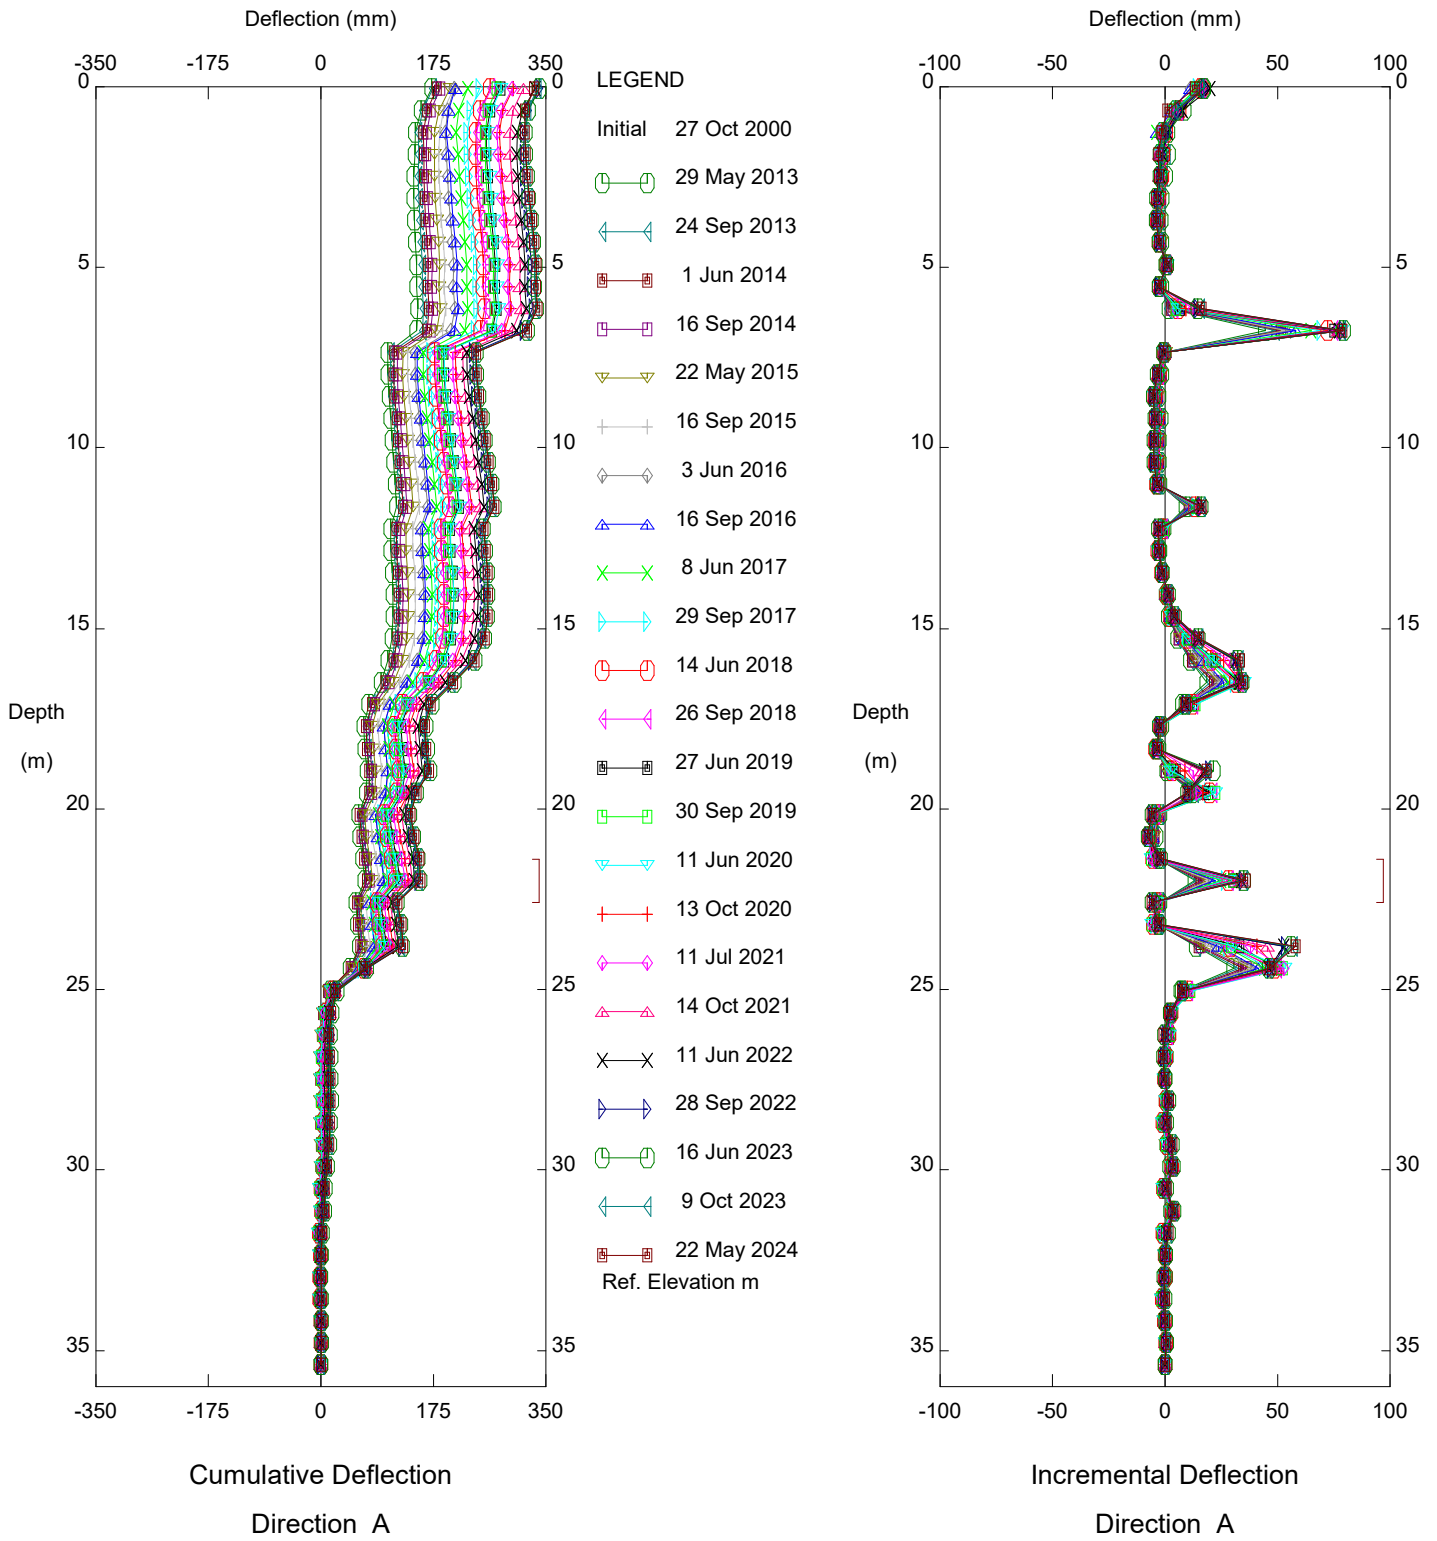
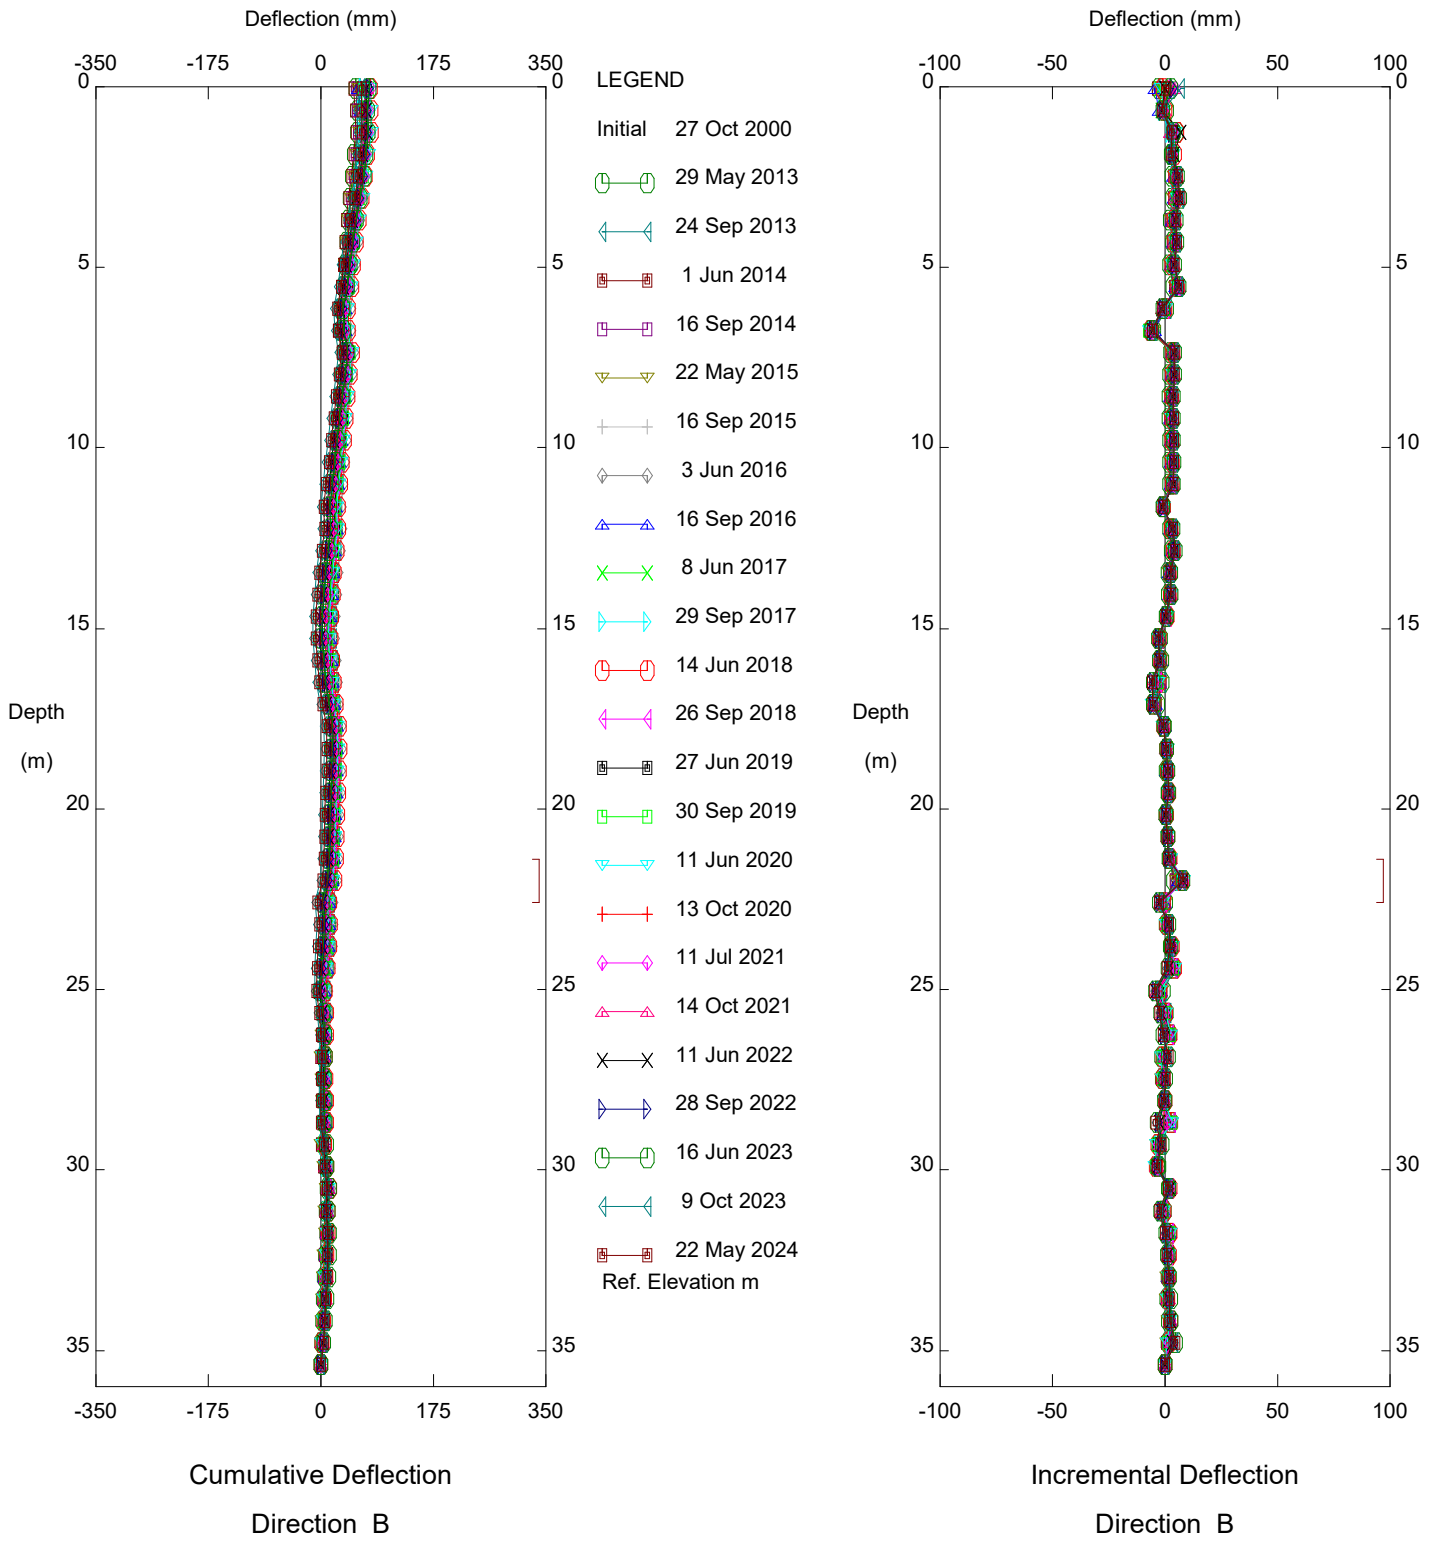
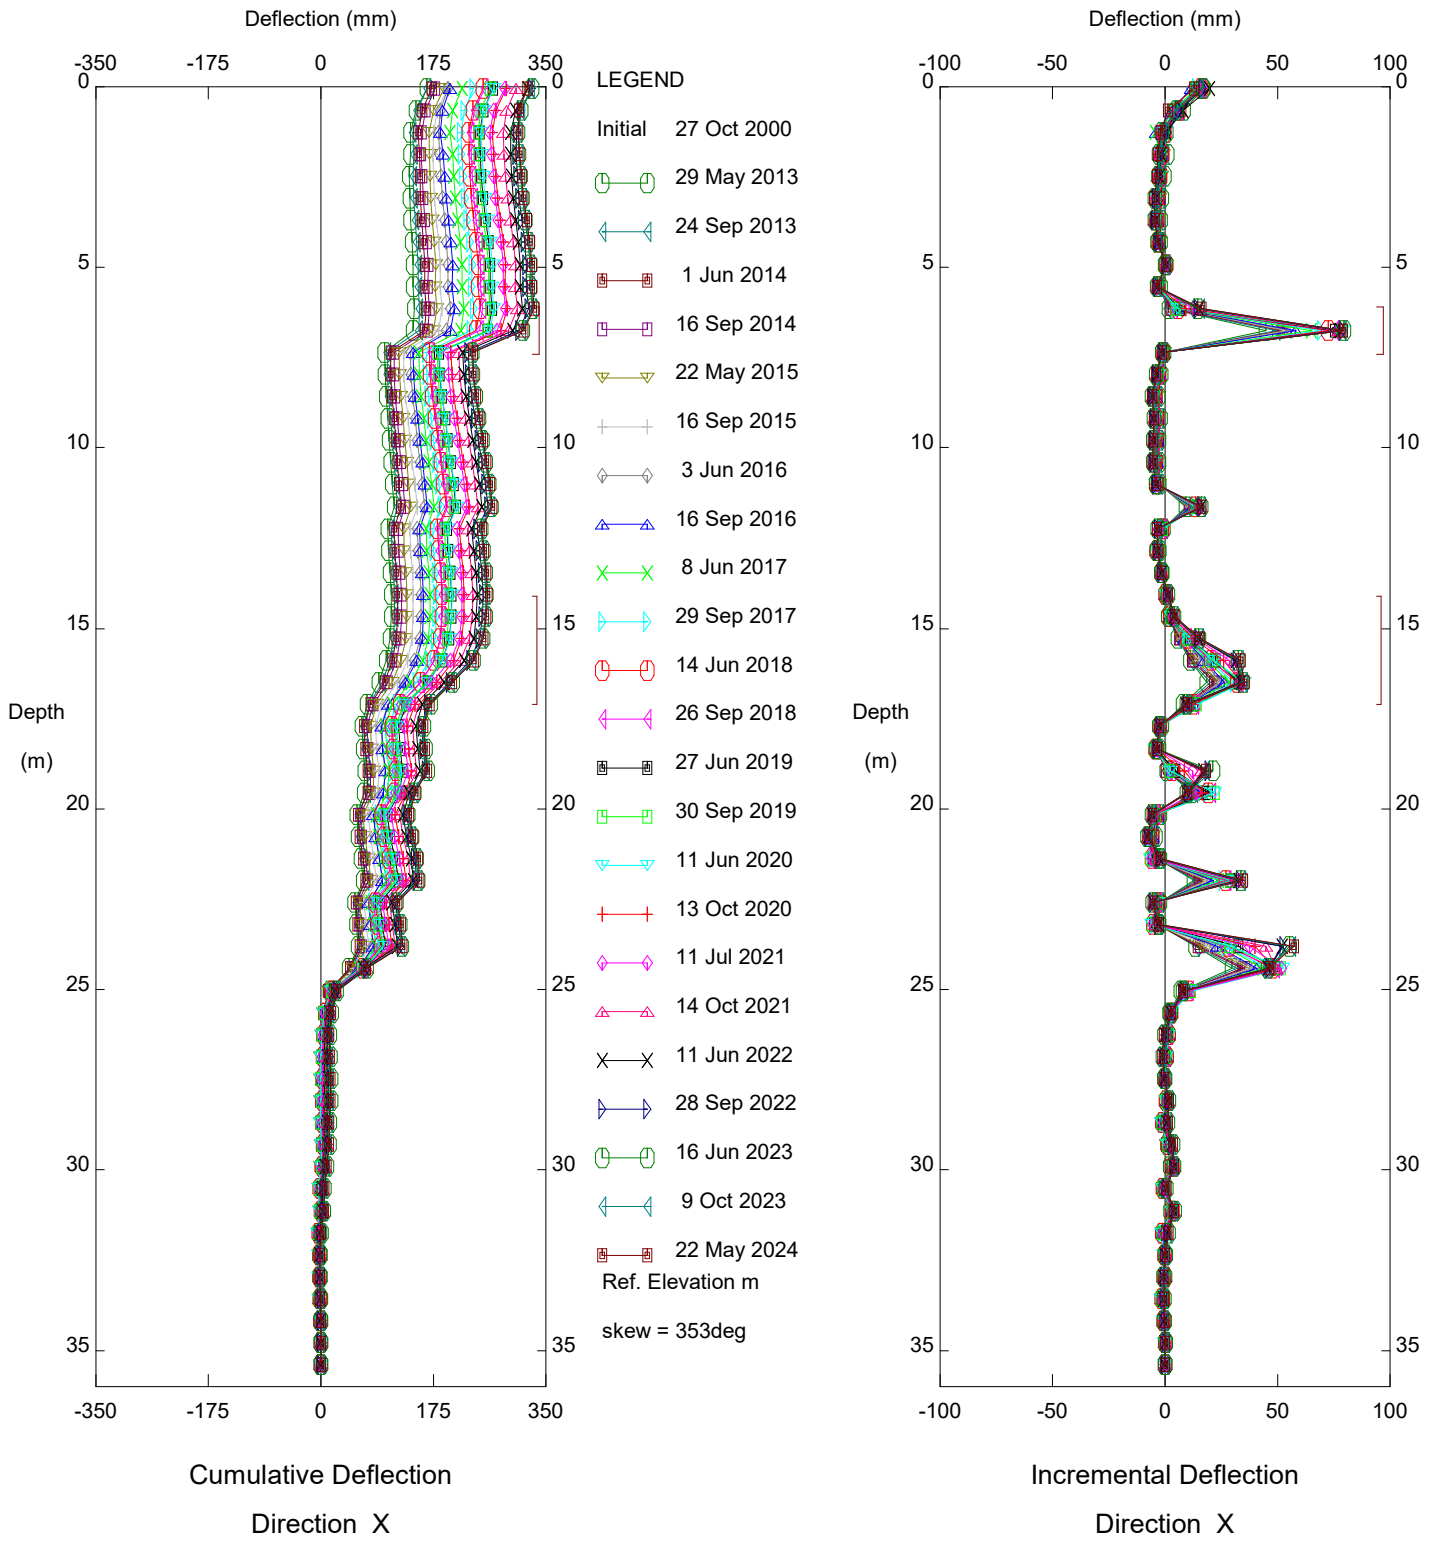
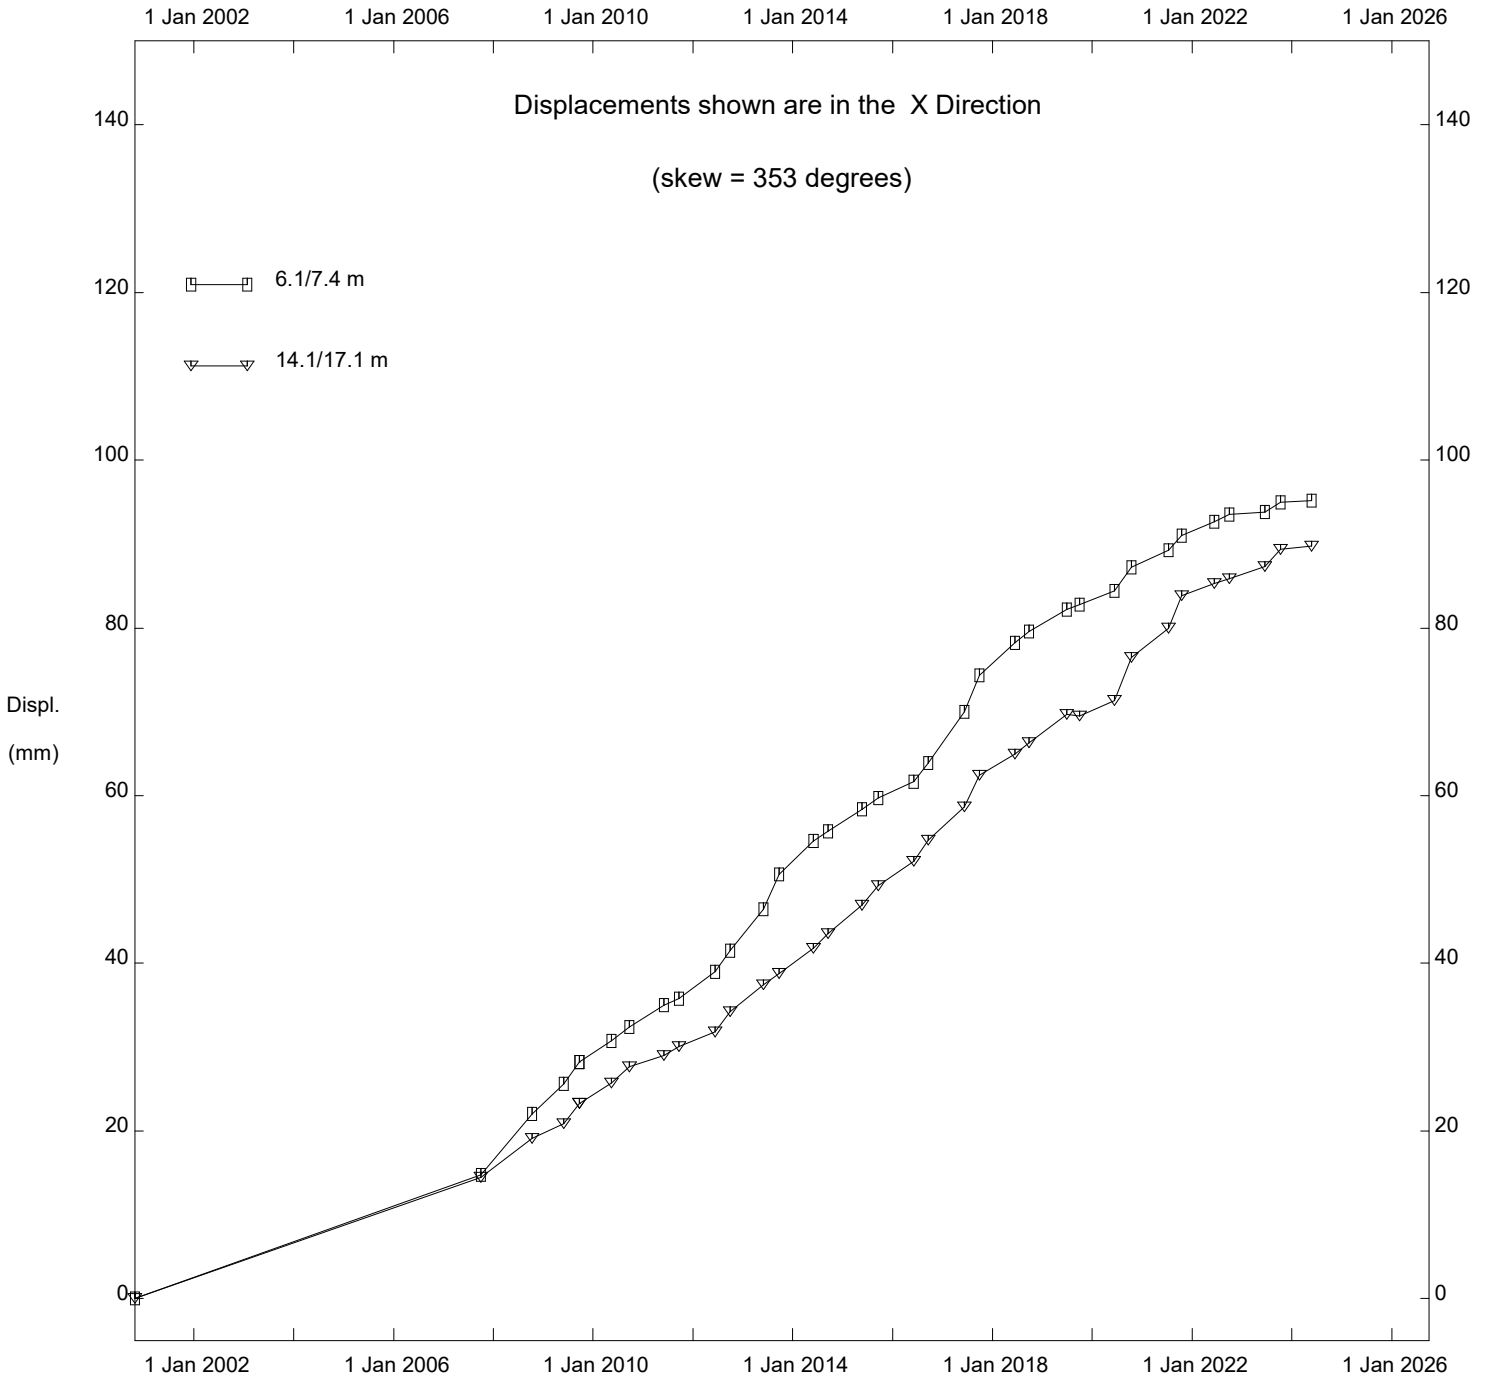
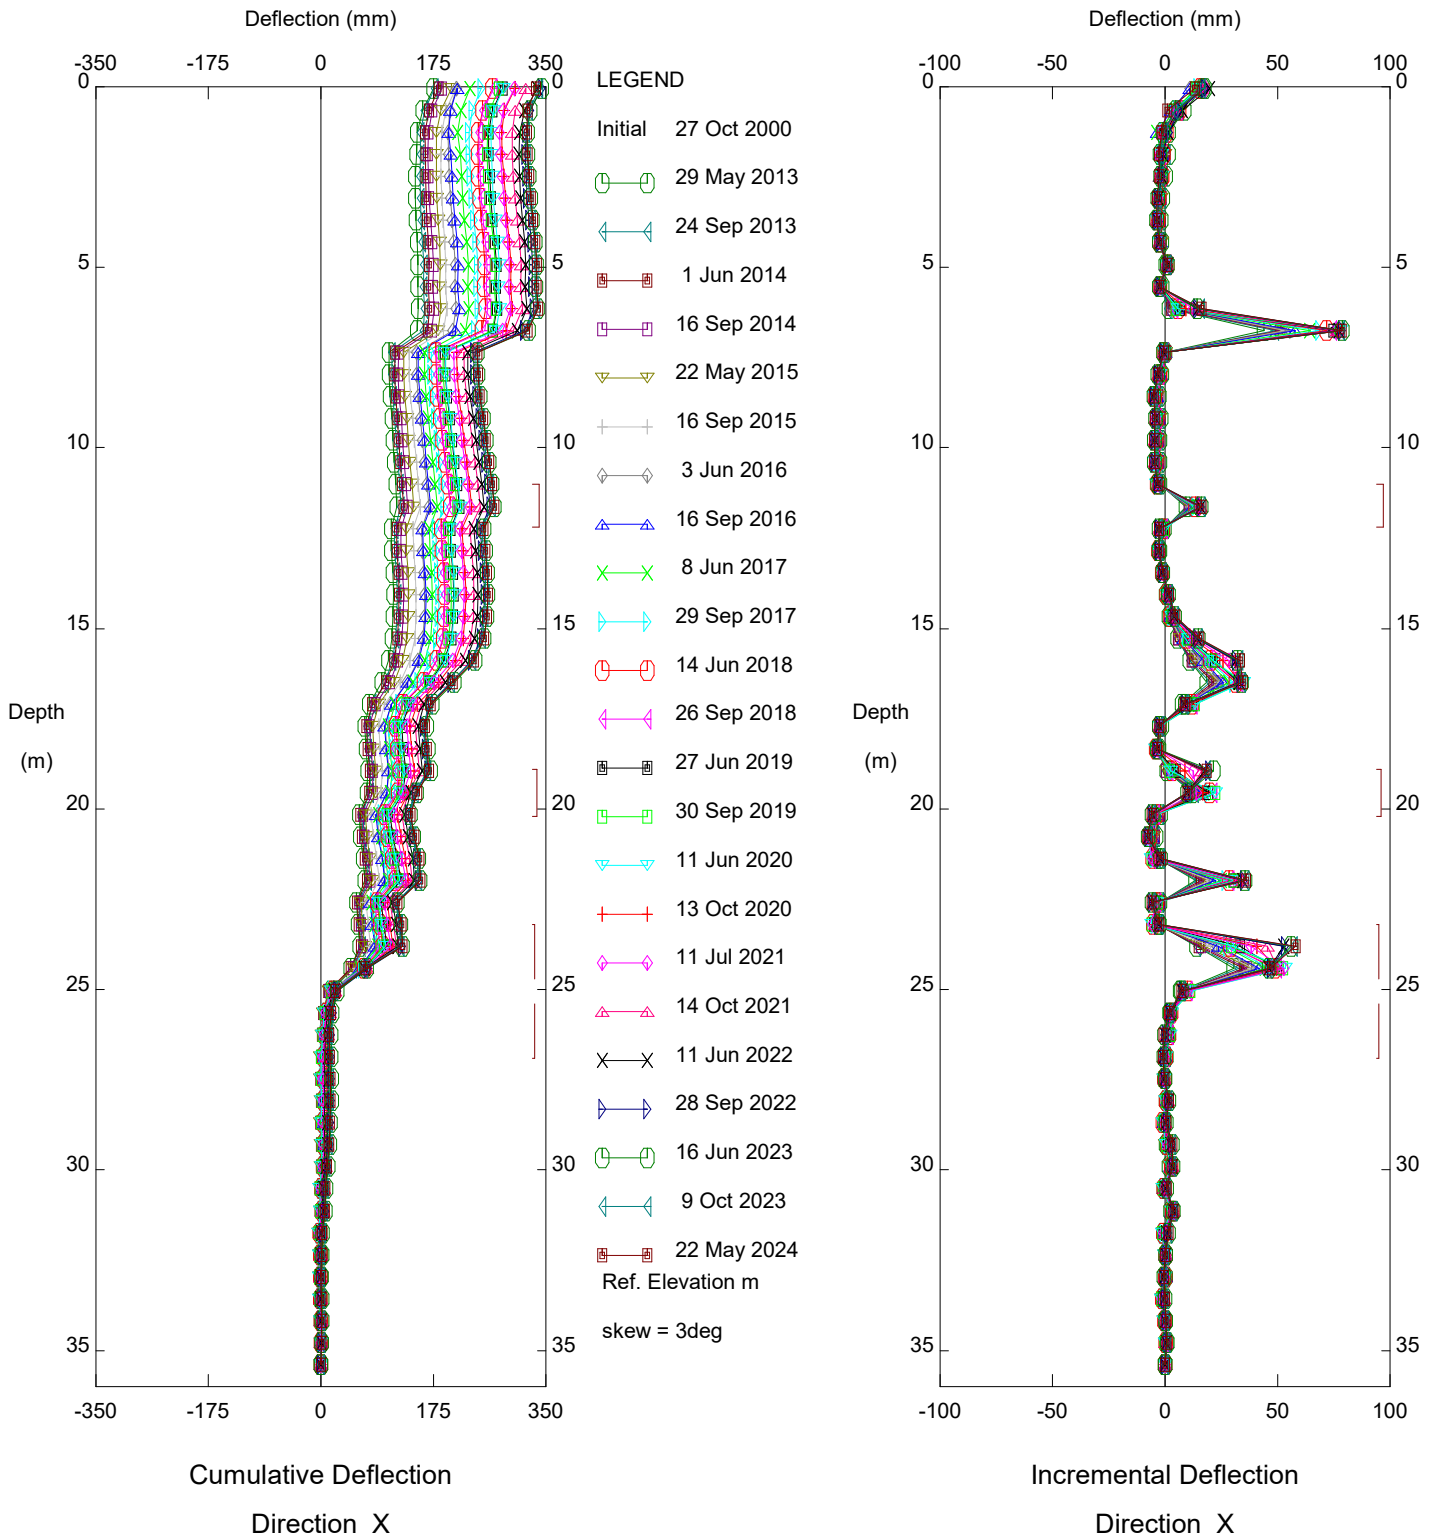
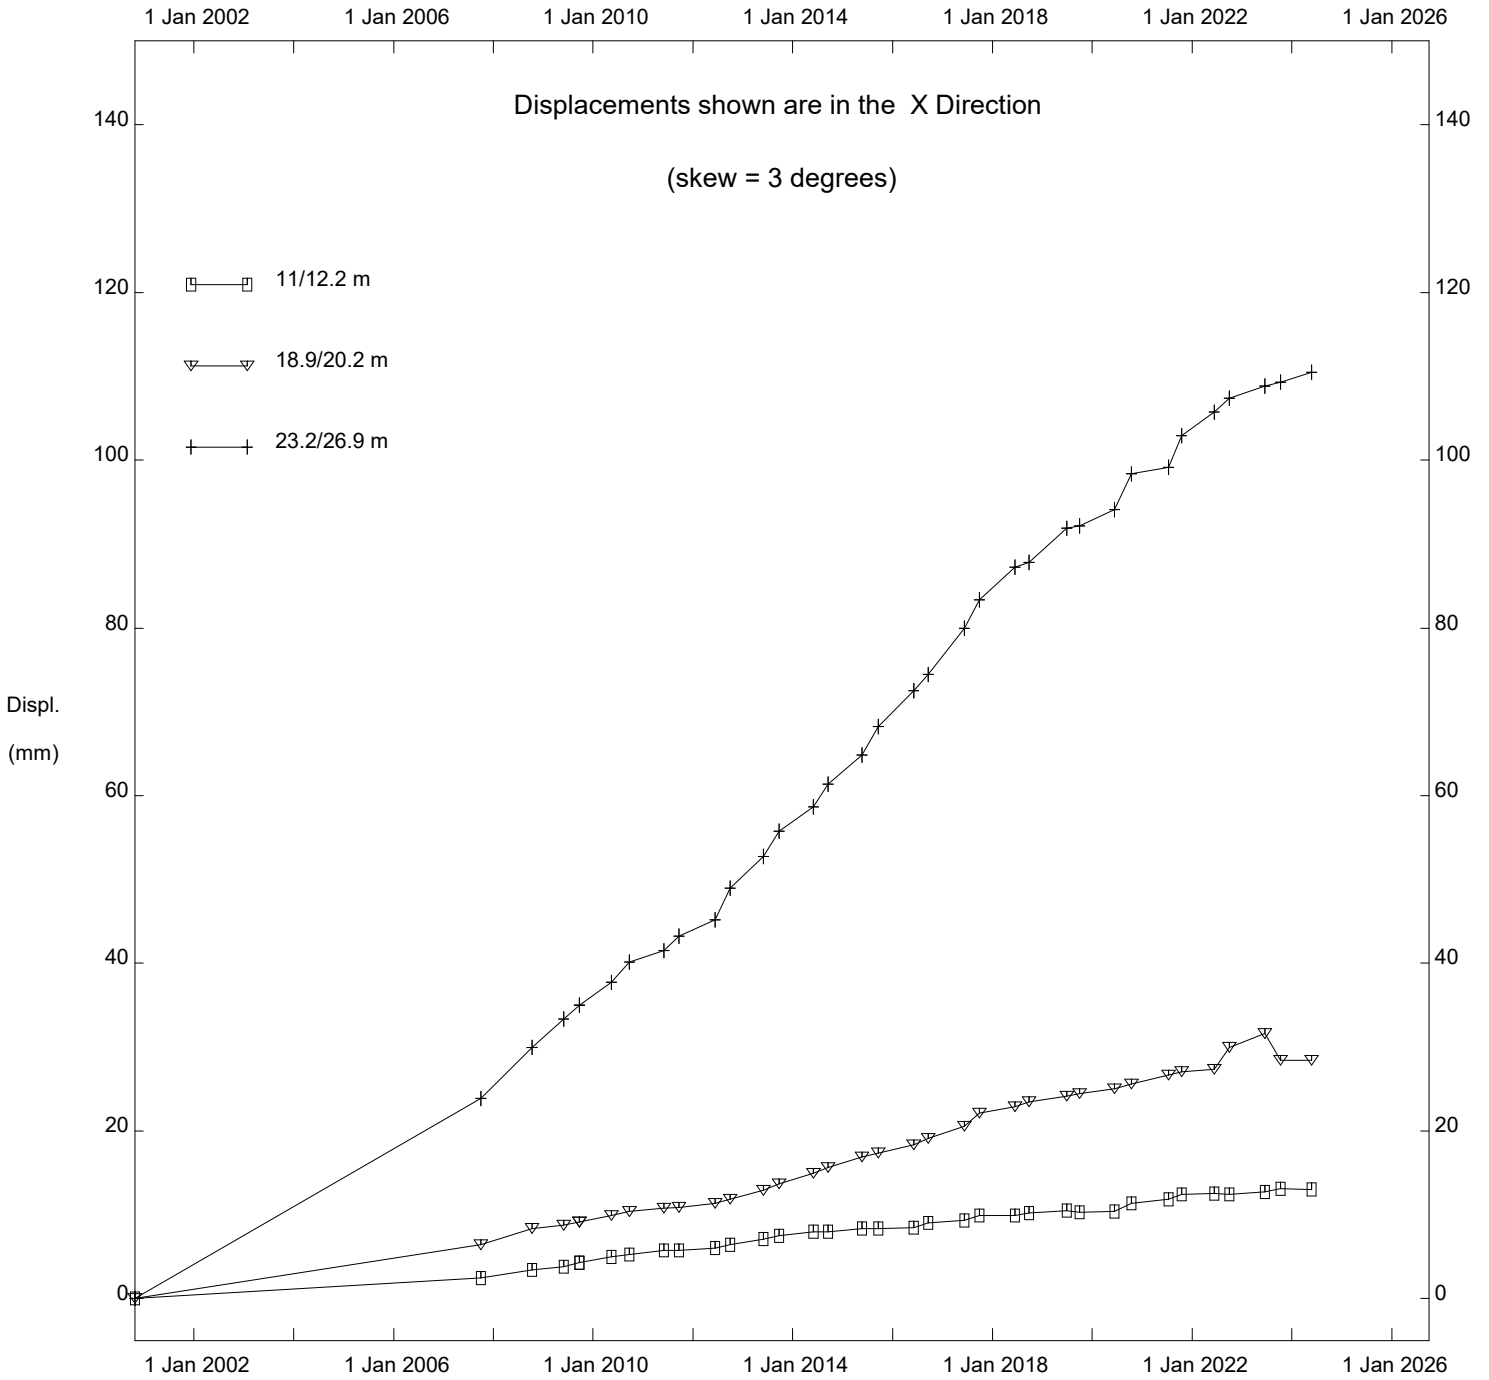
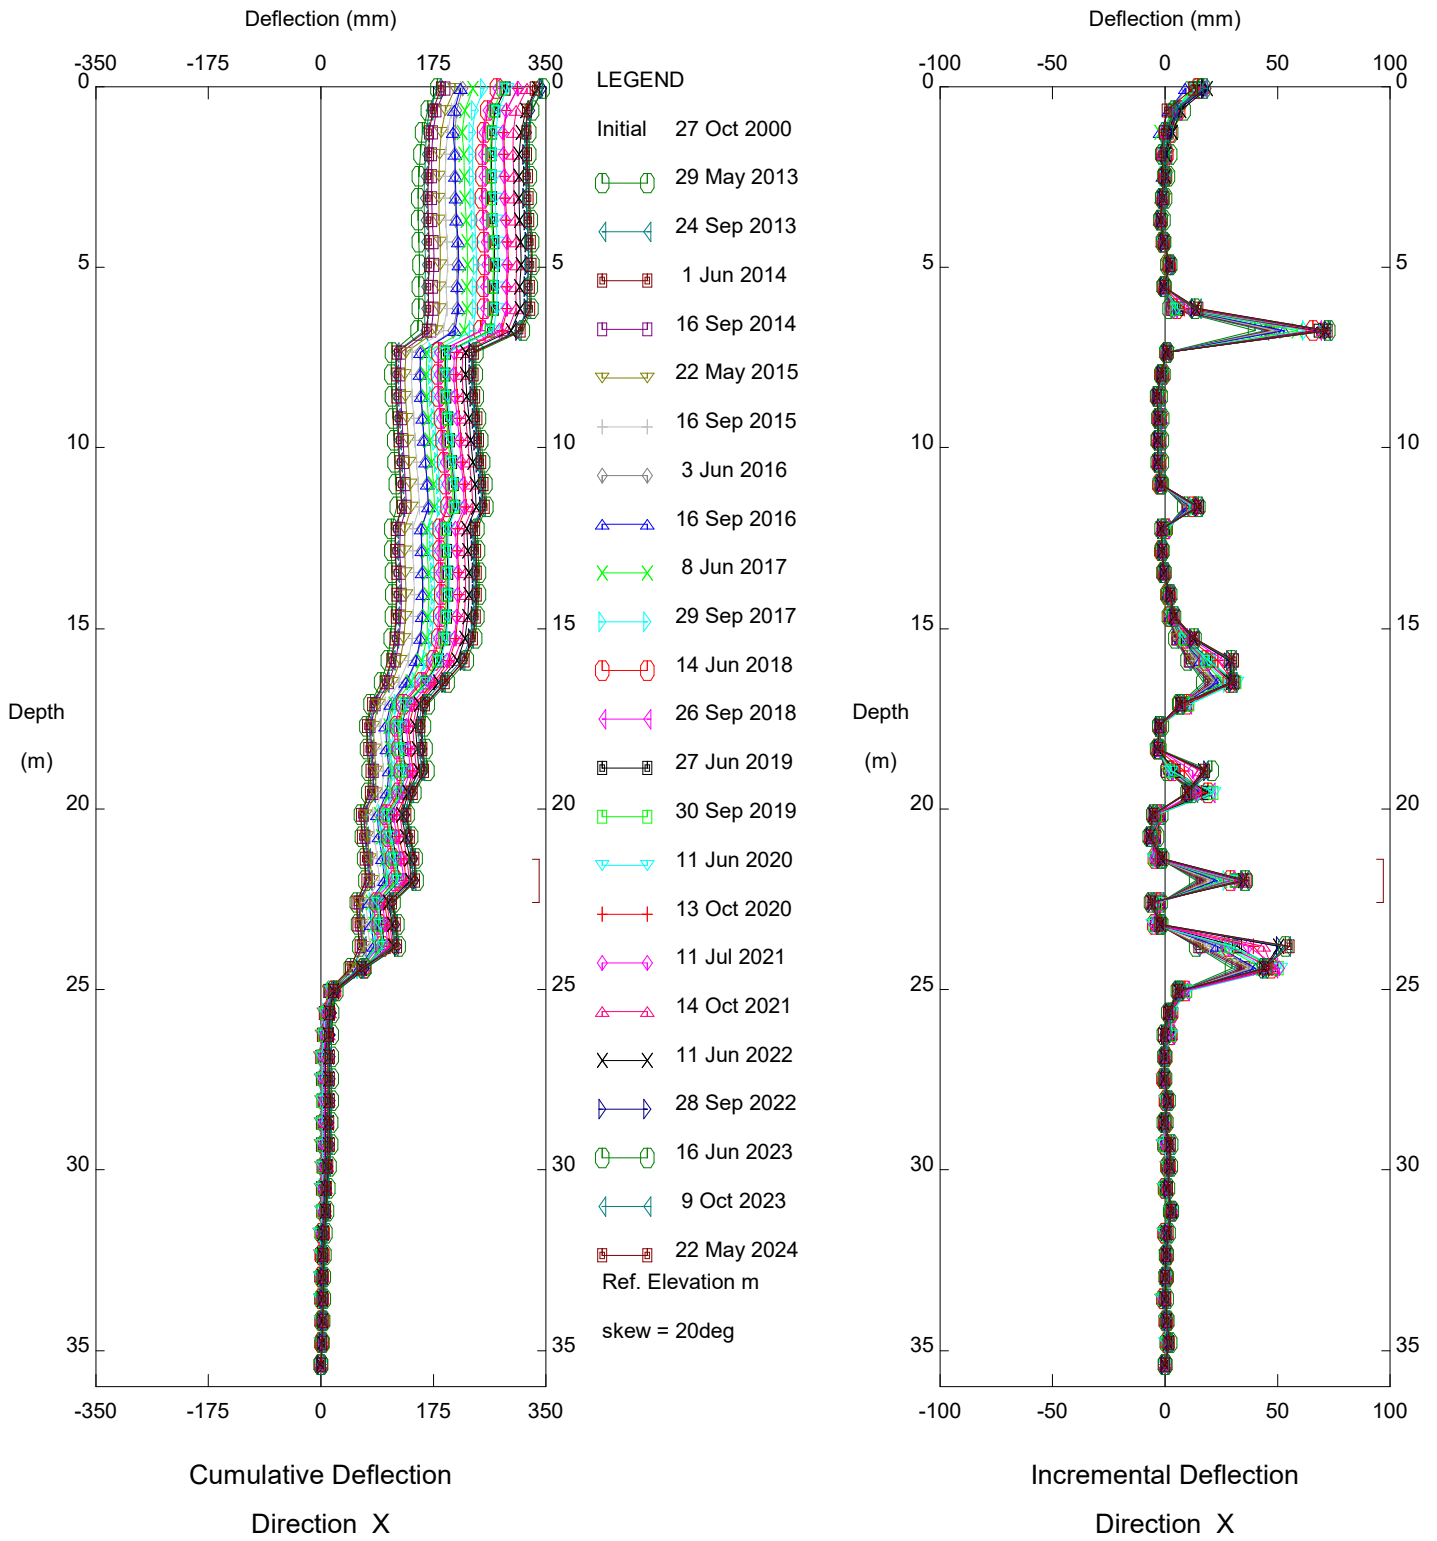
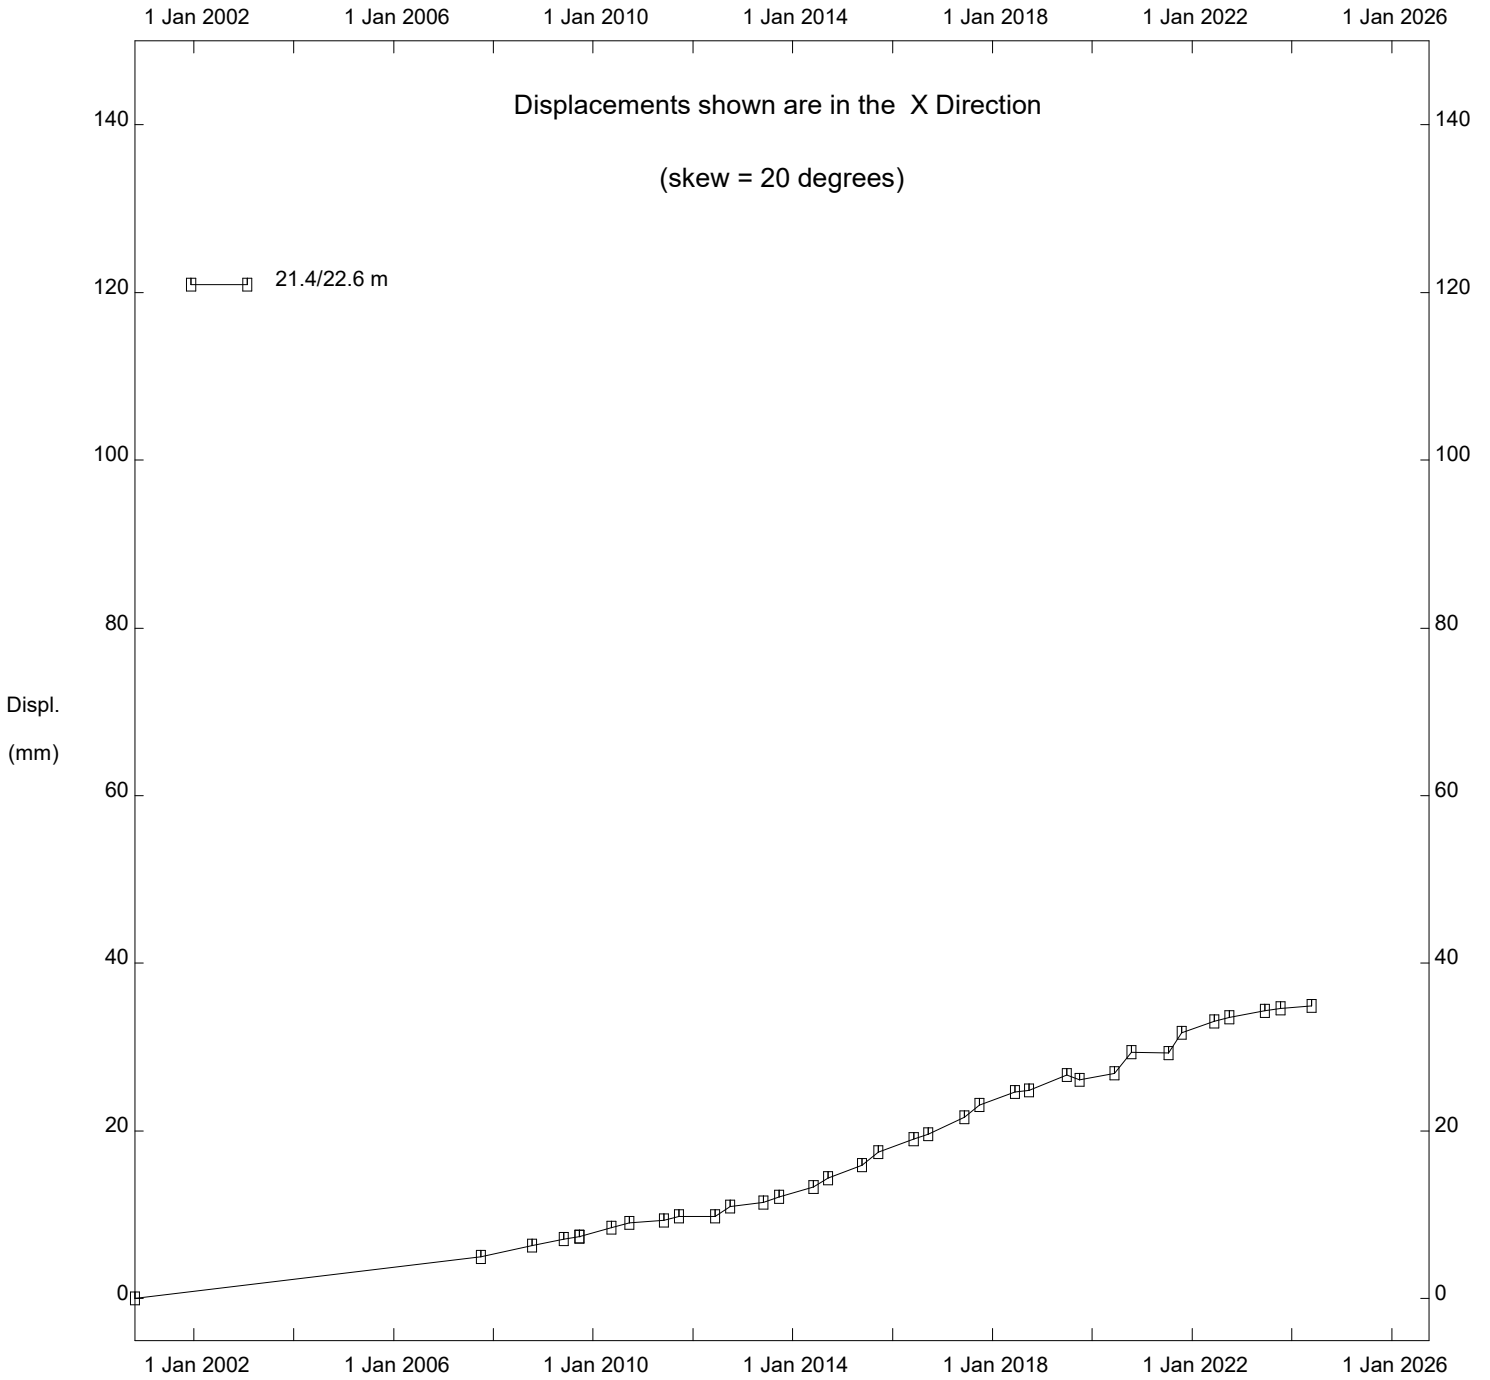
HWY 744:04 - STA. 57+700 to 58+000, Inclinometer SI98-10i

Zones of New Movement:	None
Interpretation of Monitoring Results:	<p>Slope inclinometer SI98-10i, located beyond the toe of Michelin slide showed small incremental movements along six distinct shear planes, since the fall of 2023 readings. The multitude of distinct movement zones speaks to the complexity of ongoing valley wall deformations along Judah Hill. Since the slope indicator was installed in October 2000 the sum of the movements over all these zones is 372.0 mm. The movement rates in these zones ranged from no discernible movement to 2.0 mm/yr. The movement rates showed small changes since the previous readings in the spring of 2023, except for an increase in movement of 10.3 mm/yr over 18.9 m to 20.2 m depth, and a decrease in the rate of movement of 5.8 mm/yr over 14.1 to 17.7 m depth. and</p> <p>Slope inclinometer SI10-4 is located close to the highway and has one well defined movement zone at 6 m depth in a clay strata, and several subtle movement zones lower down in clay and clay till layers. A rate of movement of 1.7 mm/yr was measured over 5.7 m to 6.9 m depth and no discernible movement over 11.8 m to 17.9 m depth since the fall of 2023 readings. The movement is in the direction of the active</p>

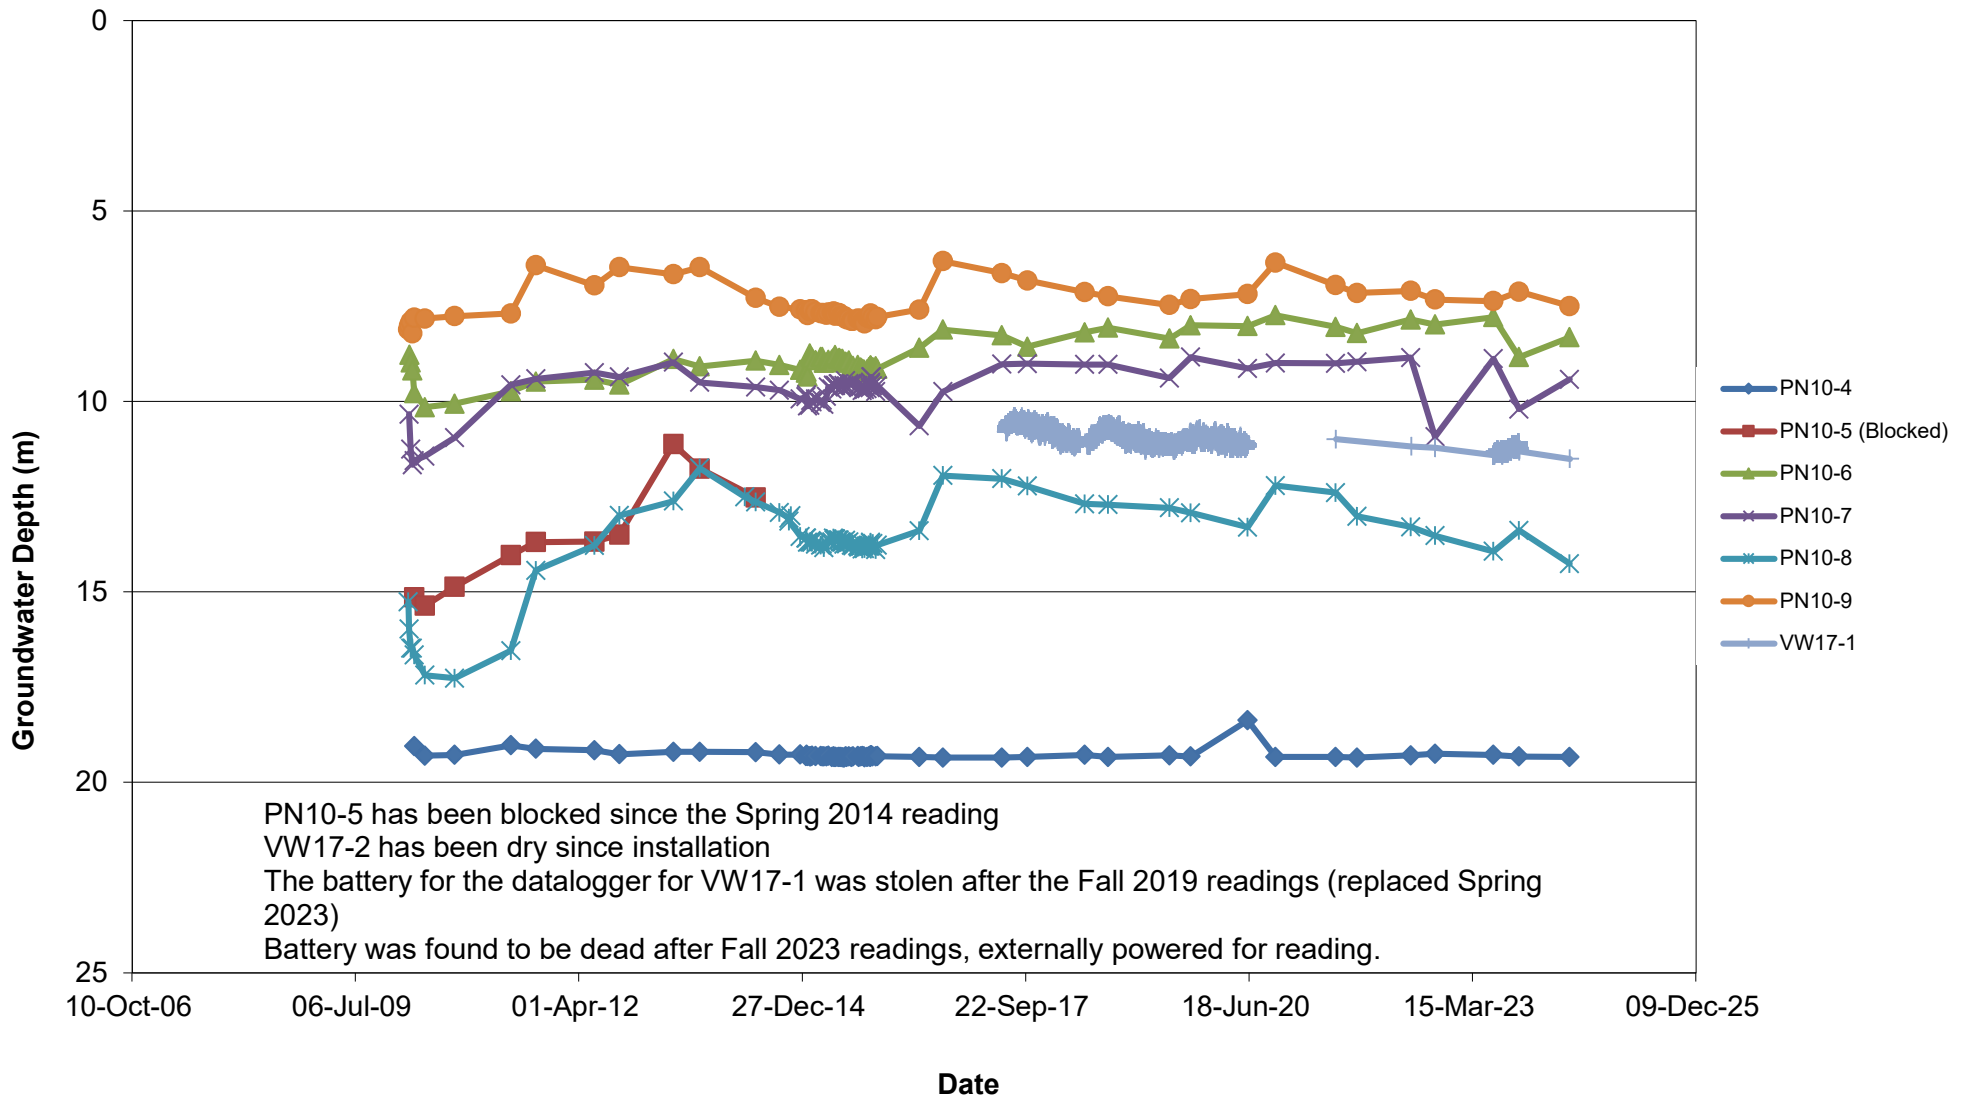
**FIGURE PH031-1
PIEZOMETRIC DEPTHS FOR HWY 744:04 JUDAH HILL (MICHELIN SLIDE)**

INSTRUMENT	DATE INITIALIZED	TIP ELEV. (m)	GROUND ELEV. (m)	CURRENT STATUS	HIGHEST RECORDED GROUNDWATER LEVEL (mBGS)	CURRENT GROUNDWATER DEPTH (mBGS)	PREVIOUS GROUNDWATER DEPTH Oct. 22/23 (mBGS)	CHANGE IN WATER LEVEL SINCE PREVIOUS READING (m)
VW17-1	June 6, 2017	502.52	514.52	Operational	10.40 on September 4, 2017	11.51	11.31	-0.20
VW17-2	June 6, 2017	496.38	514.52	Operational	DRY	DRY	DRY	N/A
