**ALBERTA TRANSPORTATION  
GEOHAZARD ASSESSMENT PROGRAM  
PEACE REGION (PEACE RIVER DISTRICT)  
2023 INSPECTION**

Site Number	Location	Name	Hwy	km
PH032	Judah Hill	Makeout Landslide	744:04	57.924
Legal Description		UTM Co-ordinates		
NE¼ 20-083-21 W5M		11U E 483171	N 6229947

**PH032-1 JUDAH HILL - MAKEOUT SLIDE  
2023 SITE INSPECTION PLAN**

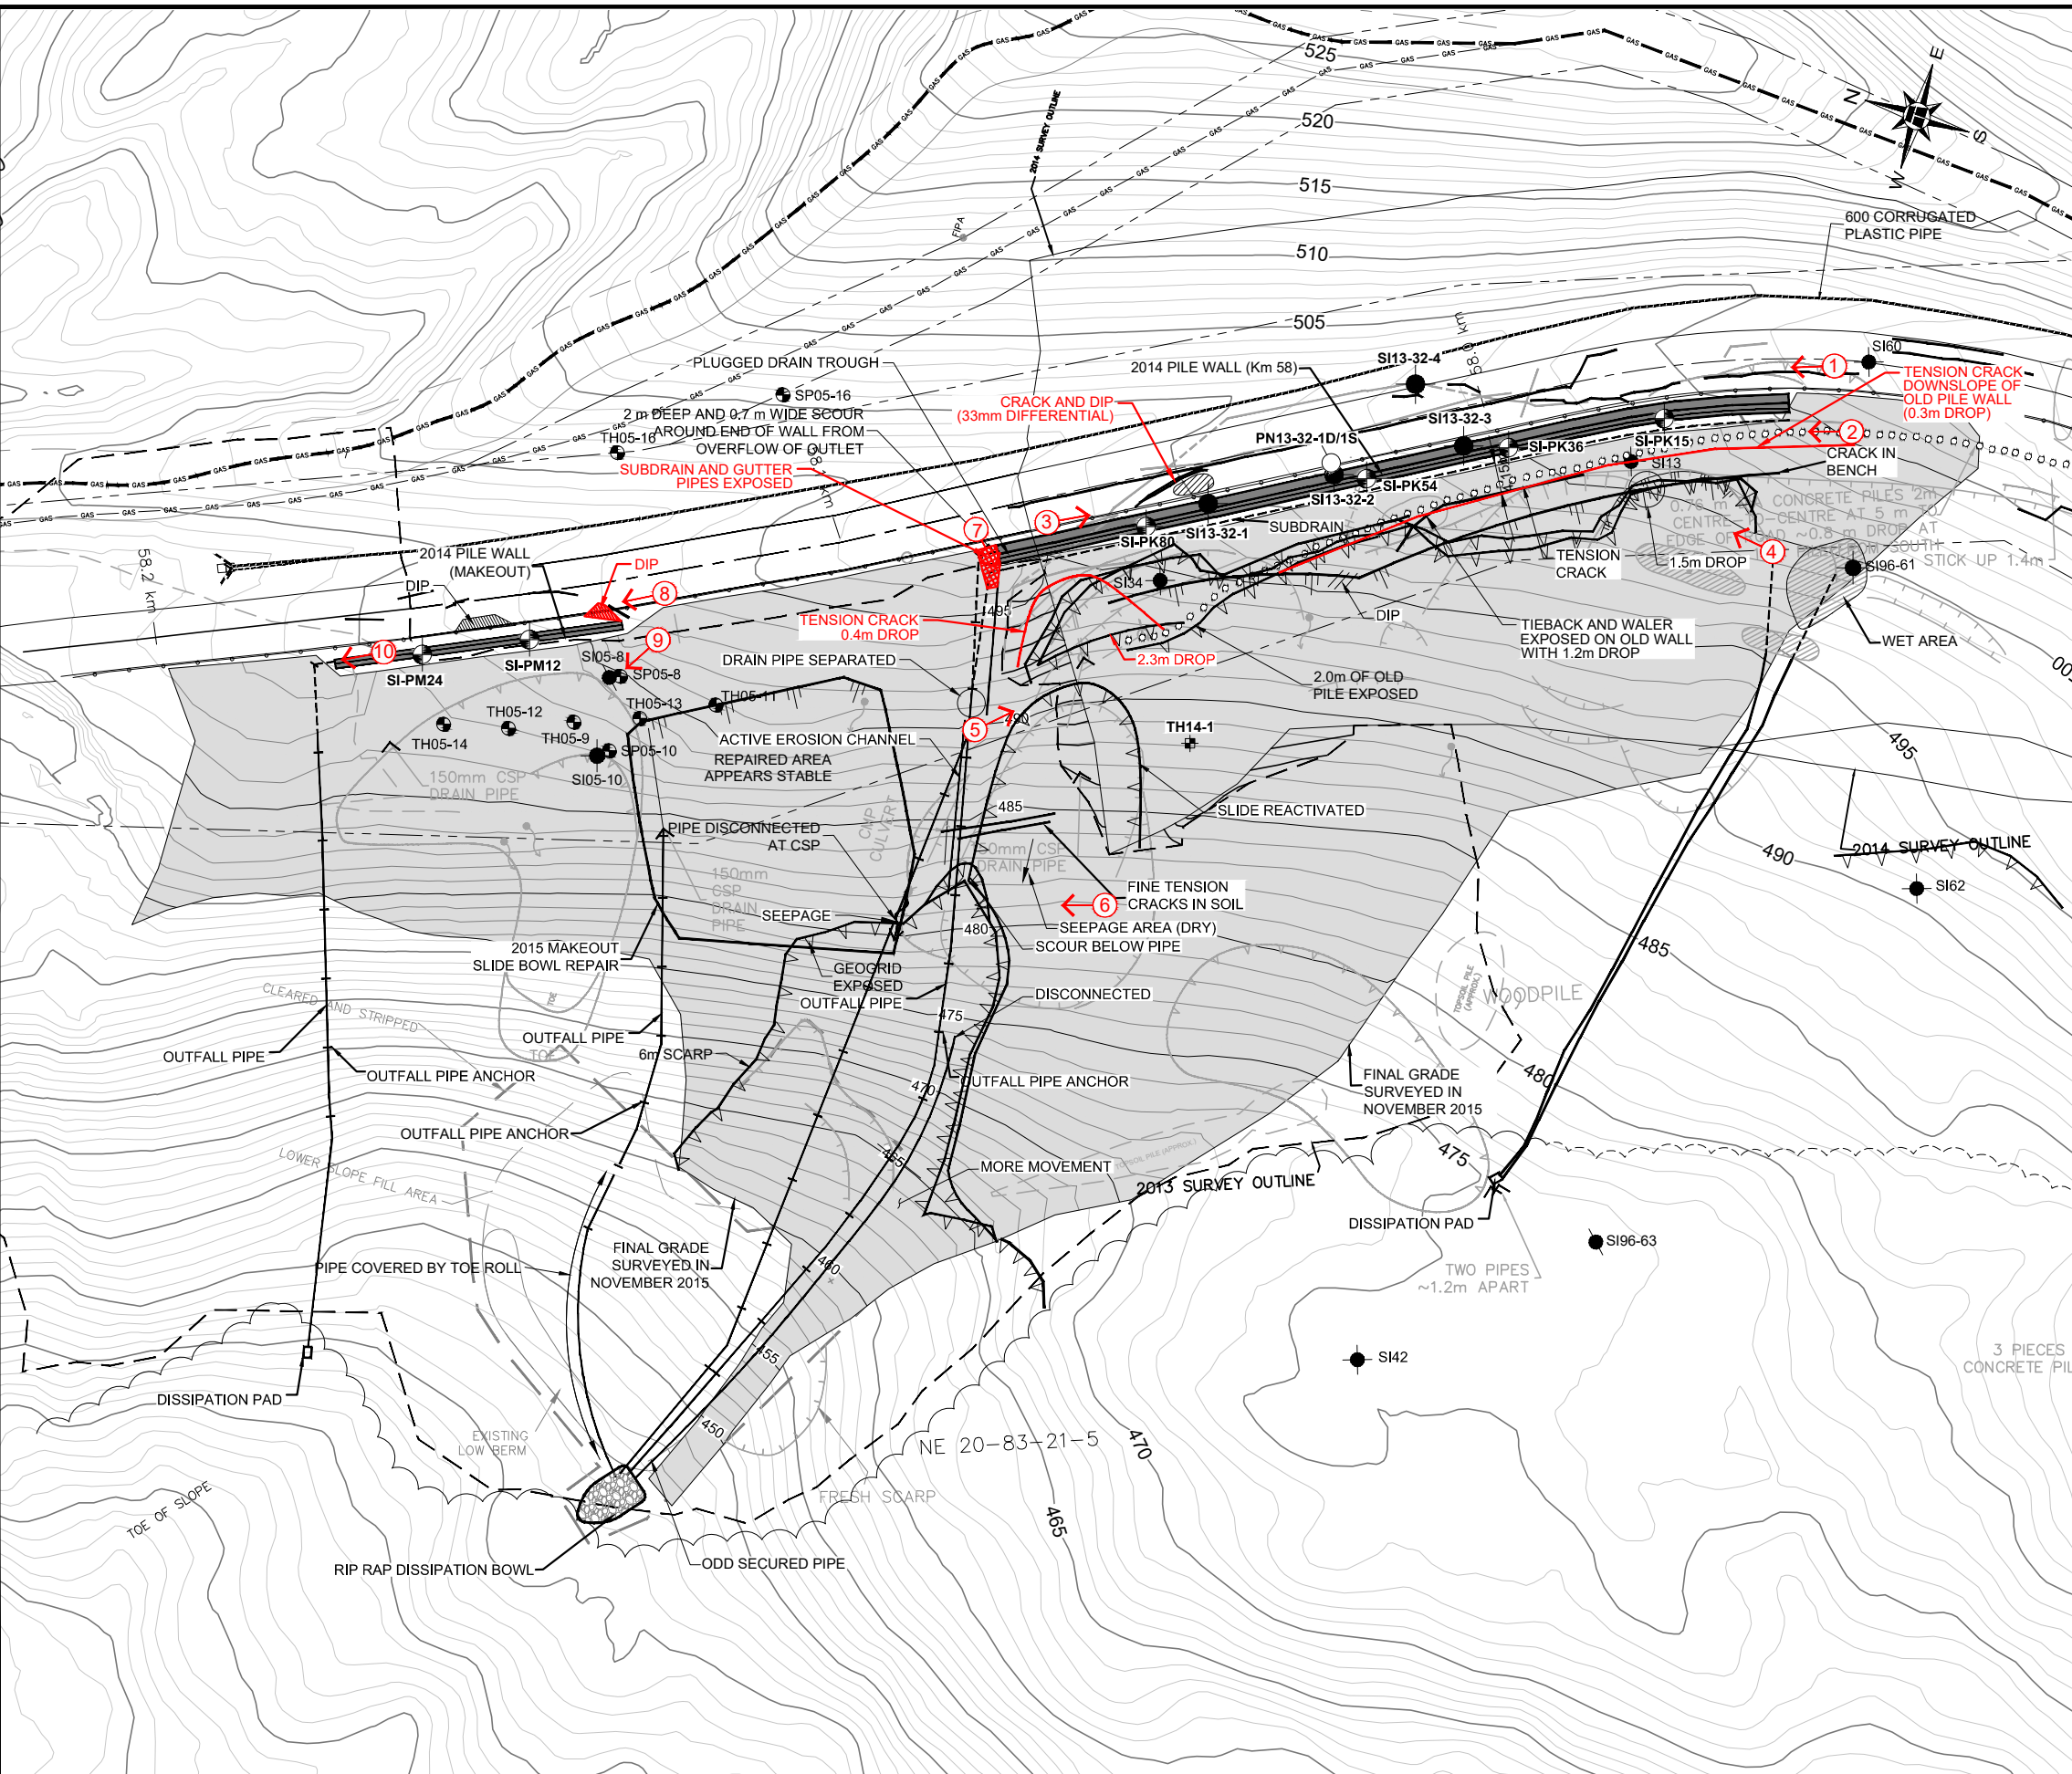
**DWG No. 32121-PH032-1**

- 1 LOCATION DATA RECORDED USING HAND HELD GPS RECEIVER. ALL LOCATIONS ARE APPROXIMATE AND ARE FOR ILLUSTRATIVE PURPOSES ONLY.
- 2 MAY 17, 2023 OBSERVATIONS SHOWN IN RED.

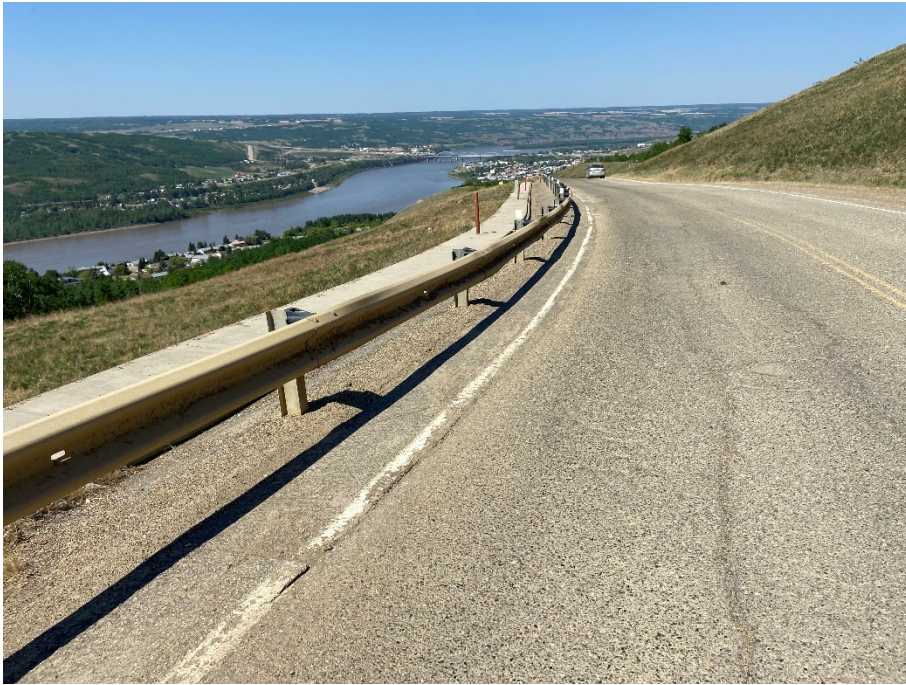
**Photo 1.**  
Looking northwest from the SBL shoulder of Hwy 744:04 at km 57.96 along the guardrail above the km 58 pile wall. There have been no major changes in the cracks in the ACP within the southern half of the wall since 2021.

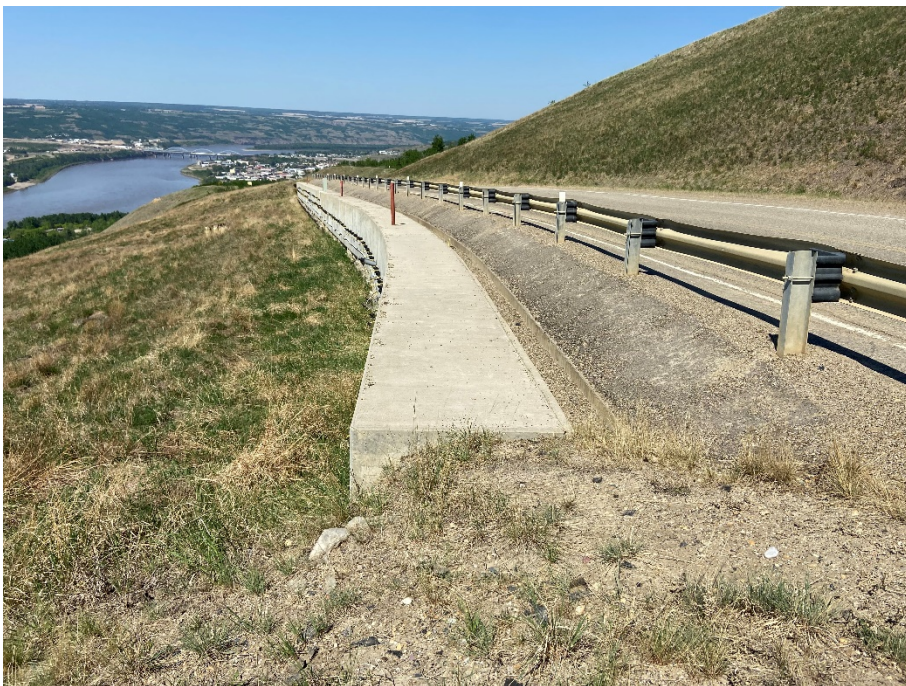
**Photo 2.**  
Looking northwest from the south end of the km 58 pile wall. The ACP shoulder protective cover was in good condition. No significant changes were noted downslope of the wall at this site relative to the 2021 condition.

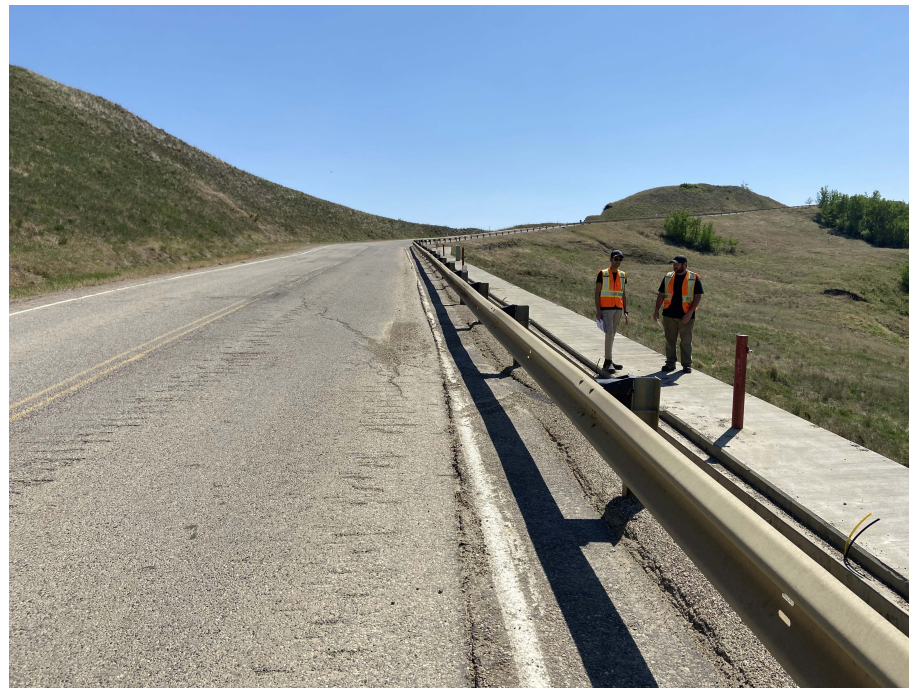
**Photo 3.**  
Looking south from the north end of the km 58 pile wall. Slightly worse crack and dip within the ACP directly behind the wall but overall road condition has not significantly changed since the 2021 condition.

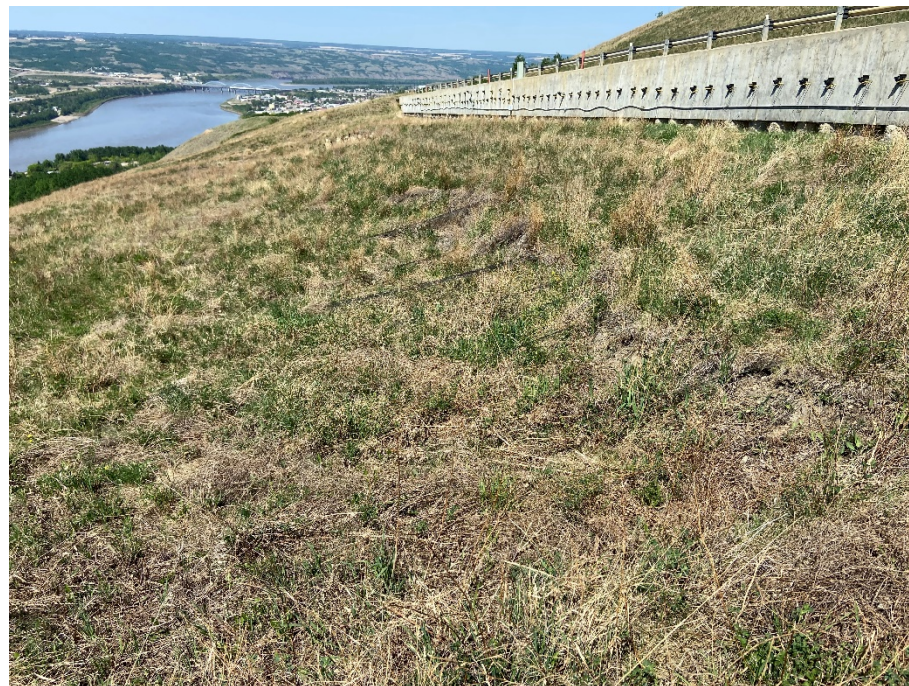
**Photo 4.**  
Looking northeast from below the north end of the km 58 pile wall. The old landslide scarps below the pile wall that were regraded in 2015 have ongoing movement. There was a tension crack along the downslope edge of the old pile wall with up to 0.3 m of drop.

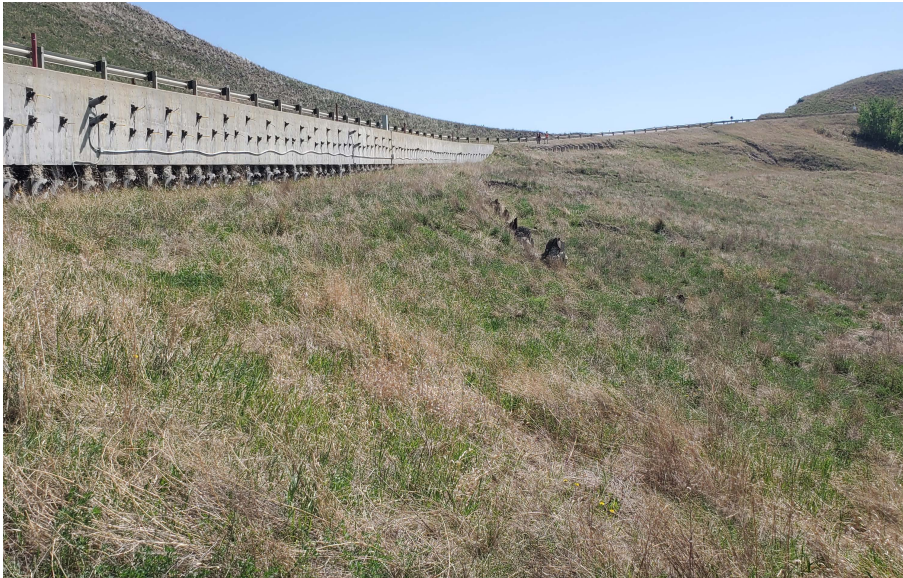
**Photo 5.**  
Looking south at the landslide scarps downslope from the km 58 pile wall (km 58.07). A new tension crack was observed in this area with up to 0.4 m drop. The old piles are exposed up to 2.0 m in height.

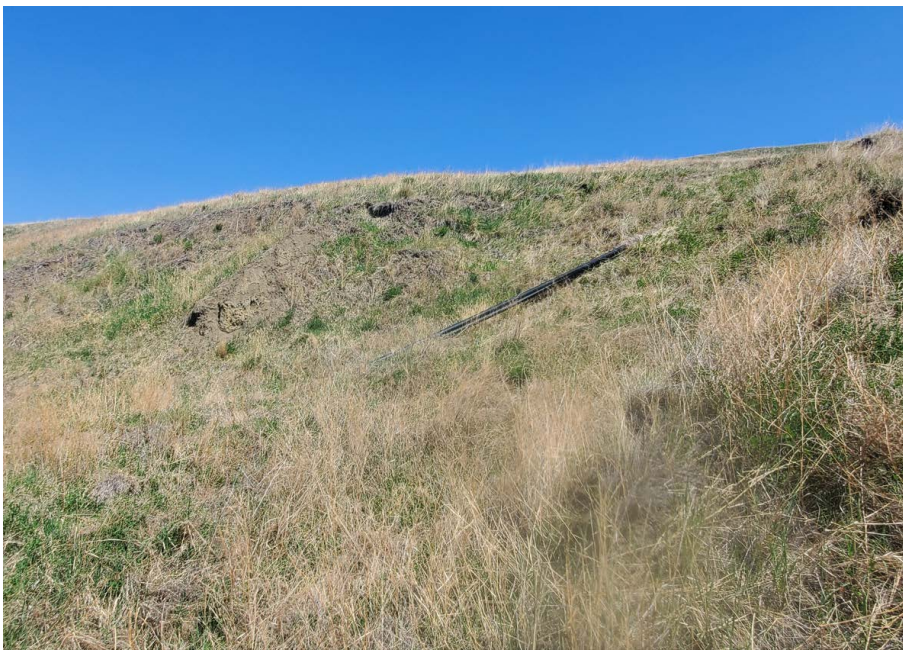
The progressing of the scour below the disconnected drain pipe at the base of the clay backfilled slide bowl will need to be monitored. This slide could grow rapidly in size and retrogress toward the highway if the water leakage is not remediated.

**Photo 6.**  
Looking at the north flank of the lower slide area between the pile walls. Seepage from a disconnected drainage pipe is causing erosion and exacerbating slide movement. No major changes from the 2021 condition.

Some further drainage efforts might be required at the wet area as a future maintenance item as history has shown that persistent seepage can lead to significant slide movements. The disconnected drain pipe below the north end of the km 58 pile wall should be reconnected to help prevent further retrogression of the landslide scarp that has formed below it.

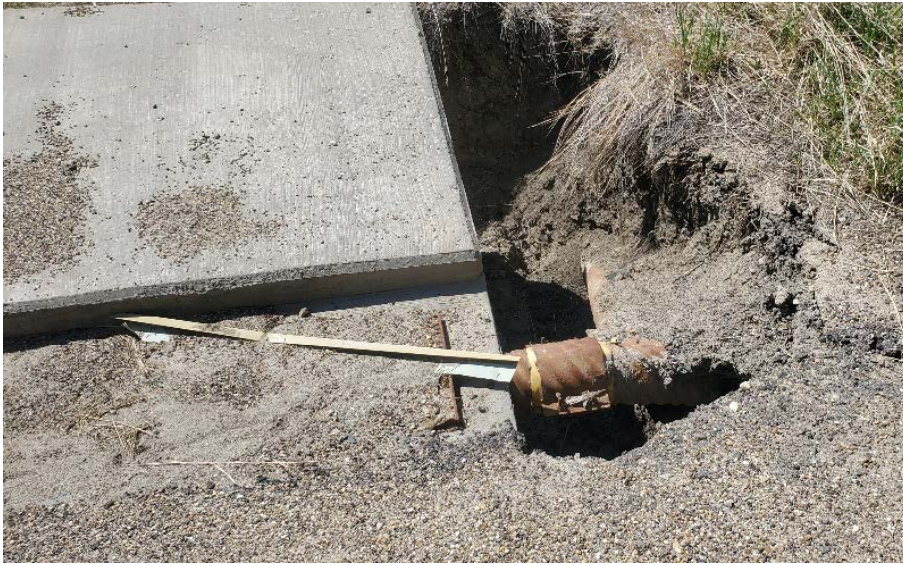
<input checked="" type="checkbox"/> Erosion	<p>Both ends of the km 58 pile wall have become eroded by runoff water and water overtopping the outlet of the pile wall due to blockage of the drain trough with sediment buildup. Scour at the north end of the wall has become worse exposing the gutter and subdrain outlet pipes (Photo 7).</p> <p>The solid HDPE outlet drain pipe for the clay backfilled area became disconnected from the perforated CSP drain pipe at the base in 2018 and erosion damage is ongoing.</p>	<input checked="" type="checkbox"/>
<input type="checkbox"/> Seepage	<p>No major changes observed at previous seepage area in the lower slope area between the pile walls near the active erosion gully (Photo 6).</p>	<input type="checkbox"/>
<input type="checkbox"/> Bridge/Culvert Distress		<input type="checkbox"/>
<input checked="" type="checkbox"/> Other	<p>No change observed in the ACP shoulder protective cover at either pile walls (Photos 2 and 8).</p>	<input type="checkbox"/>

**Photo 7.**  
Looking at the north end of the km 58 pile wall where the drain outlet has become blocked and caused water overflow and scour exposing the subdrain and gutter pipes.

The drain troughs for both the km 58 and Makeout pile walls will require annual cleaning. The void formed at the north end of the km 58 pile wall from water overtopping the drain trough outlet should be lined with non-woven geotextile and backfilled with gravel and topped with Class 1M riprap.

The pile wall surface drainage gutters will require to be regularly cleaned in order to continue to provide erosion protection for the partially buried pile wall and avoid clogging of its solid downrain pipes. The void at the north end of the km 58 pile wall needs to be backfilled with granular fill and topped with Class 1 riprap to prevent further expansion of the erosion damage.

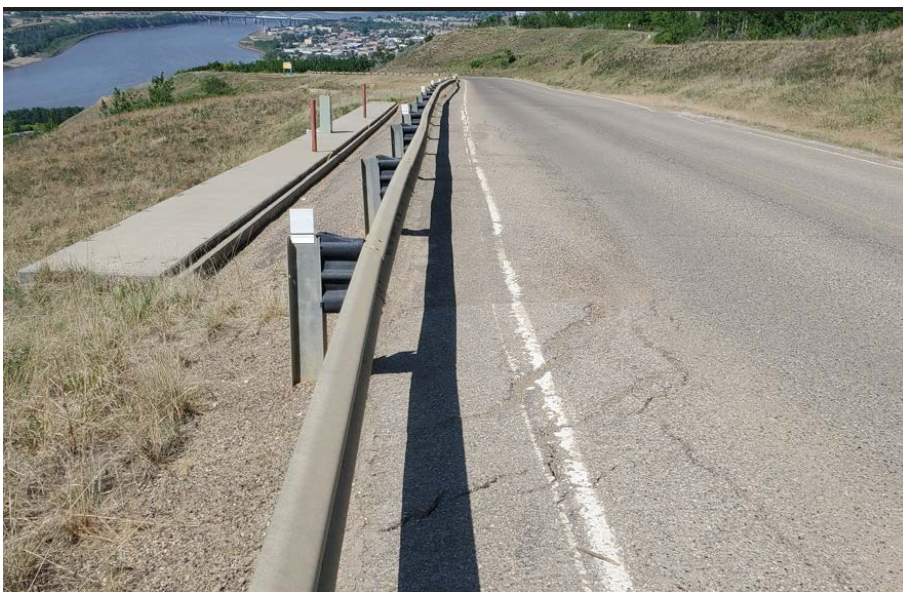
**Photo 8.**  
Looking northwest at the highway above the "Makeout" pile wall. Some increased dip around the SBL shoulder near the middle and south end of the wall and ACP cracking was slightly worse relative to the 2021 condition.

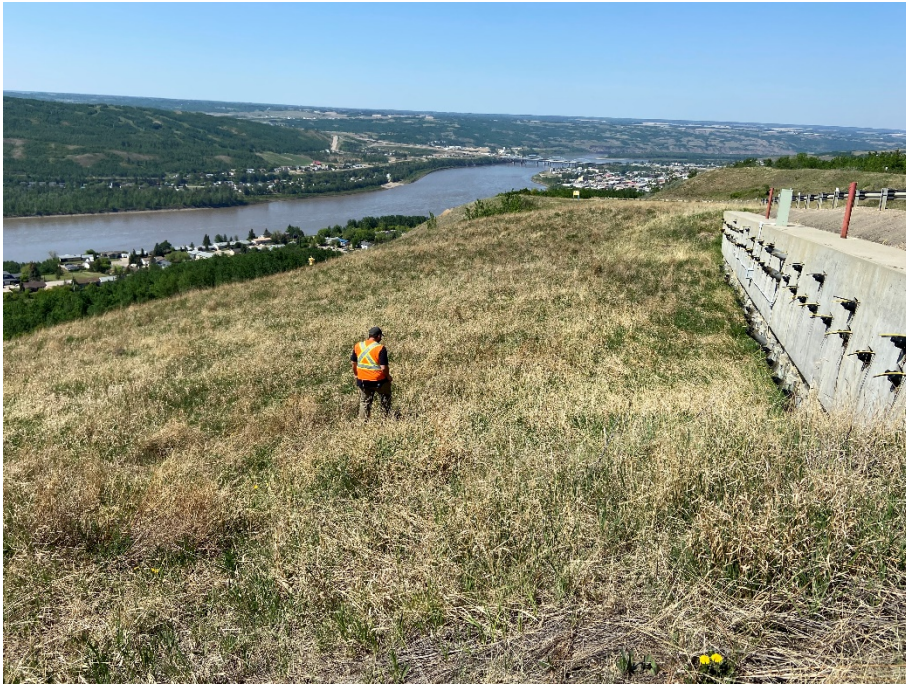
**Photo 9.**  
Looking north at the bench and graded area below the “Makeout” pile wall. Area appeared in good condition and had no observable changes from 2021.

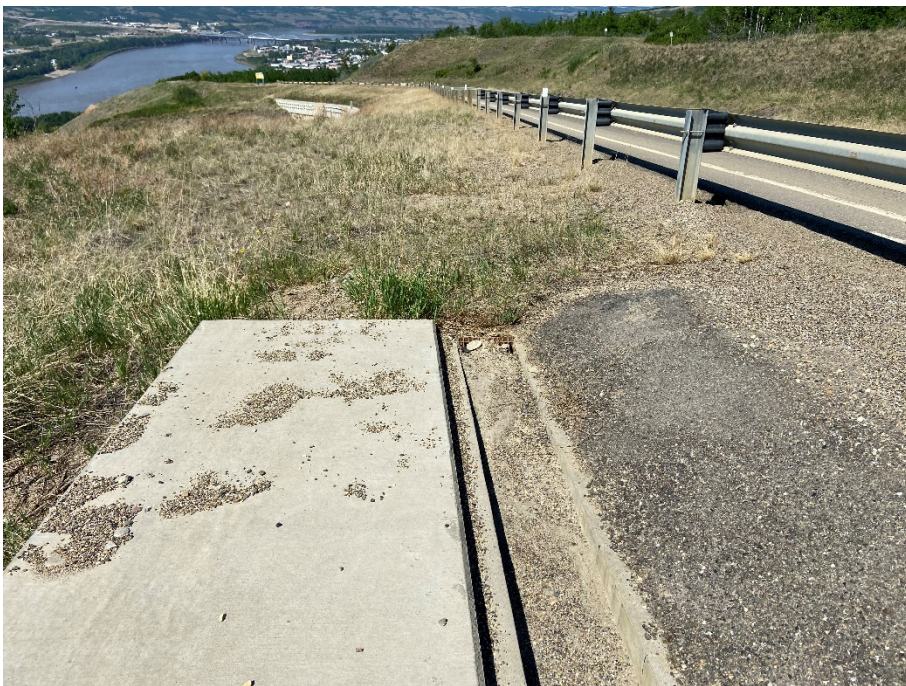
**Photo 10.**  
Looking at the north end of the top of the “Makeout” pile wall. Drainage trough inlet was relatively clear and functioning.
