**ALBERTA TRANSPORTATION AND  
ECONOMIC CORRIDORS  
GEOHAZARD ASSESSMENT PROGRAM  
PEACE REGION (PEACE RIVER DISTRICT)  
2024 INSPECTION**

Site Number	Location	Name	Hwy	km
PH033	Judah Hill	CNR Slide	744:04	59.451
Legal Description		UTM Co-ordinates (NAD 83)		
NE¼ 29-083-21 W5M		11V E 482645	N 6231308

Date	PF	CF	Total
<b>Previous Inspection:</b>	May 17, 2023	17	4	68 (Slide Risk Rating)
<b>Current Inspection:</b>	May 28, 2024	17	4	68 (Slide Risk Rating)
<b>Road WAADT:</b>	630	<b>Year:</b>		2023
<b>Inspected By:</b>	Don Proudfoot, Tyler Clay, Cole Szakacs (Thurber). Rocky Wang, Robert Senior (TEC)			
<b>Report Attachments:</b>	<input checked="" type="checkbox"/> Photographs <input checked="" type="checkbox"/> Plans <input type="checkbox"/> Maintenance

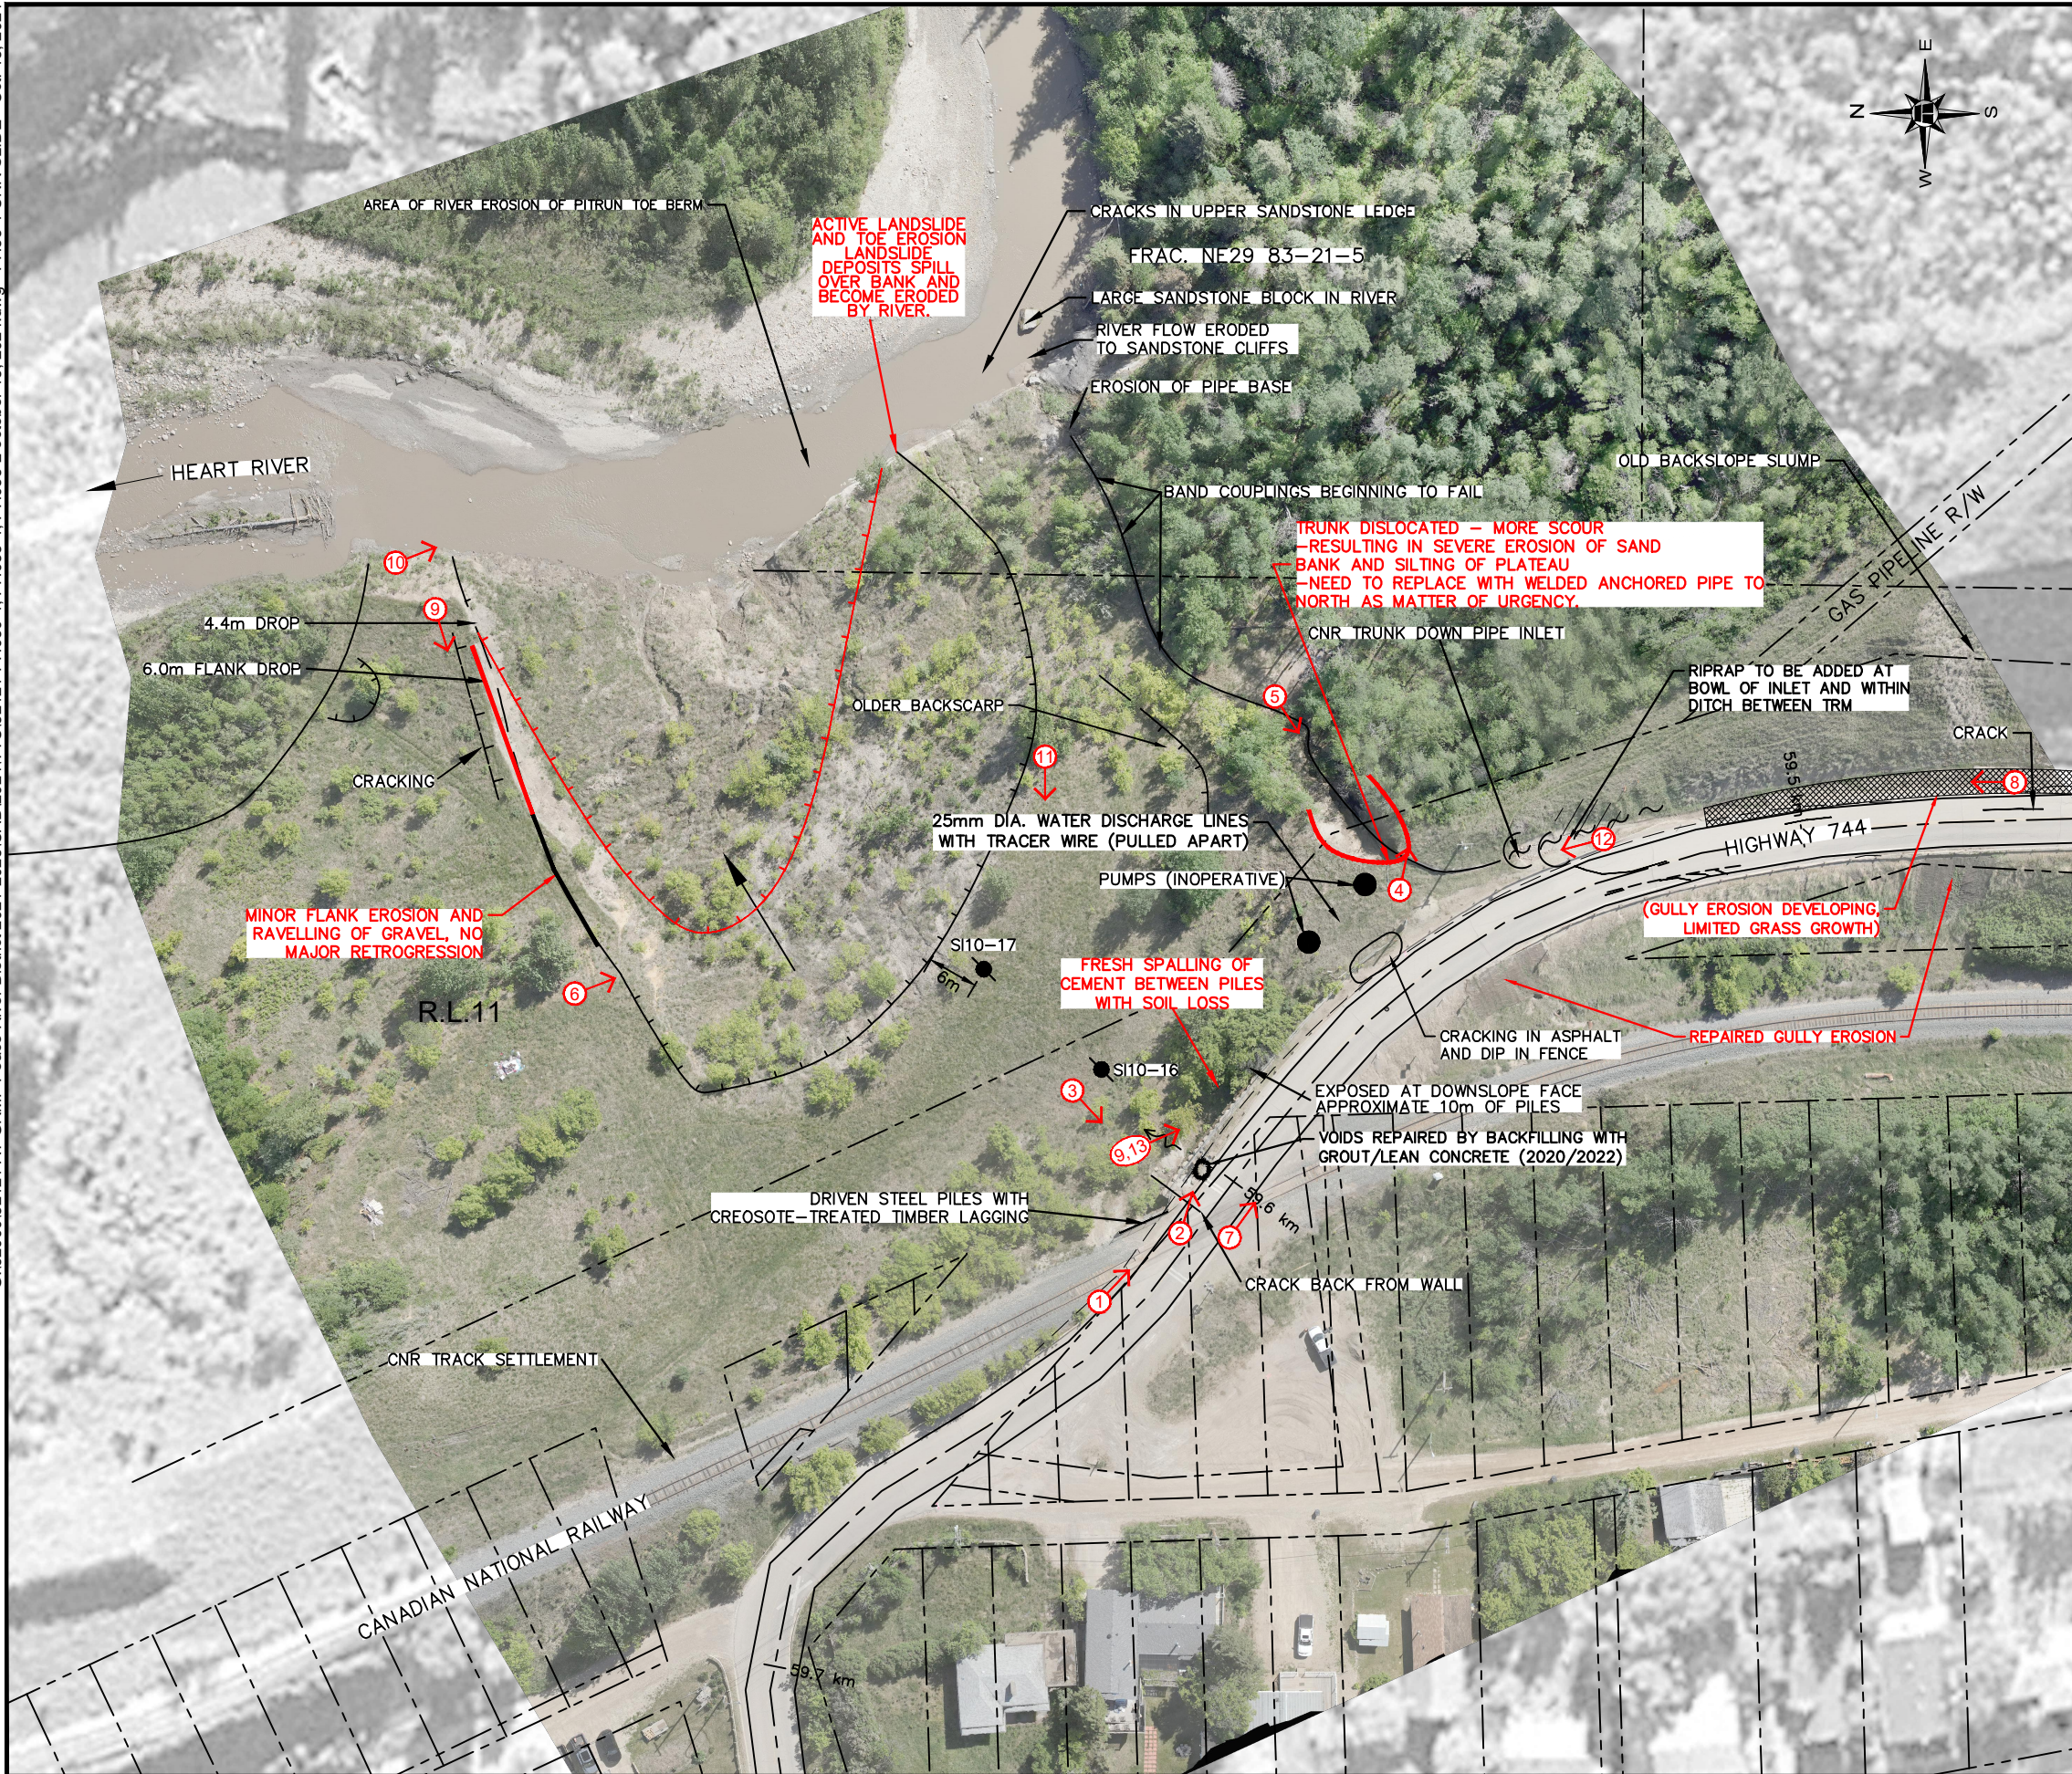
DWG No. 32121-PH033-1-1

PH033-1 JUDAH HILL - CNR SLIDE  
2024 SITE INSPECTION PLAN

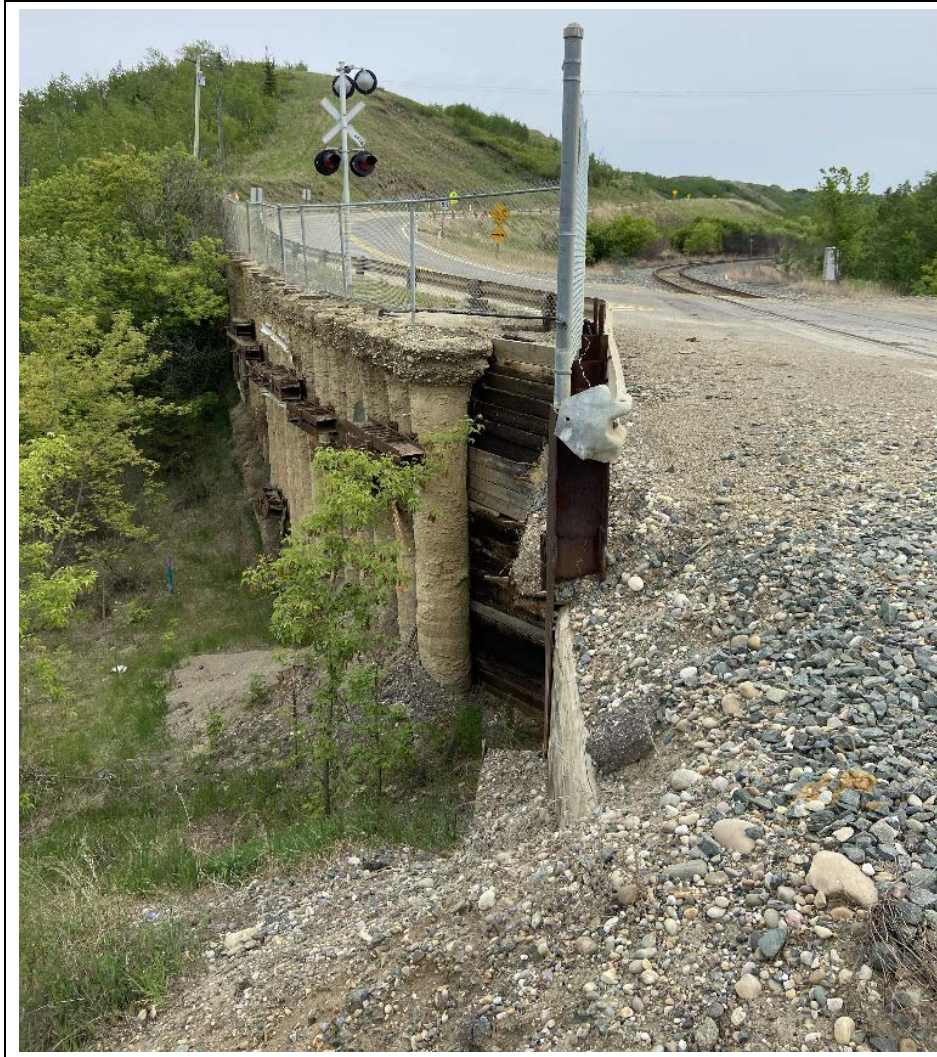
<input type="checkbox"/> Seepage		<input type="checkbox"/>	<input type="checkbox"/>
<input checked="" type="checkbox"/> Bridge/Culvert	<p>The pipe conduit has completely failed immediately below the crest of the upper valley slope. As a result, a scour gully with vertical headwall is actively expanding in the slope below the breakage and sediment is accumulating in the intermediate plateau below (Photos 4 and 5).</p>	<input checked="" type="checkbox"/>	<input type="checkbox"/>
<input checked="" type="checkbox"/> Other	<p>Increased concrete spalling and sloughing between the piles on the CNR retaining wall (noted in previous years). (Photos 1,3 and 13).</p>	<input checked="" type="checkbox"/>	<input type="checkbox"/>

**Photo 1.**  
Looking southeast from the north end of the CNR pile wall. Grout / lean concrete overflow from the 2022 repair of the void behind the wall is visible at the toe of the wall.

- Replace the wall parging with a more robust solution and fill the voids between piles. Install drainpipes through the new wall facing to avoid blocking seepage. Fill any voids behind the wall with grout or granular fill with non-woven geotextile filter. Options are currently being reviewed and will be presented in a future preliminary engineering report.
- Replace CPP drainpipe with a realigned anchored welded pipe. (\$300k - \$450k)

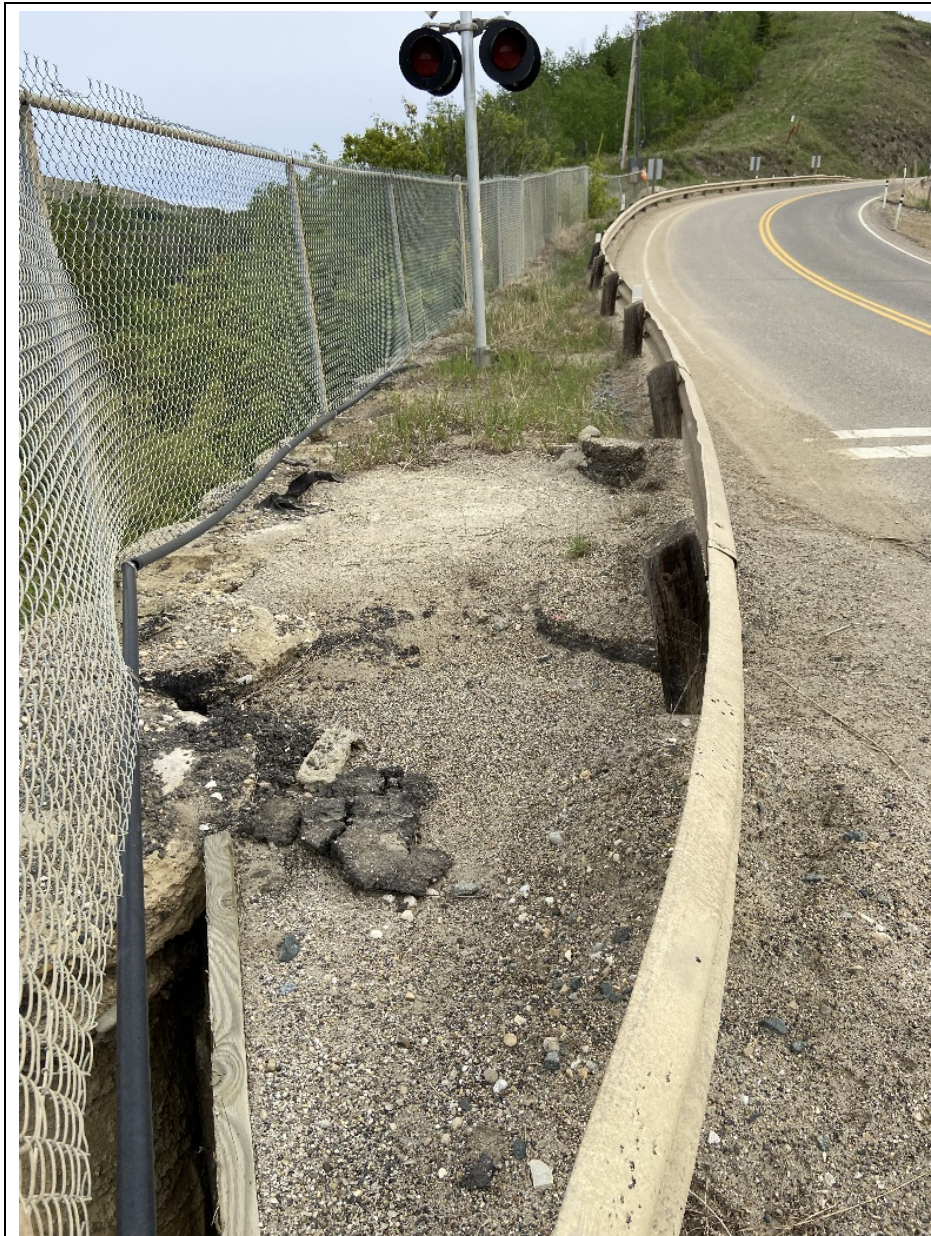
The repairs to the erosion voids (formed behind the pile wall in 2020 and 2022) appear to be performing as intended but there is still ongoing erosion and soil loss between the piles which will likely lead to future formation of voids that can reach the ground surface behind the wall with little to no visible indication. A structural (e.g., wire mesh facing) facing tied into the concrete and/or anchors on the downslope side of the piles to contain fill/grout and prevent future soil loss is recommended. Surface drainage should also be directed away from the area behind the pile wall to reduce erosion rates and future void formation.

**Photo 2.**  
View of the repaired area behind the pile wall where erosion voids formed in 2020 and 2022. The repair involved geotextile supported by wood cribbing and backfilled with grout/lean concrete. The voids were a result of soil loss between the piles, and over 5 m in depth prior to repair. The repairs appeared to be working as intended during the 2024 inspection and no visible signs of void formation were identified along the ground surface behind the wall.

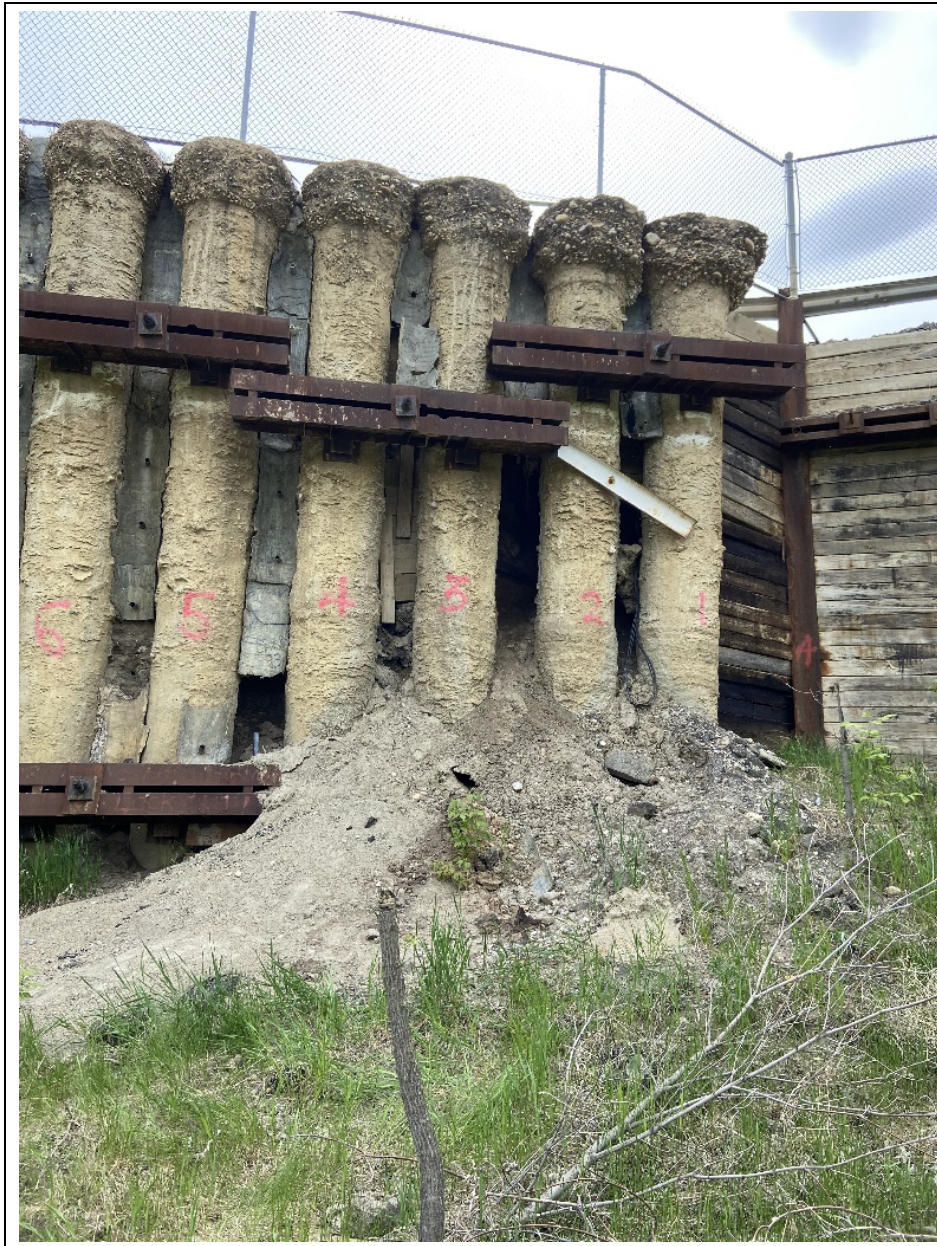
**Photo 3.**  
Looking south at the soil loss between the northernmost piles (1 to 5) of the CNR pile wall north of Hwy 744:04 at km 59.61. Increased buildup of soil spalling between the piles since 2023. Note wood cribbing set behind the piles to help contain the grout backfill for the void repair; however, some grout still did flow through and has set along the toe of the piles.

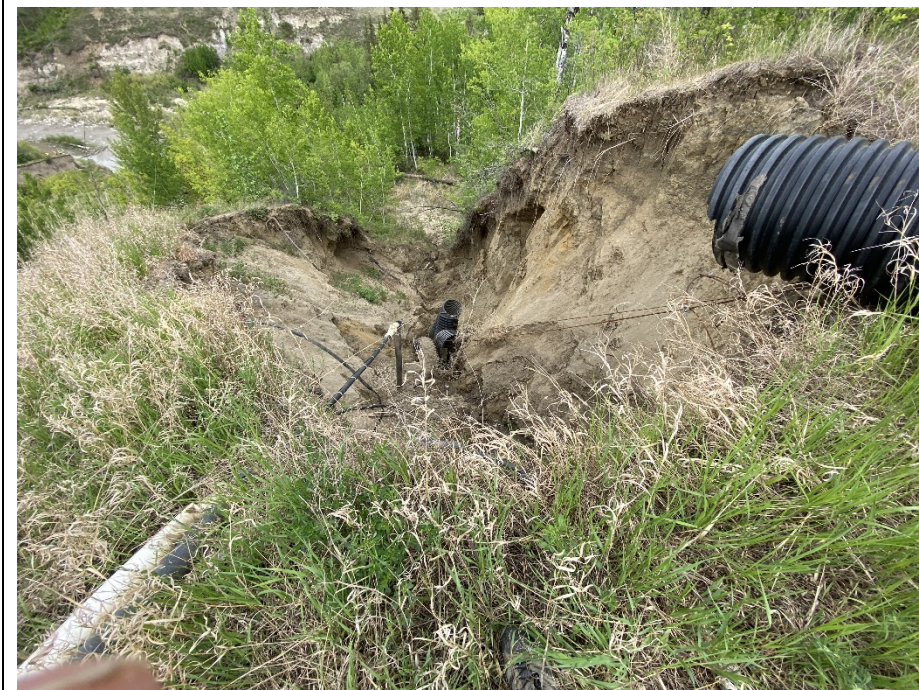
The CNR drainage trunk pipe is broken immediately below the crest of the valley slope and both water and sediment are pouring directly onto the slope below. A large and active scour gully with vertical drop has formed immediately beneath the break in the pipe. We recommended that this be addressed as a matter of urgency, preferably by replacing the existing segmented CPP with a welded anchored pipe along a flatter alternate alignment in addition to re-profiling and armoring the inlet.

**Photo 4.**  
Looking northeast at break in CNR CPP Trunk pipe and erosion gully at crest of the Heart River valley slope. More pipe segments have fallen into the gully since the 2023 inspection.

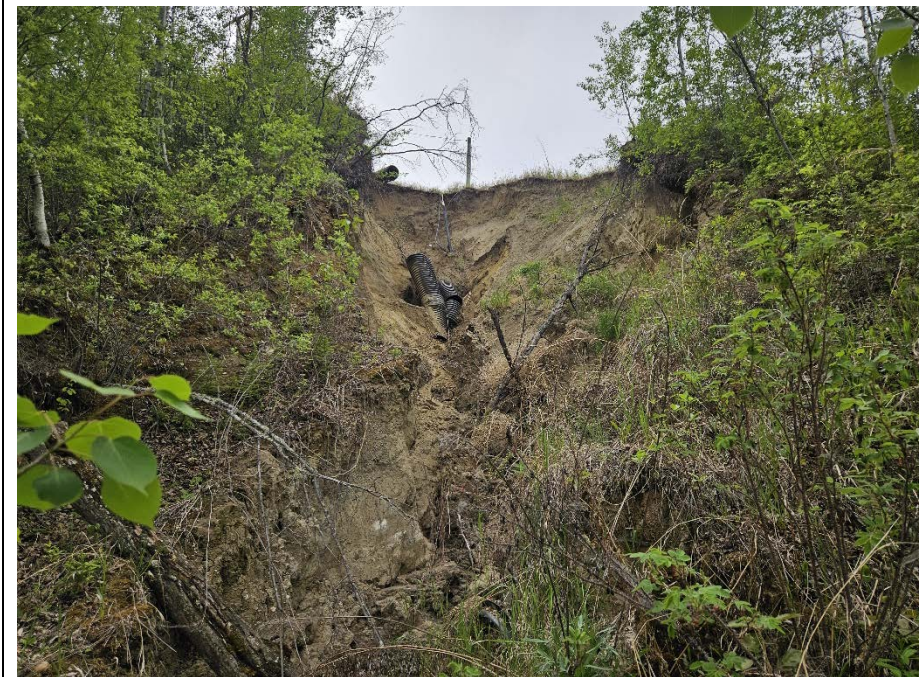
**Photo 5.**  
Looking southwest from below the scour gully headwall caused by the breakage in the CNR CPP Trunk pipe. There has been some retrogression and lateral expansion at the gully headwall since 2023.

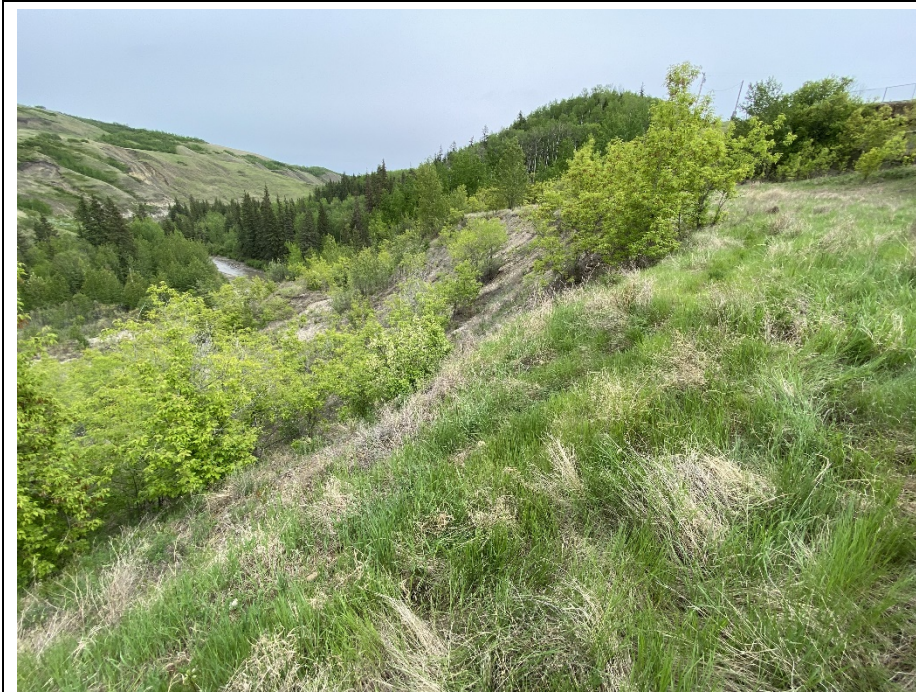
**Photo 6.**  
Looking southeast from the north side of the lower slide main scarp. No major changes observed in the slope area directly below the pile wall since 2023.

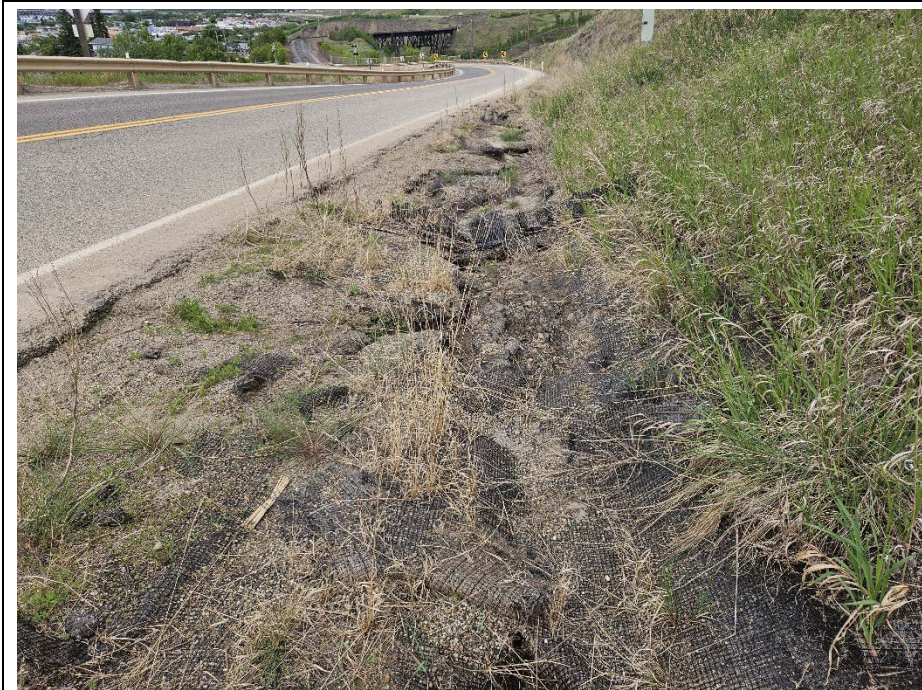
**Photo 8.**  
Looking north towards the east ditch with previous erosion damage that was repaired in 2022 (regraded, with TRM and ditch barriers). Vegetation was not well established and there was a minor erosion channel starting to develop within the ditch bottom and some barriers were partially undermined.

- Consider a curb and gutter along the edge of asphalt, or a depressed swale, to channel water away from edge of pavement and to divert runoff away from the back of the piles.
- Fill any new rills around the guardrail posts with gravel covered with seeded topsoil.
- Regrade ditch where the check dams are undermined, line ditch bottom with granular fill and replace the TRM, replace / re-install check dams. Clean out drain inlet area and use material to fill

in ditch where required. Alternatively, extend planned rock riprap from inlet area to 100 m to the south.

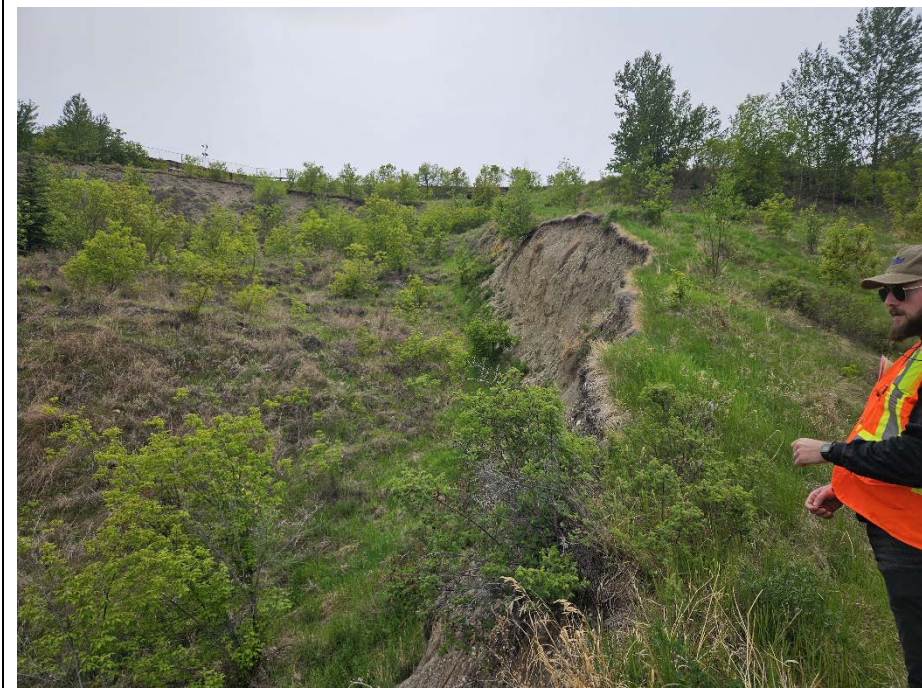
**Photo 9.**  
Looking west at the slide lower slide mass. There was some increased erosion along the slide flank relative to the 2023 condition but no major expansion.

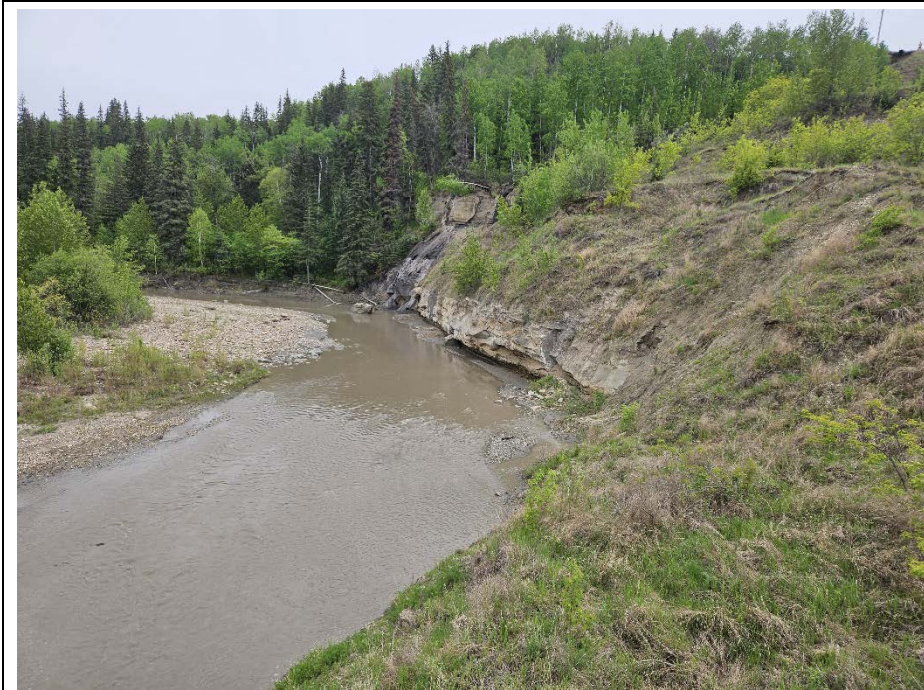
<b>Observations:</b>	<b>Description:</b>	<b>Worsened?</b>	
		<b>Yes</b>	<b>No</b>
<input type="checkbox"/> Pavement	text	<input type="checkbox"/>	<input type="checkbox"/>
<input checked="" type="checkbox"/> Slope Movement	No obvious retrogression of upper main backscarp since 2008. Backscarp has vegetation growth. No obvious slope movement directly downslope from the wall, upslope of S10-17. (Photos 6, 9 and 11) Continued erosion along the northwest near-vertical flank and river erosion of the lower landslide toe but no major expansion from the 2023 condition. (Photo 10)	<input type="checkbox"/>	<input checked="" type="checkbox"/>

**Photo 10.**  
Looking south towards the base of the lower slide and bedrock exposure at the river. Some minor lower slide activity and active erosion of slide materials entering over the bank. No major change from the 2023 condition.

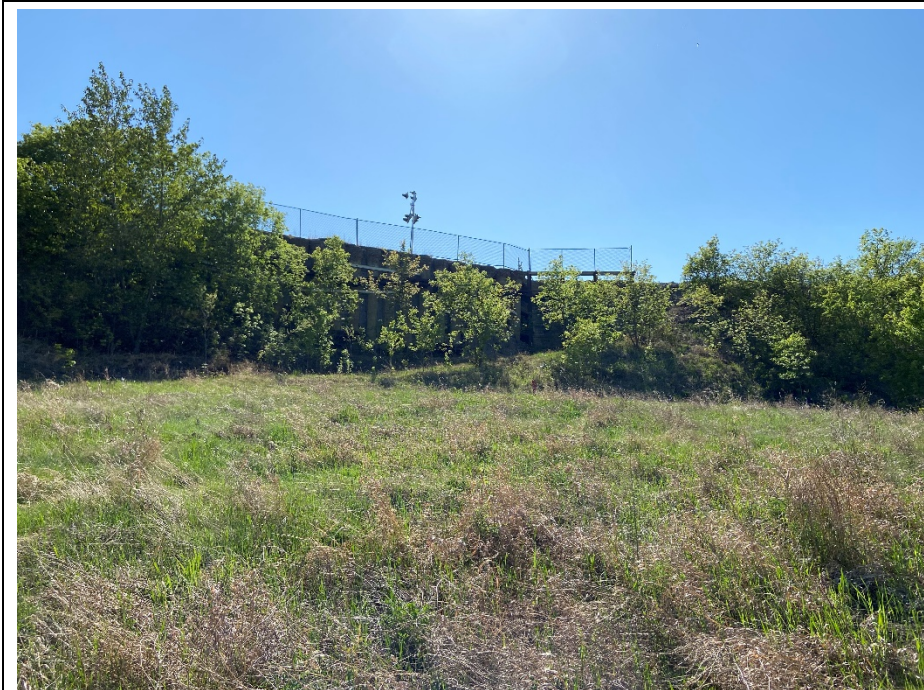
**Photo 11.**  
View towards the lower slope area downslope from the base of the pile wall and immediately upslope of the main slide scarp monitored by S110-17. No visible indications of landslide movement were observed in this area and conditions were similar to 2023 inspection.

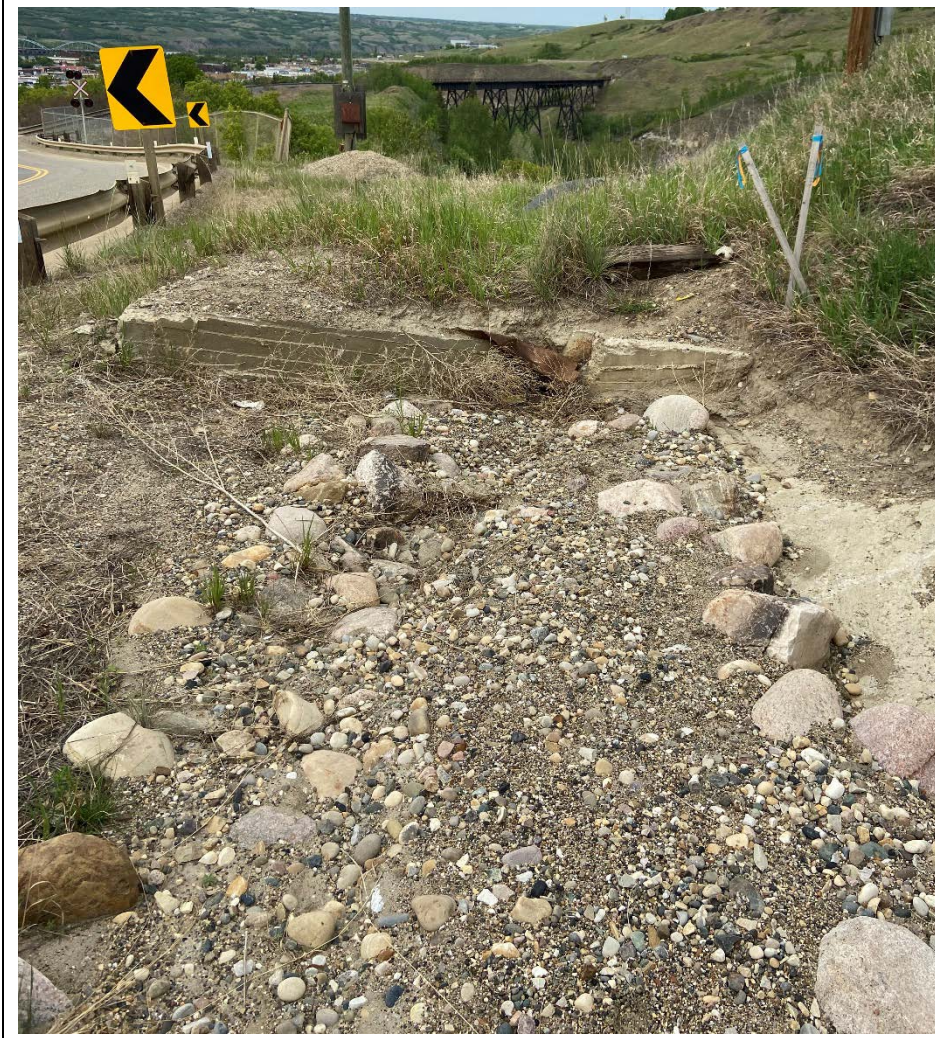
<input checked="" type="checkbox"/> Erosion	<p>Previous sideslope erosion rills and gulying near km 59.55 and km 59.48 have been repaired and no new erosion damage was observed. There was increased grass growth since 2023. (Photo 7)</p> <p>Active erosion is occurring below the severed section of the CNR Trunk downslope drainpipe and vertical headwall has been formed. There has been retrogression and lateral expansion since 2023 (Photos 4 and 5).</p> <p>Repaired erosion voids (first observed in 2020 and 2022) were in good condition as viewed from the top of the pile wall and there were no visible signs of new void formation at the ground surface behind the wall. (Photos 1 and 2)</p> <p>East ditch (south from km 59.51) erosion was repaired in 2022 by regrading and installing TRM and ditch barriers. A minor erosion channel (first noted in 2023) has developed within the ditch bottom and the ditch barriers were partially undermined at some locations with increased depth relative to the 2023 condition. (Photo 8)</p> <p>A section between the ditch repair and drainpipe inlet is yet to be repaired (grading and riprap placement) due to ground disturbance agreements over the ACTO gas line. Drainpipe inlet had minor sand and gravel buildup (likely from upslope ditch erosion) but was not blocked and had no major change from the 2023 condition. (Photo 12)</p>	<input checked="" type="checkbox"/>	<input type="checkbox"/>

**Photo 12.**  
Buildup of eroded ditch sediment (sand and gravel) at the down pipe trunk inlet.

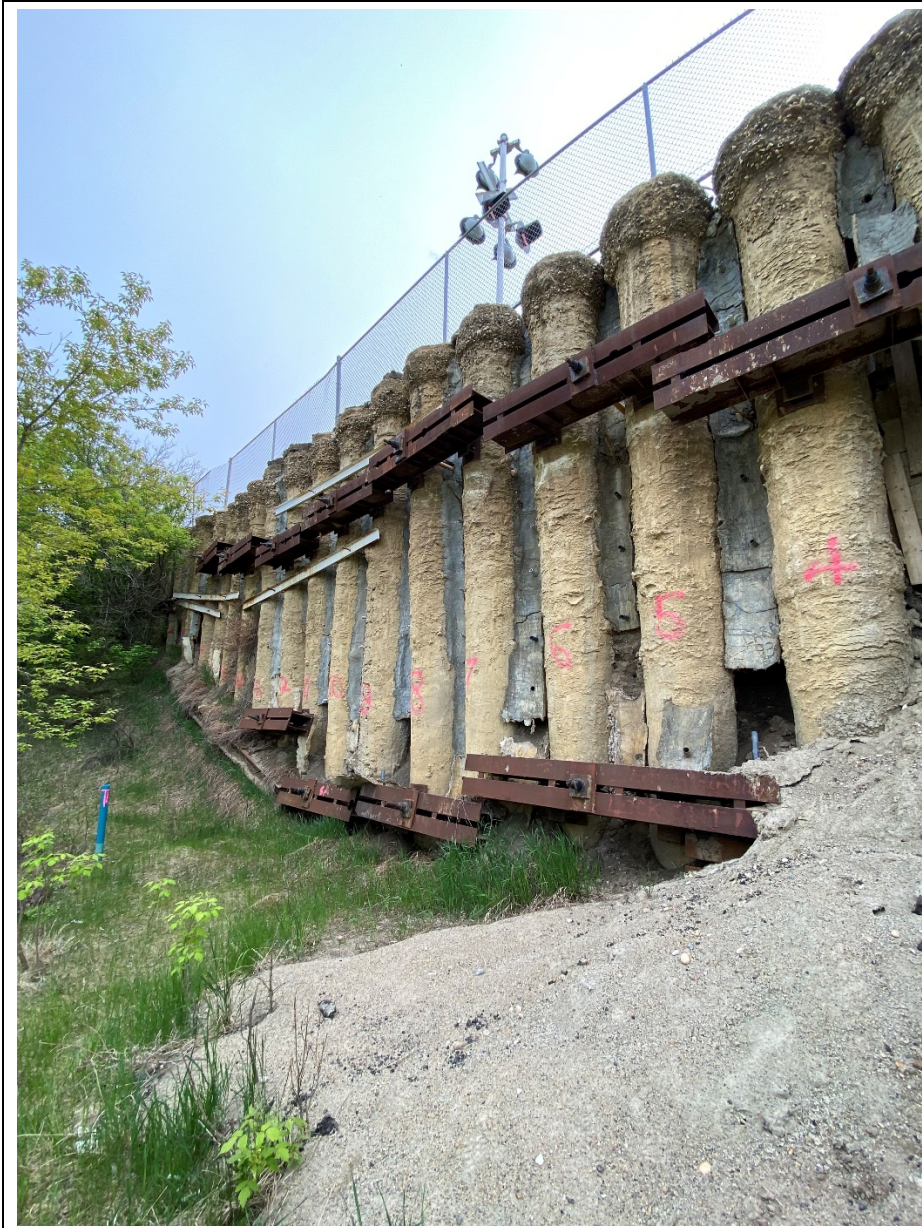
**Photo 13.**  
Looking towards the southeast at the base of the pile wall with spalling concrete between the piles.
