**ALBERTA TRANSPORTATION
GEOHAZARD ASSESSMENT PROGRAM
PEACE REGION – PEACE-HIGH LEVEL
2019 INSPECTION**

Site Number	Location	Name	Hwy	km
PH012	Judah Hill	Heart River Slides	744:04	57.114
Legal Description		UTM Co-ordinates		
SE¼ 20-083-21 W5M		11V E 483284		N 6229209

Date	PF	CF	Total
Previous Inspection:	5-June-2019	13	4	52
Current Inspection:	6-August-2019	13	5	65
Road AADT:	660		Year:	2018
Inspected By:	Ed Szmata, TRANS		Don Proudfoot, Thurber	
Report Attachments:	<input checked="" type="checkbox"/> Photographs			
	<input type="checkbox"/> Plans		<input checked="" type="checkbox"/> Maintenance Items

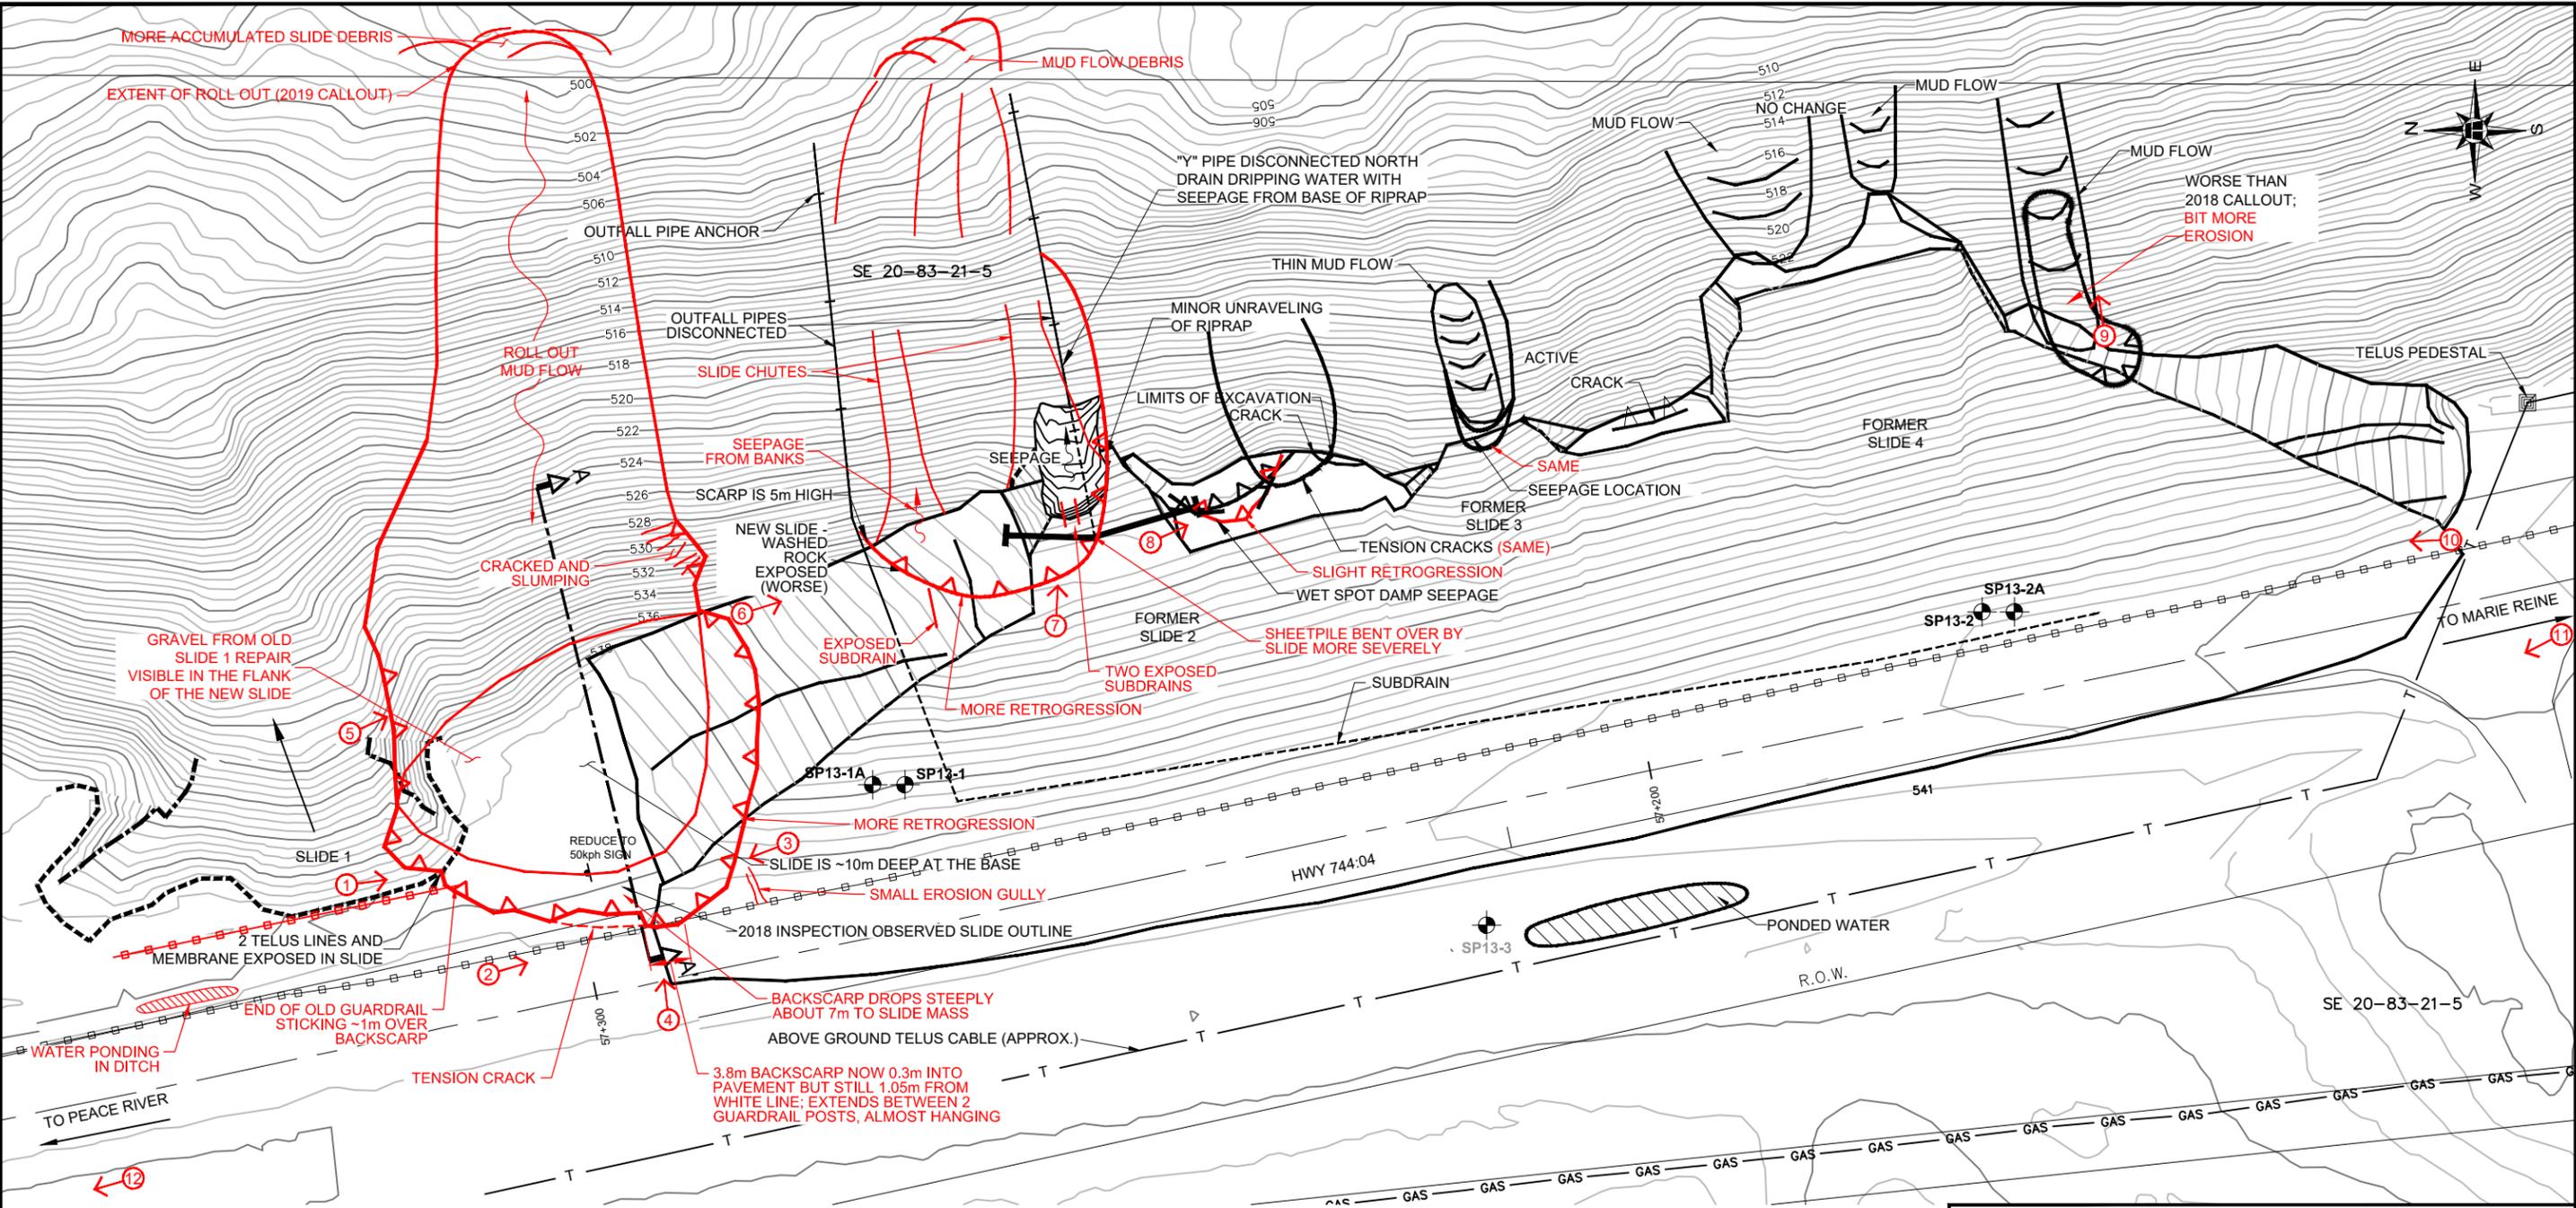
AUGUST 6, 2019 PH012-1 CALLOUT PLAN

Dimensions:	See attached Figures		
Maintenance:	None since 2012.		
Observations:	Description	Worsened?	
<input checked="" type="checkbox"/> Pavement Distress	The backscarp of the new landslide at km 57+300 has retrogressed 0.3 m into the edge of the pavement	<input checked="" type="checkbox"/>

<input checked="" type="checkbox"/> Slope Movement	<p>The new landslide (located at km 57+300) that had formed south of Slide 1 in 2017 and coalesced with Slide 1 has grown and has active retrogression of the main scarp (Photos 1 to 5). The minimum offset from the guardrail has changed from 1.1 m east of the guardrail to 0.3 m west of the guardrail since June 5, 2019.</p> <p>Slide and earth flow movements have occurred around the sheet pile wall and the structure has become deflected and outflanked (Photo 6).</p>	<input checked="" type="checkbox"/>
<input checked="" type="checkbox"/> Erosion	<p>Scouring was observed at the base of former Slide 2, which was repaired in 2015. Scouring is occurring below the disconnected "Y" connector pipe below the sheet pile wall. An active scour channel is getting progressively deeper and retrogressing towards the road at the south end of the site (Photo 9).</p> <p>Additional thin mud flows and seepage have occurred at several locations below the base of the previous repairs at former Slides 3 and 4 (Photo 8).</p>	<input checked="" type="checkbox"/>

Recommendations:	Cost
<p><u>Immediate:</u> Warning signs (“Landslide zone” and “Sharp drop off”) and barricades should be erected to warn and protect the public of the landslide hazard. The landslide has the potential to retrogress quickly and hence routine inspections of the site should be conducted by the MCI and Maintenance Contractor to determine if a further movement has occurred that would warrant a partial road closure. TRANS should anticipate that a gravel detour might be required around the slide area soon until a more permanent solution can be completed.</p>	\$50,000
<p><u>Short Term:</u> The slide that has formed between Slide 1 and the 2014-2015 repairs needs to be addressed soon due to the recent rapid retrogression towards/into the highway. Short term repairs to try to slow the retrogression of the slide consist of removing the slide debris by pushing it over the bank, installing a subdrain and buttressing the backscarp of the slide with a wedge of gravel. Since the slide scarp has already extended past the guardrail a short re-alignment or road widening toward the west will also be required to maintain the same road width at this location</p>	\$300,000

<p><u>Longer Term:</u> A longer-term repair would consist of realigning the highway much further away from the new slide area to allow some slope flattening to occur. The re-alignment could start about 120 m south of former Slide 4 and tie back into the existing highway near the lookout recreation area parking lot. The total length of the re-alignment would be in the order of 500 m. This would require acquiring some land from the current landowner located to the west of the highway. The highway would need to be moved far enough from the landslides to allow some offloading and flattening of the side slope in the area of the new slide and at the failed sheet pile wall. Once these areas have been offloaded to create a bench between the flattened slope and the natural steep valley slope, the bench should be covered with a membrane and soil nails to reinforce it against future retrogression. Some repairs to the subdrains and downpipes would also be required. The sloughs in the field would be filled in with some of the excess grading material to improve surface drainage.</p>	\$1.5 million plus land acquisition costs

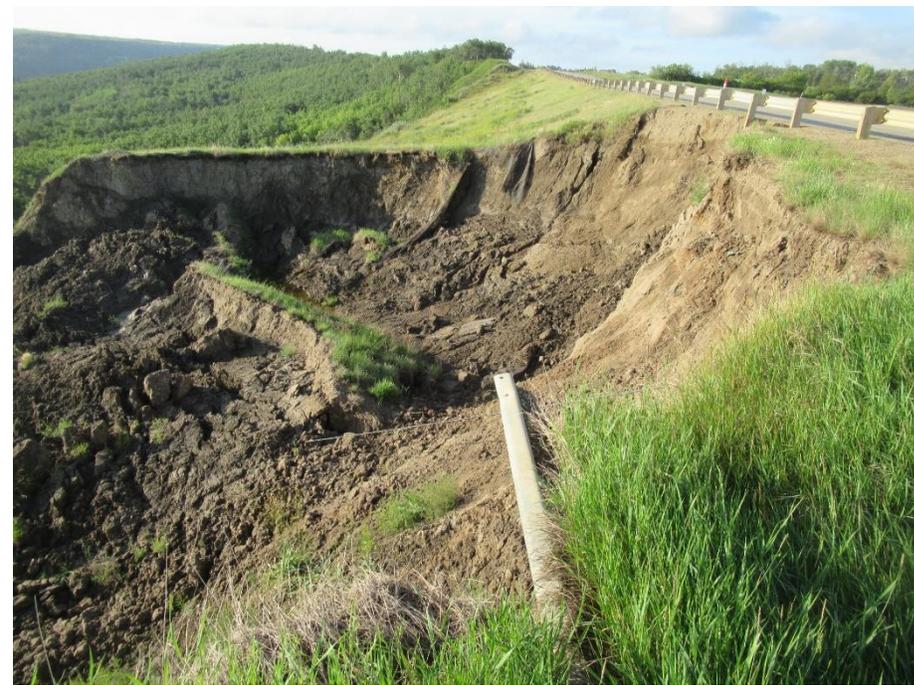
Photo 1. (Aug. 6/19)
Looking south
towards the top of the
'new' slide bowl
(57+300).

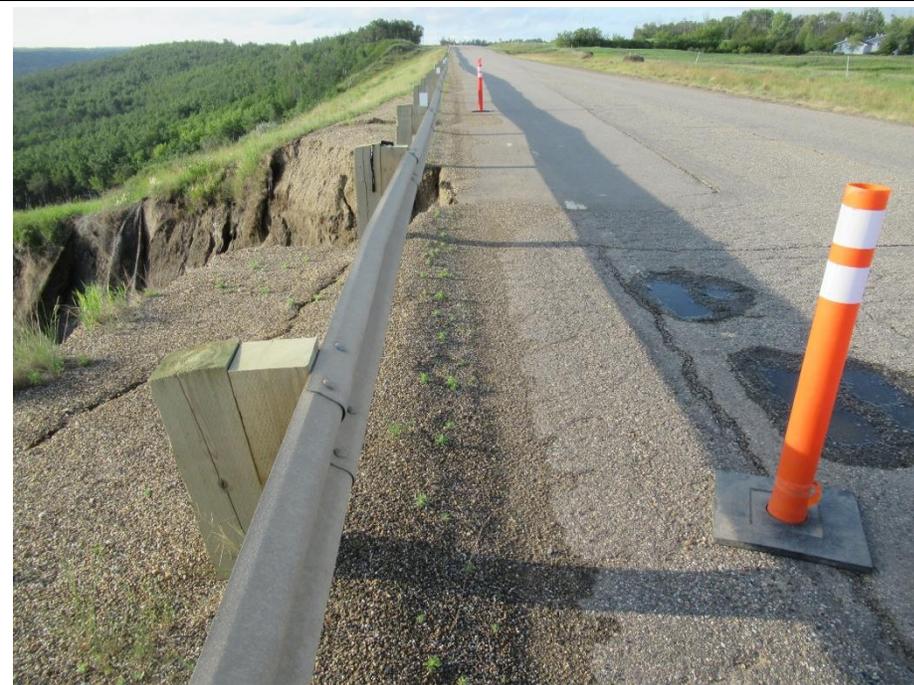
Photo 2. (Aug. 6/19)
Looking south
towards the new slide
which has grown and
retrogressed into the
edge of the
pavement.

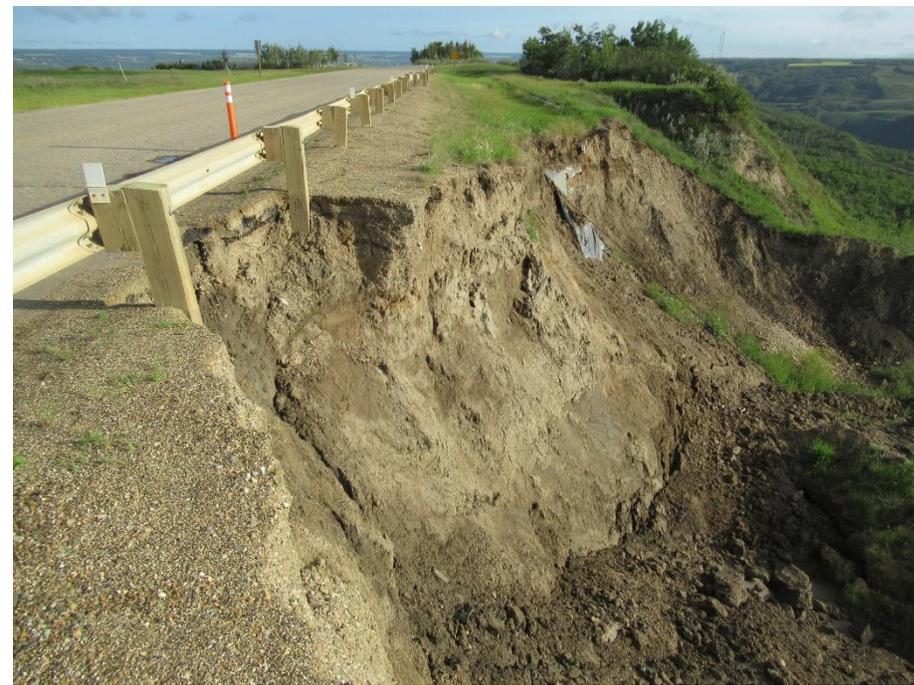
Photo 3. (Aug. 6/19)
Looking south at the
'new' slide area.

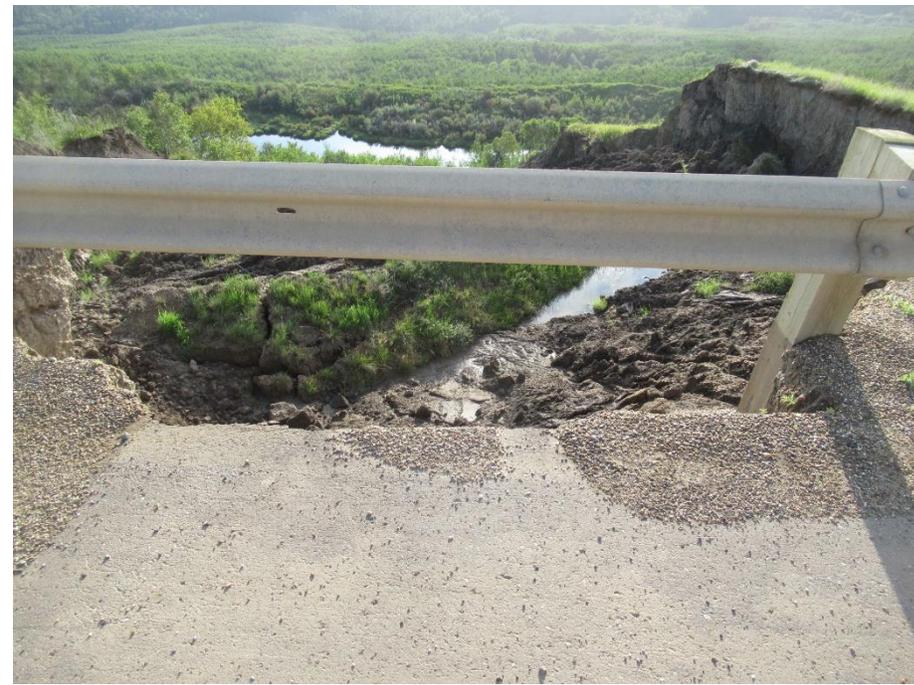
Photo 4. (Aug. 6/19)
Looking east down
the centre of the new
landslide toward the
Heart River valley.

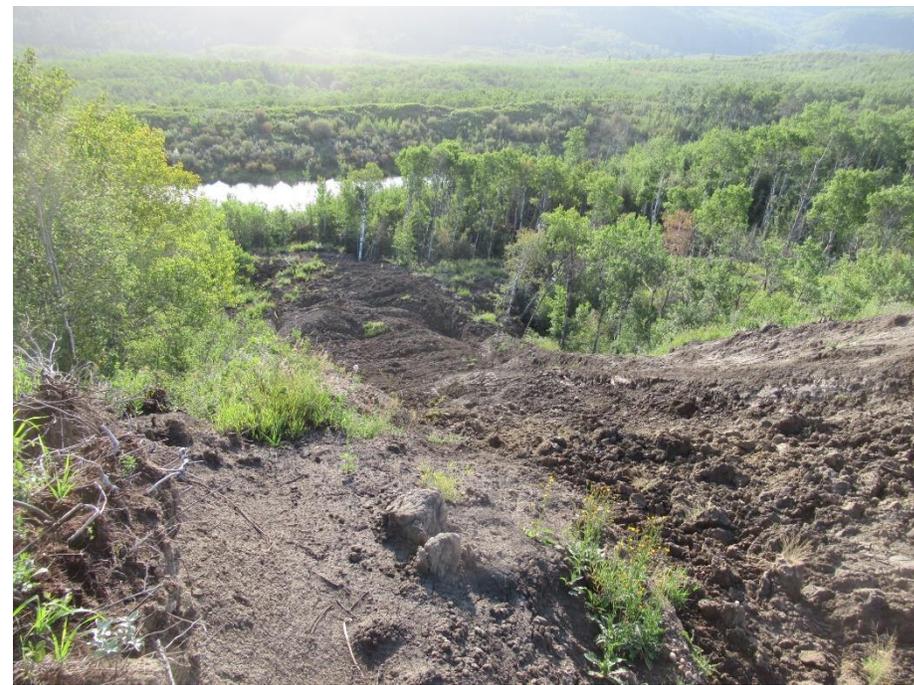
Photo 5. (Aug. 6/19)
Looking southeast at the mudflow and soil debris from the new slide sliding down into the Heart River valley.

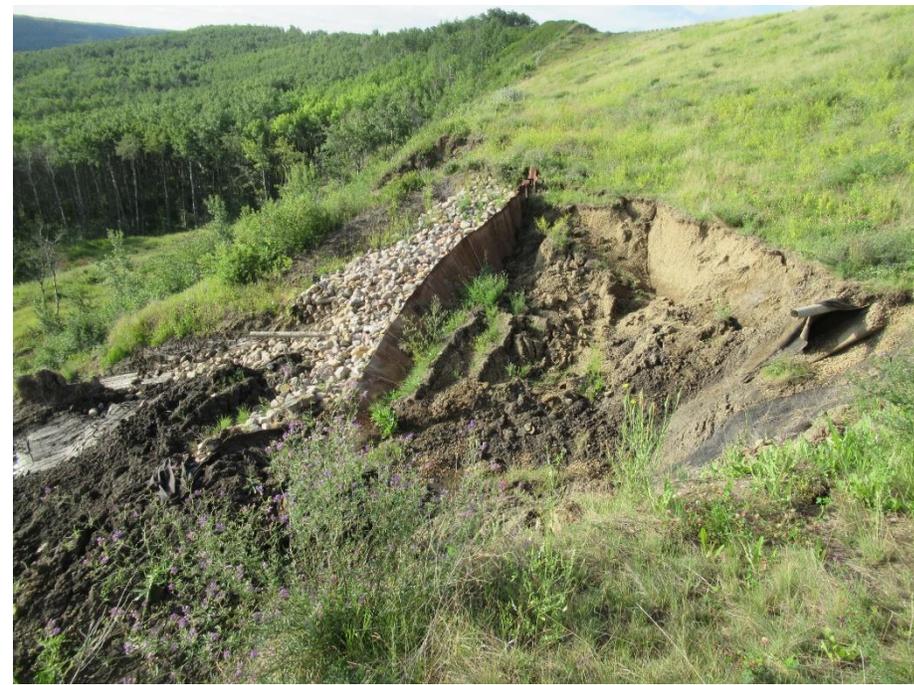
The sheet pile wall has been compromised from slope movements and is deflected and ineffective. Ongoing slide movement and loss of material upslope from the wall due to earth flows are expected in the following years. Loss of material here could begin to undermine the upslope repairs above former slide 2.

Photo 6. (Aug. 6/19)
Looking south from north end of Heart River Landslide repair excavation (Former Slide 2). Slide movement has deflected and outflanked the sheet pile wall

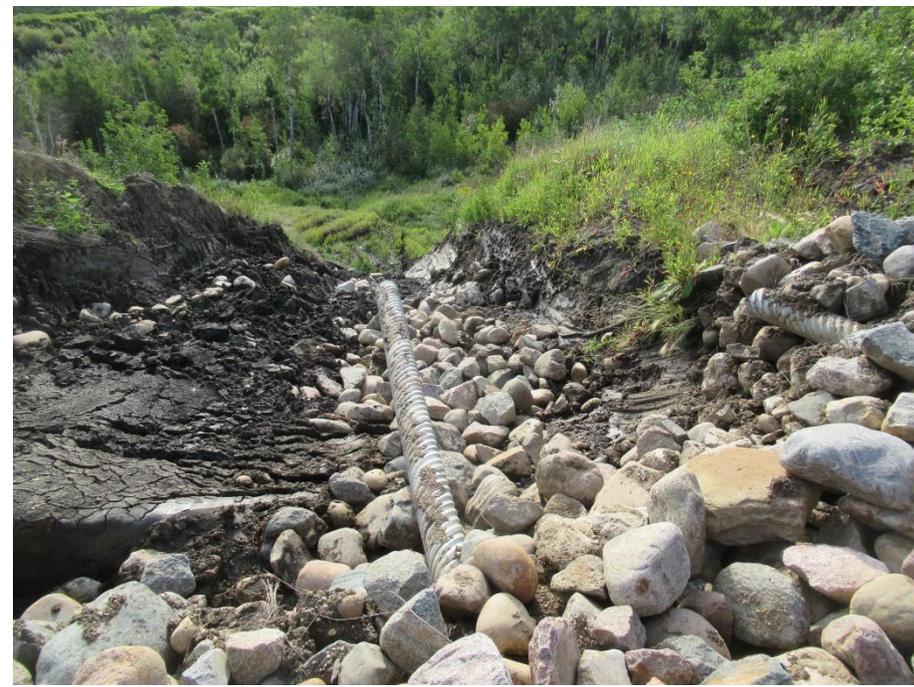
Photo 7. (Aug. 6/19)
Looking east at the mudflow below the severed drainpipe at the sheet pile wall below former slide 2.

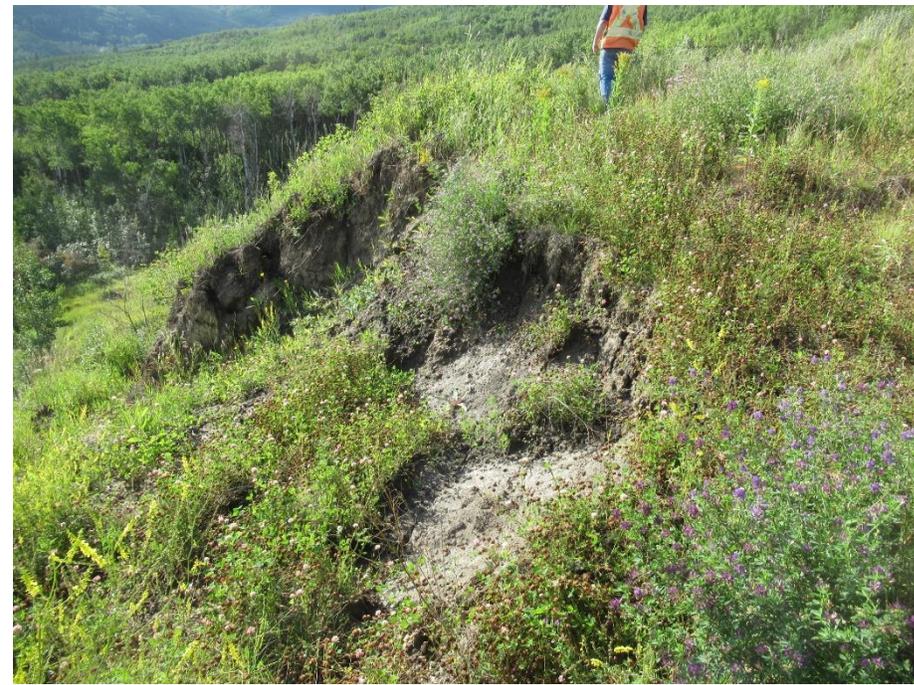
Photo 8. (Aug. 6/19)
Looking southeast at some recent shallow movement in the native slope south of the sheet pile wall, below former slide 2.

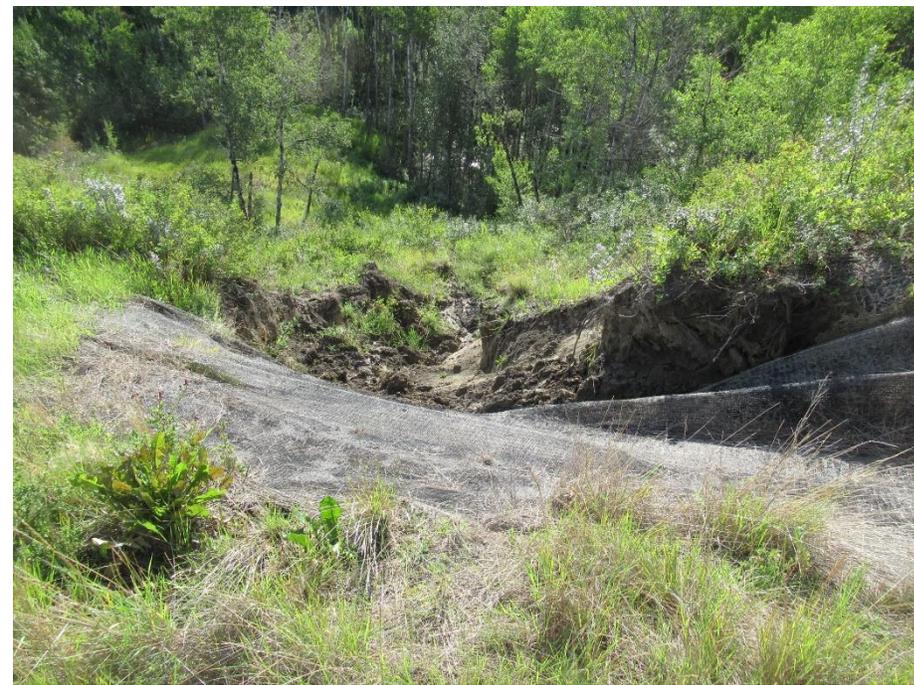
Scours in seepage zones in the till underlying the 2014-2015 repair from Contract CON0015153 continue to develop resulting in thin mud flows on the colluvium slope below the locations of the former slides 2, 3 and 4.

Photo 9. (Aug. 6/19)
Looking east at the erosion gully along the south end of former Slide 4.

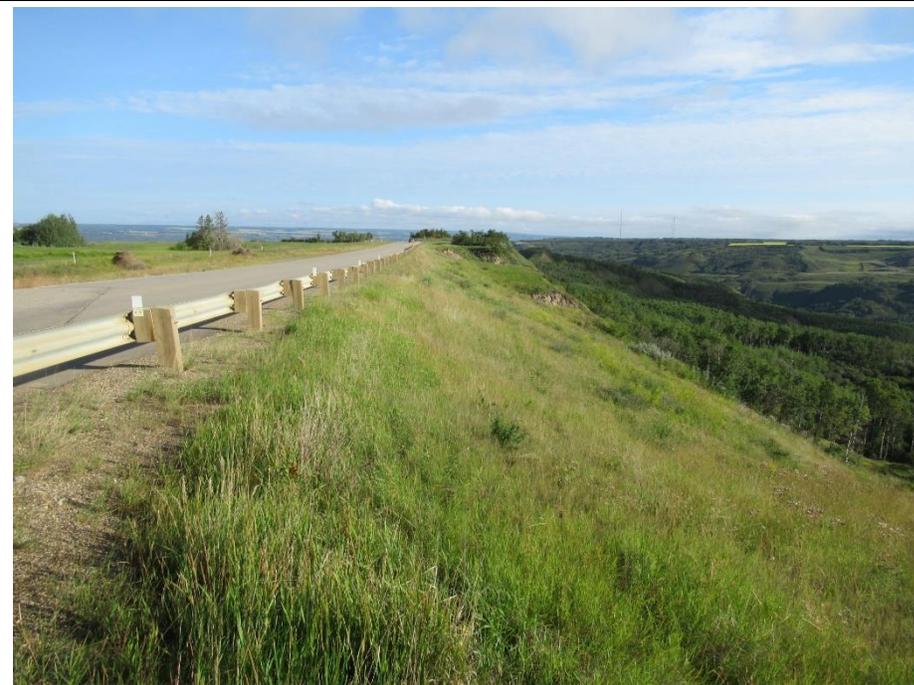
Photo 10.(Aug. 6/19)
Looking north from south of the location of former Slide 4. Overall repairs from 2014 are performing well. Overall slope is well vegetated and there are no apparent slumps in the granular backfill slope.

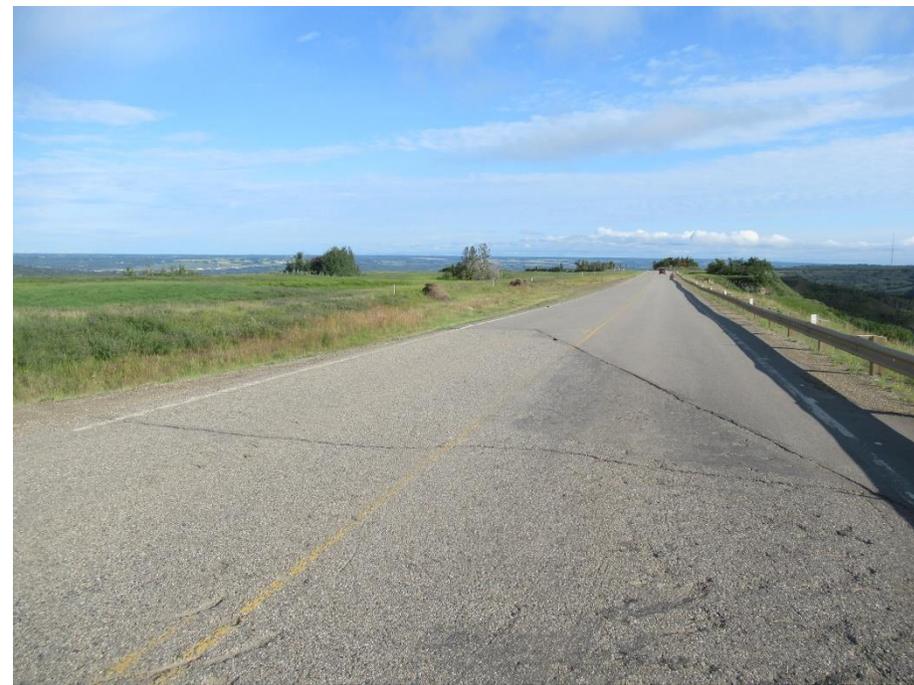
Photo 11.(Aug. 6/19)
Looking northwest at the field where the proposed re-alignment will be located.

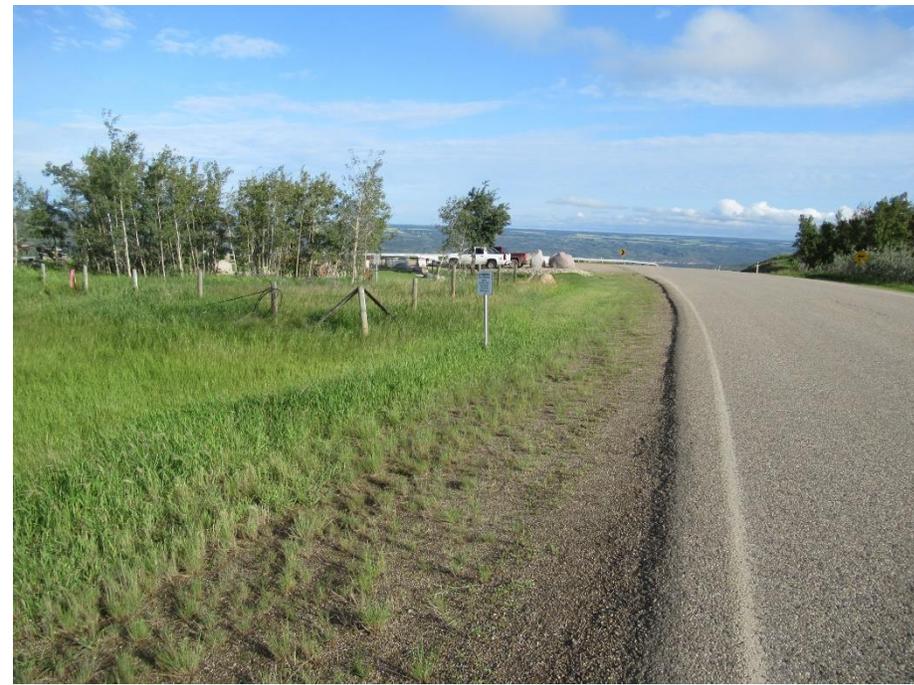
Photo 12.(Aug. 6/19)
Looking toward the parking lot where the re-alignment will rejoin the existing alignment. Note the gas line marker sign in the forefront. A Telus cable is looped on the fence post.

<p>A former gas line and a telus line run through the area and will need to be considered during the design of the re-alignment.</p>

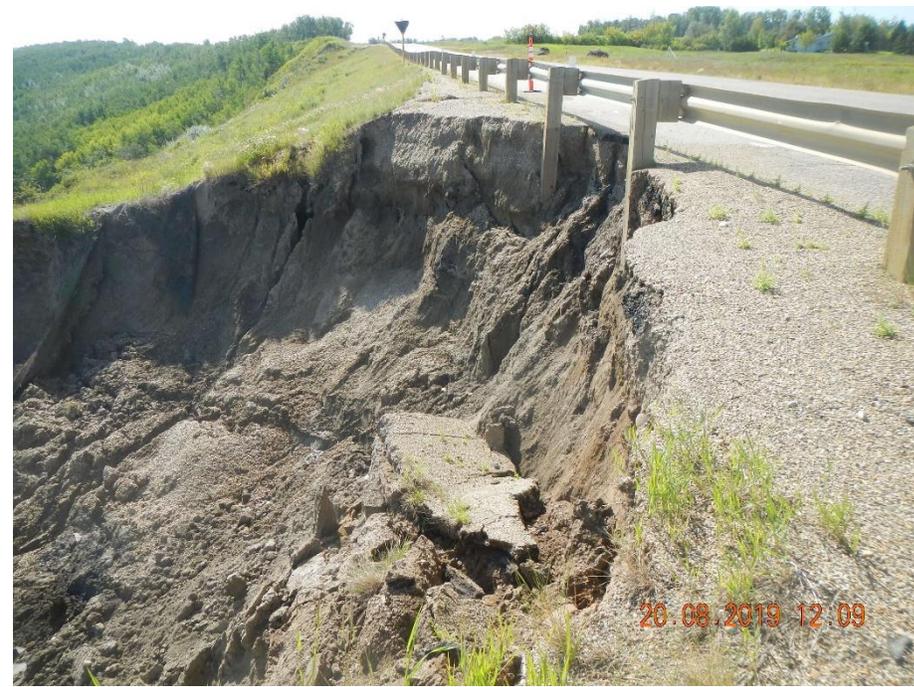
Photo 13 (Aug20/19)

Taken by Erwin Kurz of TRANS, this photo shows that another piece of the backscarp (along the tension crack shown in Photo 2) has retrogressed and fallen into the landslide since our August 6, 2019 visit

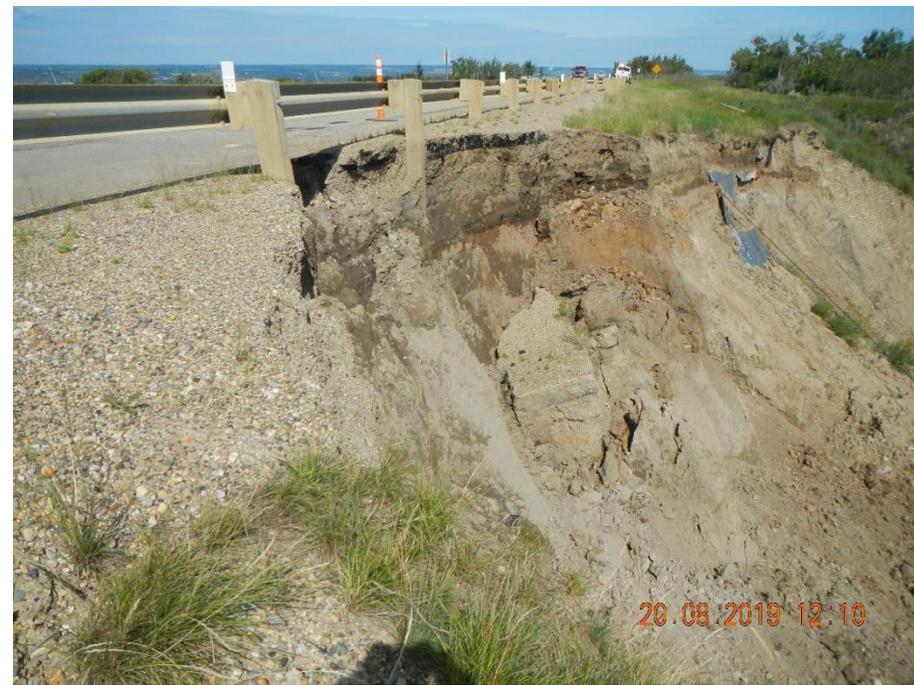
Photo 14 (Aug20/19)

Taken by Erwin Kurz of TRANS, this photo shows indications of additional backscarp retrogression toward the highway (compare to Phot 3)
