**ALBERTA TRANSPORTATION
GEOHAZARD ASSESSMENT PROGRAM
PEACE REGION (PEACE RIVER DISTRICT)
2023 INSPECTION**

Site Number	Location	Name	Hwy	km
PH072	Judah Hill	Sunshine Landslide	744:04	58.154
Legal Description		UTM Co-ordinates		
NE¼ 20-083-21 W5M		11U E 483150	N 6230060

PH072-1 SUNSHINE SLIDE
2023 SITE INSPECTION PLAN

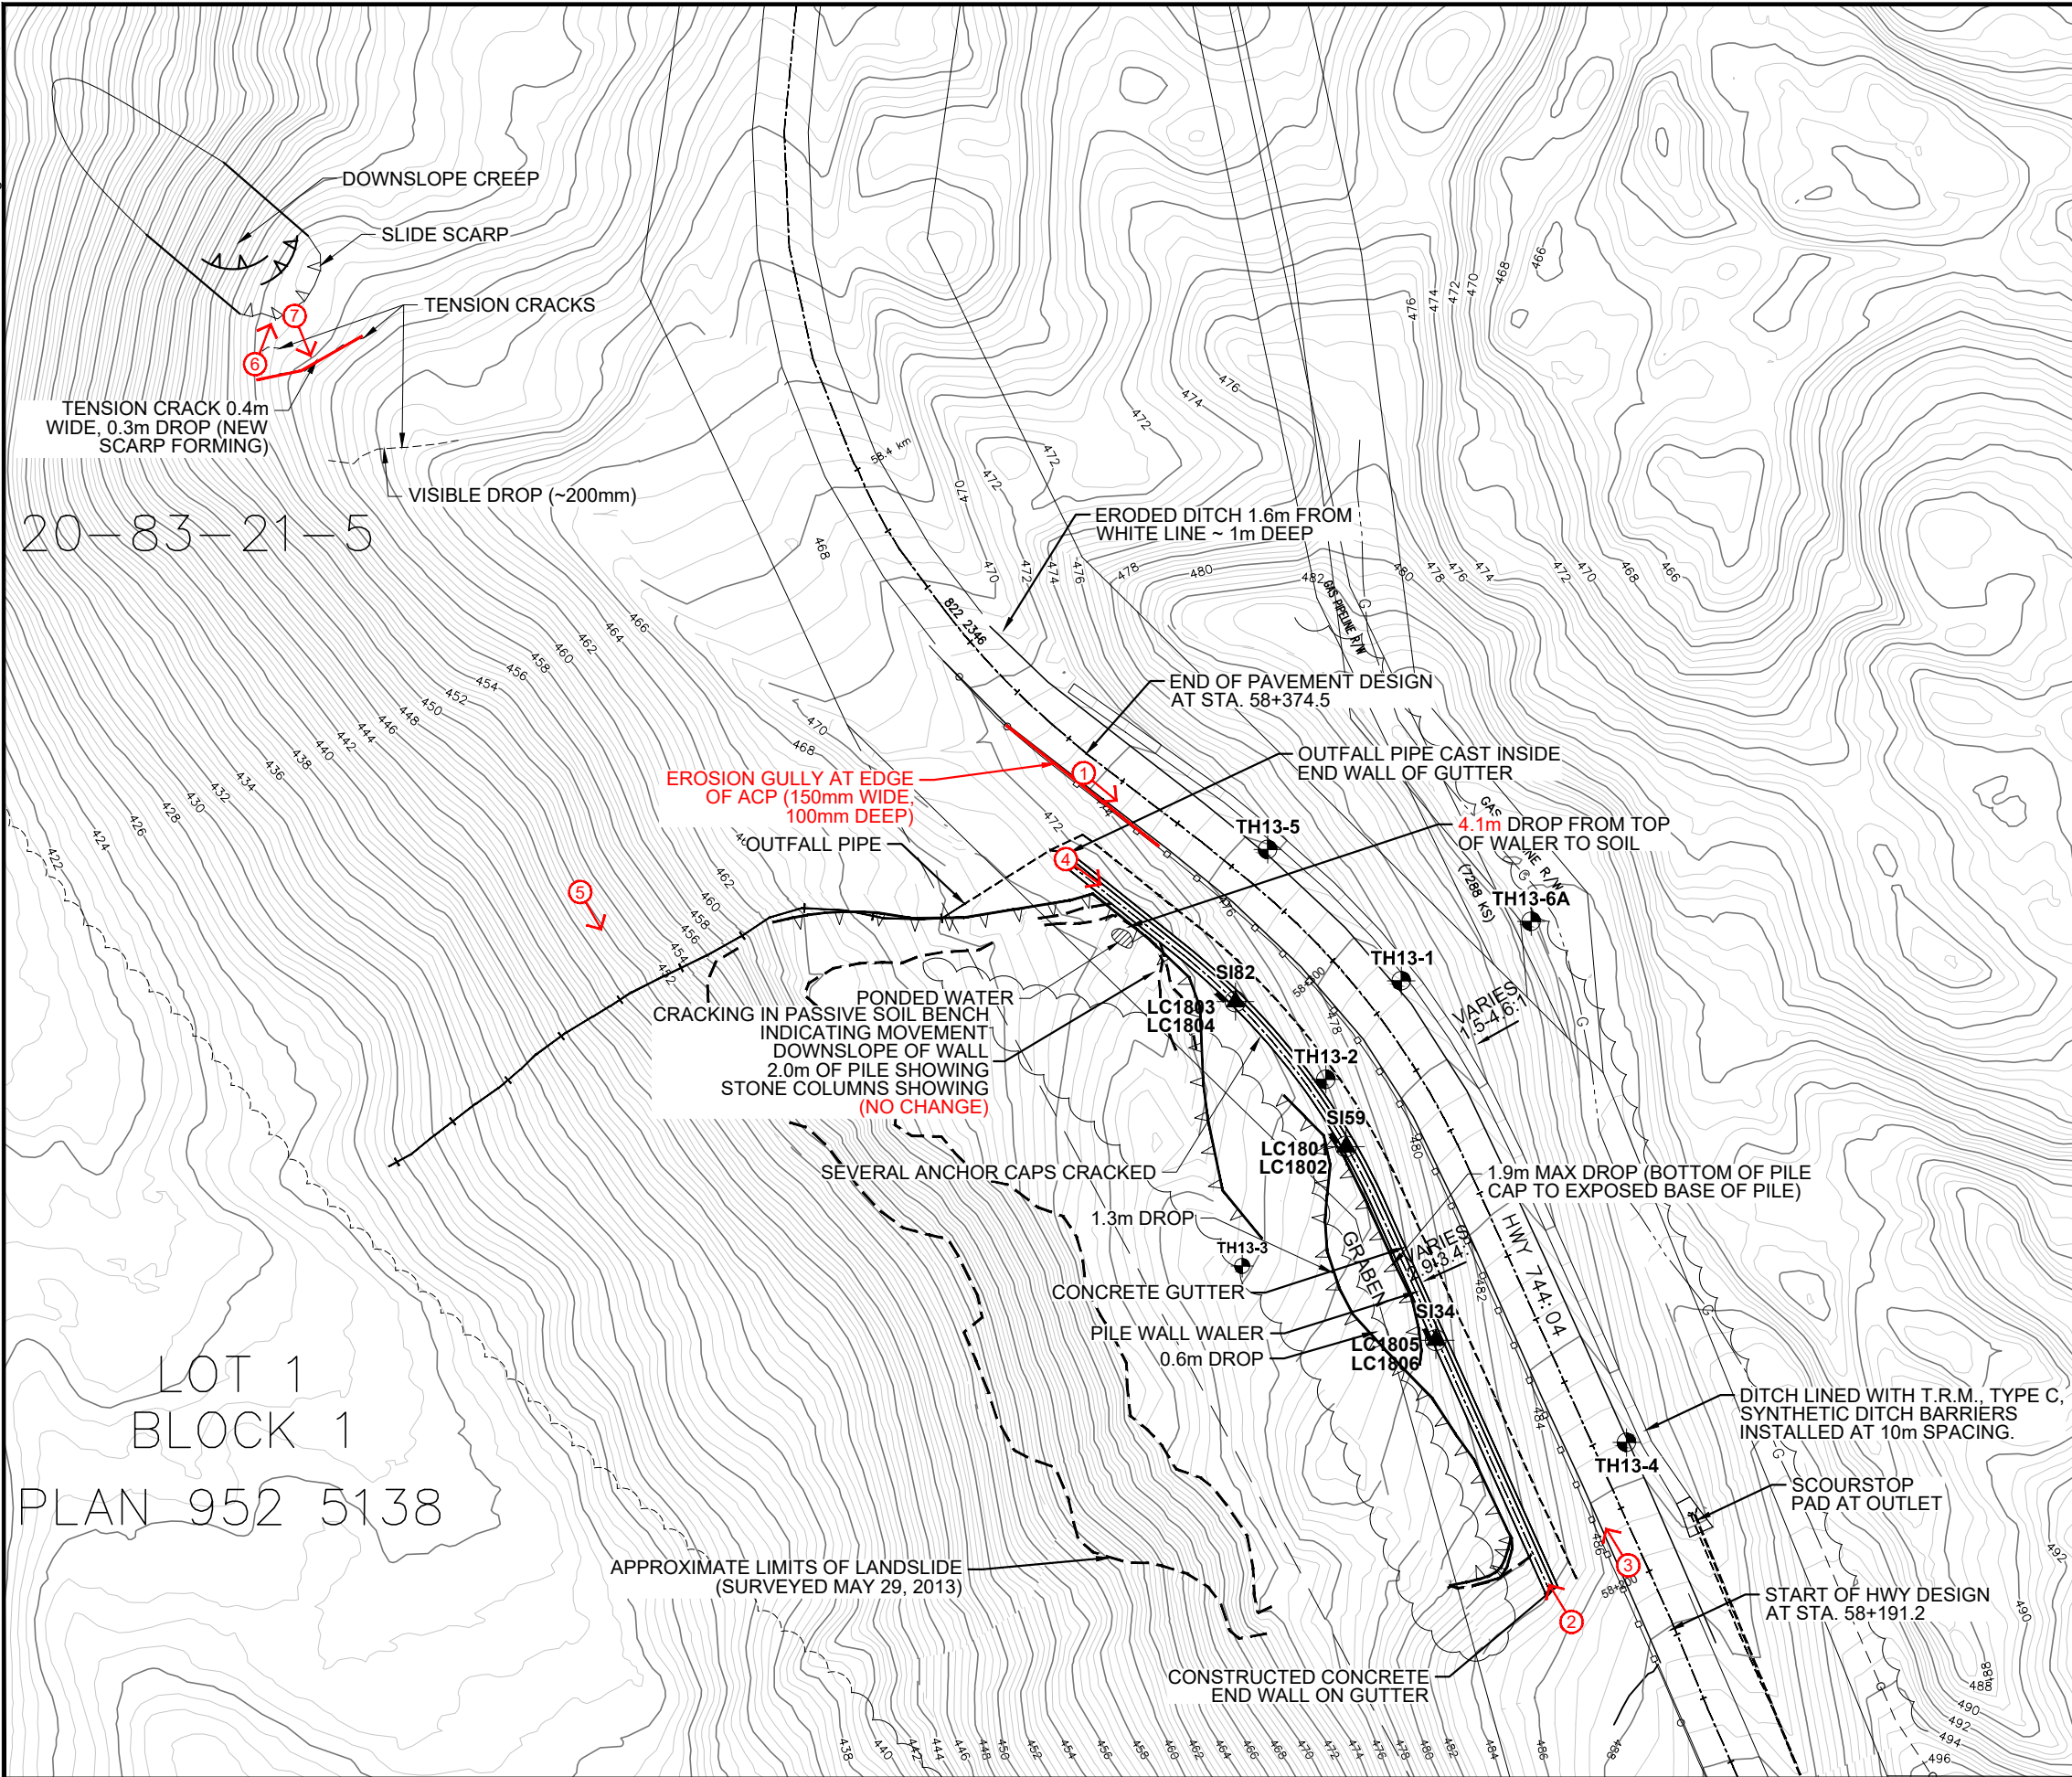
NOTE:
1. MAY 17, 2023 OBSERVATIONS SHOWN IN RED.

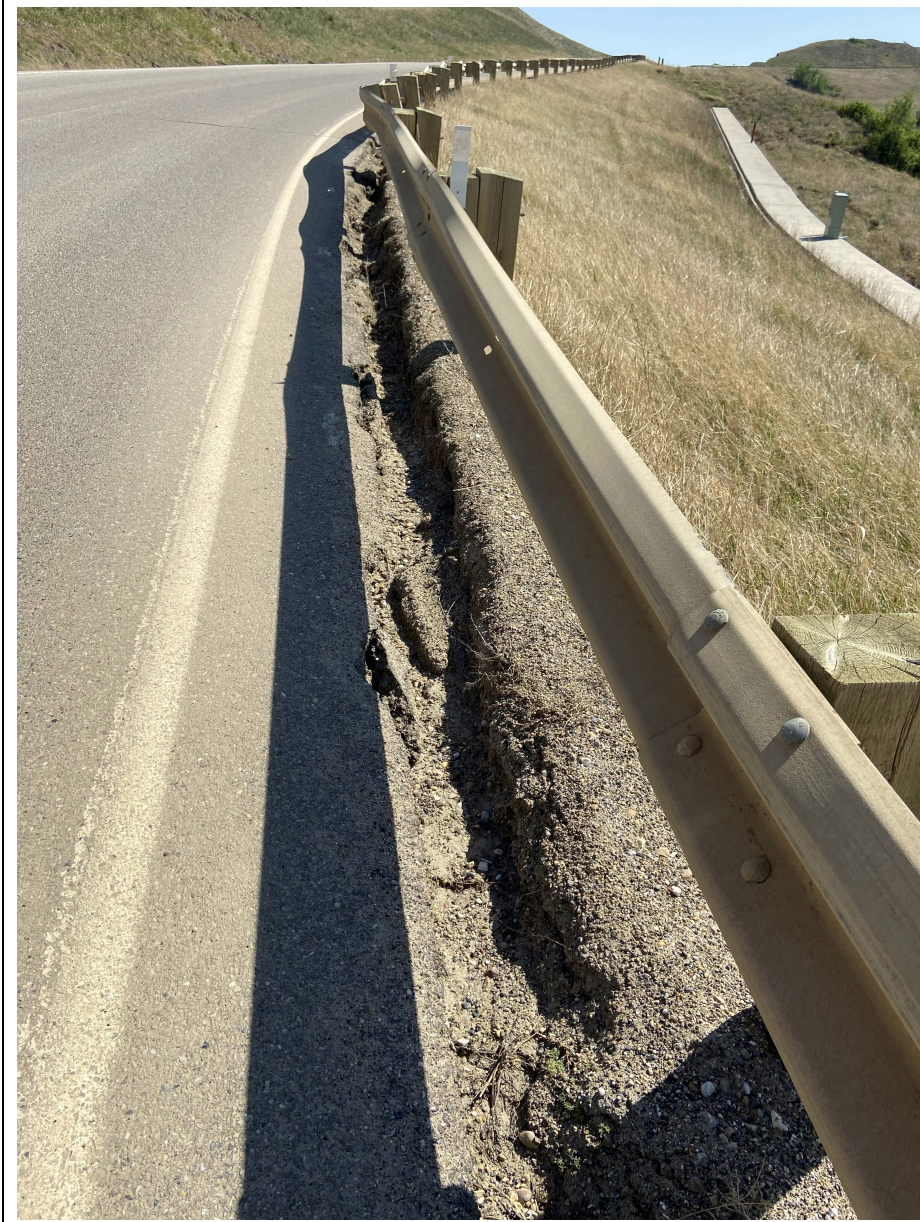
<input checked="" type="checkbox"/> Erosion	An erosion gully (0.15 m wide, 0.1 m deep) approximately 30 m in length has developed parallel to the edge of the ACP near the north end of the pile wall near KM 58.35 (Photo 1).	<input type="checkbox"/>
<input type="checkbox"/> Seepage		<input type="checkbox"/>
<input type="checkbox"/> Bridge/Culvert Distress		<input type="checkbox"/>
<input checked="" type="checkbox"/> Other	The wall surface gutter drain periodically clogs with sediment and/or vegetation and needs to be cleaned on a regular basis. Several anchor caps are cracked.	<input type="checkbox"/>
Instrumentation:		
SI-34, 59 and 82	Three slope inclinometers were installed in retaining wall piles during construction. Since the final lock off the soil anchors in September of 2014, the slope inclinometers have shown about 0 mm to 7 mm of downslope movement in the pile wall. Spring 2023 movement rates are small and measure between 0 mm/yr to 1 mm/yr.

Photo 1.
Looking south
along the SBL of
Hwy 744:04 at km
58.35 at the north
end of the
Sunshine pile wall.
An erosion gully
has developed
parallel to the
edge of the ACP.

The erosion gully forming on the west edge of the road near the north end of the pile wall (km 58.35) should be backfilled with granular fill to provide support and minimize further undermining and damage to the ACP. Maintenance

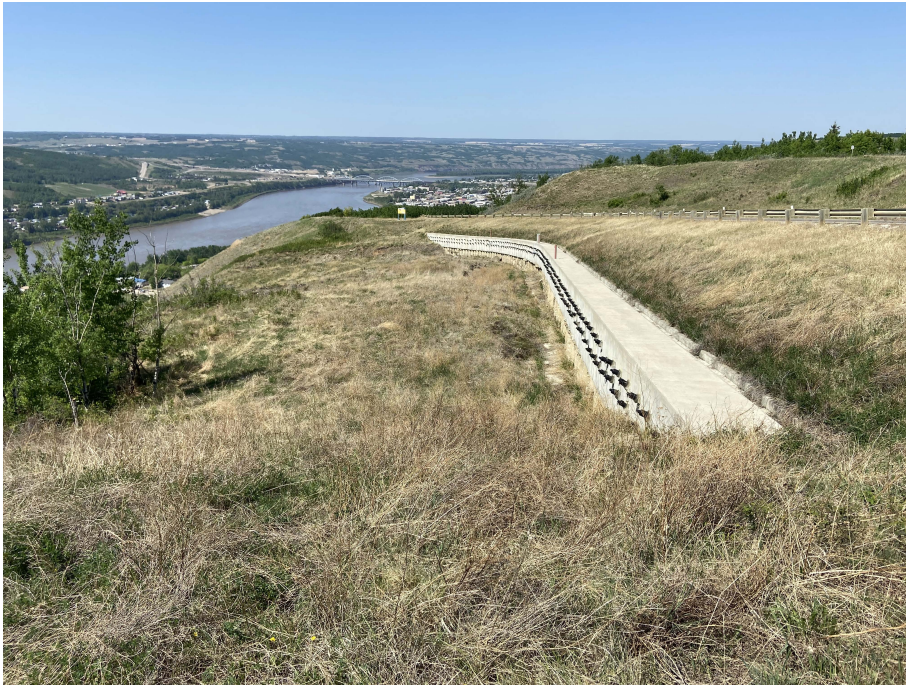
Photo 2.
Looking northwest from south end of the Sunshine pile wall at km 58.200. No major visible changes from the 2021 condition.

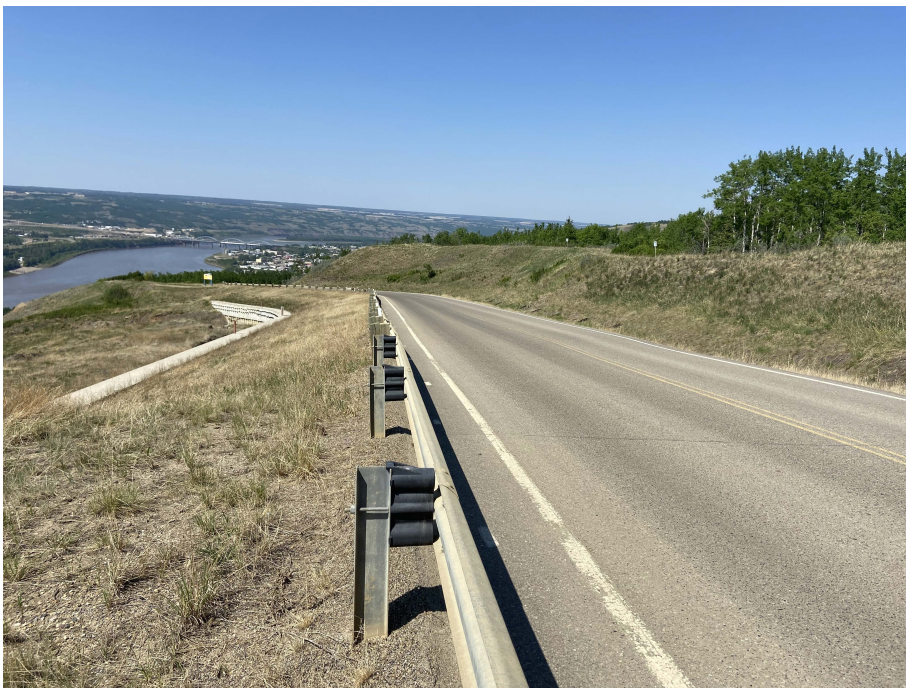
Photo 3.
Looking northwest from south end of the Sunshine pile wall at km 58.200 along the highway. No damage to the ACP surface was observed.

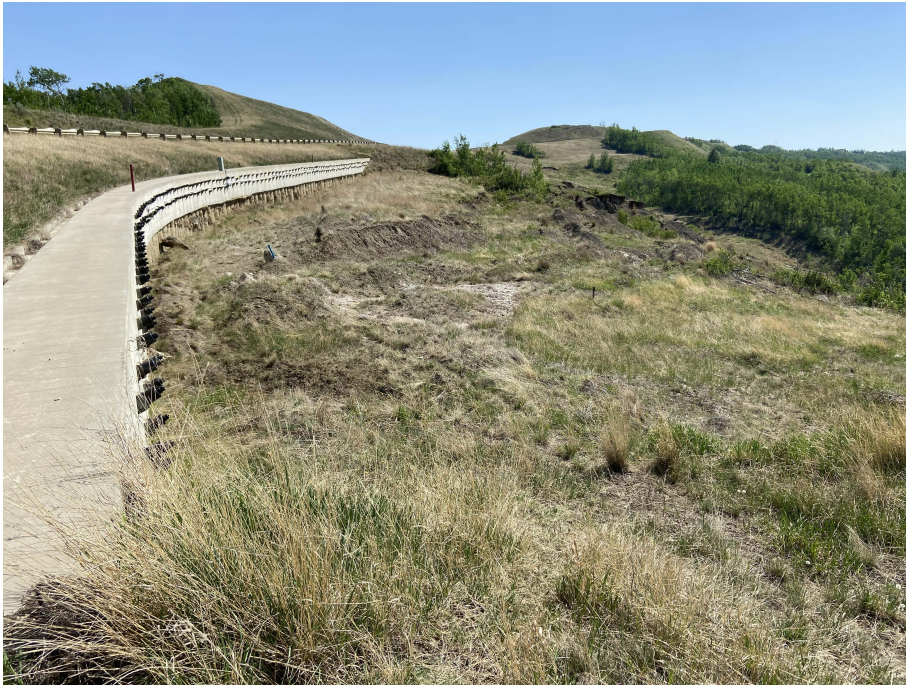
Photo 4.
Looking southeast along the pile wall at km 58.33. Head scarp cracks immediately below the wall appear unchanged since the 2021 inspection.

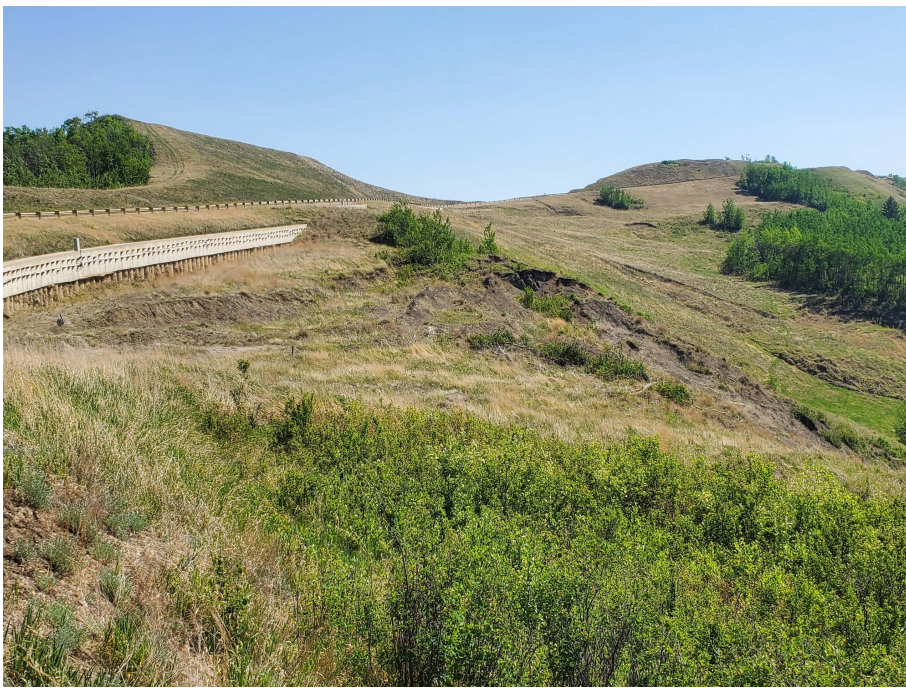
Photo 5.
Looking southeast at the lower slide area below the wall. Active ongoing slide movement within the lower slope.

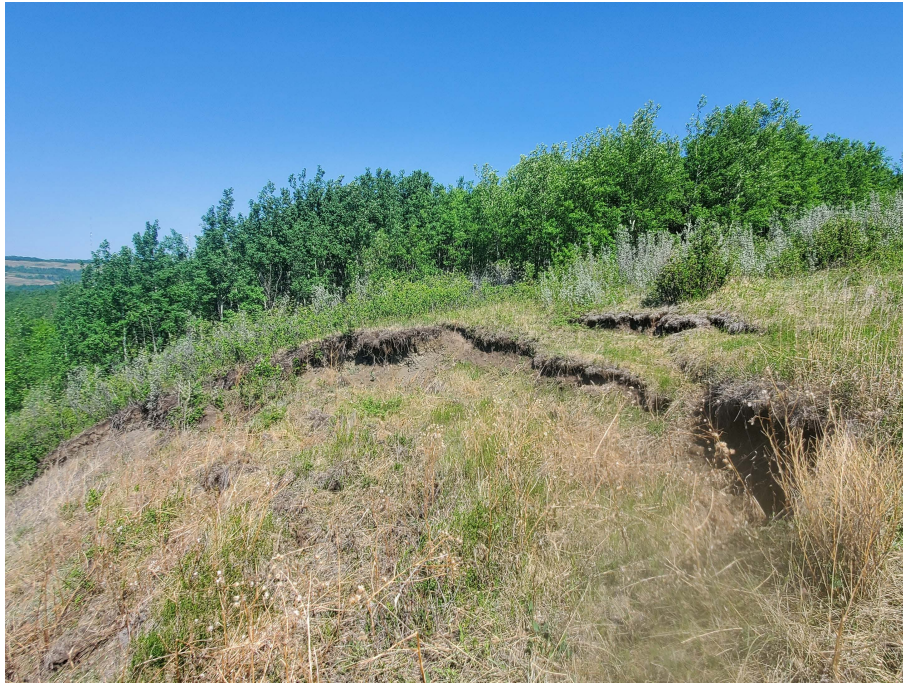
Photo 6.
Slide area (first observed in 2019) approximately 100 m NW of the north end of the pile wall. No major change at the main scarp since the 2021 inspection; ongoing creep movement further downslope.

The new slide area should be monitored during the PH072 annual inspections or alternatively a new site should be created. Monitoring

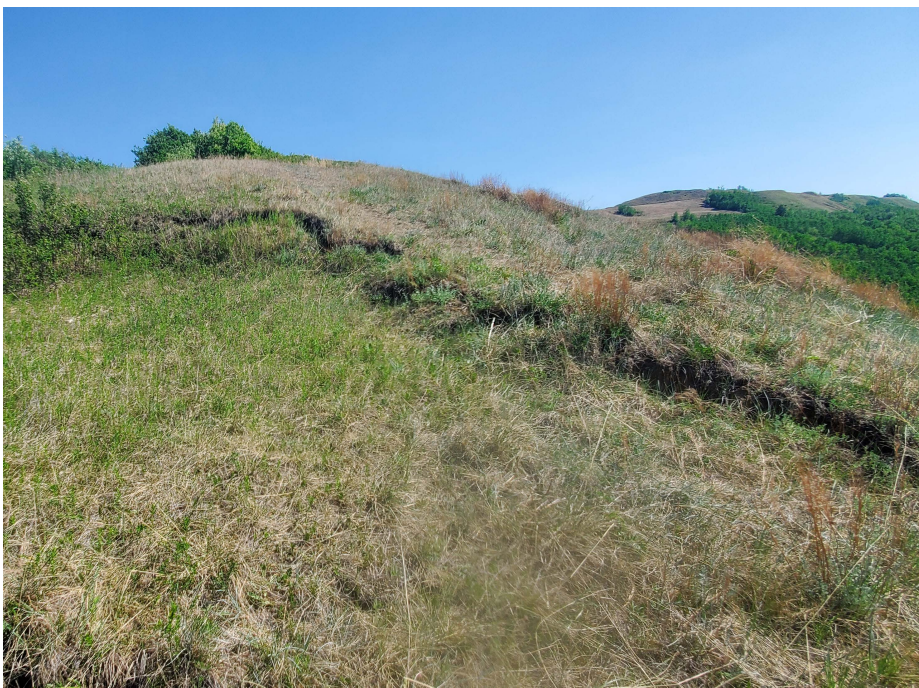
Photo 7.
Looking east at one of three tension cracks observed upslope from the slide scarp in previous photo. The crack was opened up to 0.4 m wide and with up to 0.3 m of drop. Will likely become the main head scarp in the future.
