## ALBERTA TRANSPORTATION AND ECONOMIC CORRIDORS GEOHAZARD – INSTRUMENTATION MONITORING PEACE REGION – (PEACE RIVER DISTRICT) SPRING 2024

Site Number	Location	Name	Hwy	km
PH072	HWY 744:04 C1 58.154	Sunshine Slide	744:04	Km 58.2
Legal Descriptio	n: 16-20-83-21 W5	UTM Co-ordinates		
		11U E 483111	N 62	30075

Current Monitoring:	23-May-2024	Previous Monitoring	16-Jun-2023
Instruments Read By:	.T and Mr. Nixson Mationg, of Thurber

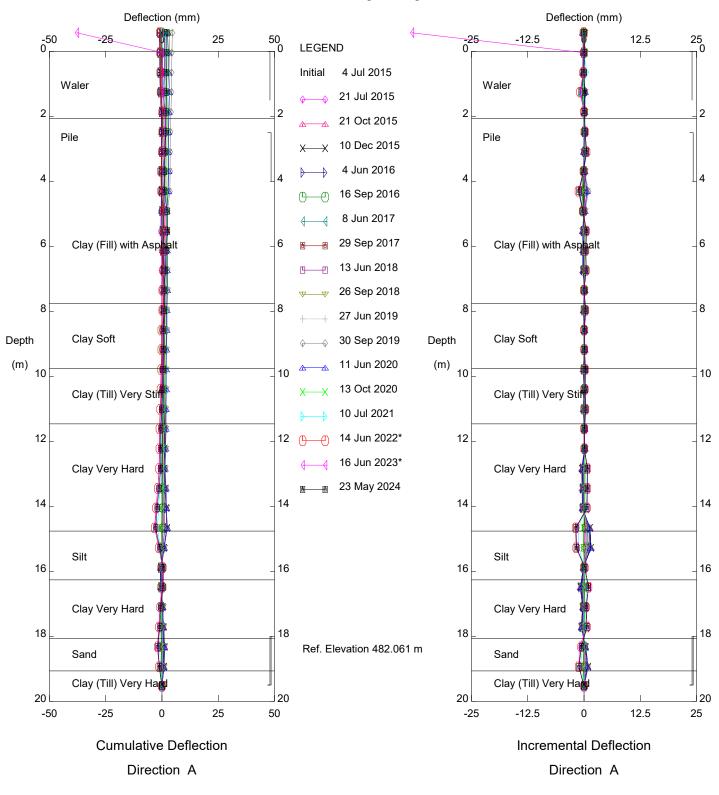
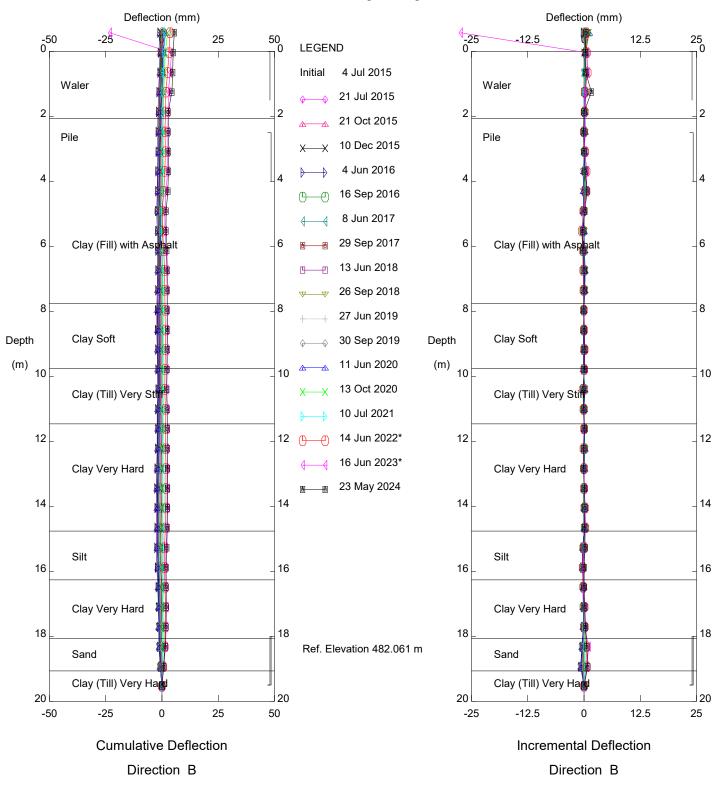
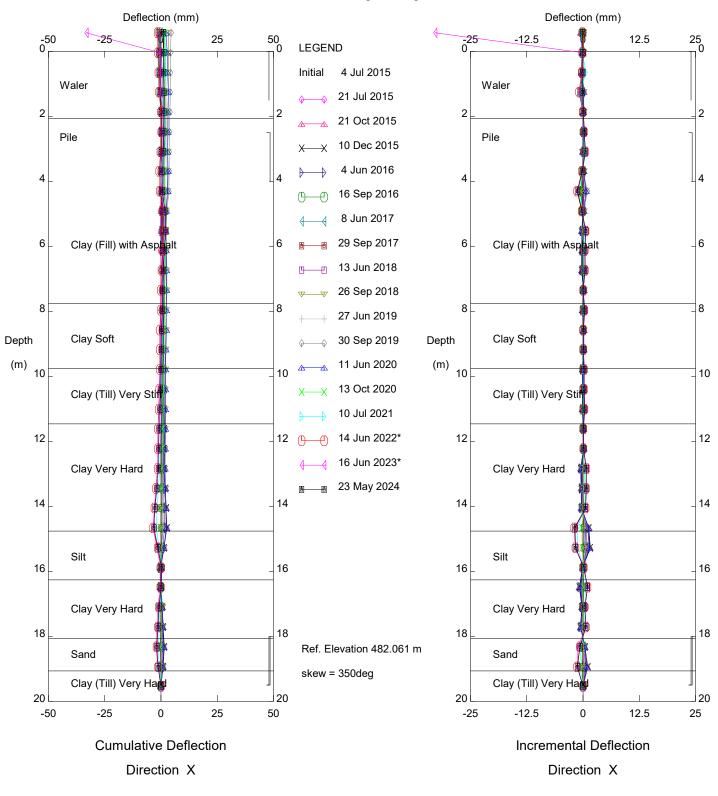
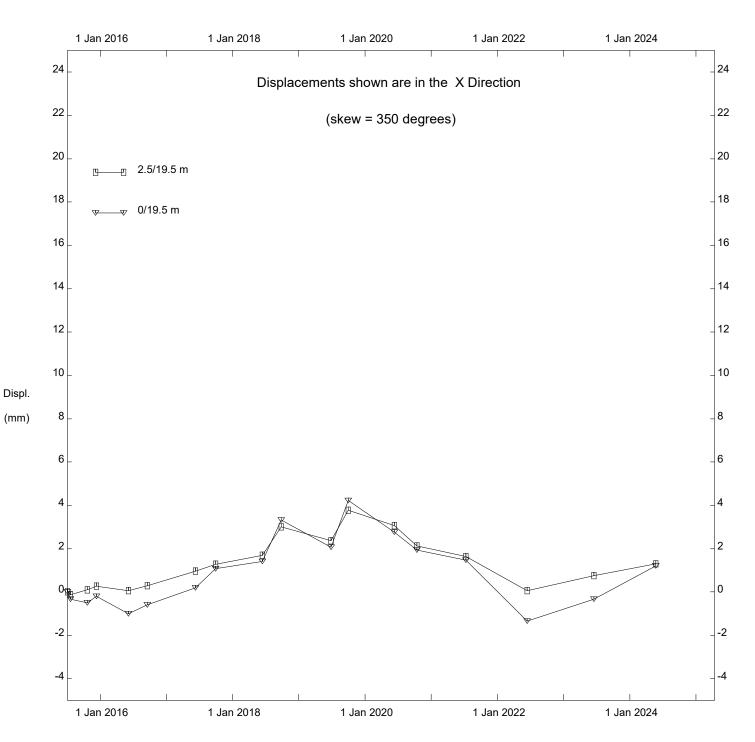
PH072 Sunshine (Post Construction), Inclinometer Pile 34

Discussion
Zones of New Movement:	None
	Pile 34 showed a rate of movement of 0.6 mm/yr over the length of the pile and a rate of movement of 1.6 mm/yr over the combined length of the pile and waler since the spring of 2023 readings. Pile 34 has shown a total cumulative pile head movement of 1.3 mm in the downslope direction since completion of construction and a total cumulative movement of 1.2 mm in the downslope direction over the combined length of the pile and waler.
Interpretation of Monitoring Results:	Pile 59 showed a rate of movement of 0.1 mm/yr over the length of the pile and a rate of movement of 0.6 mm/yr over the combined length of the pile and waler since the spring of 2023 readings. Pile 59 has shown a total cumulative pile head movement of 4.4 mm in the downslope direction since completion of construction with a total cumulative movement of 5.6 mm in the downslope direction over the combined length of the pile and waler.

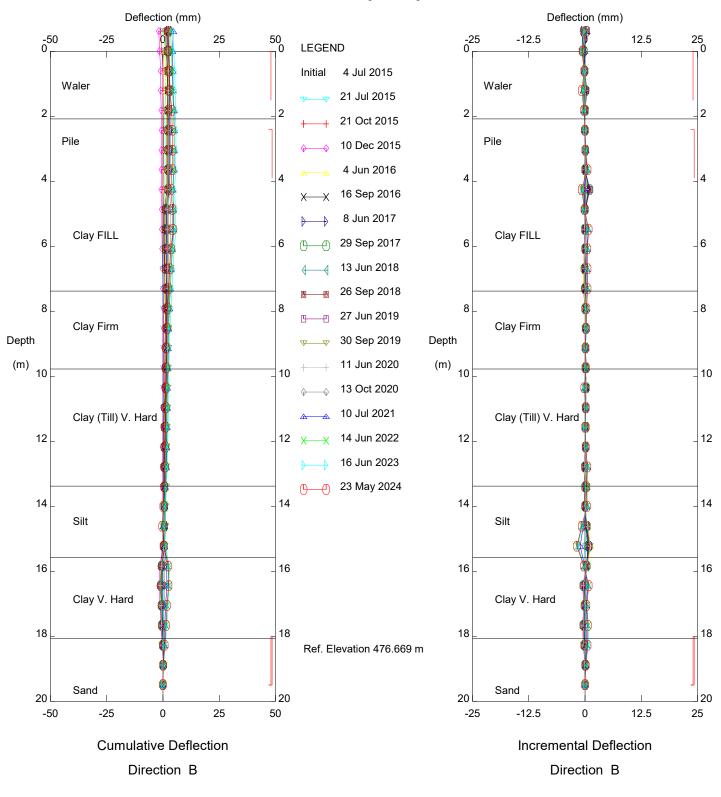
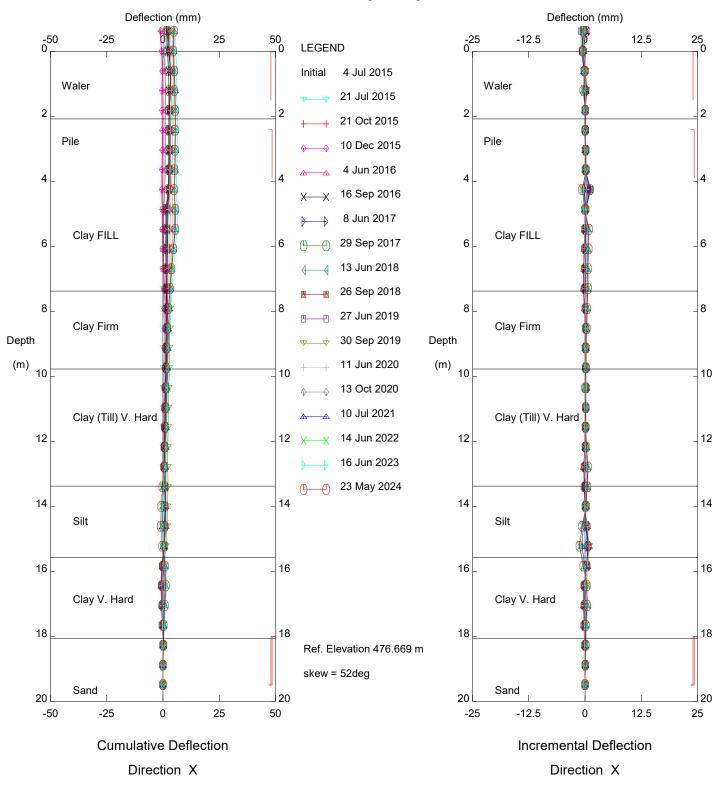
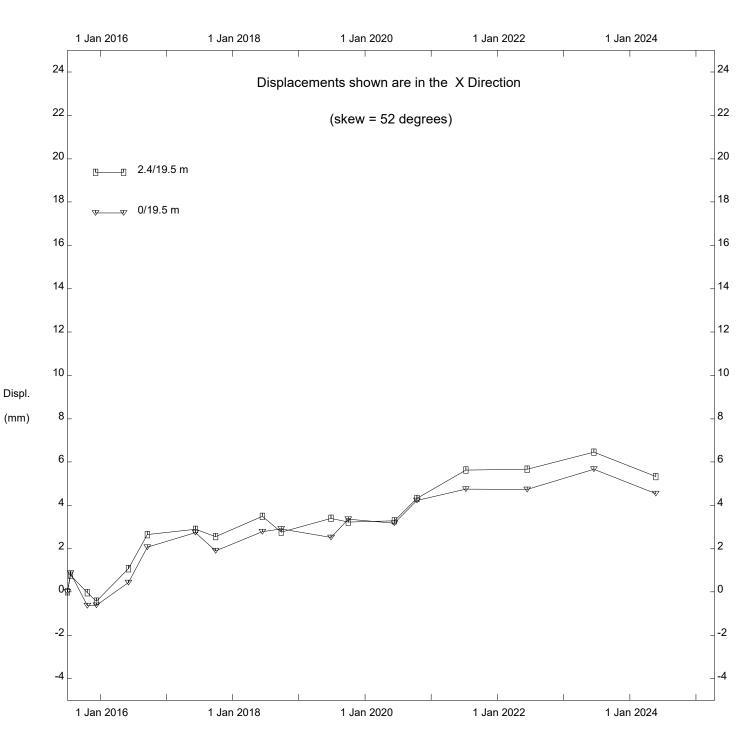
PH072 Sunshine (Post Construction), Inclinometer Pile 82

Pile 82 showed a rate of movement of 1.2 mm/yr over the length of the pile and a rate of movement of 1.2 mm/yr over the combined length of the pile and waler, in the uphill direction, since the spring of 2023 readings. Pile 82 has shown a total cumulative pile head movement of 5.3 mm in the downslope direction since completion of construction and a total cumulative movement of 4.5 mm in the downslope direction over the combined length of the pile and waler.
	The six load cells (VC1805, VC1806, VC1801, VC1802, VC1803 and

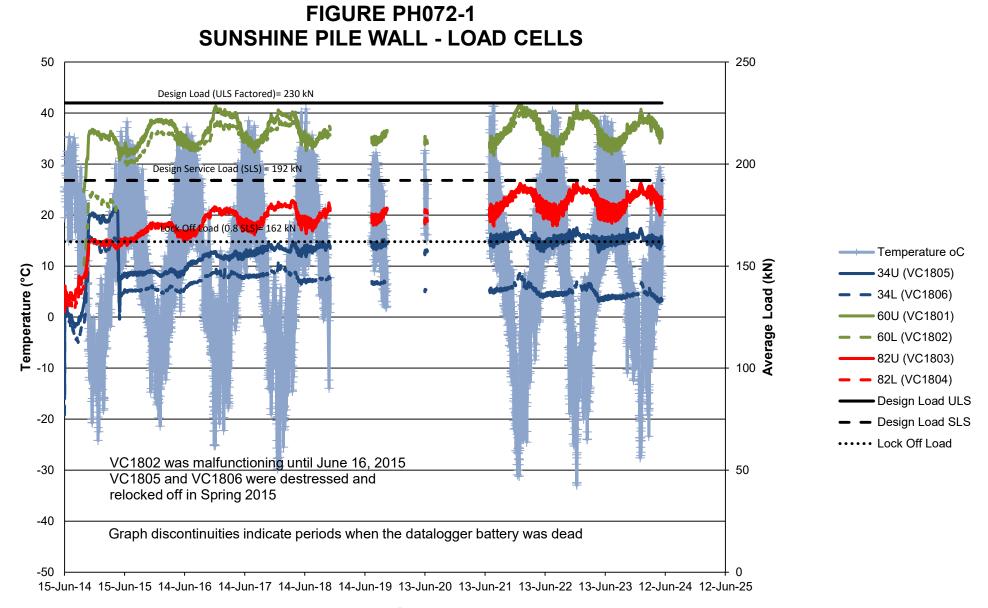
VC1804) are connected to an RST DT2040 datalogger which was initially programmed to take readings once per day. Starting in the spring of 2015, the datalogger was reprogrammed to take readings twice per day. The latest load cell readings, as of May 23, 2024, show minor changes compared to the previous readings taken in on June 16, 2023. The changes range from a decrease of 1.23 kN in load cell VC1806 (anchor 34L) to an increase of 2.80 kN in VC1801 (anchor 34U). Load cell VC1803 (anchor 82U) measured an all-time high load of 191.52 kN on January 15, 2023. It should also be noted that load cells VC1801 (anchor 60U), VC1802 (anchor 60L) are showing loads that are higher than the design service load, but these loads are still lower than the ULS factored design load.
	Overall, the load cells show a trend of stable loads over the past several readings cycles.
	Overall, the SI and load cell readings show that the pile wall has been effective in stabilizing the landslide movement at this site.

1. Load cell data is recorded twice daily with datalogger on site. Dataloggers are uploaded twice annually during instrumentation readings. See Figure PH072-1 in Appendix A for combined historical instrument readings. Datalogger battery was dead between November 14, 2018 to July 25, 2019, October 27, 2019 to June 11, 2020, and between June 27, 2020 to July 10, 2021.
