**ALBERTA TRANSPORTATION
GEOHAZARD ASSESSMENT PROGRAM
PEACE REGION (PEACE RIVER DISTRICT)
2023 INSPECTION**

| Site Number | Location | Name | Hwy | km |
|---|---|---|---|---|
| SH031-1 | Southwest of High Prairie | Road Gear Ranch | 747:02 | 32.1-32.3 |

**SH031-1: HWY 747:02 km 32.1 TO km 32.3
2023 SITE INSPECTION PLAN**

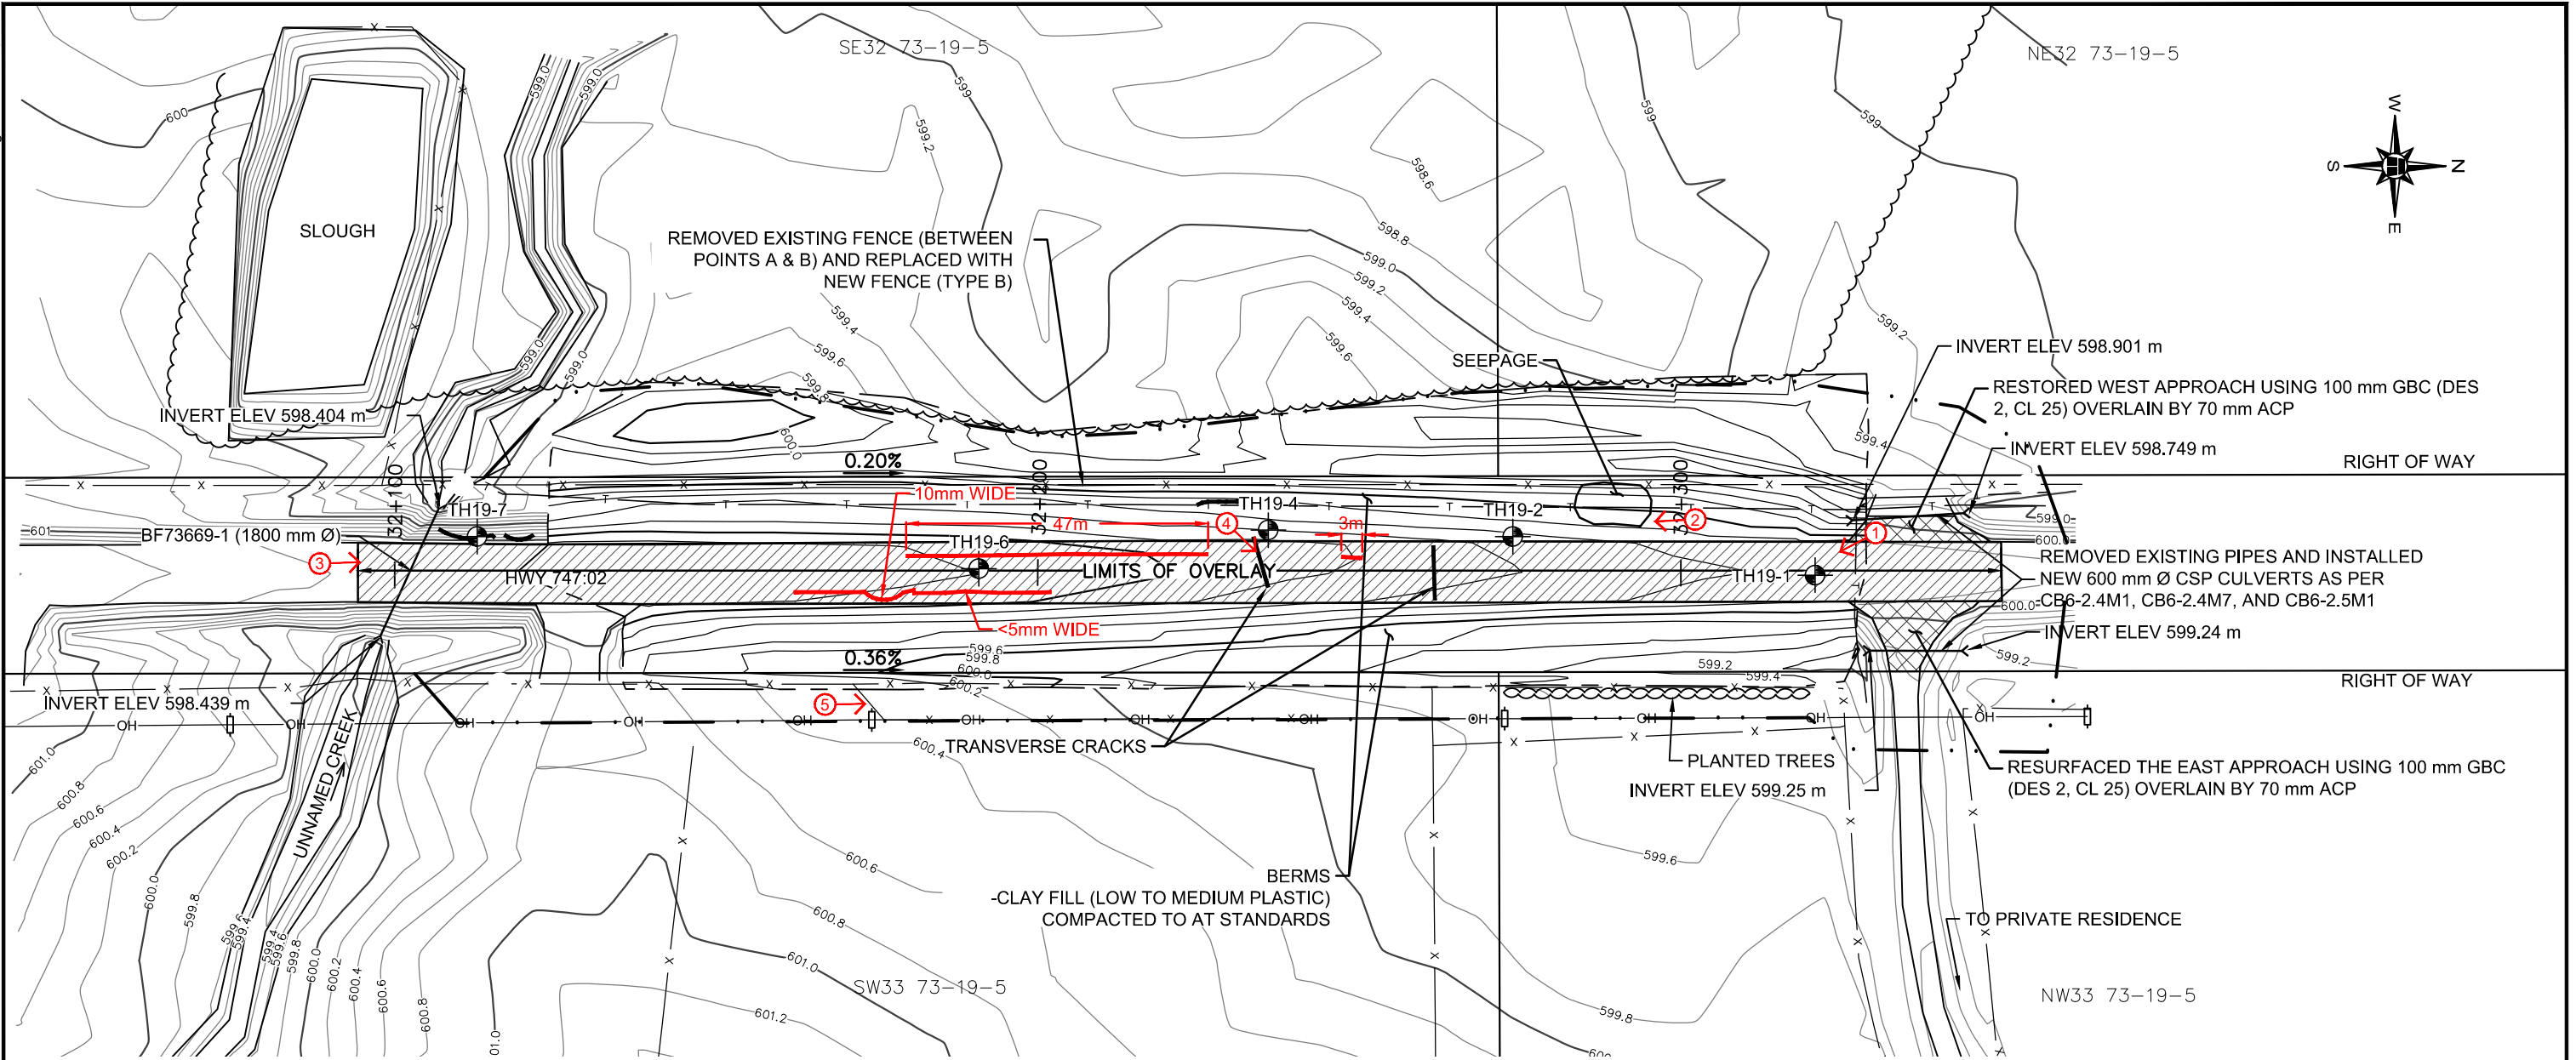
DWG No. 32121-SH031-1

1. ORIGINAL SURVEY COMPLETED BY WSP ON FEBRUARY 5, 2019
2. AS-BUILT SURVEY COMPLETED BY WSP ON JULY 25, 2020
3. ALL DISTURBED AREAS COVERED WITH SALVAGED TOPSOIL AND SEEDED
4. JUNE 2023 OBSERVATIONS SHOWN IN RED.

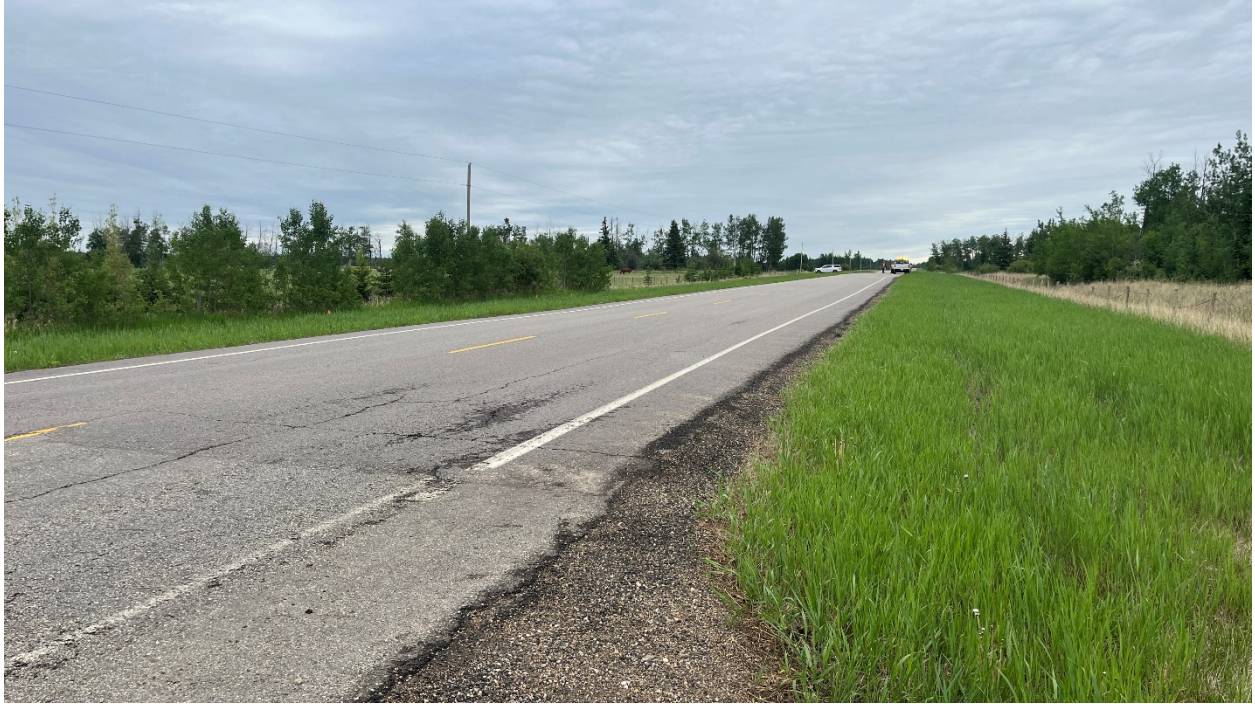
Photo 1 – Looking southeast along SBL at the north end of the site.

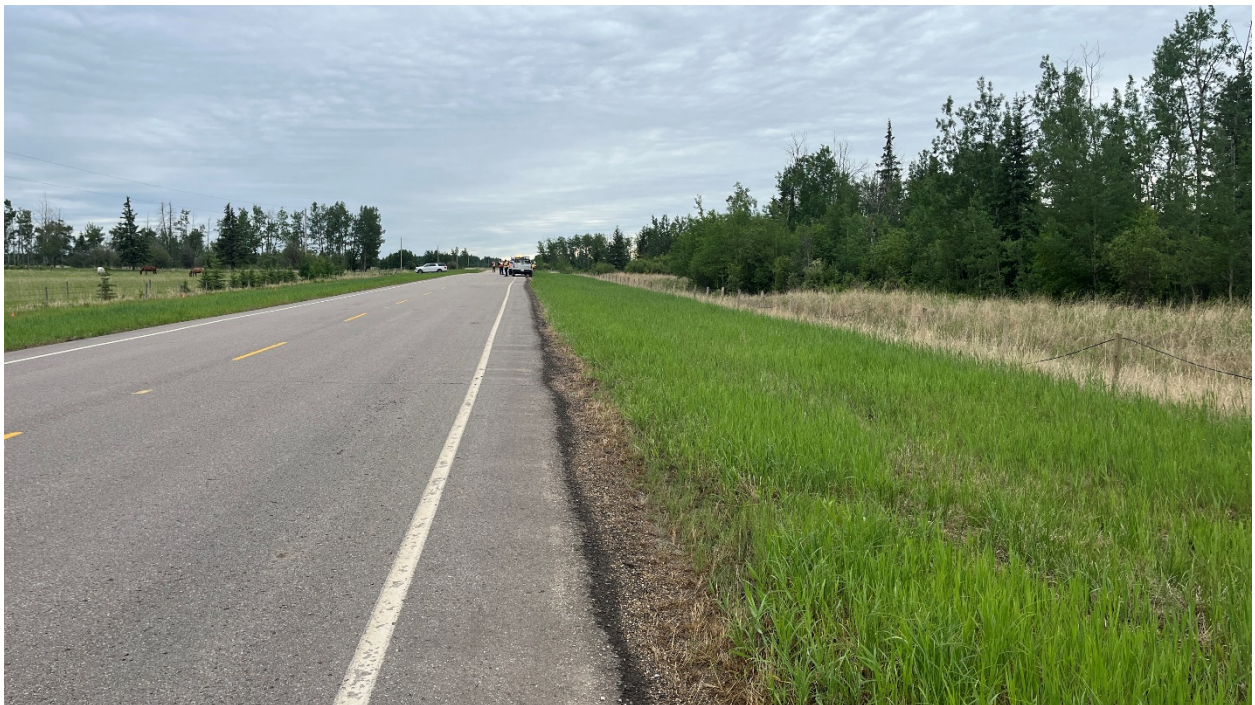
Photo 2 – Looking south along SBL.

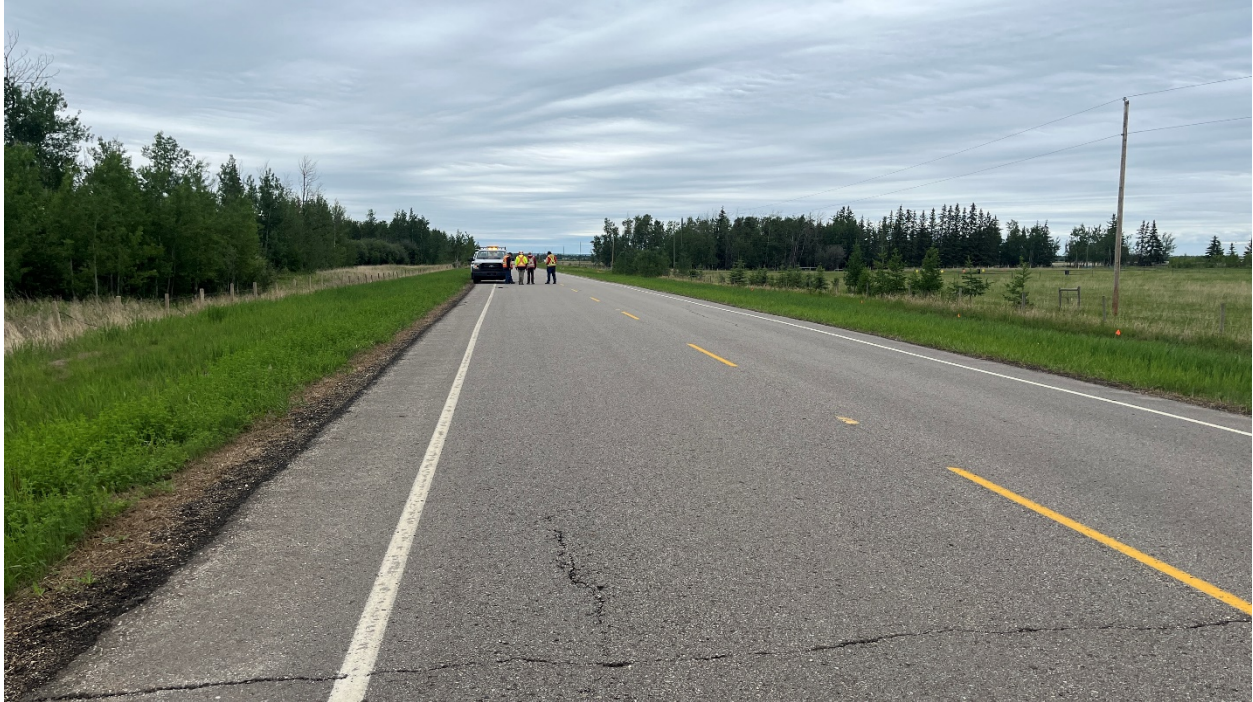
| <input checked="" type="checkbox"/> Bridge/Culvert Distress | 1800 mm culvert at south end of site – in good condition. | <input type="checkbox"/> |

Photo 3: Looking north from the south end of the site near the 1800 mm diameter culvert.

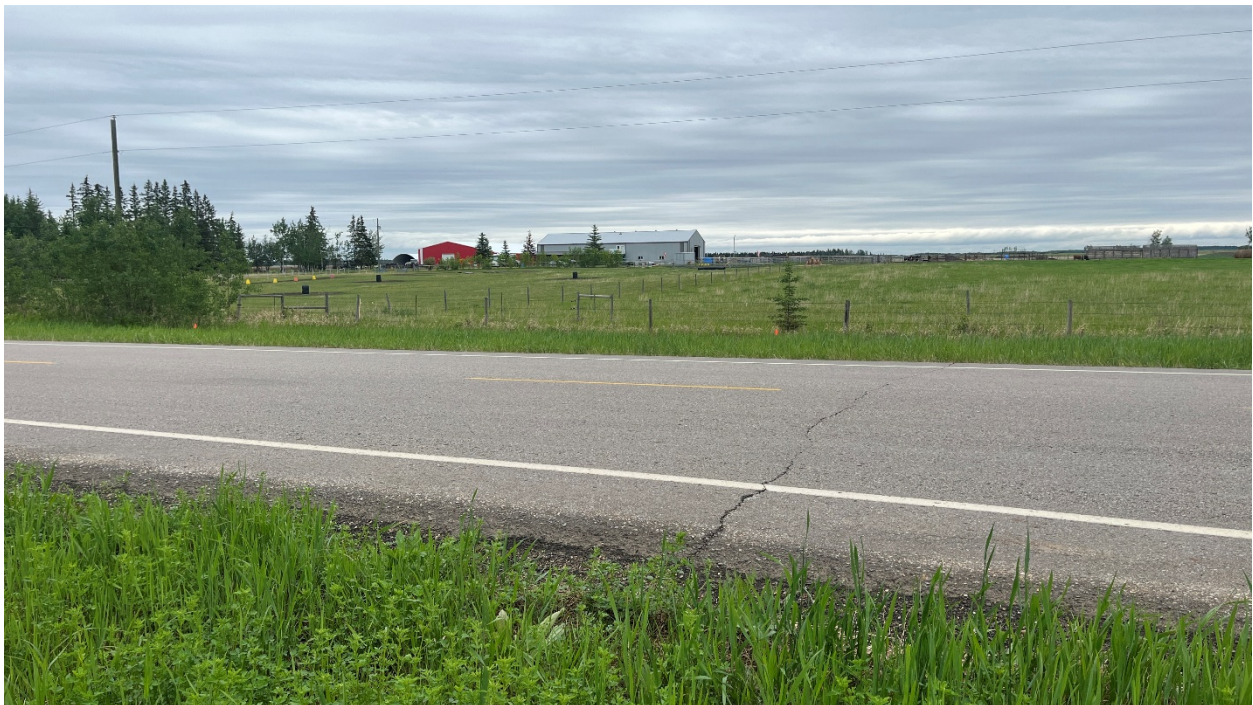
| <input checked="" type="checkbox"/> Pavement Distress | Transverse and longitudinal cracks noted in the middle portion of the site. | <input checked="" type="checkbox"/> |

Photo 4: Looking northeast at transverse cracking on the pavement at the middle portion of the site.

- It is understood that an overlay is scheduled for this highway (km 0 to km 44) in August 2023.

This site has been scheduled for Geohazard inspection every two years on the current contract. This seems reasonable so that the cracks that reflected through from 2023 inspections can be monitored.

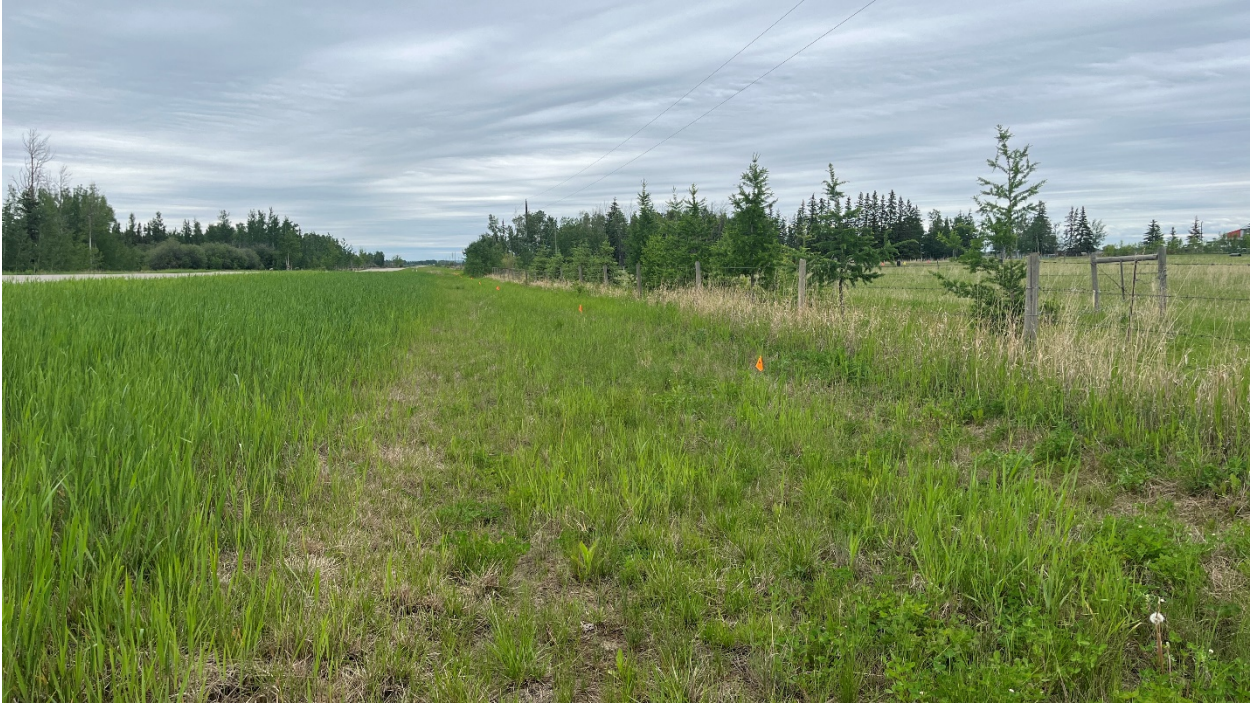
| <input type="checkbox"/> Erosion | Previously observed defective erosion matting along the east ditch near the fence was fixed. | <input type="checkbox"/> |

Photo 5: Looking north along east ditch.
