THURBER ENGINEERING LTD.

November 15, 2023

**ALBERTA TRANSPORTATION AND ECONOMIC CORRIDORS GRMP (CON0022164)
PEACE REGION (PEACE RIVER DISTRICT)
INSTRUMENTATION MONITORING RESULTS – FALL 2023**

SITE SH037: HWY 747:02, NICHOLLS CREEK SLIDE

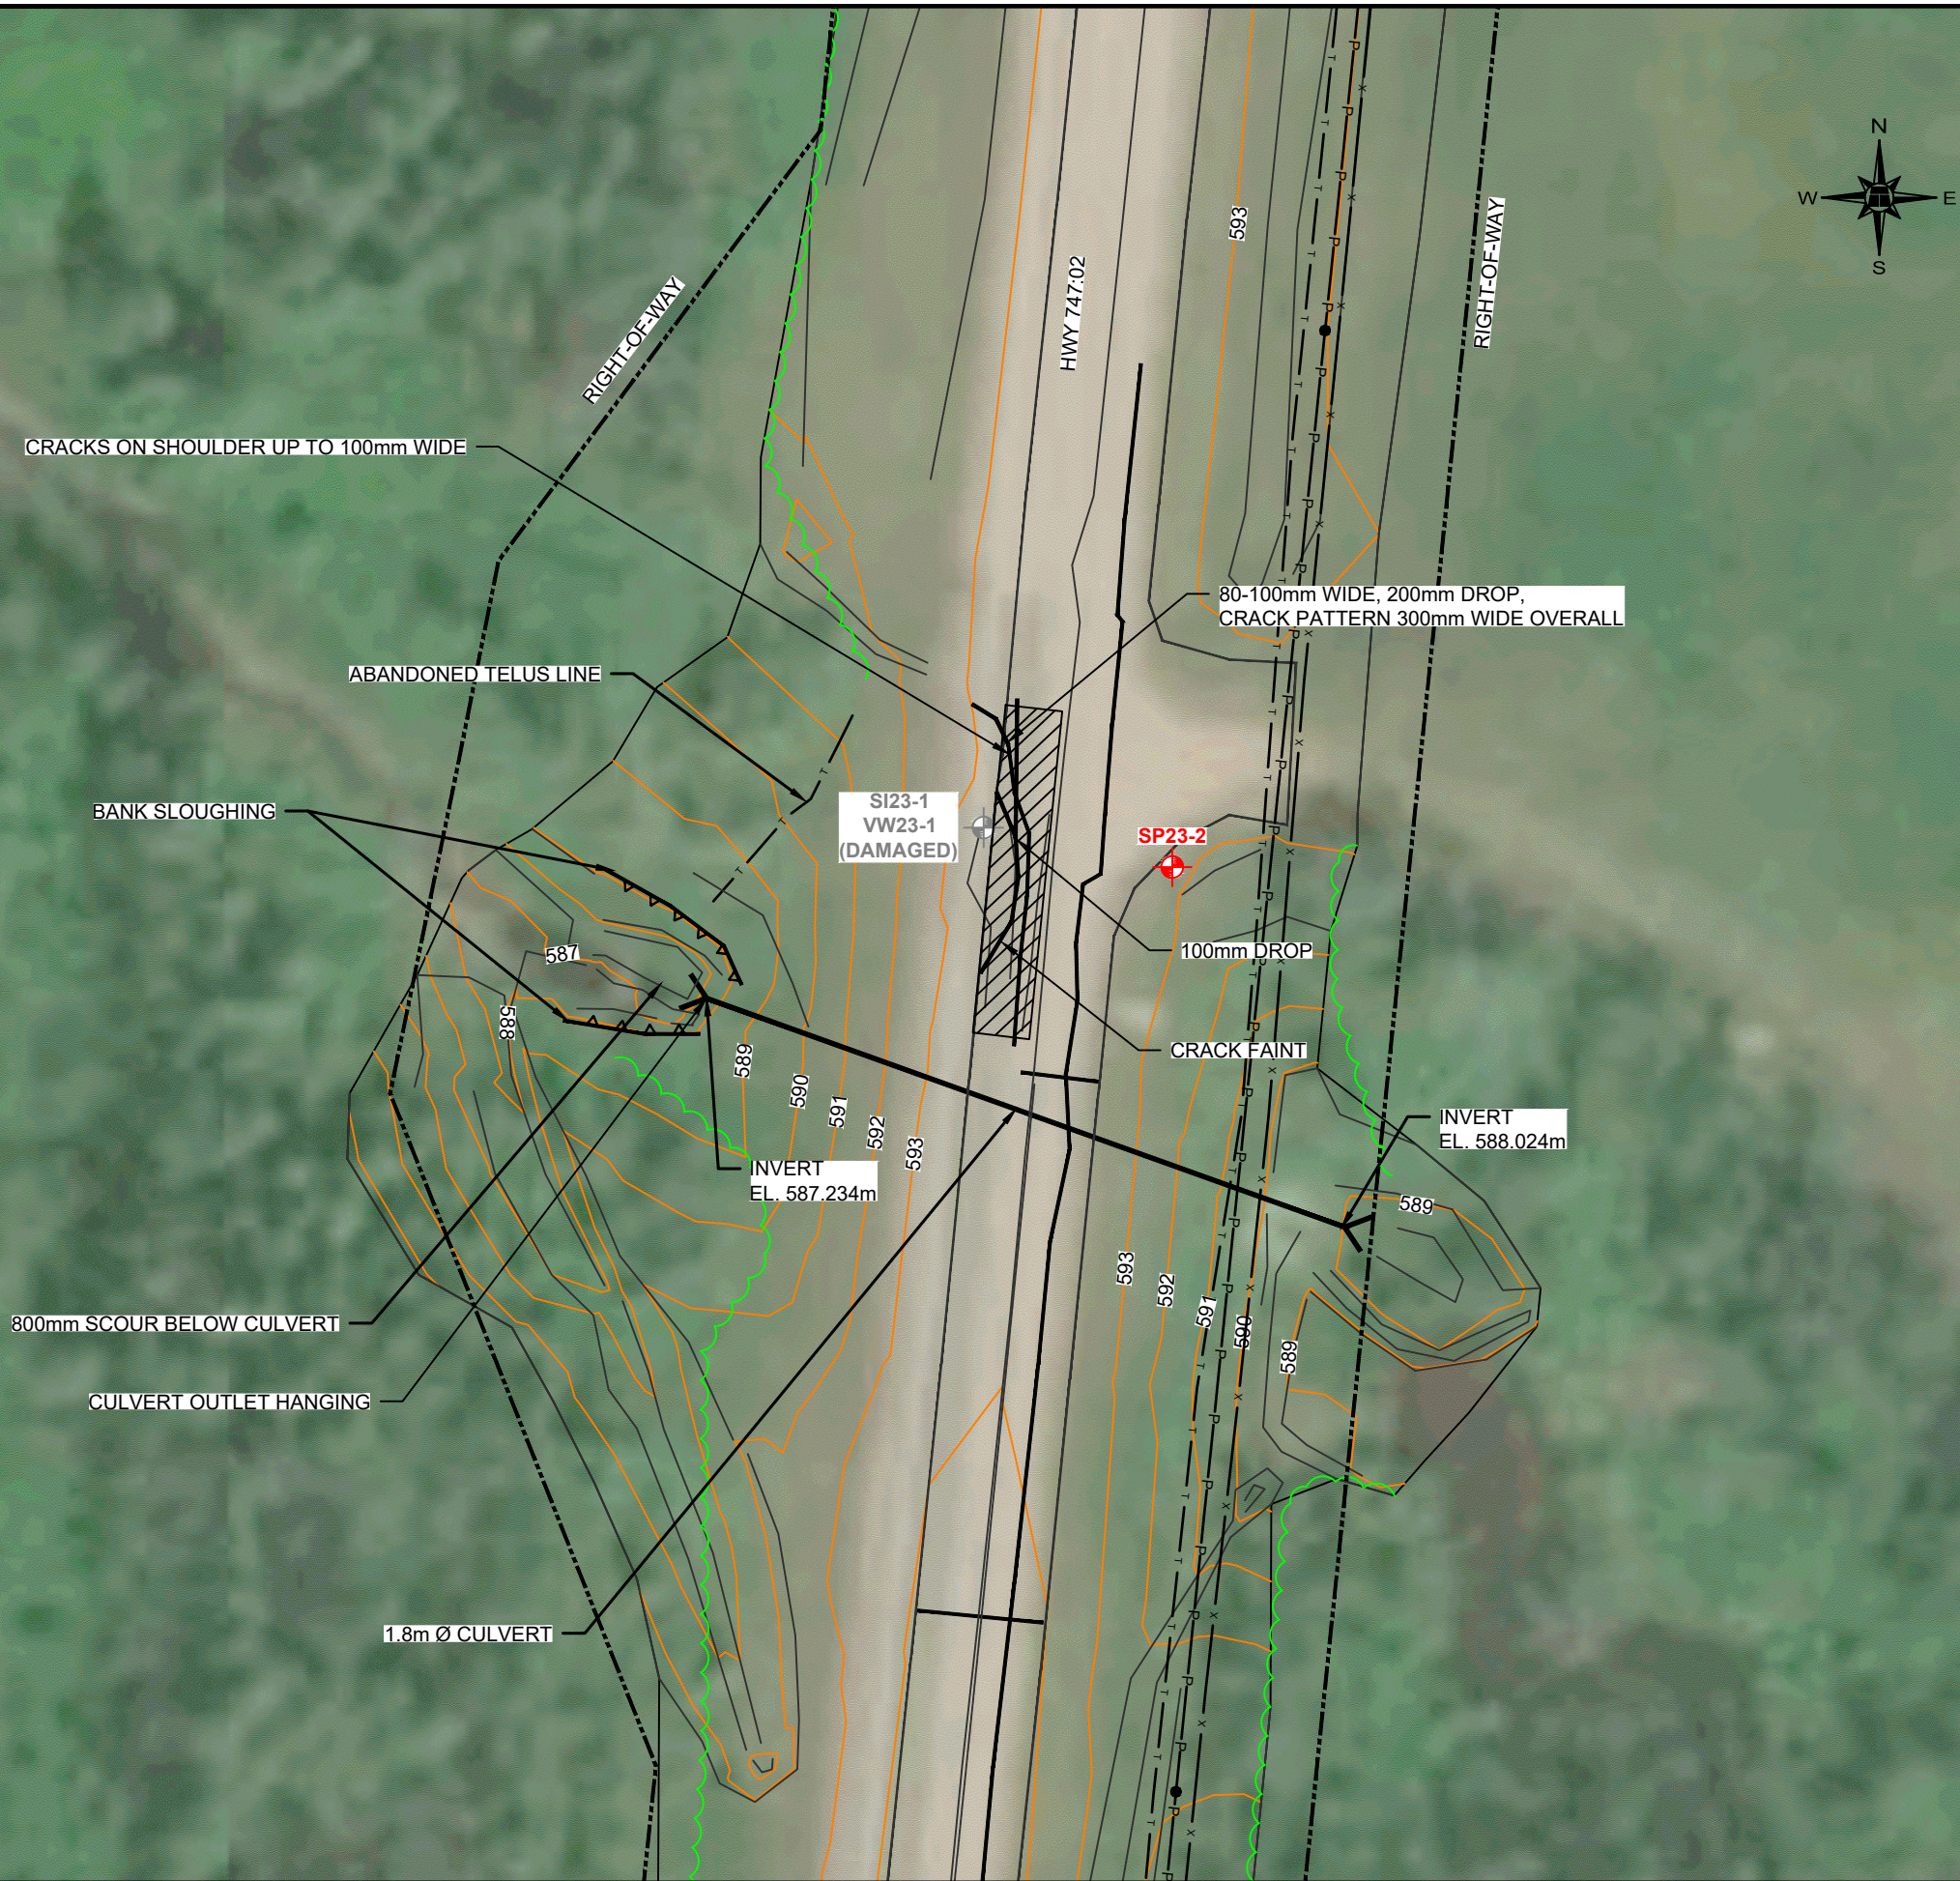
DWG NO. 32121-SH037-1

One standpipe piezometer (SP23-2) was read at the Hwy 747:02 Nicholls Creek Slide site on October 8, 2023 by Mr. Niraj Regmi, G.I.T. and Mr. Nixon Mationg, both of Thurber Engineering Ltd. Slope inclinometer SI23-1 was damaged at 1.2 m below ground and could not be read. VW23-1 did not show any data (B unit or temperature) during the reading and is likely damaged at 1.2 m below ground.

<i>*SI23-1, bent at 4.0 ft , probe will not go down, , damaged during paving and guardrail install. If repair needed, mechanical excavation required, to deep to dig by hand.</i>
<i>**Attached to SI23-1, VW23-1 showed no reading from instrument. Probably cutoff at 4 ft.</i>

An attempt could be made to repair the slope inclinometer and vibrating wire piezometer, however a backhoe will be needed to complete the repairs.

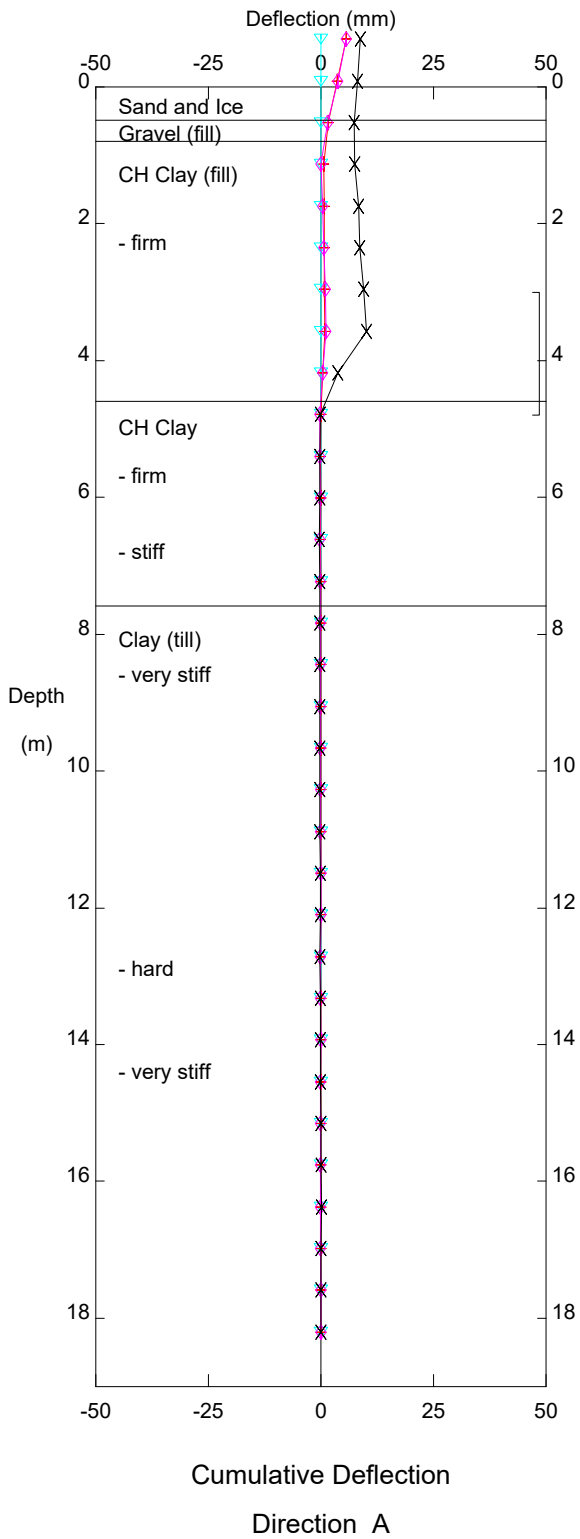
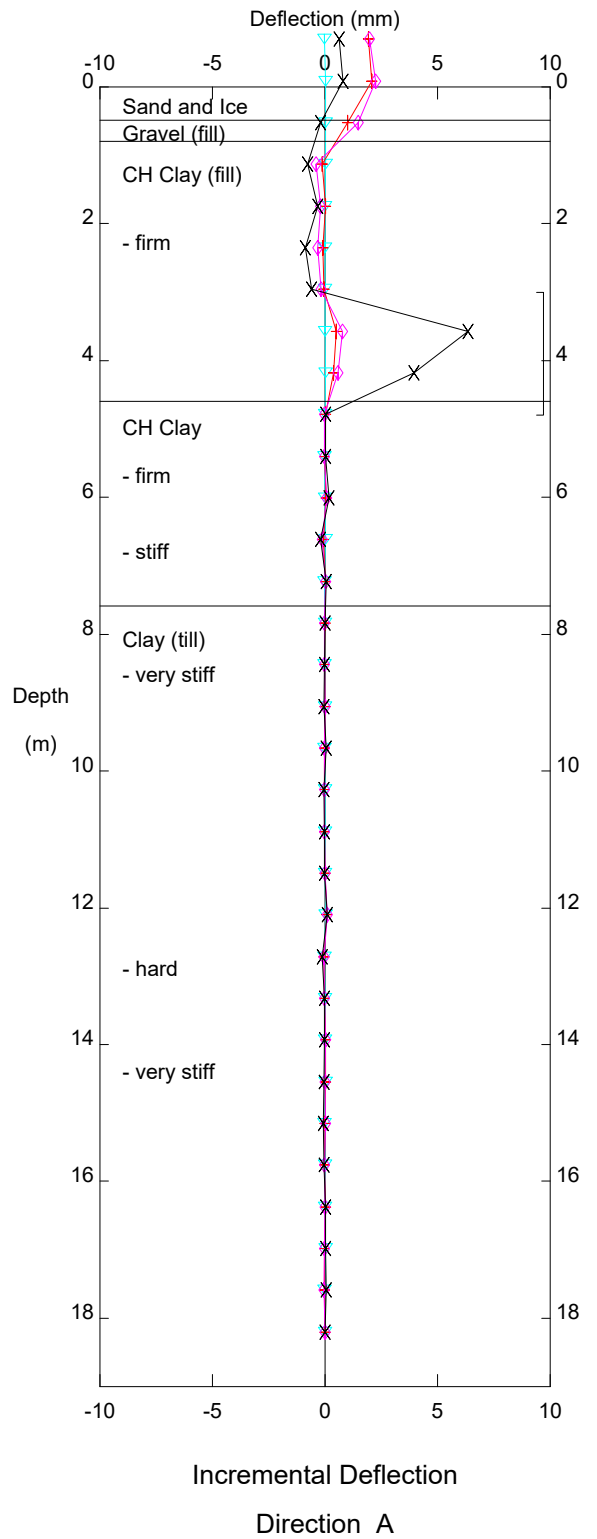
Hwy 747:02 km 35.2 Nicholls Creek, Inclinometer SI23-1

Slope inclinometer SI23-1 has been damaged since the previous reading on June 11, 2023.

INSTRUMENT #	DATE INITIALIZED	TOTAL CUMULATIVE RESULTANT MOVEMENT AT NOTED DEPTH SINCE INITIAL READING (mm)	MAXIMUM RATE OF MOVEMENT (mm/yr)	CURRENT STATUS	DATE OF PREVIOUS READING	INCREMENTAL MOVEMENT SINCE PREVIOUS READING (mm)	RATE OF MOVEMENT (mm/yr)	CHANGE IN RATE OF MOVEMENT SINCE PREVIOUS READING (mm/yr)
SI23-1	January 13, 2023	9.7 mm over 3.0 m to 4.8 m depth in 241° direction	32.6 mm/yr in June 2023	Damaged	June 11, 2023	N/A	N/A	N/A

The instruments should be read again in the spring of 2024, if an attempt to repair the SI and VWP is made.

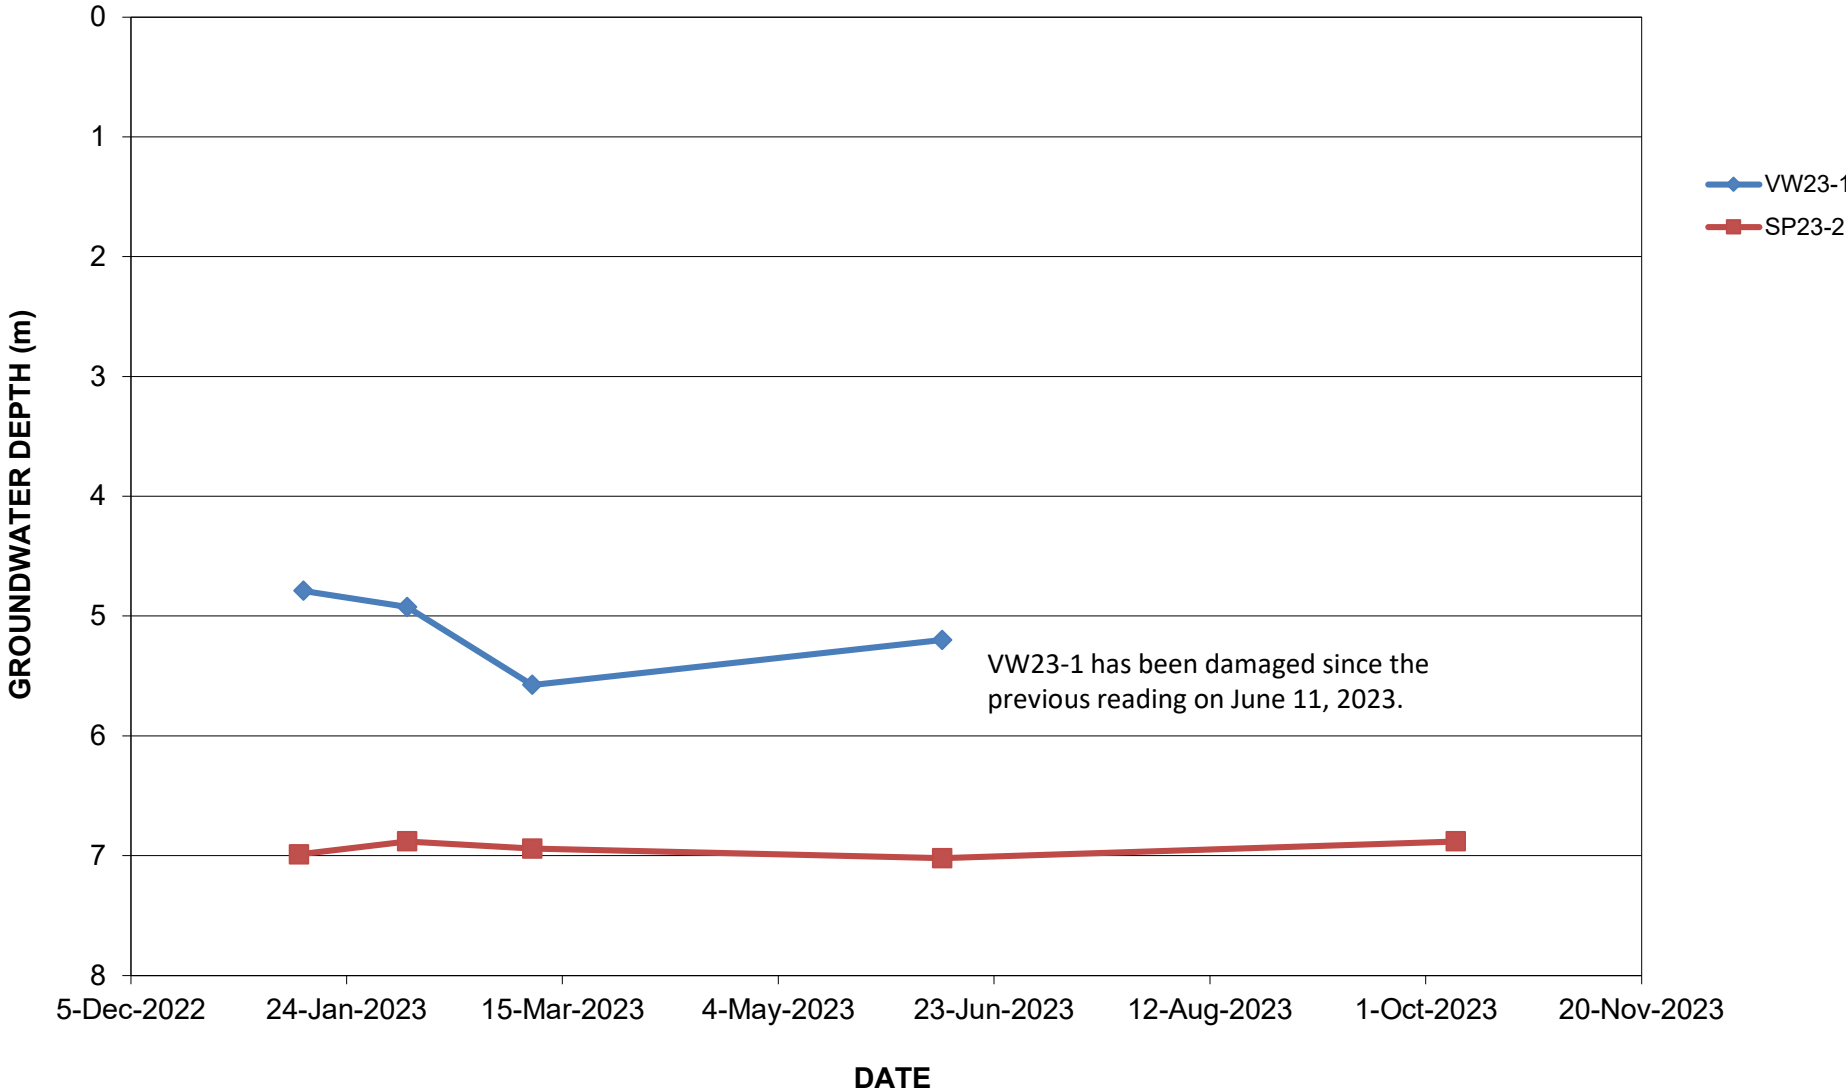
**FIGURE SH037-1
PIEZOMETRIC DEPTHS FOR HWY 747:02 NICHOLLS CREEK SLIDE**

Vibrating wire piezometer VW23-1 has been damaged since the previous reading on June 11, 2023. Standpipe piezometer SP23-2 showed an increase in groundwater level of 0.14 m compared to the previous reading on June 11, 2023. Table SH037-2 summarizes the vibrating wire piezometer readings. Table SH037-3 summarizes the standpipe piezometer readings. Piezometer readings are also plotted in Figures SH037-1 (by depth) and SH037-2 (by elevation) in Appendix A.
