**ALBERTA TRANSPORTATION AND
ECONOMIC CORRIDORS
GEOHAZARD ASSESSMENT PROGRAM
PEACE REGION - SWAN HILLS
2024 INSPECTION**

Site Number	Location	Name	Hwy	km
SH037-1	Southwest of High Prairie	Nicholls Creek Slide	747:02	35.2
Legal Description		UTM Co-ordinates		
SW09-74-19-W5		11U N 6,138,622	E 508,118

**SH037: HWY 747:02 km 35.2 NICHOLLS CREEK
2024 SITE INSPECTION PLAN**

DWG NO. 32121-SH037-1

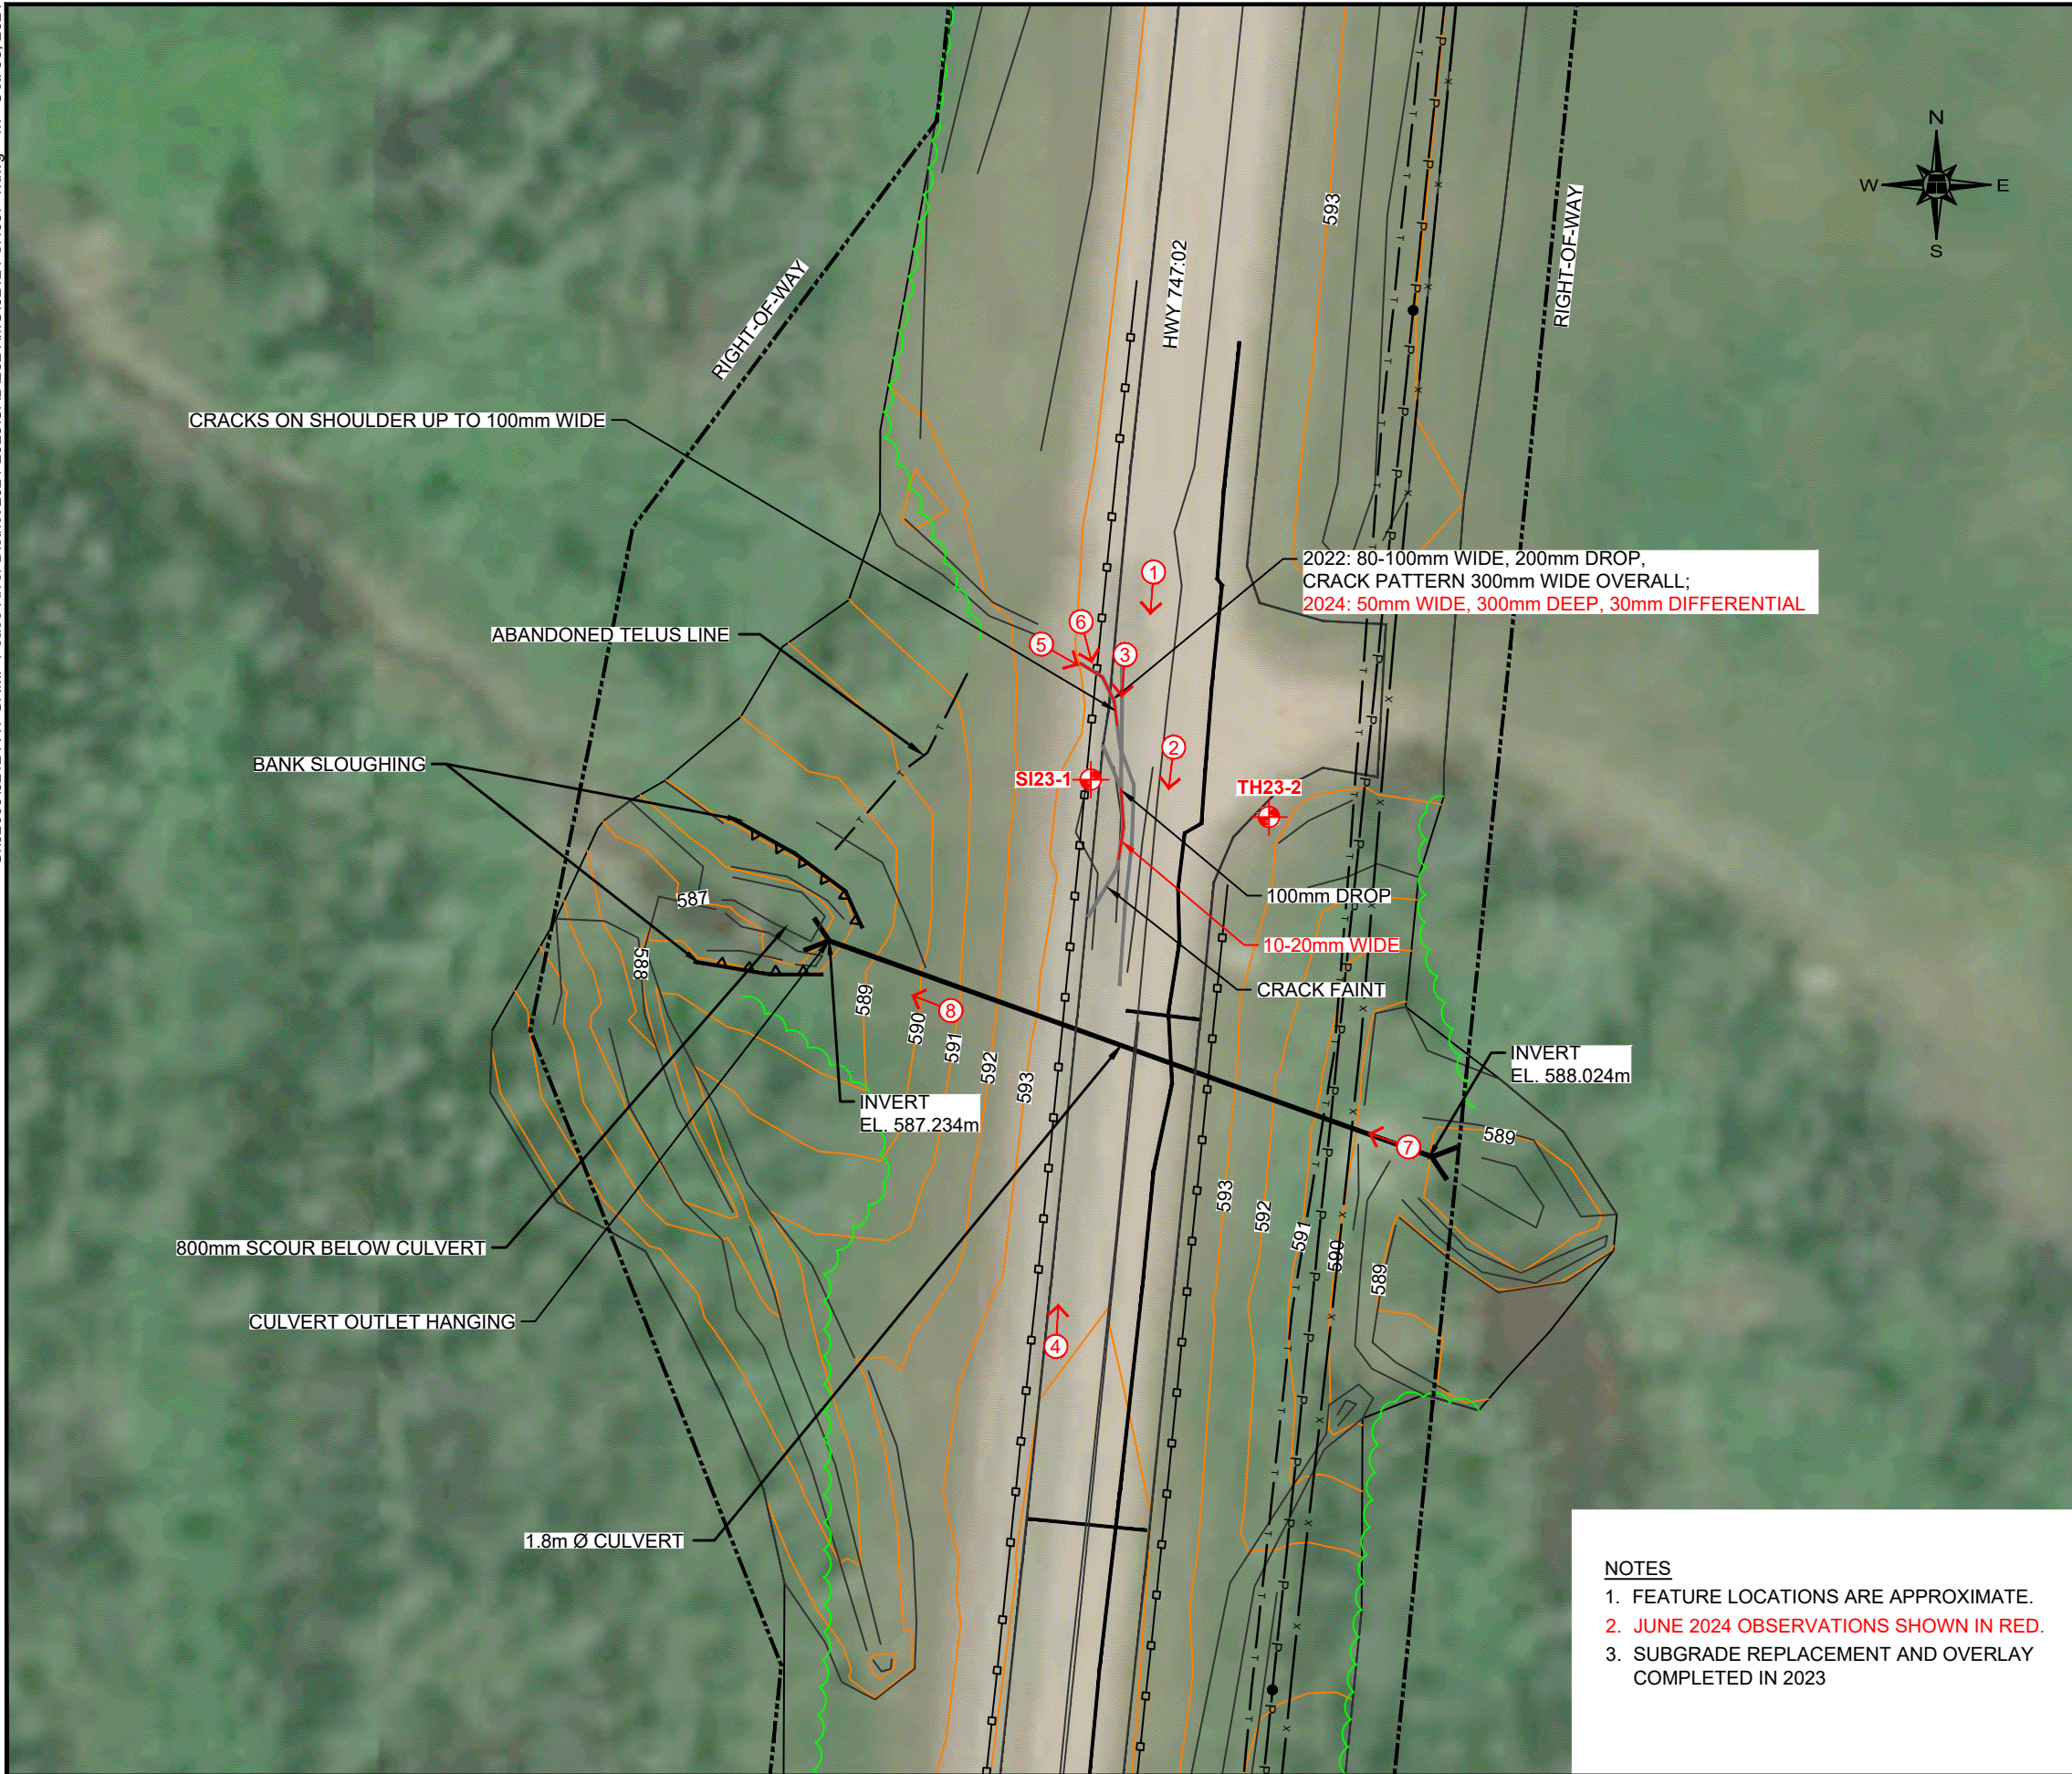
Observations:	Description	Worsened?	
<input checked="" type="checkbox"/> Pavement Distress	The main scarp has resurfaced after the subgrade replacement and overlay. The scarp crack has extended into the highway west of the fogline. Tension cracks reappeared where main scarp was previously present on the SBL.	<input checked="" type="checkbox"/>	
<input checked="" type="checkbox"/> Slope Movement	The landslide occurred within the west embankment fill adjacent to BF71661 (Nicholls Creek). On the west side of the highway a deep scour hole is present at the culvert outlet and the creek bank has eroded and sloughed into the river. Loss of support at the toe of the fill has contributed to the instability. Based on SI23-1 the base of the slide is about 3.5 m BGS. The flank of the slide continues into the tree line; no toe roll was observed.	<input checked="" type="checkbox"/>	
<input checked="" type="checkbox"/> Erosion	There is some bank erosion on the south side of the highway along Nicholls Creek and on either side of the culvert outlet.	<input type="checkbox"/>

Since the main scarp has resurfaced after the subgrade repairs and pavement overlay, we recommend proceeding with the detailed design for this landslide repair which consists of sub-excavating the failed slide mass down to intact foundation soil, rebuilding the slope with a compacted clay fill toe berm to a slightly flatter 4.5H:1V inclination, and extension of the culvert outlet to accommodate the toe berm. The 2021 BIM inspection report for BF71661 noted it was constructed in 1961 and had an estimated replacement year of 2024. Although there may be some opportunity to combine work packages for both sites into a single tender the urgency of the slide repair likely negates this option.

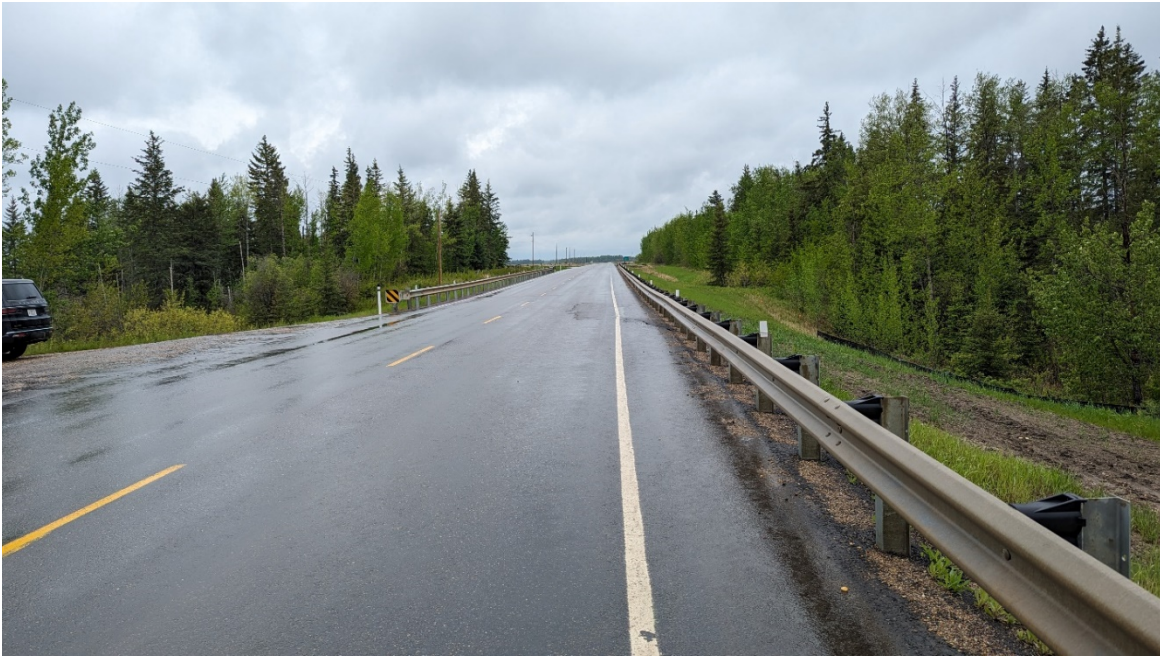
Photo 1 – Looking south along southbound lane from the north end of site. The scarp that has retrogressed into the highway is visible on the shoulder.

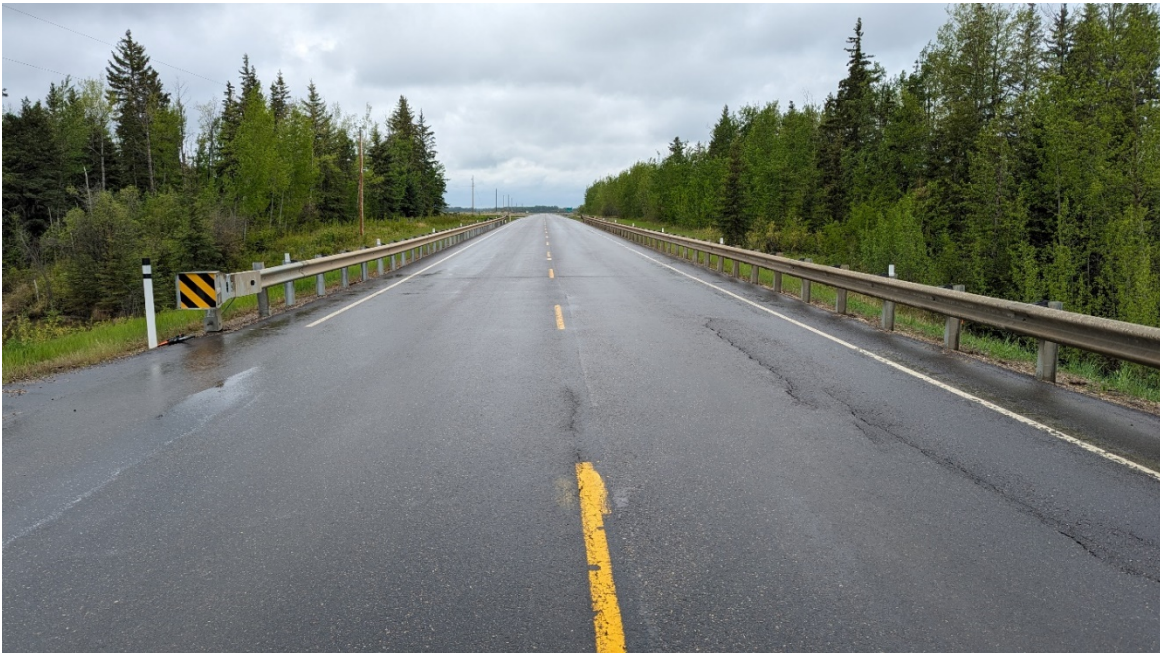
Photo 2 – Looking north along the centerline of highway. Tension cracks resurfacing on southbound lane. New guardrails installed on both sides of the highway.

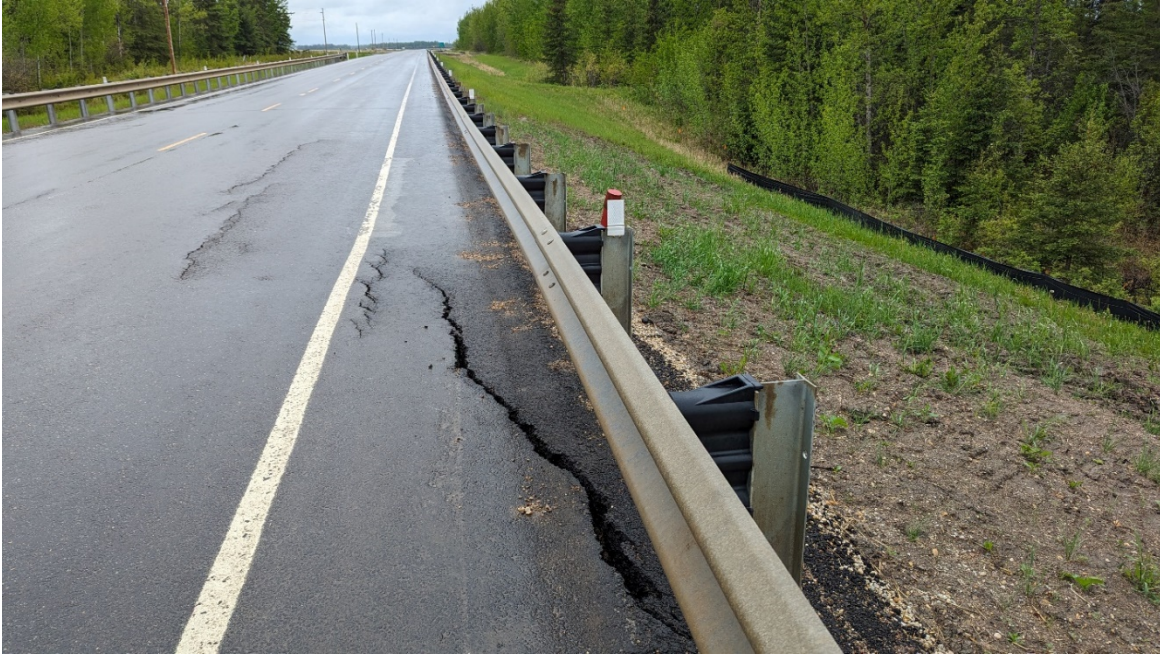
Photo 3: Looking south at scarp crack that retrogressed into the highway. Tension cracks observed along the southbound lane.

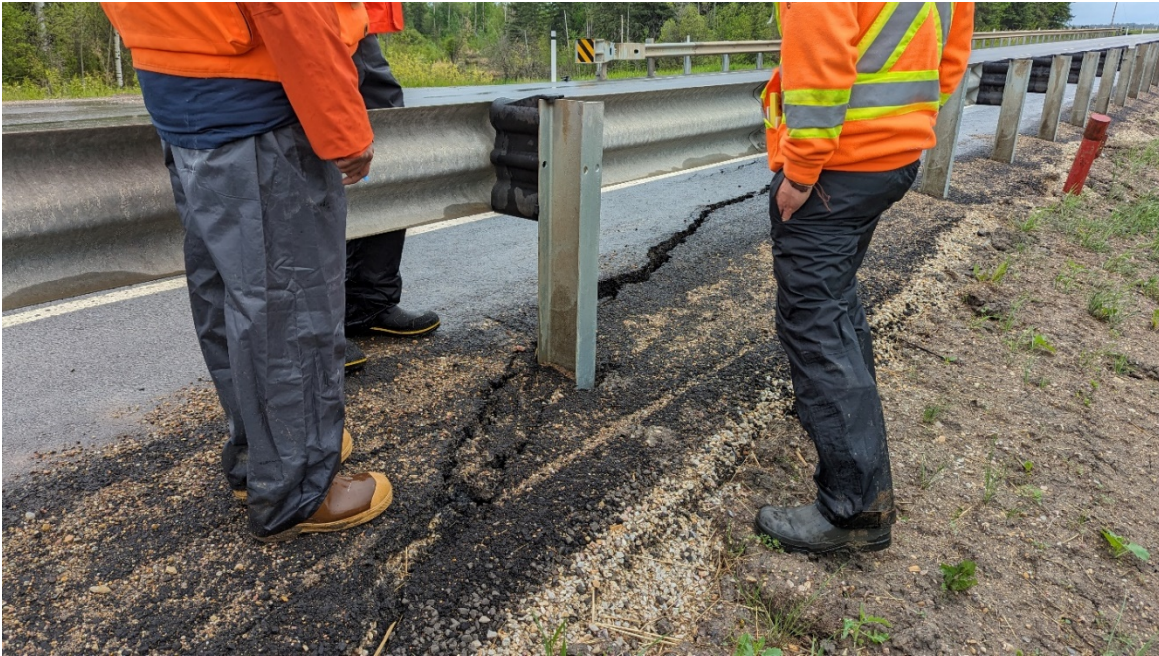
Photo 5: A close look at open cracks on the highway SBL shoulder.

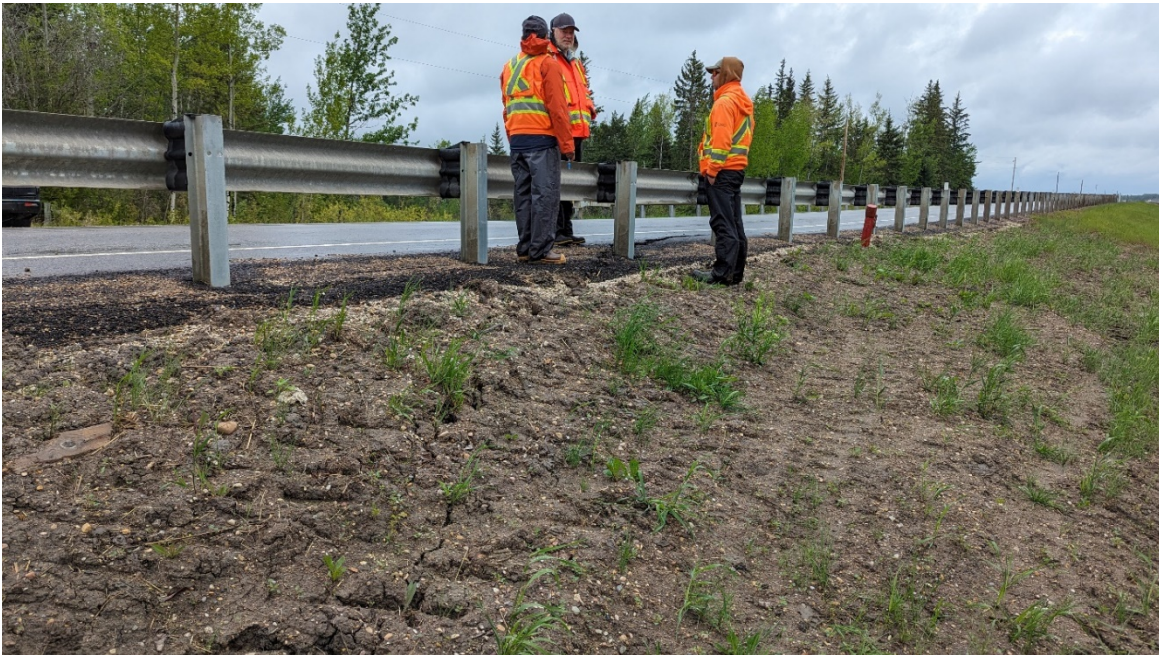
Photo 6: Looking southeast at crack that has retrogressed towards the highway.

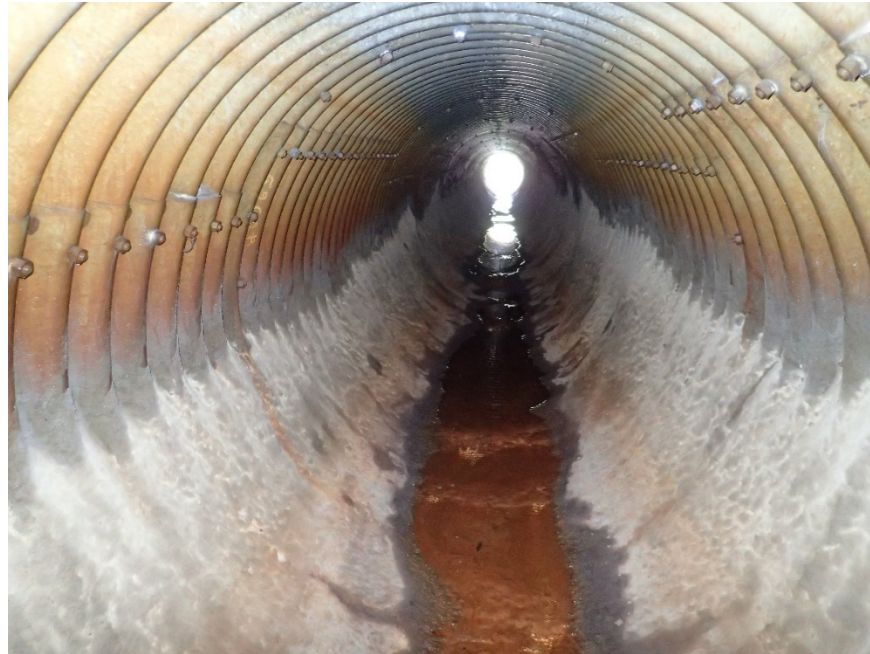
<input checked="" type="checkbox"/> Bridge/Culvert	The culvert outlet had about 800 mm of scour below it. The concrete apron at the outlet also has extensive cracks and perforations. This was not visible during the 2024 inspection due to a higher water level in the creek. Walk through of culvert was completed and there was no obvious sidewall distortion of the culvert.	<input type="checkbox"/>
<input type="checkbox"/> Other		<input type="checkbox"/>

Photo 7: Walk through of culvert conducted and indicated no obvious sidewall distortion.

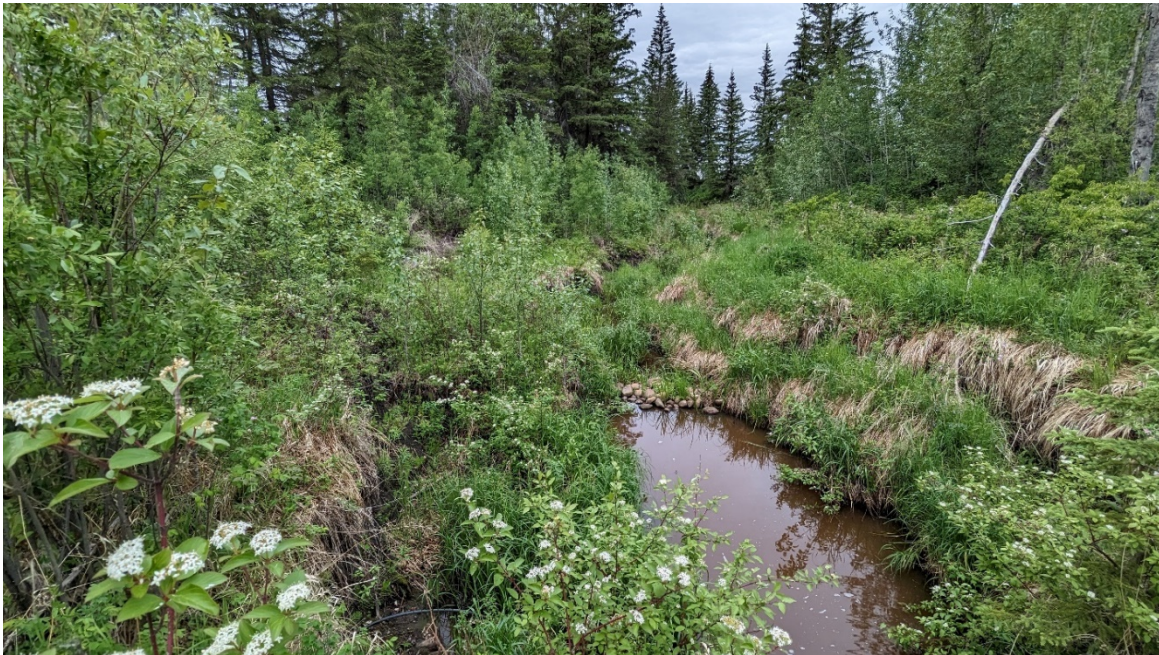
Photo 8: Looking west from above the culvert outlet location at creek and bank erosion.
