**ALBERTA TRANSPORTATION
GEOHAZARD ASSESSMENT PROGRAM
PEACE REGION – PEACE RIVER DISTRICT
2024 CALL OUT INSPECTION**

Site Number	Location	Name	Hwy	km
SH037	S of High Prairie	Nicholls Creek Slide	747:02	35.2
Legal Description		UTM Co-ordinates (NAD 83)		
SW09-74-19-W5		11U N 6,138,622	E 508,118

Date	PF	CF	Total
Previous Inspection:	August 9, 2022	12	4	48
Current Inspection:	July 12, 2024	12	4	48
Road AADT:	600	Year:	2023	
Inspected By:	Don Proudfoot, Nicole Wilder (Thurber)			
Report Attachments:	<input checked="" type="checkbox"/> Photographs <input checked="" type="checkbox"/> Plans <input type="checkbox"/> Maintenance Items

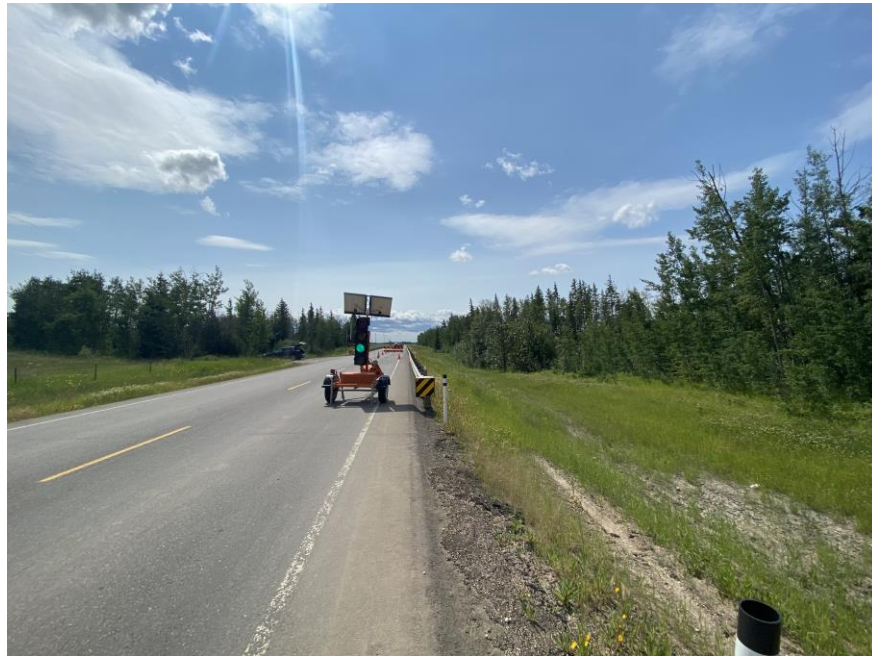
Photo 1. Looking south at traffic lights set up for the one lane closure. Photo credit: Don Proudfoot.

In the short term, the slide should be regularly monitored for regression of the slide scarp, which could require jersey barriers and widening of the highway on the east side for a detour, if it retrogresses.

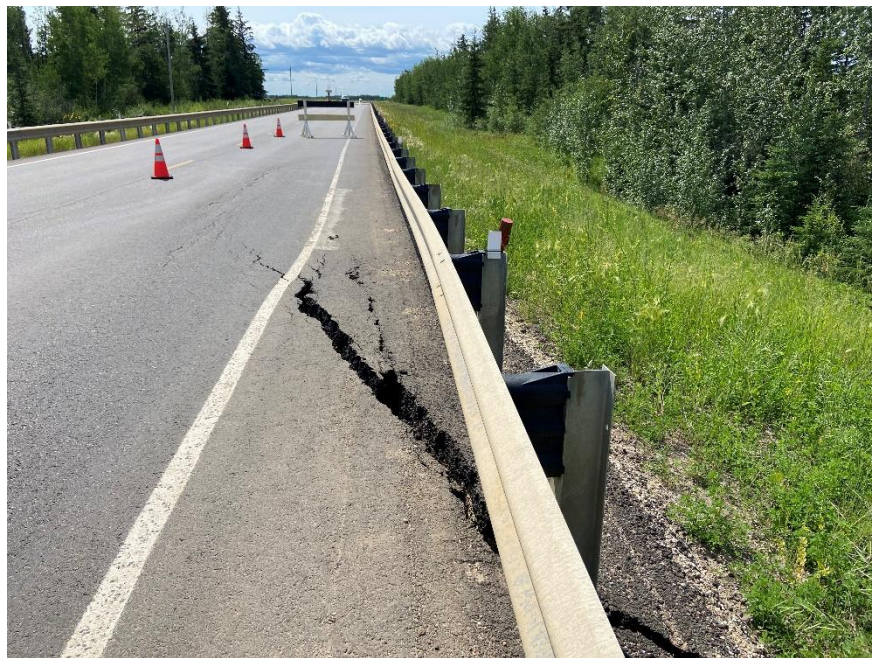
During the 2024 inspection, the pavement in the southbound lane had dropped approximately 110 mm over about 15 m length, hence why it was blocked off from traffic. There is also a substantially large crack in the shoulder up to 280 mm wide and about 800 mm deep within the open crack. The recent landslide crack was tracked using a hand-held GPS unit which is typically accurate to approximately 3 to 5 m. The scarp crack generally follows the same outline as the previous backscarp in 2023.

Photo 2. Looking south at crack open to 280 mm wide in the southbound lane shoulder. Photo credit: Don Proudfoot.

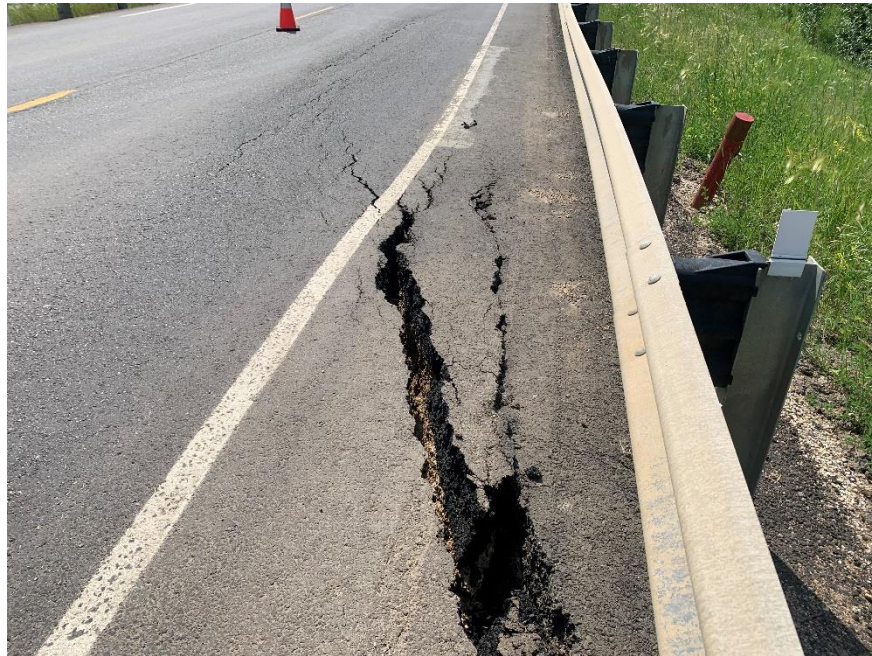
Photo 3. Looking south closer at the crack in the highway shoulder. Photo credit: Nicole Wilder.

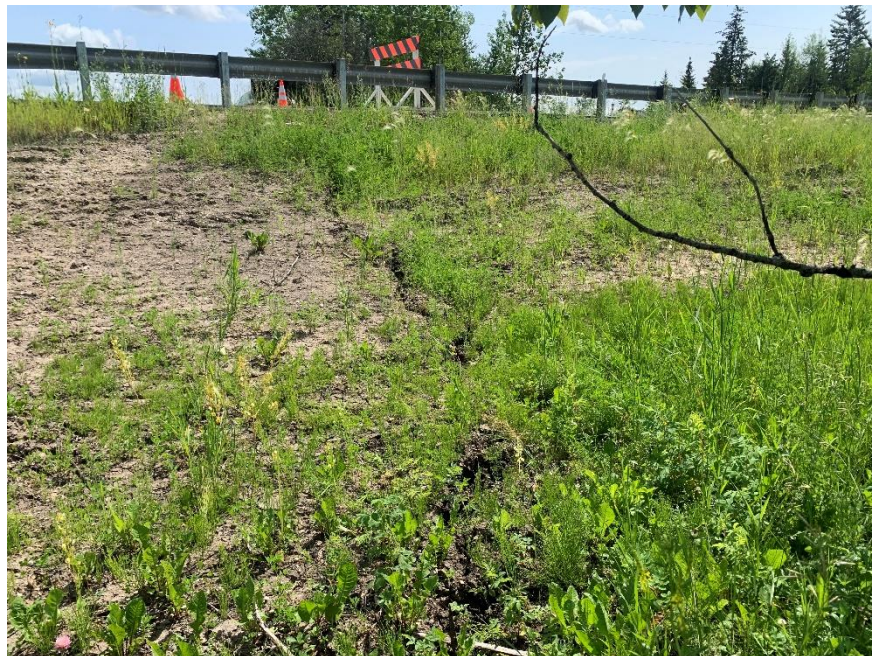
Photo 4. Looking east at the scarp crack that continues in the highway embankment. Photo credit: Nicole Wilder.

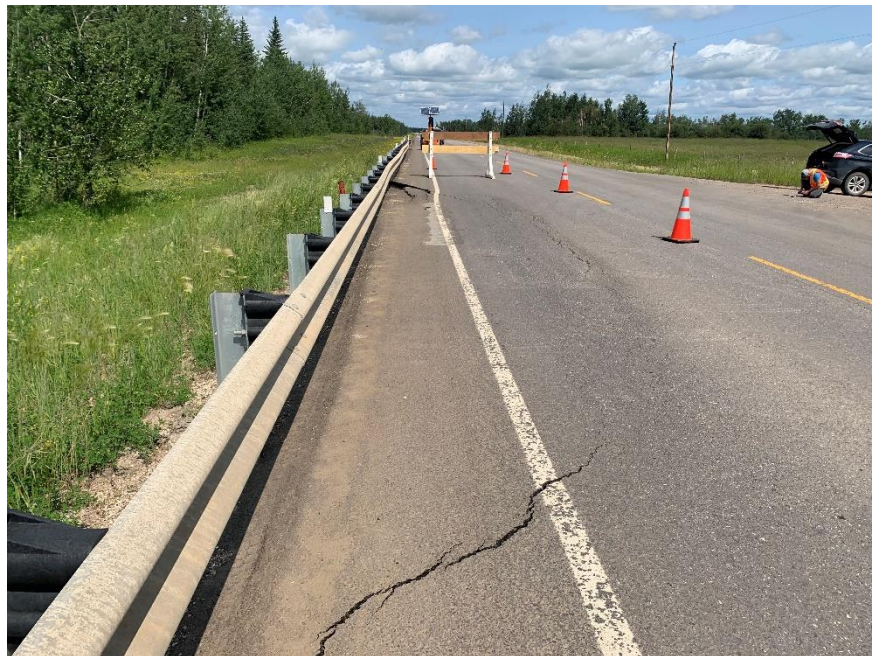
Photo 5. Looking north at the scarp crack arch in the southbound driving lane. Photo Credit: Don Proudfoot.

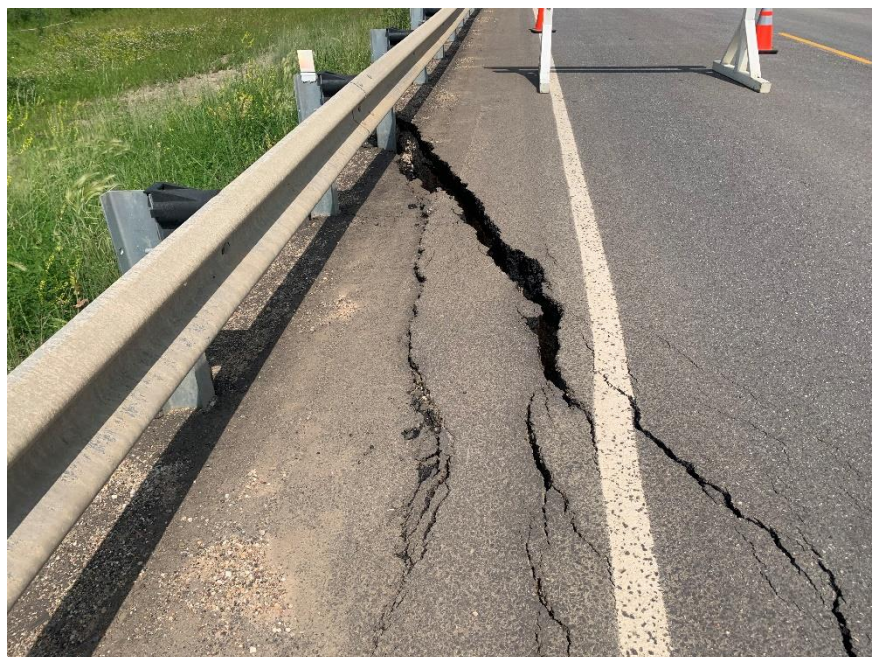
Photo 6. Looking north at the scarp crack leading into the shoulder and embankment. Photo Credit: Nicole Wilder.

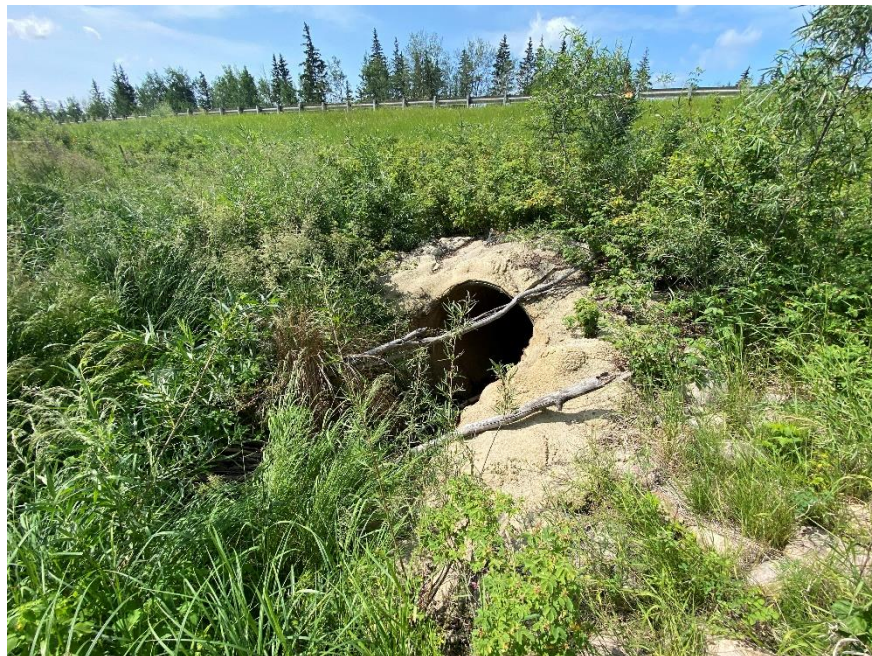
The creek appears to be eroding/undercutting the bank which causes overhang to slough into the creek and this process continues to retrogress towards the highway, the erosion is now behind the culvert outlet and there was also a scour hole below the culvert outlet noted previously.

Photo 7. Looking east at the culvert outlet. Photo Credit: Nicole Wilder.

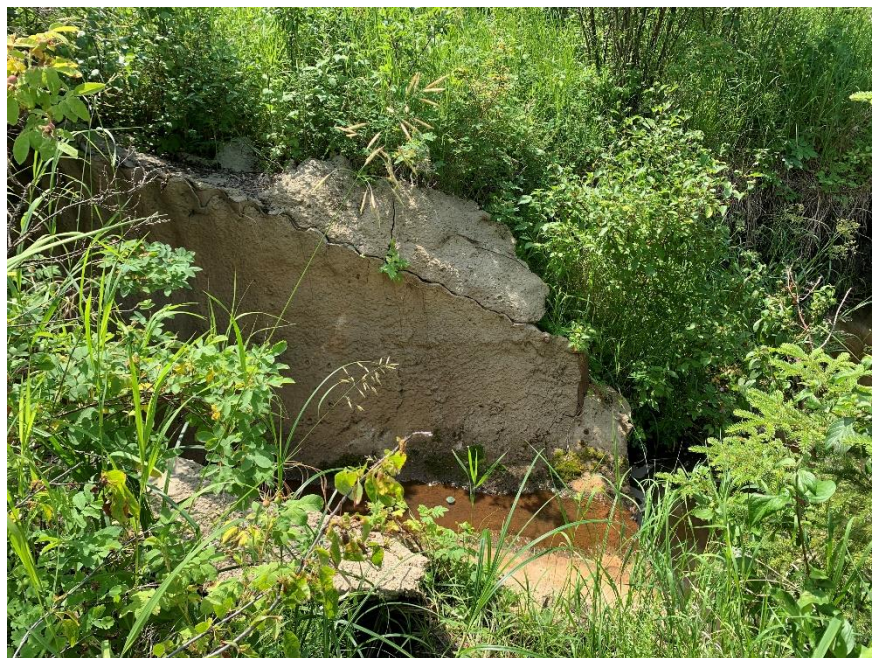
Photo 8. Looking south at the culvert outlet and higher water in the creek. Photo Credit: Nicole Wilder.

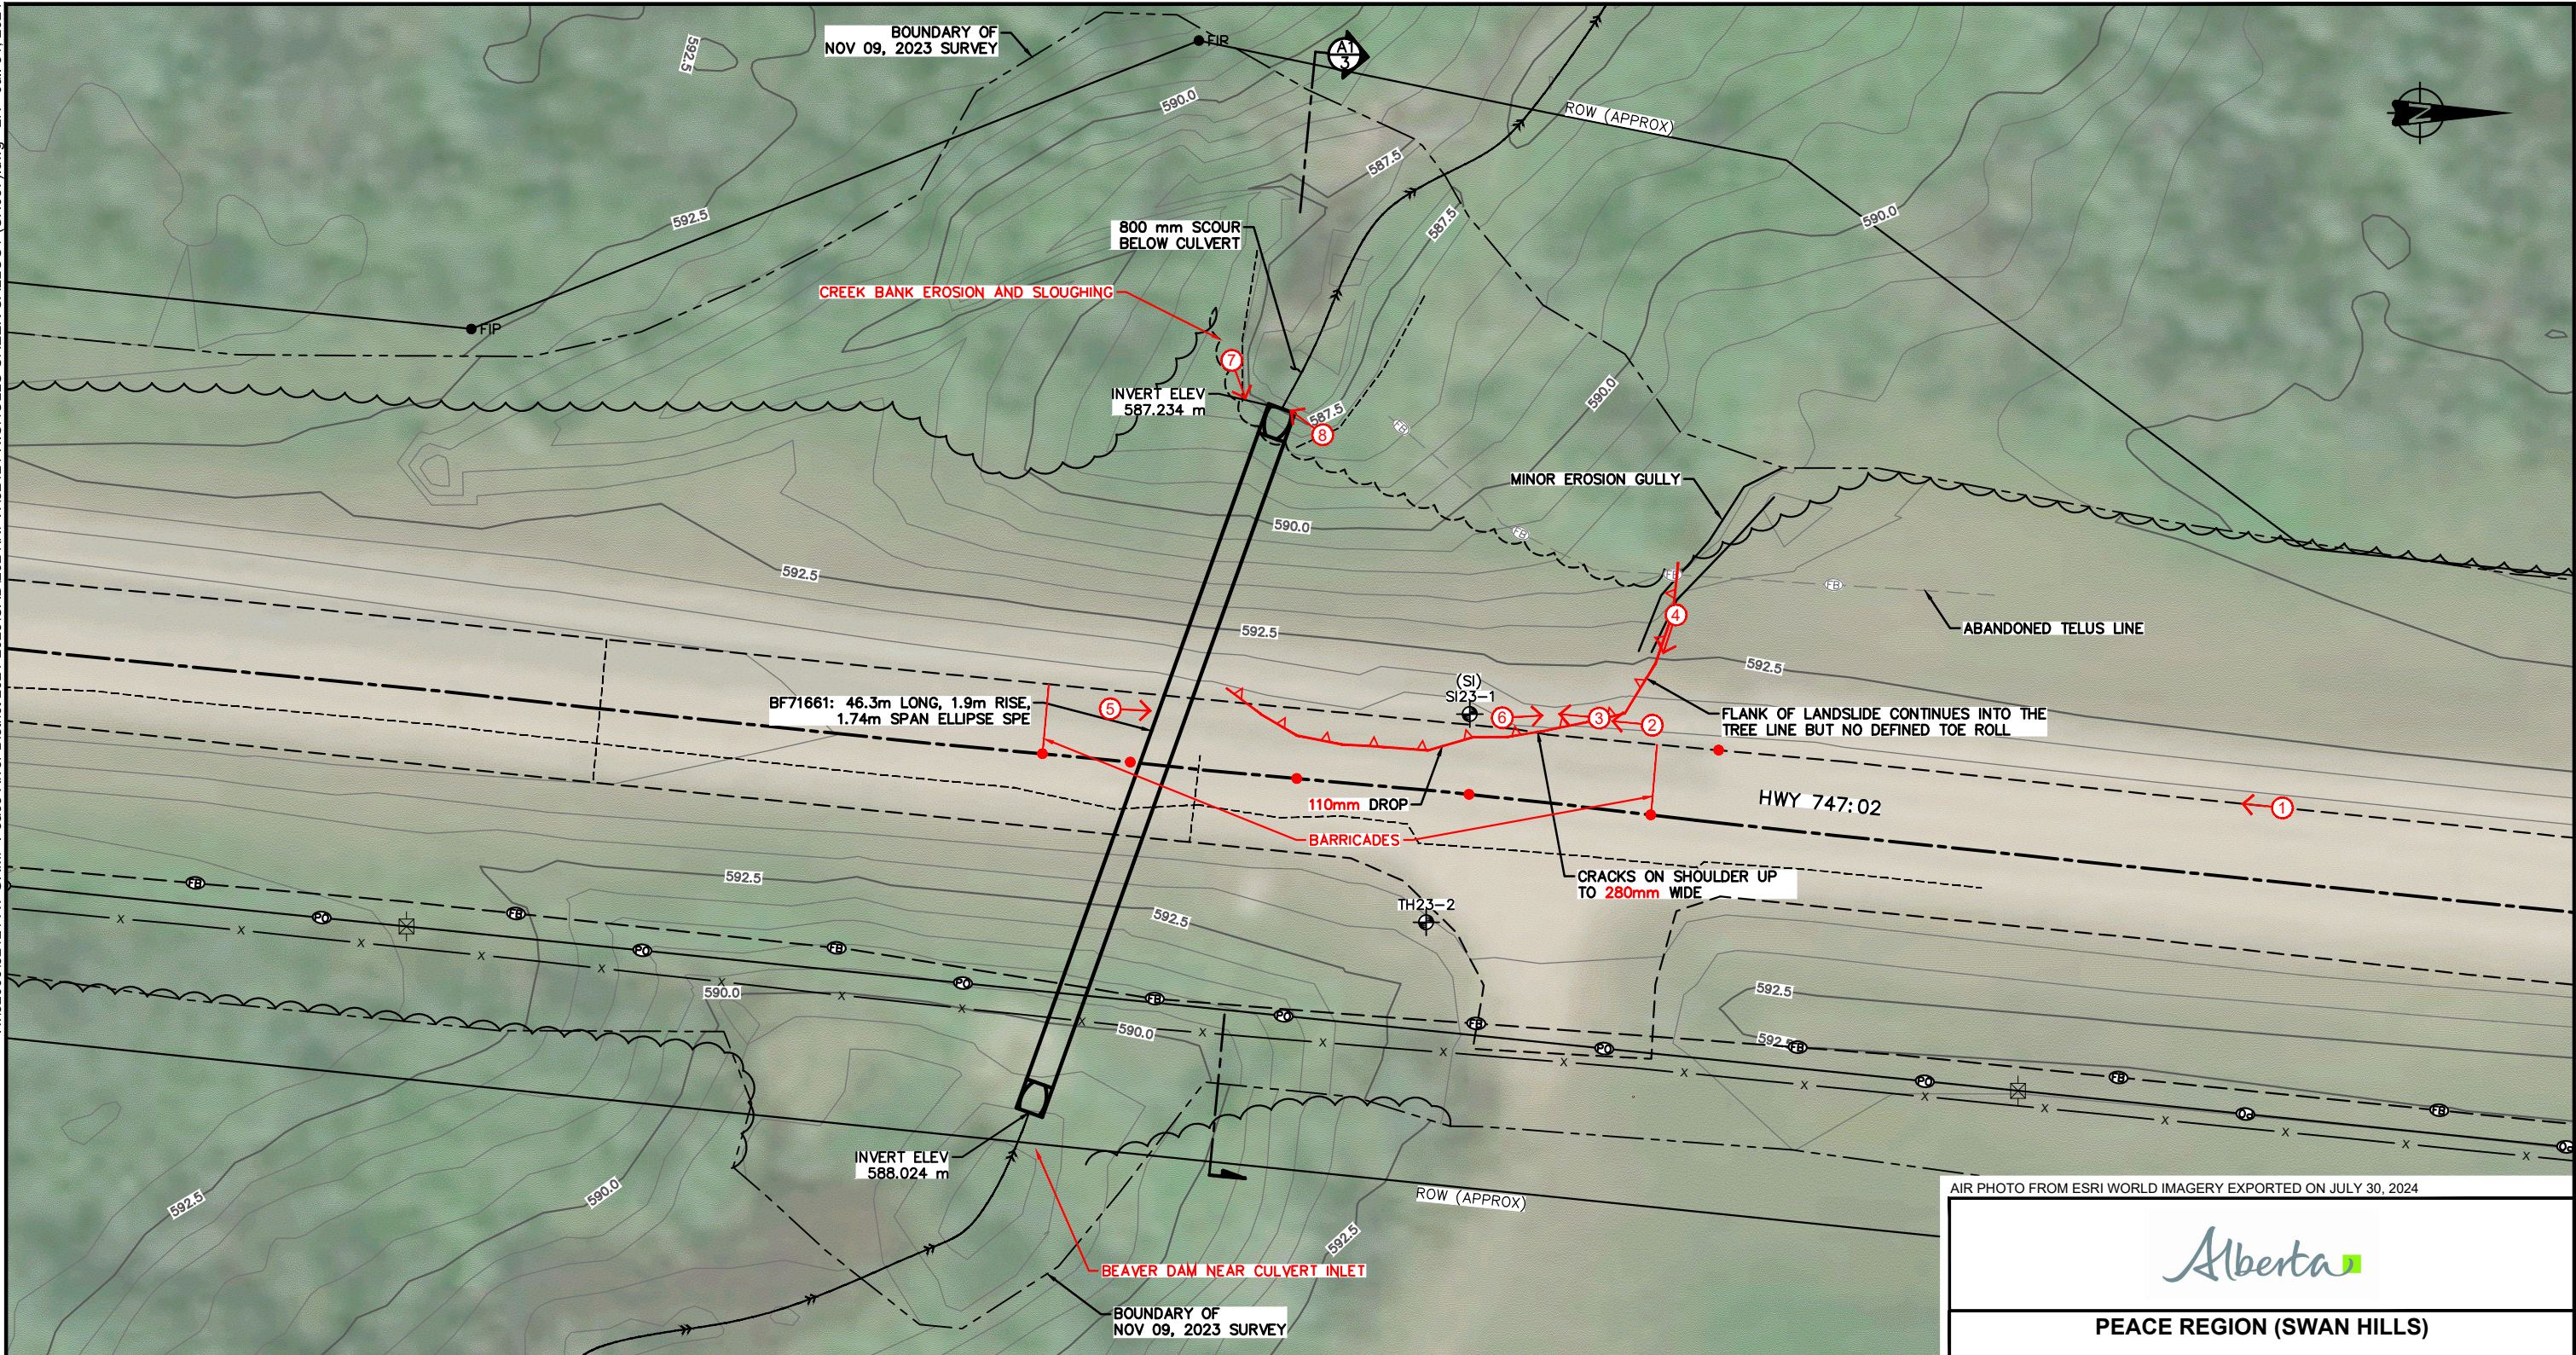
**HWY 747:02 NICHOLLS CREEK LANDSLIDE (SH037)
2024 CALLOUT PLAN**

Primary Site Issue:	Landslide in a 3.5 m high embankment above a culvert on the west side of the highway with a backscarp 2 m into pavement.	
Dimensions:	The landslide is about 15 m wide (on highway) and has about 110 mm drop in the asphalt along the backscarp.	
Date of any remediation:	The site had a subgrade replacement completed in 2023 along with a pavement overlay.	
Maintenance:		
Observations:	Description	Worse?
<input checked="" type="checkbox"/> Pavement Distress	The main scarp extends into the highway and a portion of the southbound lane has about a 110 mm drop, has been closed off to traffic by barricades and traffic lights are being used to alternate traffic through the one open lane. There are also cracks open to 280 mm wide on the southbound lane shoulder and about 800 mm deep within the open crack.	<input checked="" type="checkbox"/>
<input checked="" type="checkbox"/> Slope Movement	The landslide occurred within the west embankment fill adjacent to the meandering Nicholls Creek. On the west side of the highway the creek bank has eroded and has sloughed into the river causing it to retrogress towards the highway. The flank of the slide continues into the tree line, but no toe roll was observed.	<input checked="" type="checkbox"/>

It is anticipated that the landslide was triggered by creek erosion and continues with moderate but increasing rate of movement. Weak embankment materials and a steep embankment slope (approximately 20 degrees) have likely contributed to causing the slide. The main scarp extends into the highway and could eventually retrogress further and affect both lanes of the highway.

We recommend proceeding with the detailed design for this landslide repair which consists of sub-excavating the failed slide mass down to intact foundation soil and rebuilding the slope with a compacted clay fill toe berm to a slightly flatter 4.5H:1V inclination. The new fill material should be placed and compacted in thin horizontal lifts, benched into the intact slope surface. The more suitable excavated clay material could be used as backfill, with any excess removed from site. The existing culvert will also be rehabilitated, extended and surrounded with Des. 2 Class 25 gravel with a compacted clay seal on the end. The creek channel will require some channel excavation and be armoured with Class 3 riprap and two Class 1 riprap swales will be constructed on either side of the toe berm that lead to the newly armoured creek channel. A water act permit might be required to perform in-stream work. Thurber can provide a proposal to provide an updated detailed design, tender and C-estimate, which will likely require an additional site survey.
