**ALBERTA TRANSPORTATION AND
ECONOMIC CORRIDORS
GEOHAZARD ASSESSMENT PROGRAM
PEACE REGION -SWAN HILLS
2024 INSPECTION**

Site Number	Location	Name	Hwy	km
SH014-1	Northeast of High Prairie	Salt Creek Slide	750:02	30.57
Legal Description		UTM Co-ordinates		
NE34-76-14-W5		11U E 558,308	N	6,165,584

SH014-1: HWY 750:02 SALT CREEK SLIDE
2024 SITE INSPECTION PLAN

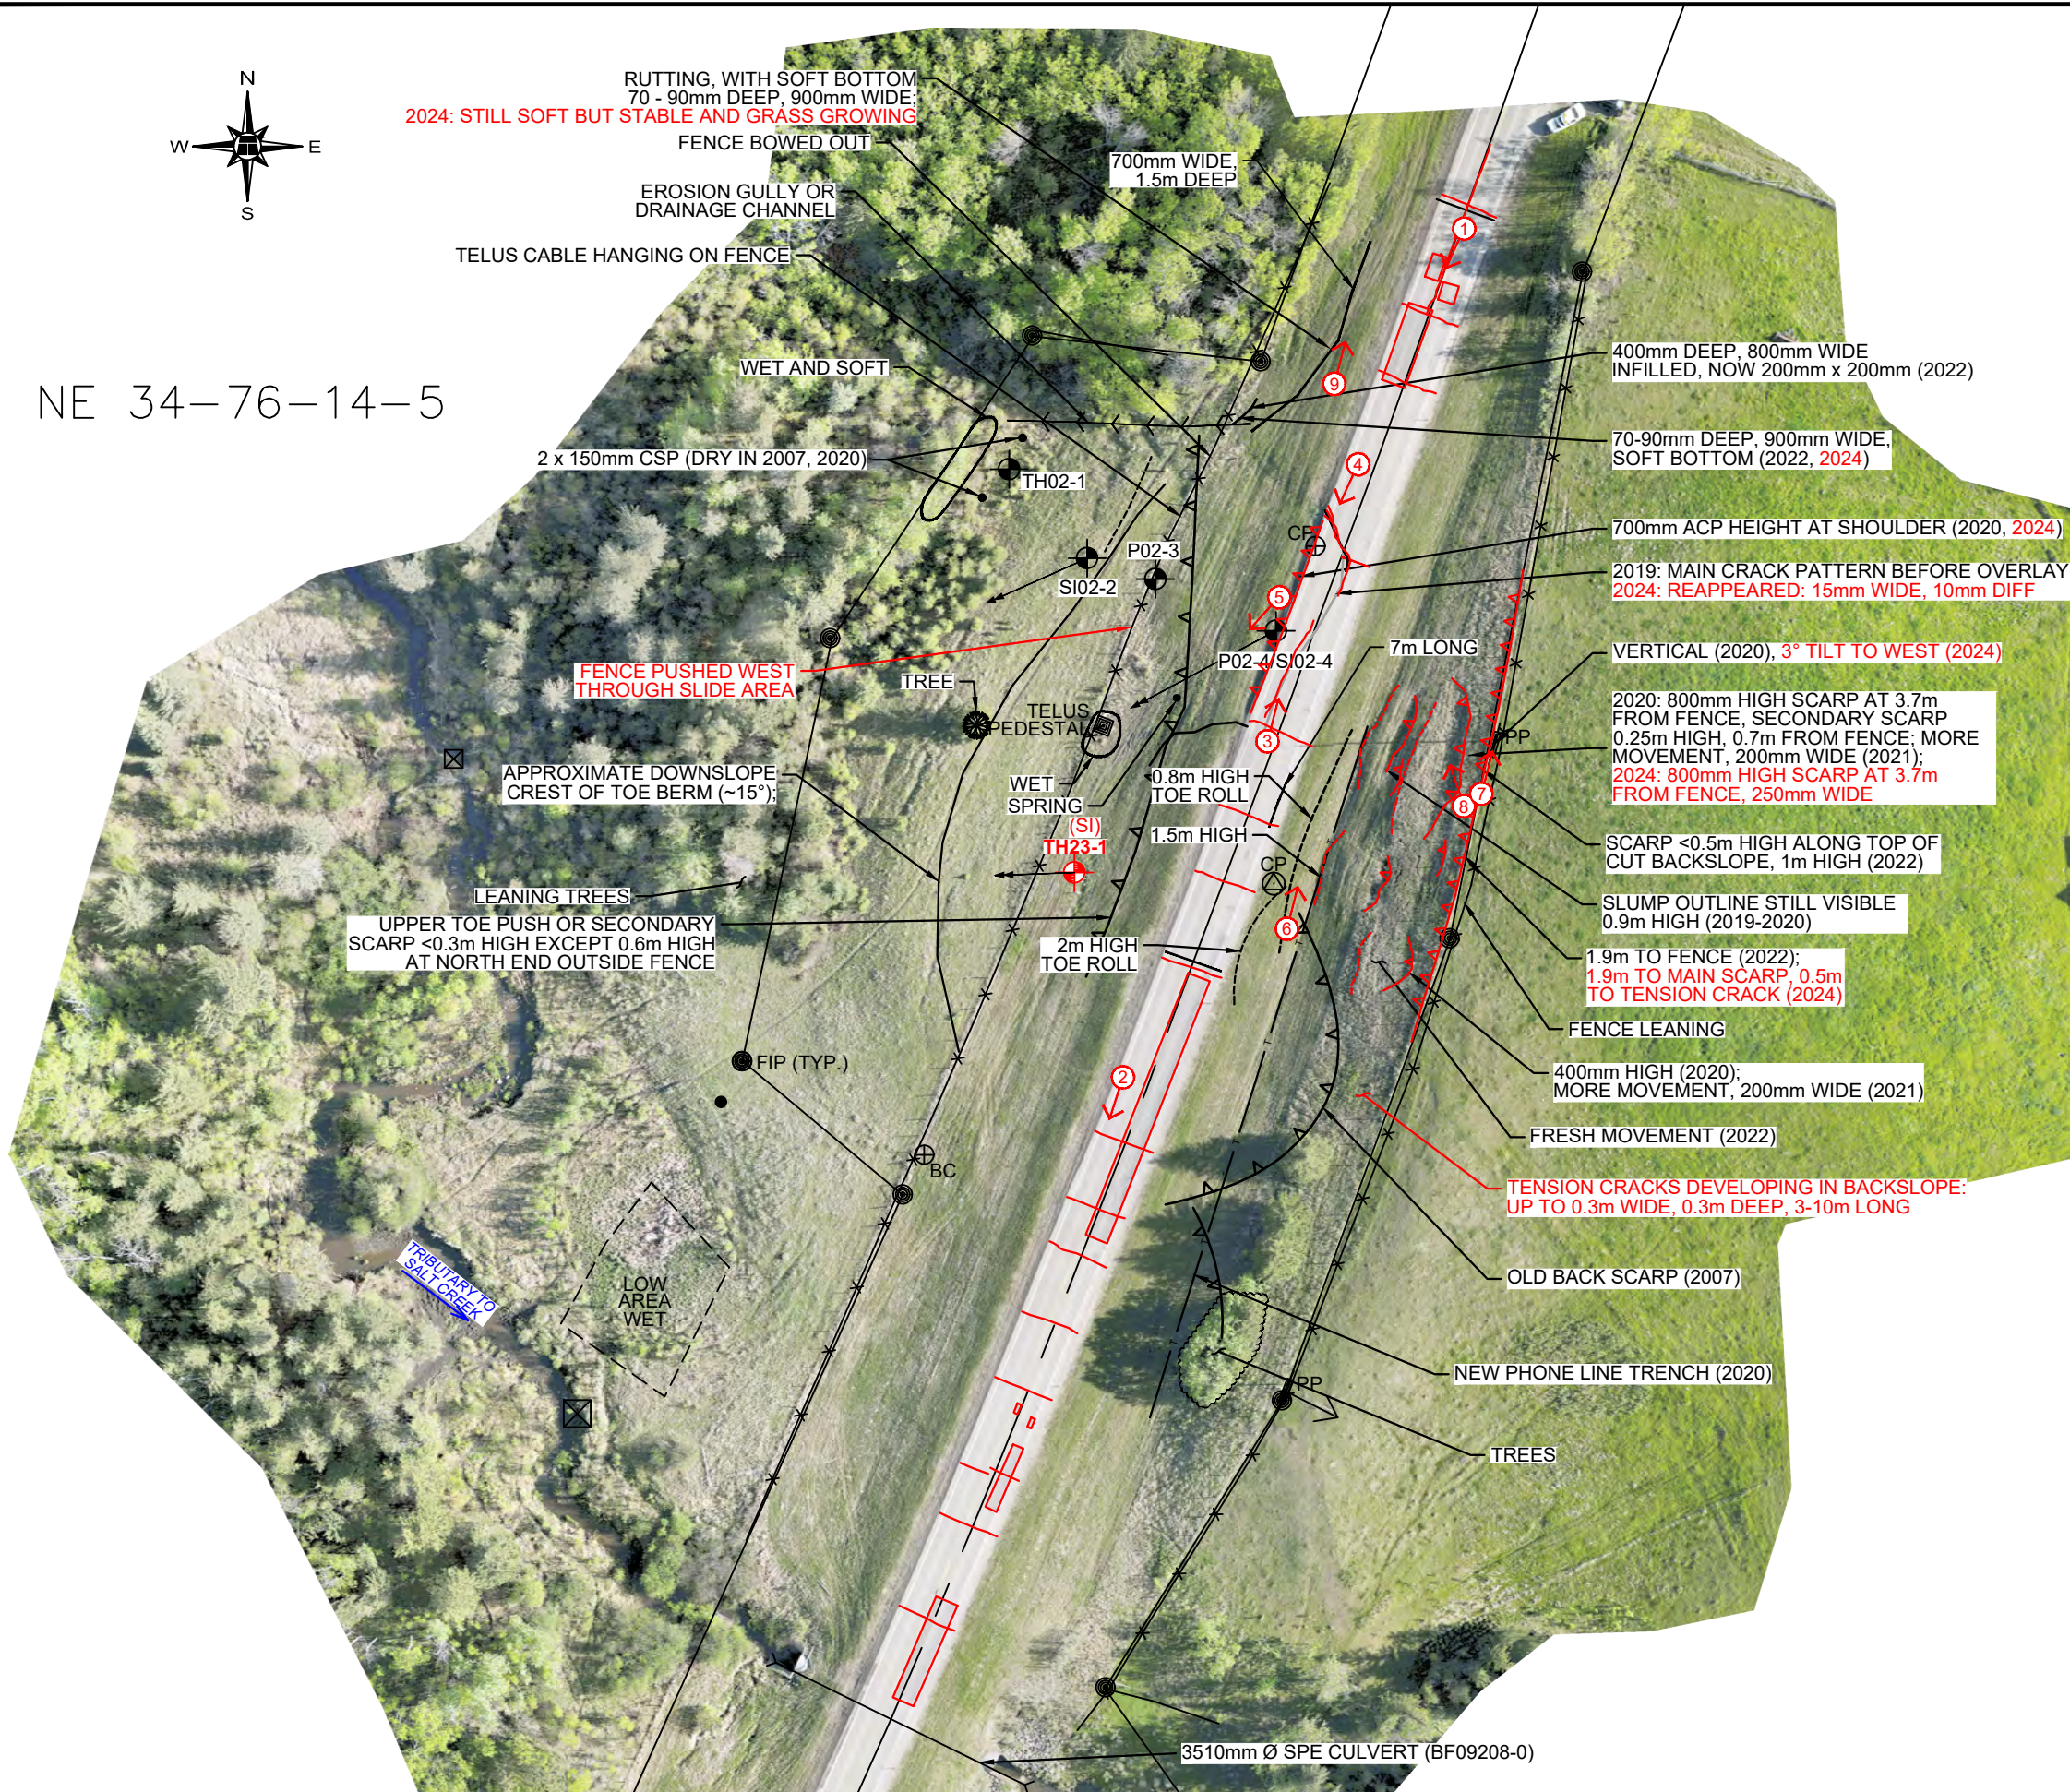
DWG No. 32121-SH014-1-1

As shown on Drawing 32121-SH014-1, the old inclinometer movement vectors show the slide is moving along an azimuth of about 242 degrees, nearly perpendicular to the general creek alignment and at a 50° skew to the highway.

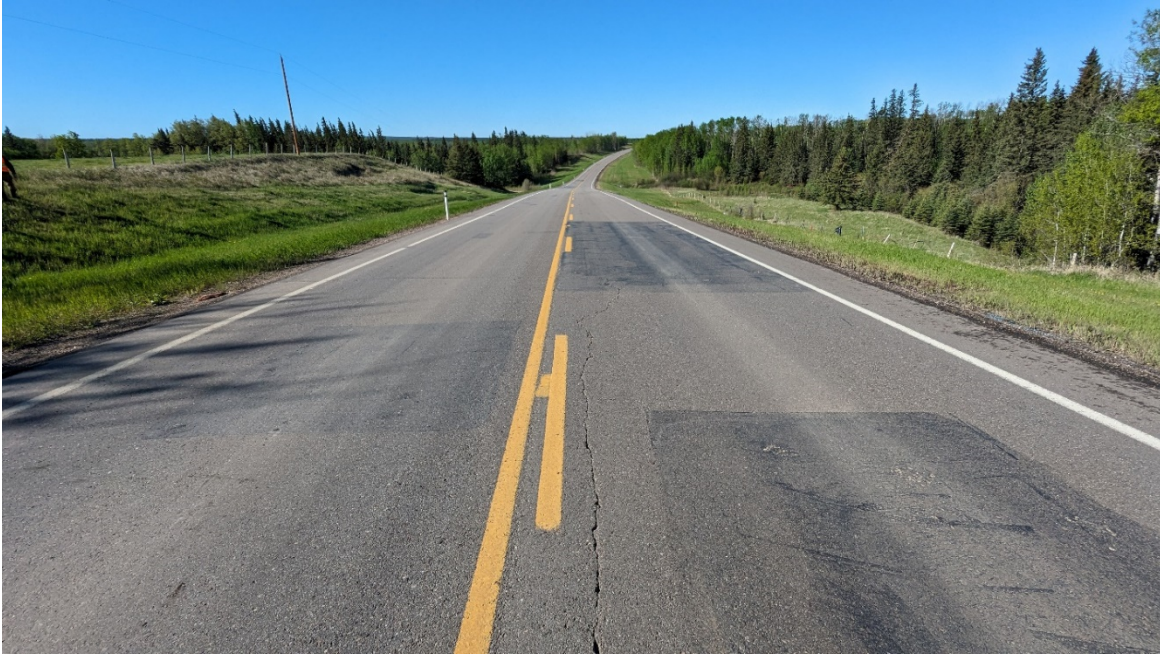
Photo 1 – Looking south at the highway surface from the northern limit of the site.

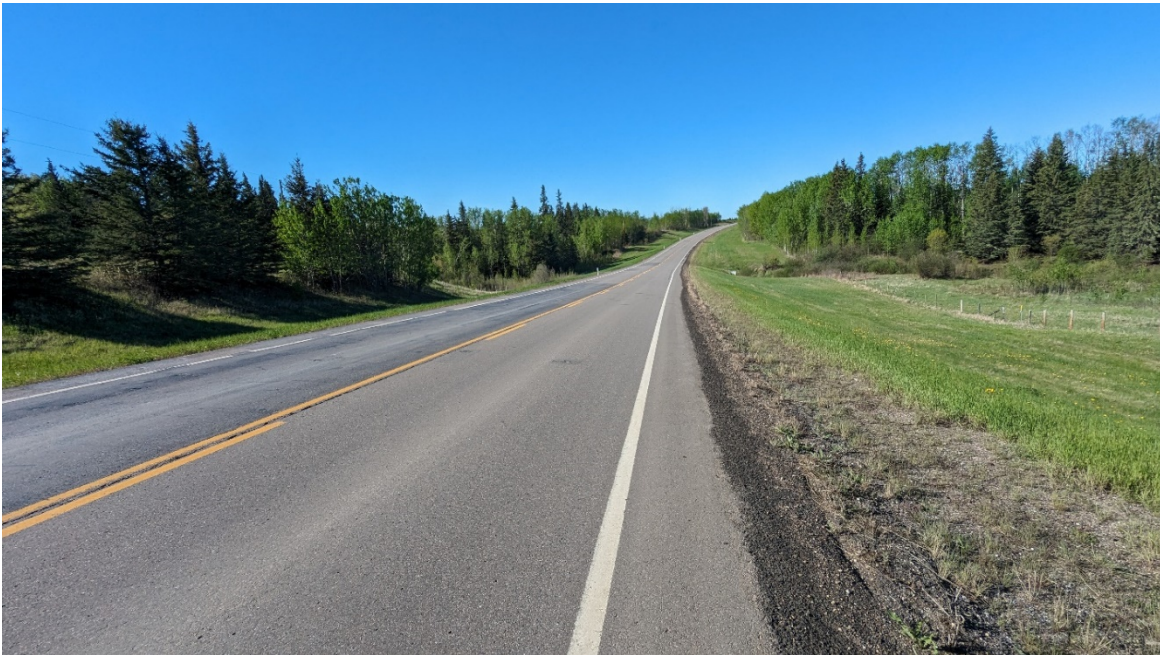
The dominant crack was about 33 m in length with an approximately 20 m long dip on the west side of the crack that had dropped about 30 mm. Crack widths were typically 20 mm to 30 mm wide. These cracks were mostly obscured by the 2022 overlay. The main crack reappeared and was 15 mm wide and had 10 mm of vertical displacement. The movements were attributed to the upper, shallower slide block. There is some concern that the extent of the overall slide may be larger than previously thought and affecting a greater length of paved roadway. This was evidenced by a previous 115 m long full width pavement patch that spans from the north approach to 30 m south of the extent of the main crack. During the 2024 inspection, there were smaller patches within this area, north of the main crack. It is possible that movement on the lower slide block may be contributing to this greater extent. There were a few long patches observed along the northbound lane, south of the main crack during the 2024 inspection.

Photo 2 – Looking south at patches along the NBL towards the south end of site.

- The MCI should regularly monitor this area for further movements or enlargement. Crack sealing and patching should be undertaken as required.

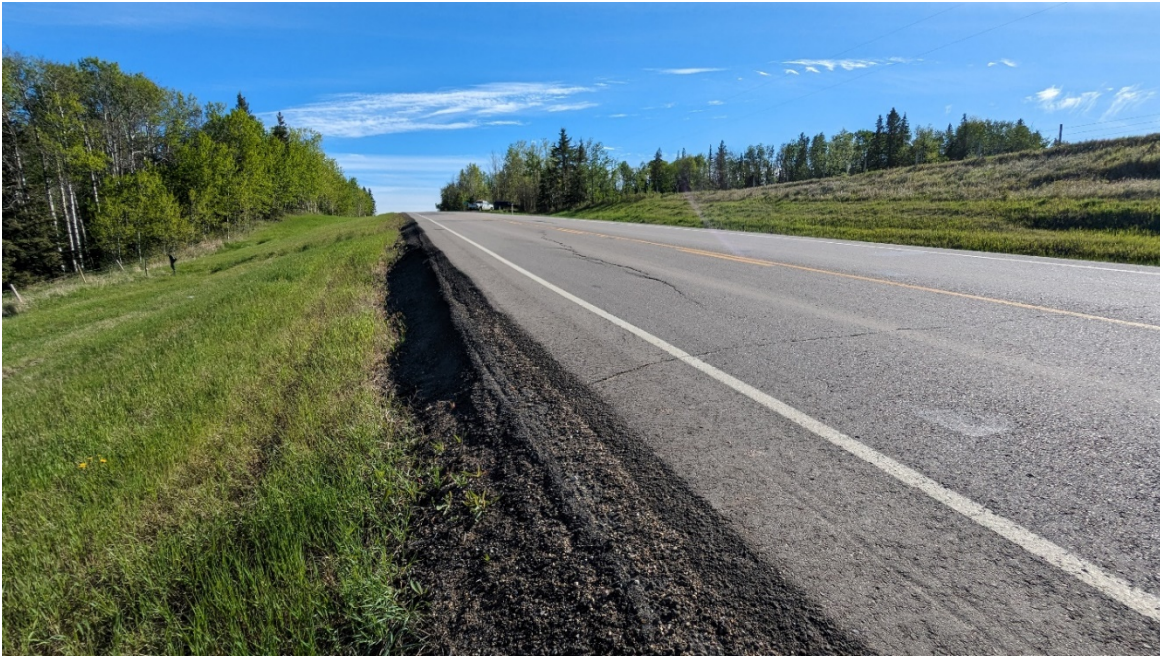
Photo 3 – Looking north at the highway surface at south extent of main crack. Significant thickness of asphalt is visible at the edge of the road.

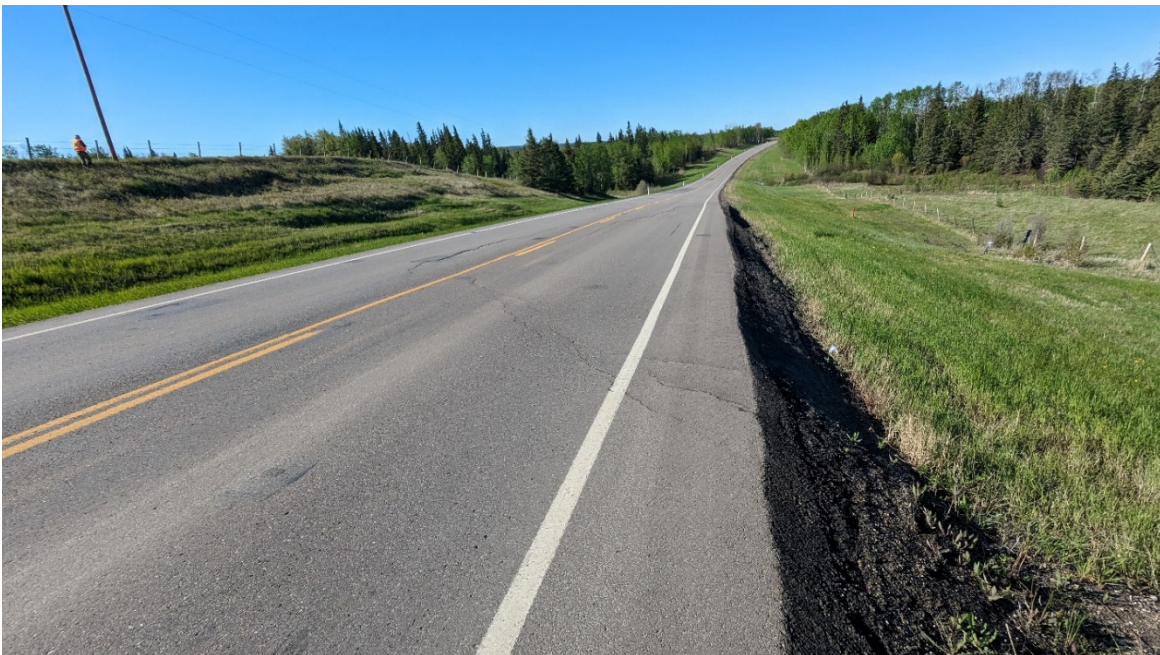
Photo 4 – Looking southeast at a main crack that has resurfaced near the north end of the site.

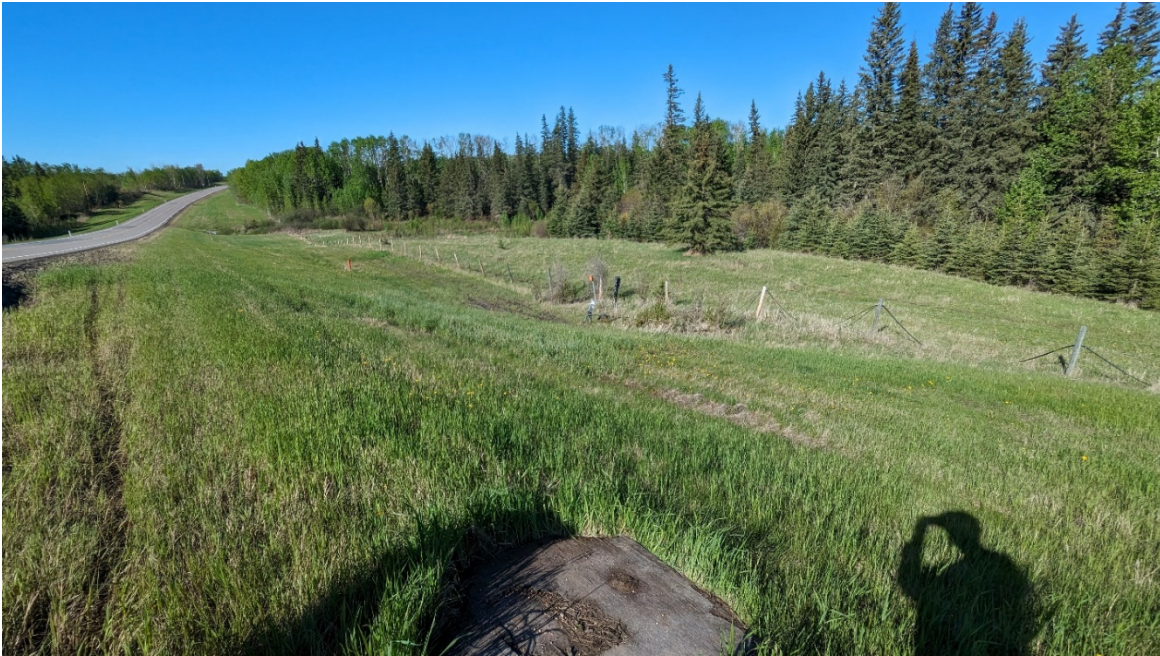
There was a linear feature just below the crest of the toe berm that appeared somewhat indicative of a forming scarp. However, it could also be related to equipment rutting. Vegetation has grown in the area since. During the 2024 inspection, observed conditions downslope of the highway embankment were similar to the previous inspection.

Photo 5 – Looking southwest downslope of the highway surface.

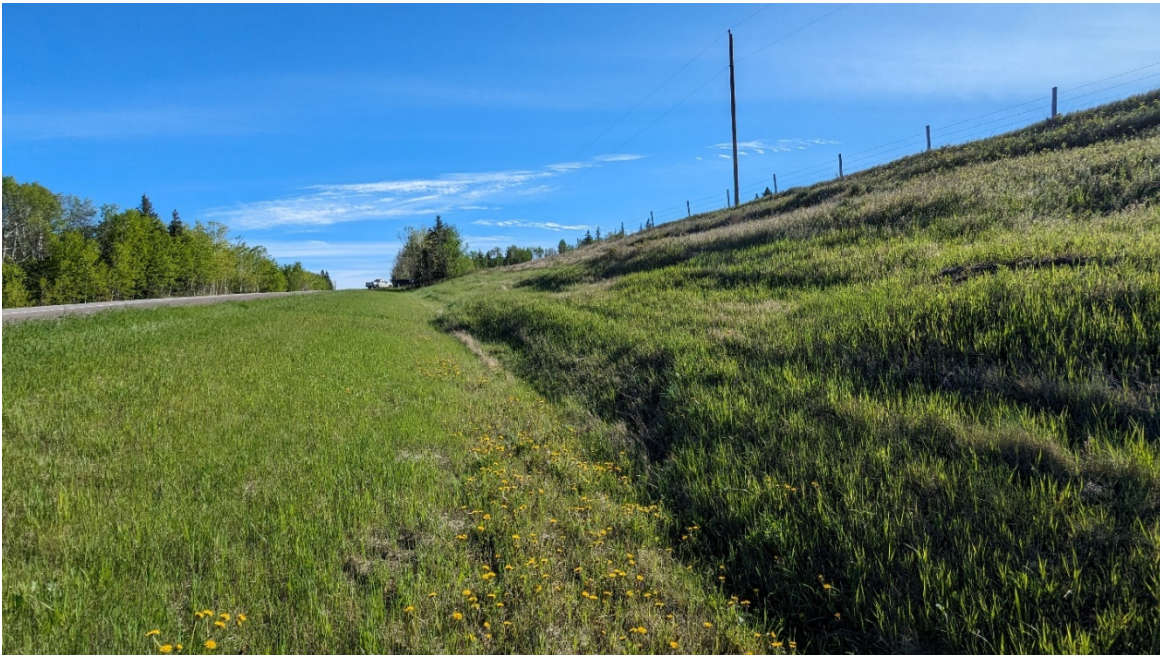
Scarps and tension cracks have formed along the top of the east backslope. The main scarp was 1.9 m from the fence and a tension crack upslope of the main scarp was 0.5 m from the fence. The fence appears to be leaning slightly. The power pole was previously observed to be vertical, however, it was observed to have a 3 degree tilt to the west during the 2024 inspection. It is not clear if the east backslope

movements are linked to the movements at and below the roadway or if they have merely been triggered by the same cause. Observed conditions of the backslope during the 2023 inspection were similar to 2022. There appears to be more movement observed during the 2024 inspection with more tension cracks developing and scarps widening.

Photo 6 – Looking north at highway east ditch and backslope slumps.

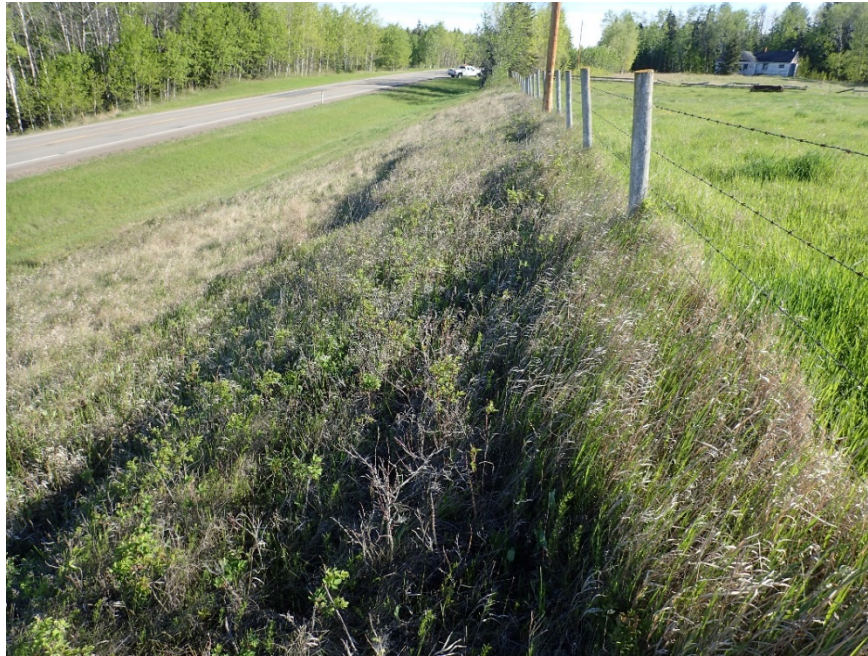
Photo 7 – Looking north at backslope scarp and tension cracks upslope of crack adjacent to fence.

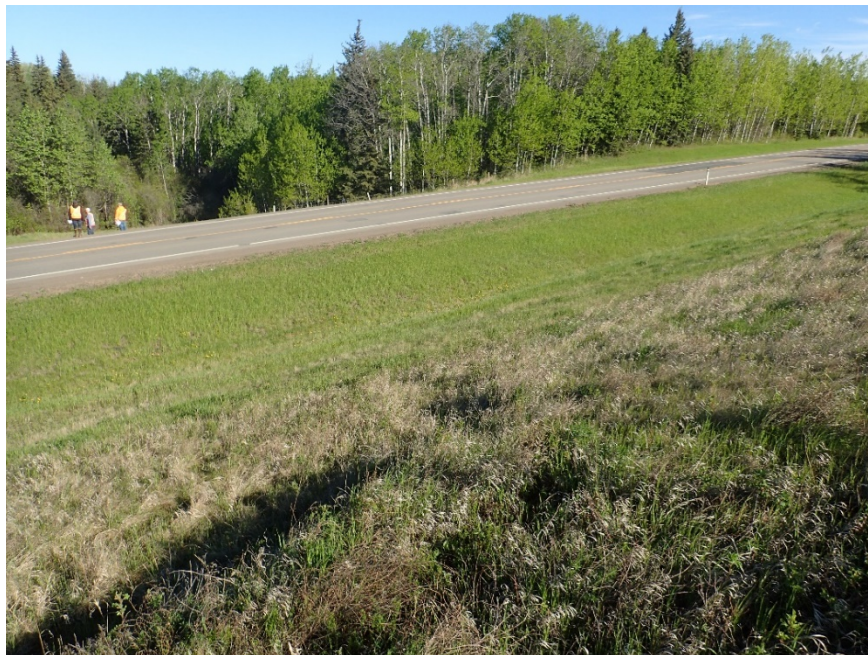
Photo 8 – Looking northwest from the backslope at the observed subsiding area in the pavement.

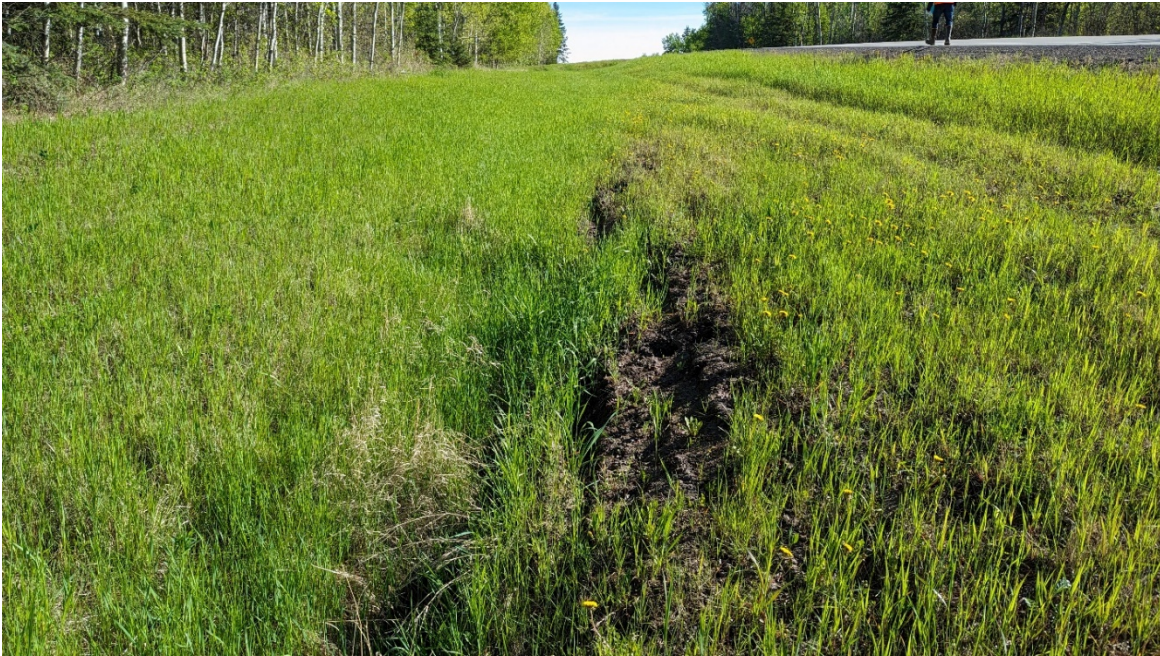
Photo 9 – Looking north at rutting in west ditch at the north end of the site.
