**ALBERTA TRANSPORTATION  
GEOHAZARD ASSESSMENT PROGRAM  
PEACE REGION (PEACE RIVER DISTRICT)  
2023 INSPECTION**

<b>Site Number</b>	<b>Location</b>	<b>Name</b>	<b>Hwy</b>	<b>km</b>
PH042	Daishowa East Hill	Pumping Well	986:01	33.2
<b>Legal Description</b>		<b>UTM Co-ordinates</b>		
NE7-85-20 W5M		11V E 491155	N 6246175

**DAISHOWA  
HWY 986:01 (PH042)  
SITE PLAN**

FIGURE PH042-1

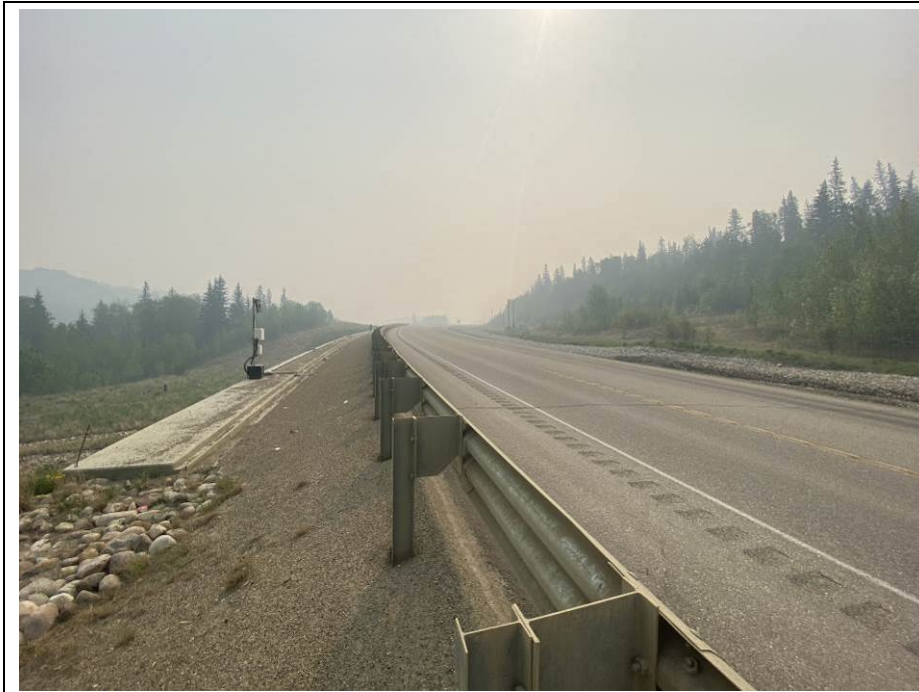
**Photo 42-01.**  
Looking east across the repaired slide area. Guardrail and pavement surface in good condition with no major change since previous inspection.

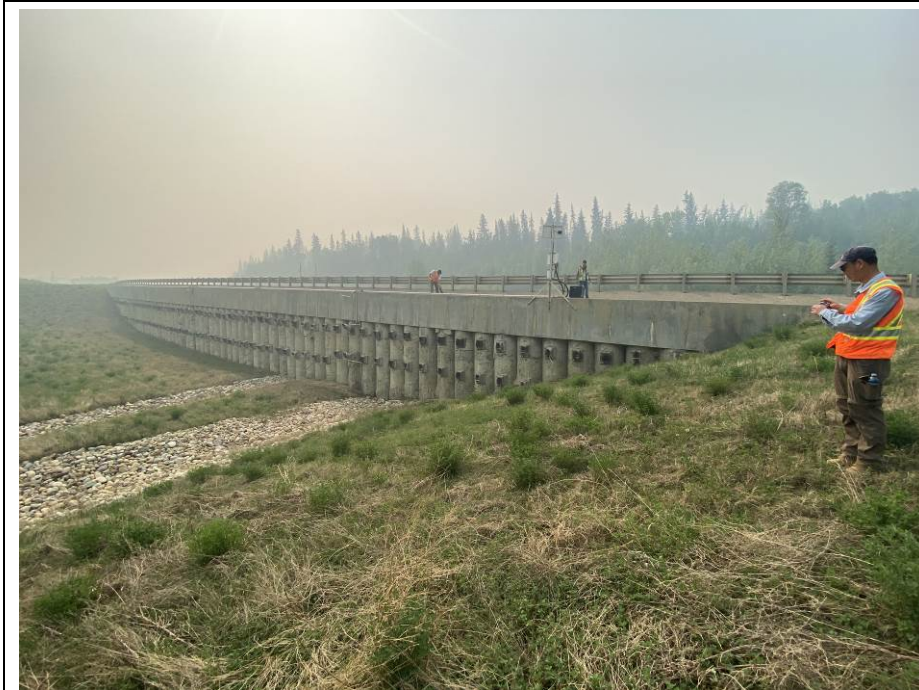
**Photo 42-02.**  
Looking southeast at the pile wall and regraded slope below. Wall appears in a good condition and there has been no observable changes in the slope below since 2021.

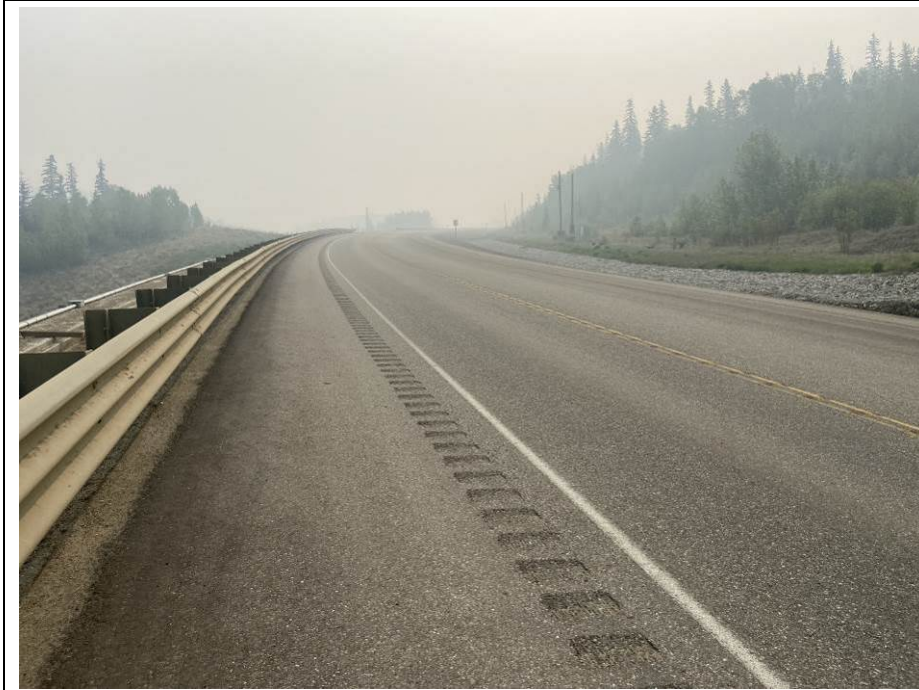
**Photo 42-03.**  
Looking east at the replaced highway segment that previously had cracking and settlement across the roadway due to landslide movement (33+210). Road surface was in a good condition at time of inspection and had no observable change from the 2021 condition.

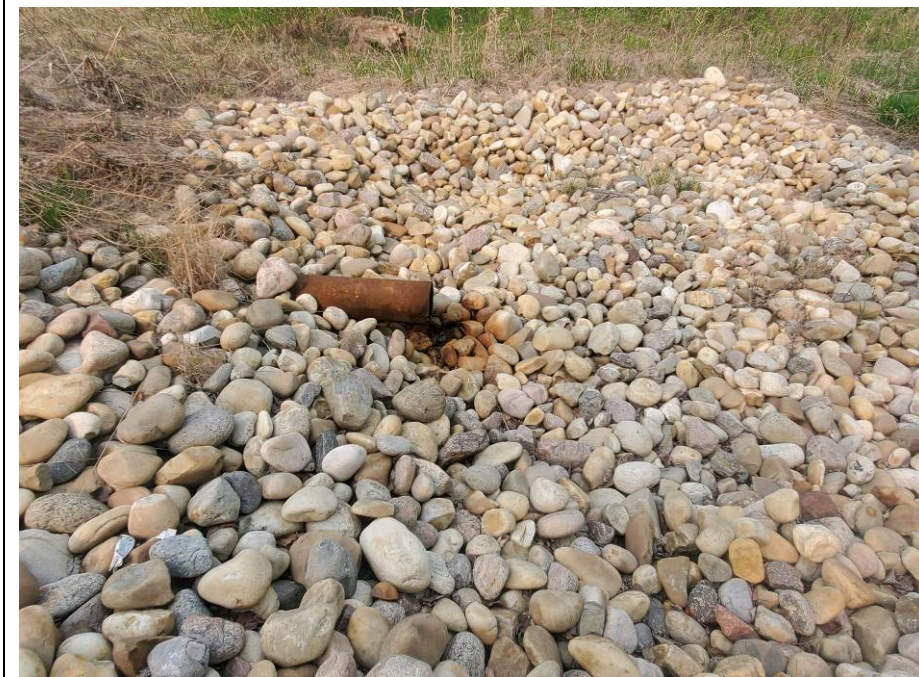
**Photo 42-04.**  
Looking at subdrain pipe outlet that was slowly dripping within the end of the armoured drainage swale from the west side of the wall.

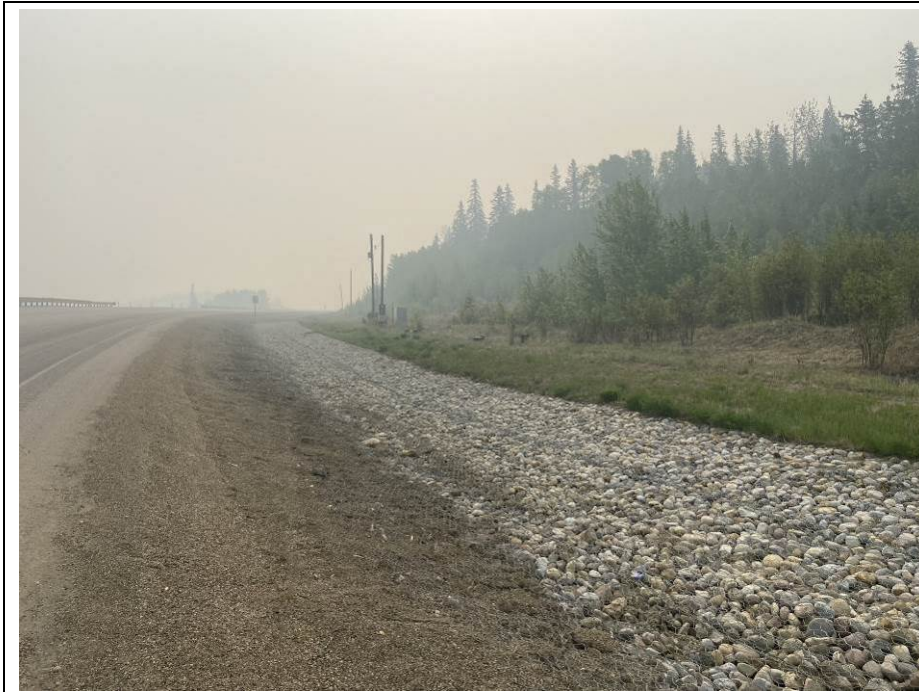
<input checked="" type="checkbox"/> Erosion	Minor rill erosion was noted between the road edge and the edge of the gabion mattress but has not significantly changed since the previous inspection. (Photo 42-05). An erosion gully (up to 0.2 m deep and 0.5 m wide) is developing near km 33+150 between the south road shoulder and heaved gabion mattress (Photo 42-06).	<input checked="" type="checkbox"/>
<input checked="" type="checkbox"/> Seepage	Drain outlets between the piles were dripping at the west end of the wall and area at the base of the wall was wet. Subdrain outlet at the end of the riprap swale was dripping. (Photo 42-04)	<input type="checkbox"/>
<input type="checkbox"/> Bridge/Culvert Distress		<input type="checkbox"/>
<input type="checkbox"/> Other		<input type="checkbox"/>
<p><b>Instrumentation:</b>  Legacy SI instrumentation (installed in 2009):  SI09-1 - Upslope of roadway; sheared at 2.6 m after September 2013  SI09-2 - Downslope of roadway; sheared at 16.8 m after June 2011  SI09-3 - Downslope of roadway; sheared at 11.0 m after May 2010  SI09-4 - Downslope of roadway; sheared at 9.8 m after September 2010</p> <p>Instrumentation has been installed to monitor performance of the pile wall and includes the following: 9 vibrating wire (VW) piezometers, 1 slope inclinometer (SI), 3 shape accelerometer arrays (SAA), 14 vibrating wire strain gauges (SG), and 9 load cells. After the spring of 2020 readings, the batteries for both dataloggers were stolen. Prior to the spring of 2022 readings, batteries were replaced, and several upgrades were completed by Thurber to the pile wall datalogger station to allow for automated readings of the pile wall instruments.</p> <p>SI18-1 (installed in the bench downslope of the pile wall) has not shown any discernible movement since it was reinitialized in the spring of 2019.</p> <p>Wall deflections have been measured in SAA17-P20 and SAA17-P40 over the length of the piles. The rate of movement ranges from 1 to 5 mm/yr with a maximum total resultant pile head movement in the downslope direction of 25 to 60 mm. These deflections are within expected design limits.</p>

**Photo 42-05.**  
View looking east at the gabion mattress installed in the south ditch across the entire site extents to repair previous erosion damage. Minor rill erosion was noted between the road edge and edge of the gabion. No major change within the area east of 33+175 since 2021.

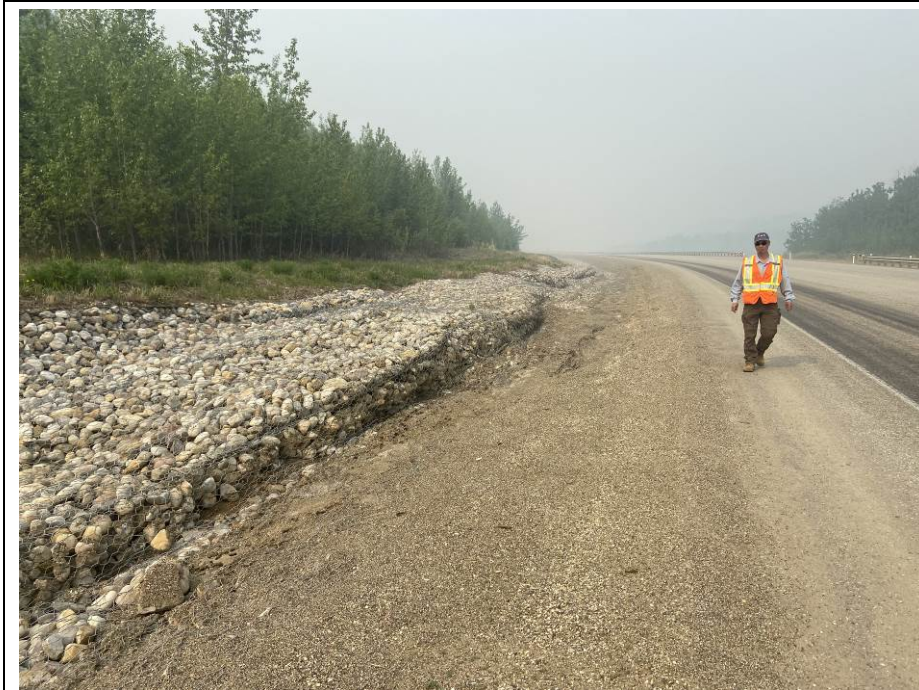
<b>Maintenance:</b>	Road overlaid in 2017.	
<b>Observations:</b>	<b>Description</b>	<b>Worsened?</b>
<input checked="" type="checkbox"/> Pavement Distress	ACP was in good condition at the time of the inspection with no signs of cracking or subsidence along previously observed extents of pavement damage due to landslide movement (Photos 42-01 and 42-03).	<input type="checkbox"/>
<input checked="" type="checkbox"/> Slope Movement	No observations of slope movement were evident at the road surface or below the pile wall along or outside the previous landslide extents (Photos 42-02). Backslope failure that occurred in 2020 near 33+125 has ongoing movement. The toe roll has lifted and deformed approximately 75 m of the gabion mattress in the south ditch, with a vertical displacement up to 1.1 m. The gabion was slightly more heaved at the slide toe but there was no significant change from the 2021 condition (Photo 42-06).	<input checked="" type="checkbox"/>

The hillside upslope/south of the highway has been affected by historic landslide movements and has always appeared hummocky during previous inspections. However, higher than usual precipitation and groundwater levels over the last few years (up to 2020) have triggered the recent new more aggressive movements. The toe roll of the landslide is clearly marked by the near-vertical heaving of the gabion

mattress lining in the ditch. The west flank is also clearly marked by shearing and displacement of the bush covered ground surface. However, the uphill backscarp and east flank were not as well defined. The toe heave has impacted the gabion mattress ditch lining and constricted ditch drainage causing erosion near the shoulder. The ditch restriction could result in overflowing of water onto the highway under high runoff conditions.

**Photo 42-06.**  
View looking west at the gabion mattress installed in the south ditch near 33+125. The toe roll of a landslide that occurred in 2020 has encompassed and deformed the gabion pushing it upwards and towards the highway. The length of gabion affected is approximately 85 m. Gabion is slightly more heaved but no significant change since previous inspection. Erosion in sideslope due to restricted flow from gabion heave.

Short term remedial measures could consist of removing the eastmost 30 m of gabion mattress (and salvaging the stones), excavating the heaved ground back to the pre-disturbance level and replacing a new gabion mattress over this section. The risk with this method is that further ground movements might heave the mattress again.

Longer term remedial measures could consist of removing the gabion mattress (and salvaging the stones) over the disturbed zone, strengthening the subsurface foundation soil, trimming the ditch smooth and then relaying new gabion mattress. The subsurface strengthening could consist of either of the following methods:

- Sub-excavating the slide material under the ditch to a depth below the slip surface and constructing a well compacted granular shear key zone to force the slip surface to toe out uphill of the ditch. The shear key would likely need to be at least 2.5 m deep and 5 m wide; or
- Installing spaced H piles parallel to, and offset about 1 m south, of the uphill edge of the ditch lining. The piles would likely need to be at about 6 m long/deep.
