Site Number	Location	Name	Hwy	km
PH042	HWY 986:01 C1 33.212 (Station 13+300)	Daishowa Well Site Slide	986:01	Km 33.2
Legal Description: 15-7-85-20 W5		UTM Co-ordinates		
		11U E 491157	N	6246211

**ALBERTA TRANSPORTATION AND ECONOMIC CORRIDORS GRMP (CON0022164)
PEACE REGION (PEACE RIVER DISTRICT)
INSTRUMENTATION MONITORING RESULTS**

SPRING 2024

SITE PH042: HWY 986:01, DAISHOWA EAST HILL (WELL SITE SLIDE)

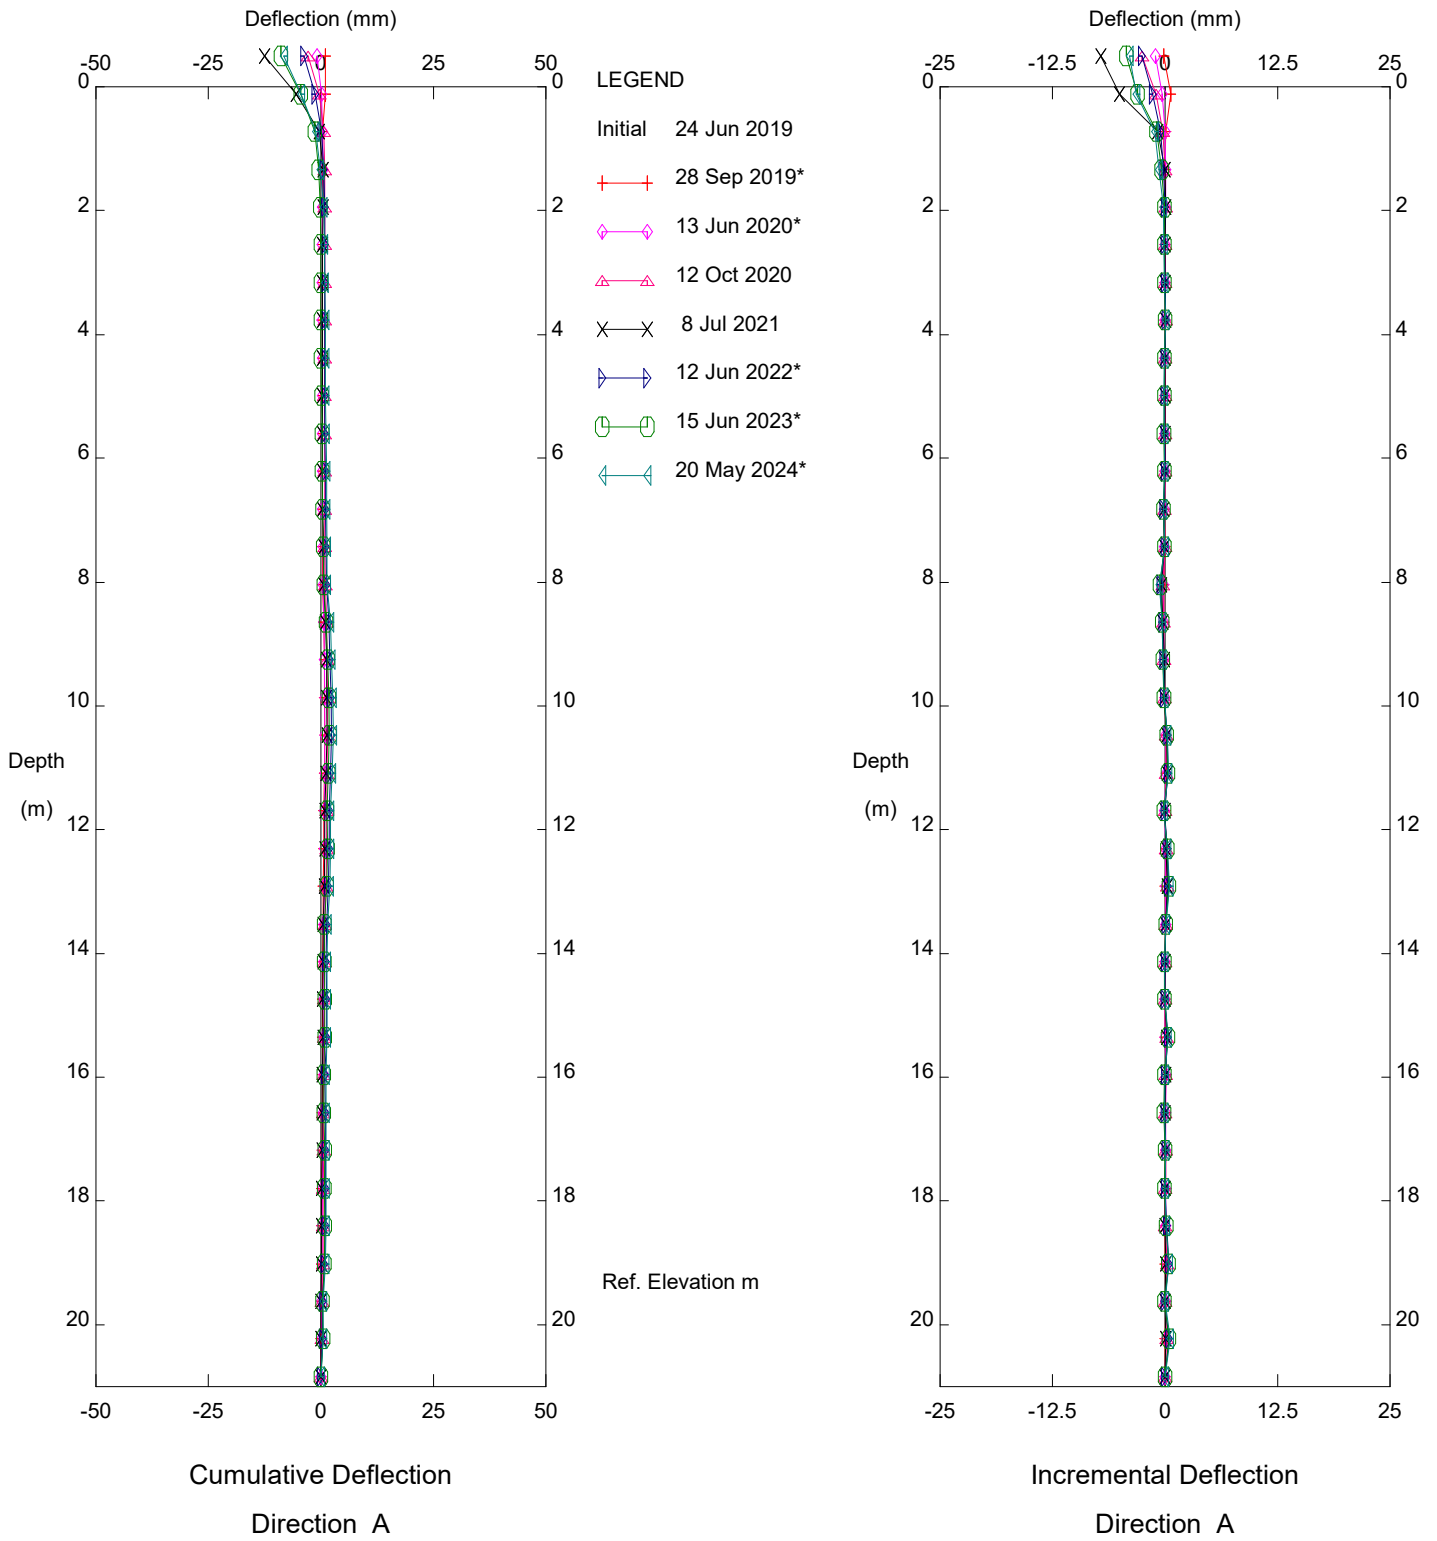
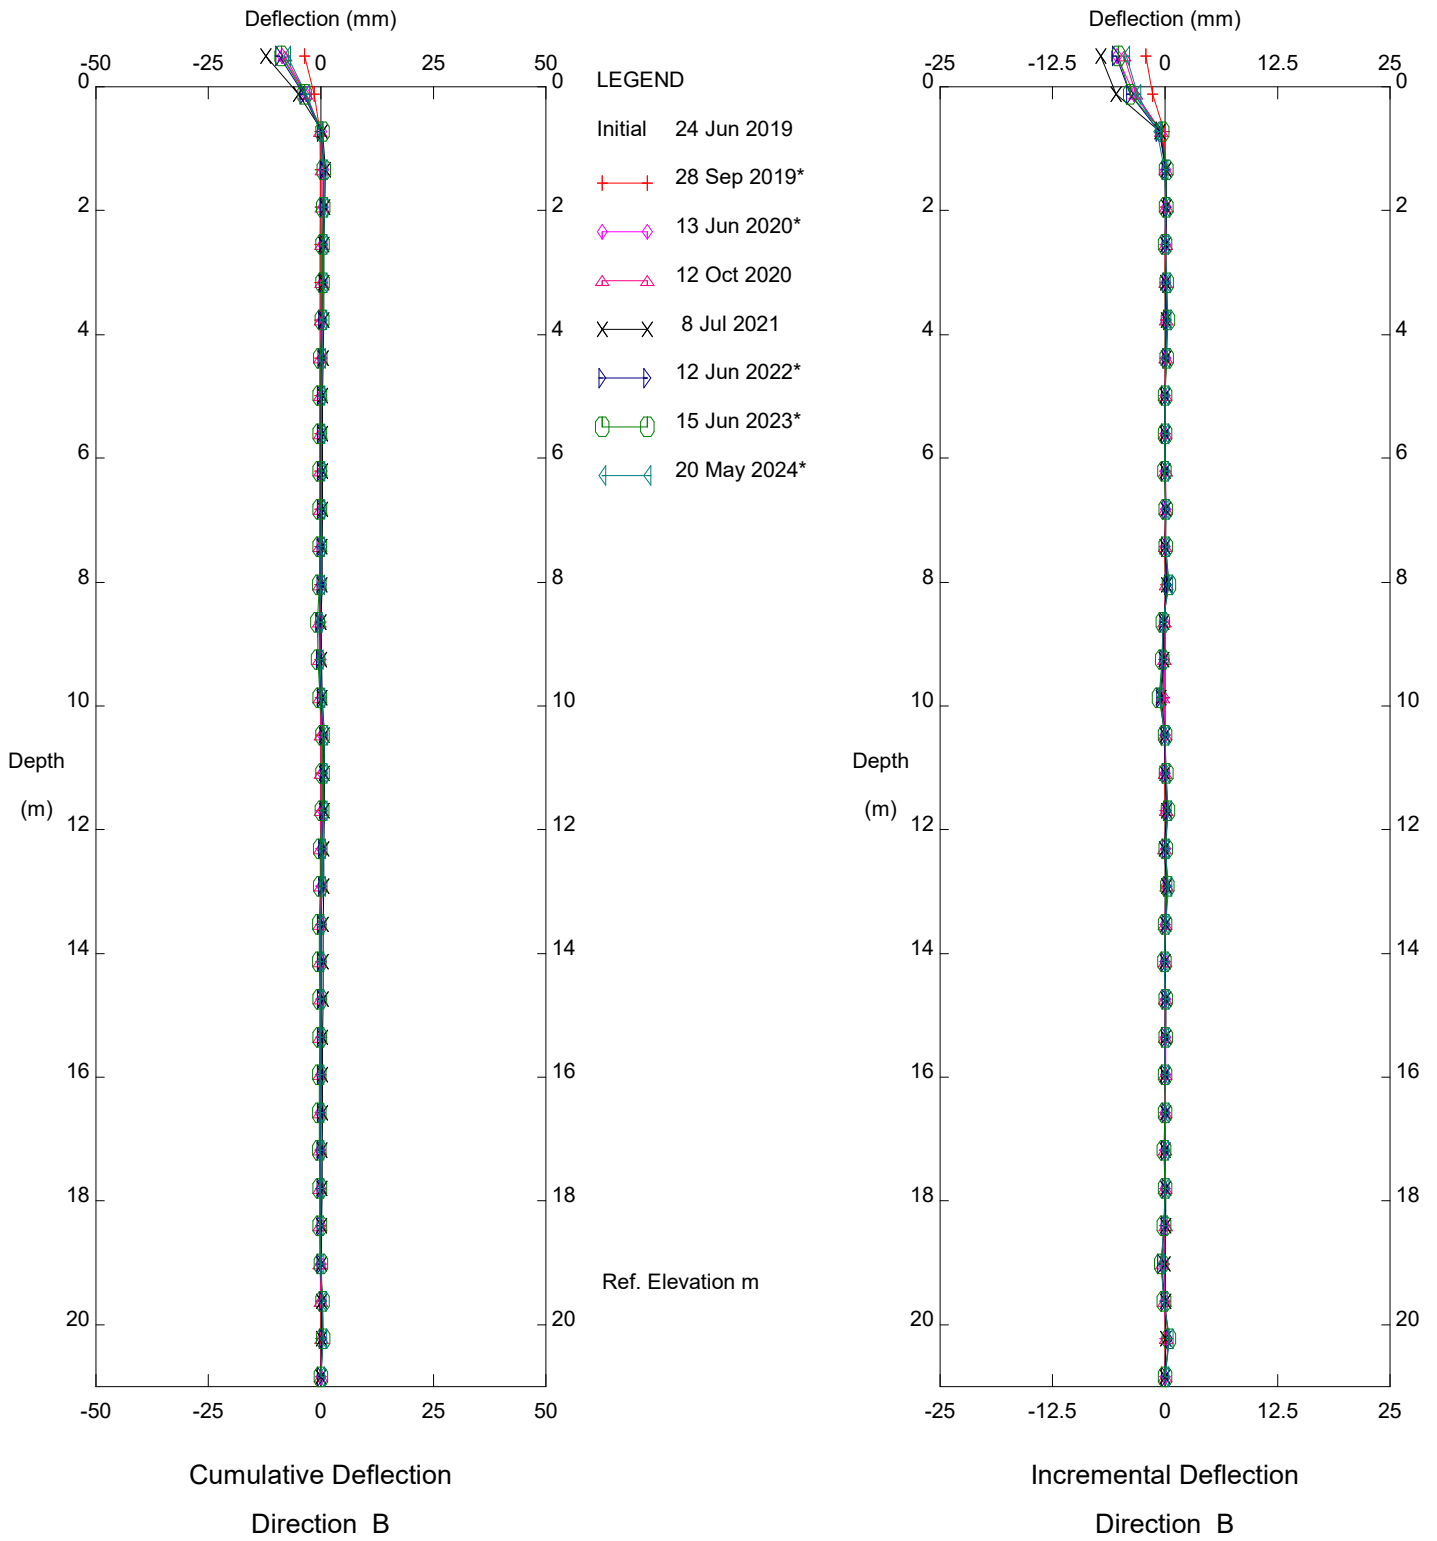
Hwy 986:01 Daishowa East Hill, Inclinometer SI18-1

Discussion	
Zones of New Movement:	None
Interpretation of Monitoring Results:	<p>SI18-1 has not shown any discernible movement since it was reinitialized during the spring of 2019 readings.</p> <p>SAA17-P20 showed an average rate of movement of 3.1 mm/yr over the length of the pile and an average rate of movement of 3.3 mm/yr over the combined length of the pile and waler since the spring of 2023 readings. SAA-P20 has shown a total pile head movement of 26.4 mm in the downslope direction to date.</p> <p>SAA17-P40 showed no discernible movement over the length of the pile and over the combined length of the pile and waler since the spring of 2023 readings. SAA17-P40 has shown a total pile head movement of 59.6 mm in the downslope direction to date.</p> <p>Both of the SAAs installed in the pile wall have shown an overall trend of downslope movement since they were installed, with higher deflections (in the order of 8 to 12 mm) during the winter months under frost loads, which rebound once the ground thaws. The total cumulative movement in the SAAs includes initial deflections during excavation and anchor installation as well as post construction movements. The overall rate of movement, after removing seasonal effects, appears to be slowly decreasing toward an equilibrium state in SAA17-P20 and appears to be at the equilibrium state in SAA17-40.</p> <p>SAA18-1, installed in the bench downslope of the pile wall, showed an average rate of movement of 2.3 mm/yr over 0.5 m to 12.5 m depth since the spring of 2023 readings. SAA18-1 has shown a total cumulative movement of 15.7 mm over this zone since it was initialized in June 2018. By comparison, SAA17-P40 has shown a total cumulative movement of 9.7 mm over this same zone since June 2018, indicating that the bench has moved 6.0 mm in the downslope direction relative to the pile wall during this time span. A plot comparing these movements is included in Appendix A. The movement in SAA18-1 should continue to be compared to the pile wall movements at SAA17 P40 for future readings to see if the bench exhibits faster downslope movement than the pile wall. The wall relies on lateral support from the bench and hence if significant separation is noted in the future, soil or grout would need to be placed in the void or another row of tie-back soil anchors would need to be added to the wall beneath the existing anchors.</p> <p>Since the spring of 2023 readings, the strain gauges showed changes in strain ranging from an increase in positive (tension) strain of 5.4 at 8.5 m depth on the downslope pile face to an increase in negative (compressive) strain of 25.7 at 2.5 m depth on the downslope pile face. The strain gauge readings are summarized in Table PH042-3.</p> <p>Vibrating wire piezometers VW17-1A and VW17-3A showed decreases in groundwater level of 0.06 m and 0.03 m, respectively, since the spring of 2023 readings. VW17-1B, VW17-2B and VW17-3B showed increases in groundwater level of 0.28 m, 0.16 m and 0.48 m, respectively. VW17-3B measured an all-time high groundwater level on April 23, 2024, however, VW17-3B has been functioning intermittently, and the temperature wire is showing large fluctuations since the spring 2023 readings. VW17-2A continued to be dry. Overall, the piezometers at the pile wall show relatively stable groundwater levels, with the exception of VW17-3B, which is showing a trend of slowly increasing groundwater level over time.</p> <p>Vibrating wire piezometers VW18-1, VW18-2, and VW18-3, installed in the south highway ditch to the east of the pile wall, showed decreases</p>

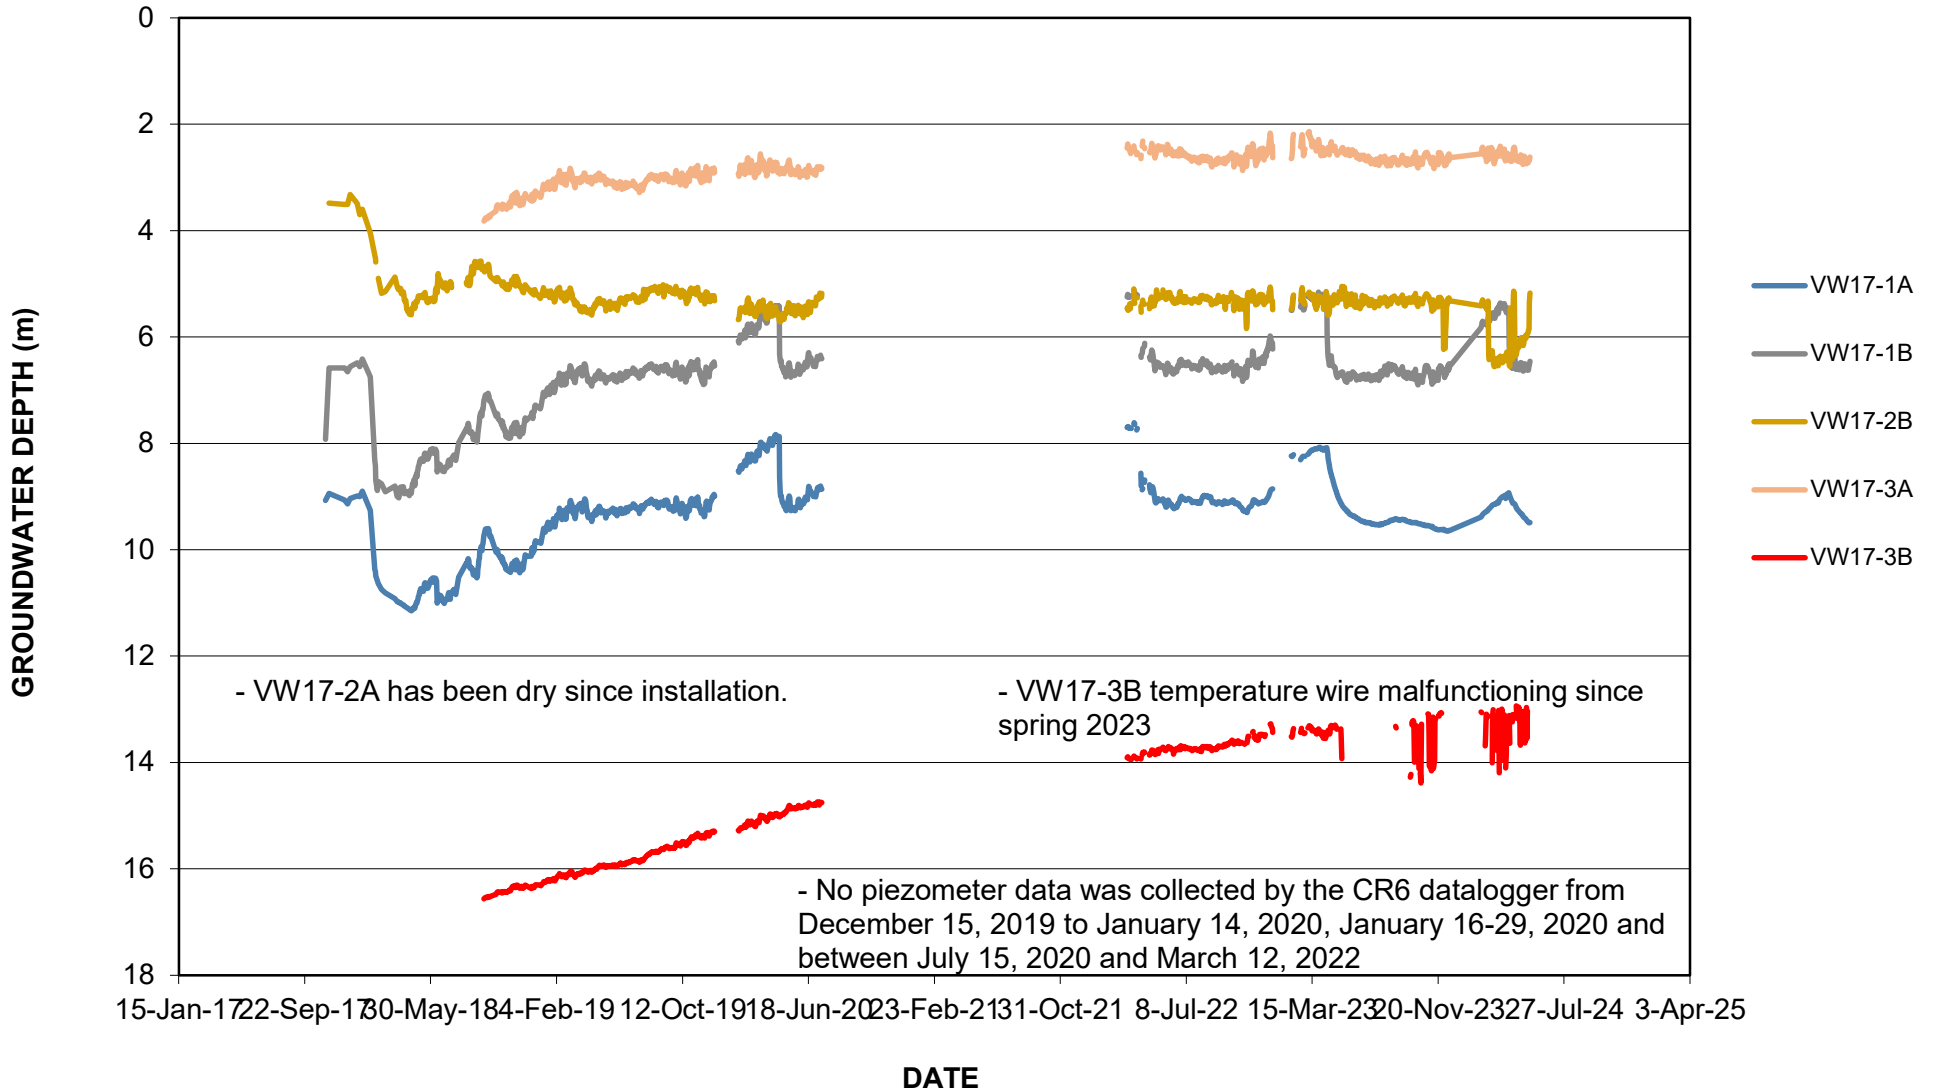
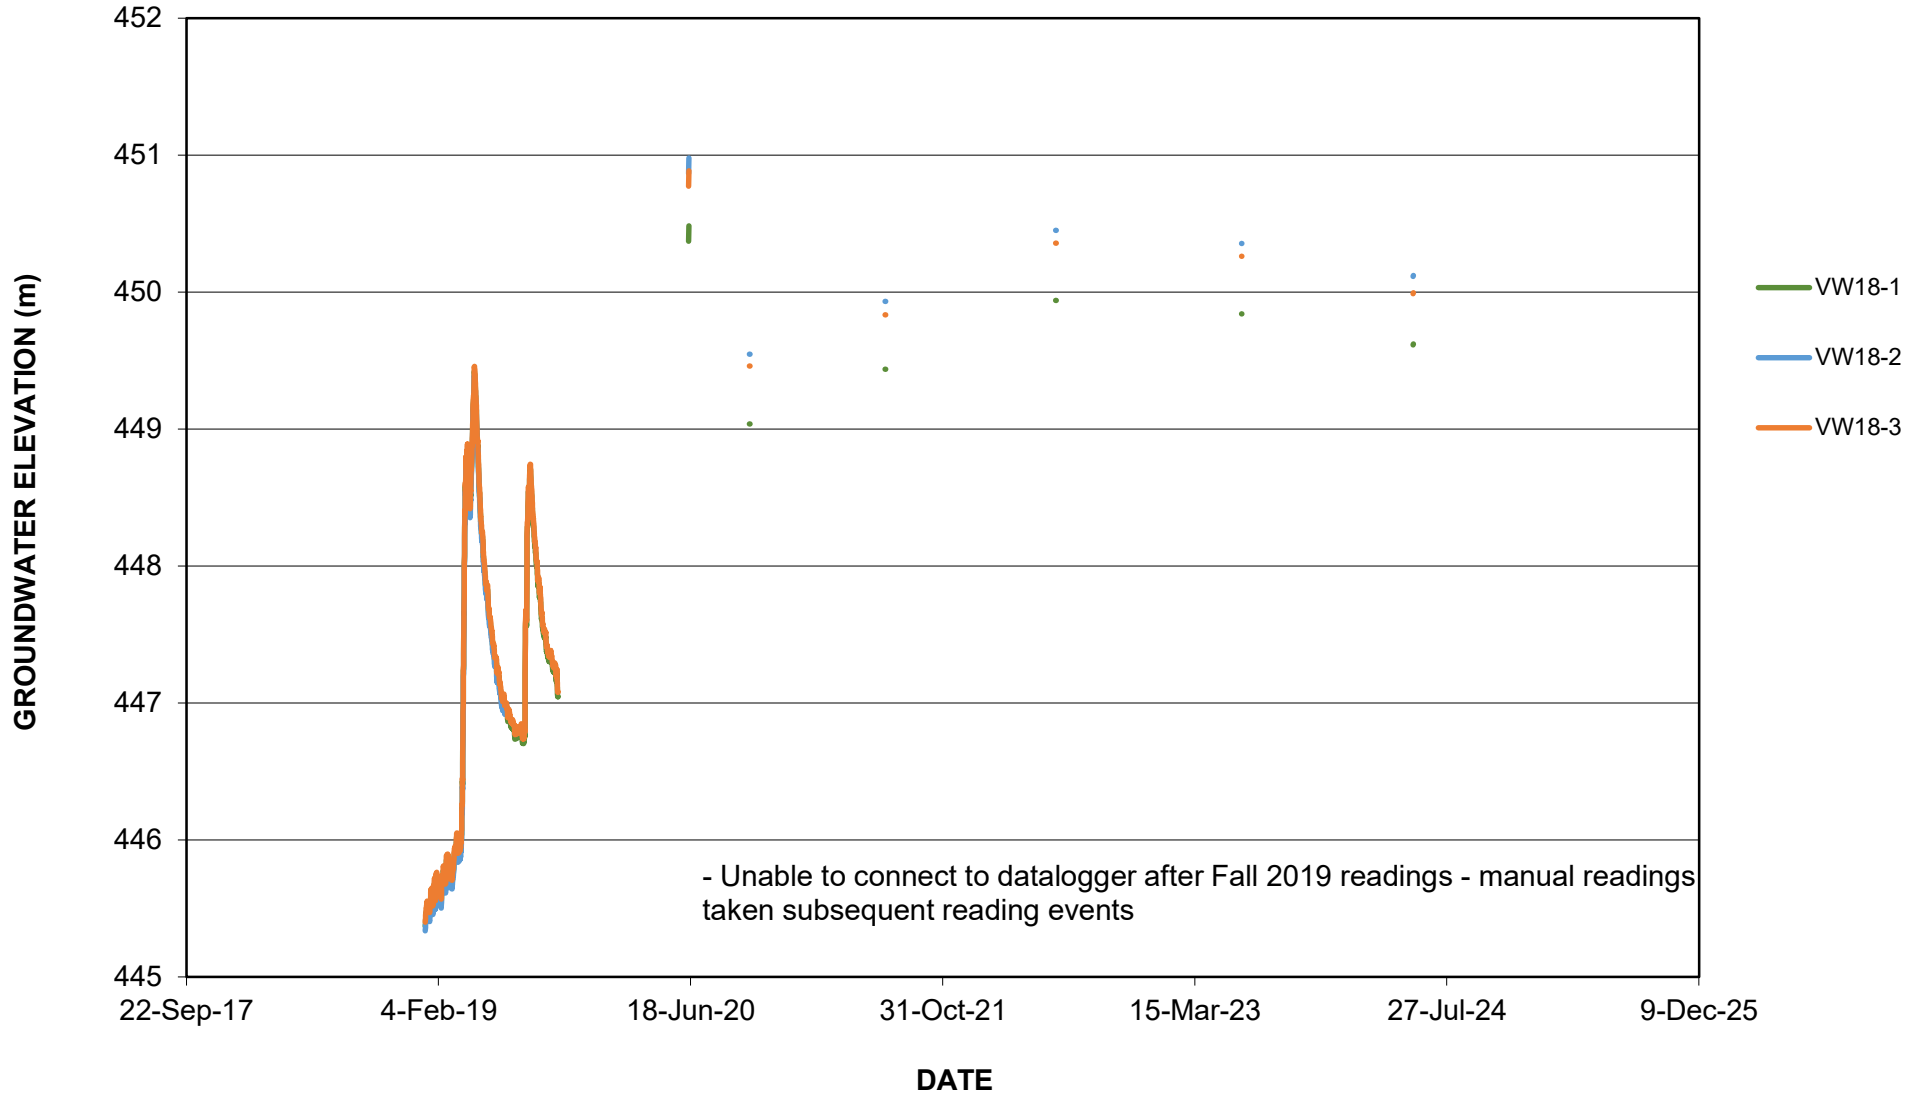
**FIGURE PH042-3
PIEZOMETRIC ELEVATIONS FOR HWY 986:01, DAISHOWA EAST HILL
(SOUTH HIGHWAY DITCH PIEZOMETERS)**

<p>in groundwater level of 0.23 m, 0.24 m, and 0.27 m, respectively, since the spring of 2023 readings.</p> <p>The load cells showed relatively minor changes in load compared to the spring of 2023 readings, ranging from a decrease of 2.38 kN in VC2011 (anchor P40A) to an increase of 1.34 kN in VC2014 (anchor P40B). It should be noted that VC2011 (anchor P40A) is measuring a current load that is above its design load. However, this is still safely below the ultimate bond strength confirmed during anchor testing activities. Overall, the load cells have shown steady anchor loads over the last two years, with temporary higher loads measured in late winter to early spring, when the depth of frost penetration is greatest, compared to the summer loads when the ground is fully thawed behind the wall.</p>
Future Work:	The instruments should be read again in the spring of 2025.
Instrumentation Repairs:	No instrument repairs are required at this time.
