**ALBERTA TRANSPORTATION
GEOHAZARD ASSESSMENT PROGRAM
PEACE REGION (PEACE RIVER DISTRICT)
2023 INSPECTION**

Site Number	Location	Name	Hwy	km
PH043A	Daishowa East Hill	Site A - Pile Wall	986:01	33.45
Legal Description		UTM Co-ordinates		
NE7-85-20 W5M		11V E 491380	N 6246075

**DAISHOWA
HWY 986:01 (PH043)
LOCATION PLAN**

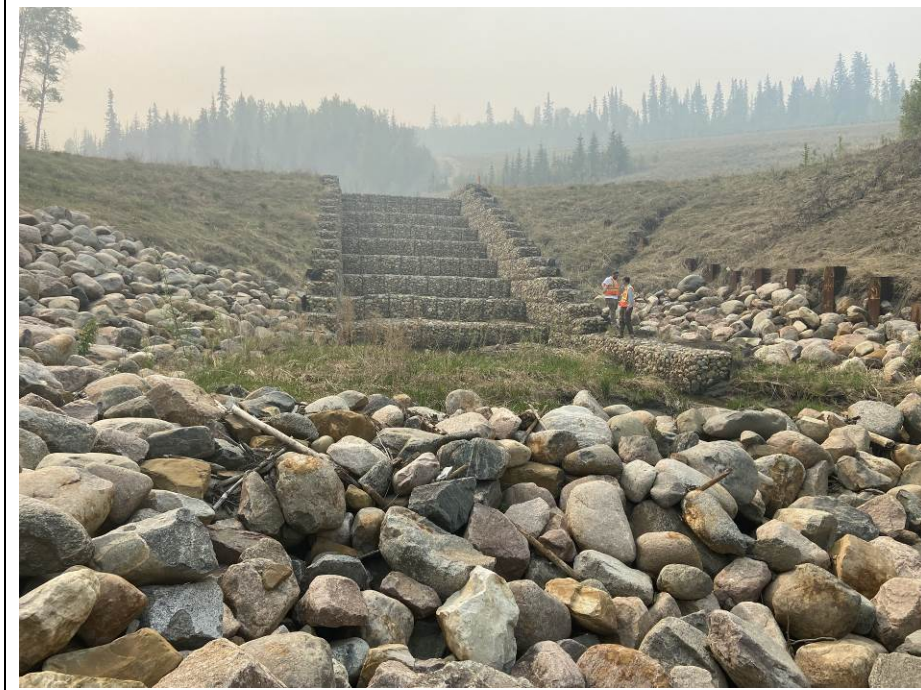
Photo 43-01.
Looking towards the southeast (upstream) at the Site A gabion drop structure. No major change from 2022 condition. Rill erosion on the right side of the photo above the steel pile wall was slightly worse.

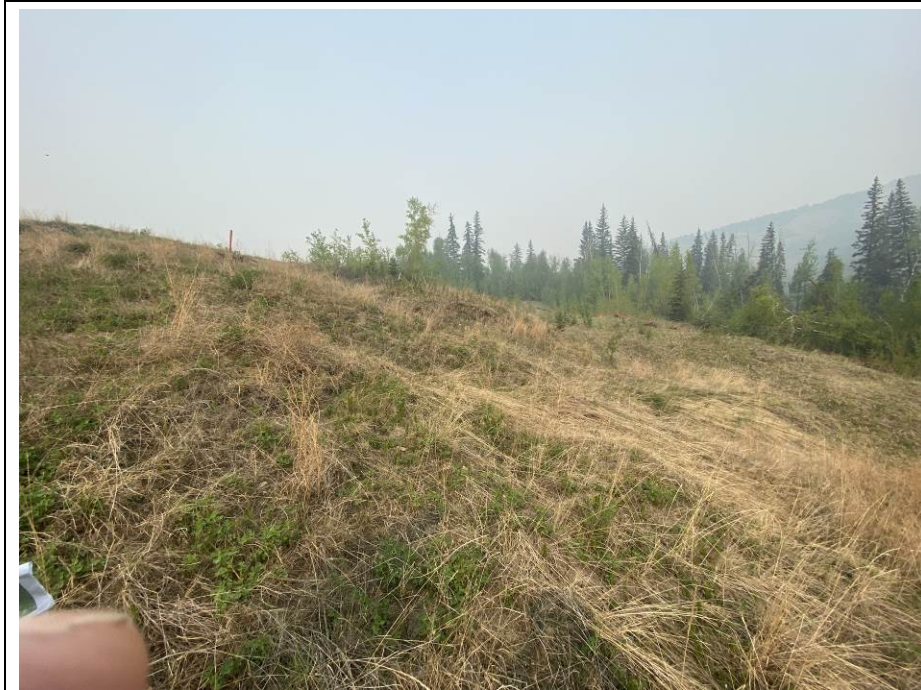
Photo 43-02.
Main slide scarp of active shallow failure downslope of the buried pile wall (33+325) first observed in 2017. Area is vegetated but appears there is active movement within the disturbed slide mass.

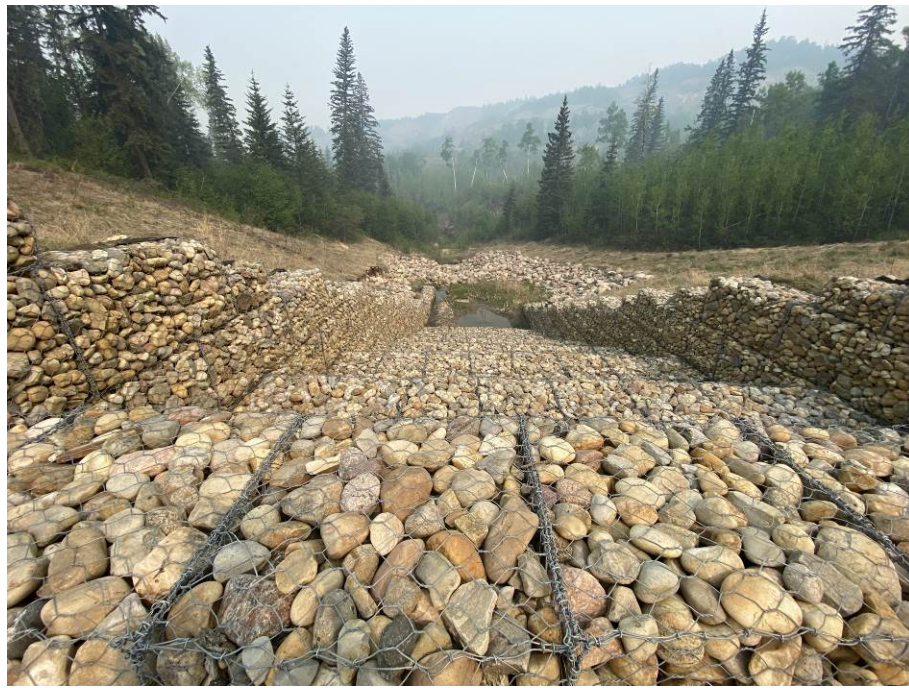
Photo 43-03. Overflow gabion drop structure and dissipation bowl at the previous culvert outlet that had extensive erosion and gullyng below Site A (33+430). Some rill erosion was noted within the fill areas that were still vegetating. Base of drop structure had a large amount of silt buildup. Minor change from 2022 condition.

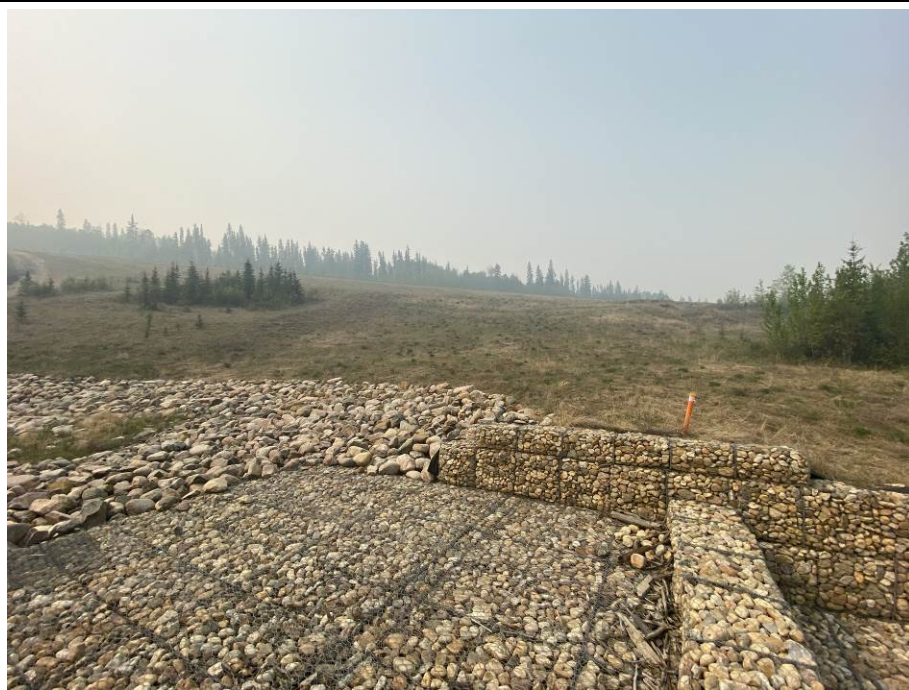
Photo 43-04. Looking south at the area of previous slumping associated with culvert erosion below pile wall (33+430). Area has since revegetated following grading of the construction access.

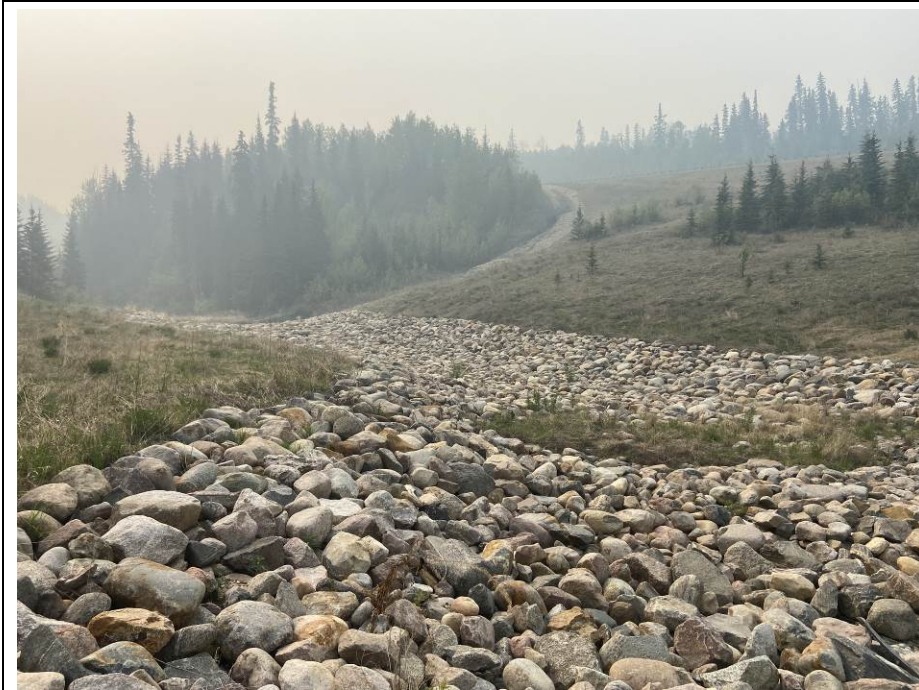
Photo 43-05.
Standing at the top of the gabion drop structure looking east towards the overflow channel riprap (33+450). Vegetation has re-established.

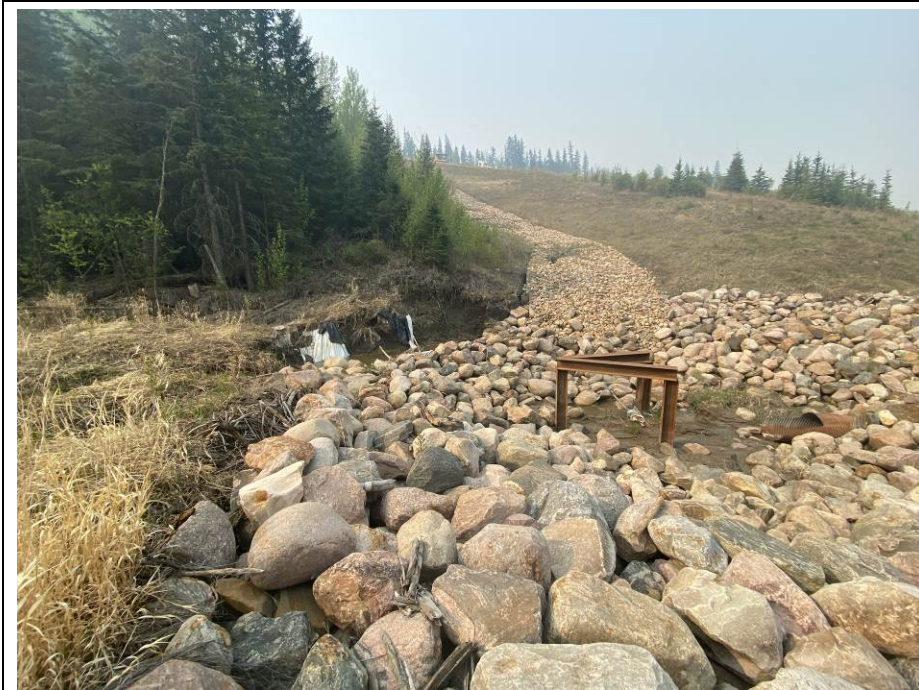
Tension cracks potentially related to sliding downslope and towards the east crotch riprap swale (near damaged section) had no change in offset between the installed lath stakes from the 2022 condition, measuring 1.16 m offset to the outside bottom of the stakes.	
<input checked="" type="checkbox"/> Erosion	Erosion rills upslope from the steel pile wall were slightly deeper (0.1 m) relative to the 2022 condition (Photo 43-01). At the culvert inlet (km 33+500) the south channel bank erosion was slightly worse with expansion of the erosion and additional riprap fallen away. (Photo 43-06). The swale riprap at the east end of Site A with erosion damage from a 2019/2020 high flow event had increased damage, gullying was deeper and wider (Photo 43-13).	<input checked="" type="checkbox"/>
<input type="checkbox"/> Seepage		<input type="checkbox"/>
<input checked="" type="checkbox"/> Bridge/Culvert Distress	Gabion drop structure silt buildup at the base (Photo 43-03). Silt buildup at the culvert inlet Culvert inlet is damaged and eroded causing water to flow under the base and come in at a joint (Photo 43-06).	<input checked="" type="checkbox"/>

Photo 43-06.
Looking south towards the culvert inlet riprap, riprap swale, and debris deflector (33+500). Note south channel bank erosion, silt buildup and erosion within the riprap swale. Slightly worse from the 2022 condition. Culvert inlet is damaged and eroded, causing water to flow under the base and come in at a joint.

(4) – Replacement of the damaged culvert inlet with a stronger SWSP with steeper end bevel. The new culvert should be grouted into the existing CSP. Additional Class 2 riprap should be added and shaped to better funnel water into the inlet.	\$30,000
--	----------

(3) – Repair south channel bank erosion near the culvert inlet and toe of the armored swale. The disturbed soils should be excavated and backfilled with gravel over non-woven geotextile. Additional Class 2 riprap should be added over the bank and blended into the toe of the armored drainage swale.	\$20,000
--	----------

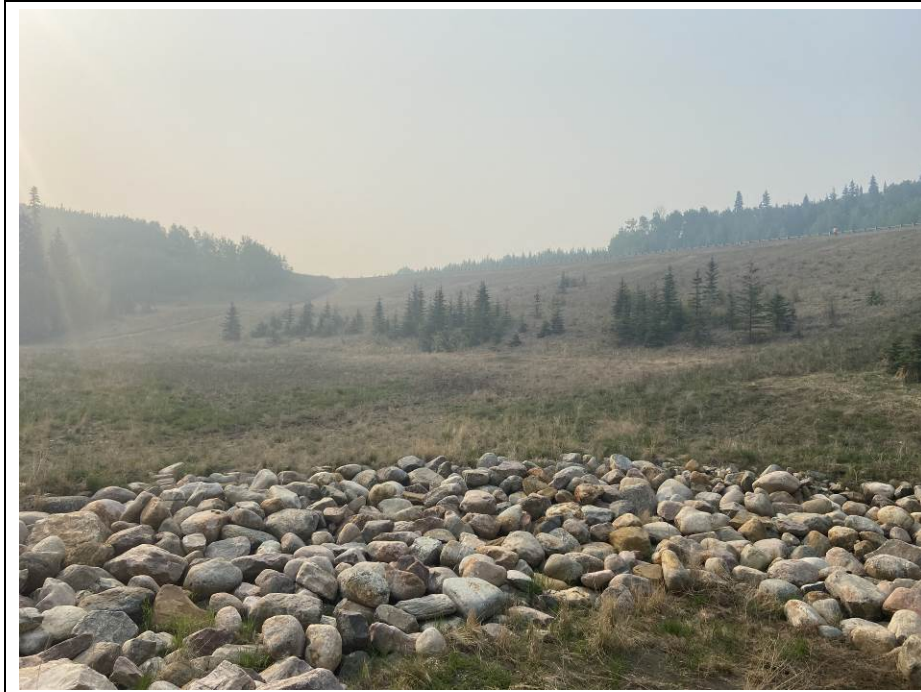
Photo 43-07.
Looking south towards the Site B highway embankment and overland flow area. Minor rill erosion is visible on the right top corner of the photo along the slope.

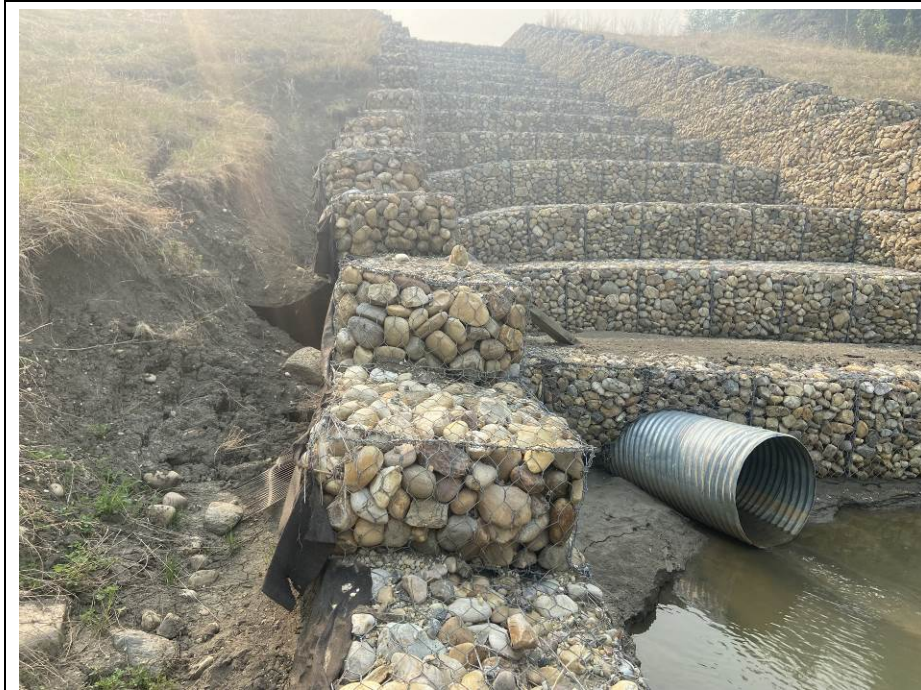
Photo 43-08.
Site B- view of the gabion drop structure and riprap dissipation bowl at the culvert outlet (33+600). Additional erosion and gabion deformation due to piping erosion from leak in the culvert joint (left side).

this area is required to prevent further damage to the drop structure and proper culvert function. The disturbed soils should be removed and then the sink hole and related erosion gully beside the gabion wall should be backfilled with Class 1M riprap over geotextile and armoured at the top with Class 1 riprap. The side of the gabion drop structure wall should be pushed back into vertical orientation as is practically possible during the riprap backfill activity. Maintenance and cleaning of the outlet to limit sediment and ice buildup prior to spring thaw will be critical to limit potential water backup and further damage. Consideration should be given to bypassing the compromised culvert joint by inserting a new internal reline pipe (e.g., expandable “slipline” or similar) and grouting the annulus between the pipes. Alternatively, an internal band could be applied across the damaged joint using a combination of gaskets and sealing materials. Further pressure grouting would also be beneficial to reinforce the void area around the joint and limit further disturbance to the drop structure.

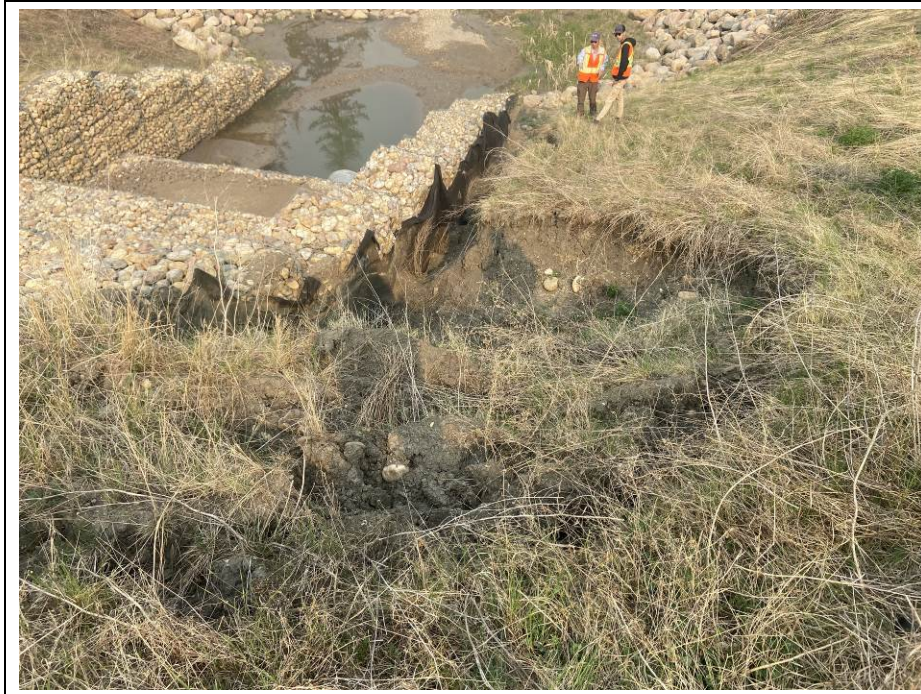
Photo 43-09.
View from above of the expanded erosion and slightly worse gabion deformation due to piping erosion from leak in the culvert joint.

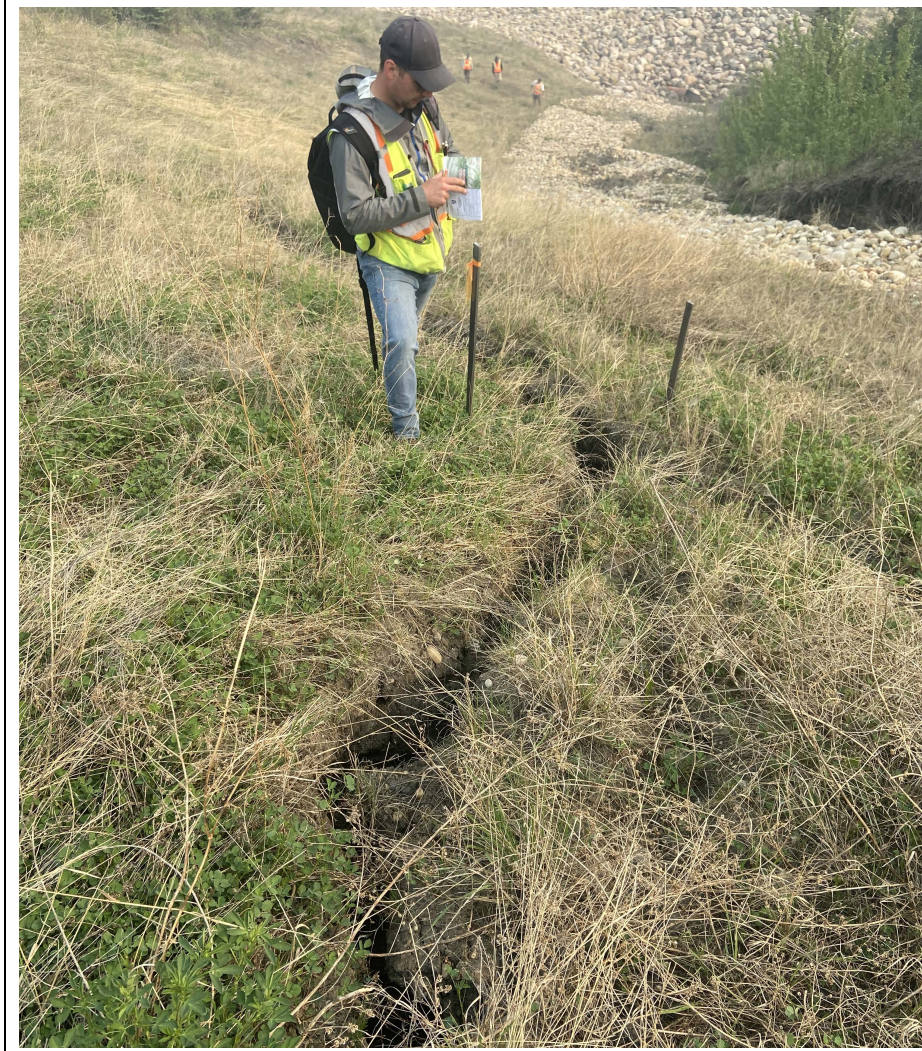
relatively shallow and not currently a direct threat to the highway. The embankment above the old pile wall has not exhibited signs of slide movement and slide related pavement damage has not been observed. The apparent tension slide crack adjacent to the swale should be monitored for movement.

Photo 43-10. Looking towards the north at survey lath stakes installed in 2022 to monitor a tension crack related to potential downslope movement towards the swale washout and erosion area (km 33+500). The offset between the outside base of the stakes measured 1.16 m and did not increase relative to the previous measurement.

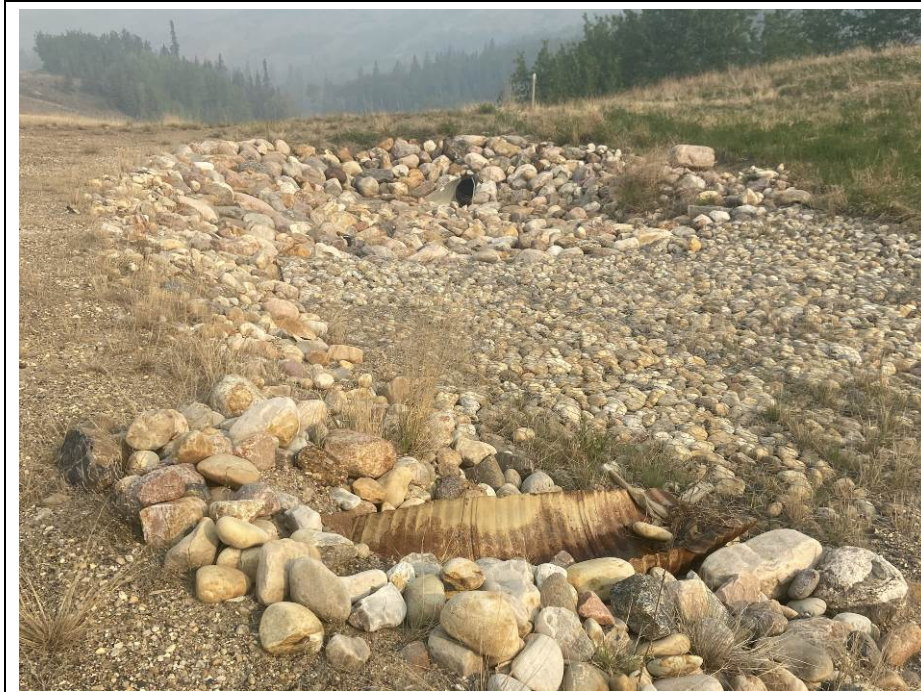
Photo 43-11.
View of culvert inlet
and riprap protection
near 33+900 on north
side of road.

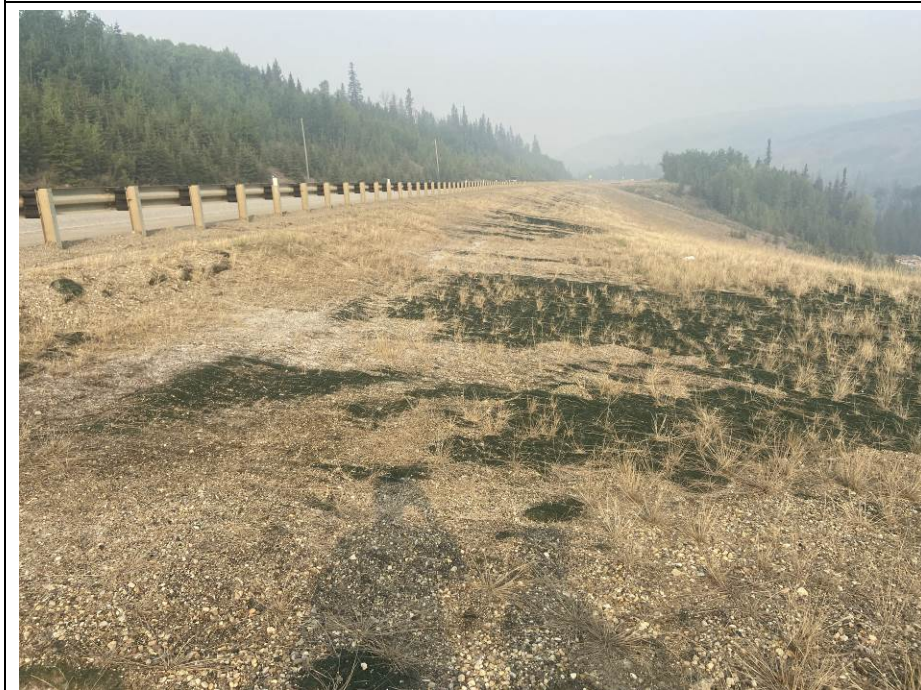
Photo 43-12.
Looking west towards
the TRM installation
on the upper portion
of the slope north of
the road (33+700).
Some vegetation
growth has started.

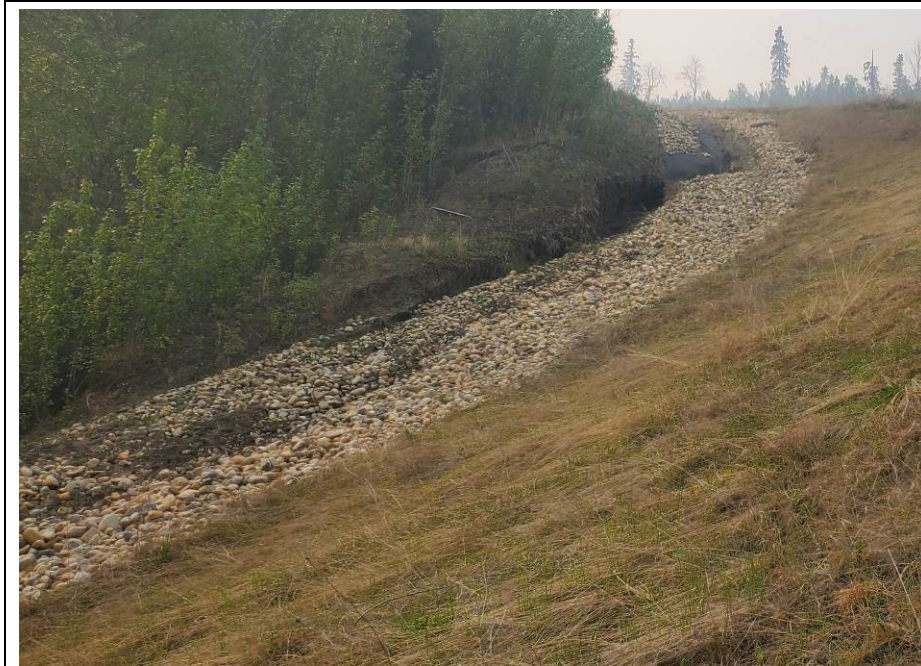
Erosion and sedimentation buildup was observed around the new erosion mitigation structures. Maintenance work is required around the culvert inlet. The east crotch swale riprap is no longer effective and should be rebuilt to prevent expansion of the erosion damage. Due to the gradient in this area, either angular riprap or anchored gabion mattress will be required.

Photo 43-13.
 Site A - looking south, upslope towards washed out riprap and extensive erosion damage within the riprap swale at the east side of Site A (33+500), likely the result of a high-flow event in 2019/2020. Deeper and expanded erosion damage since 2022.

(4) - Repair of the armored swale. Existing rock should be salvaged and used with additional imported material to line the armored swale with gabion mattress anchored at intervals to the slope. Swale alignment improvements should also be made (reduction of super elevation in the upper curve) and a cross berm should be added near the top to divert highway runoff into the swale.	\$35,000
---	----------

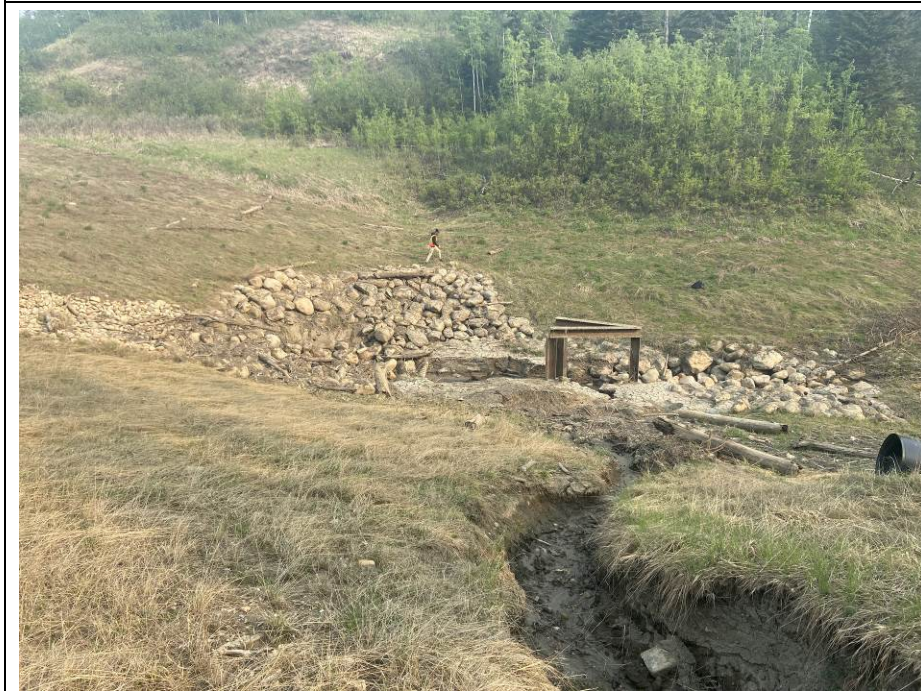
<input checked="" type="checkbox"/> Other	Increased debris buildup near the culvert inlet indicative of flooding during a high flow event. (Photos 43-14 and 43-15)	<input checked="" type="checkbox"/>
<p>Instrumentation:</p> <p>Spring 2023 Readings:</p> <ul style="list-style-type: none"> • SI-7 – No discernible movement measured. • SI-8 –2.0 mm/yr over 0.3 m to 1.5 m depth, creep (< 1.0 mm/yr) over 1.5 m to 4.0 m depth. • SI-9 –5.3 mm/yr over 0.3 m to 2.7 m depth. <p>Generally consistent movement rate trend measured at SI's 8 and 9 since 2006.</p>		
<p>Assessment:</p> <p>The culvert and erosion control mitigation work should reinforce the embankment toe and reduce rates of soil loss from this area and the potential of destabilizing the upper embankment slope. Current erosion control measures appear mostly effective in controlling drainage at the site with the exception of the lower embankment culvert inlet (33+800) which has become damaged apparently during a high flow event. The culvert inlet requires repairs to restore full drain capacity. The end slope of the inlet should be cut steeper and shorter and lined with a stronger SWSP (with concrete collar) to resist hydraulic uplift forces. The riprap around the culvert needs to be reconfigured and should be "benched" into the slope as is practical to reduce displacement and sliding. The CPP downpipe requires replacement and realignment, which was caused by a local landslide in the lower valley slope. The gully erosion upslope occurring downslope from the break will continue to retrogress upslope towards the highway and could initiate deeper instabilities.</p> <p>During the spring of 2018 a sinkhole developed beside the lower portion of the drop structure, caused by water flowing under pressure from a separated joint in the underlying C.S.P. culvert creating a subsurface void. The void was grouted, and the sinkhole backfilled, however distortions to the overlying gabion baskets/mattresses remain. It is believed the outlet of the C.S.P., which sits in the flow dissipation bowl, froze underwater and that the pressurized water eroded the sinkhole out the side of the pipe and drop structure. During the 2023 inspection further void formation as a result of piping erosion was observed to occur and cause displacement of the gabion drop structure and ongoing erosion damage. Repair of</p>

Photo 43-14.
 Site B culvert inlet with riprap protection and steel H-beam debris deflector. Inlet become severely damaged and blocked with fallen riprap during a high flow event in 2019/2020 (33+800). No major changes from 2022 condition. Increased erosion at gully on left side of photo. Repairs required in this area.

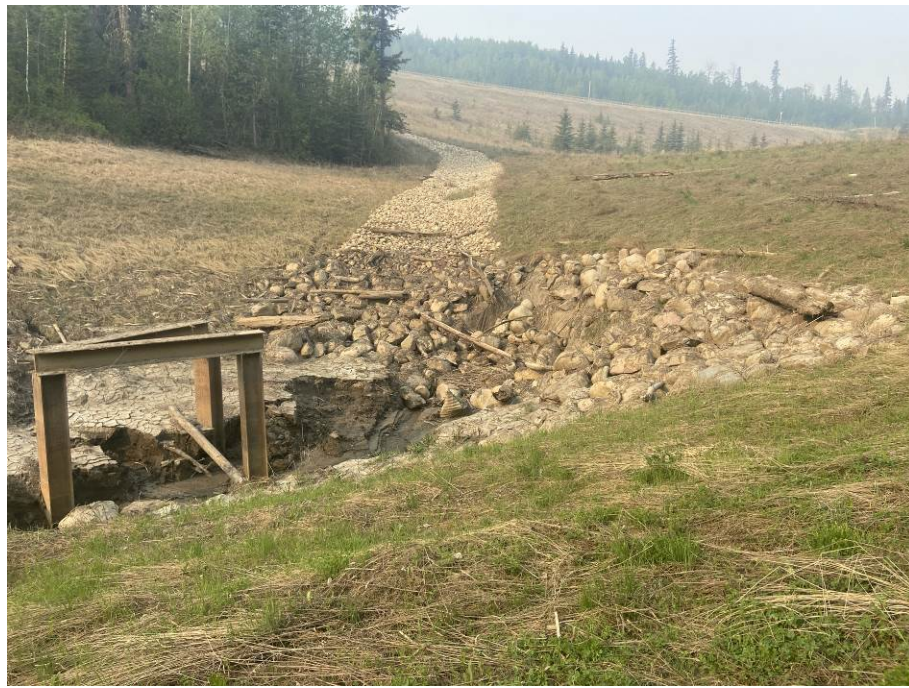
Photo 43-15.
 Damage around culvert inlet due to a high flow event. Culvert pipe at the inlet was effectively pinched and twisted shut and was filled with woody debris. Additional riprap above the inlet has collapsed and buried it. Additional woody debris buildup. Repairs required in this area (33+800).

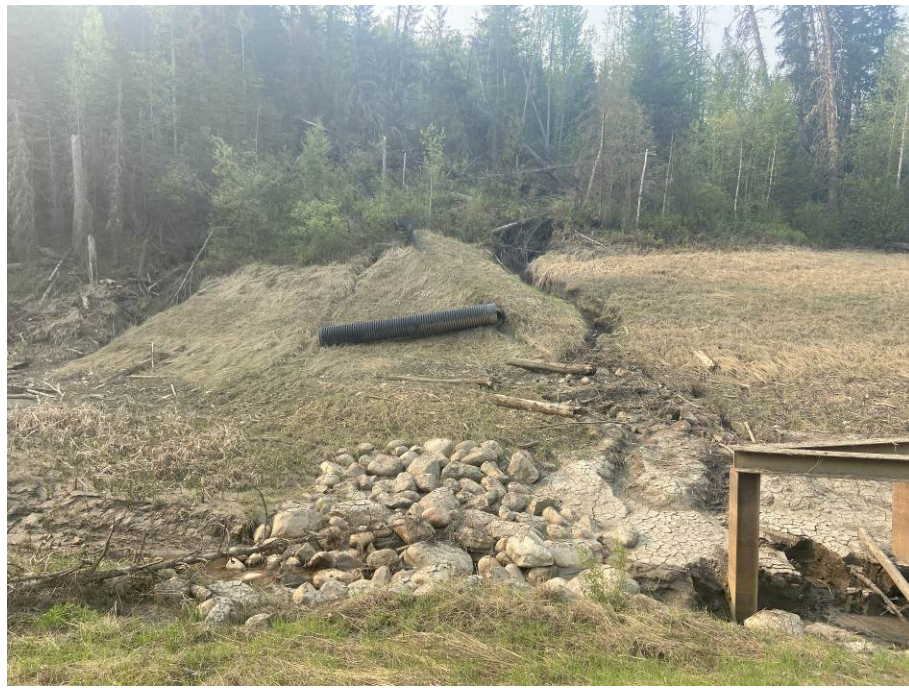
Increased gully erosion was noted near the outlet of the CPP down pipe (33+800) due to a leaking joint caused by a local landslide movement (Photo 43-16). Further upslope from the CPP down pipe outlet is an additional break in the pipe that has resulted in large erosion gully developing (2 m wide, 1.4 m deep) offset approximately 200 m from the highway.	
<input type="checkbox"/> Seepage		<input type="checkbox"/>
<input checked="" type="checkbox"/> Bridge/Culvert Distress	<p>Culvert inlet at 33+800 is still damaged from high flow event and has severely reduced flow capacity. Additional riprap above the inlet had collapsed above it and slid down burying it (Photos 43-14 and 43-15).</p> <p>Piping erosion has formed a void in the previously damaged area and location where culvert joint and grouting repairs were made. The gabion baskets and mattresses in the bottom part of the drop structure have settled and tilted around the area of damage. There was an expansion of the erosion damage around the north side of the drop structure and baskets were slightly more deformed (Photos 43-08 and 43-09).</p>	<input checked="" type="checkbox"/>

Photo 43-16.
 Looking south towards the outlet of the CPP down pipe near the culvert inlet (33+800). Rill erosion was noted to be occurring upslope from the pipe outlet due to a leaking joint that requires repair. Increased gully erosion was noted on the right side of the pipe.

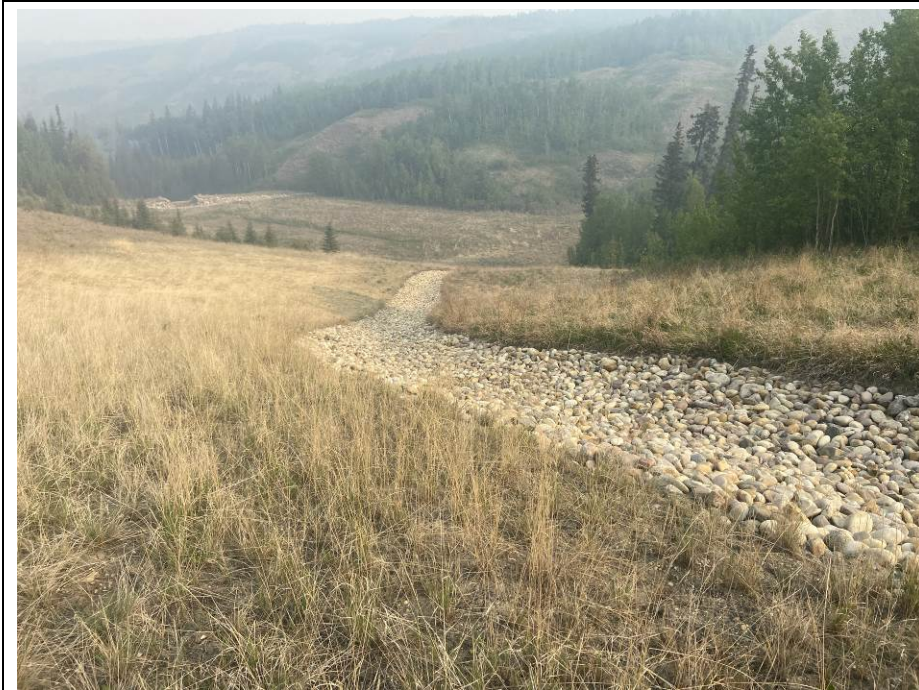
Photo 43-17.
Looking west towards the highway slope, overland flow area of Site B.

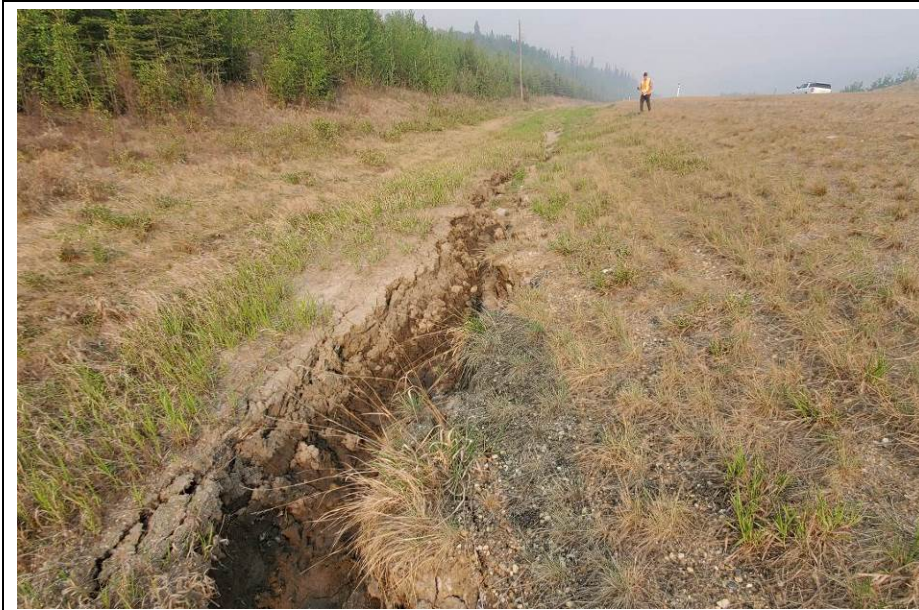
Photo 43-18.
Looking west at the south ditch erosion where a gully has developed (0.8 m wide, 0.5 m deep) in area with previous erosion that had vegetated between approximately km 34+150 to km 34+000.

<p>(2) – Repair erosion in south ditch and armor similar to north ditch with TRM and gabion mattress in section with gradient above 5%. Backslope could be used as borrow source to fill gullies. Estimate length of repair section is between 250 m to 300 m in order to extend the armoured section to the culvert inlet.</p>	\$75,000
<p>(1) – Repair erosion rills on north sideslopes above gabion mattress in ditch. Grade and line with TRM and composite rolls.</p>	\$15,000
<p>The outlet of the drop structure should be carefully cleared of excess ice and the outlet of the CSP steamed open in early Spring to limit further sinkhole expansion and damage.</p>	Maintenance
<p>Remove sand accumulation from side of roadway which is causing channelization of surface runoff on embankments and highway ditch.</p>	Maintenance

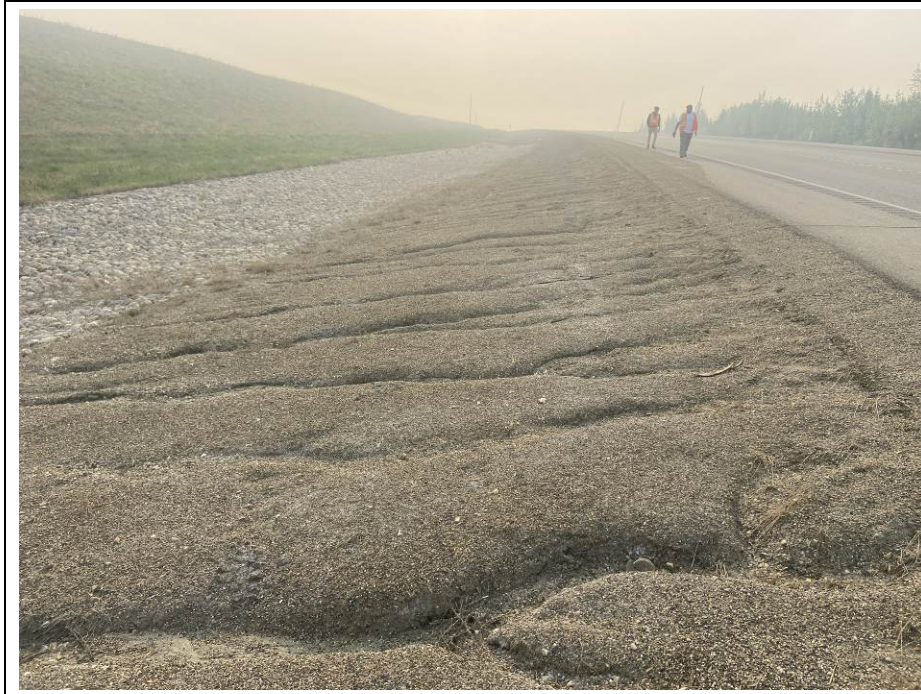
<input checked="" type="checkbox"/> Erosion	<p>Rills were slightly worse between the road and north ditch gabion armour at km 34+000 (Photo 43-19).</p> <p>South ditch erosion has caused a gully to develop (0.8 m wide, 0.5 m deep) in area with previous erosion that vegetated between approximately km 34+150 to km 34+000 (Photo 43-18).</p> <p>Previous area of erosion rills at top of embankment at the east end of the site has been graded and TRM installed with vegetation becoming better established (Photo 43-12).</p>	<input checked="" type="checkbox"/>

Photo 43-19. Rill erosion between the road and north ditch gabion armour (km 34+000) was slightly worse compared to the 2022 condition. TRM should be added to reduce rates of erosion.
