**ALBERTA TRANSPORTATION AND
ECONOMIC CORRIDORS
GEOHAZARD ASSESSMENT PROGRAM
PEACE REGION (PEACE RIVER DISTRICT)
2024 INSPECTION**

Site Number	Location	Name	Hwy	km
PH043	Daishowa East Hill	Diashowa Retaining Wall – Site A / Site B	986:01	33.45 – 33.74
Legal Description		UTM Co-ordinates (NAD 83)		
NE7/NW8-85-20 W5M		11V E 491380	N 6246075

Date	PF	CF	Total
Previous Inspection:	May 18, 2023 Site A – Pile Wall	6	4	24 (Slide Risk Rating)
	Site B	11	5	55 (Slide Risk Rating)
Current Inspection:	May 29, 2024 Site A – Pile Wall	8	3	24 (Slide Risk Rating)
	Site B	11	5	55 (Slide Risk Rating)
Road WAADT:	870	Year:	2023	
Inspected By:	Don Proudfoot, Tyler Clay, Cole Szakacs (Thurber). Rocky Wang, Robert Senior (TEC)			
Report Attachments:	<input checked="" type="checkbox"/> Photographs <input checked="" type="checkbox"/> Plans <input type="checkbox"/> Maintenance

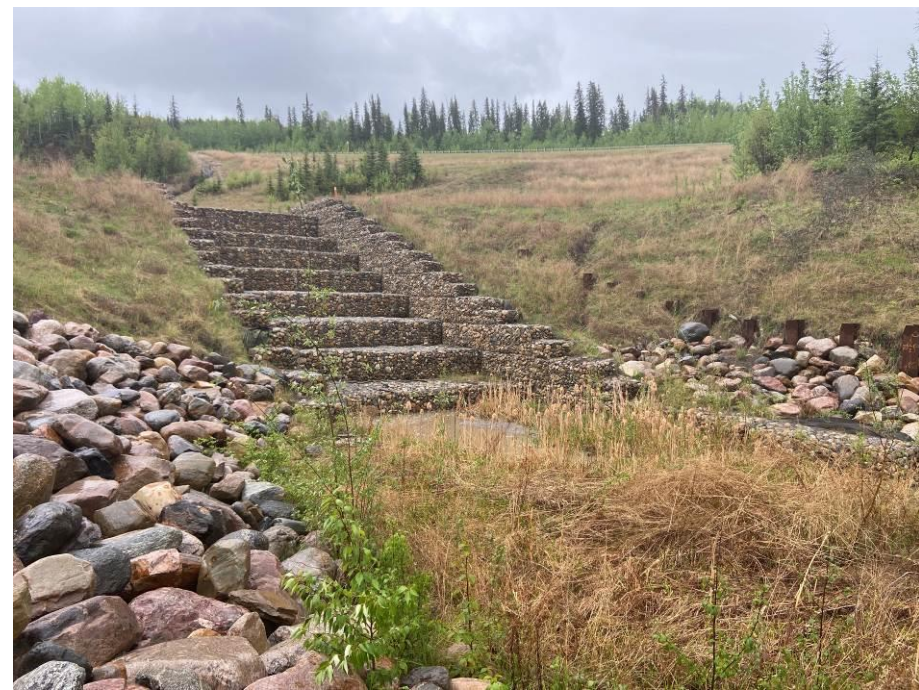
<input checked="" type="checkbox"/> Erosion	<p>Site A</p> <p>Rill erosion upslope from the steel pile wall was slightly deeper relative to the 2023 condition. (Photo 43-01)</p> <p>At the culvert inlet (33+500) the south channel bank erosion was slightly worse with expansion of the erosion and additional riprap fallen away. (Photo 43-06)</p> <p>The swale riprap at the east end of Site A with erosion damage from a 2019/2020 high flow event</p>	<input checked="" type="checkbox"/>	<input type="checkbox"/>

Photo 43-01.
Looking towards the southeast (upstream) at the Site A gabion drop structure. No major change from 2023 condition. Rill erosion on the right side of the photo above the steel pile wall was slightly worse.

- (1) Site B -repair erosion rills on north sideslopes above gabion mattress in ditch. Grade and line with TRM and composite rolls. (\$15k)
- (1) Site A - fill erosion gully with rock above pile wall at outlet drop structure. (\$5k)

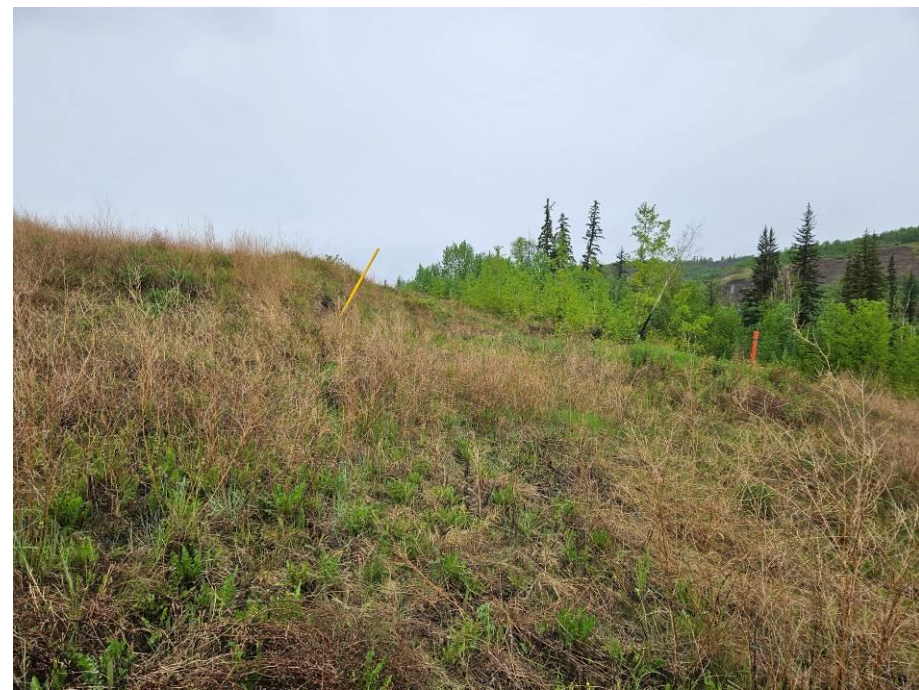
Photo 43-02.
Main slide scarp of active shallow failure downslope of the buried pile wall (33+325) first observed in 2017. Area is vegetated but appears there is active movement within the disturbed slide mass. No scarp retrogression since 2023.

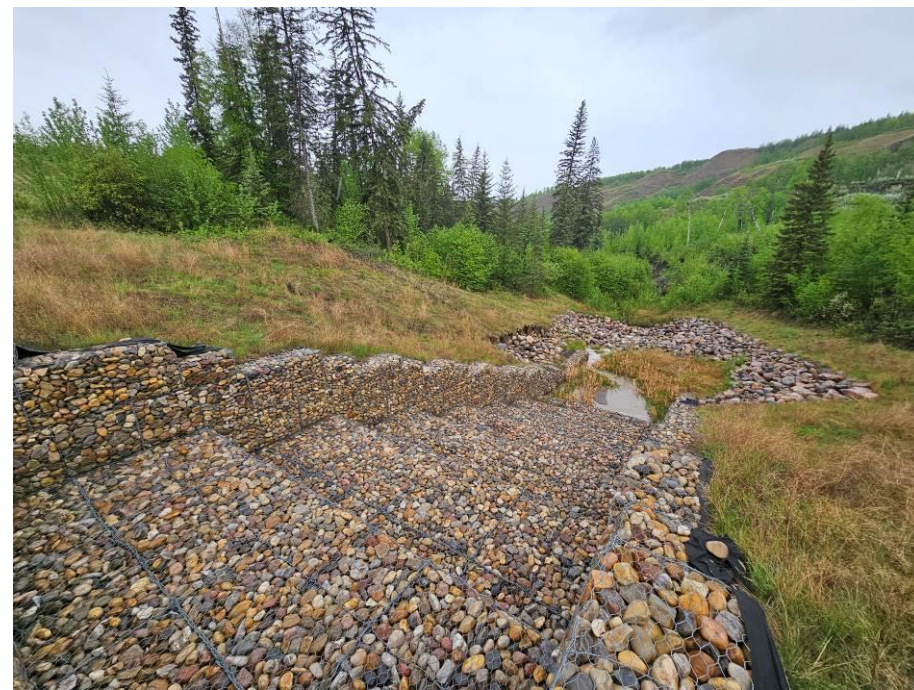
Photo 43-03.
Overflow gabion drop structure and dissipation bowl at the previous culvert outlet that had extensive erosion and gulying below Site A (33+430). Some rill erosion was noted within the fill areas that were still vegetating. Dissipation bowl at base of drop structure had a large amount of silt buildup. Minor change from 2023 condition.

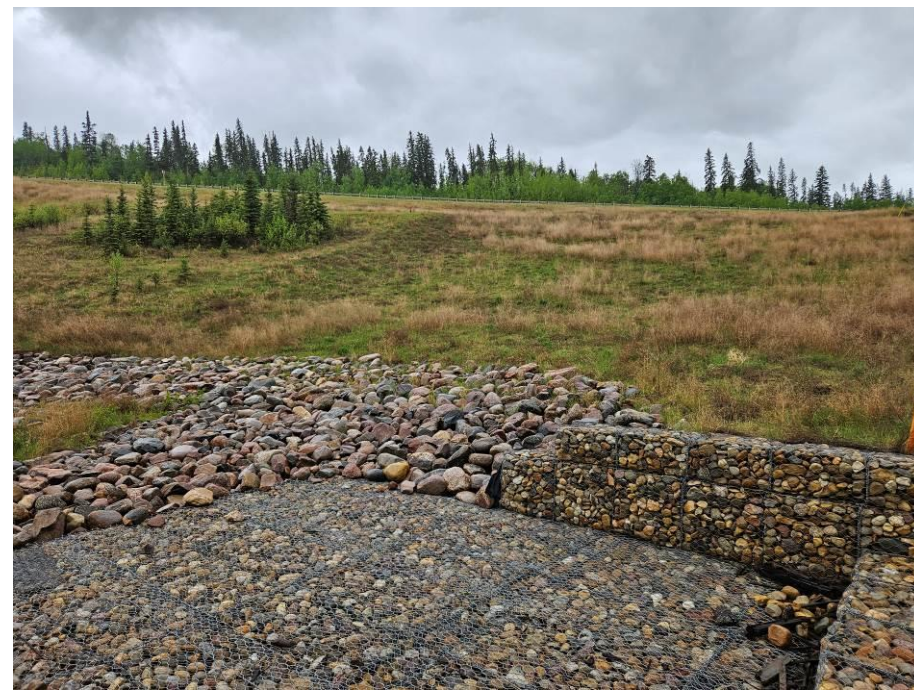
Photo 43-04.
Looking south at the area of previous slumping associated with culvert erosion below pile wall and regraded slide during construction in 2017 (33+430). Area has since revegetated following grading of the construction access. No change from 2023 condition.

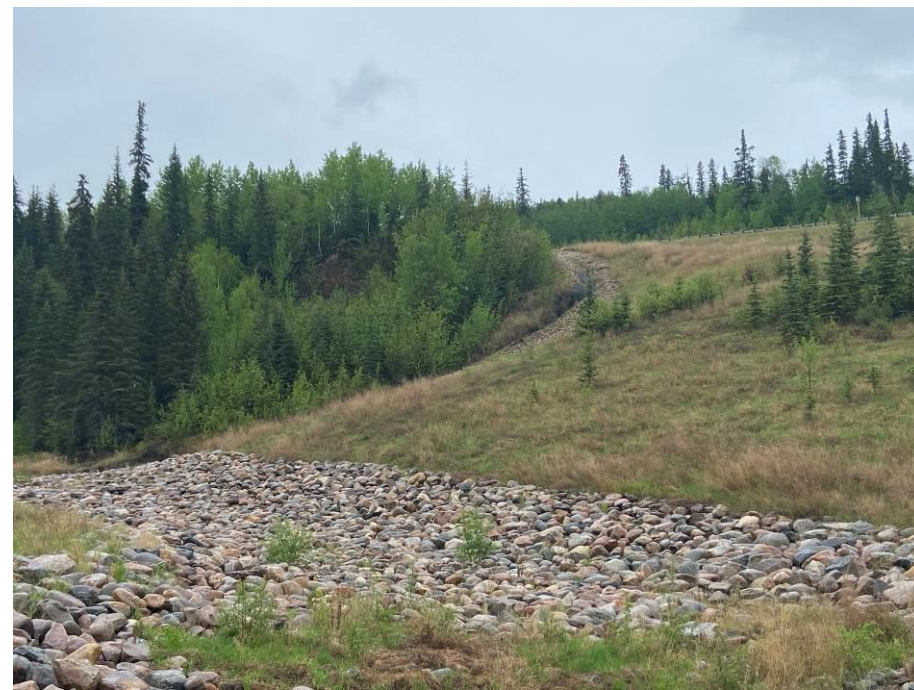
Photo 43-05.
Site A - Standing at the top of the gabion drop structure looking southeast towards the rock washout and gully erosion in the armoured swale near 33+525. Erosion was worse from 2023. Armoured overflow channel in the valley bottom was in good condition.

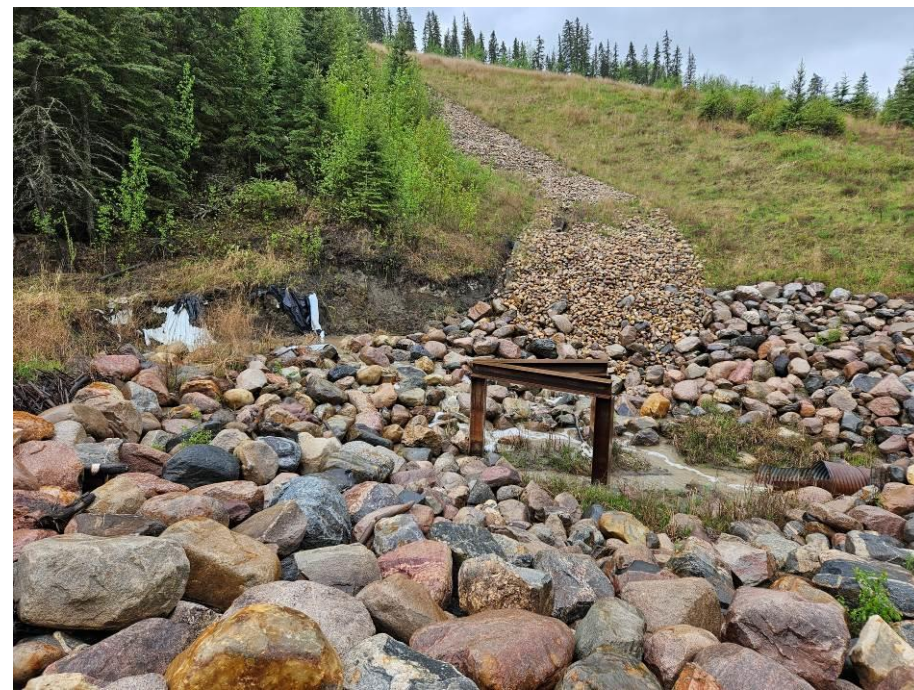
Photo 43-06.
Site A - Looking south towards the culvert inlet riprap, riprap swale, and debris deflector (33+500). Note south channel bank erosion and fallen riprap. Slightly worse from the 2023 condition. Culvert inlet was damaged and eroded, causing water to flow under the base and come in at a joint.

- (4) Site A - replacement of the damaged culvert inlet with a stronger SWSP with steeper end bevel. The new culvert should be grouted into the existing CSP. Additional Class 2 riprap should be added and shaped to better funnel water into the inlet. (\$30k)

- (3) Site A - repair south channel bank erosion near the culvert inlet and toe of the armored swale. The disturbed soils should be excavated and backfilled with gravel over non-woven geotextile. Additional Class 2 riprap should be added over the bank and blended into the toe of the armored drainage swale. (\$25k)

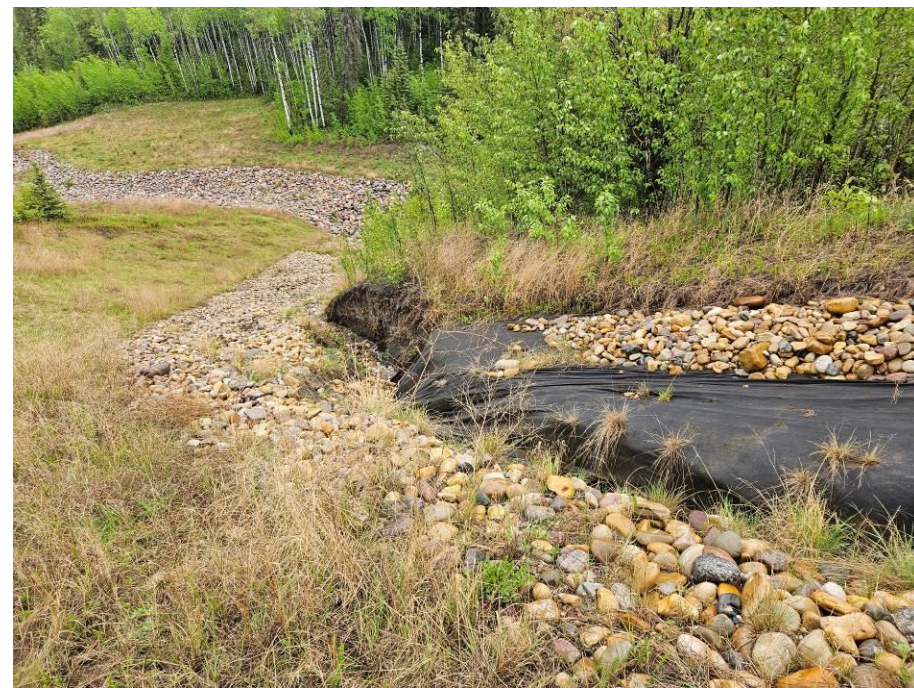
<p>had increased damage, gulying was deeper and wider. (Photo 43-07)</p> <hr/> <p>Site B</p> <p>Rills were slightly worse between the road and north ditch gabion armour at km 34+000 (Photo 43-20).</p> <p>South ditch erosion has an expanded gully (1.2 m wide, 0.7 m deep) in area with previous erosion that vegetated between approximately 34+150 and 33+900. (Photo 43-19)</p> <p>Previous area of erosion rills at top of embankment at the east end of the site has been graded and TRM installed. TRM appears effective in reducing rill erosion development. Limited vegetation growth within the upper road embankment likely due to sand and salt runoff from winter road maintenance. At end of TRM section at west end of site rill erosion looked similar to the 2023 condition. (Photos 43-09 and 43-14)</p> <p>Increased gully erosion was noted near the outlet of the CPP down pipe (33+800) due to a leaking joint caused by a local landslide movement. Further upslope from the CPP down pipe outlet is an additional break in the pipe that has resulted in large erosion gully developing (2 m wide, 1.4 m deep) offset approximately 200 m from the highway. (Photo 43-16)</p>

Photo 43-07.
Site A - looking north, downslope towards washed out riprap and extensive erosion damage within the riprap swale at the east side of Site A (33+500), likely the result of a high-flow event in 2019/2020. Deeper and expanded erosion damage since 2023.

- (4) Site A - repair of the armored swale. Existing rock should be salvaged and used with additional imported material to line the armored swale with gabion mattress anchored at intervals to the slope. Swale alignment improvements should also be made (reduction of super elevation in the upper curve) and a cross berm should be added near the top to divert highway runoff into the swale. (\$45k)

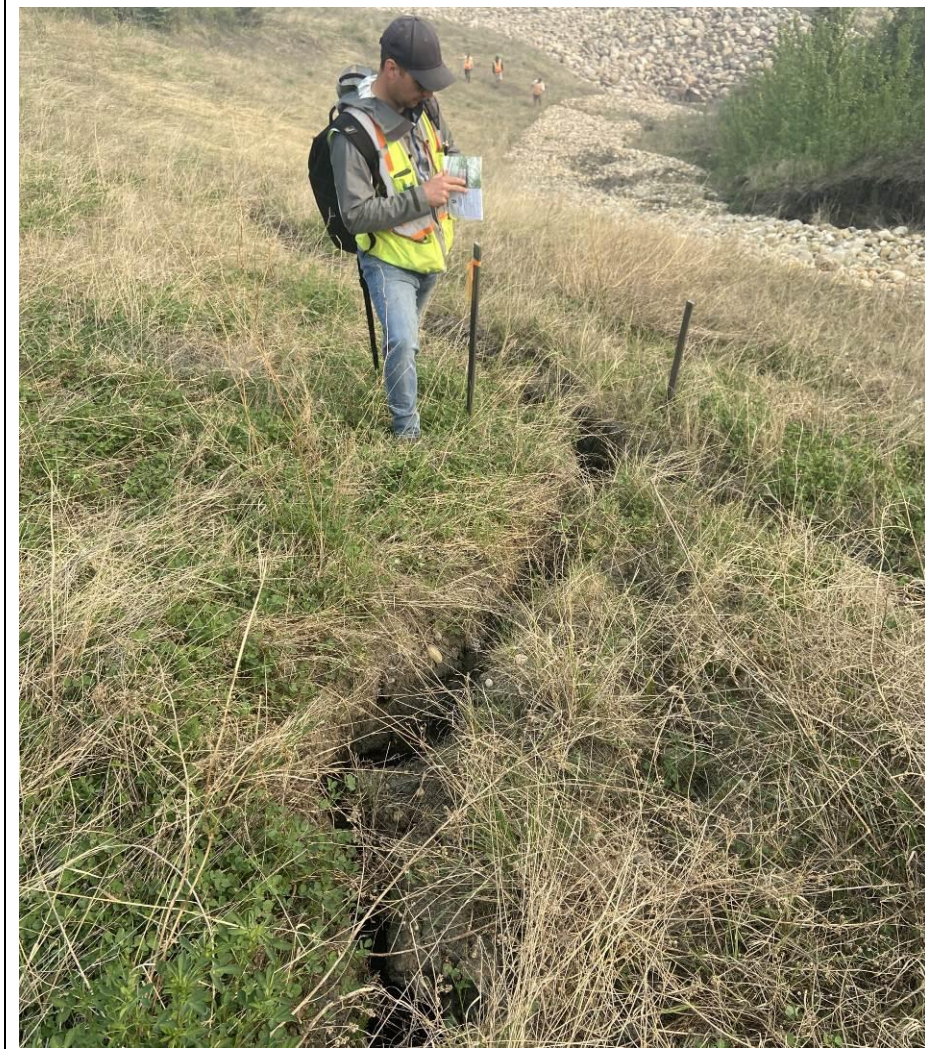
Photo 43-08. Looking towards the north at survey lath stakes installed in 2023 to monitor a potential tension crack related to potential downslope movement towards the swale washout and erosion area (km 33+500). The offset between the outside base of the stakes measured 1.16 m and did not increase relative to the previous measurement. Feature could be result of erosion.

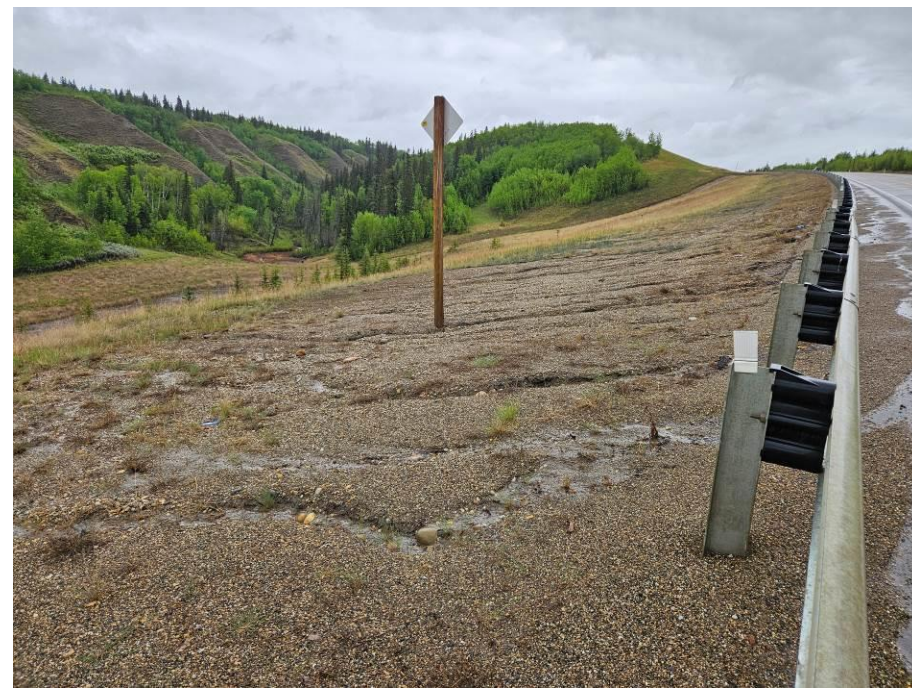
Photo 43-09.
Looking east from the top of the Site B highway embankment. Minor rill erosion within top of embankment where TRM ends. No significant change from the 2023 condition.

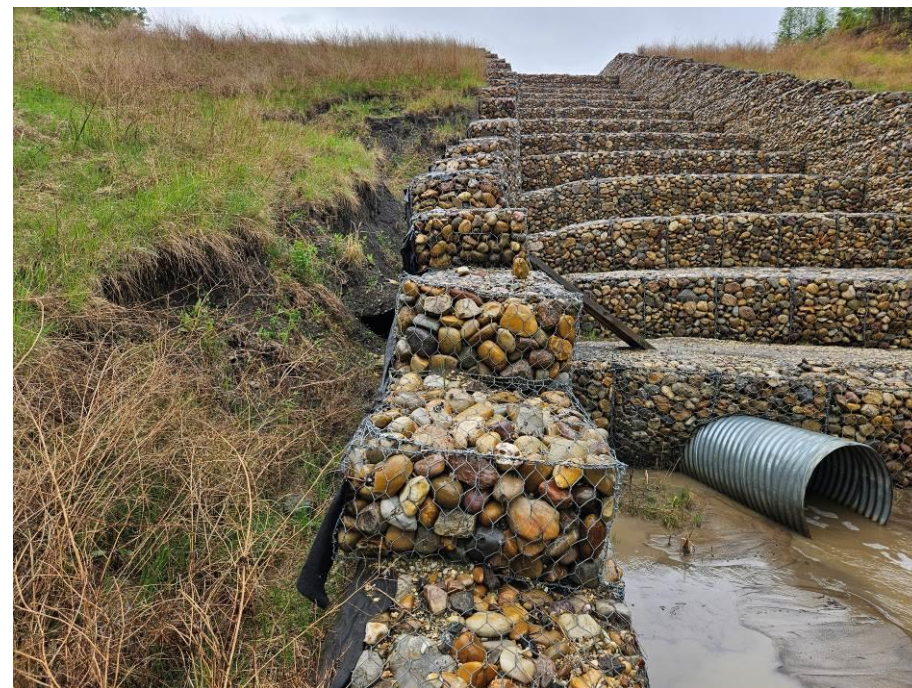
side of the drop structure and baskets were slightly more deformed (Photos 43-10 and 43-11).		
<input checked="" type="checkbox"/> Other	No significant beaver activity noted at the creek between Sites A and B. Additional woody debris buildup upslope of the Site B culvert inlet, indicative of flooding during high flow conditions. (Photo 43-15)	<input type="checkbox"/>	<input checked="" type="checkbox"/>

Photo 43-10.
Site B- view east from the base of the gabion drop structure and riprap dissipation bowl at the culvert outlet (33+600). Additional erosion expansion and gabion deformation due to piping erosion from leak in the culvert joint (left side).

-
- (4) Site B- drop structure erosion repair. The disturbed soils outside the drop structure wall should be excavated and backfilled with Class 1M riprap placed over non-woven geotextile. Class 1 rock should be placed as armour cover and to reinforce the toe of the backfilled zone. (\$150k)

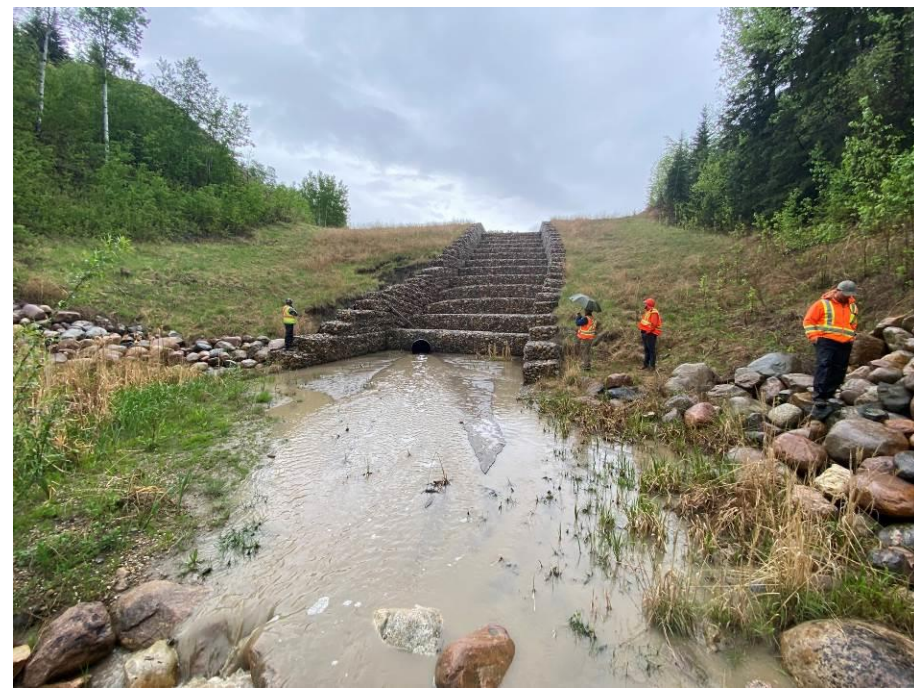
Photo 43-11.
Site B- view of the gabion drop structure and riprap dissipation bowl at the culvert outlet (33+600). Additional sediment buildup in dissipation bowl.

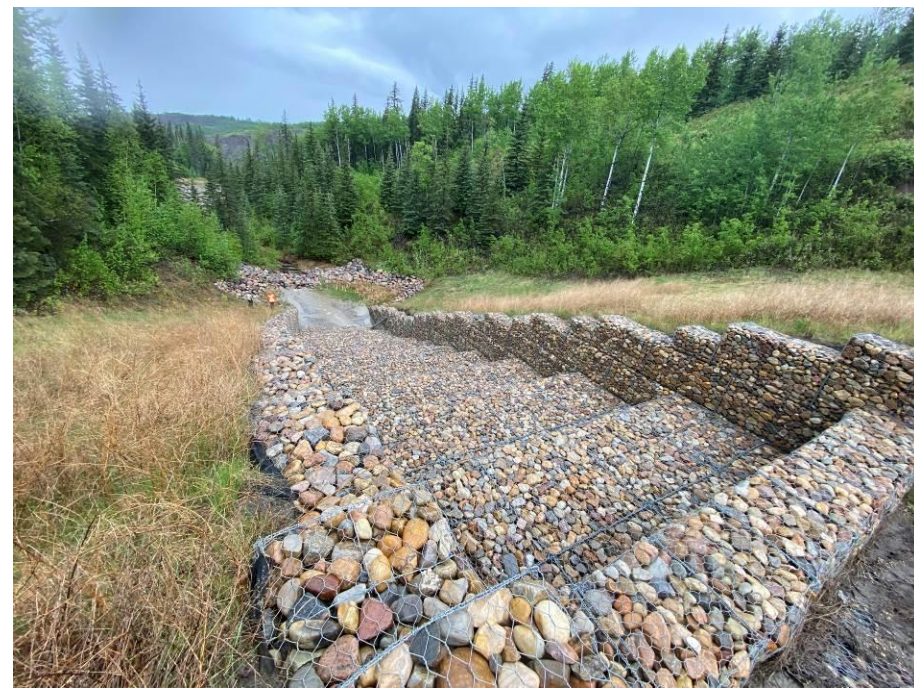
Photo 43-12.
Site B- view northeast from the top of the gabion drop structure the culvert outlet in the valley bottom (33+600). Top of structure appeared in good condition with no major change from the 2023 condition.

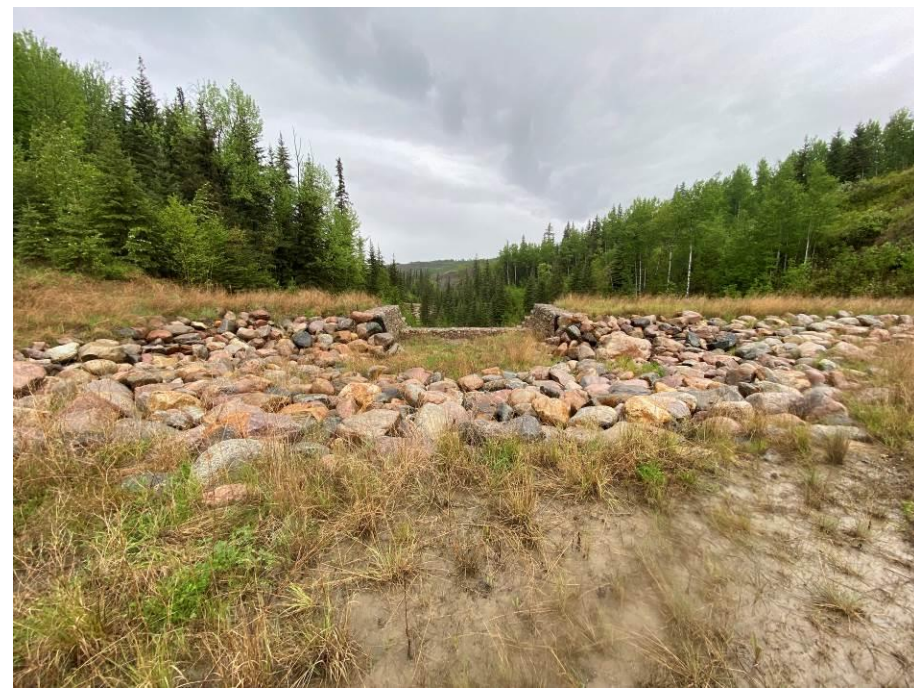
Photo 43-13.
Site B- view east at upstream of the gabion drop structure with riprap berm at west end of overland flow toe berm (33+625). No change from 2023 condition.

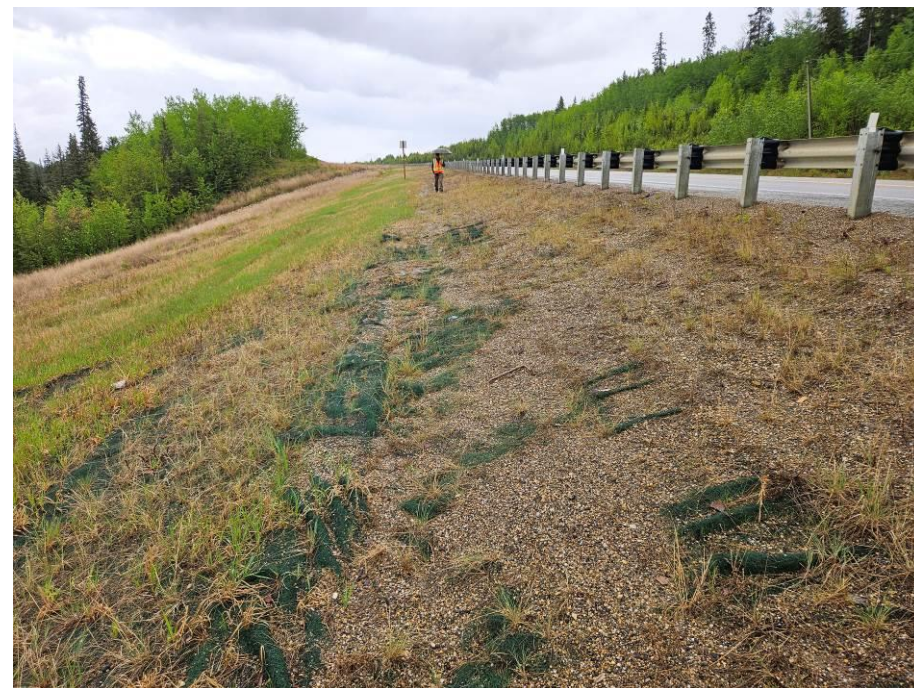
Photo 43-14.
Looking east towards the TRM installation on the upper portion of the slope north of the road (33+800). Limited vegetation growth within the upper road embankment likely due to sand and salt runoff from winter road maintenance.

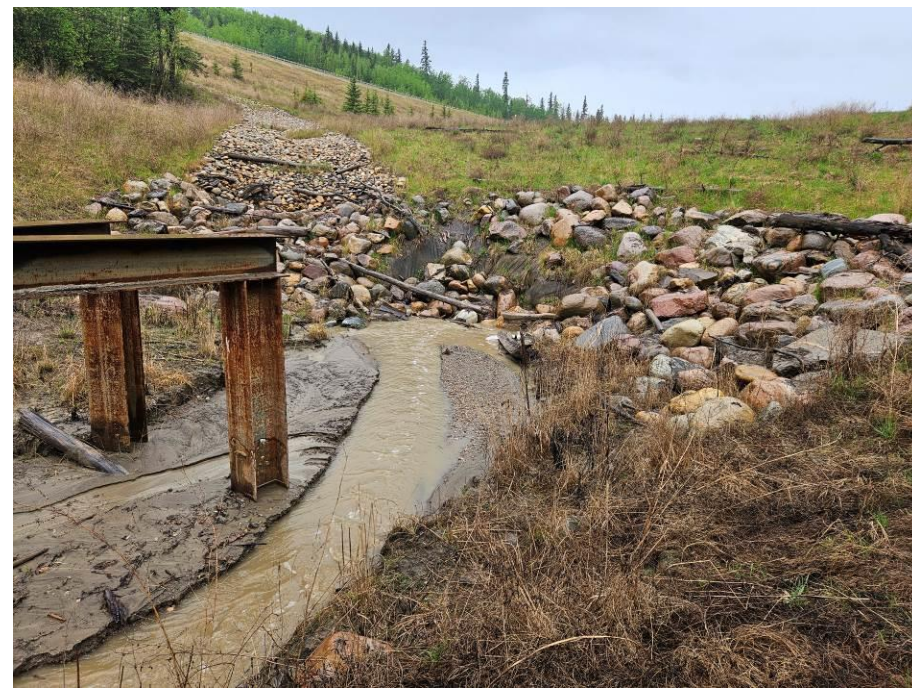
Photo 43-15.
Damage around culvert inlet due to a high flow event in 2021/2022. Culvert pipe at the inlet was effectively pinched and twisted shut and was filled with woody debris. Additional riprap above the inlet has collapsed and buried it. Additional woody debris buildup. Repairs required in this area (33+800).

- (4) Site B - replace culvert inlet at km 33+800 within valley bottom. Replace with concrete faced headwall and rebuild embankment slope. The new inlet should comprise a liner with SWSP. Additional rip should be added and shaped around the reinforced headwall. (\$85k)

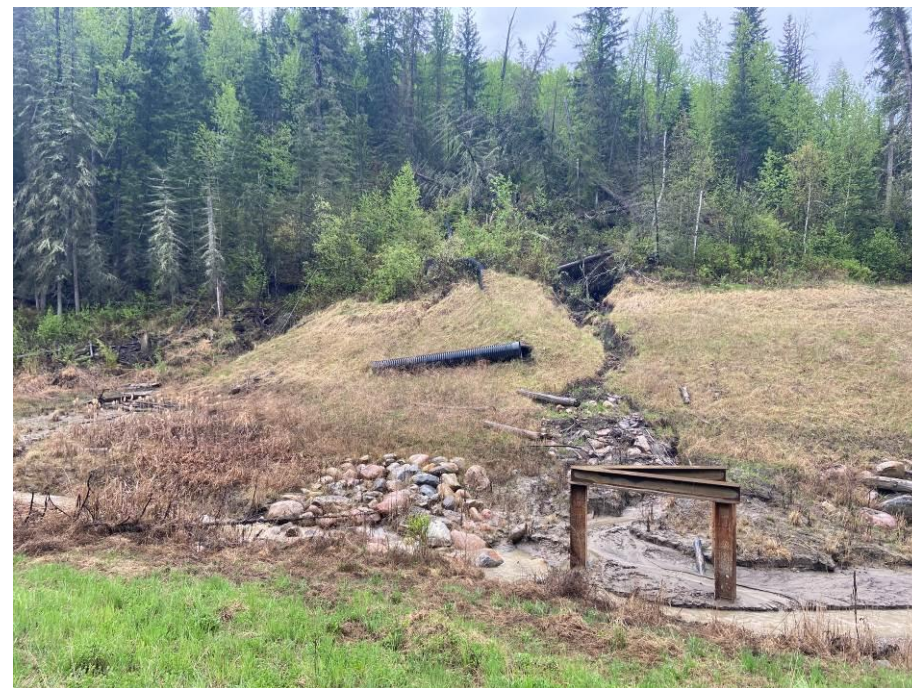
Photo 43-16.
Looking south towards the outlet of the CPP down pipe near the culvert inlet (33+850). Gully erosion was noted to be occurring upslope from the pipe outlet due to a leaking joint that requires repair. Increased gully erosion was noted on the right side of the pipe. Large gully erosion headwall developing upslope in the trees and sliding of gully sidewalls. Expanded erosion since 2023.

- (3) Site B - replace CPP down pipe severed by landslide. Replace with welded HDPE pipe seated below ground to new Big-O jointed pipe and regrade slope. Run a new Big-O pipe at surface to the creek along a shifted alignment outside of unstable slope area. (\$125k)

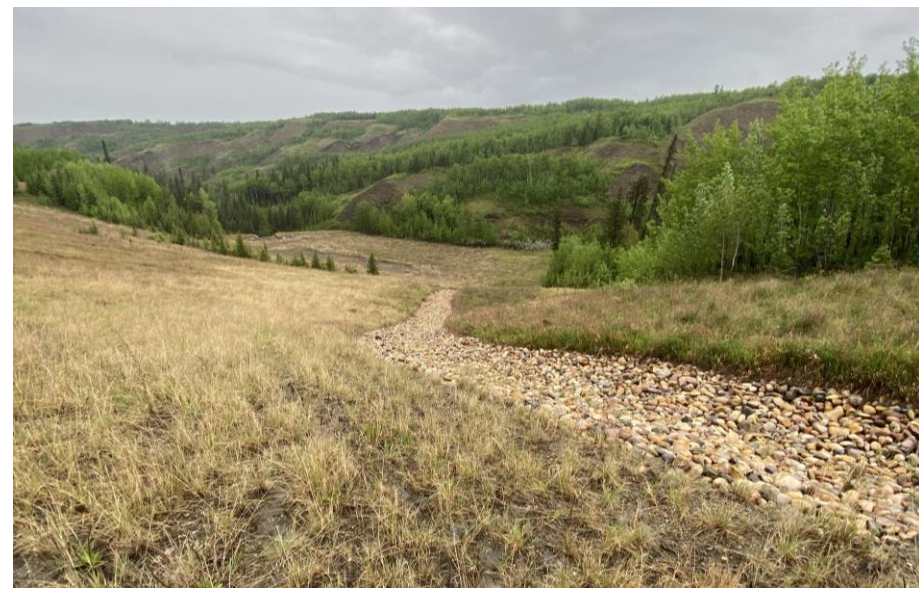
Photo 43-17.
Looking northwest from the top of Site B towards the armored swale and overland flow area (33+875). No changes from the 2023 condition.

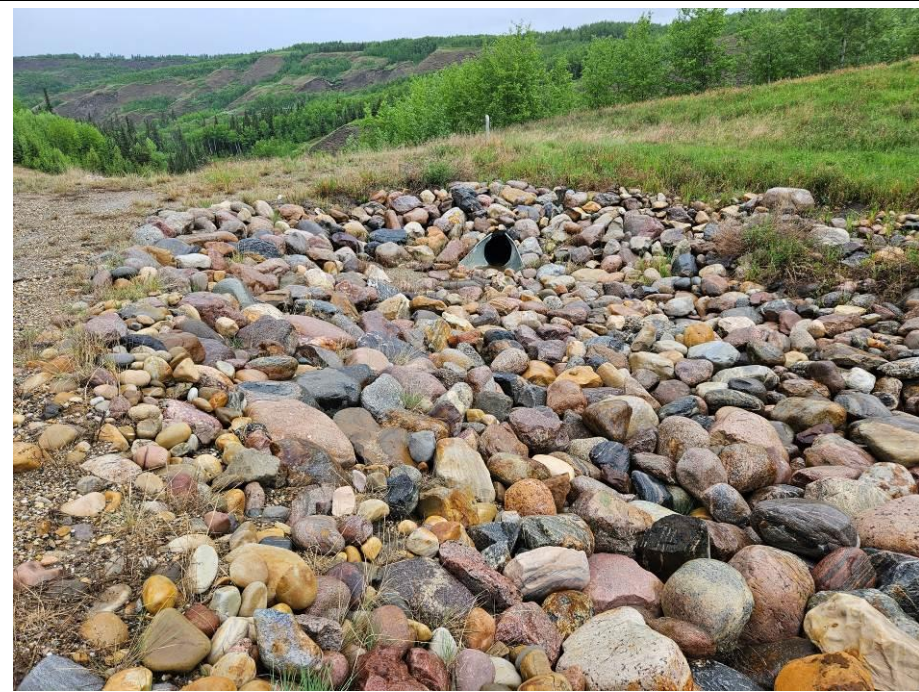
Photo 43-18.
View of culvert inlet and riprap protection near 33+900 on north side of road. No visible changes from the 2023 condition.

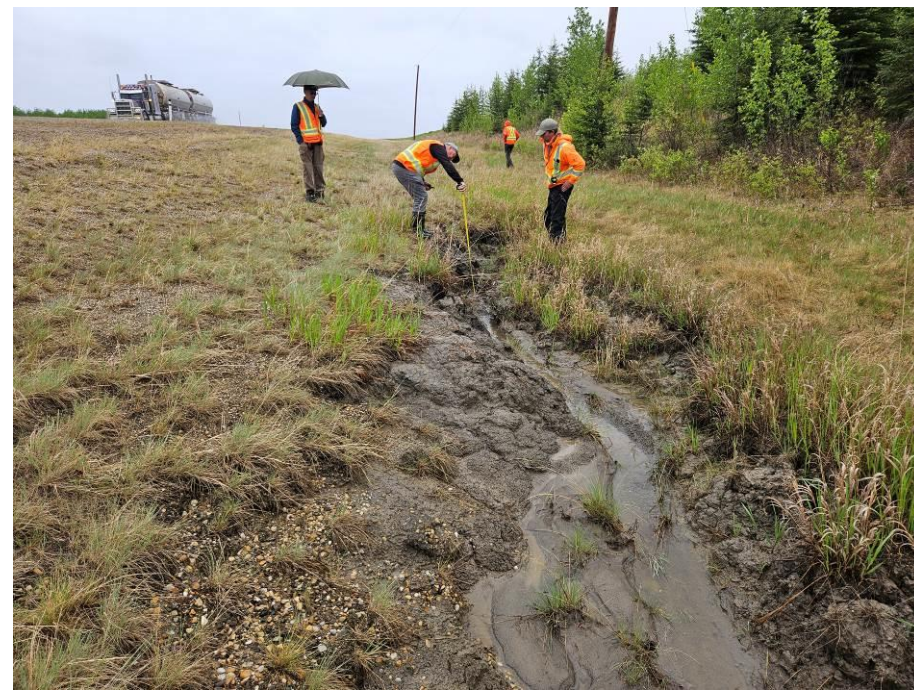
Photo 43-19.
Looking upslope (east) at the south ditch erosion where a gully has developed (up to 1.2 m wide, 0.7 m deep) between approximately 33+900 and 34+150. Erosion has become deeper and wider since 2023.

- (2) Site B - repair erosion in south ditch and armor similar to north ditch with TRM and gabion mattress in section with gradient above 5%. Backslope could be used as borrow source to fill gullies. Estimate length of repair section is between 250 m to 300 m in order to extend the armoured section to the culvert inlet. (\$85k)

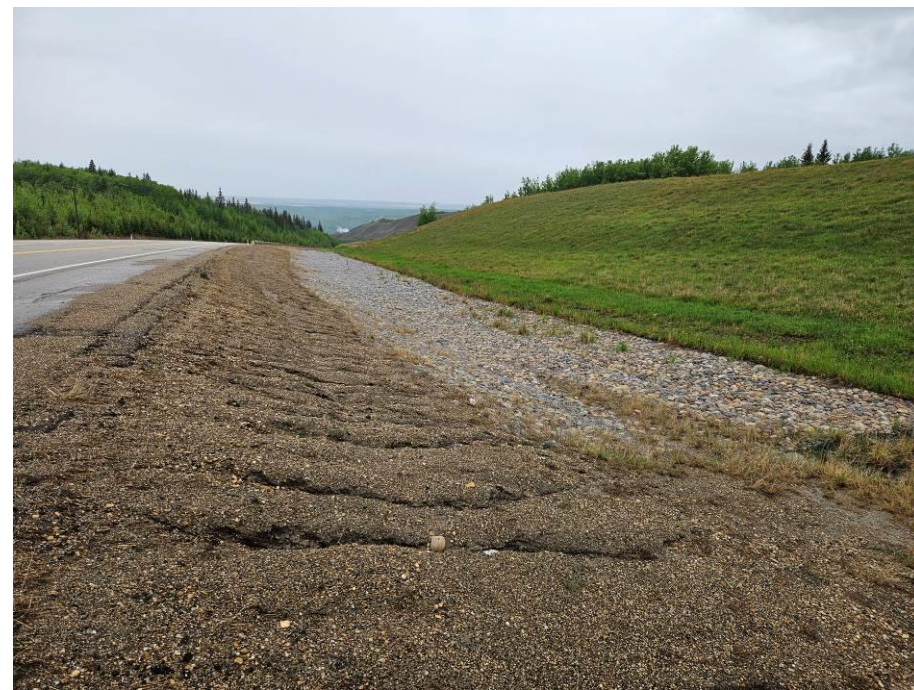
Photo 43-20.
Rill erosion between the road and north ditch gabion armour (km 34+000) was slightly worse compared to the 2023 condition. TRM should be added to reduce rates of erosion.
