Site Number	Location	Name	Hwy	km
PH043	HWY 986:01 C1 33.357	Daishowa Retaining Wall	986:01	Km 33.4
<b>Legal Description:</b> 9-7-85-20 W5		<b>UTM Co-ordinates</b>		
		11U E 491412.57	N	6246098.92

<b>Current Monitoring:</b>	20-May-2024	<b>Previous Monitoring</b>	15-Jun-2023
<b>Instruments Read By:</b>	Mr. Niraj Regmi, G.I.T and Mr. Nixon Mationg, of Thurber

**ALBERTA TRANSPORTATION AND ECONOMIC CORRIDORS GRMP (CON0022164)  
PEACE REGION (PEACE RIVER DISTRICT)  
INSTRUMENTATION MONITORING RESULTS**

**SITE PH043-1: HWY 986:01, DAISHOWA EAST HILL PILE WALL  
SITE PH043-2: HWY 986:01, DAISHOWA EAST HILL SITE B**

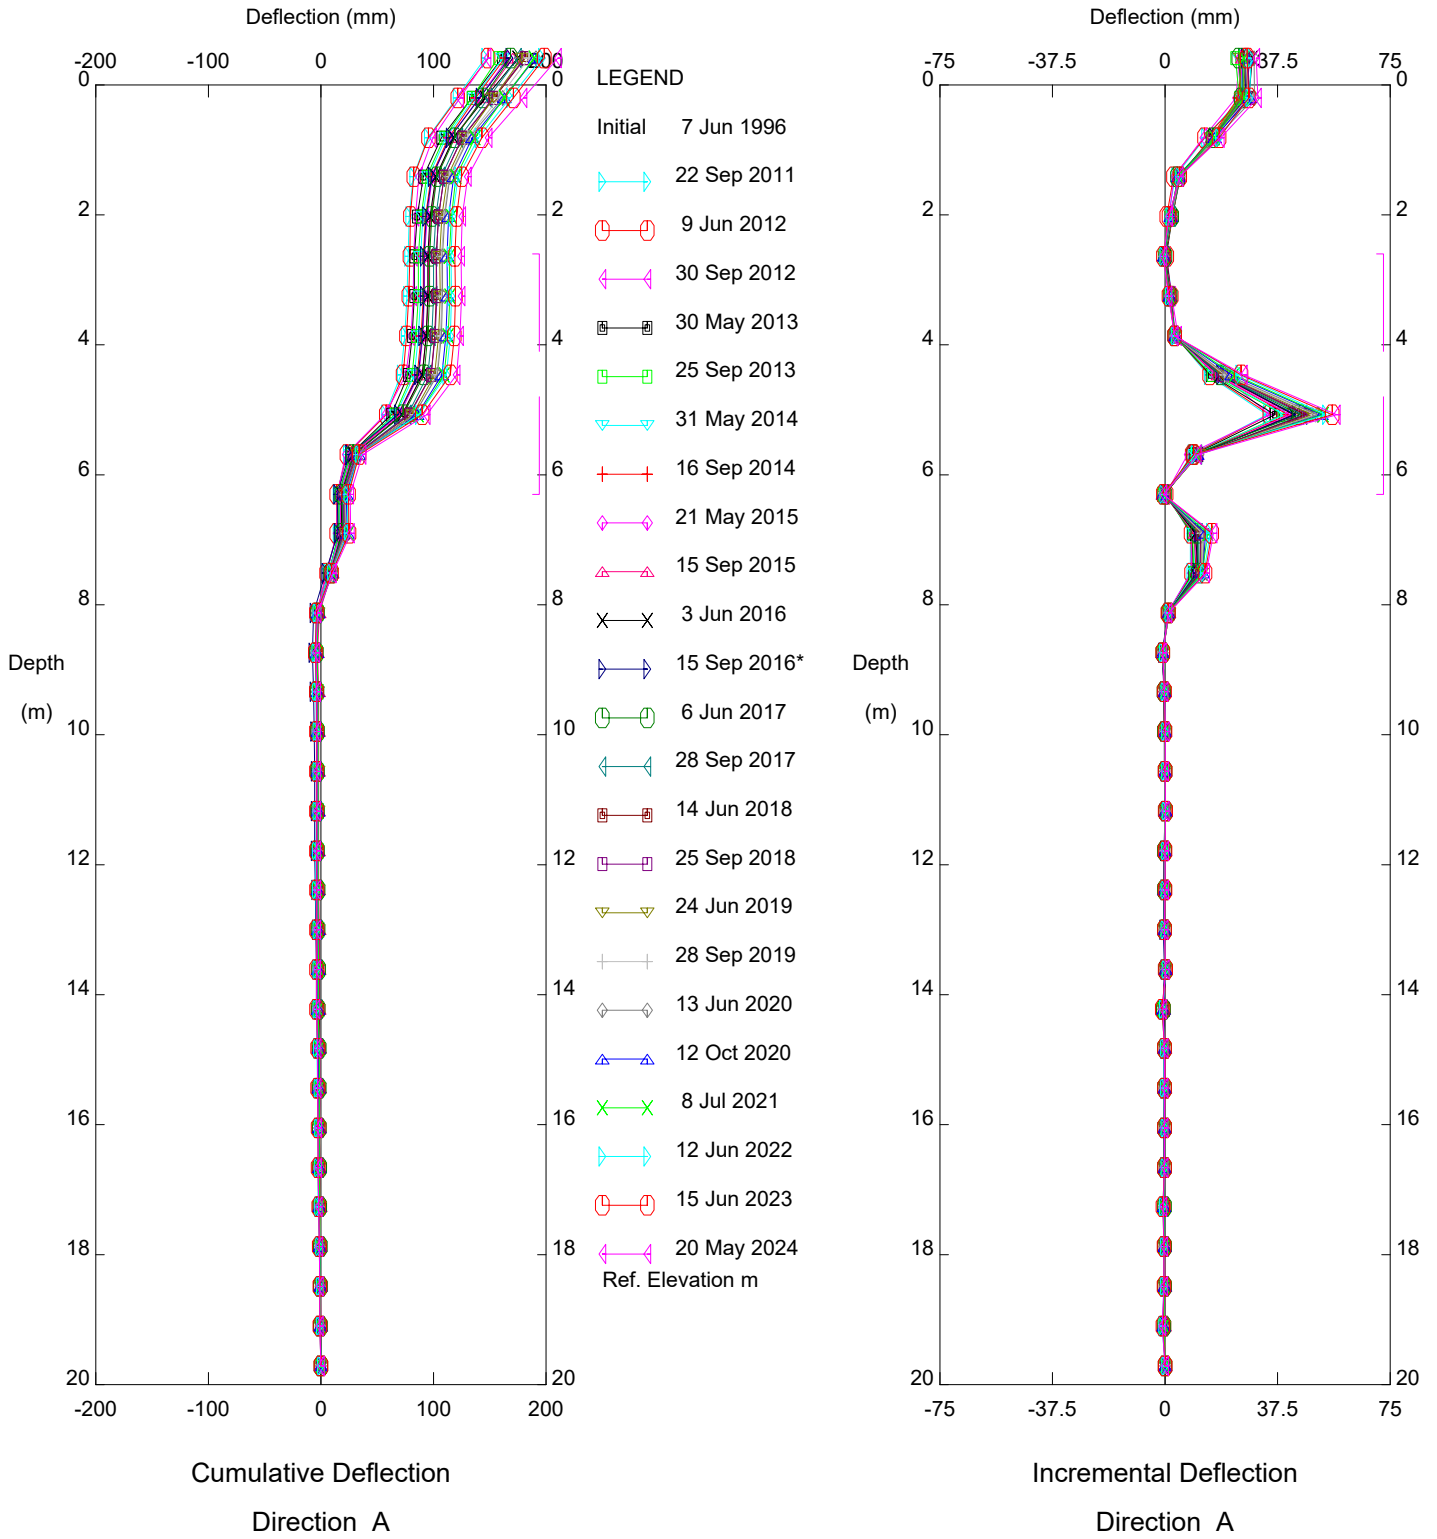
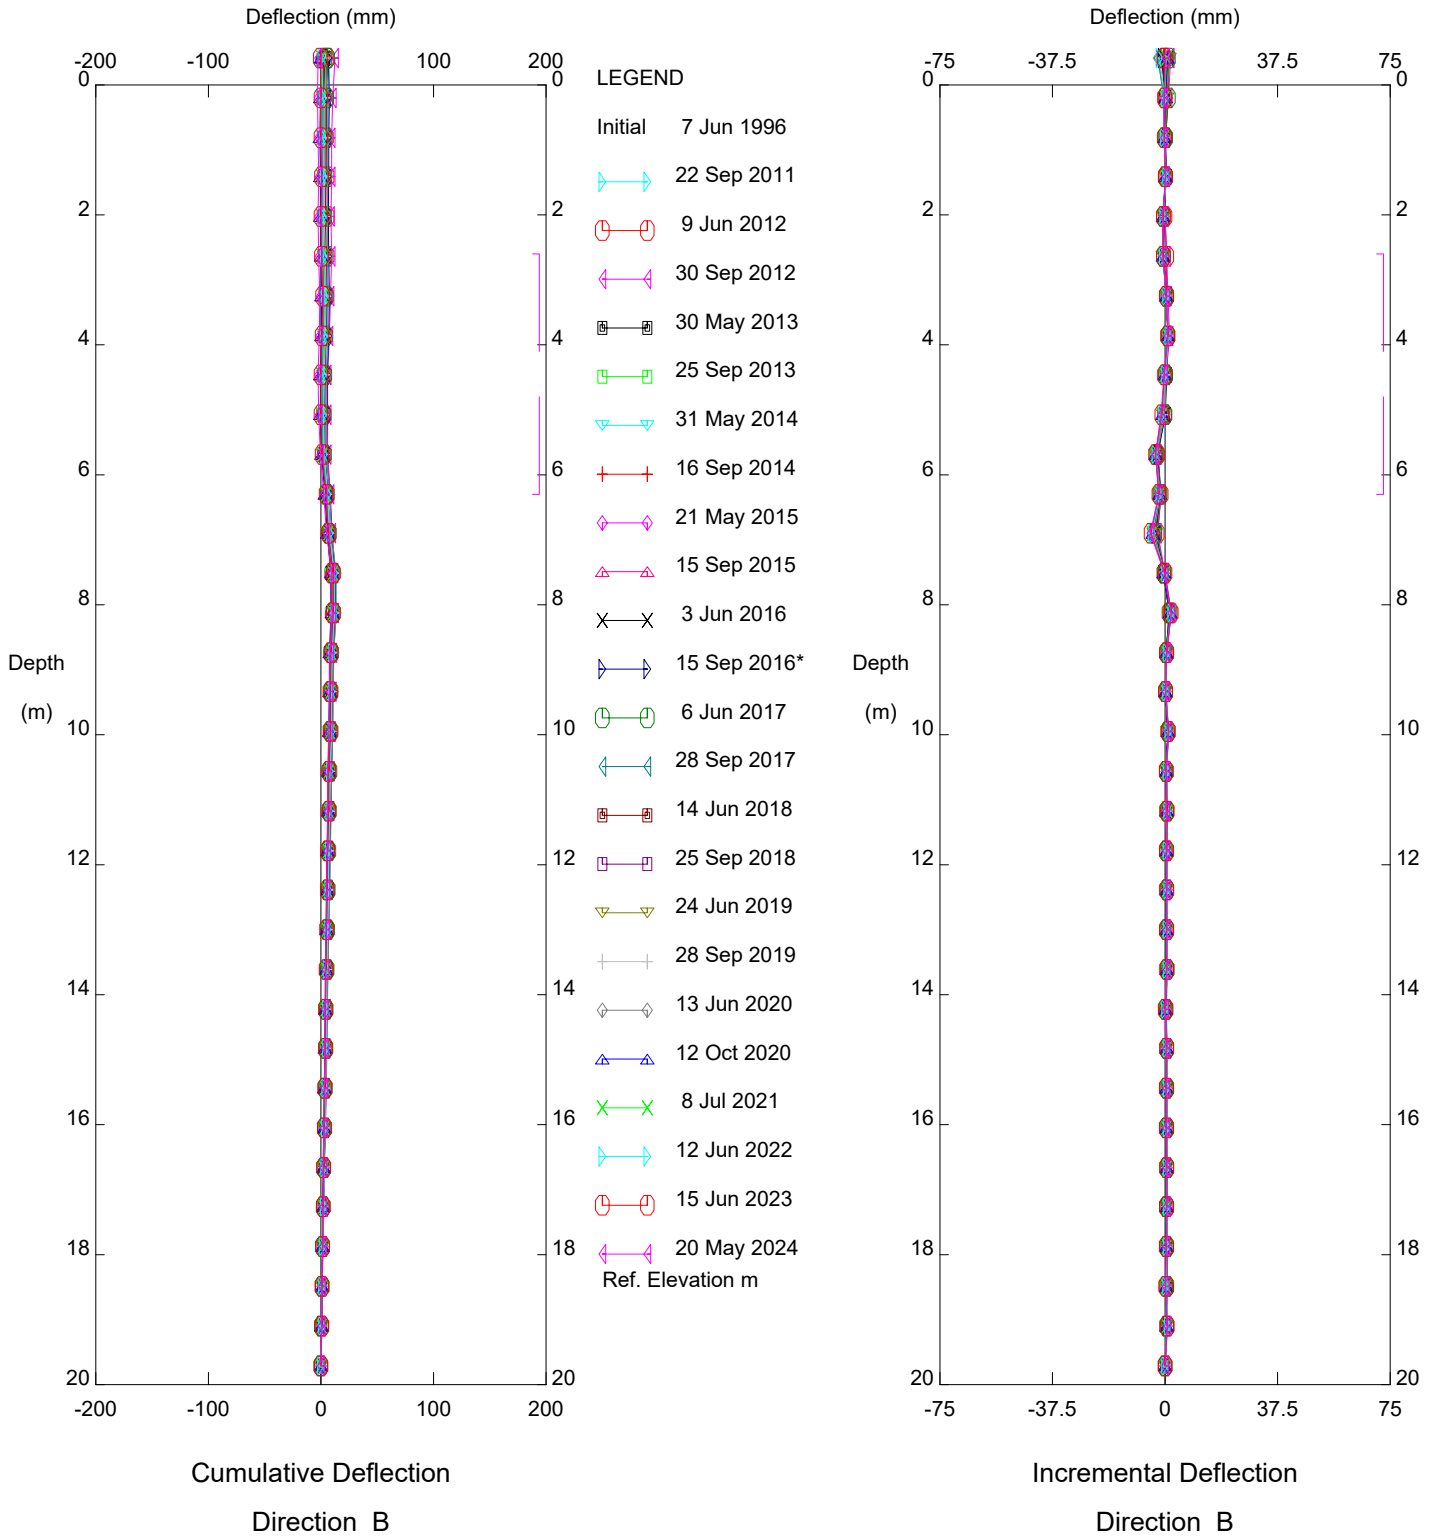
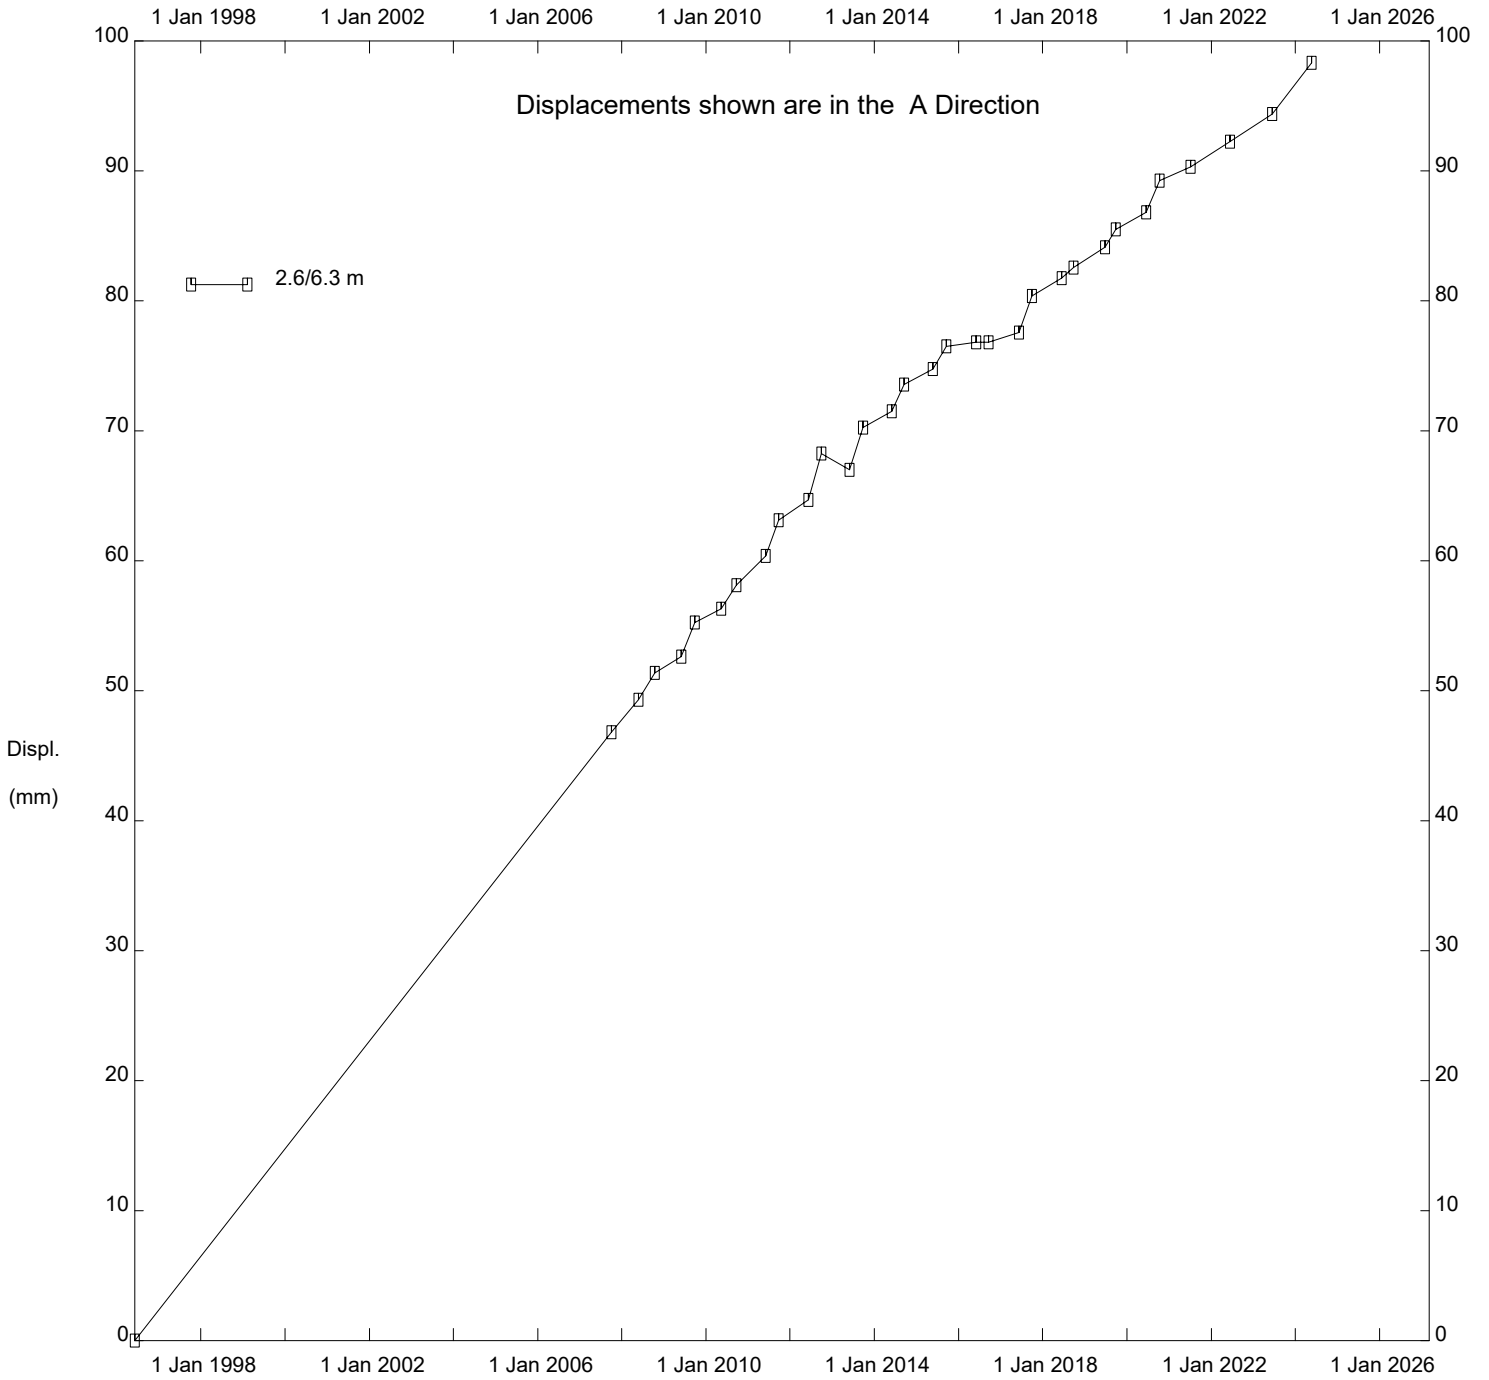
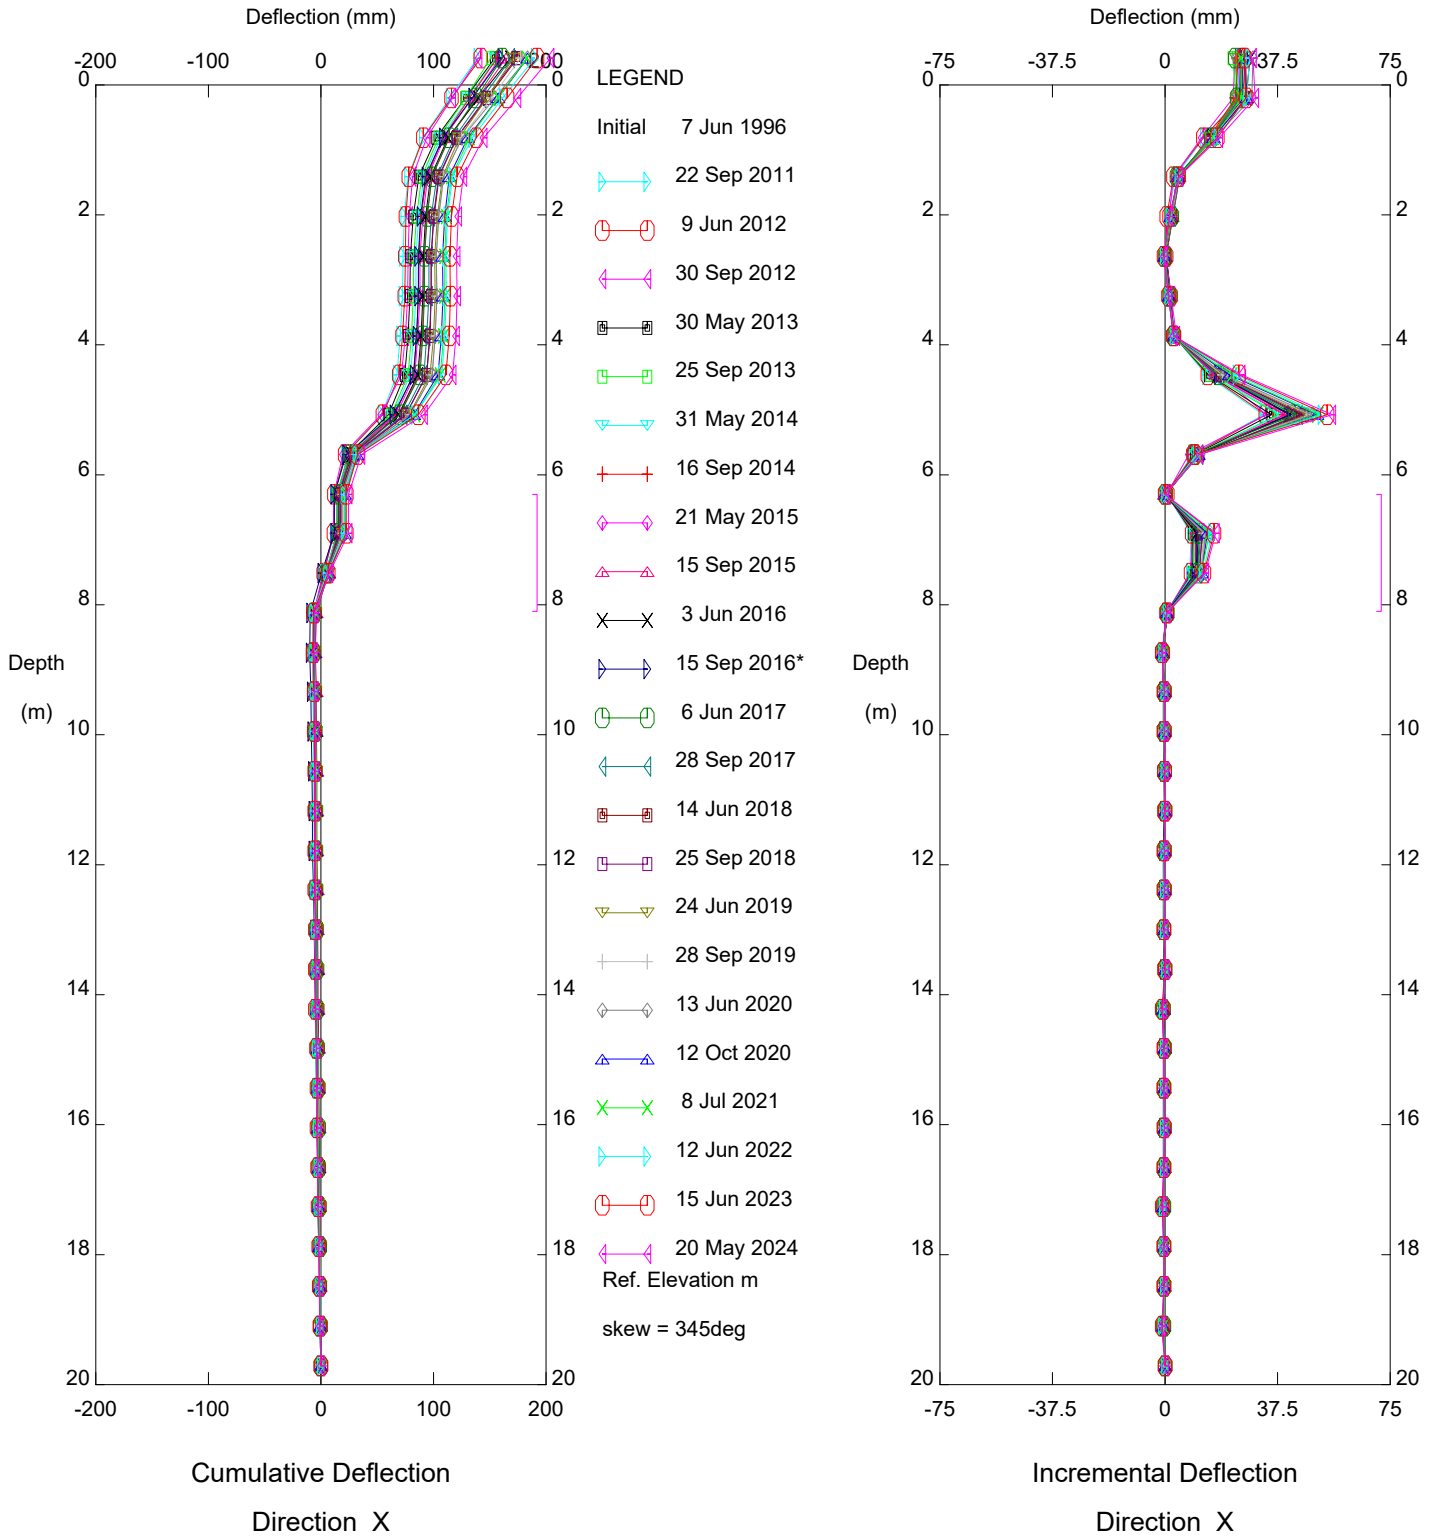
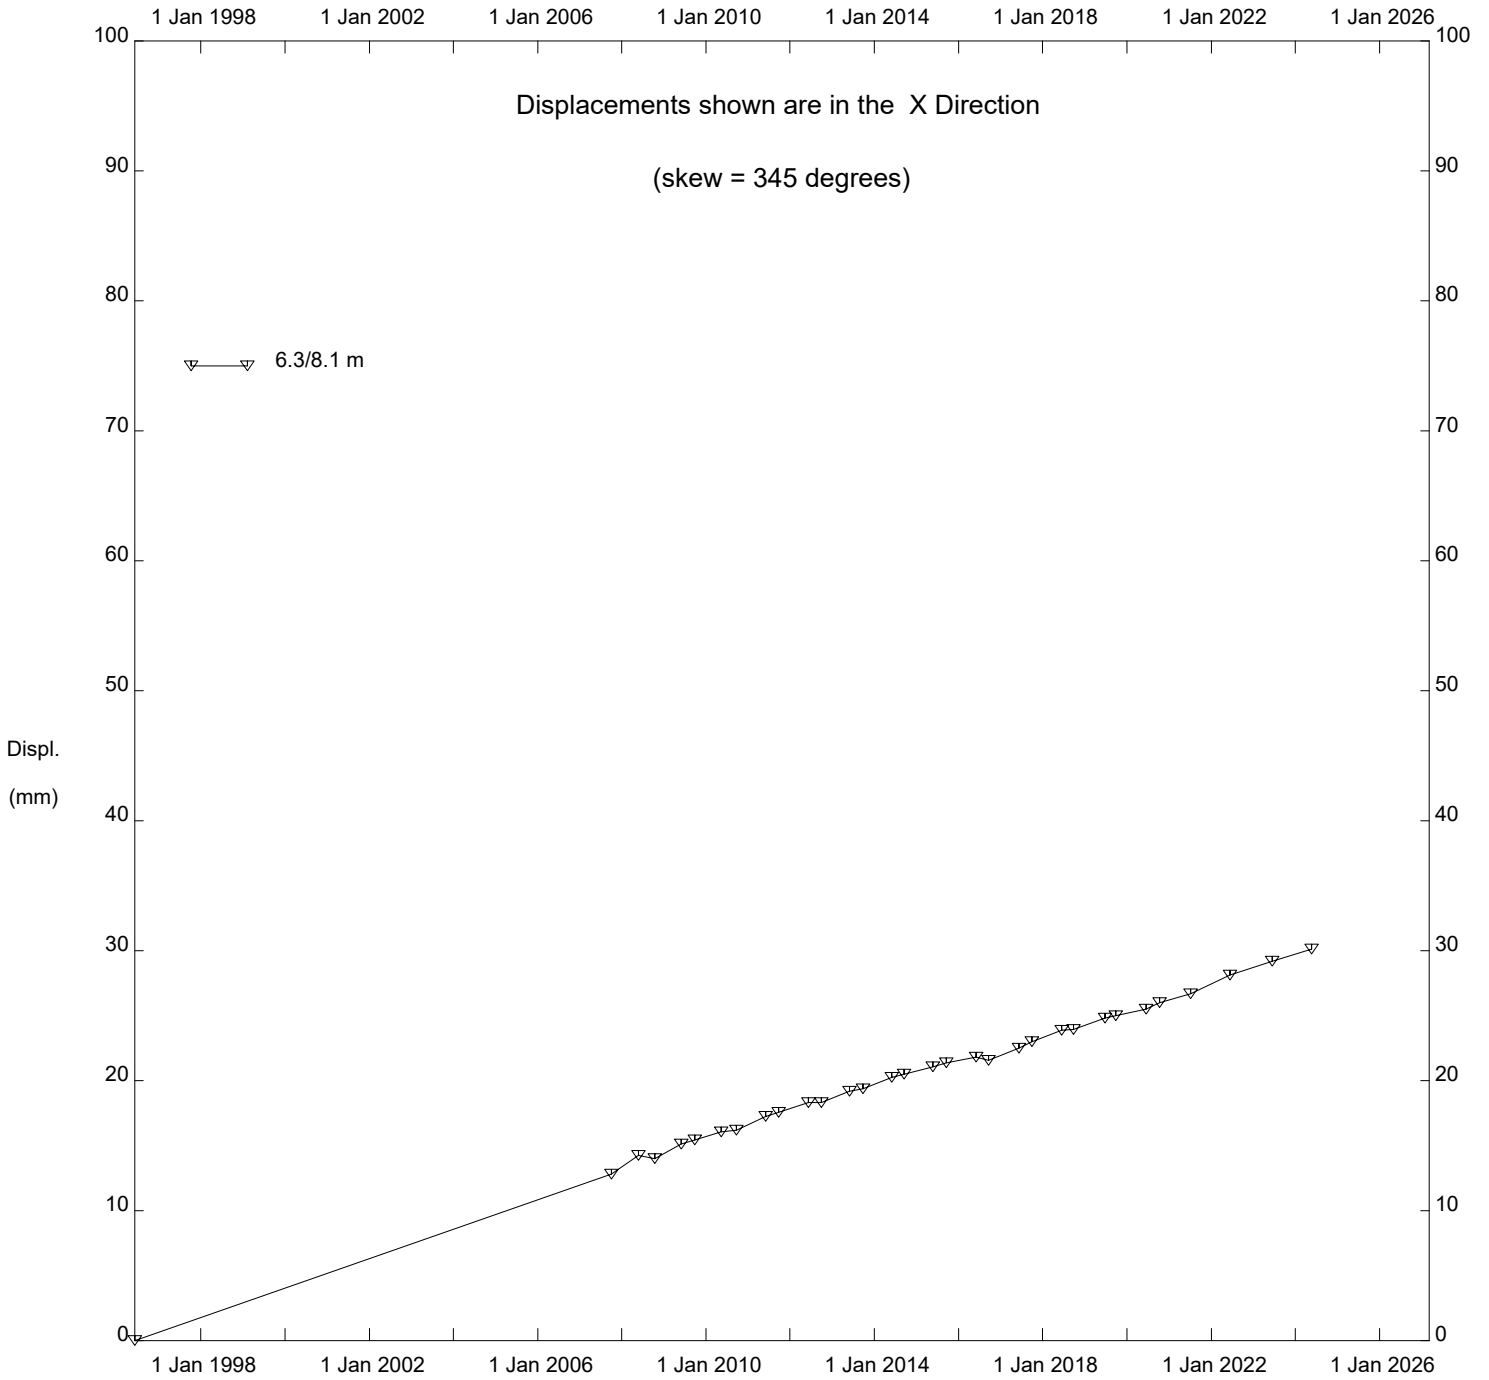
HWY 986:01 - STA. 13+540, Inclinometer SI-4

Discussion	
<b>Zones of New Movement:</b>	None
<b>Interpretation of Monitoring Results:</b>	<p><b>Pile Wall Site (PH043-1)</b></p> <p>Slope inclinometers SI-4, SI-5 and SI-6 are located east of the wall and the main slide block. All three SI's have shown a consistent rate of movement trend, however the shallow movement zones in SI-5 and SI-6 show some acceleration in movement since the spring of 2023 readings.</p> <p>Slope inclinometer SI-4 showed rates of movement of 4.2 mm/yr and 1.1 mm/yr over 2.6 m to 6.3 m depth and 6.3 m to 8.1 m depth, respectively, since the spring of 2023 readings.</p> <p>SI-5 showed rates of movement of 5.3 mm/yr and 1.5 mm/yr over 0.5 m to 1.7 m depth and 1.7 m to 4.1 m depth, respectively.</p> <p>SI-6 showed a rate of movement of 9.5 mm/yr over 0.1 m to 5.0 m depth and no discernible movement over 5.0 m to 6.8 m depth.</p> <p>Slope inclinometer SI03-6, installed upslope of the pile wall and highway, showed a rate of movement of 0.1 mm/yr over 4.7 m to 6.0 m depth since the spring of 2023 readings.</p> <p>Only two (SI04-1 and SI04-3) of the three slope inclinometers installed in the pie wall are currently operational.</p>

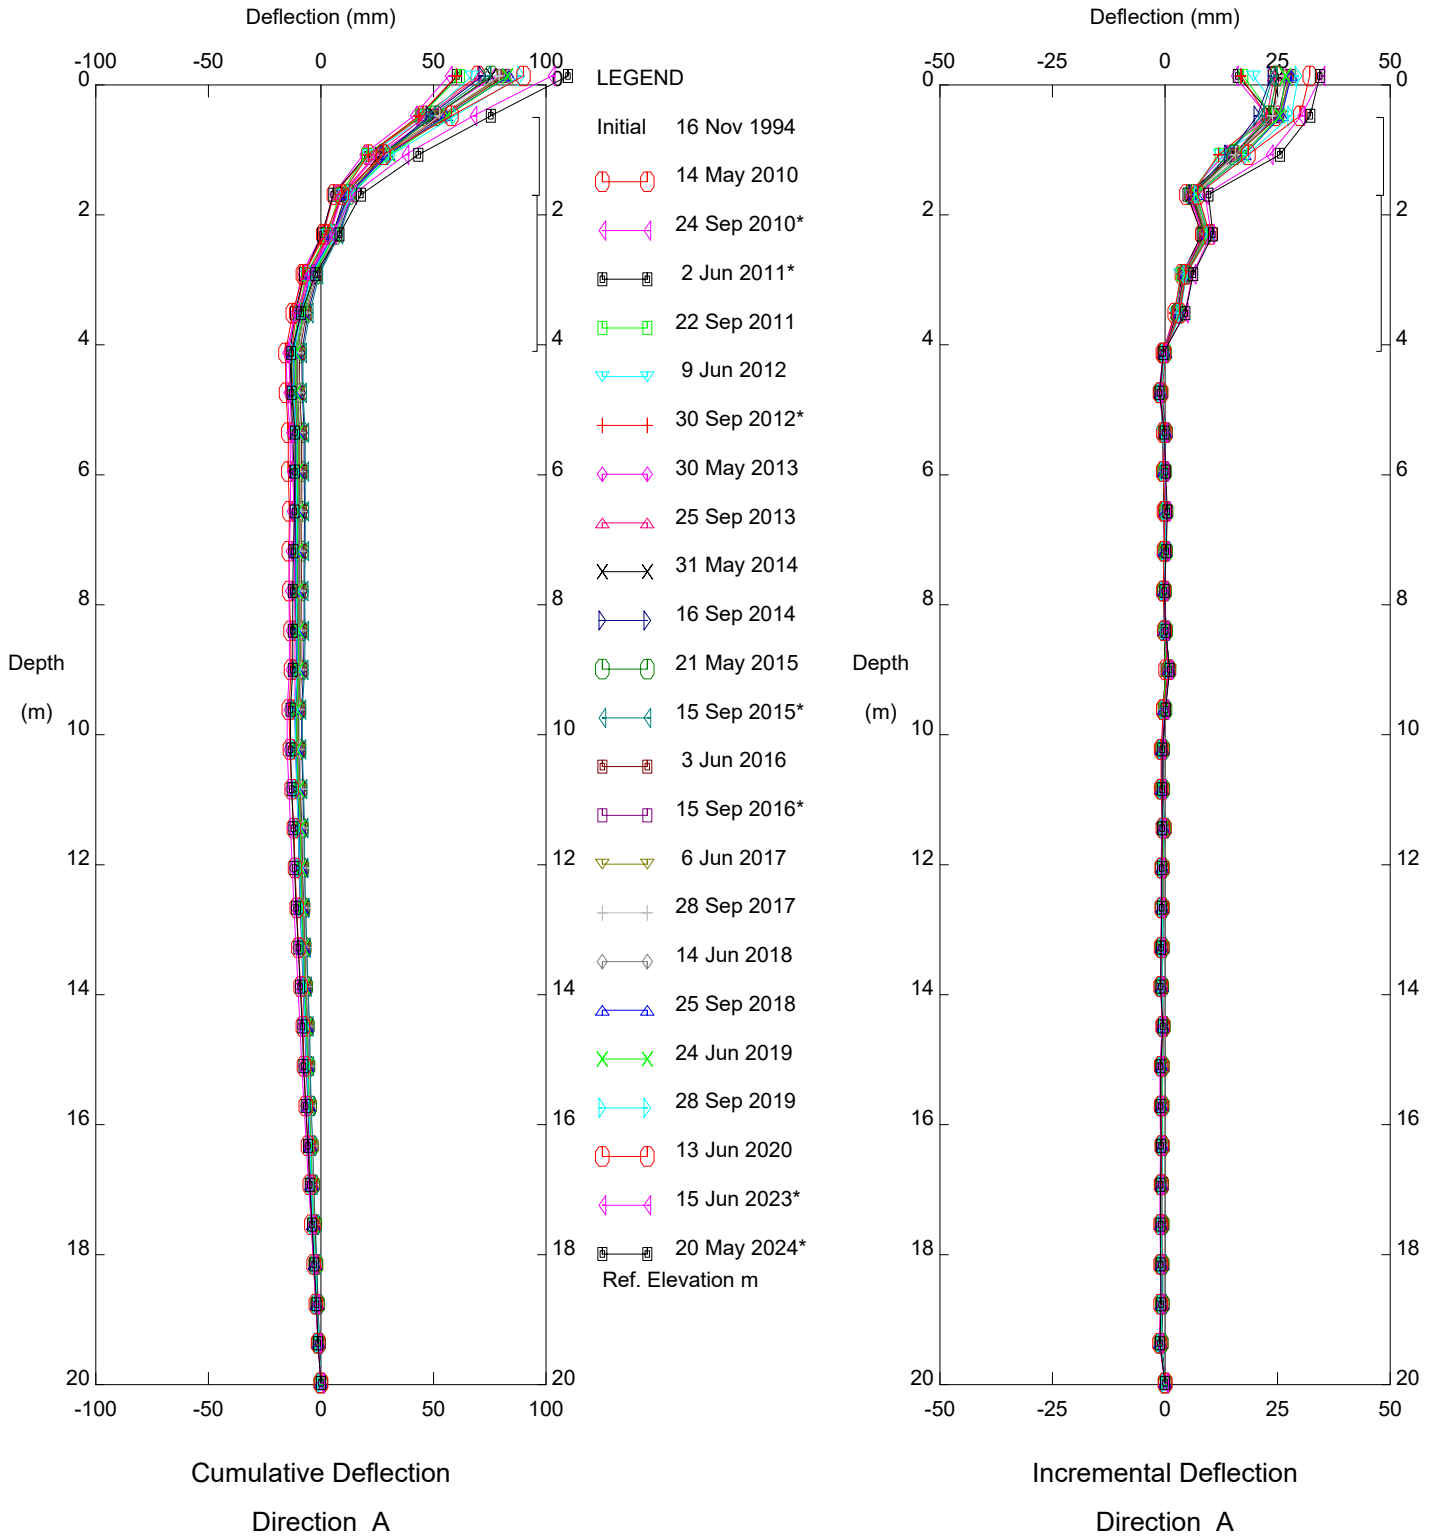
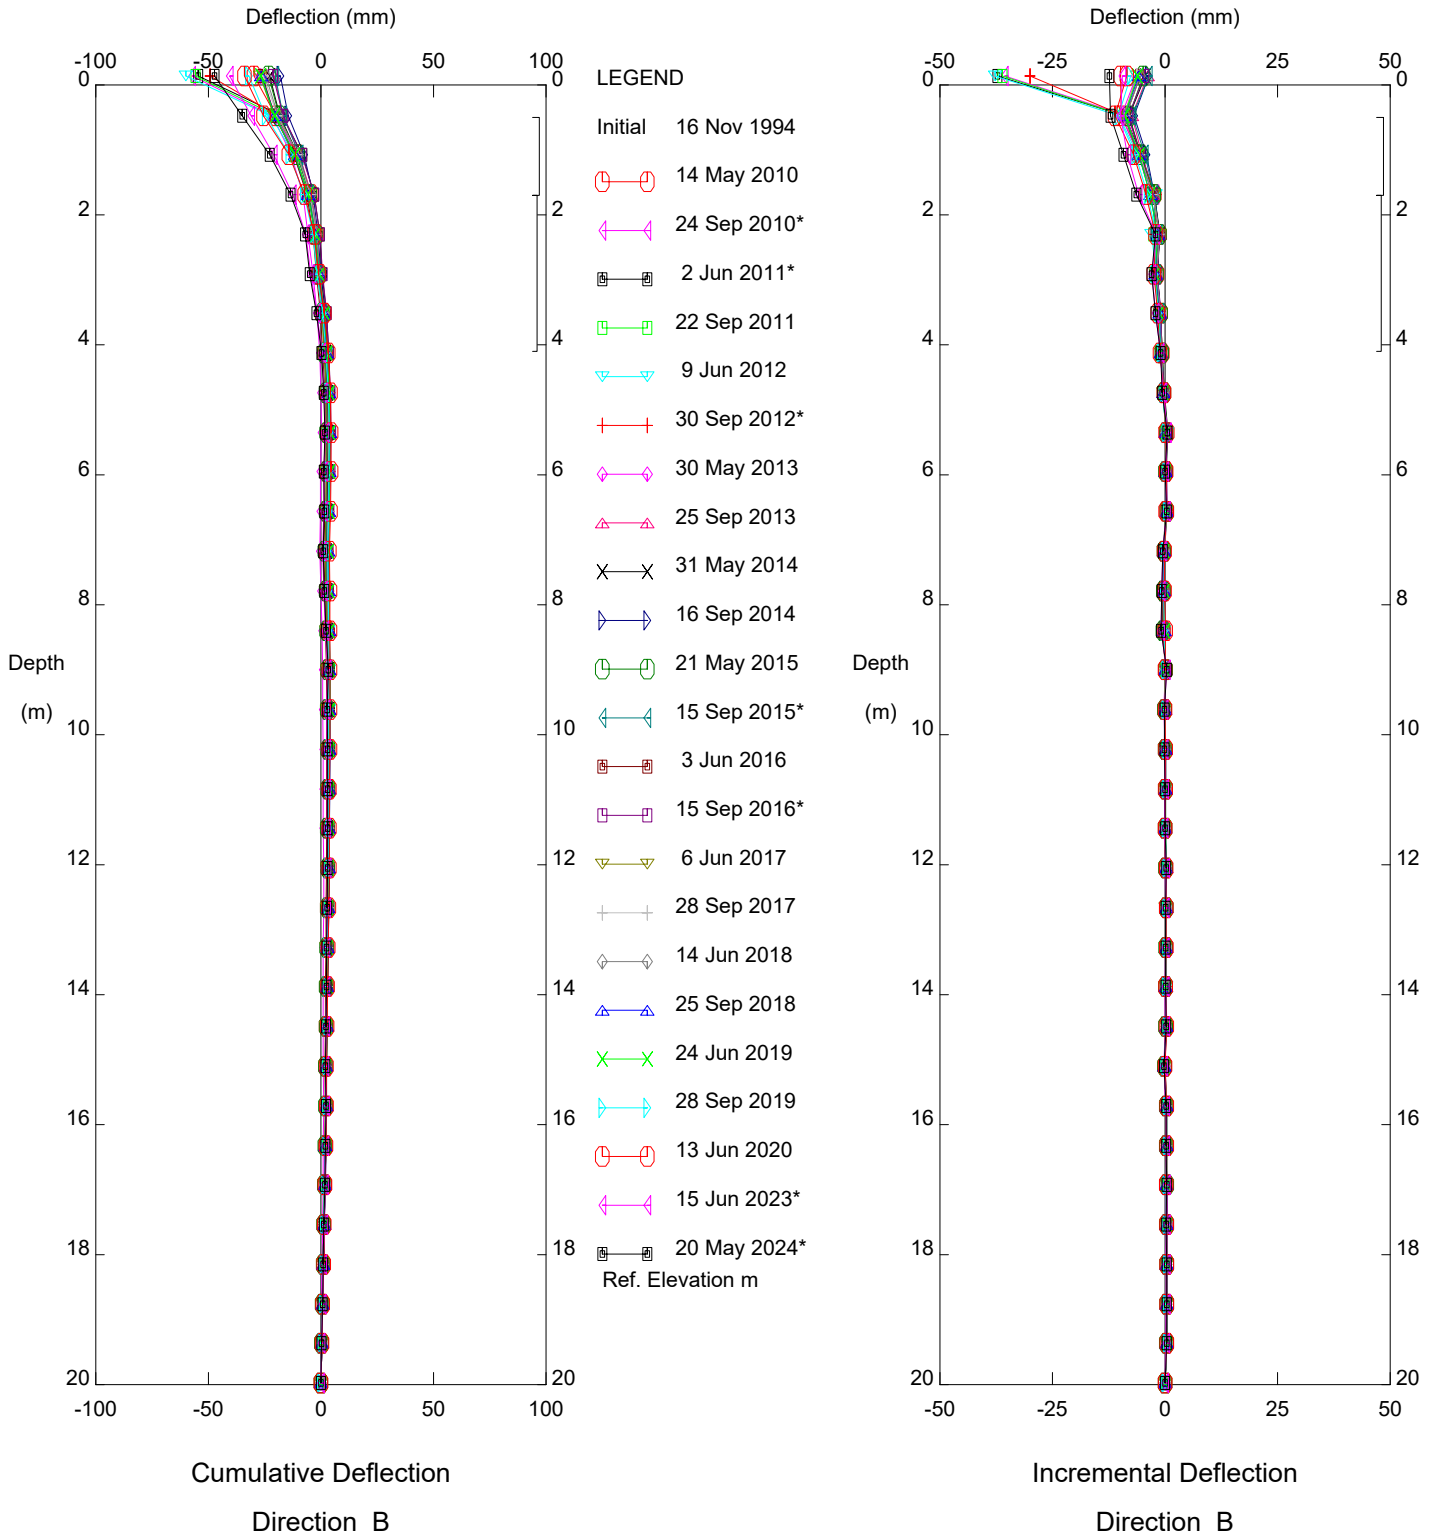
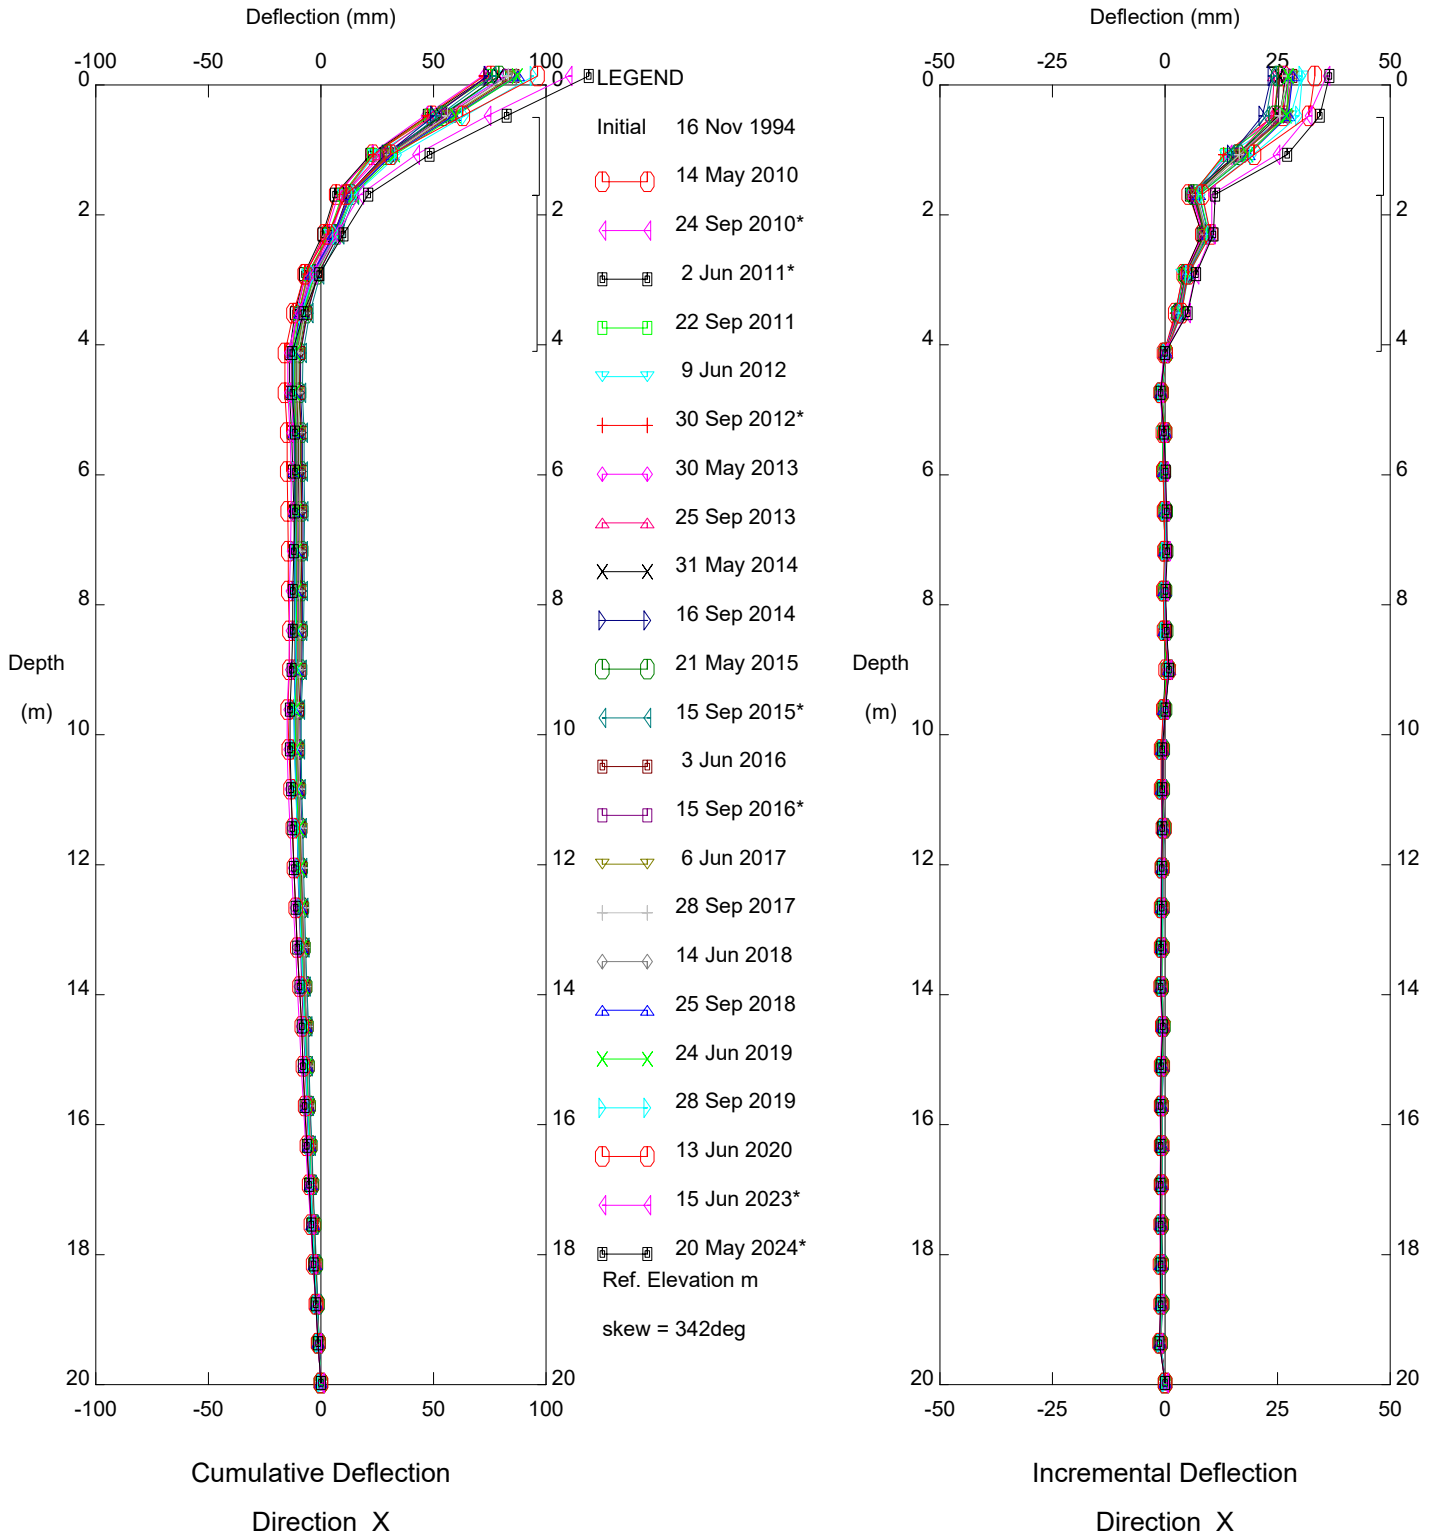
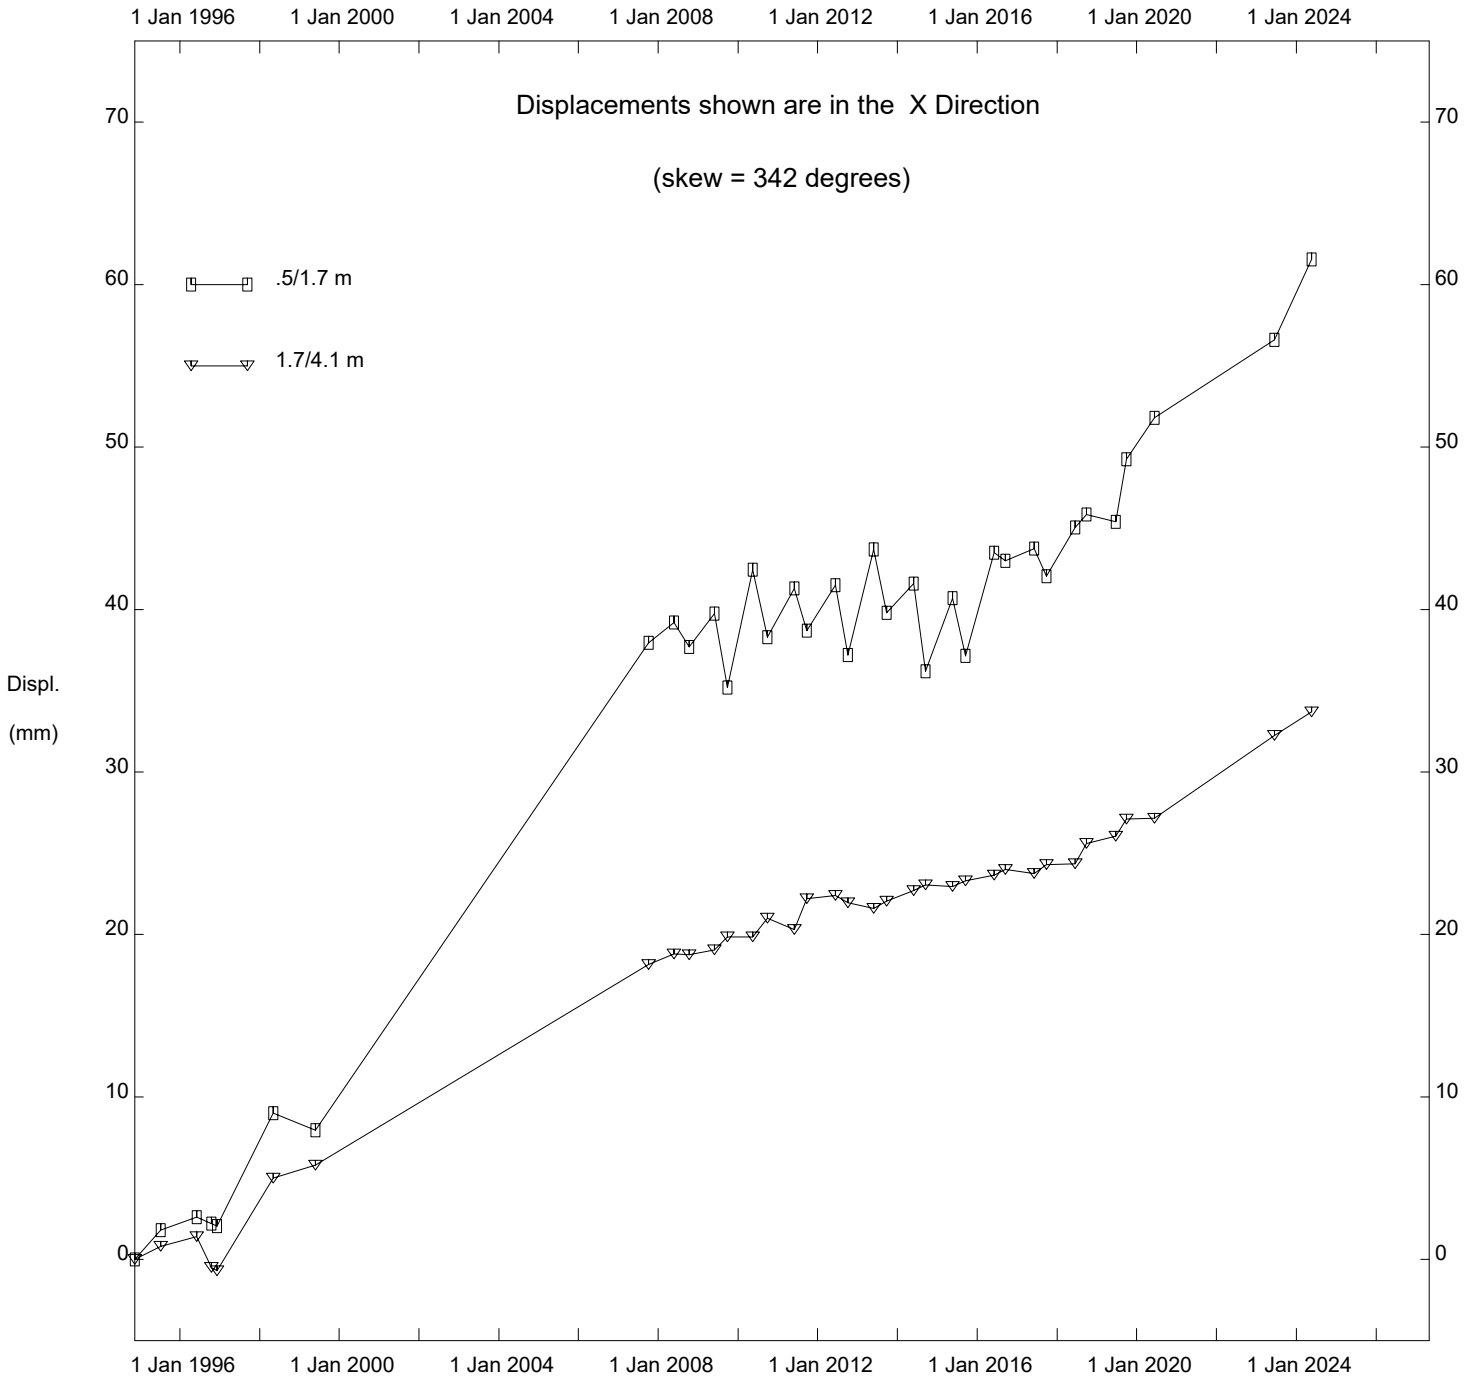
HWY 986:01 - STA. 13+540, Inclinometer SI-5

30.2 mm over 6.3 m to 8.1 m depth in 3° Direction	2.9 mm/yr between May and Sept. 2003			1.0	1.1	<0.1
SI-5	Nov. 16, 1994	56.6 mm over 0.5 m to 1.7 m depth in 7° Direction	16.7 mm/yr in May 2003	Operational	June 15, 2023	4.9	5.3	3.7

33.7 mm over 1.7 m to 4.1 m depth in 7° Direction	6.8 mm/yr In September 1997			1.4	1.5	-0.2
SI-6	Apr. 9, 1996	196.0 mm over 0.1 m to 5.0 m depth in 26° Direction	48.3 mm/yr in May 2005	Operational	June 15, 2023	8.9	9.5	7.3

<b>Future Work:</b>	The instruments should be read again in the spring of 2025.
<b>Instrumentation Repairs:</b>	The repair of SI-5 was finalized during the fall of 2023 readings with the installation of a larger diameter casing stickup protector.
<b>Additional Comments:</b>
