Site Number	Location	Name	Hwy	km
PH043	HWY 986:01 C1 33.357	Daishowa Retaining Wall	986:01	Km 33.4
<b>Legal Description:</b> 9-7-85-20 W5		<b>UTM Co-ordinates</b>		
		11U E 491412.57	N	6246098.92

<b>Current Monitoring:</b>	20-May-2024	<b>Previous Monitoring</b>	15-Jun-2023
<b>Instruments Read By:</b>	Mr. Niraj Regmi, G.I.T and Mr. Nixon Mationg, of Thurber

**ALBERTA TRANSPORTATION AND ECONOMIC CORRIDORS GRMP (CON0022164)  
PEACE REGION (PEACE RIVER DISTRICT)  
INSTRUMENTATION MONITORING RESULTS**

**SITE PH043-1: HWY 986:01, DAISHOWA EAST HILL PILE WALL  
SITE PH043-2: HWY 986:01, DAISHOWA EAST HILL SITE B**

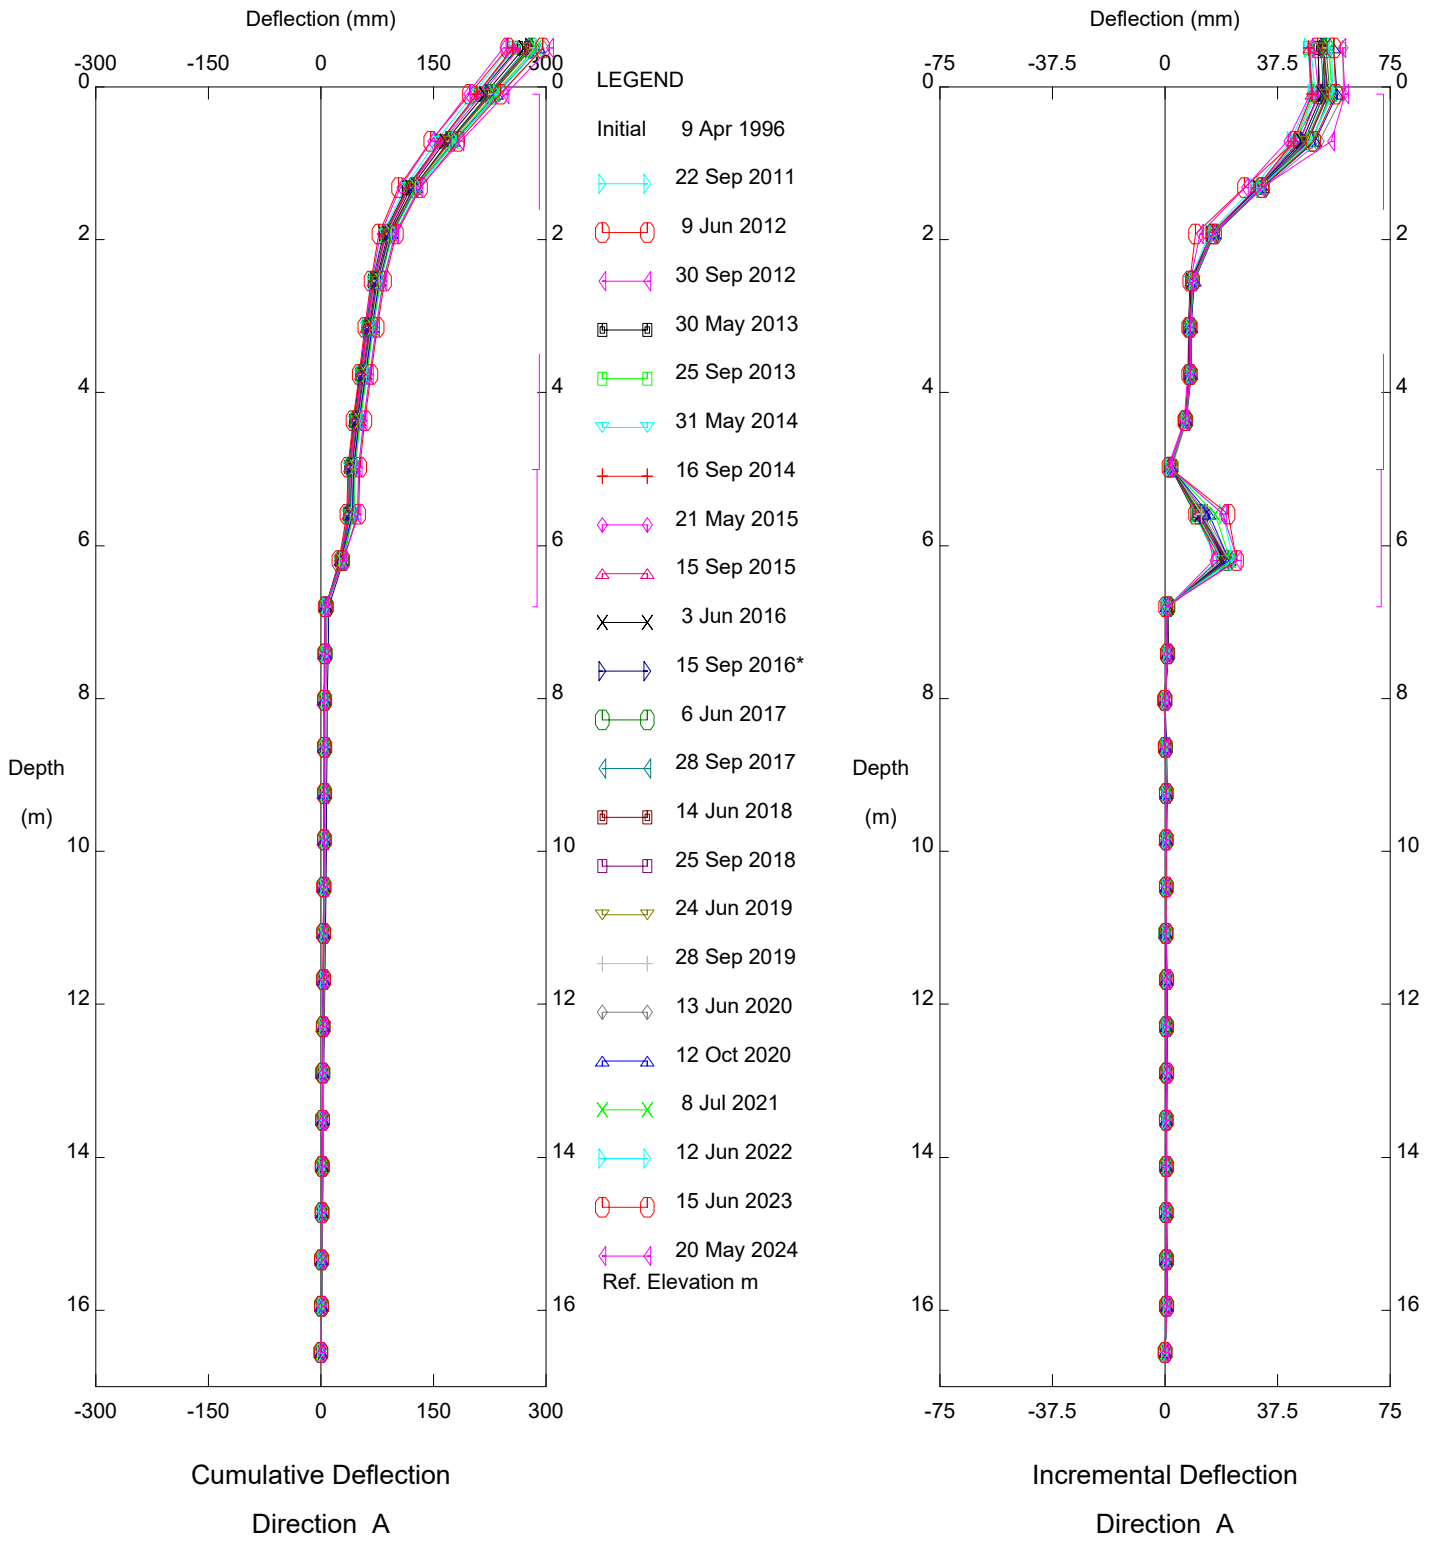
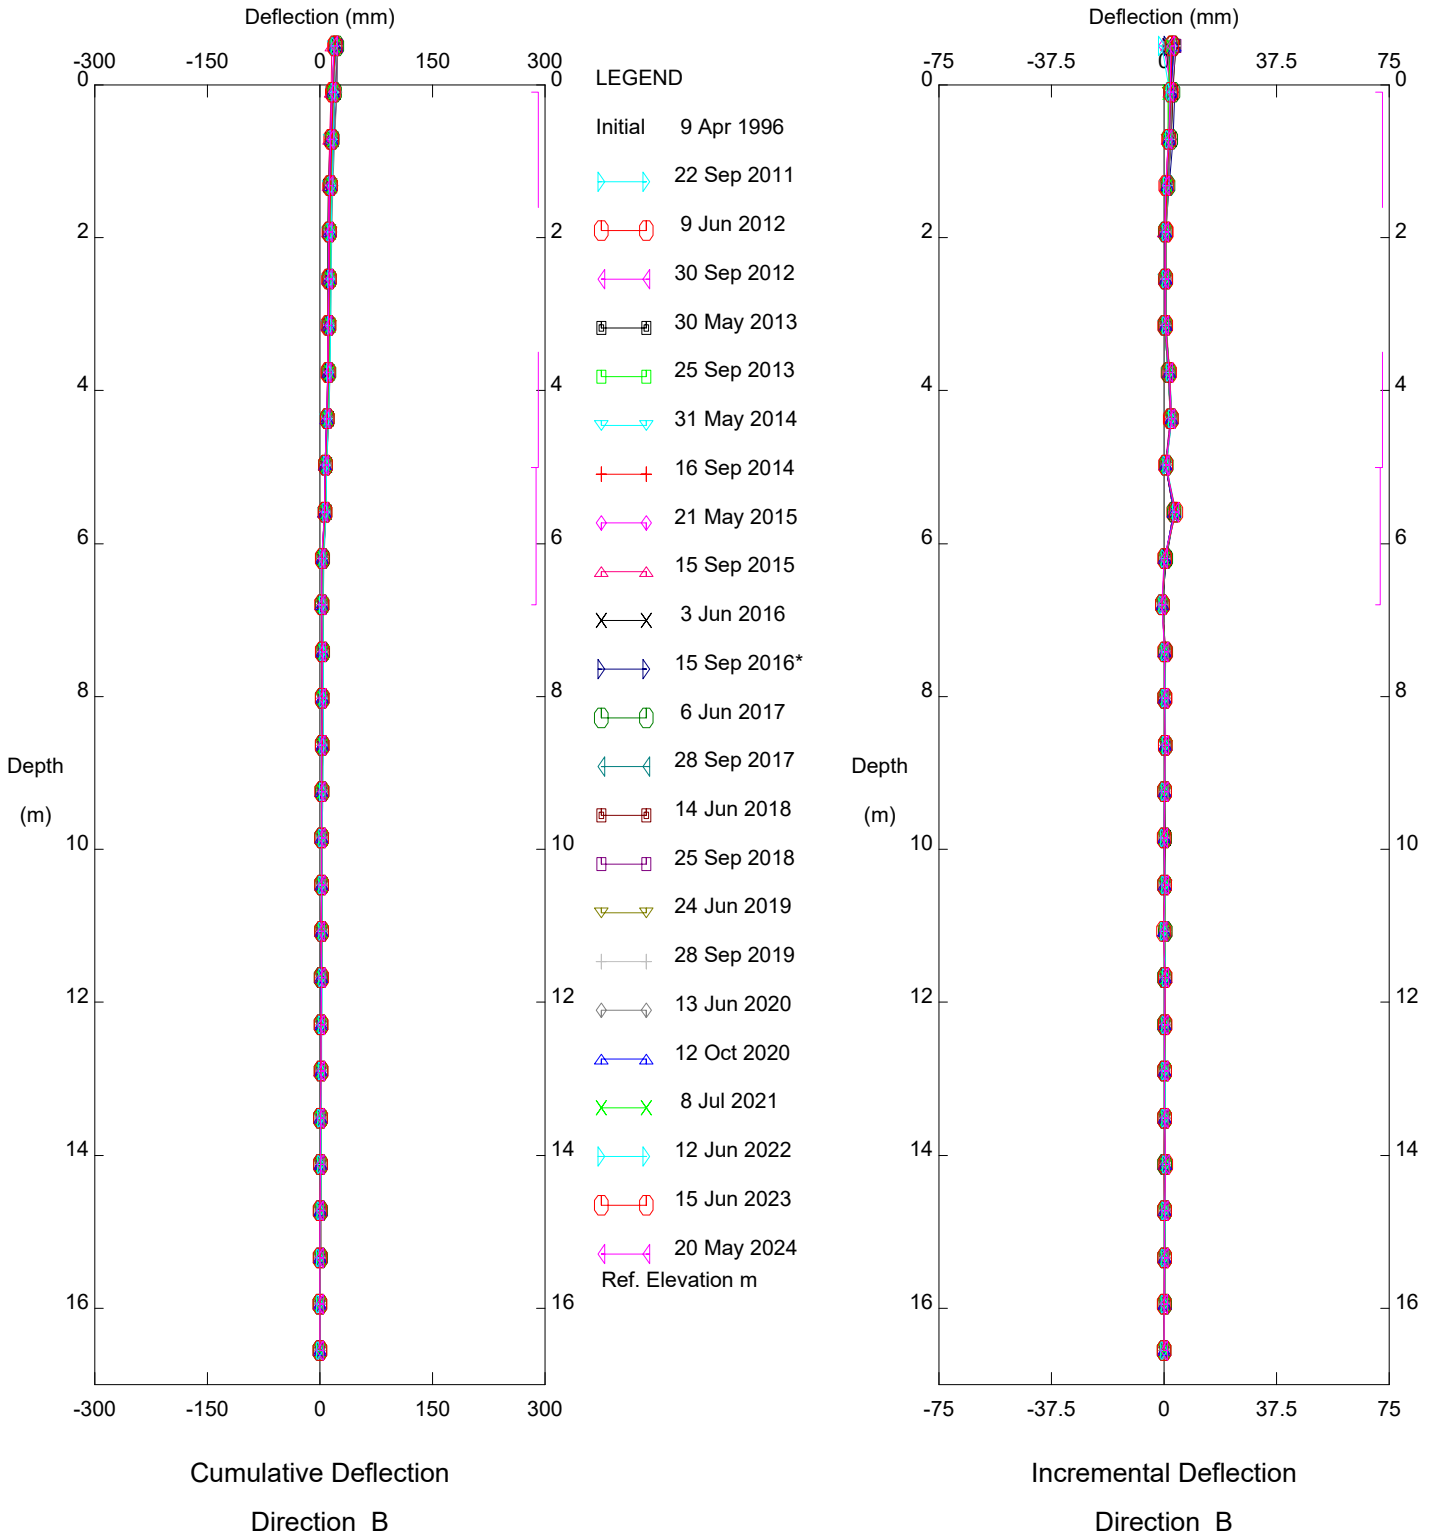
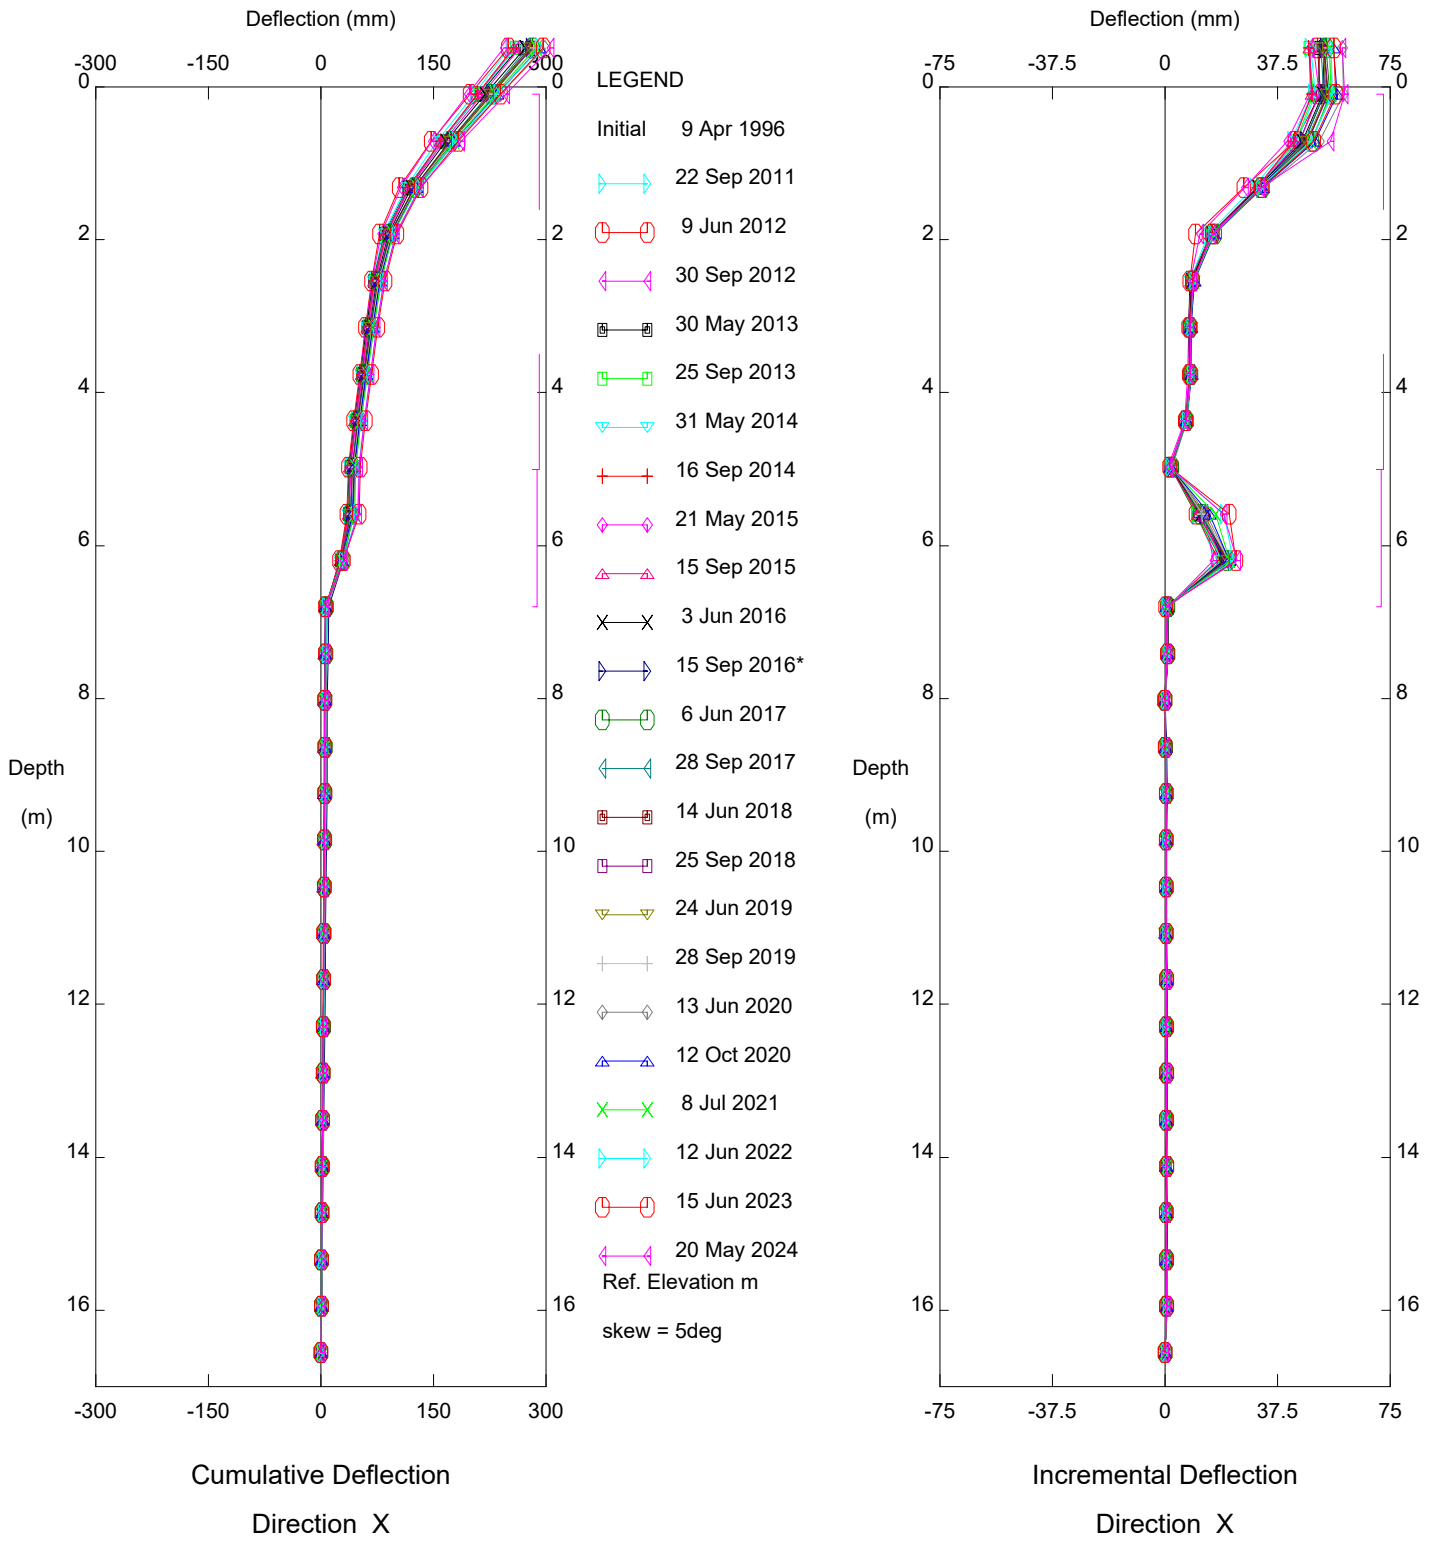
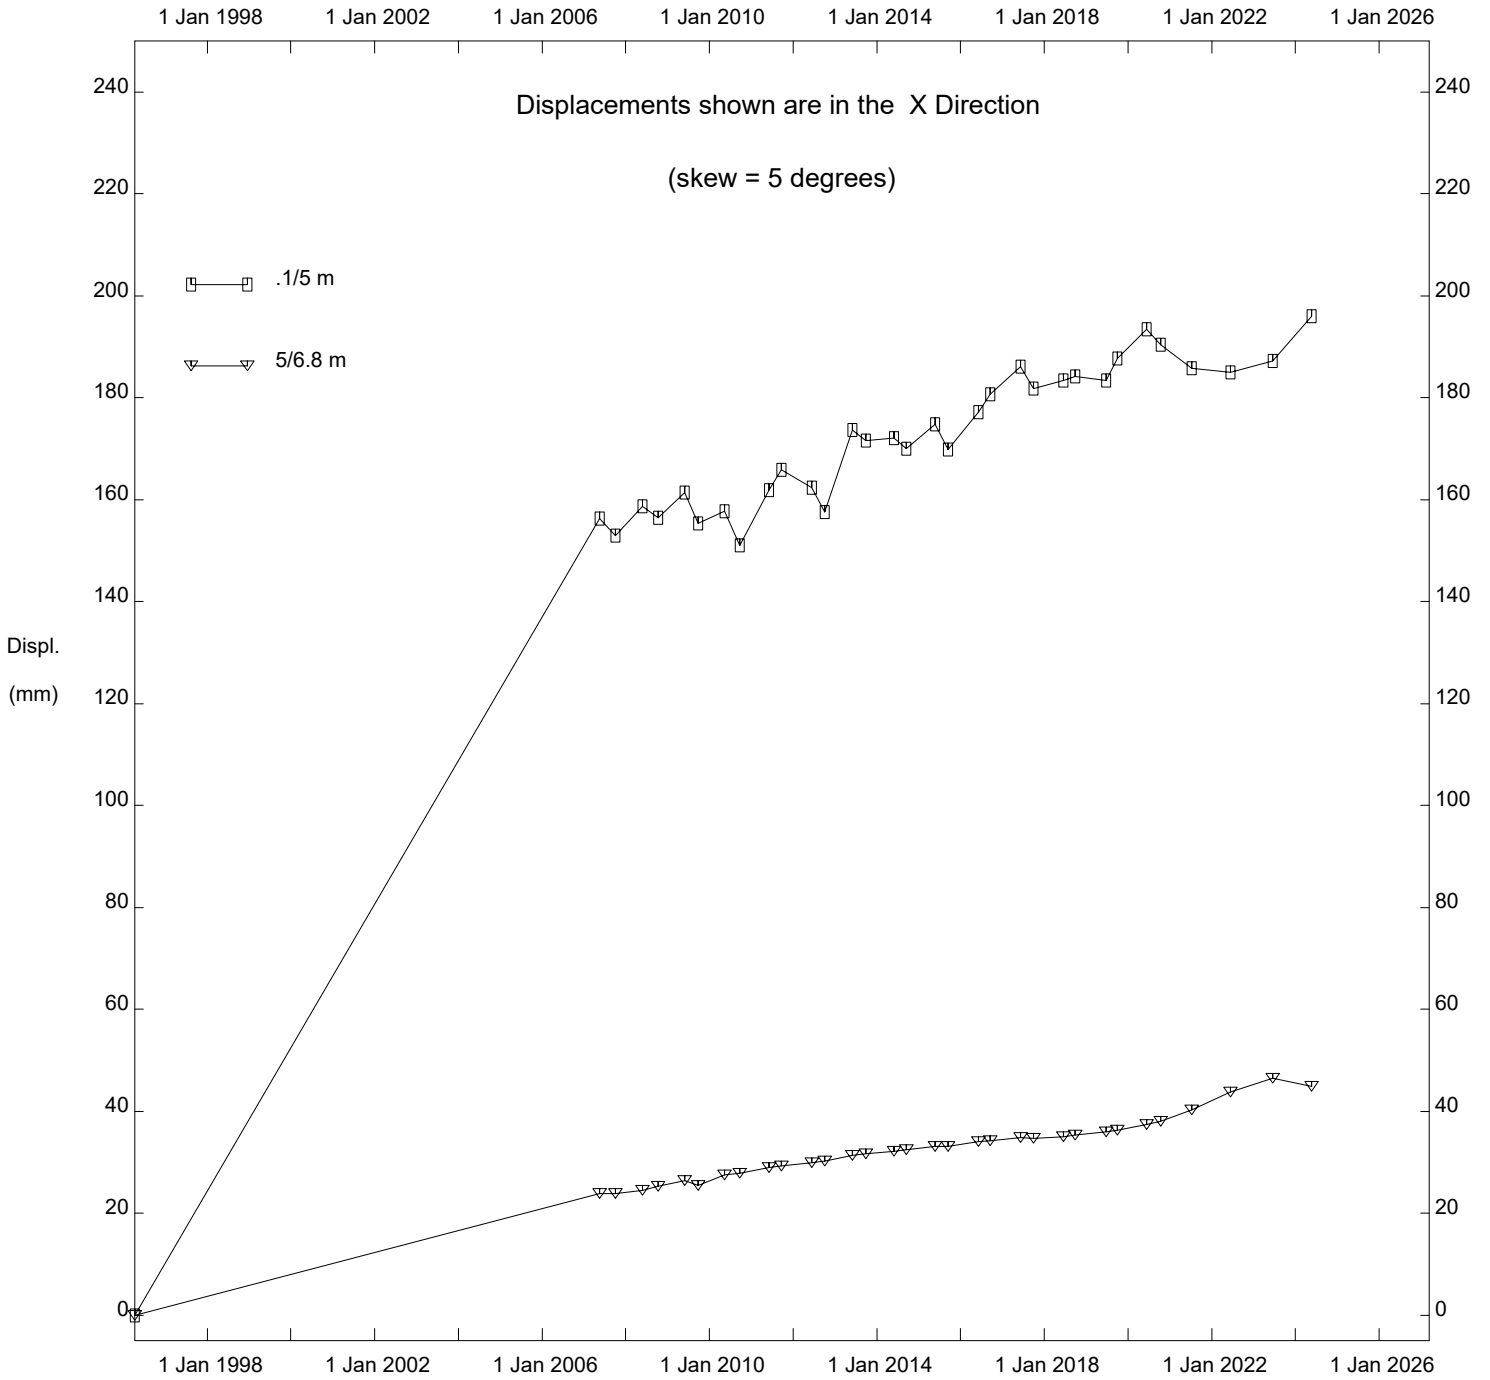
HWY 986:01 - STA. 13+540, Inclinator SI-6

Discussion	
<b>Zones of New Movement:</b>	None
<b>Interpretation of Monitoring Results:</b>	<p><b>Pile Wall Site (PH043-1)</b></p> <p>Slope inclinometers SI-4, SI-5 and SI-6 are located east of the wall and the main slide block. All three SI's have shown a consistent rate of movement trend, however the shallow movement zones in SI-5 and SI-6 show some acceleration in movement since the spring of 2023 readings.</p> <p>Slope inclinometer SI-4 showed rates of movement of 4.2 mm/yr and 1.1 mm/yr over 2.6 m to 6.3 m depth and 6.3 m to 8.1 m depth, respectively, since the spring of 2023 readings.</p> <p>SI-5 showed rates of movement of 5.3 mm/yr and 1.5 mm/yr over 0.5 m to 1.7 m depth and 1.7 m to 4.1 m depth, respectively.</p> <p>SI-6 showed a rate of movement of 9.5 mm/yr over 0.1 m to 5.0 m depth and no discernible movement over 5.0 m to 6.8 m depth.</p> <p>Slope inclinometer SI03-6, installed upslope of the pile wall and highway, showed a rate of movement of 0.1 mm/yr over 4.7 m to 6.0 m depth since the spring of 2023 readings.</p> <p>Only two (SI04-1 and SI04-3) of the three slope inclinometers installed in the pie wall are currently operational.</p>

33.7 mm over 1.7 m to 4.1 m depth in 7° Direction	6.8 mm/yr In September 1997			1.4	1.5	-0.2
SI-6	Apr. 9, 1996	196.0 mm over 0.1 m to 5.0 m depth in 26° Direction	48.3 mm/yr in May 2005	Operational	June 15, 2023	8.9	9.5	7.3

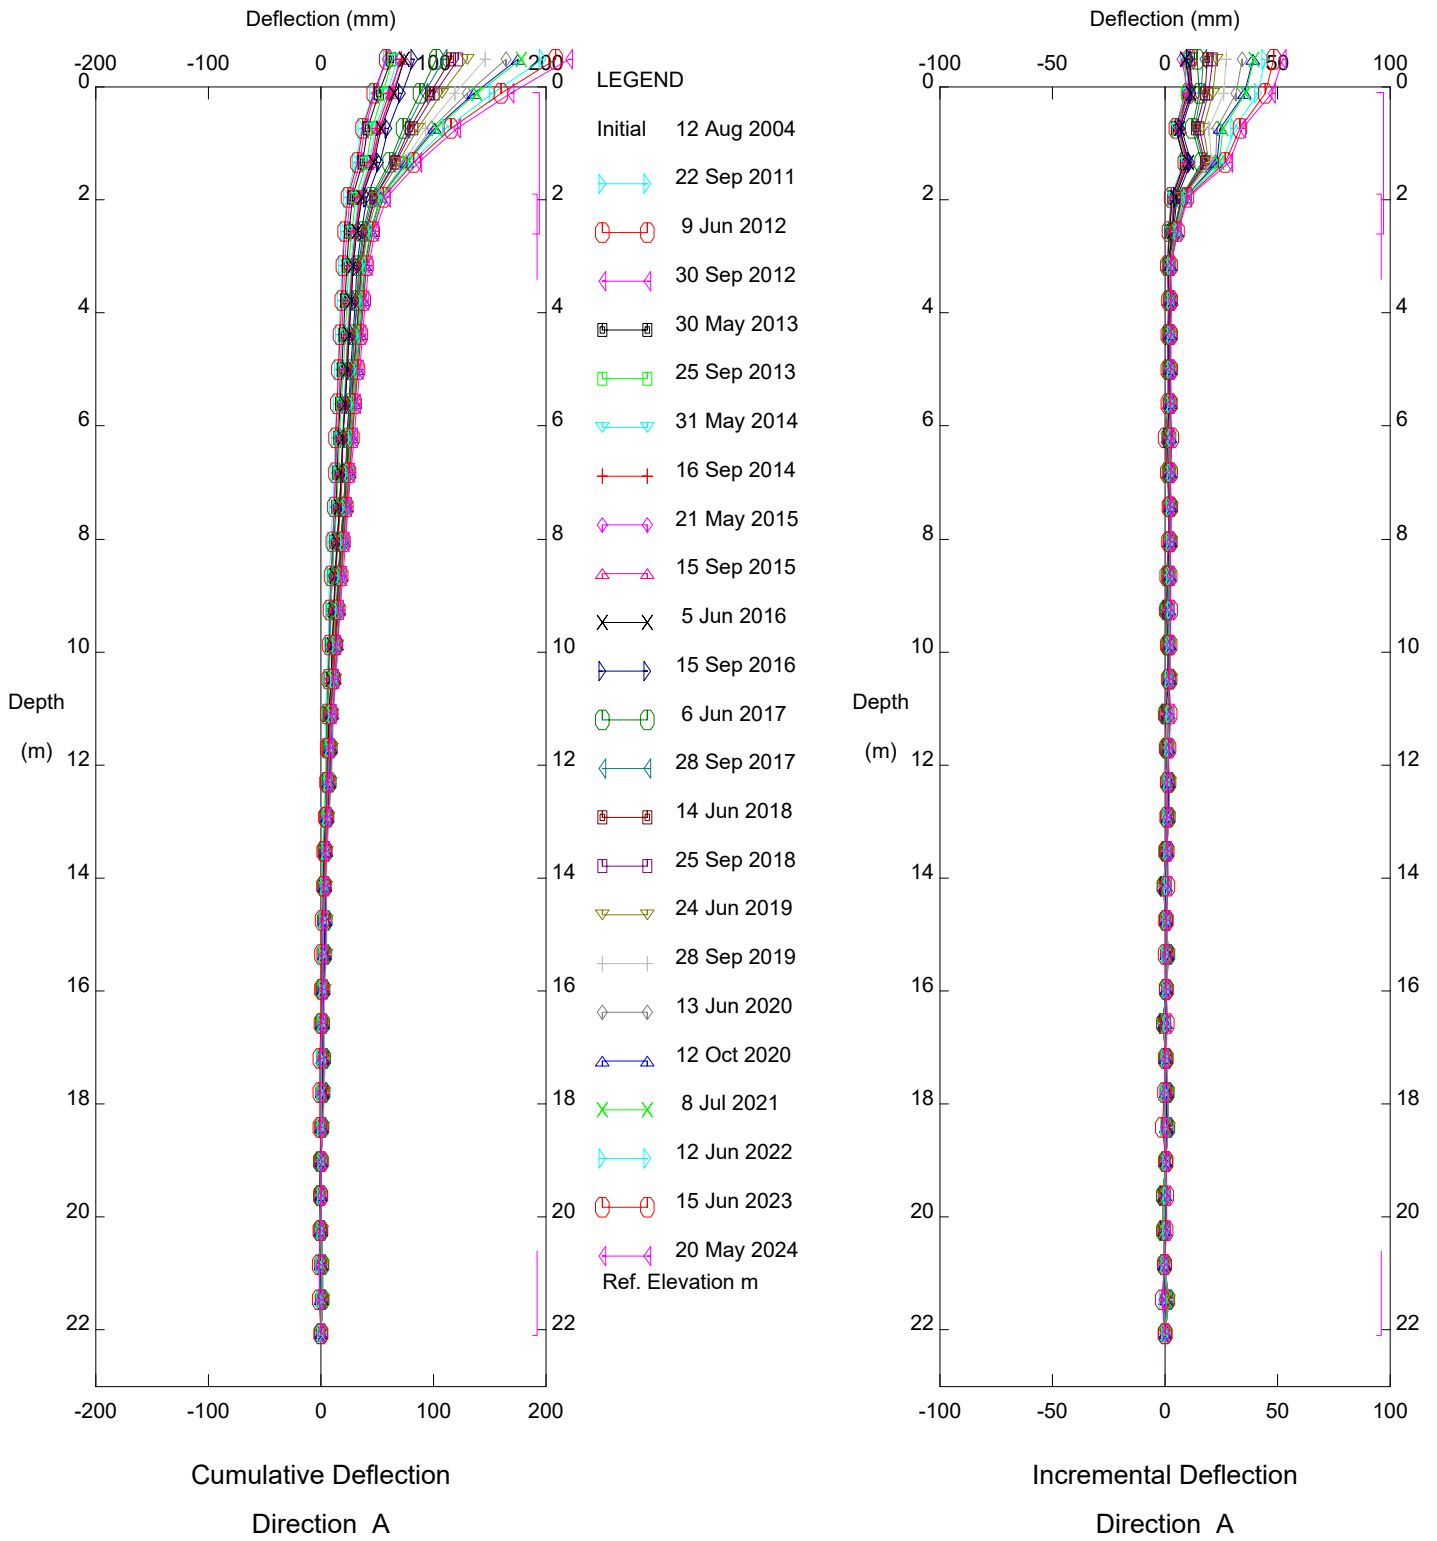
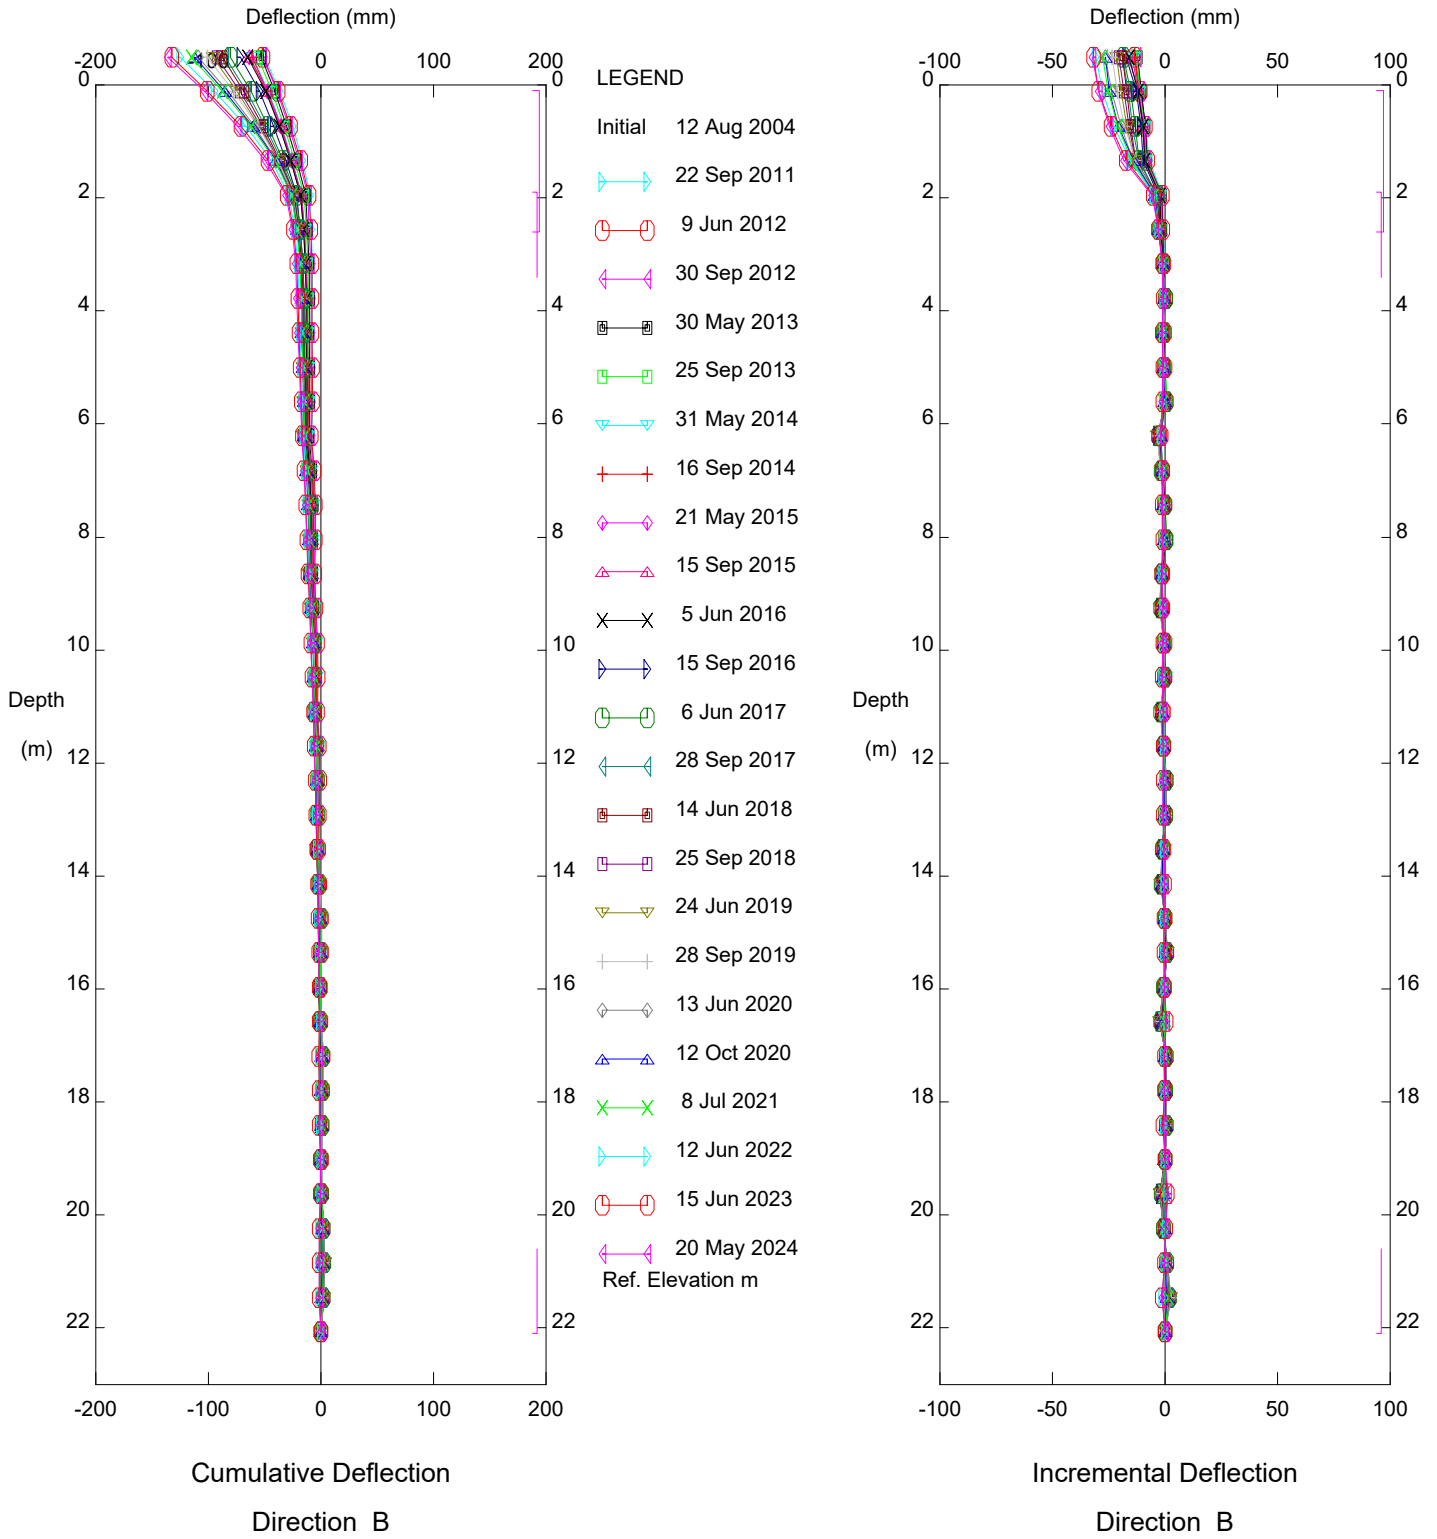
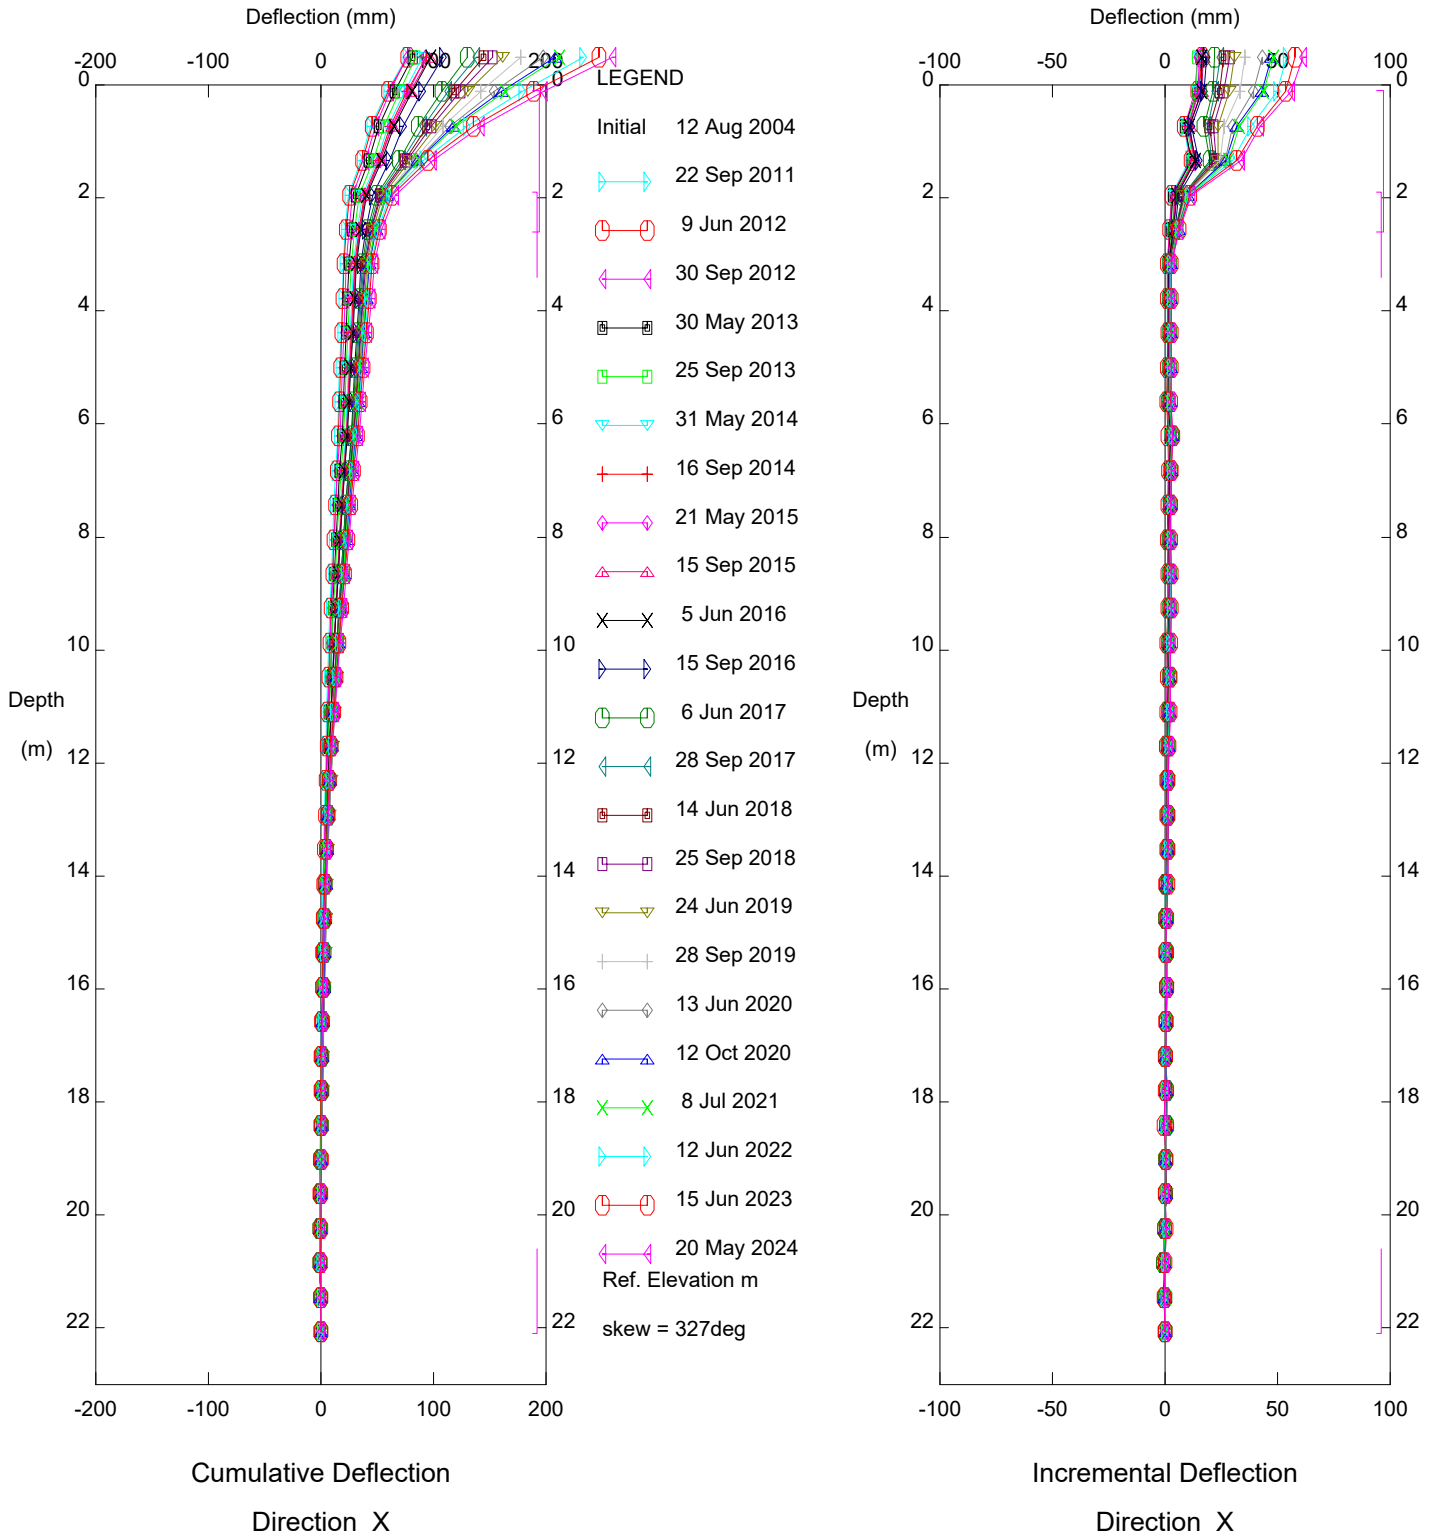
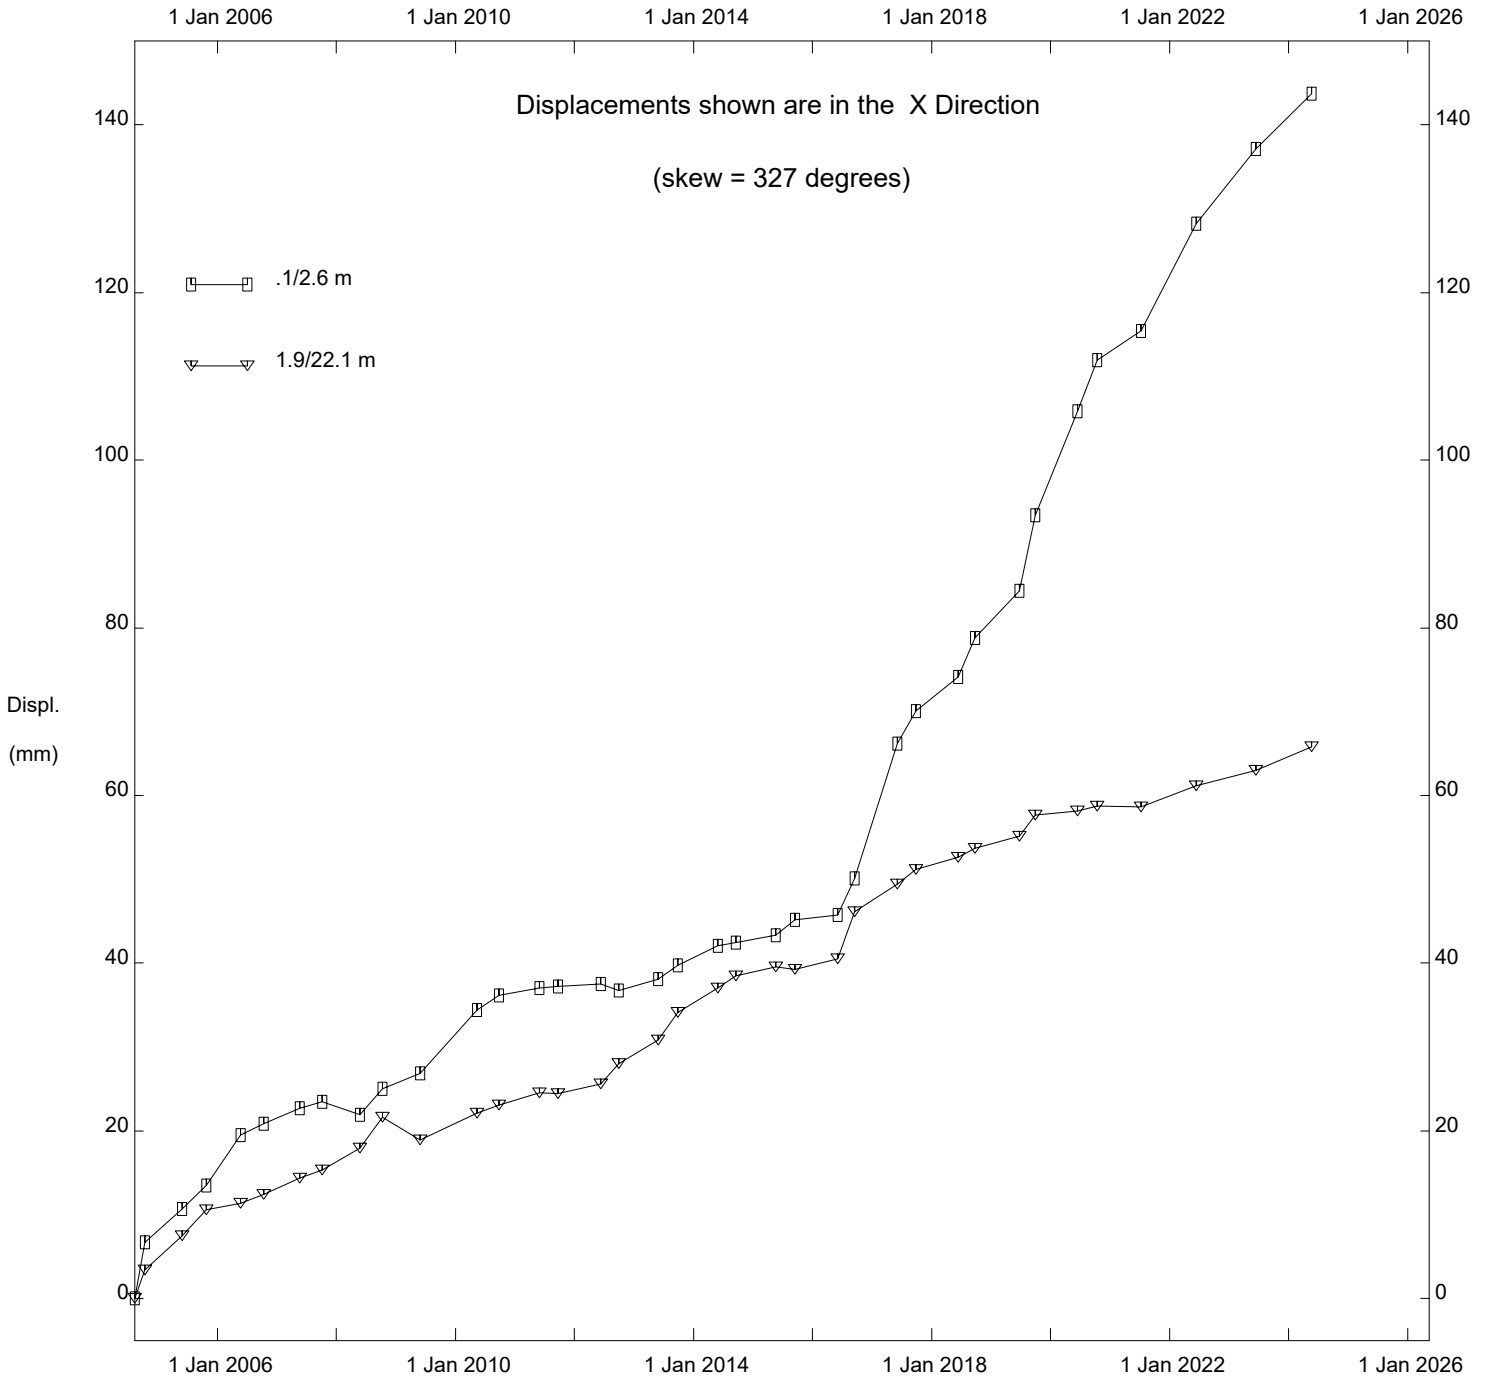
HWY 986:01 - STA. 13+540, Inclinometer SI04-1

<p>SI04-1 showed a rate of movement of 7.0 mm/yr over 0.1 to 2.6 m since spring of 2023 and a rate of movement of 3.1 mm/yr over the length of the pile. The pile head has deflected a total of 65.8 mm to date</p> <p>SI04-3 showed a rate of movement of 16.1 mm/yr over 0.1 to 1.4 m depth since the spring of 2023 readings and a rate of movement of 4.1 mm/yr over the length of the pile. The pile head has deflected 110.4 mm to date</p> <p>. There was a noticeable increase in movement in SI04-1 during 2017 and 2018 when a landslide movement occurred downslope of the wall during erosion repairs of erosion and construction of a gabion drop structure at the creek level. A driven steel pile wall and grading were carried out to mitigate those movements. The increased movement rate trend is still observed within the upper 2 m. Some slope flattening was also carried out consisting of removing some soil from the top of the pile wall near SI04-3.</p> <p>Pneumatic piezometer PN03-1 showed a decrease in groundwater level of 0.51 m since the spring of 2023 readings, which represents the lowest groundwater level measured in the instrument since October 2007. Pneumatic piezometer PN03-2 showed an increase in groundwater level of 0.02 m since the spring of 2023 readings.</p> <p><b>Site B (PH043-2)</b></p> <p>Slope inclinometers SI-7, SI-8 and SI-9 are located in the highway side slope (Station 33+820), about 300 m north of the pile wall.</p> <p>SI-7 continued to show no discernible movement.</p> <p>SI-8 showed a rate of movement of 5.7 mm/yr over 0.3 m to 1.5 m depth and a rate of movement of 0.6 mm/yr over 1.5 m to 4.0 m depth since the spring of 2023 readings.</p> <p>SI-9 showed a rate of movement of 10.4 mm/yr over 0.3 m to 2.7 m depth since the spring of 2023 readings.</p>
