Site Number	Location	Name	Hwy	km
PH043	HWY 986:01 C1 33.357	Daishowa Retaining Wall	986:01	Km 33.4
<b>Legal Description:</b> 9-7-85-20 W5		<b>UTM Co-ordinates</b>		
		11U E 491412.57	N	6246098.92

<b>Current Monitoring:</b>	20-May-2024	<b>Previous Monitoring</b>	15-Jun-2023
<b>Instruments Read By:</b>	Mr. Niraj Regmi, G.I.T and Mr. Nixon Mationg, of Thurber

**ALBERTA TRANSPORTATION AND ECONOMIC CORRIDORS GRMP (CON0022164)  
PEACE REGION (PEACE RIVER DISTRICT)  
INSTRUMENTATION MONITORING RESULTS**

**SITE PH043-1: HWY 986:01, DAISHOWA EAST HILL PILE WALL  
SITE PH043-2: HWY 986:01, DAISHOWA EAST HILL SITE B**

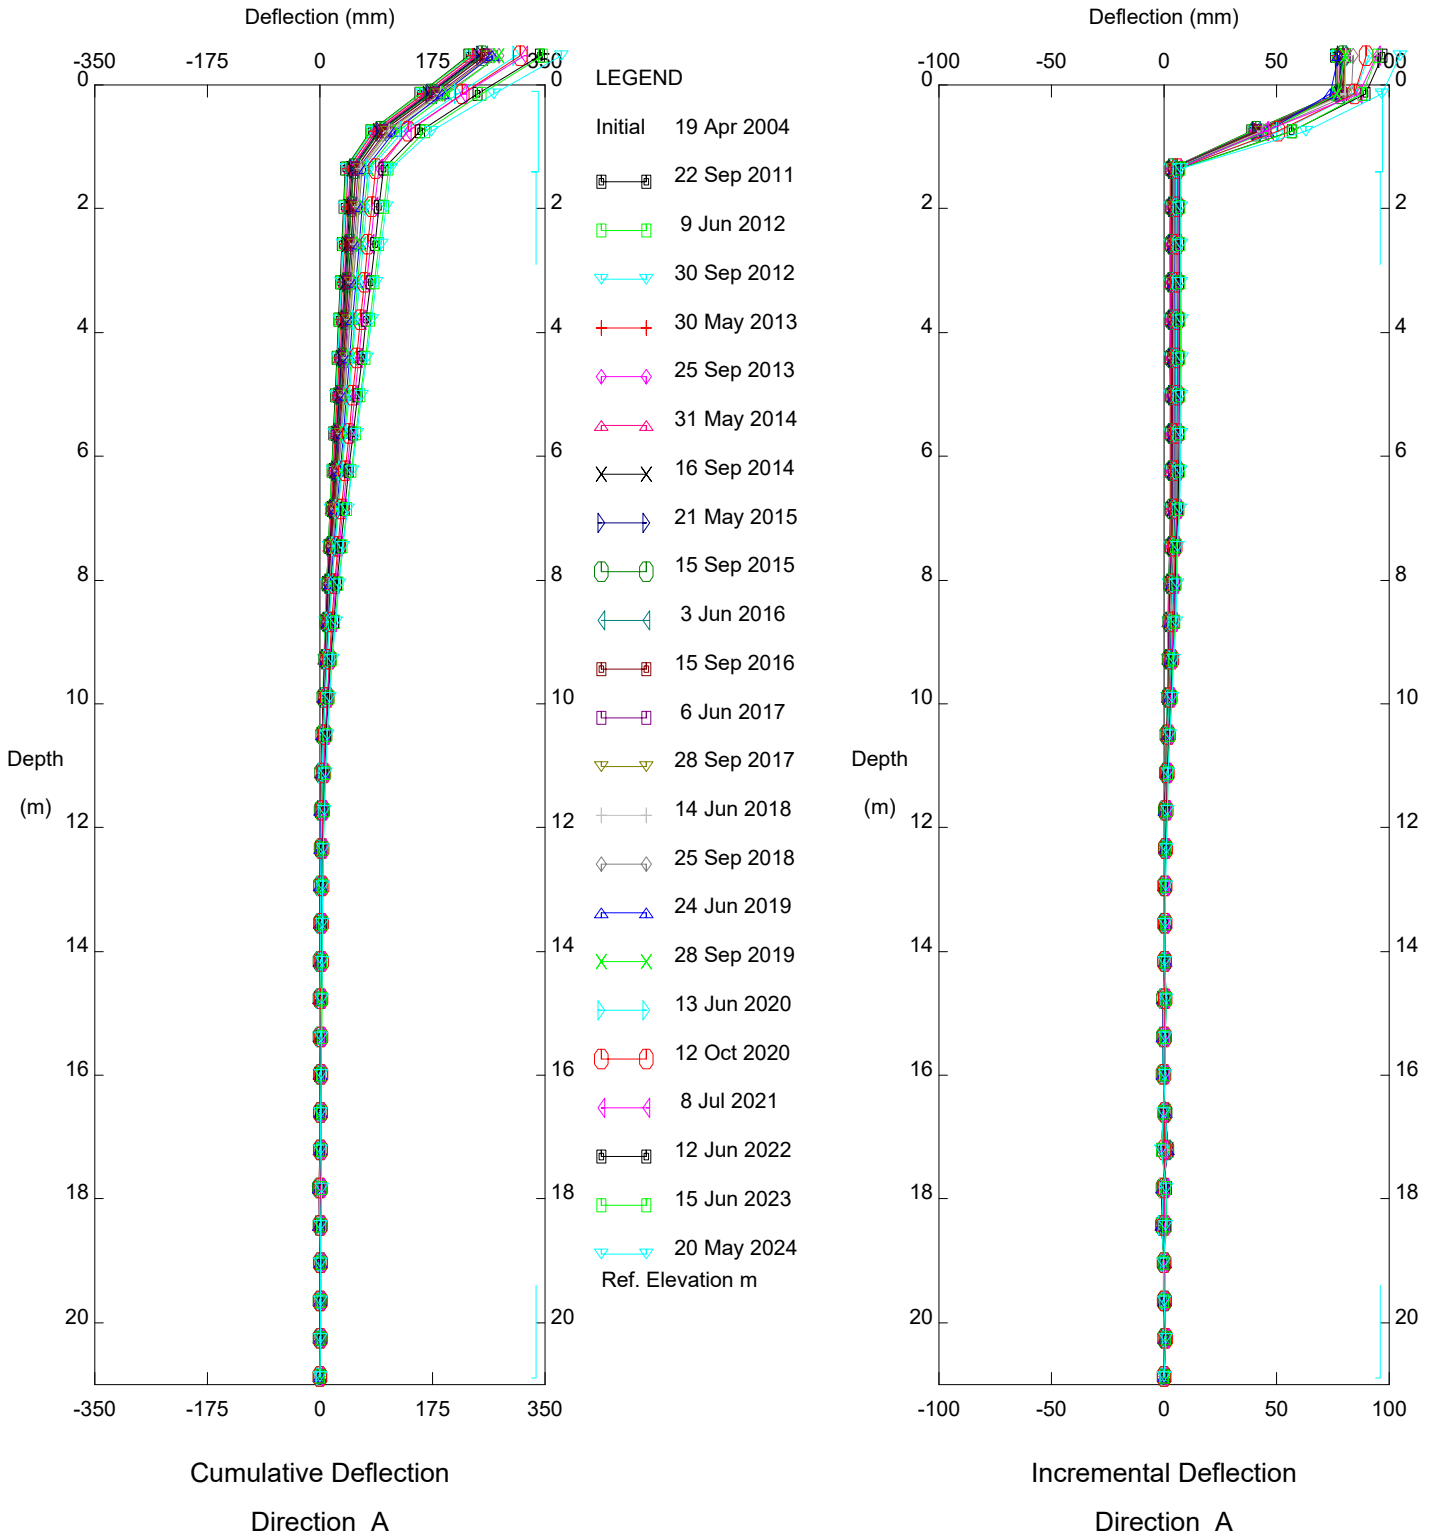
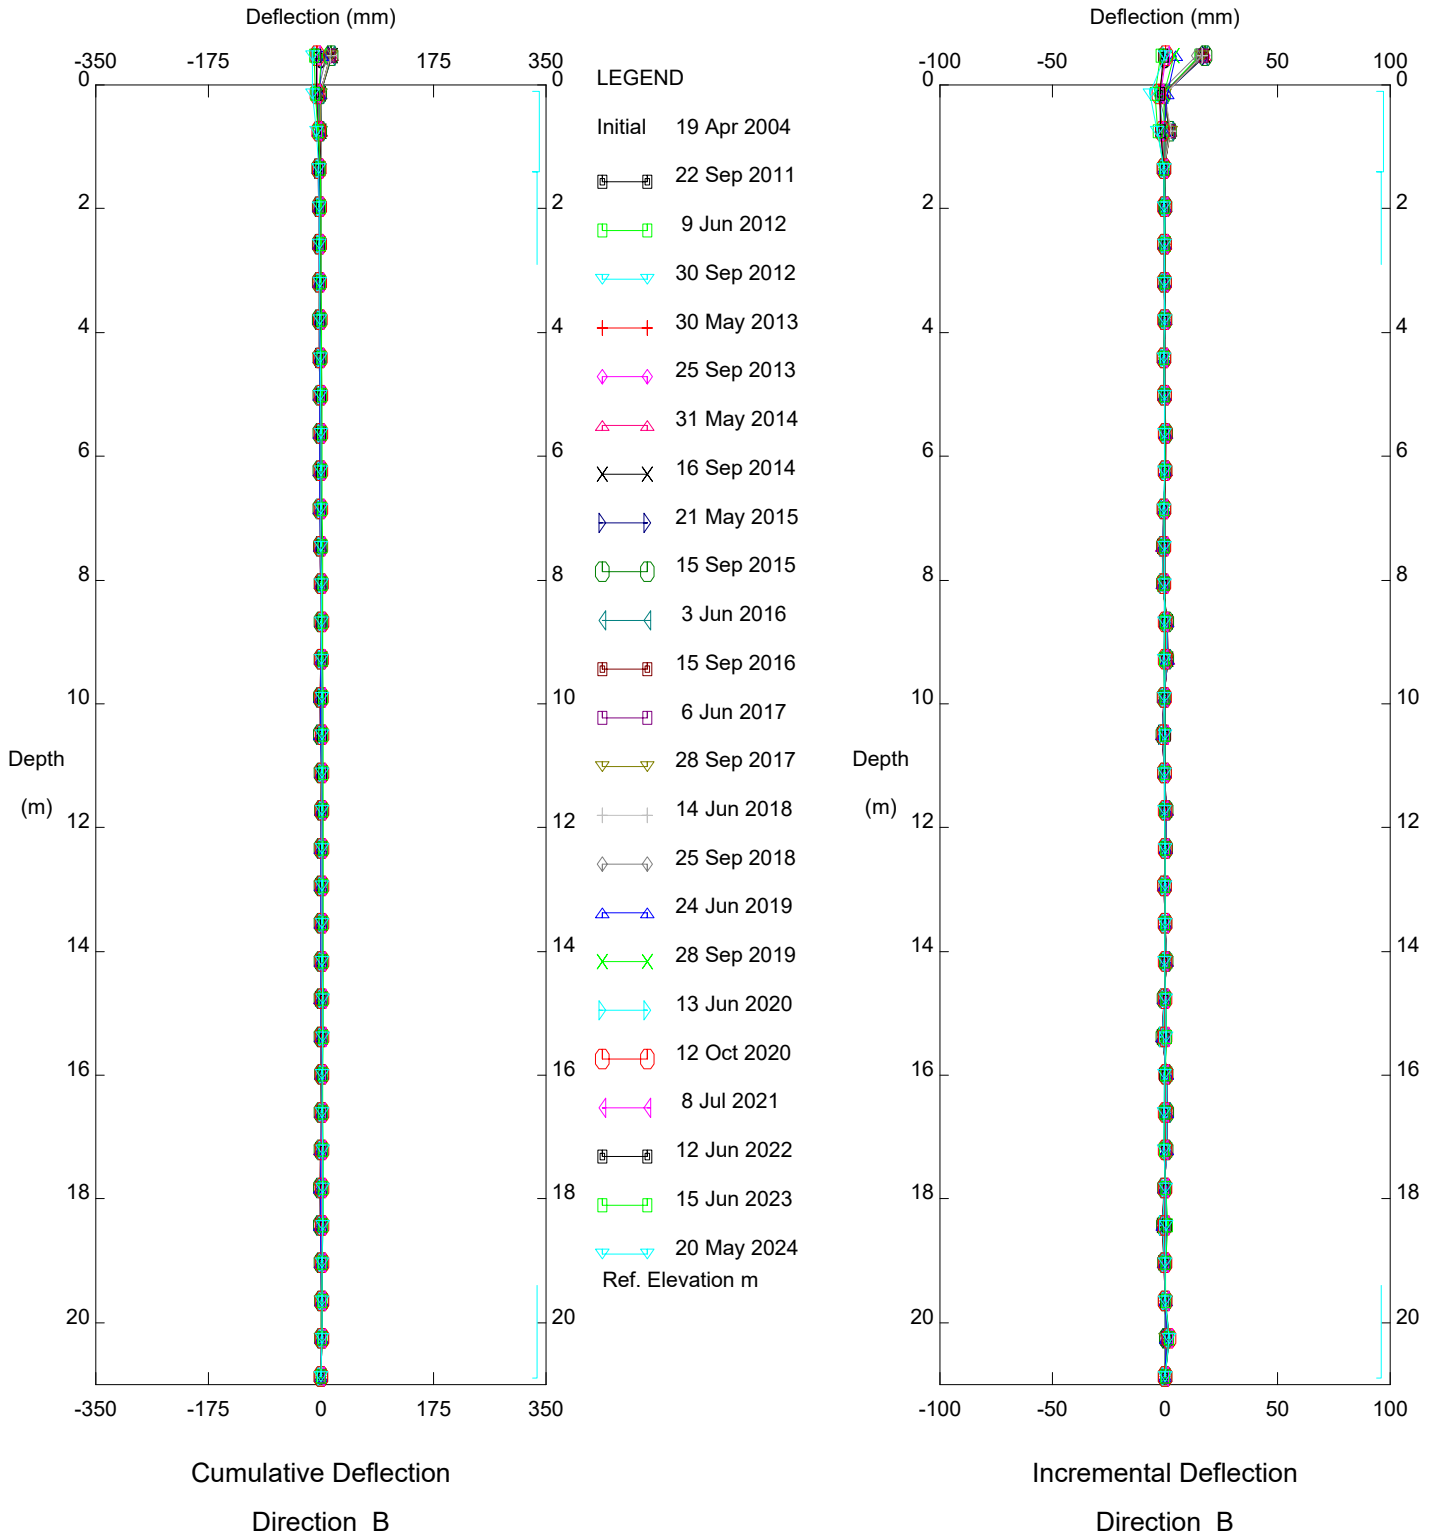
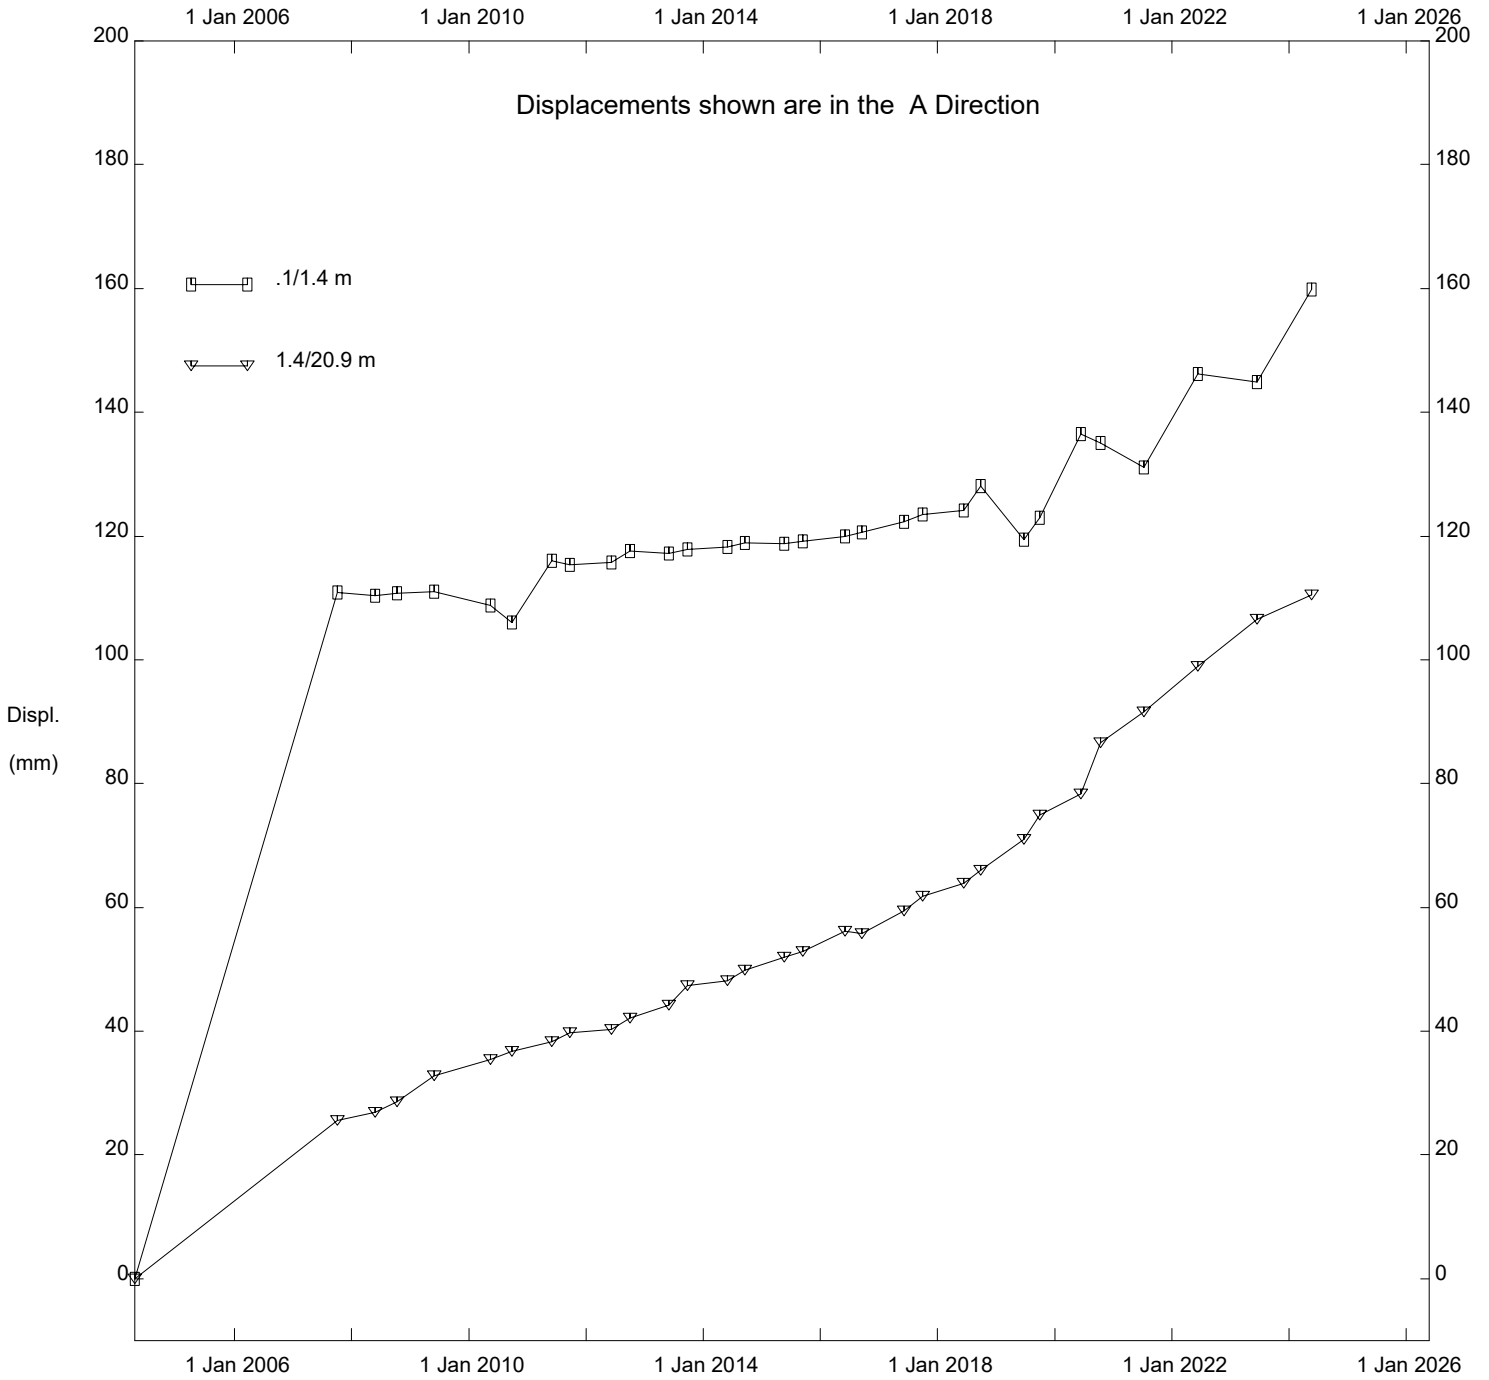
HWY 986:01 - STA. 13+540, Inclinometer SI04-3

<p>SI04-1 showed a rate of movement of 7.0 mm/yr over 0.1 to 2.6 m since spring of 2023 and a rate of movement of 3.1 mm/yr over the length of the pile. The pile head has deflected a total of 65.8 mm to date</p> <p>SI04-3 showed a rate of movement of 16.1 mm/yr over 0.1 to 1.4 m depth since the spring of 2023 readings and a rate of movement of 4.1 mm/yr over the length of the pile. The pile head has deflected 110.4 mm to date</p> <p>. There was a noticeable increase in movement in SI04-1 during 2017 and 2018 when a landslide movement occurred downslope of the wall during erosion repairs of erosion and construction of a gabion drop structure at the creek level. A driven steel pile wall and grading were carried out to mitigate those movements. The increased movement rate trend is still observed within the upper 2 m. Some slope flattening was also carried out consisting of removing some soil from the top of the pile wall near SI04-3.</p> <p>Pneumatic piezometer PN03-1 showed a decrease in groundwater level of 0.51 m since the spring of 2023 readings, which represents the lowest groundwater level measured in the instrument since October 2007. Pneumatic piezometer PN03-2 showed an increase in groundwater level of 0.02 m since the spring of 2023 readings.</p> <p><b>Site B (PH043-2)</b></p> <p>Slope inclinometers SI-7, SI-8 and SI-9 are located in the highway side slope (Station 33+820), about 300 m north of the pile wall.</p> <p>SI-7 continued to show no discernible movement.</p> <p>SI-8 showed a rate of movement of 5.7 mm/yr over 0.3 m to 1.5 m depth and a rate of movement of 0.6 mm/yr over 1.5 m to 4.0 m depth since the spring of 2023 readings.</p> <p>SI-9 showed a rate of movement of 10.4 mm/yr over 0.3 m to 2.7 m depth since the spring of 2023 readings.</p>

* Bottom of SI04-3 sitting at 69ft
