**ALBERTA TRANSPORTATION  
GEOHAZARD ASSESSMENT PROGRAM  
PEACE REGION (PEACE RIVER DISTRICT)  
2023 INSPECTION**

<b>Site Number</b>	<b>Location</b>	<b>Name</b>	<b>Hwy</b>	<b>km</b>
PH007	Daishowa East Hill	Gabion Channel & Erosion Control Section	986:01	12.55
<b>Legal Description</b>		<b>UTM Co-ordinates</b>		
NE7-85-20 W5M		11V E 490505	N 6246235

**DAISHOWA**  
**HWY 986:01 (PH007)**  
**LOCATION PLAN**

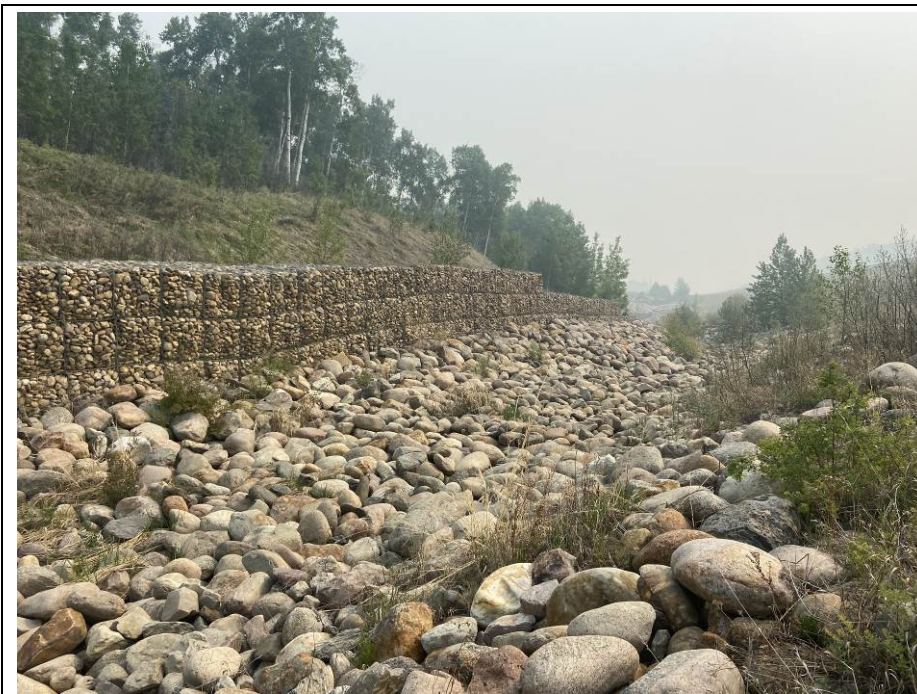
**Photo 7-01.**  
Gabion retaining wall and armoured channel observed in good condition (32+310).

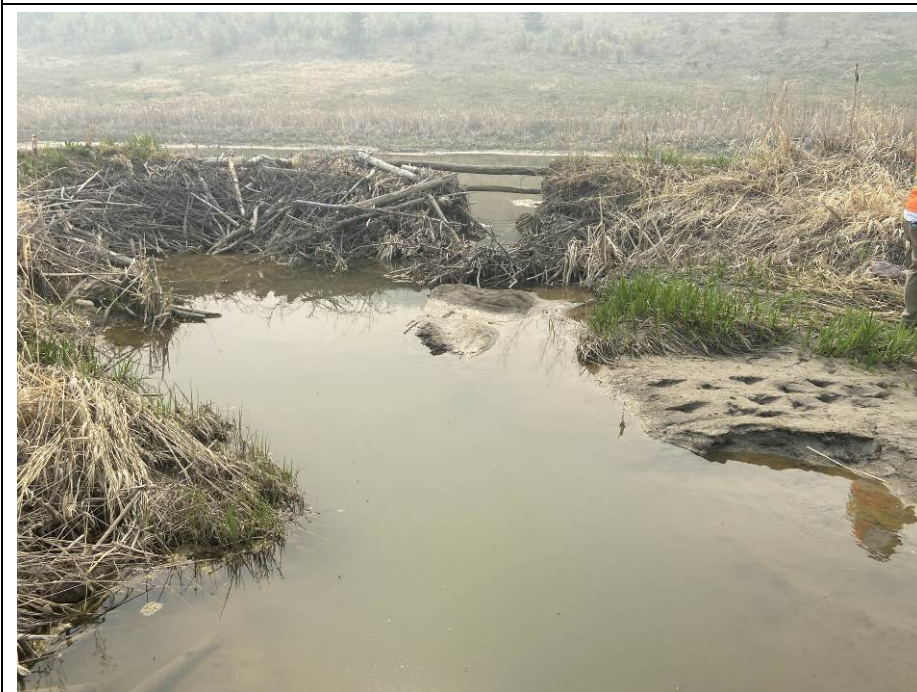
**Photo 7-02.**  
Maintenance contractor excavated a drain slot through beaver dam to drain water into the channel near km 32+825.

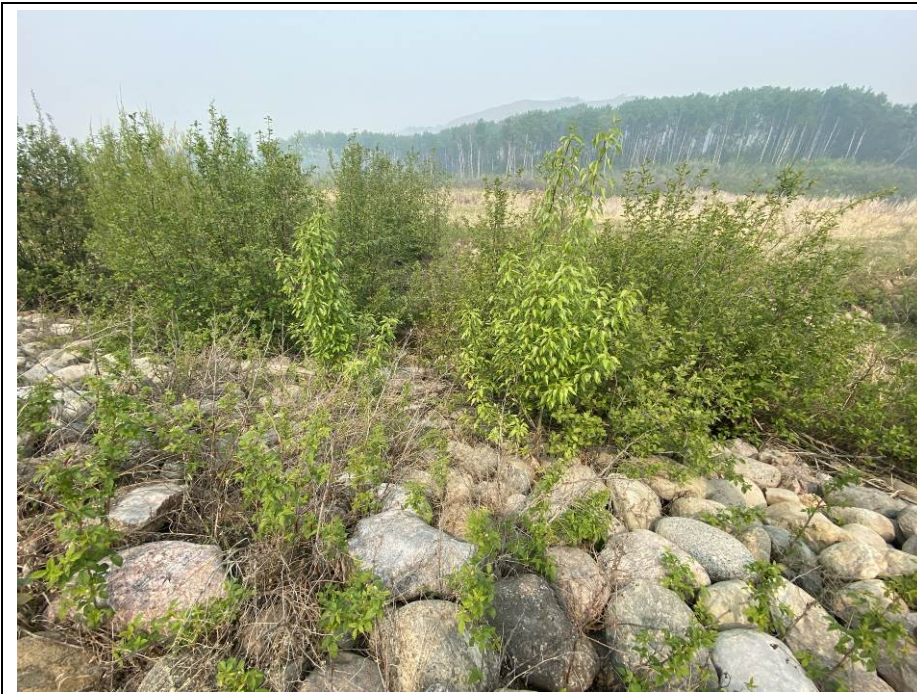
The willow and alder growth noted within the upper portion of the North Channel may reduce the hydraulic capacity of the inlet, and this should be checked by a hydraulic engineer.

**Photo 7-03.**  
Alder and willow tree growth within the riprap downstream of the armoured channel inlet near km 32+800.

If it is determined that the hydraulic capacity of the north channel inlet is being adversely affected by willow growth, they should be cut flush to the channel bottom with the roots left in place.

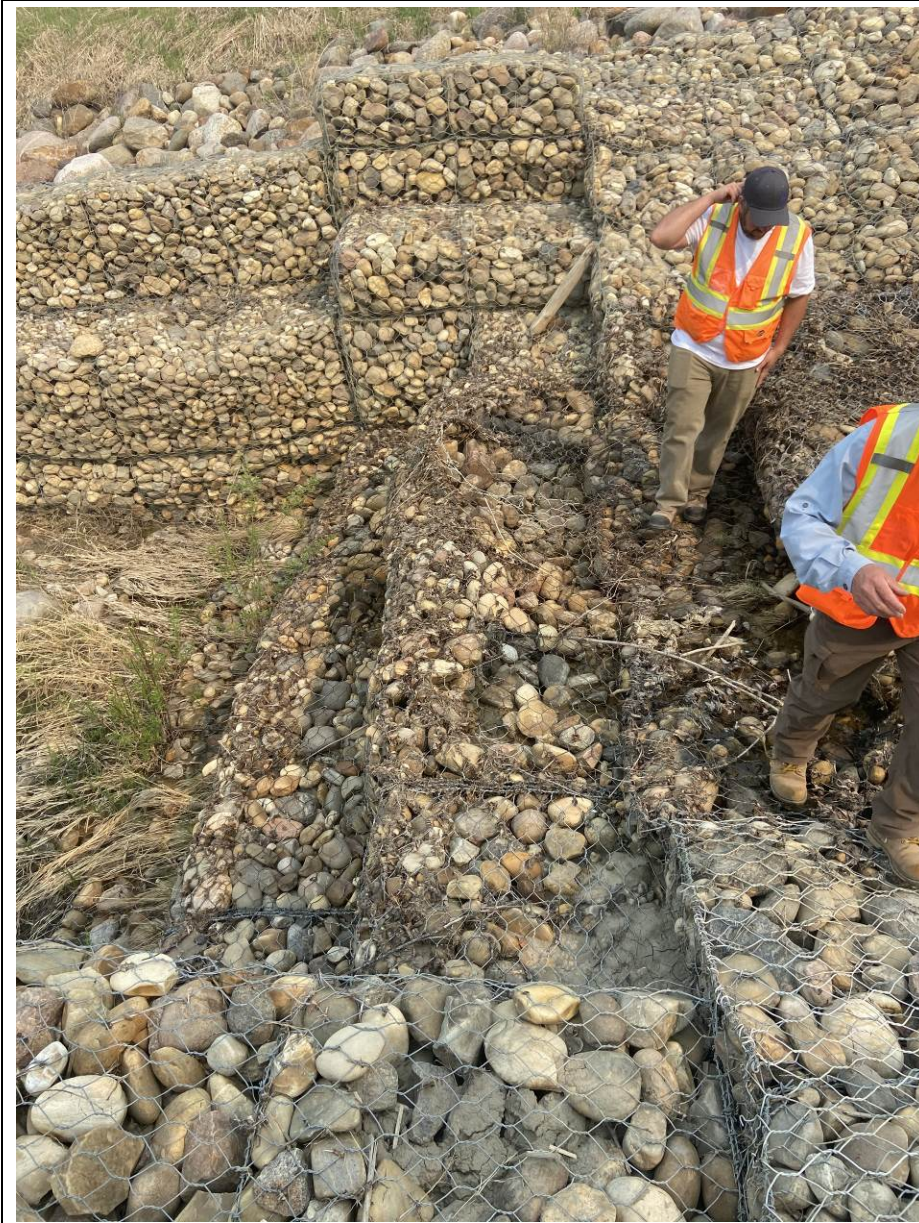
**Photo 7-04.** Close-up view of the internal upper gabion drop structure (32+540). Baskets in the channel centre have some bagging and broken wire. Maintenance is recommended to prevent further damage / loss of gabion rock. Overall, the structure is intact and functioning as intended.

Gabion baskets in the north channel within the drop structure should be rewired and shaped where they have come apart.

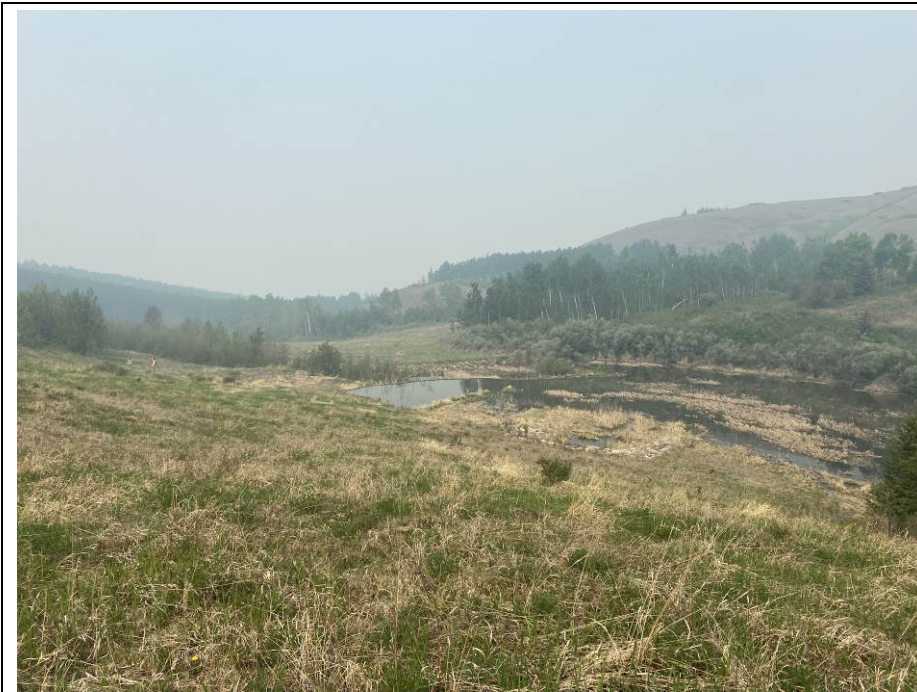
**Photo 7-05.**  
Wetland area near km 31+950 with higher water level due to beaver dam approximately 2 m high.

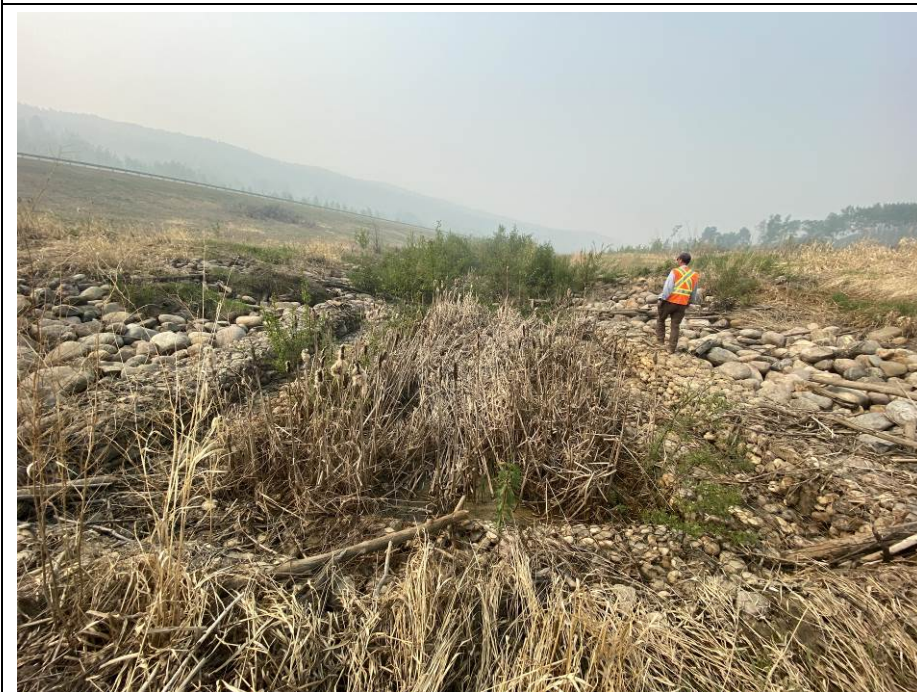
**Photo 7-06.**  
North channel gabion inlet structure. Cat tails growing within centre of channel, but flow capacity is still ok. Condition was generally comparable to previous inspections (32+855).

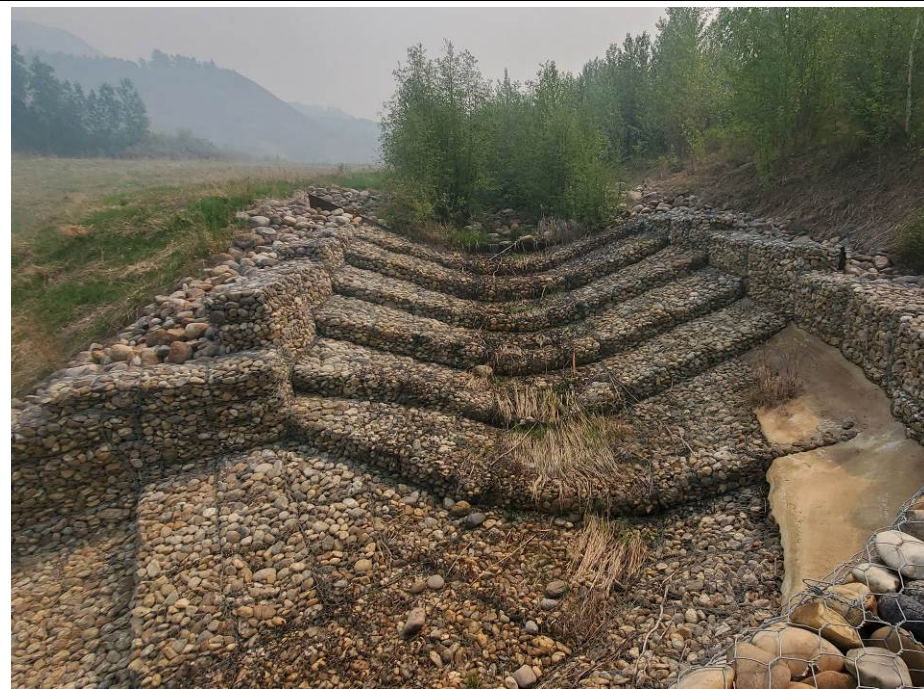
**Photo 7-07.**  
View of the upper segment of the gabion channel bend and drop structure (31+800). Gabions within the middle of the channel showing some bagging and wire damage that will require eventual maintenance to prevent further basket damage. Overall structure was intact and functioning as intended.

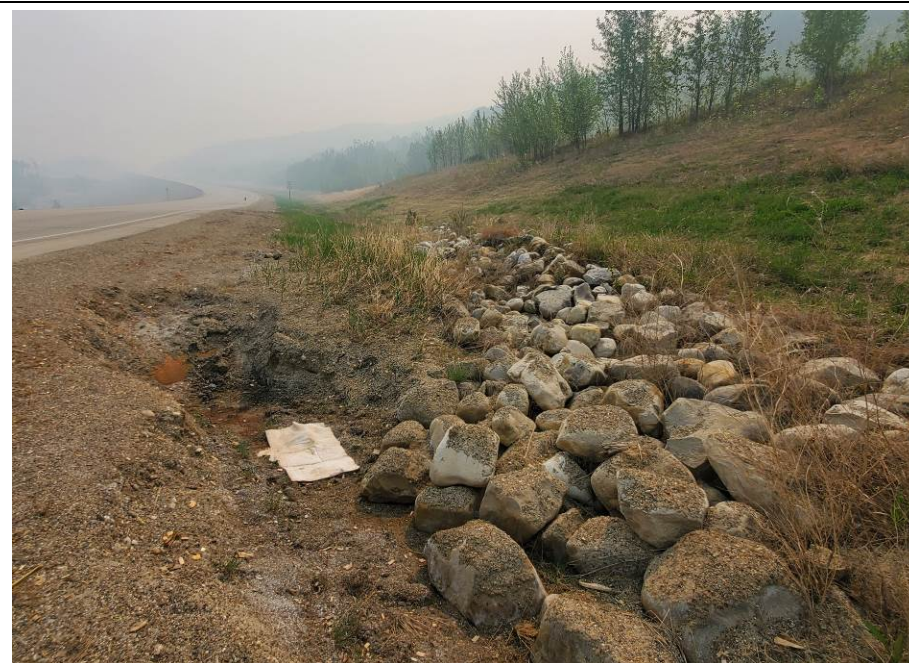
**Photo 7-08.**  
Erosion around the culvert intake structure at the west end of the erosion control test ditch (32+050). Erosion has slightly filled in since the 2020 condition but area still needs to be graded and riprap adjusted to ensure water flow enters the culvert.

The erosion around the culvert inlet (32+050) should be backfilled and riprap reconfigured.

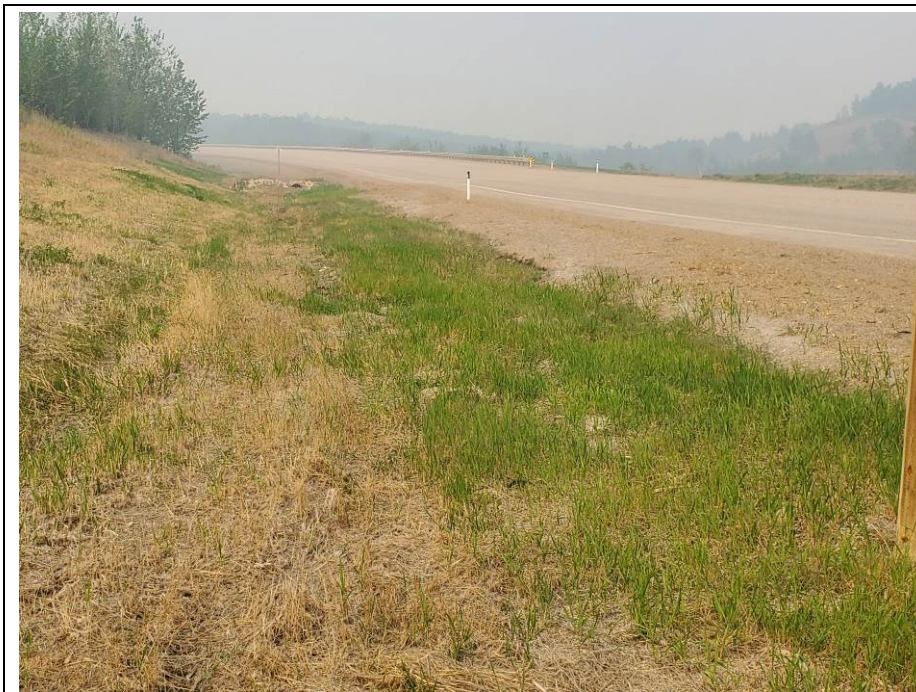
**Photo 7-09.**  
Previously observed channelized erosion has since revegetated on the north side of the ditch within the rolled erosion control product (turf reinforced matting) test section (32+100).

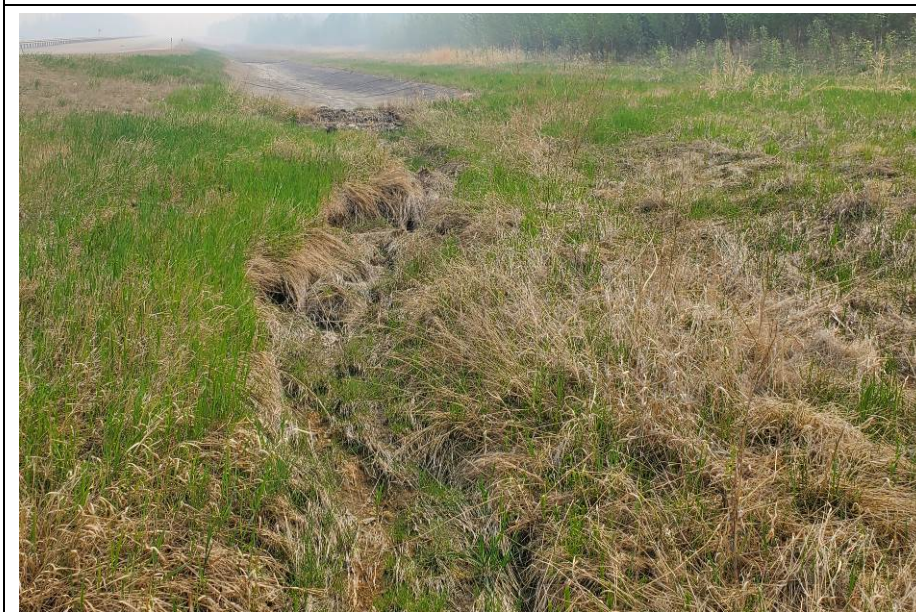
**Photo 7-10.**  
Looking east towards 300 m diameter channel sock erosion control section (32+150). Section had good vegetation growth through area of previous channelized erosion near the downstream boundary of the geomembrane section.

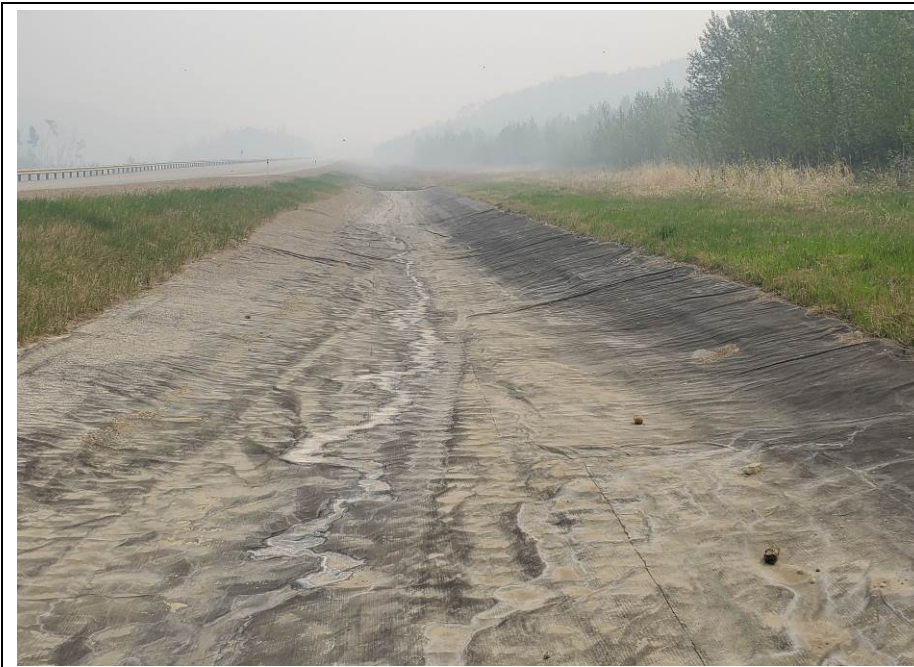
**Photo 7-11.**  
Looking upslope (east) at the Coletanche geomembrane erosion control section (32+250). Was in good condition with no new damage observed in previous patch repair area.

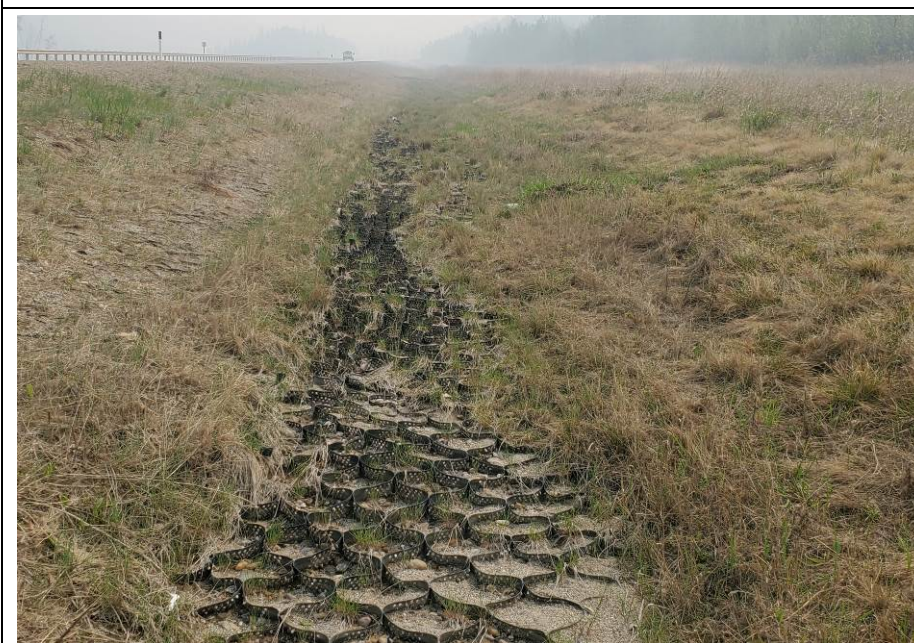
**Photo 7-12.**  
Looking upslope the ditch (east) at the geoweb control section (32+400). No major change since the 2020 condition; Section had vegetation growth and some cells were only partially filled and broken. Some minor rill damage was noted on the north side of the ditch.

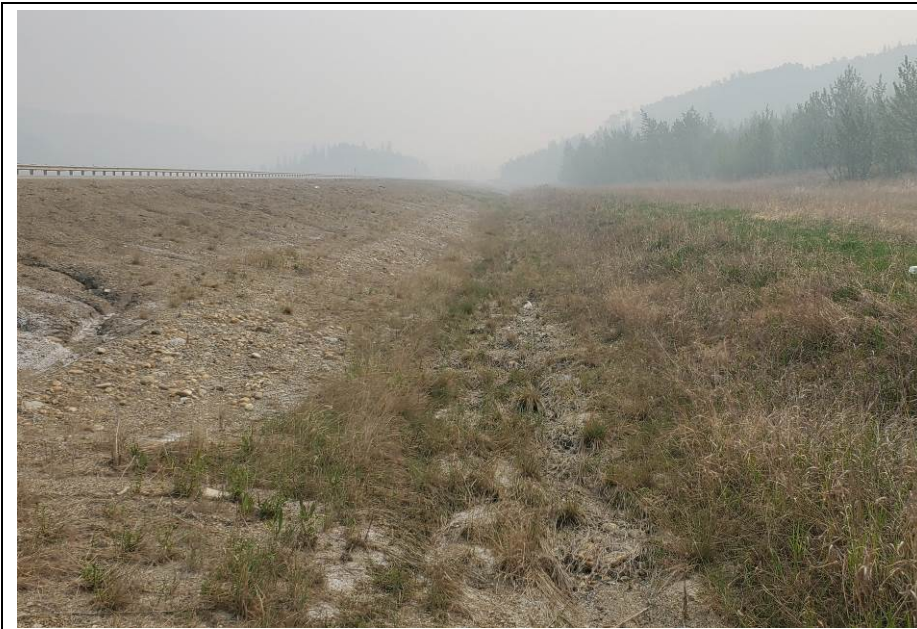
**Photo 7-13.**  
 Looking upslope the ditch (east) at the gabion mattress section (32+500). Section had vegetation growth and was performing well. Minor rill damage was noted on the north side of the ditch.

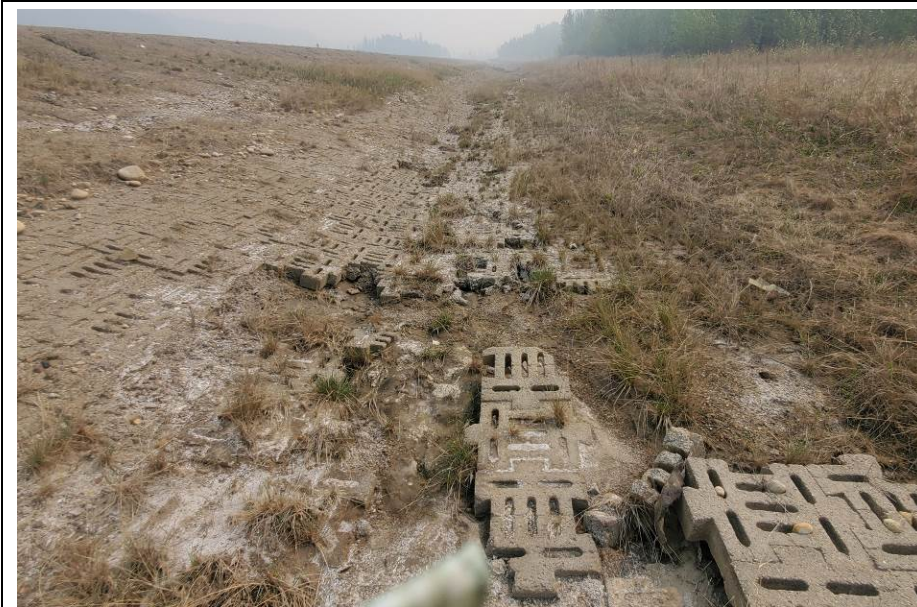
**Photo 7-14.**  
 View of the damage within the interlocked concrete block (i.e. Lafarge paving stones) paving stone section (32+600). Blocks have deteriorated and broken up in numerous locations and have been undermined by erosion exposing geotextile fabric beneath. Overall section is worse relative to the other test sections.

The paving stones section of the south ditch lining will continue to deteriorate and will eventually need to be repaired. Gabion mattress would be a good replacement strategy.

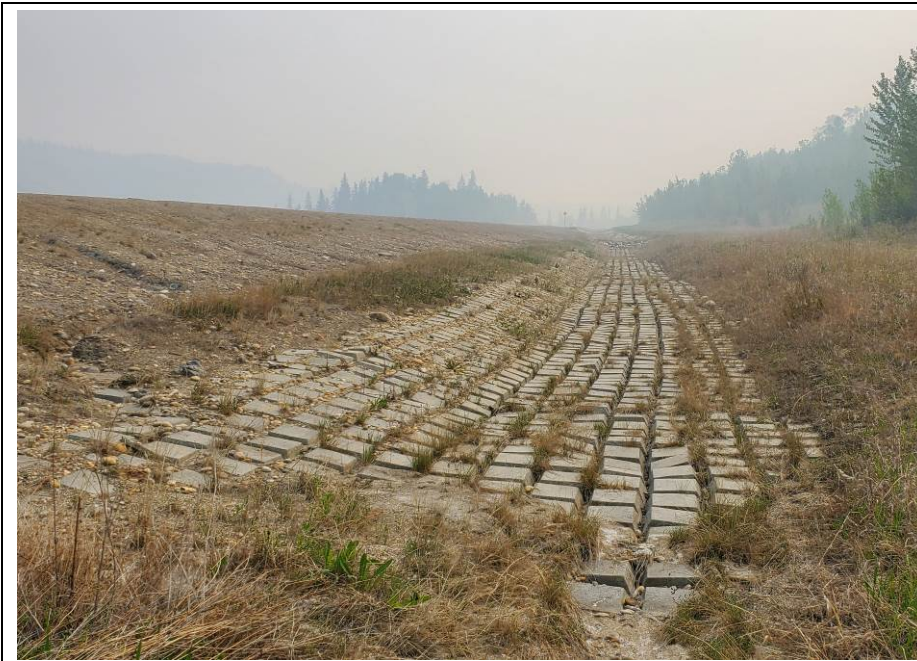
**Photo 7-15.**  
Looking east towards cabled concrete section (32+700). Section was performing well. Minor erosion damage was noted on the north side of the ditch. No major change from the 2020 condition.

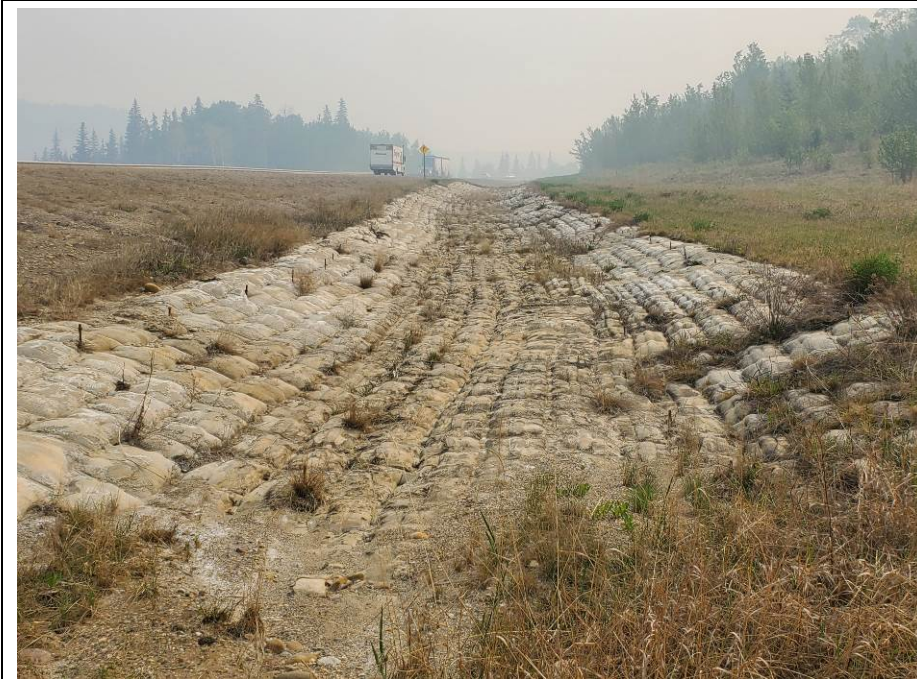
The majority of the exposed cables in the concrete section have been cut; however, there is still some protruding rebar pins in the pillow concrete section that should be cut flush or preferably driven back in the ground and capped with concrete.

**Photo 7-16.**  
Looking east towards pillow concrete section (32+800). Section was performing well. Minor concrete deterioration was noted in select areas, but erosion mitigation function was not impacted.

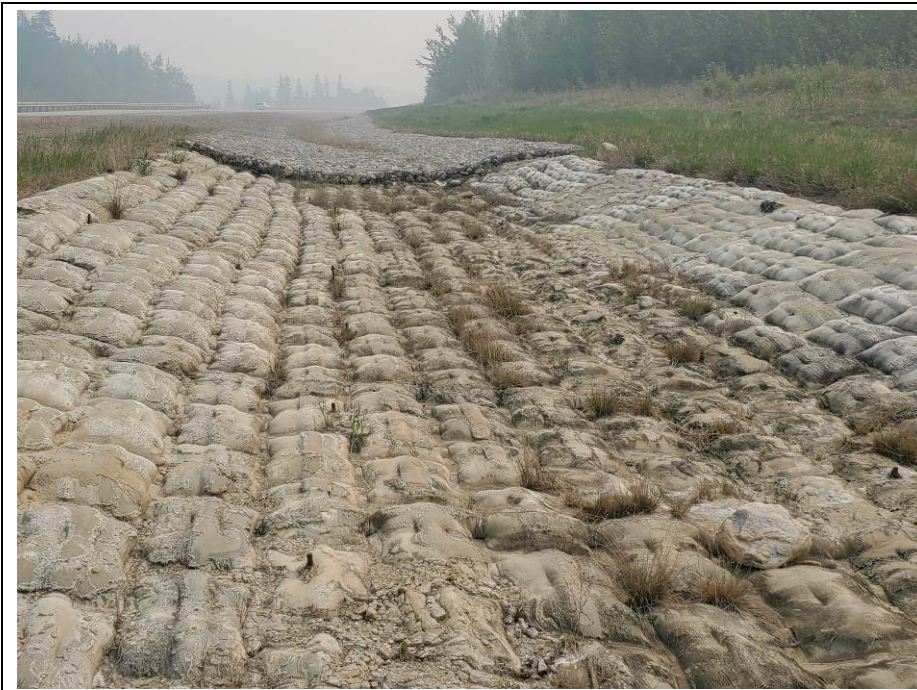
**Photo 7-17.** Looking east (upslope) at the top of the erosion control test ditch (32+900). Ditch upslope of the test section has been lined with gabion mattress as part of the 2018/2019 East Daishowa (PH42) mitigation work. The ditch and new mitigation works were in good condition with no observable change from the 2020 condition.
