Site Number	Location	Name	Hwy	km
PH071	Hwy 986:01 C1 28.474	Daishowa West Hill	986:01	Km 28.5
Legal Description: 8-9-85-21 W5		UTM Co-ordinates		
		11U E 485023	N	6245526

**ALBERTA TRANSPORTATION AND ECONOMIC CORRIDORS GRMP (CON0022164)
PEACE REGION (PEACE RIVER DISTRICT)
INSTRUMENTATION MONITORING RESULTS**

FALL 2024

SITE PH071: HWY 986:01, DAISHOWA WEST HILL

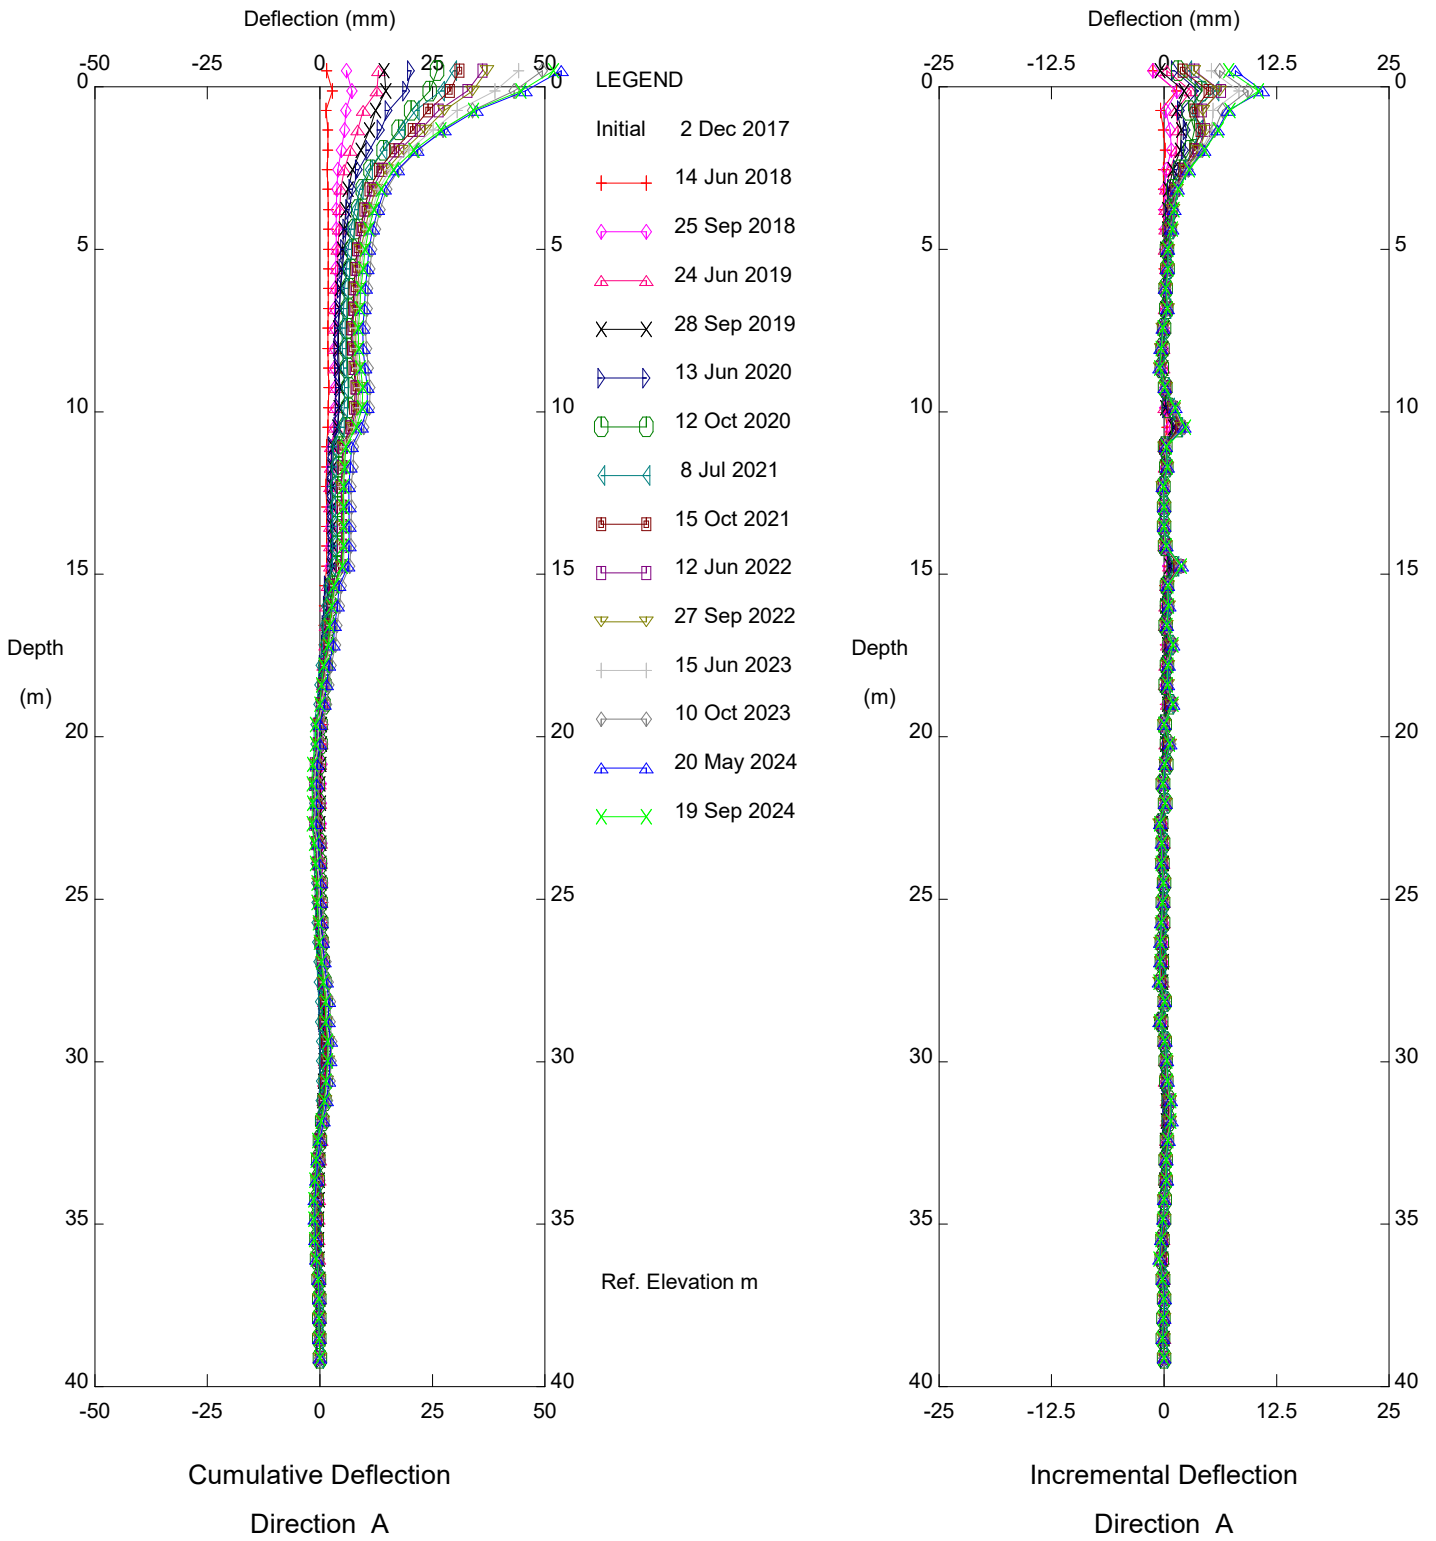
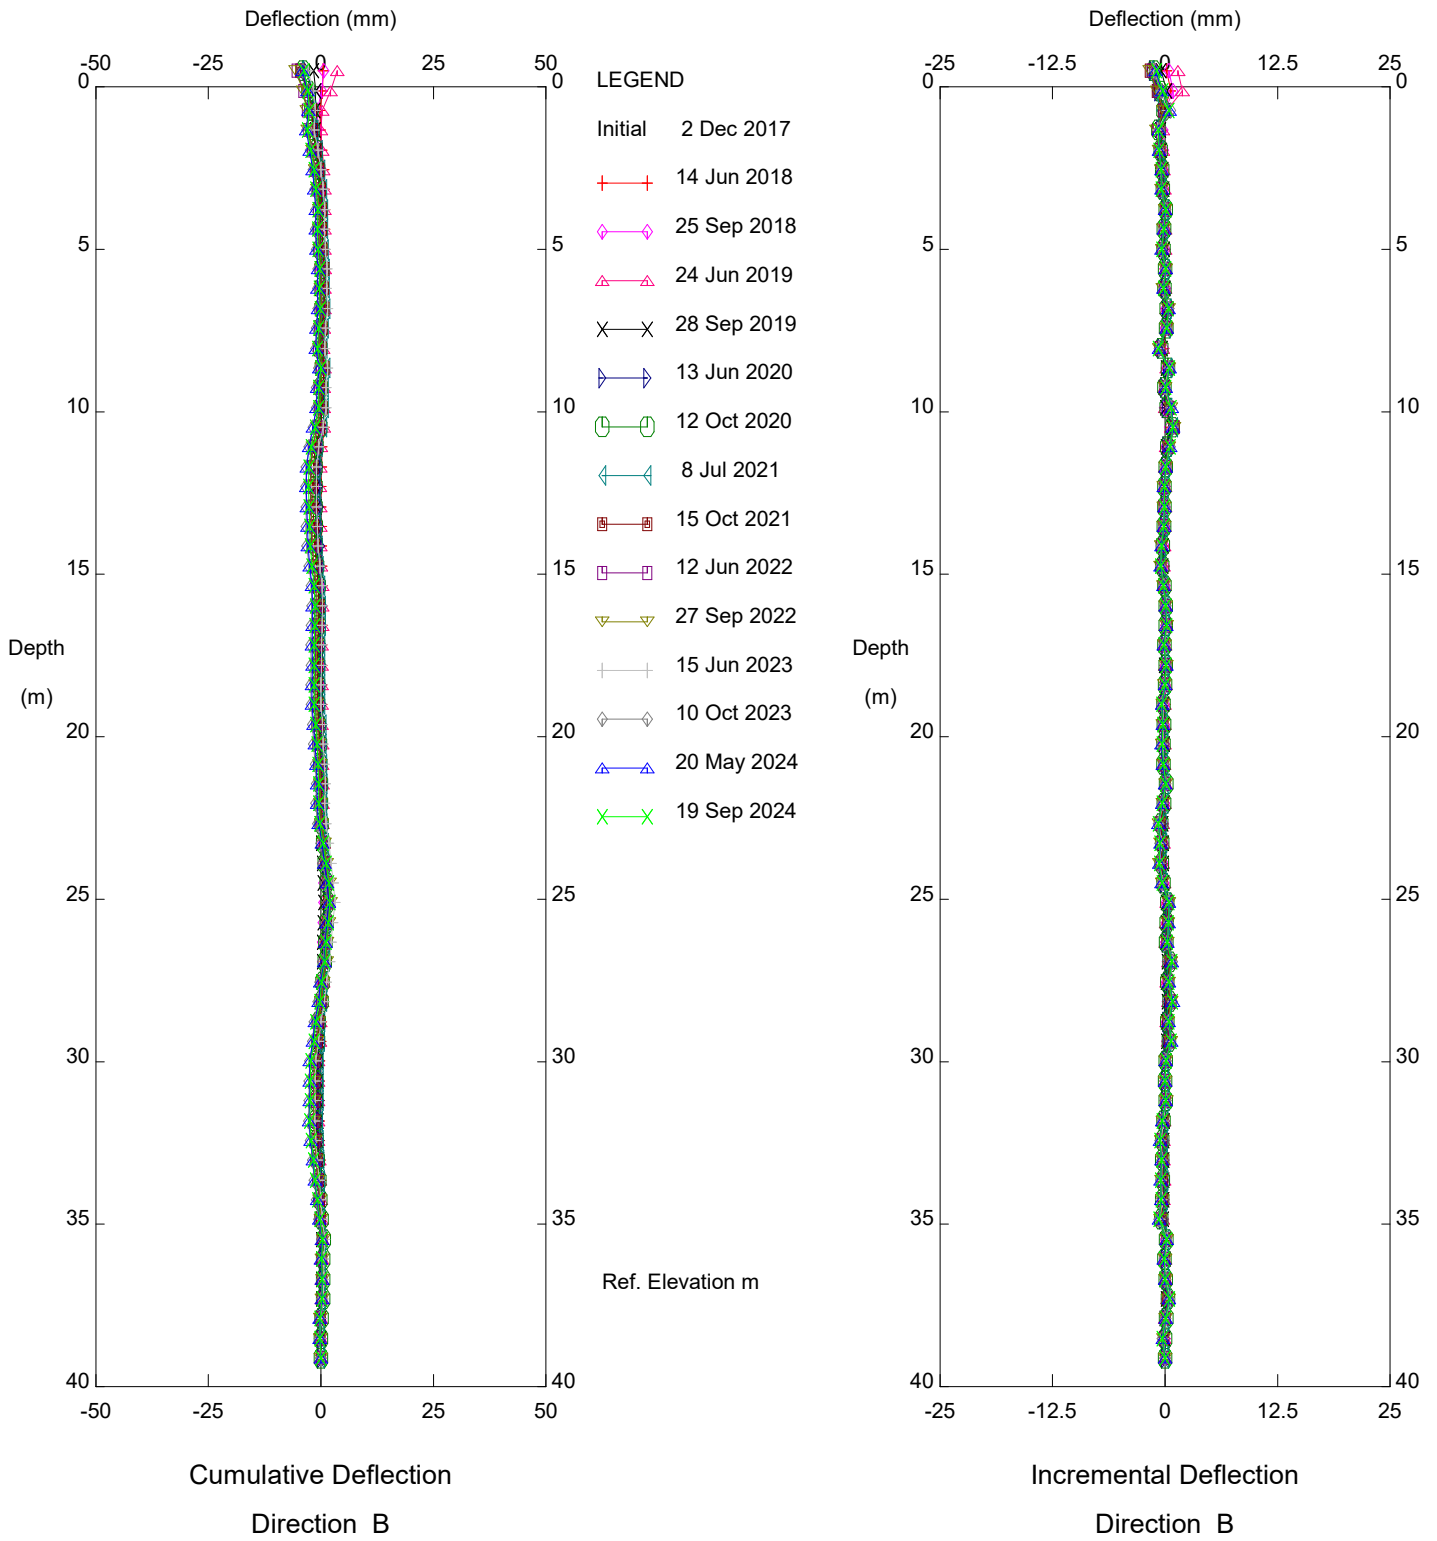
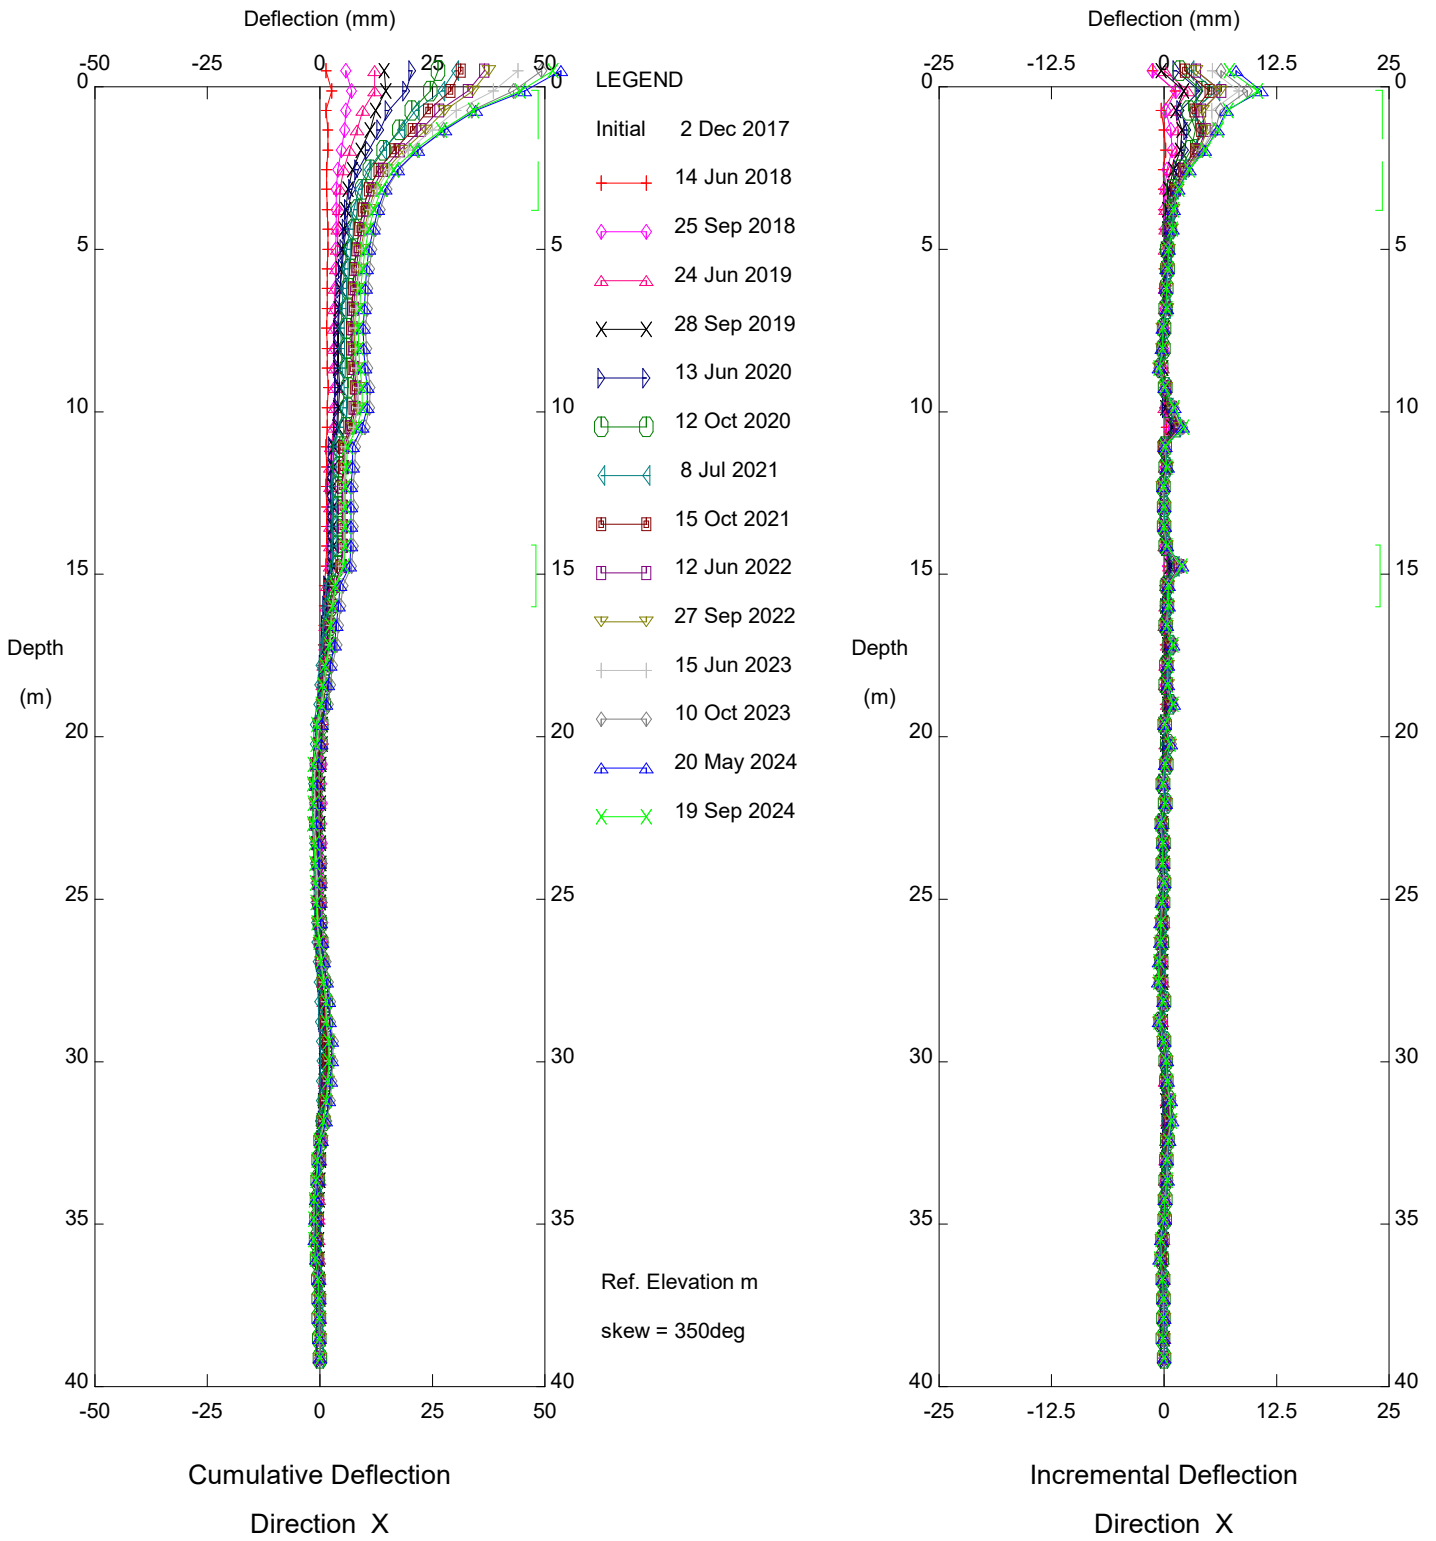
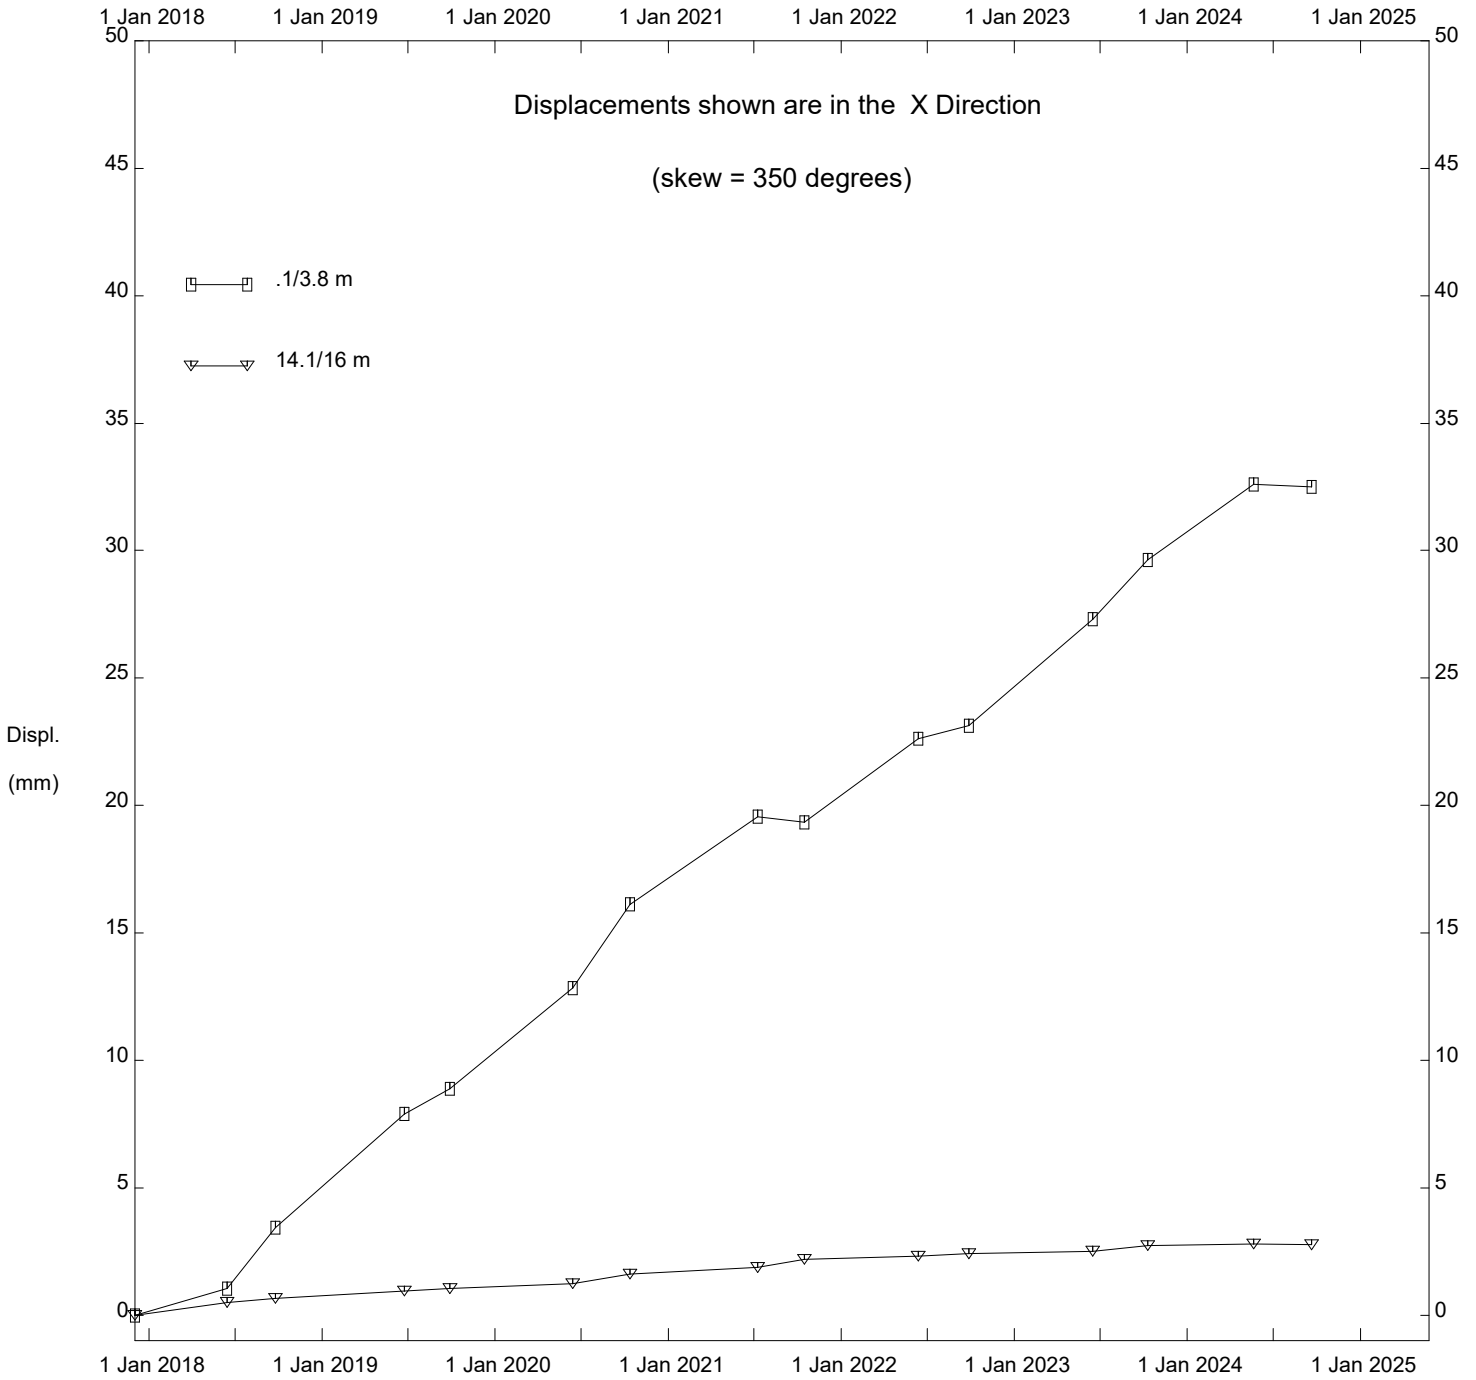
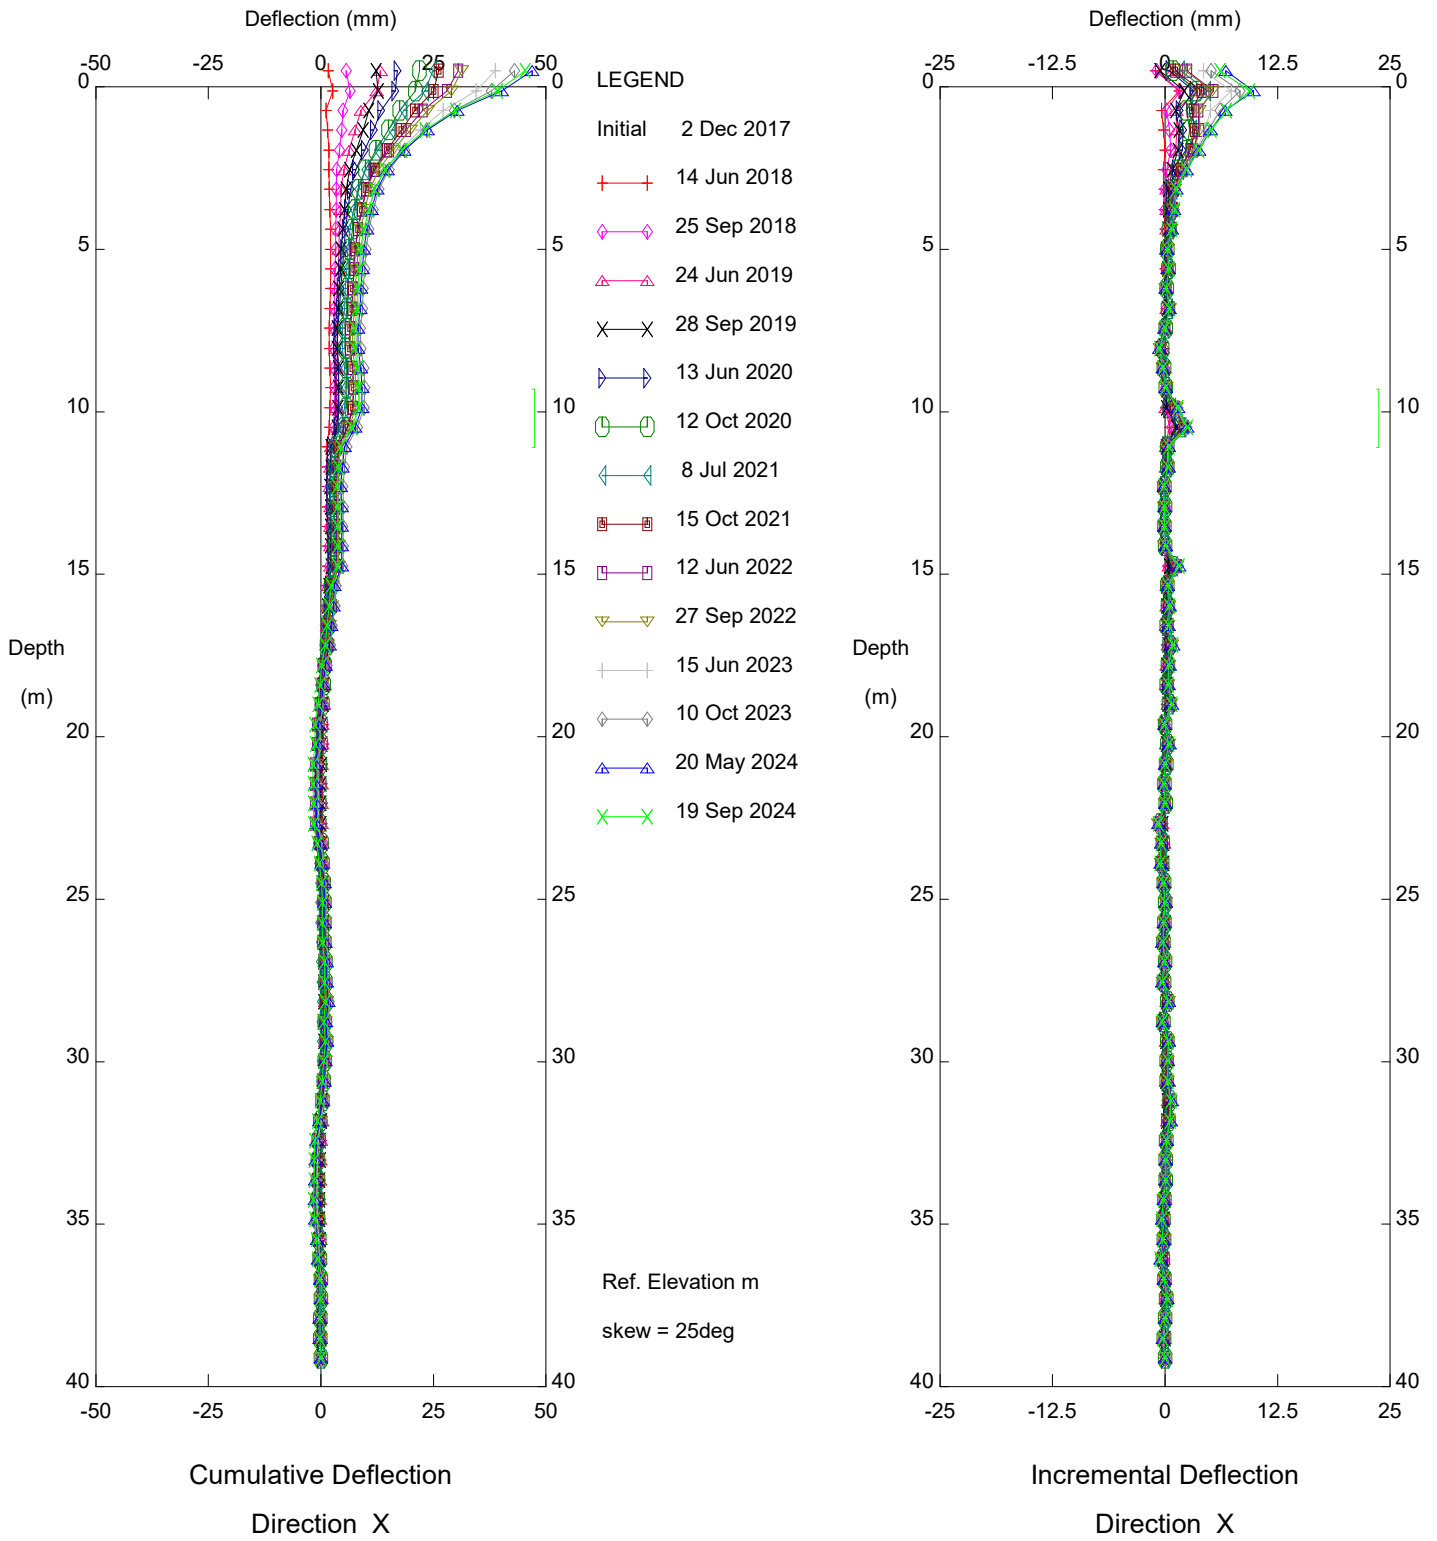
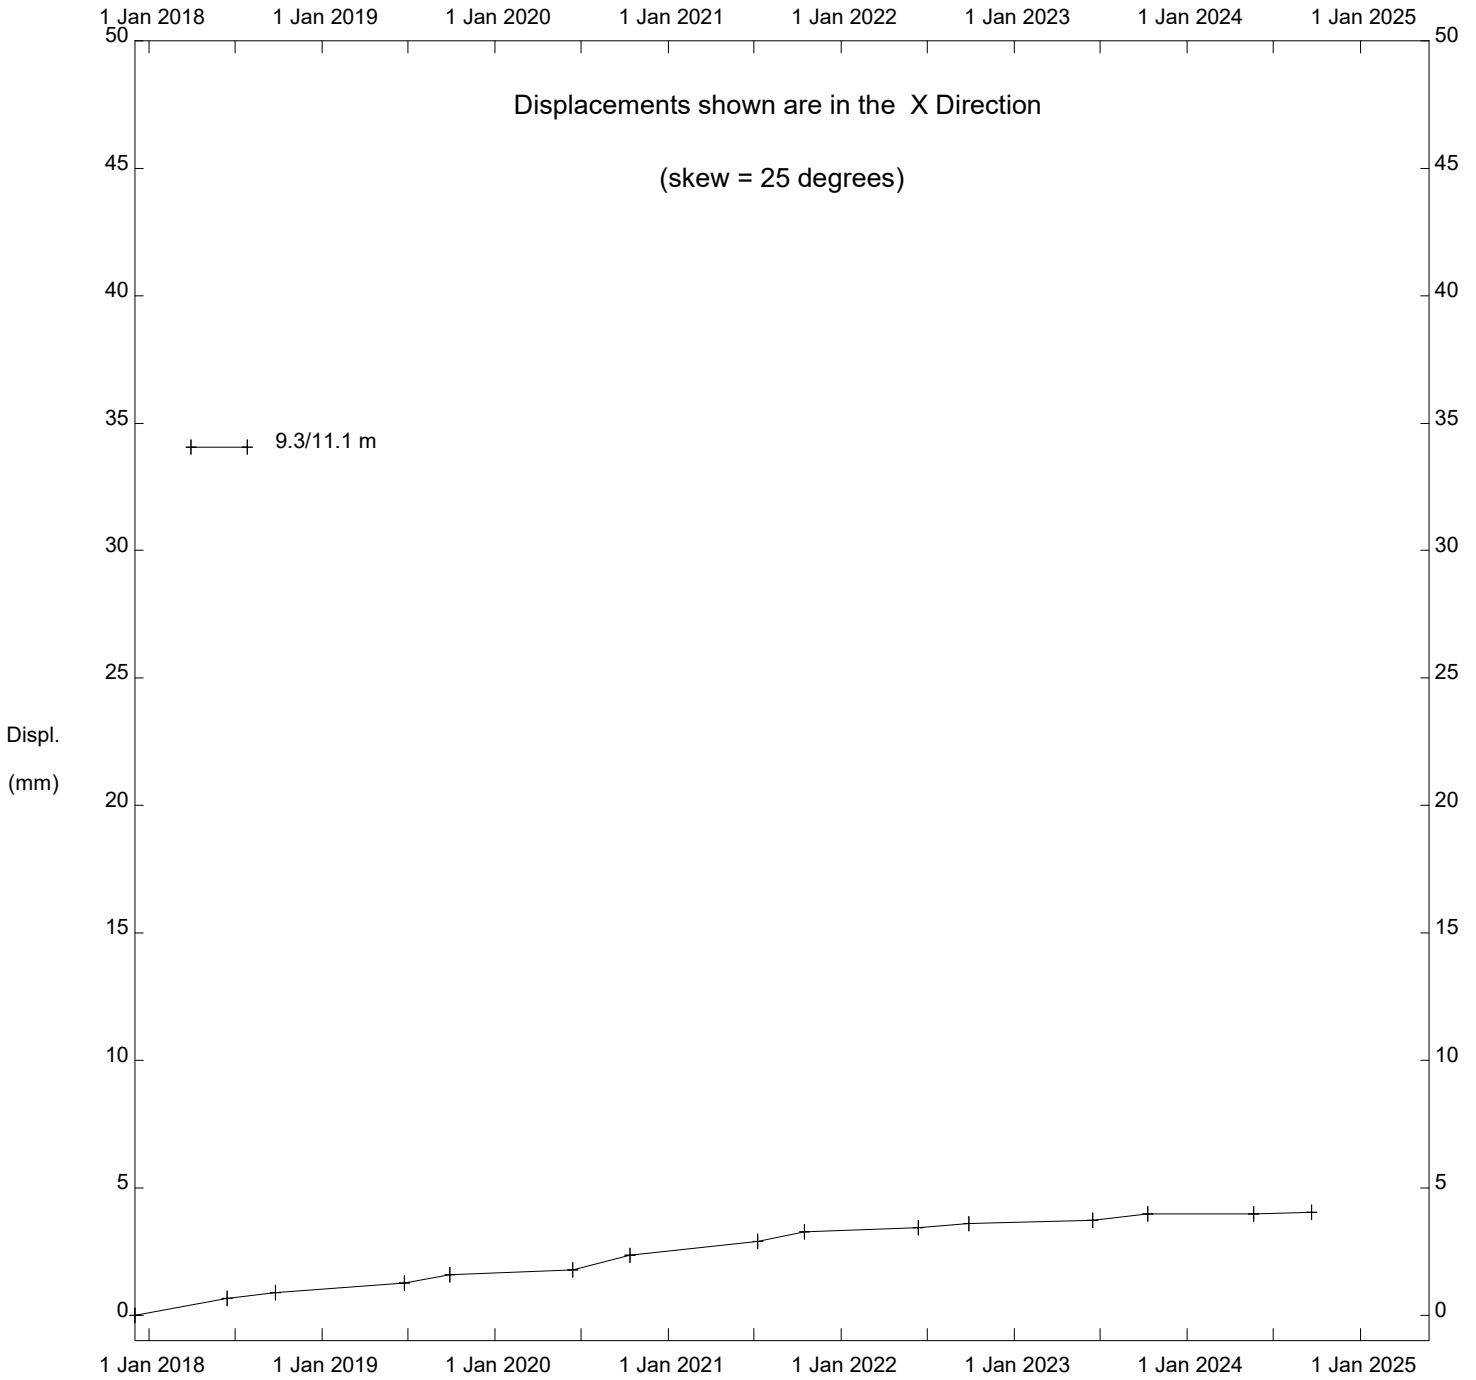
PH071 Daishowa West, Inclinometer SI16-3

Discussion	
Zones of New Movement:	None
Interpretation of Monitoring Results:	<p>Slope Indicators and SAAs</p> <p>SI16-3 showed no discernible movement over 0.1 m to 3.8 m depth and 14.1 m to 16.0 m depth, respectively, since the spring of 2024 readings. SI16-3 showed a rate of movement of 0.2 mm/yr over 9.3 m to 11.1 m depth.</p> <p>SAA-P060 showed a rate of movement of 1.6 mm/yr over 2.5 m to 29.5 m depth, and a rate of movement of 1.3 mm/yr over the full length of the pile and waler since the spring of 2024 readings. SAA-P060 has shown a cumulative pile head deflection of 18.5 mm to date in the downslope direction. SAA-P060 has shown an overall relatively steady rate of movement since the end of construction with a total incremental movement of about 6.5 mm in the downslope direction since completion of construction..</p> <p>SAA-P097 has shown no discernible movement since the spring of 2024 readings. SAA-P097 has shown a total pile head deflection of 17.5 mm in the downslope direction to date. SAA-P097 had shown an overall trend of steady</p>

Future Work:	<p>The instruments should be read again in the spring of 2025. It is recommended to continue monitoring the deflections in the pile wall and the load cell readings to see if there are further increases in deflection or loads compared to the</p>

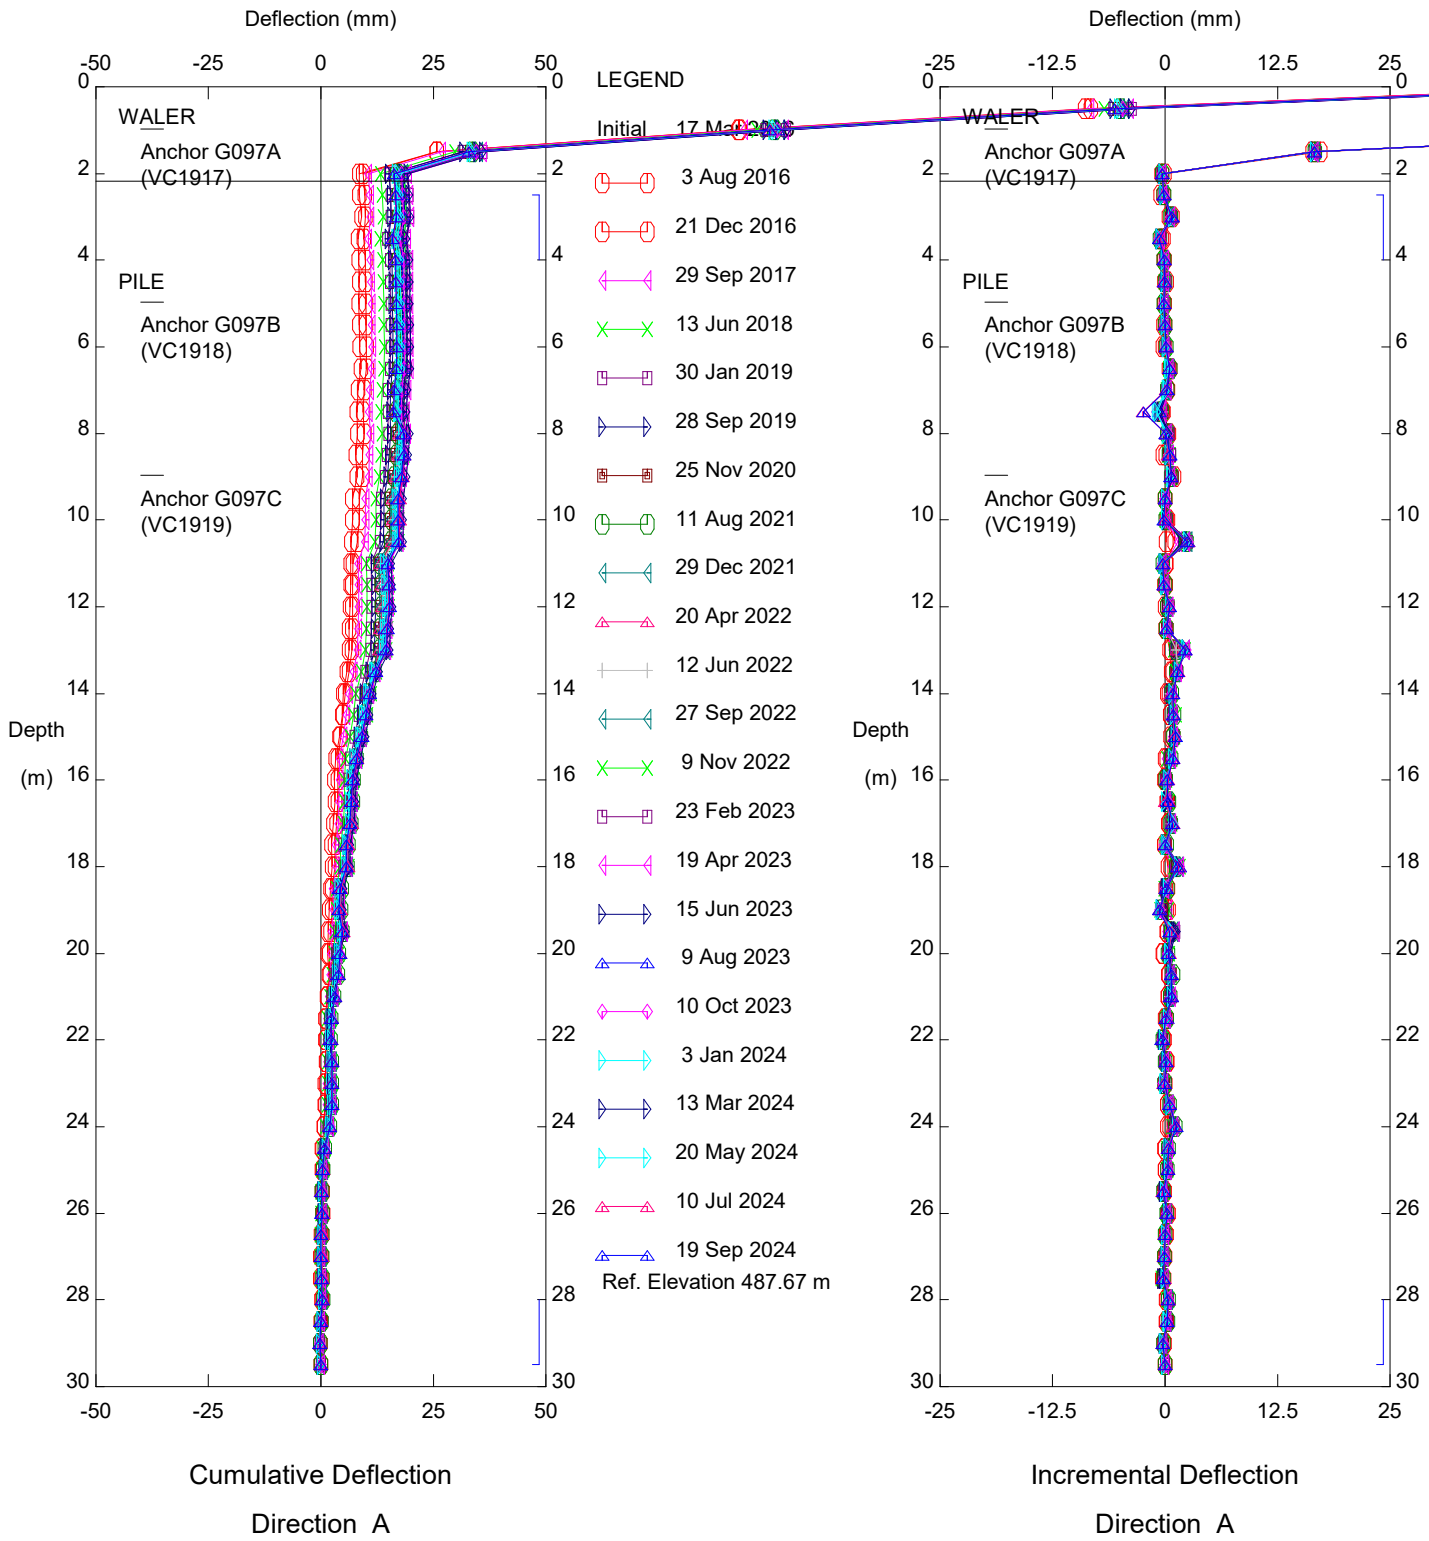
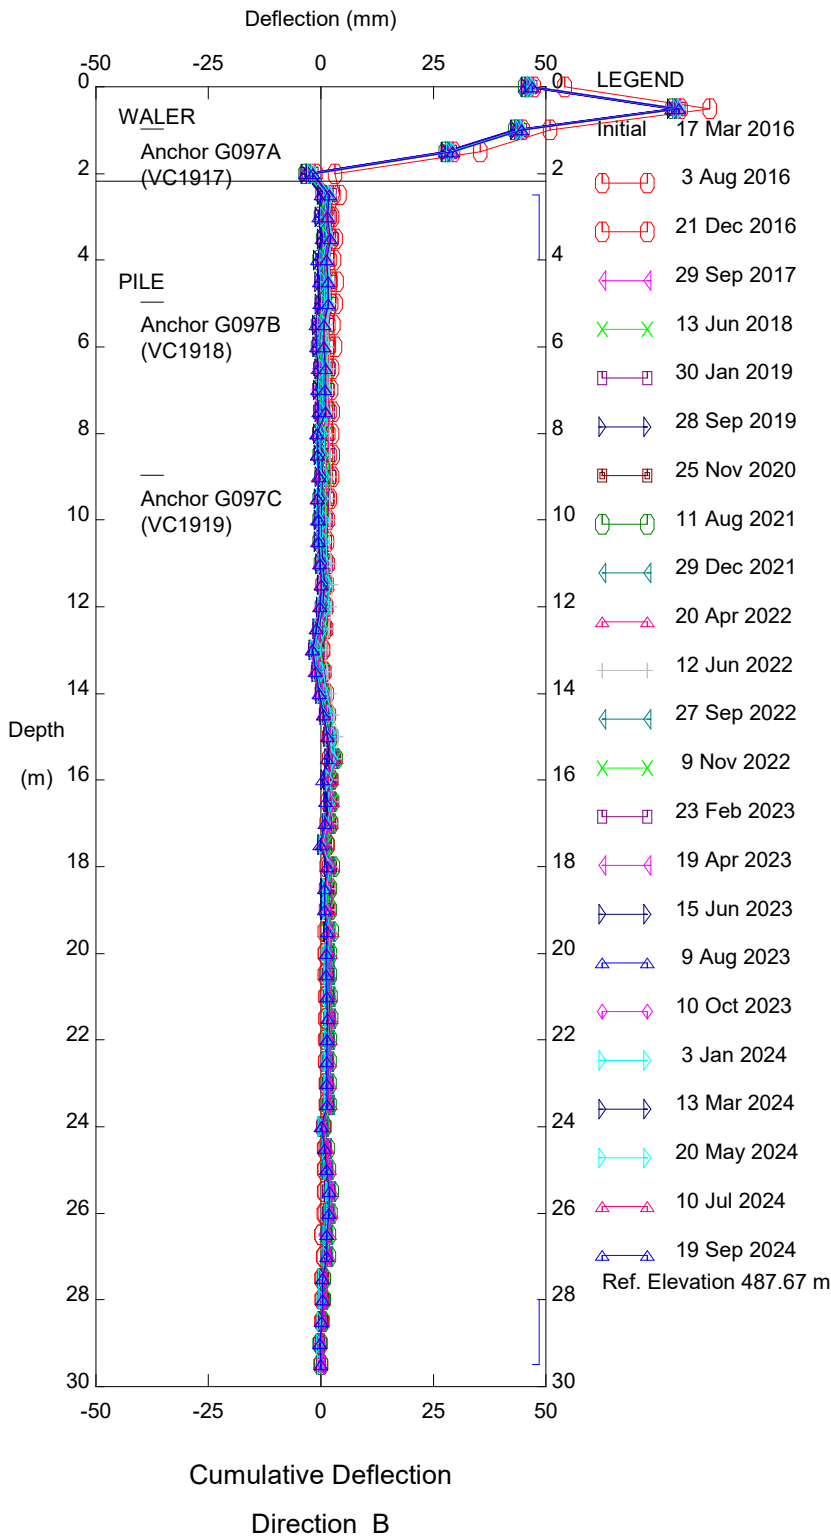
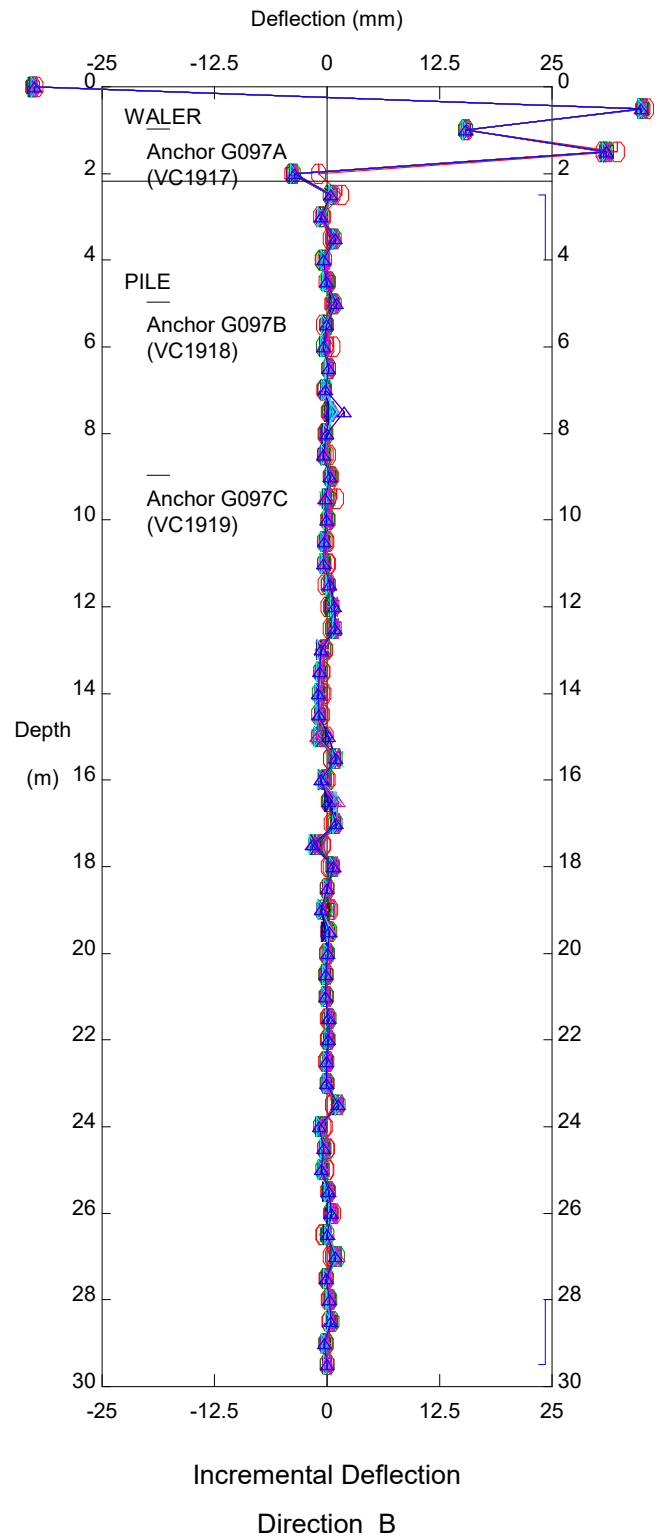
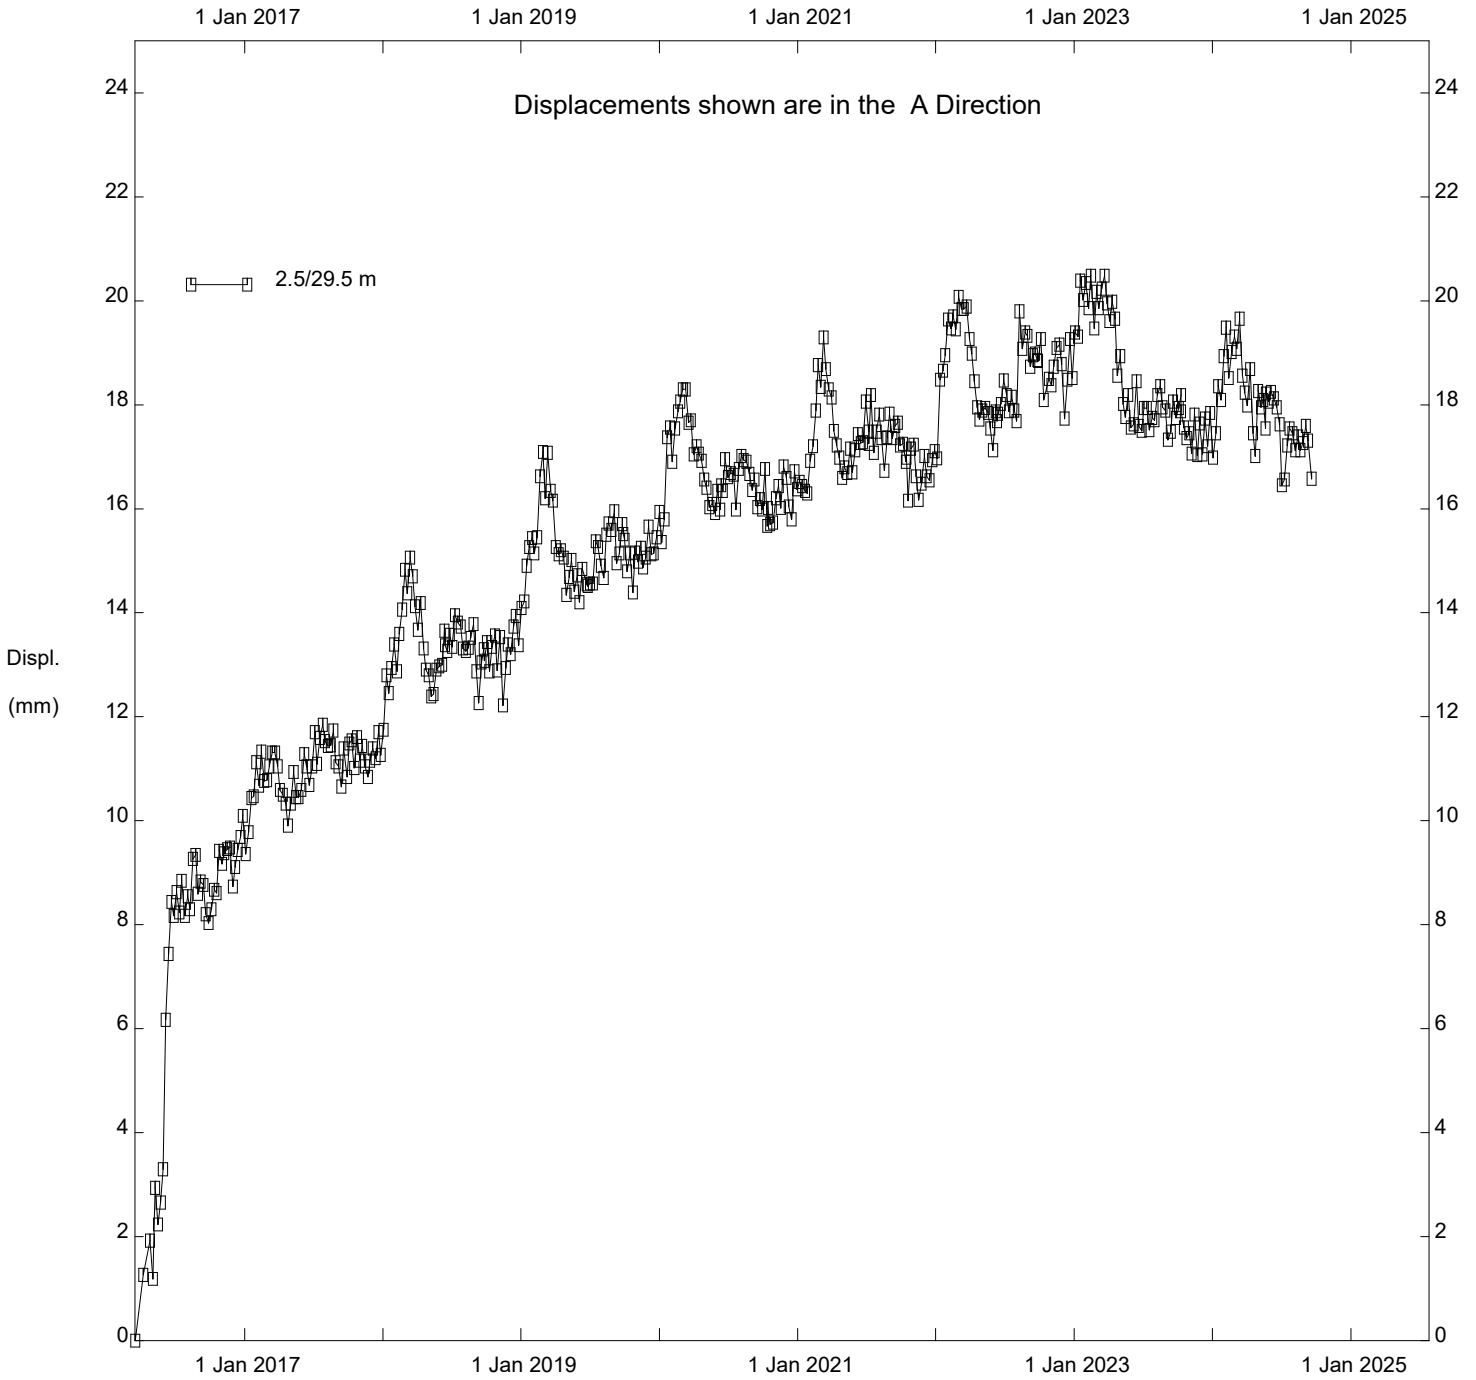
Hwy 986:01 Daishowa West, Inclinator SAA-P097

<p>downslope movement since the end of construction, with peaks of higher downhill movement rates during the winter months.</p> <p>Strain Gauges</p> <p>The strain gauge readings in Pile P066 are summarized in Table PH071-3. Overall, the strain gauges showed relatively small changes in microstrain value compared to the previous readings in the spring of 2023. The greatest change in microstrain was in strain gauge #17 at 2.6 m depth in the downslope face of the pile, which showed a decrease in positive (compressive) microstrain of 10.7 microstrain compared to the spring of 2024 readings.</p> <p>Piezometers</p> <p>Vibrating wire piezometer VW16-1A showed a groundwater elevation of 488.07 m and was dry during the spring 2024 readings. VW16-1B, and VW16-1C, located upslope of the wall, showed an increase in groundwater level of 0.41 m and 0.04 m respectively since the spring of 2024 readings. VW16-2C and VW16-2B, also located upslope of the wall, showed increases in groundwater levels of 0.76 m and 0.50 m, respectively since the spring of 2024 readings. The groundwater level of 482.13 m, measured in VW16-2C on September 5, 2024 was the highest measured in the instrument since it was initialized. However, the overall trend since end of construction had been a gradual increase in the groundwater table upslope of the wall to what now appears to be a relatively steady level with cyclical seasonal fluctuations.</p> <p>VW16-2A continued to be dry (this piezometer has only shown a groundwater level above the tip during a period between August 9, 2022, and September 21, 2022).</p> <p>Of the piezometers located downslope of the wall, VW16-3A showed a decrease in groundwater level of 0.21 m, and VW16-3B showed no change in groundwater level since the spring of 2024 readings.</p> <p>VW16-4A continued to be dry. VW16-5A was dry during the current readings. VW16-4A and VW16-5A tend to remain dry except for brief periods that correspond to either higher than normal rainfall or spring thaw.</p> <p>Load Cells</p> <p>The load cells generally showed small changes in measured load compared to the spring of 2024 readings, ranging from a decrease of 4.78 kN in VC1920 (anchor P060A) to an increase of 3.90 kN in VC1922 (anchor P060B).</p> <p>It should be noted that load cells VC1922, anchor P060B, and VC1918, anchor P097B, have each lost the function of one vibrating wire channel. The loads that are now reported for these three load cells are based on the average of the two functioning channels and projecting a reading for the now malfunctioning channel based on the last reading taken for that channel and the changes observed in the two functional channels since that time.</p> <p>Load cells VC1924 (anchor P022A) and VC1923 (anchor P022B) lost function of a second vibrating wire channel during July 2024, and the readings reported were the most recent available reading.</p> <p>Since the end of construction, the load cells have generally shown an overall trend of increasing load, with the highest seasonal loads measured towards the end of each winter. The current loads measured in the upper two anchor rows at all three piles, as well as the lower row at P022, are above the design loads. However, the recent readings for P060 and P097 appear to show that the anchor loads in the upper two anchor rows in P060 and P097 are starting to level off.</p>
