Site Number	Location	Name	Hwy	km
PH071	Hwy 986:01 C1 28.474	Daishowa West Hill	986:01	Km 28.5
Legal Description: 8-9-85-21 W5		UTM Co-ordinates		
		11U E 485023	N	6245526

**ALBERTA TRANSPORTATION AND ECONOMIC CORRIDORS GRMP (CON0022164)
PEACE REGION (PEACE RIVER DISTRICT)
INSTRUMENTATION MONITORING RESULTS**

FALL 2024

SITE PH071: HWY 986:01, DAISHOWA WEST HILL

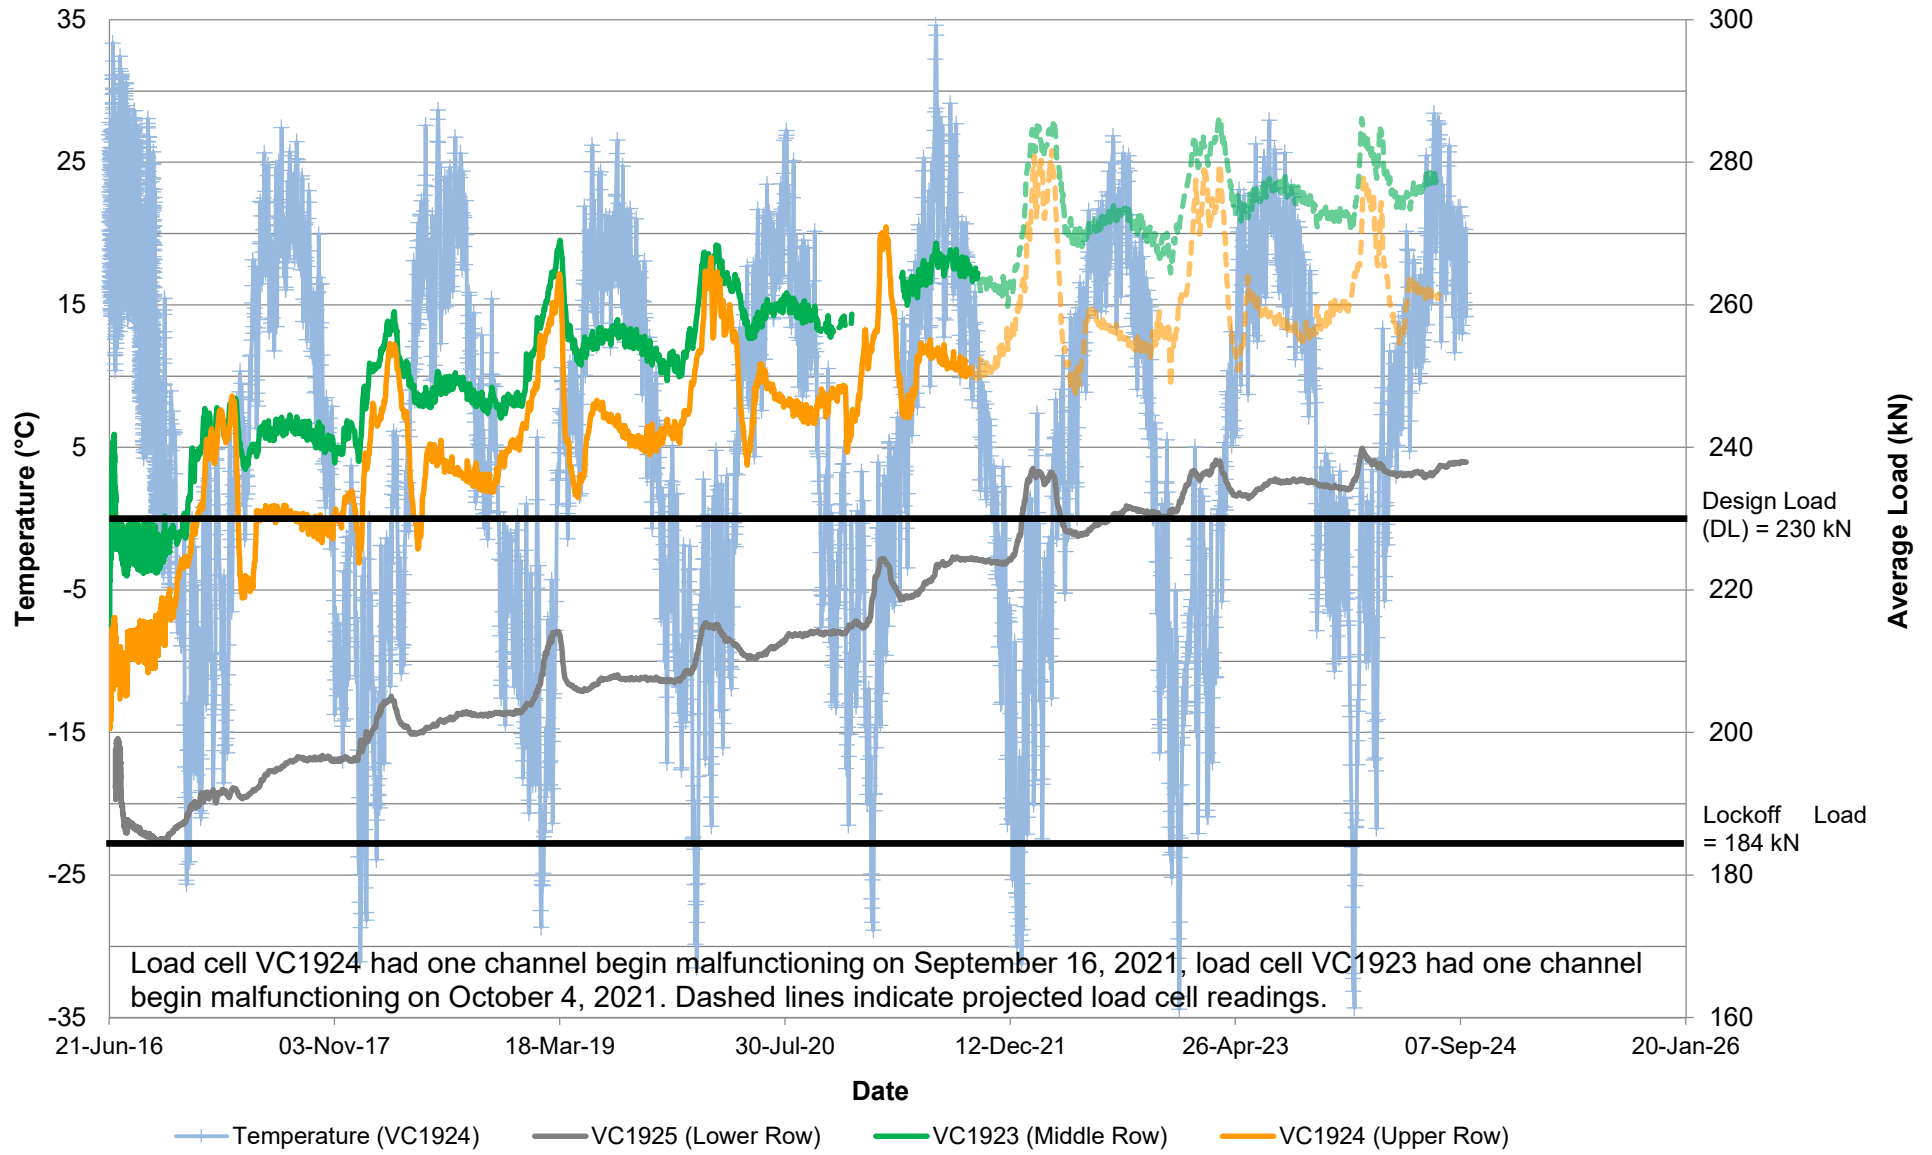
**FIGURE PH071-3
LOAD CELL DATA FOR HWY 986:01, DAISHOWA WEST (PILE P022)**

- 2) Load is based on reading from July 25, 2024. As of September 16, 2021, only two wire channels are functional on load cell VC1924. The reported loads after this date are based on the average of the two functional channels and a projected reading for the now malfunctional channel. After July 25, only one wire channel was functional, so July 25, 2024 reading was used for comparison.

- 3) Load is based on reading from July 16, 2024. As of October 4, 2021, only two wire channels are functional on load cell VC1923. The reported loads after this date are based on the average of the two functional channels and a projected reading for the now malfunctional channel. After July 25, only one wire channel was functional, so July 16, 2024 reading was used for comparison.

<p>warning threshold values. If the deflections and or load cell readings continue to increase, it may become necessary to add additional anchors to the pile wall.</p> <p>It is recommended to wait and see if load cells VC1924 (anchor P022A) and VC1923 (anchor P022B) regain functioning of one of their vibrating wire channels by the spring of 2025 readings. If only one vibrating wire channel is functioning going forwards, the readings should be reported based on only the working channel, and comparisons should be made based off this new estimated load. Alternatively, a projected load trend based on the historic data may need to be estimated for input into future wall performance assessments. The load cells at these anchors have not shown a clear trend of leveling off and projected loads are up to 50 kN above the design load level. With respect to these observations, a review of the current anchor load distribution could be undertaken to better assess the pile wall performance.</p>

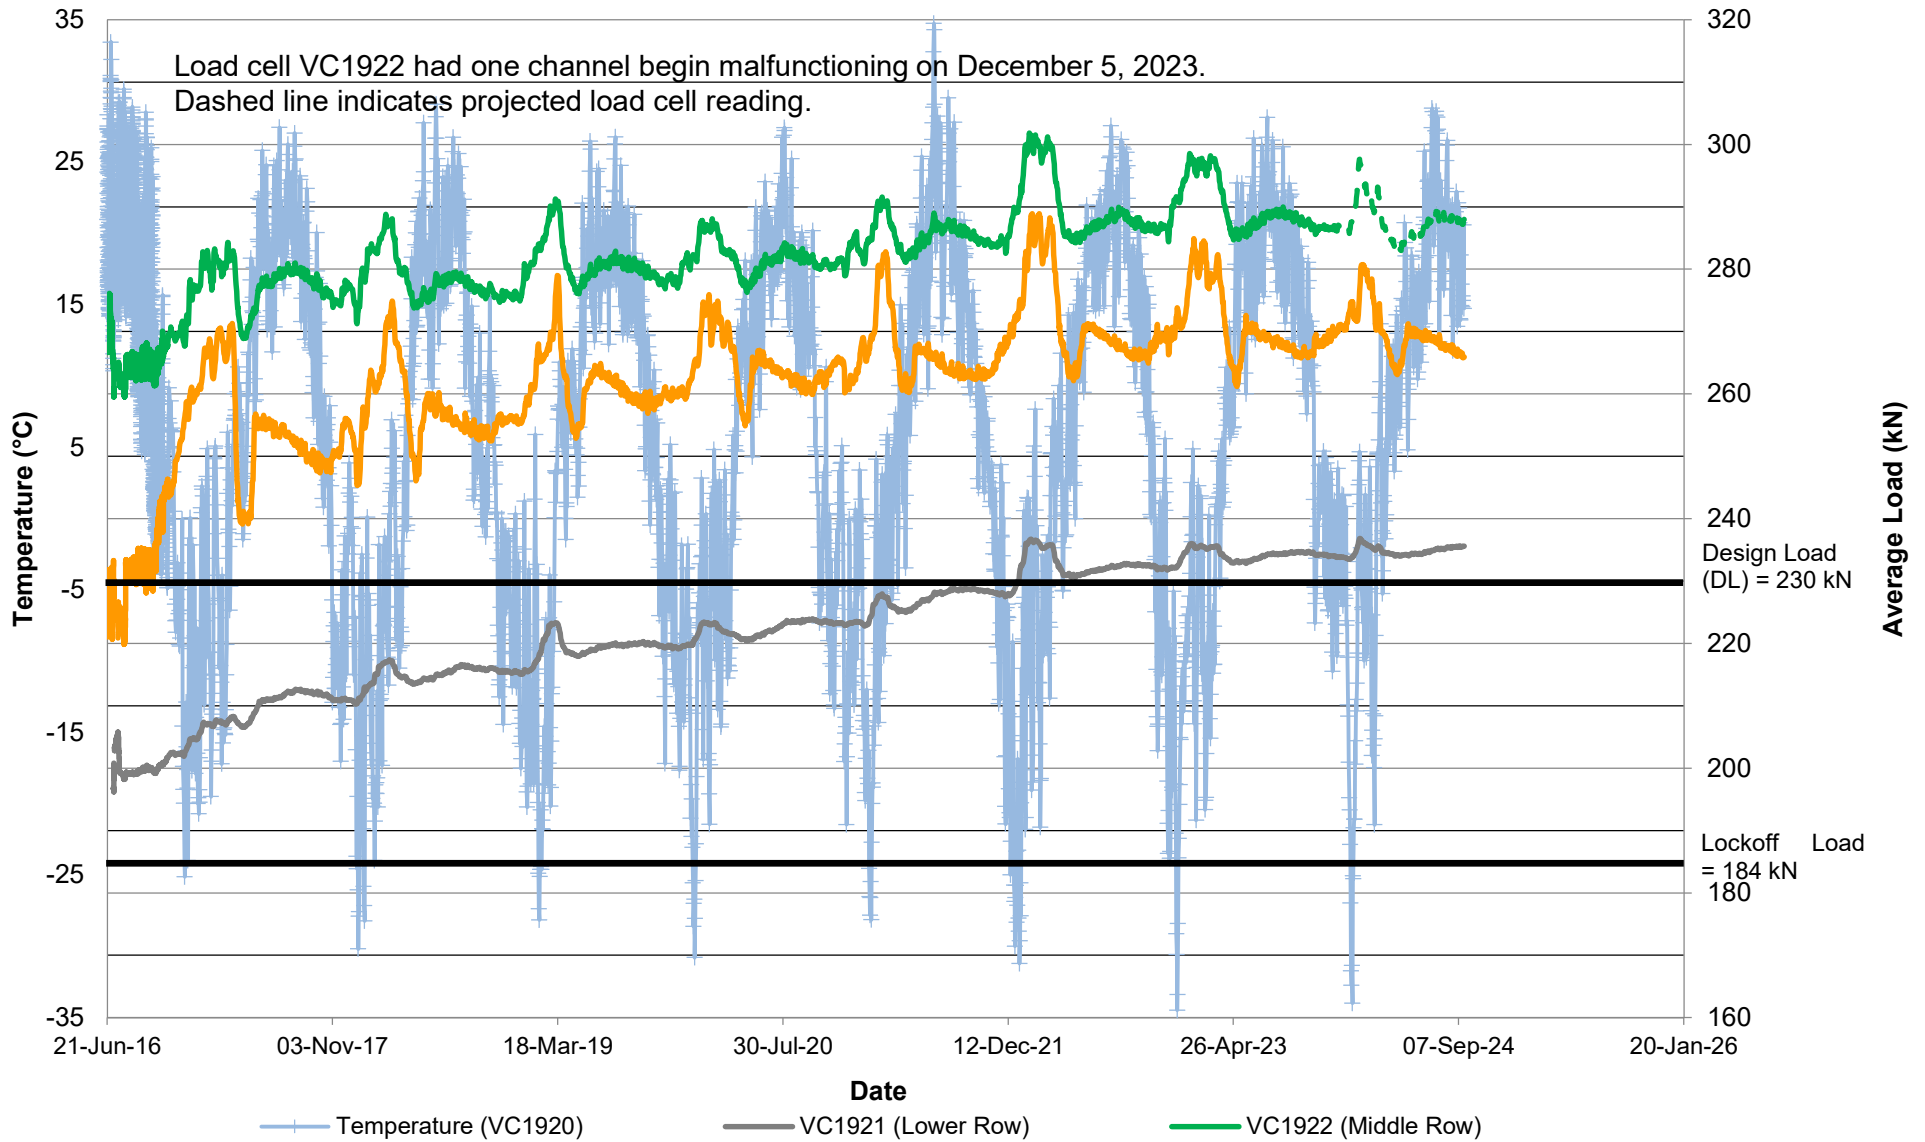
FIGURE PH071-4
LOAD CELL DATA FOR HWY 986:01, DAISHOWA WEST (PILE P060)

<p>downslope movement since the end of construction, with peaks of higher downhill movement rates during the winter months.</p> <p>Strain Gauges</p> <p>The strain gauge readings in Pile P066 are summarized in Table PH071-3. Overall, the strain gauges showed relatively small changes in microstrain value compared to the previous readings in the spring of 2023. The greatest change in microstrain was in strain gauge #17 at 2.6 m depth in the downslope face of the pile, which showed a decrease in positive (compressive) microstrain of 10.7 microstrain compared to the spring of 2024 readings.</p> <p>Piezometers</p> <p>Vibrating wire piezometer VW16-1A showed a groundwater elevation of 488.07 m and was dry during the spring 2024 readings. VW16-1B, and VW16-1C, located upslope of the wall, showed an increase in groundwater level of 0.41 m and 0.04 m respectively since the spring of 2024 readings. VW16-2C and VW16-2B, also located upslope of the wall, showed increases in groundwater levels of 0.76 m and 0.50 m, respectively since the spring of 2024 readings. The groundwater level of 482.13 m, measured in VW16-2C on September 5, 2024 was the highest measured in the instrument since it was initialized. However, the overall trend since end of construction had been a gradual increase in the groundwater table upslope of the wall to what now appears to be a relatively steady level with cyclical seasonal fluctuations.</p> <p>VW16-2A continued to be dry (this piezometer has only shown a groundwater level above the tip during a period between August 9, 2022, and September 21, 2022).</p> <p>Of the piezometers located downslope of the wall, VW16-3A showed a decrease in groundwater level of 0.21 m, and VW16-3B showed no change in groundwater level since the spring of 2024 readings.</p> <p>VW16-4A continued to be dry. VW16-5A was dry during the current readings. VW16-4A and VW16-5A tend to remain dry except for brief periods that correspond to either higher than normal rainfall or spring thaw.</p> <p>Load Cells</p> <p>The load cells generally showed small changes in measured load compared to the spring of 2024 readings, ranging from a decrease of 4.78 kN in VC1920 (anchor P060A) to an increase of 3.90 kN in VC1922 (anchor P060B).</p> <p>It should be noted that load cells VC1922, anchor P060B, and VC1918, anchor P097B, have each lost the function of one vibrating wire channel. The loads that are now reported for these three load cells are based on the average of the two functioning channels and projecting a reading for the now malfunctioning channel based on the last reading taken for that channel and the changes observed in the two functional channels since that time.</p> <p>Load cells VC1924 (anchor P022A) and VC1923 (anchor P022B) lost function of a second vibrating wire channel during July 2024, and the readings reported were the most recent available reading.</p> <p>Since the end of construction, the load cells have generally shown an overall trend of increasing load, with the highest seasonal loads measured towards the end of each winter. The current loads measured in the upper two anchor rows at all three piles, as well as the lower row at P022, are above the design loads. However, the recent readings for P060 and P097 appear to show that the anchor loads in the upper two anchor rows in P060 and P097 are starting to level off.</p>

Future Work:	<p>The instruments should be read again in the spring of 2025. It is recommended to continue monitoring the deflections in the pile wall and the load cell readings to see if there are further increases in deflection or loads compared to the</p>

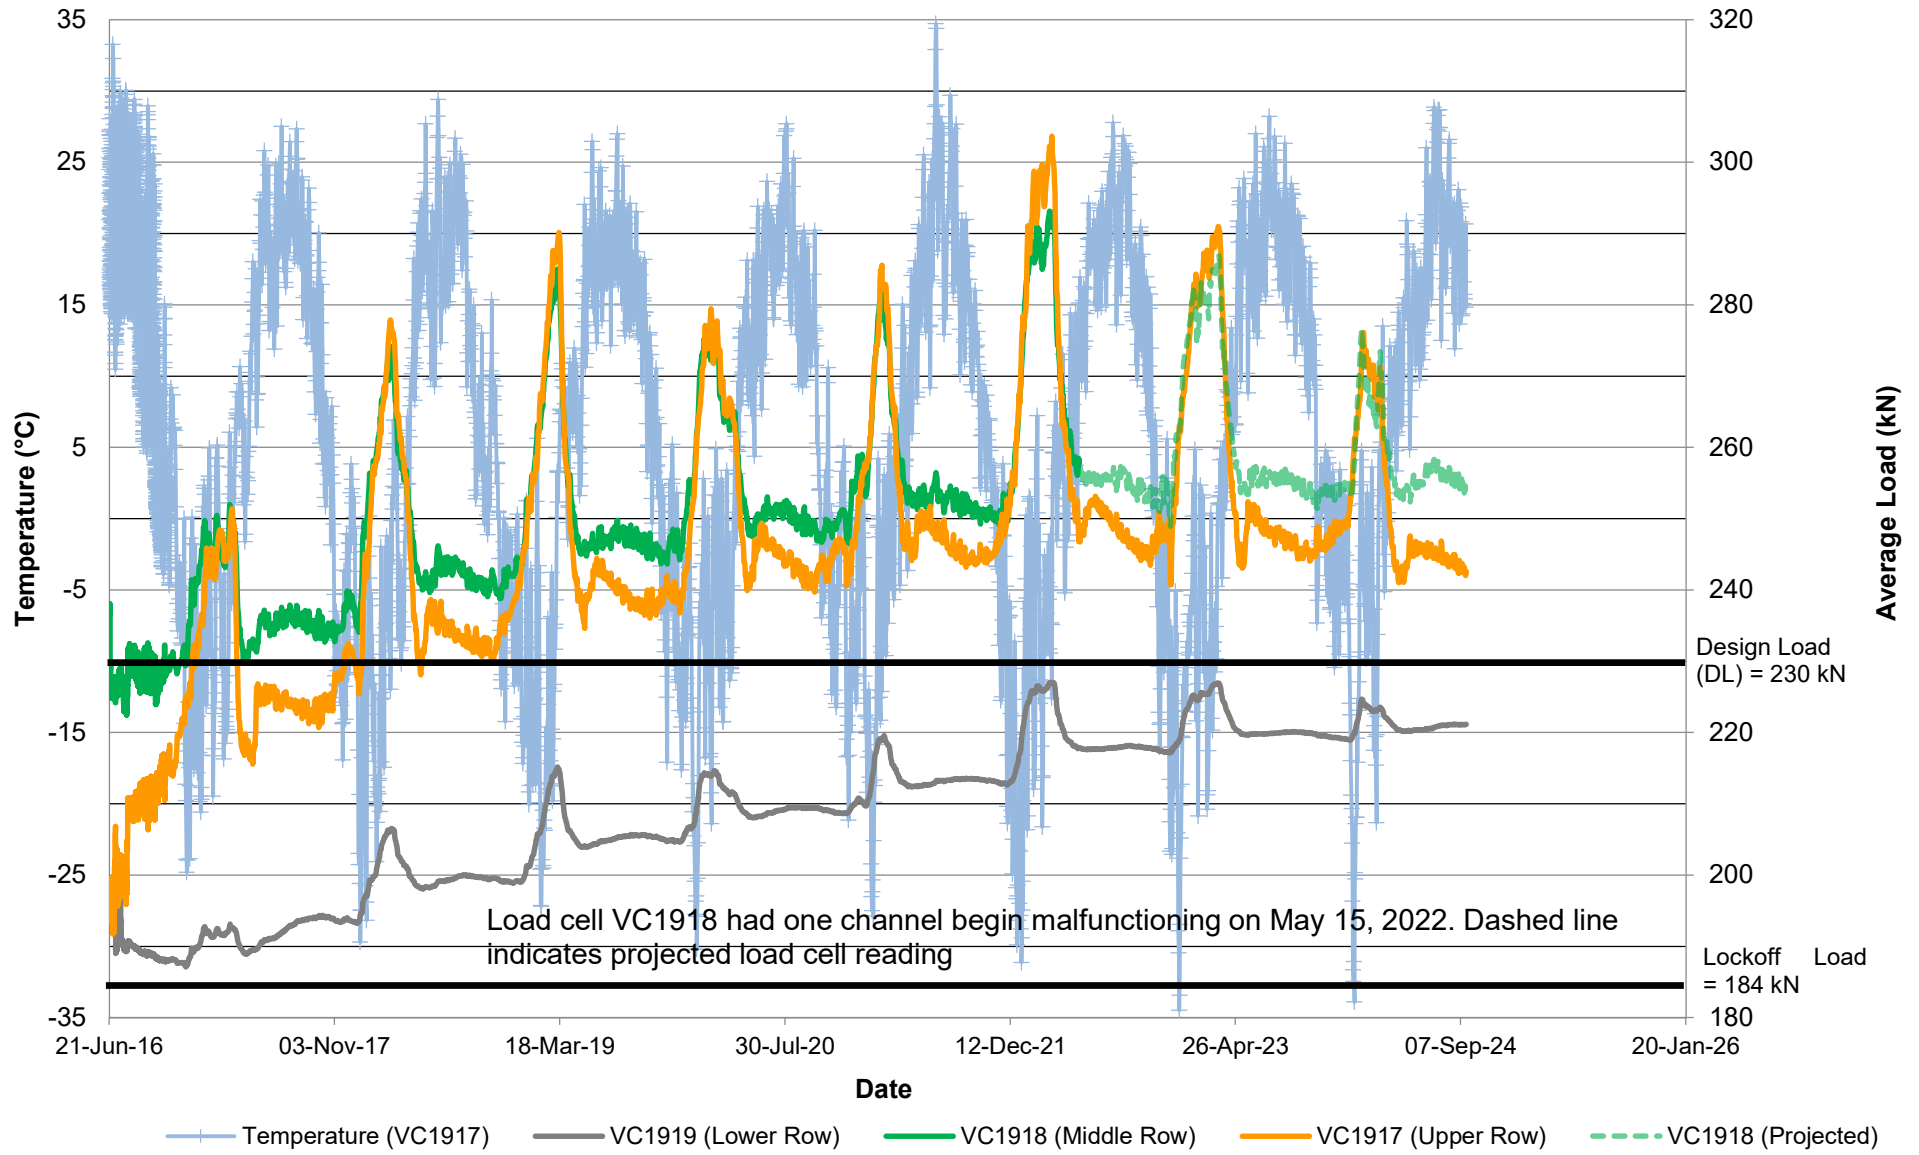
**FIGURE PH071-5
LOAD CELL DATA FOR HWY 986:01, DAISHOWA WEST (PILE P097)**

- 4) As of May 15, 2022, only two wire channels are functional on load cell VC1918. The reported loads after this date are based on the average of the two functional channels and a projected reading for the now malfunctional channel.
