Site Number	Location	Name	Hwy	km
PH071	Hwy 986:01 C1 28.474	Daishowa West Hill	986:01	Km 28.5
Legal Description: 8-9-85-21 W5		UTM Co-ordinates		
		11U E 485023	N	6245526

**ALBERTA TRANSPORTATION AND ECONOMIC CORRIDORS GRMP (CON0022164)
PEACE REGION (PEACE RIVER DISTRICT)
INSTRUMENTATION MONITORING RESULTS**

SPRING 2024

SITE PH071: HWY 986:01, DAISHOWA WEST HILL

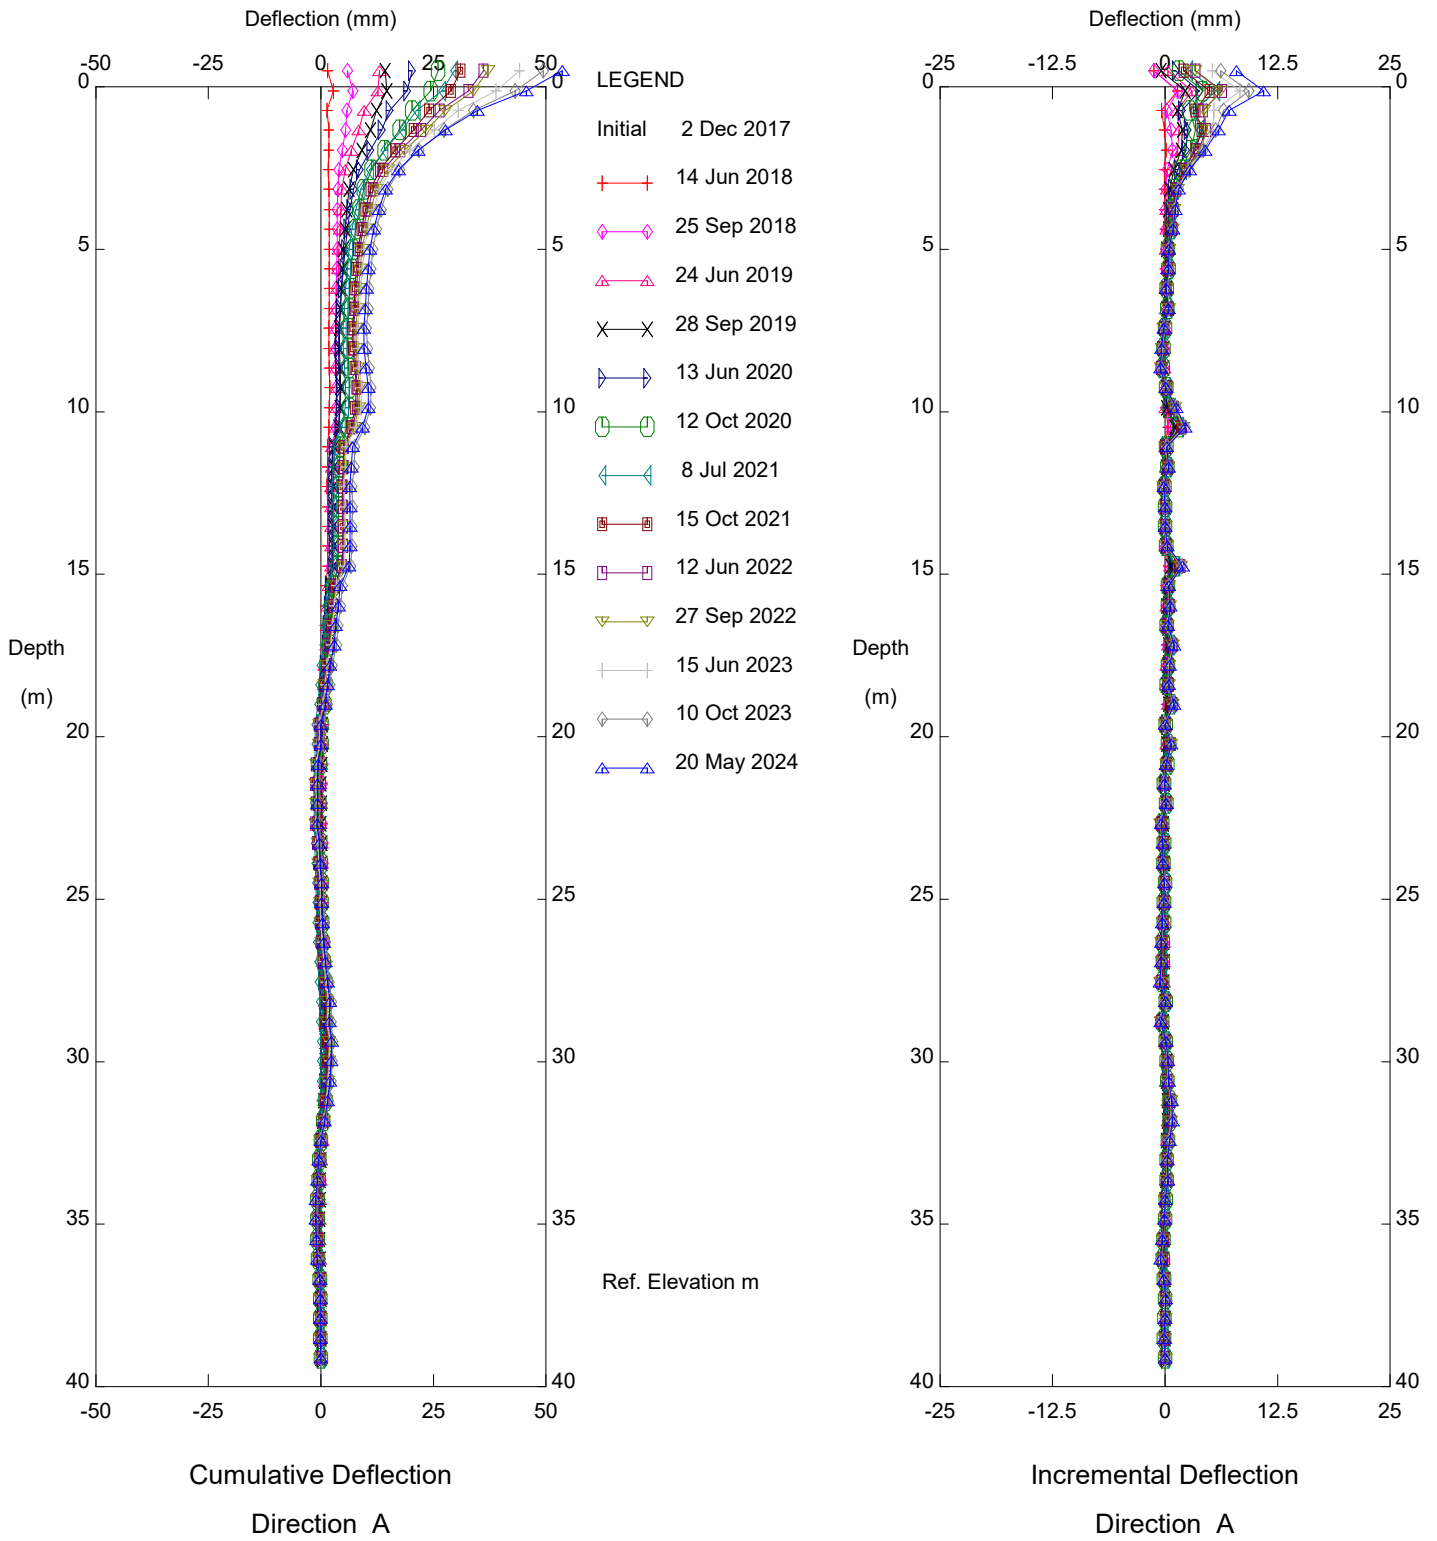
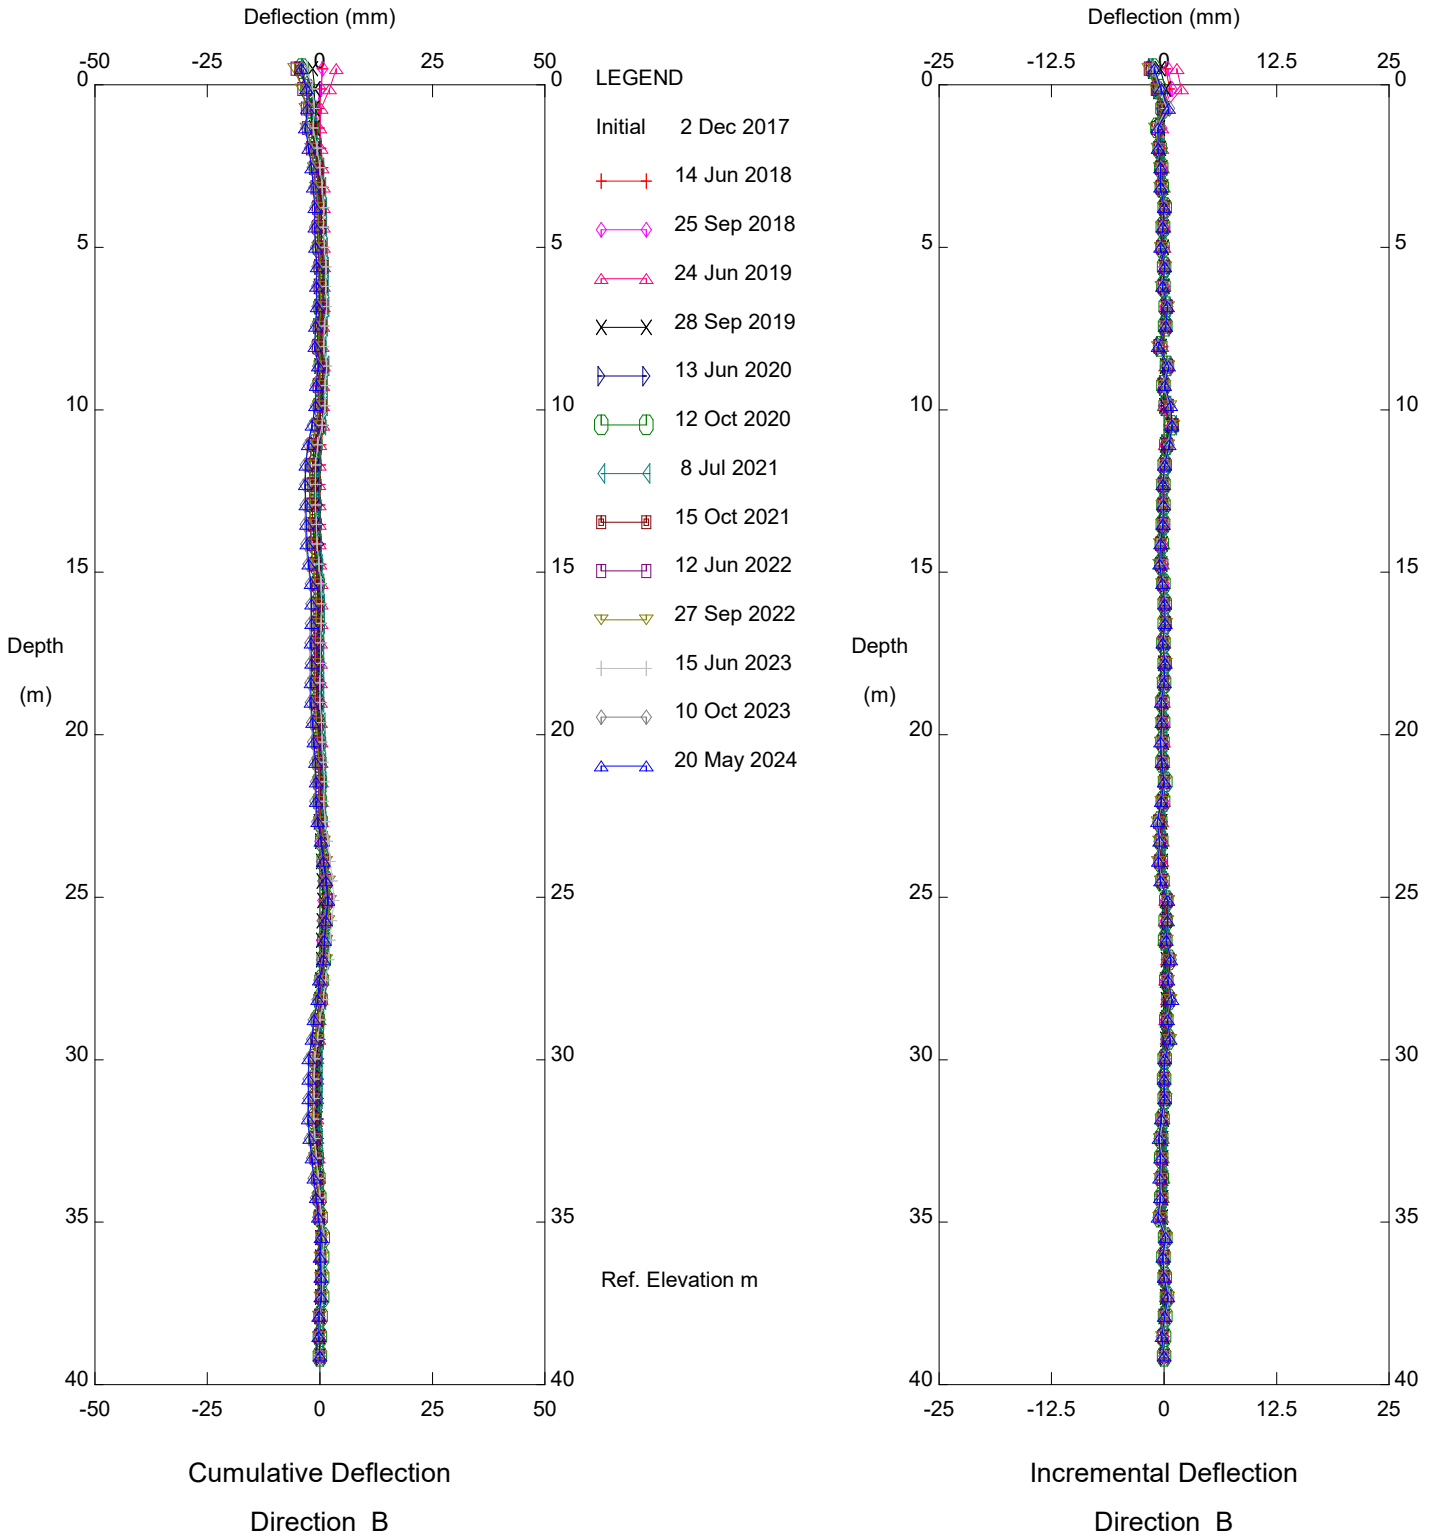
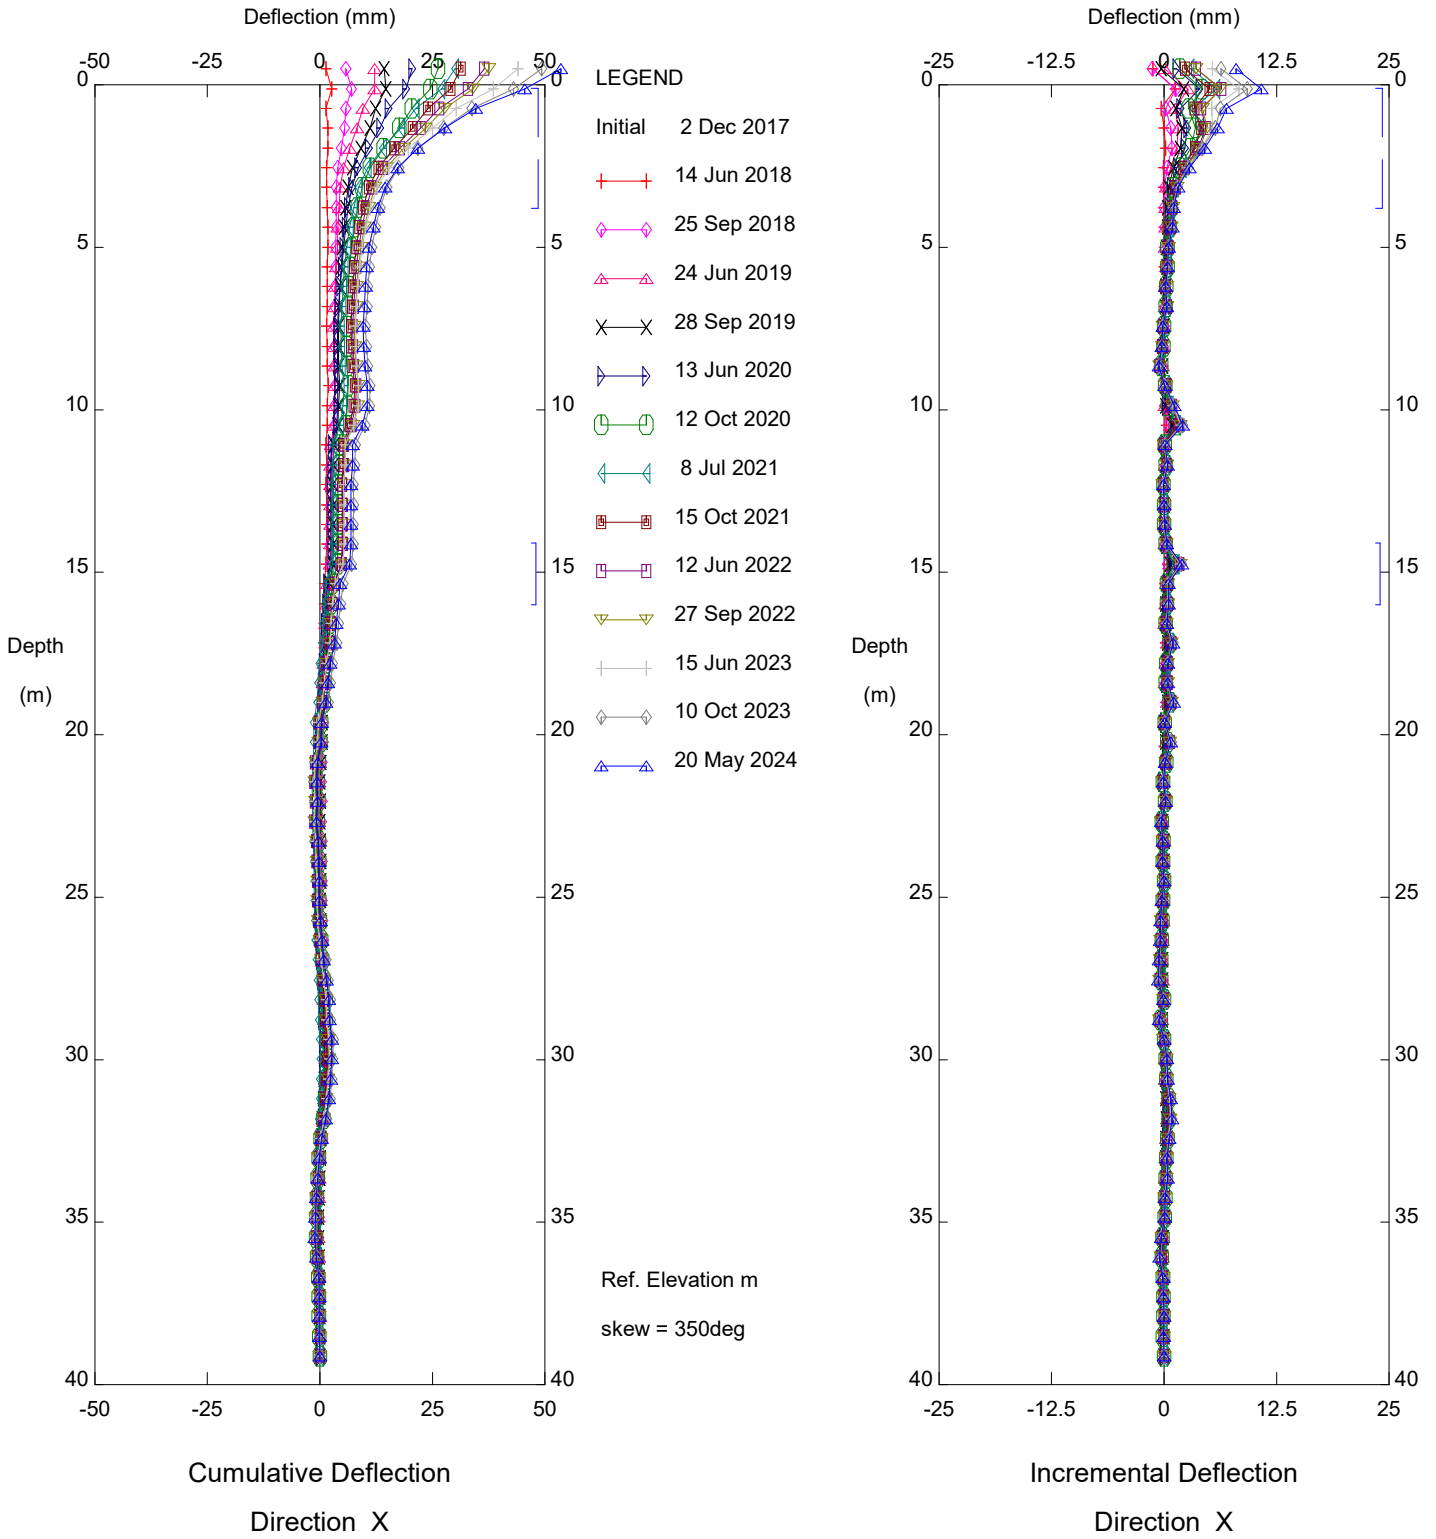
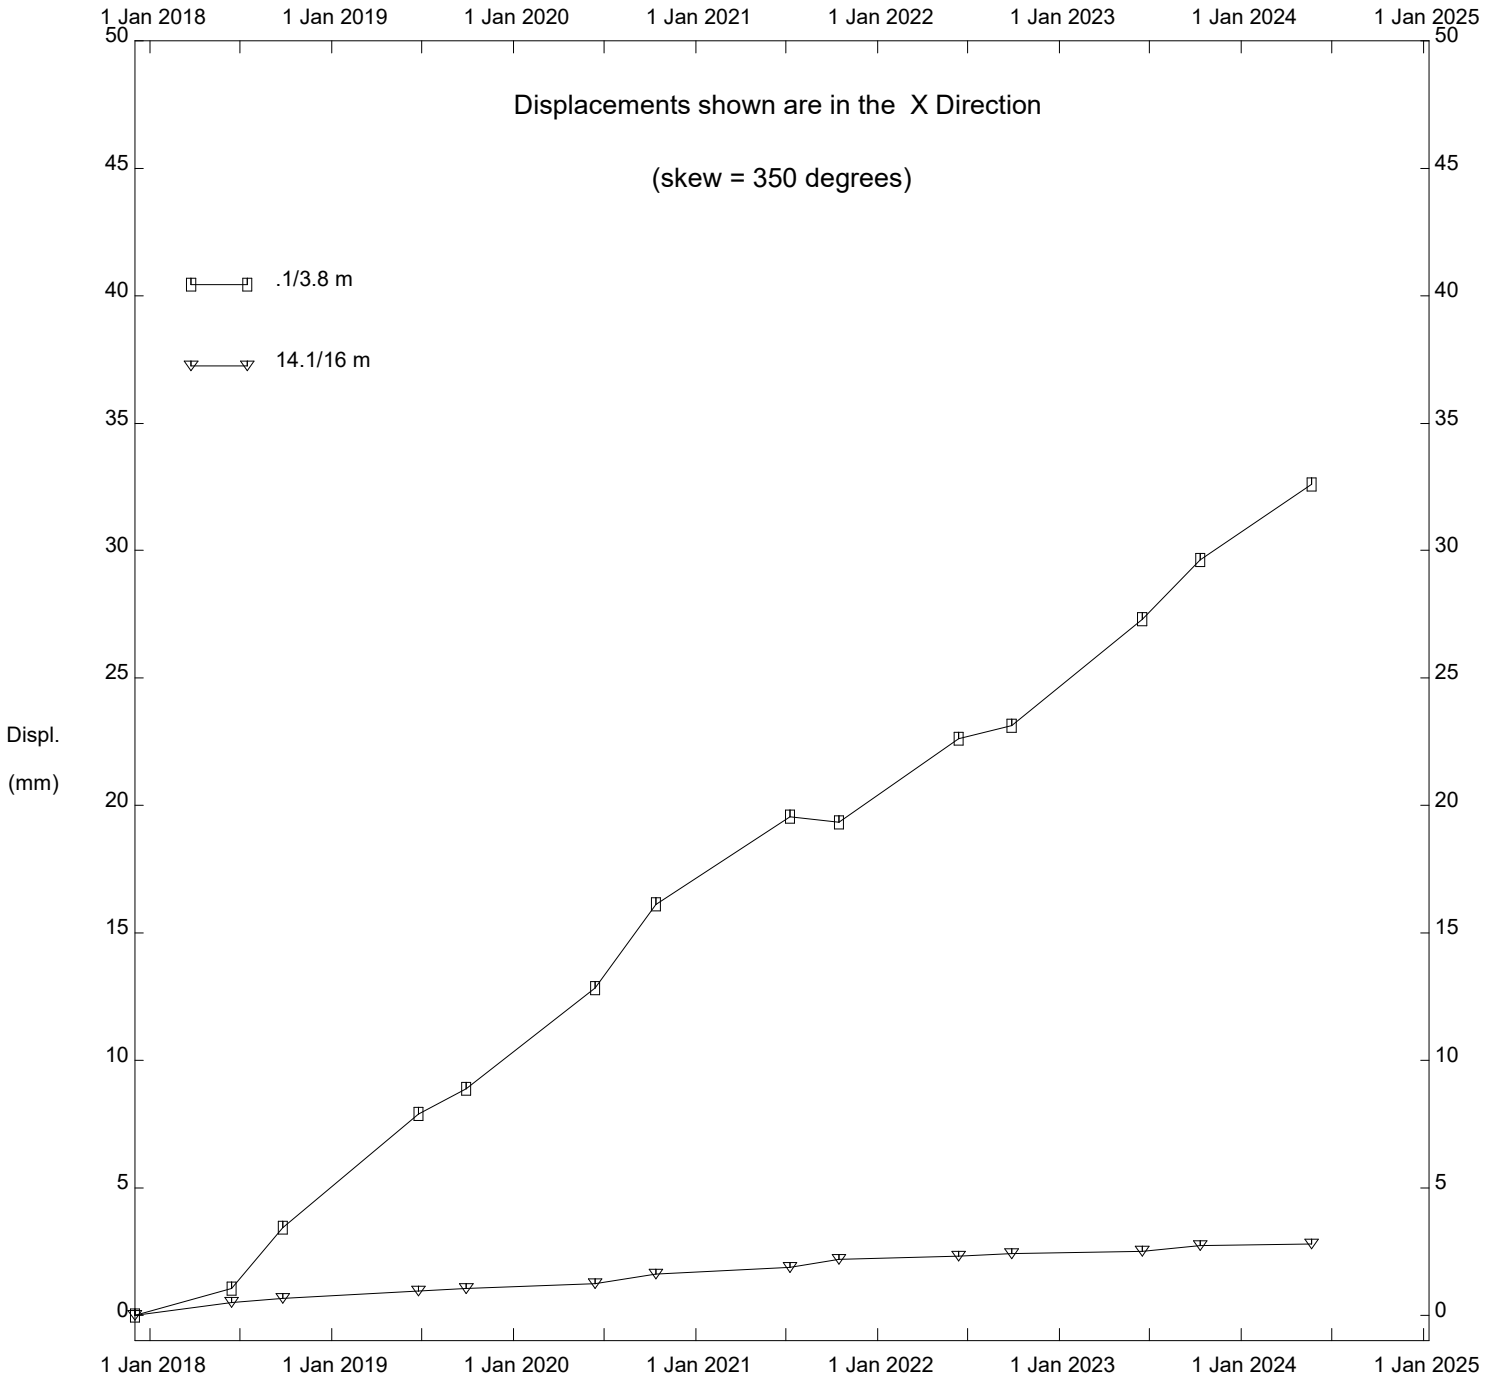
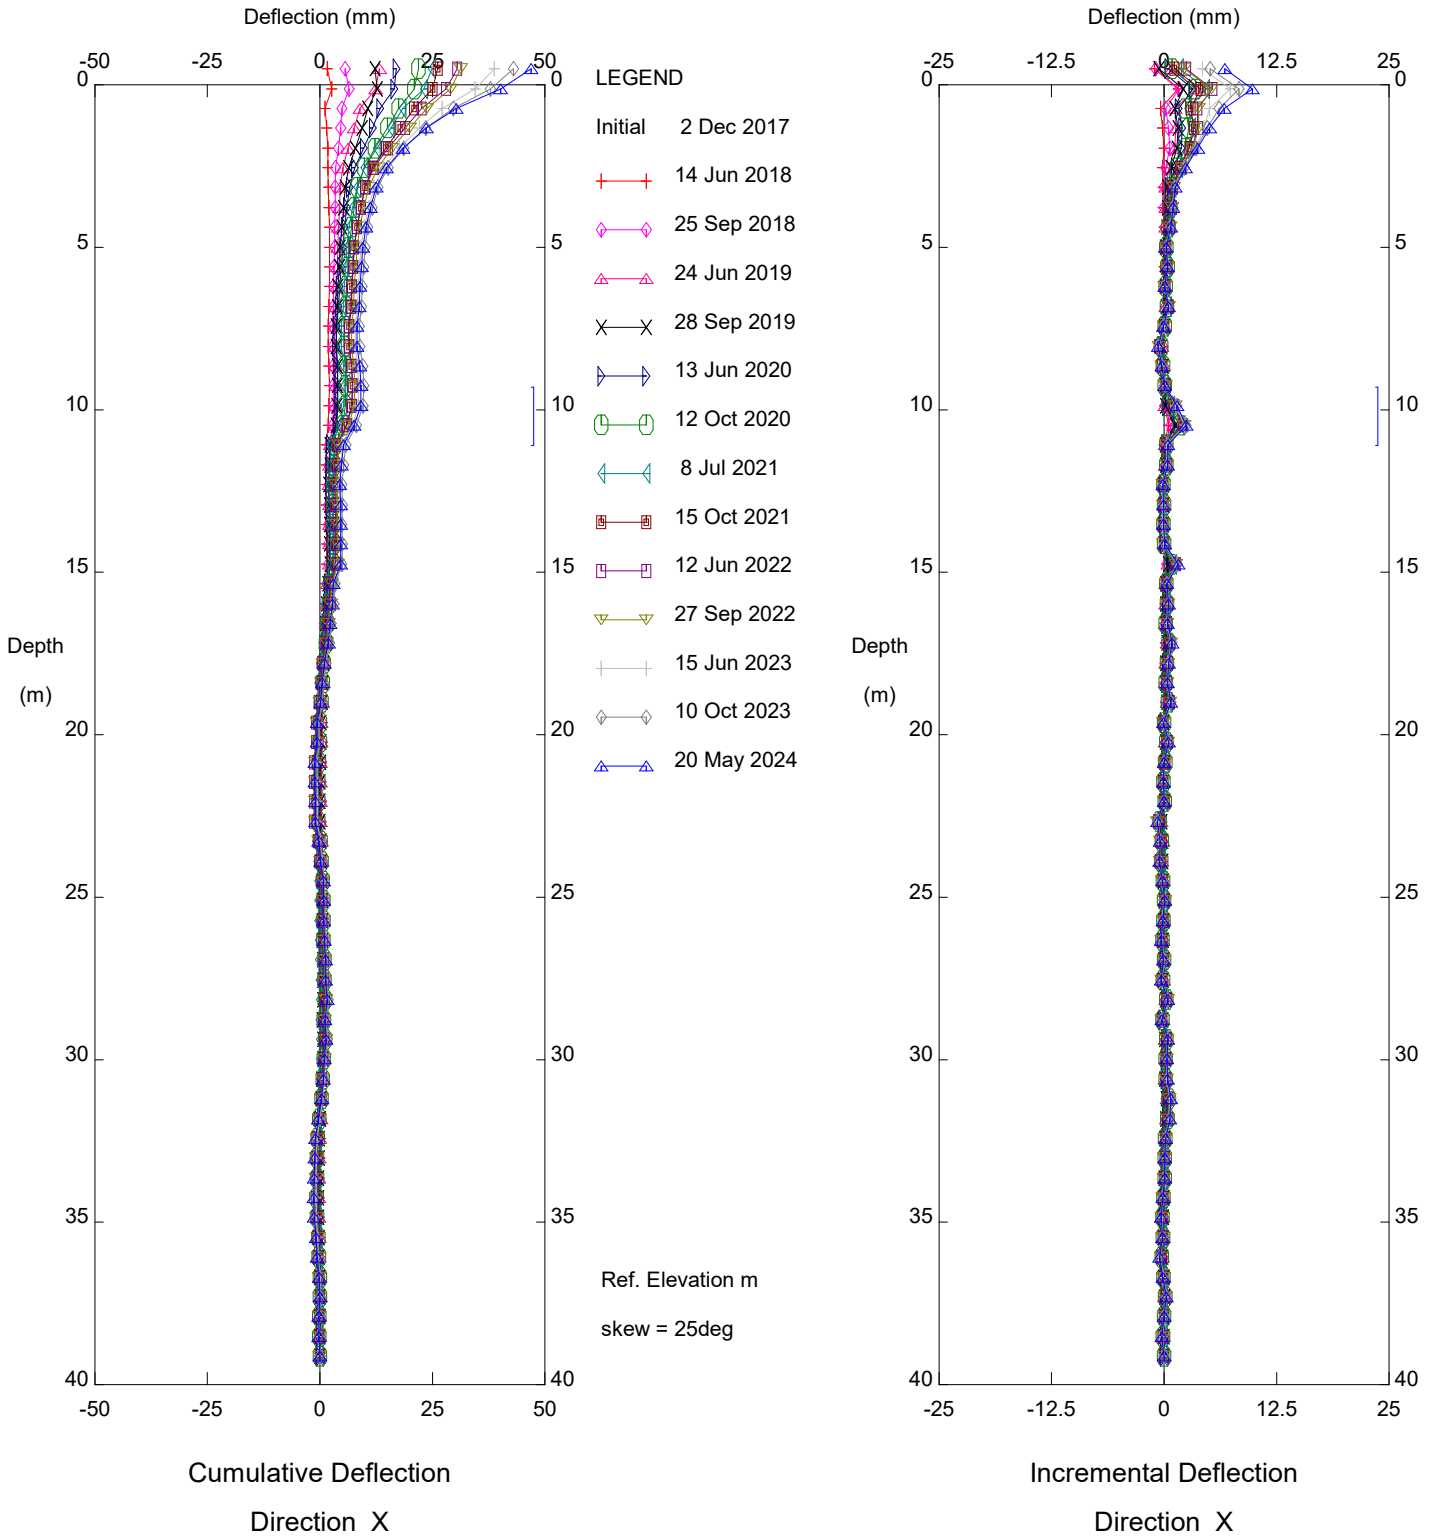
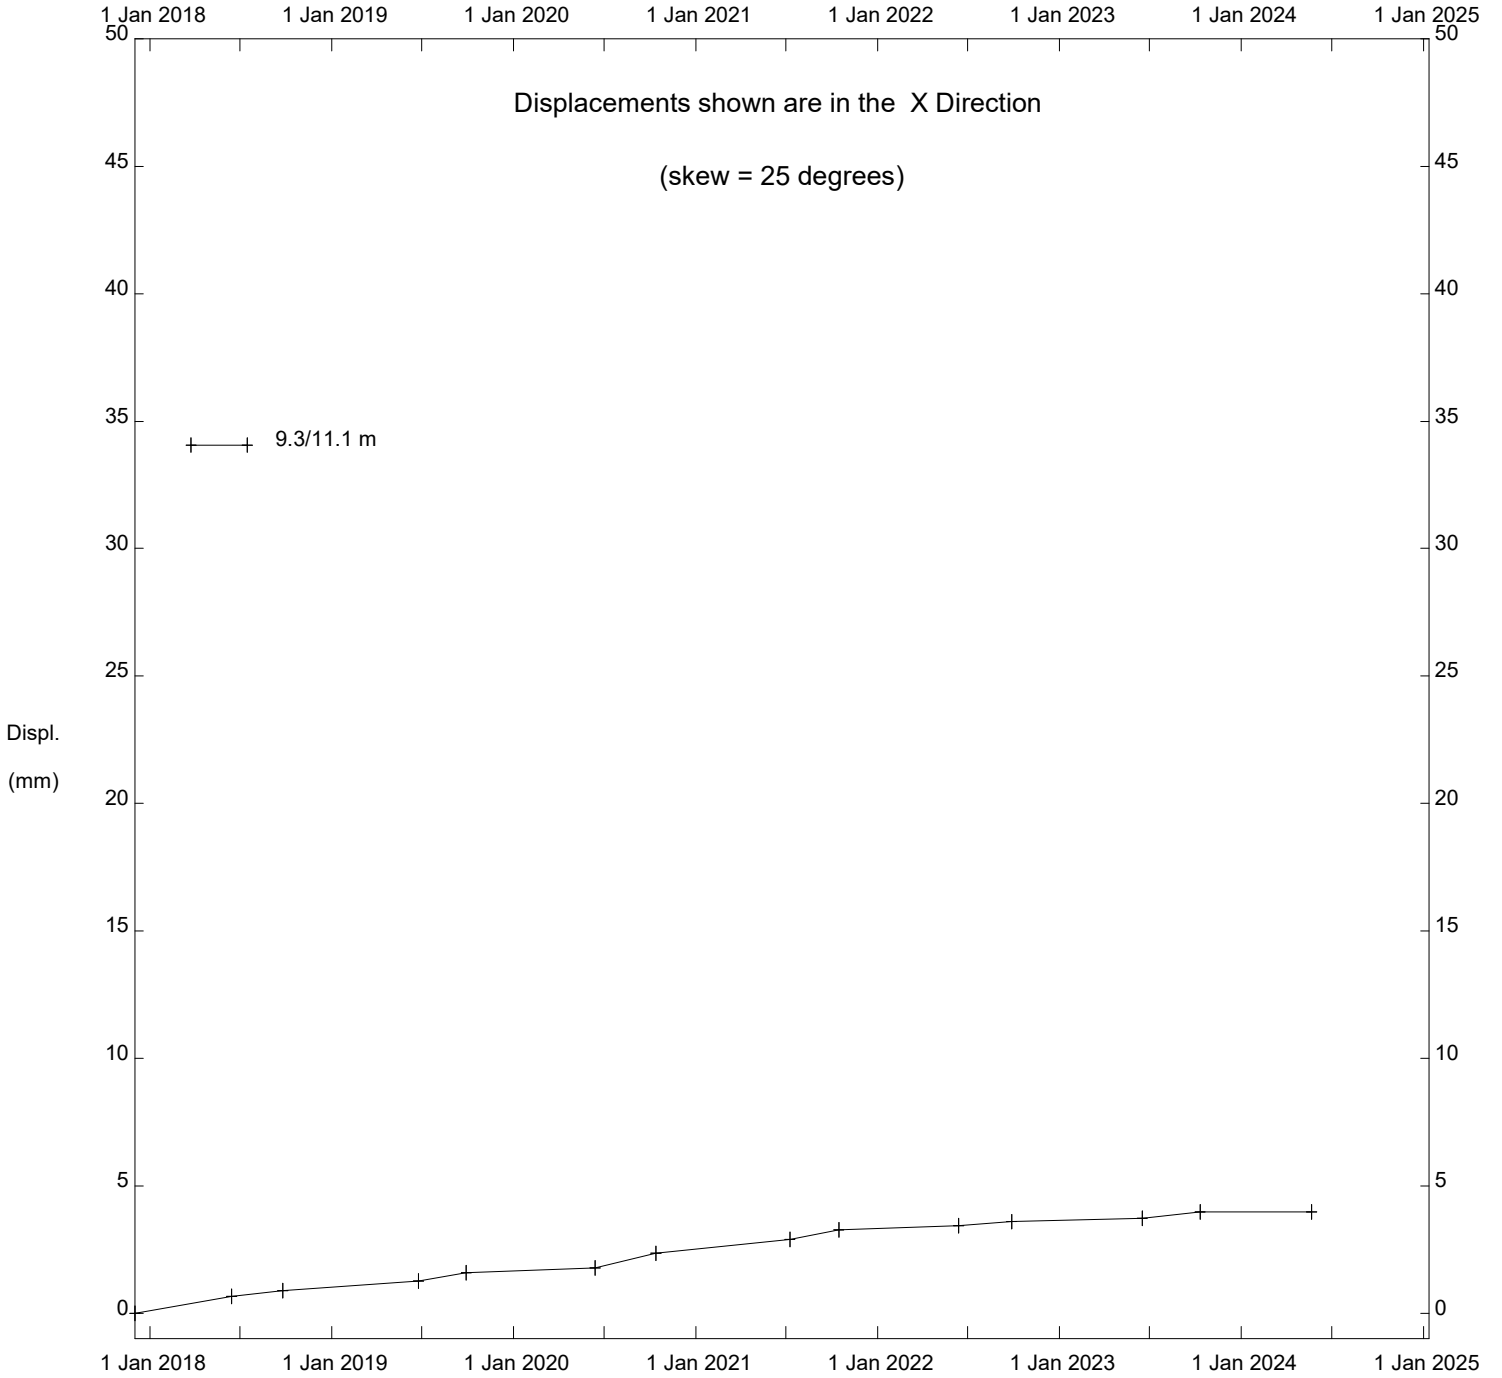
PH071 Daishowa West, Inclinometer SI16-3

Discussion	
Zones of New Movement:	None
Interpretation of Monitoring Results:	<p>SI16-3 showed rates of movement of 4.8 mm/yr and 0.1 mm/yr over 0.1 m to 3.8 m depth and 14.1 m to 16.0 m depth, respectively, since the fall of 2023 readings. SI16-3 showed no discernible movement over 9.3 m to 11.1 m depth.</p> <p>SAA-P060 showed a rate of movement of 0.6 mm/yr over 2.5 m to 29.5 m depth, and a rate of movement of 1.2 mm/yr over the full length of the pile and waler since the fall of 2023 readings. SAA P060 has shown a cumulative pile head deflection of 17.9 mm to date in the downslope direction. SAA-P060 has shown an overall relatively steady rate of movement since the end of construction with a total incremental movement of about 5.9 mm in the downslope direction since completion of construction. The Wall movement appears to be approaching an equilibrium level at this location.</p> <p>SAA-P097 has shown 0.6 mm of uphill movement since the fall of 2023 readings. SAA-P097 has shown a total pile head deflection of 17.5 mm in the downslope direction to date. SAA-P097 had shown an overall trend of steady</p>

Future Work:	<p>The instruments should be read again in the fall of 2024. It is recommended to continue monitoring the deflections in the pile wall and the load cell readings to see if there are further increases in deflection or loads compared to the warning threshold values. If the deflections and or load cell readings</p>

continue to increase, it may become necessary to add additional anchors to the pile wall.
Instrumentation Repairs:	No instrument repairs are required at this time.
Additional Comments:

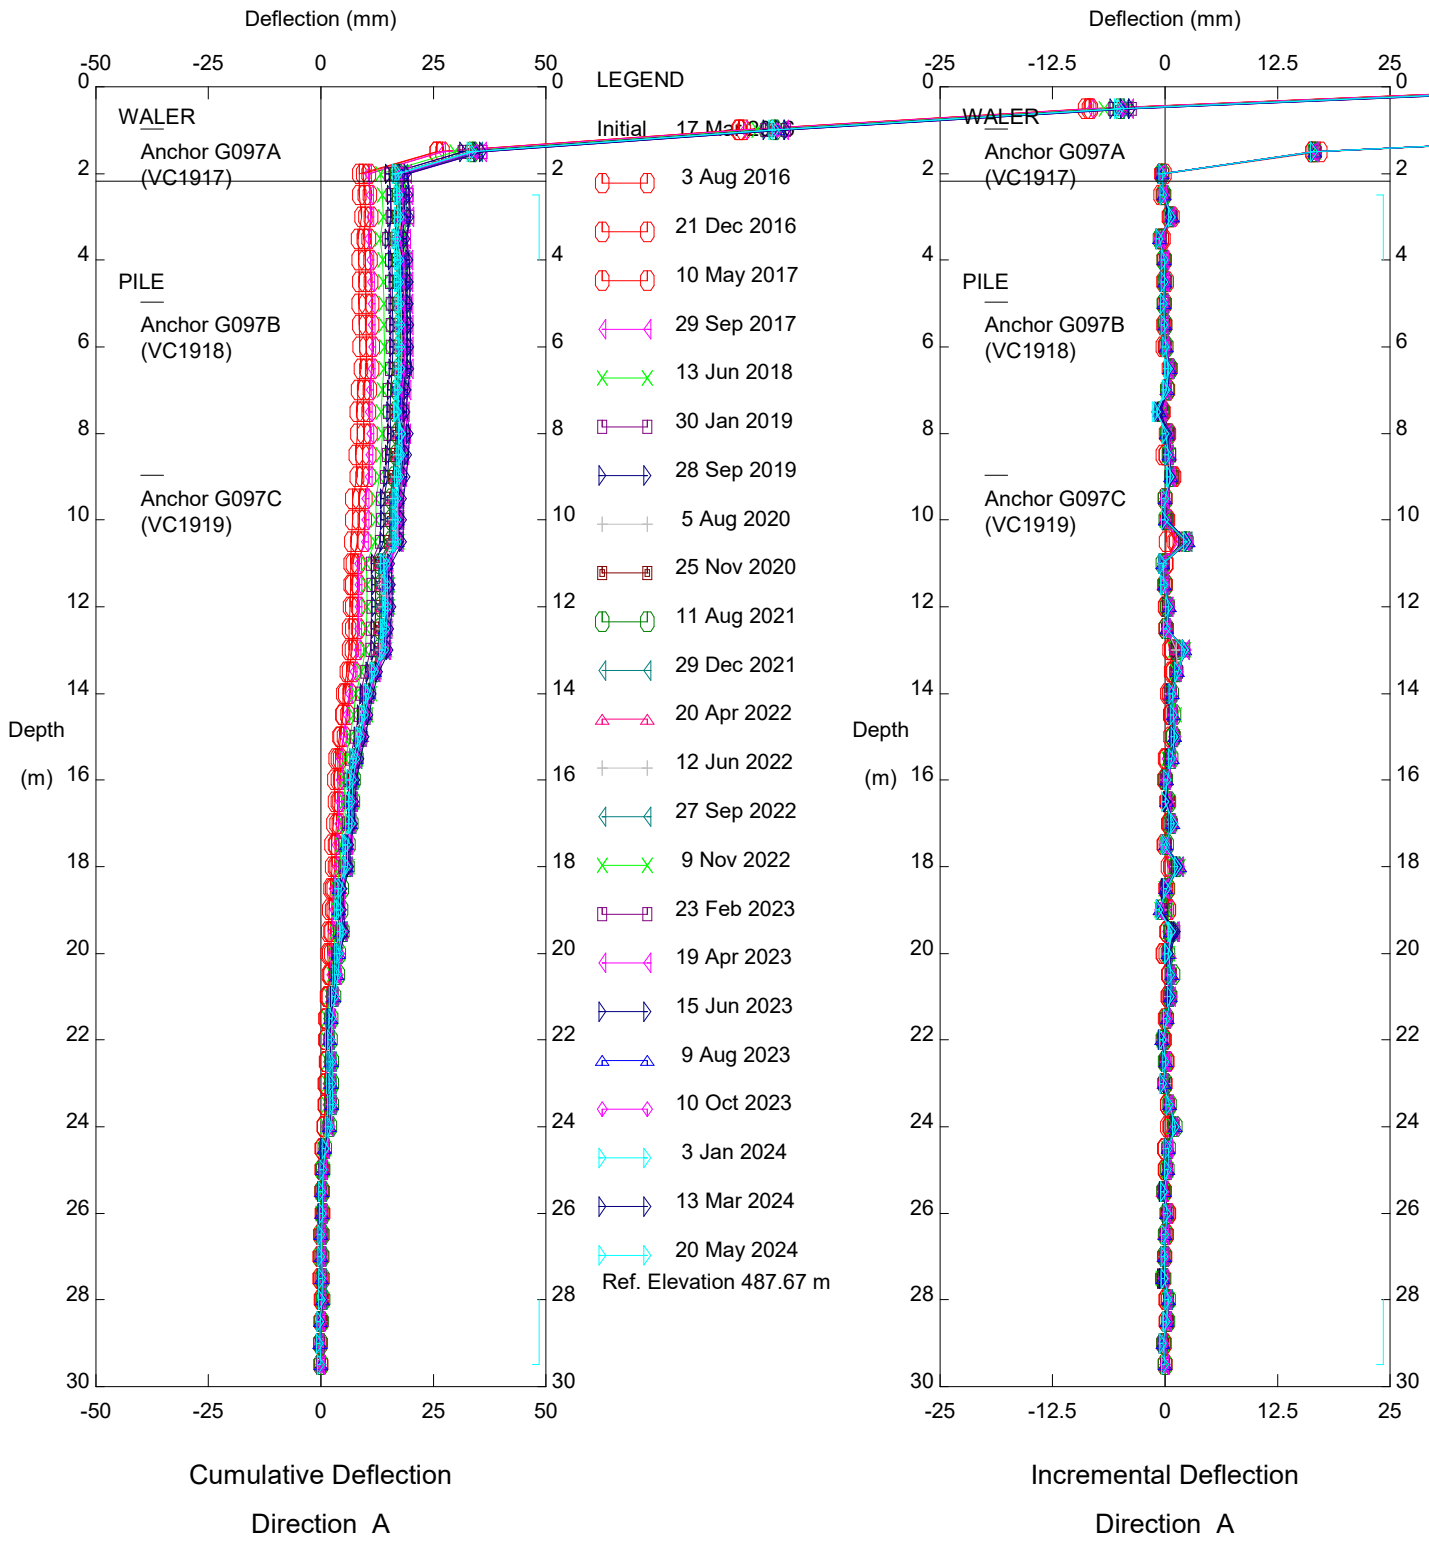
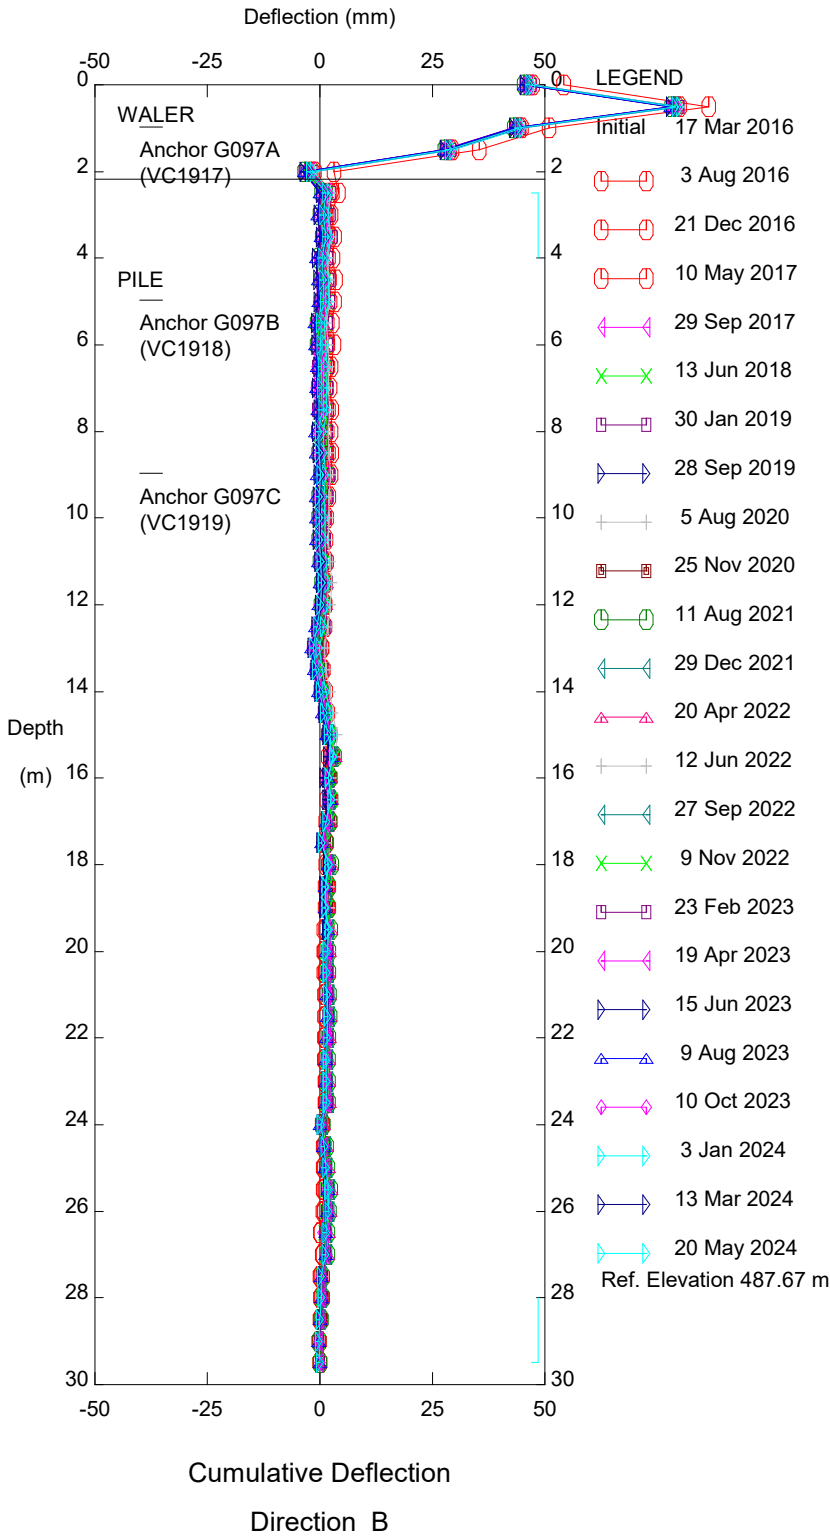
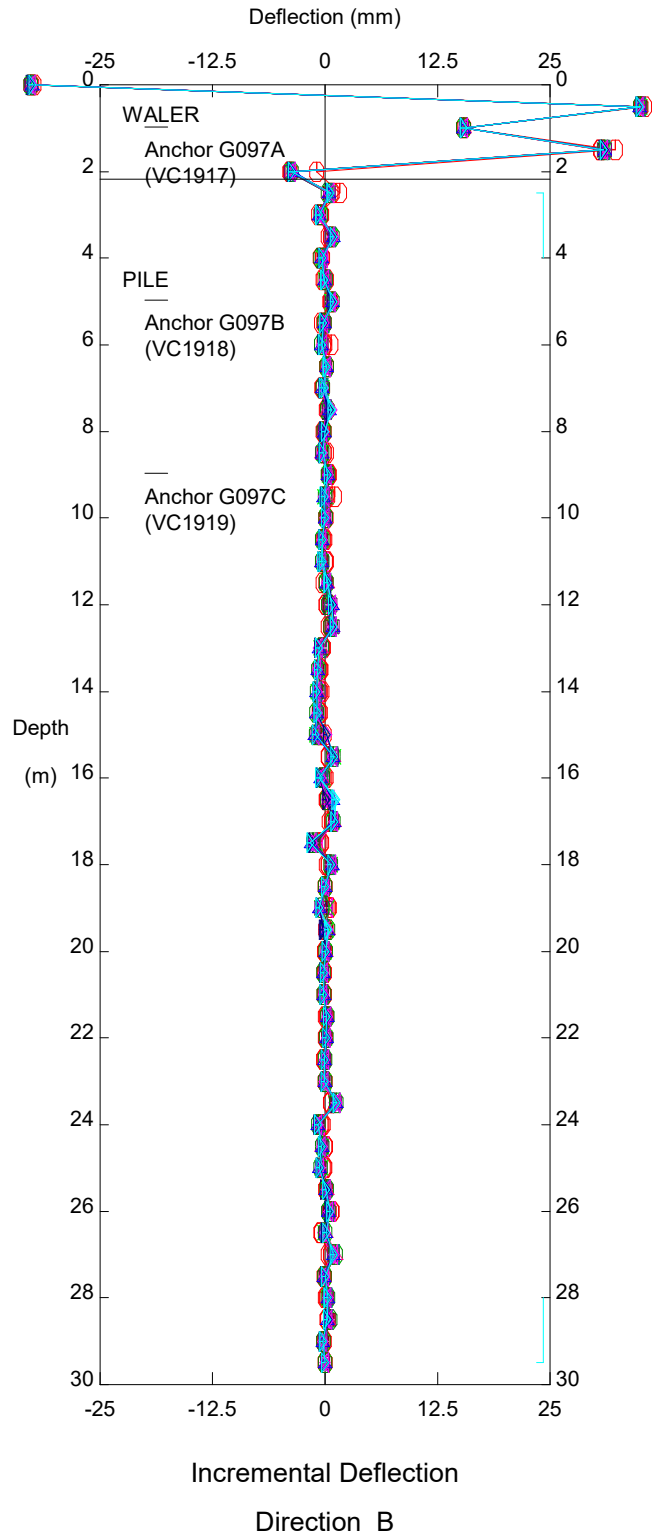
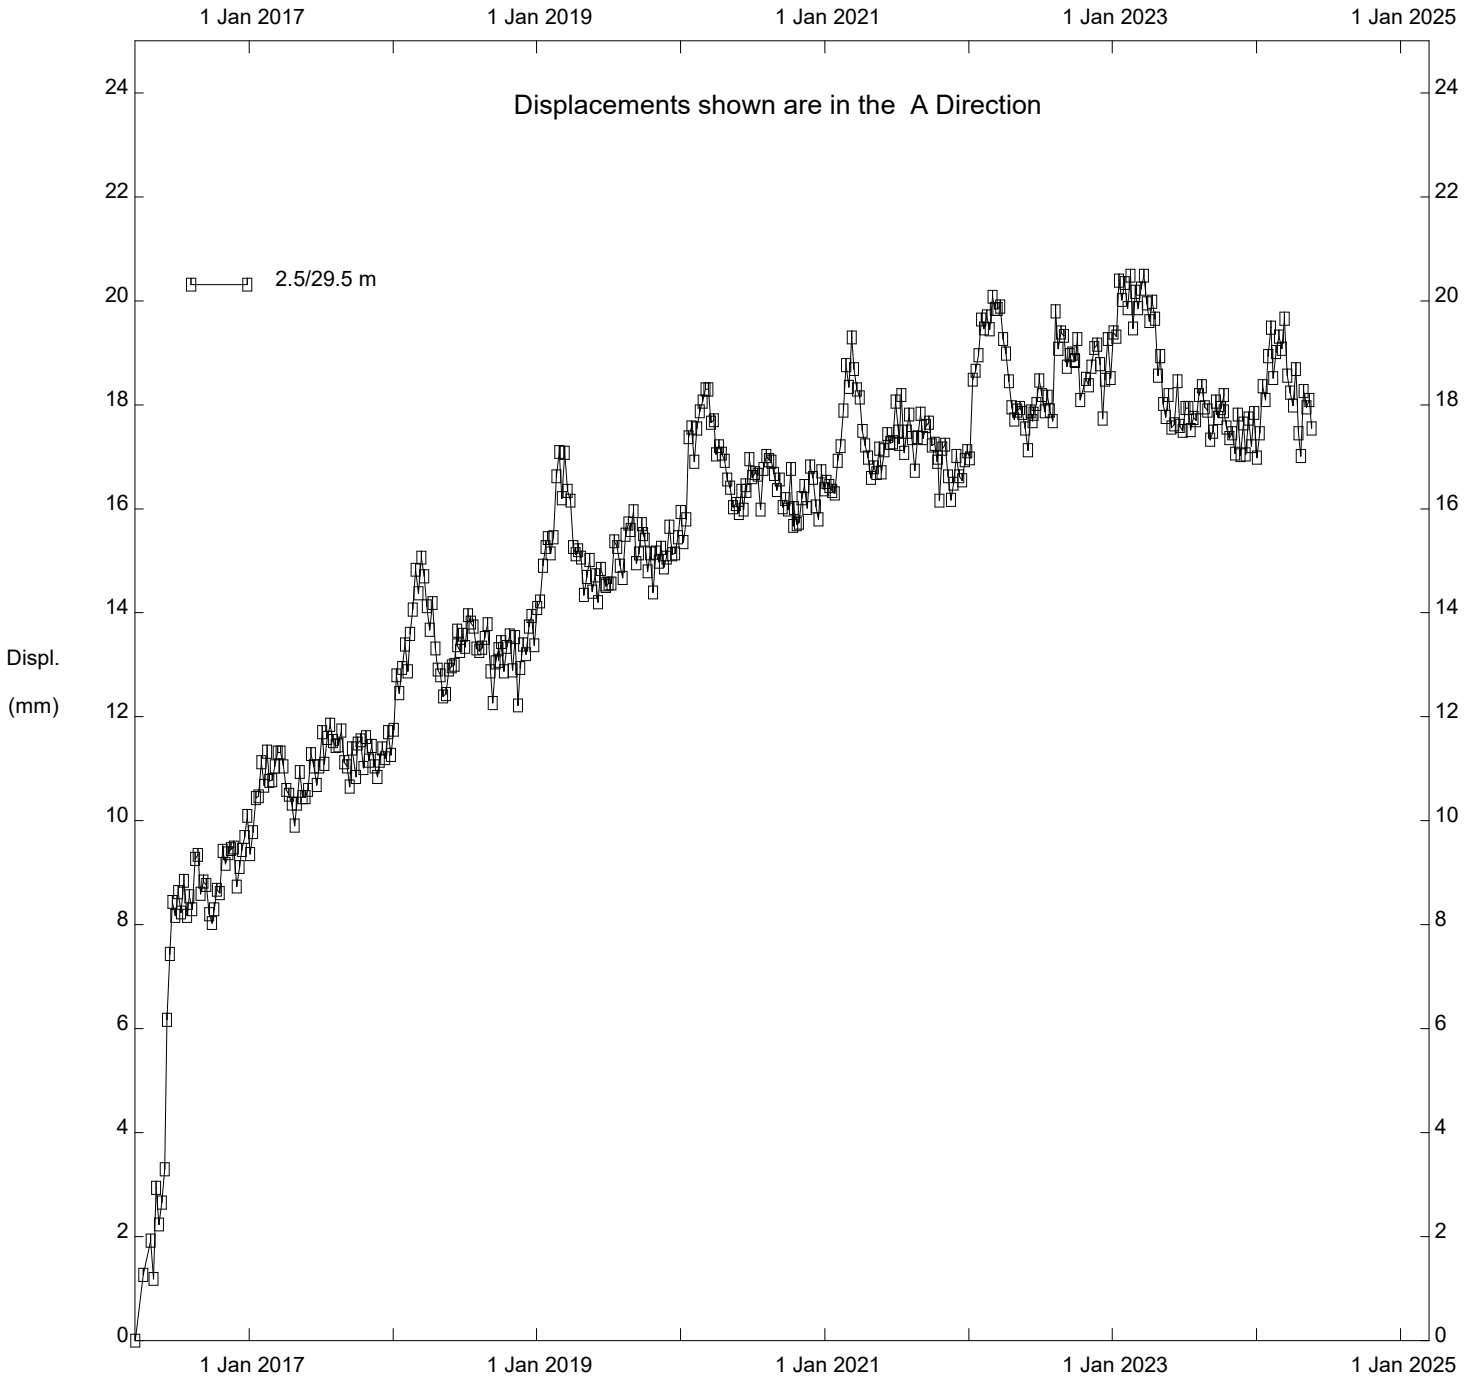
Hwy 986:01 Daishowa West, Inclinometer SAA-P097

<p>downslope movement since the end of construction, with peaks of higher downhill movement rates during the winter months. However, the more recent readings for SAA P097 seem to indicate that the pile wall is reaching a state of equilibrium at its location.</p> <p>The strain gauge readings in Pile P066 are summarized in Table PH071-3. Overall, the strain gauges showed relatively small changes in microstrain value compared to the previous readings in the fall of 2023. The greatest change in microstrain was in strain gauge #11 at 0.6 m depth in the upslope face of the pile, which showed an increase in positive (compressive) microstrain of 6.9 microstrain compared to the fall of 2023 readings.</p> <p>Vibrating wire piezometer VW16-1A was dry during the spring 2024 readings. VW16-1B, and VW16-1C, located upslope of the wall, showed a decrease in groundwater level of 0.60 m and 1.05 m respectively since the fall of 2023 readings. VW16-2C and VW16-2B, also located upslope of the wall, showed decreases in groundwater levels of 0.83 m and 0.26 m, respectively since the fall of 2023 readings. However, the overall trend since end of construction had been a gradual increase in the groundwater table upslope of the wall to what now appears to be a relatively steady level that fluctuates slightly seasonally.</p> <p>VW16-1A appears to follow an overall cyclical pattern, with groundwater levels registered above the tip elevation each year from late spring to early winter, while for the rest of the year the groundwater level remains below the tip. VW16-2A continued to be dry (this piezometer has only shown a groundwater level above the tip during a period between August 9, 2022, and September 21, 2022).</p> <p>Of the piezometers located downslope of the wall, VW16-3A and VW16-3B showed increases in groundwater level of 0.18 m and 0.16 m, respectively, since the fall of 2023 readings.</p> <p>VW16-4A continued to be dry. VW16-5A was dry during the current readings. VW16-4A and VW16-5A tend to remain dry except for brief periods that correspond to either higher than normal rainfall or spring thaw.</p> <p>The load cells generally showed small changes in measured load compared to the fall of 2023 readings, ranging from a decrease of 3.93 kN in VC1922 (anchor P060B) to an increase of 7.85 kN in VC1924 (anchor P022A). Load cells VC1923 (anchor P022B) and VC1921 (anchor P060C) registered their maximum recorded loads since the instruments were initialized on February 1, 2024.</p> <p>It should be noted that load cells VC1924 (anchor P022A), VC1923 (anchor P022B), VC1922 (anchor P060B) and VC1918 (anchor P097B) have each lost the function of one vibrating wire channel. The loads that are now reported for these three load cells are based on the average of the two functional channels and projecting a reading for the now malfunctioning channel based on the last reading taken for that channel and the changes observed in the two functional channels since that time.</p> <p>Since the end of construction, the load cells have generally shown an overall trend of increasing load, with the highest seasonal loads measured towards the end of each winter. The current loads measured in the upper two anchor rows at all three piles, as well as the lower row at P022, are above the design loads. However, the recent readings for P060 and P097 appear to show that the anchor loads in the upper two anchor rows in P060 and P097 are starting to level off.</p>
