Site Number	Location	Name	Hwy	km
PH071	Hwy 986:01 C1 28.474	Daishowa West Hill	986:01	Km 28.5
Legal Description: 8-9-85-21 W5		UTM Co-ordinates		
		11U E 485023	N	6245526

**ALBERTA TRANSPORTATION AND ECONOMIC CORRIDORS GRMP (CON0022164)
PEACE REGION (PEACE RIVER DISTRICT)
INSTRUMENTATION MONITORING RESULTS**

SPRING 2024

SITE PH071: HWY 986:01, DAISHOWA WEST HILL

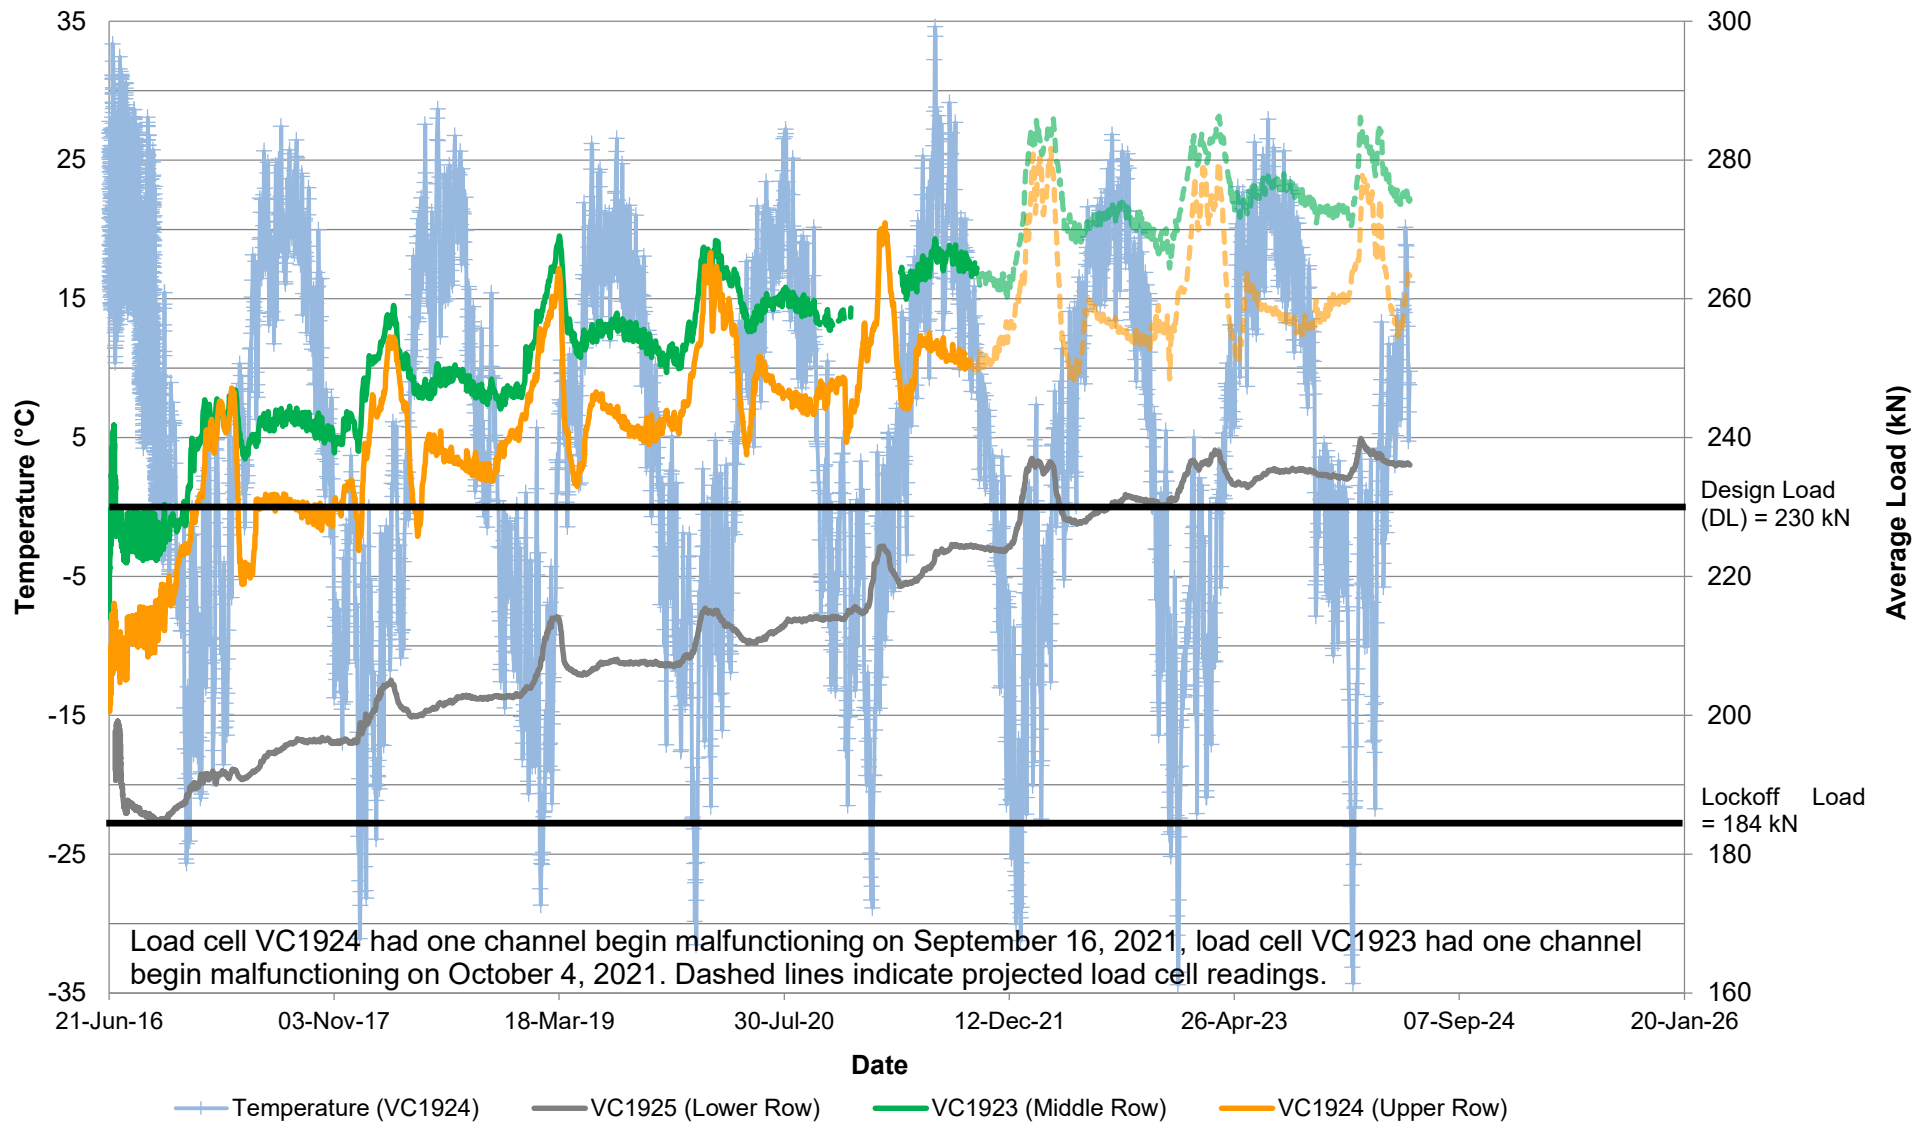
**FIGURE PH071-3
LOAD CELL DATA FOR HWY 986:01, DAISHOWA WEST (PILE P022)**

- 2) As of September 16, 2021, only two wire channels are functional on load cell VC1924. The reported loads after this date are based on the average of the two functional channels and a projected reading for the now malfunctioning channel.

- 3) As of October 4, 2021, only two wire channels are functional on load cell VC1923. The reported loads after this date are based on the average of the two functional channels and a projected reading for the now malfunctioning channel.

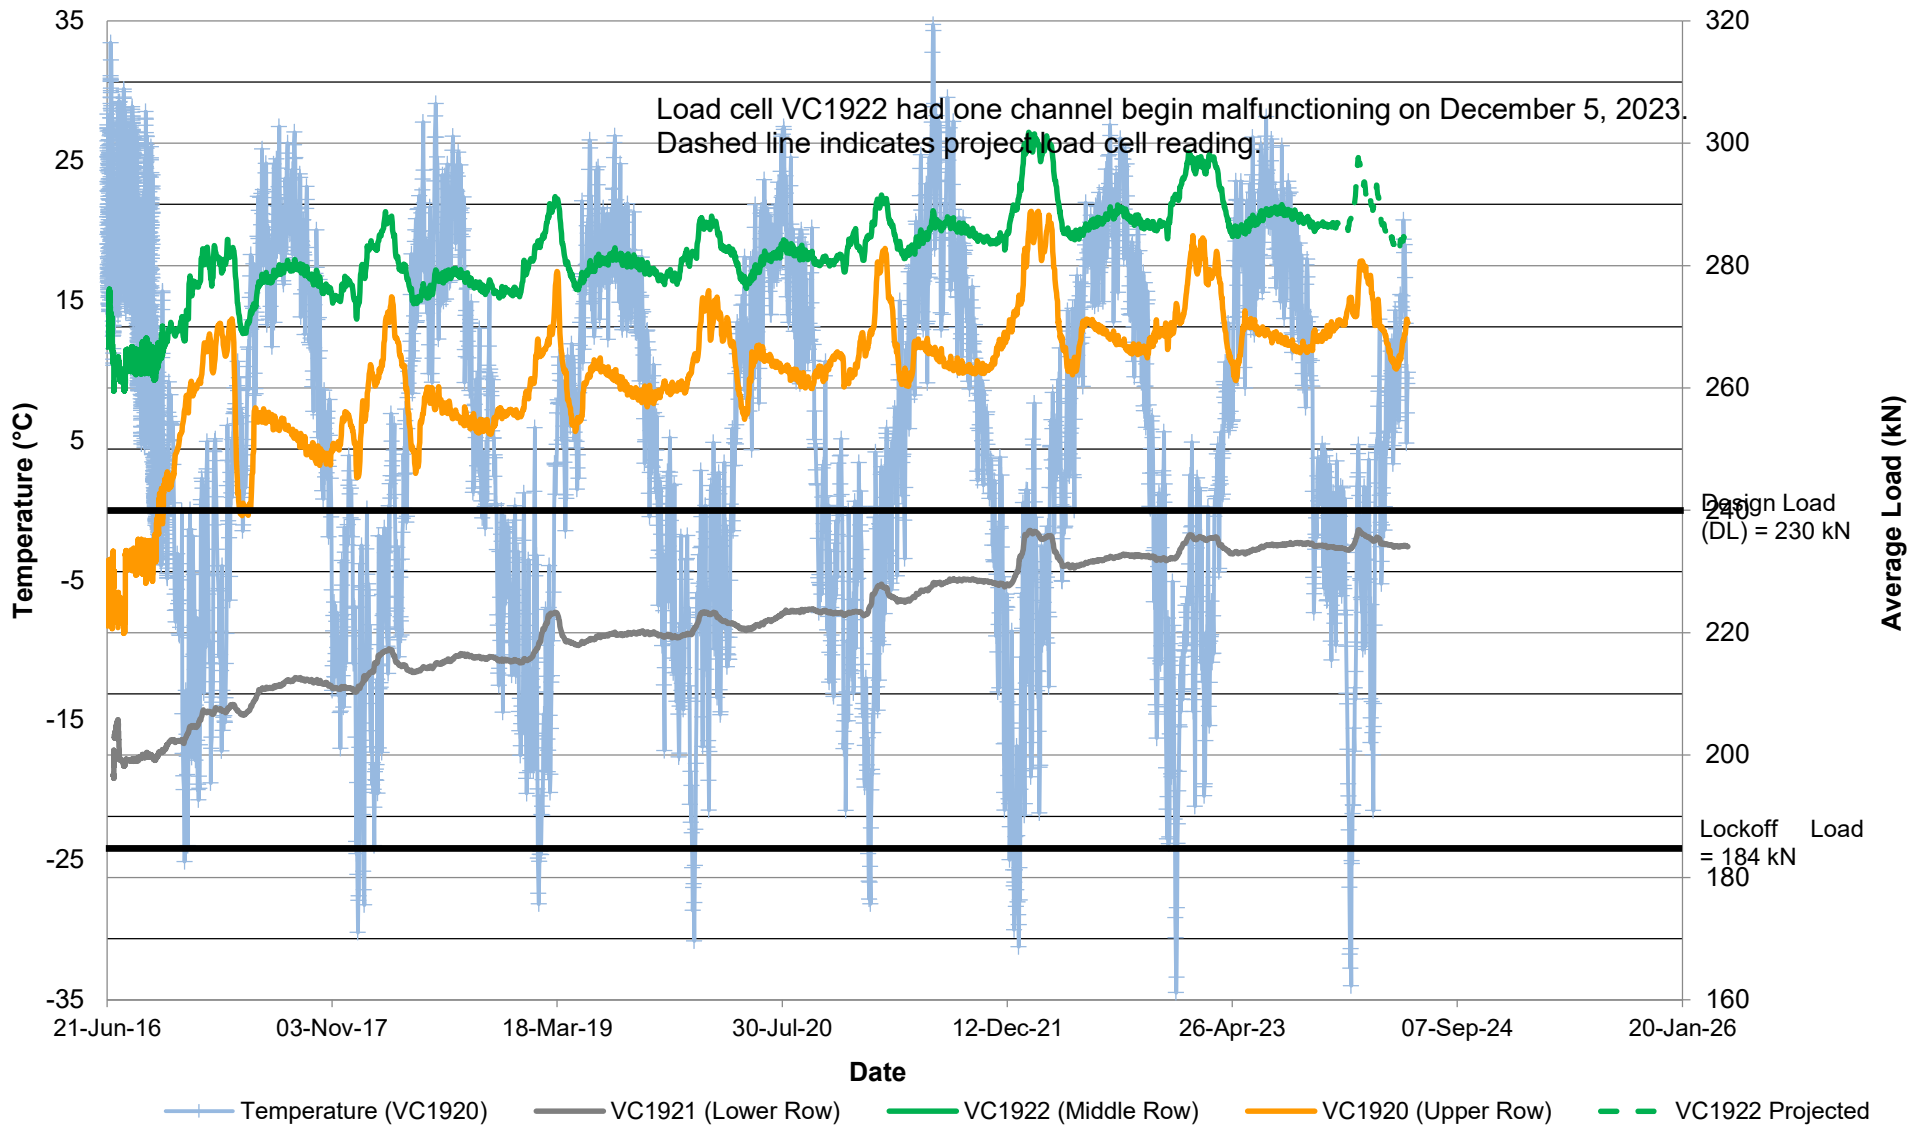
FIGURE PH071-4
LOAD CELL DATA FOR HWY 986:01, DAISHOWA WEST (PILE P060)

<p>downslope movement since the end of construction, with peaks of higher downhill movement rates during the winter months. However, the more recent readings for SAA P097 seem to indicate that the pile wall is reaching a state of equilibrium at its location.</p> <p>The strain gauge readings in Pile P066 are summarized in Table PH071-3. Overall, the strain gauges showed relatively small changes in microstrain value compared to the previous readings in the fall of 2023. The greatest change in microstrain was in strain gauge #11 at 0.6 m depth in the upslope face of the pile, which showed an increase in positive (compressive) microstrain of 6.9 microstrain compared to the fall of 2023 readings.</p> <p>Vibrating wire piezometer VW16-1A was dry during the spring 2024 readings. VW16-1B, and VW16-1C, located upslope of the wall, showed a decrease in groundwater level of 0.60 m and 1.05 m respectively since the fall of 2023 readings. VW16-2C and VW16-2B, also located upslope of the wall, showed decreases in groundwater levels of 0.83 m and 0.26 m, respectively since the fall of 2023 readings. However, the overall trend since end of construction had been a gradual increase in the groundwater table upslope of the wall to what now appears to be a relatively steady level that fluctuates slightly seasonally.</p> <p>VW16-1A appears to follow an overall cyclical pattern, with groundwater levels registered above the tip elevation each year from late spring to early winter, while for the rest of the year the groundwater level remains below the tip. VW16-2A continued to be dry (this piezometer has only shown a groundwater level above the tip during a period between August 9, 2022, and September 21, 2022).</p> <p>Of the piezometers located downslope of the wall, VW16-3A and VW16-3B showed increases in groundwater level of 0.18 m and 0.16 m, respectively, since the fall of 2023 readings.</p> <p>VW16-4A continued to be dry. VW16-5A was dry during the current readings. VW16-4A and VW16-5A tend to remain dry except for brief periods that correspond to either higher than normal rainfall or spring thaw.</p> <p>The load cells generally showed small changes in measured load compared to the fall of 2023 readings, ranging from a decrease of 3.93 kN in VC1922 (anchor P060B) to an increase of 7.85 kN in VC1924 (anchor P022A). Load cells VC1923 (anchor P022B) and VC1921 (anchor P060C) registered their maximum recorded loads since the instruments were initialized on February 1, 2024.</p> <p>It should be noted that load cells VC1924 (anchor P022A), VC1923 (anchor P022B), VC1922 (anchor P060B) and VC1918 (anchor P097B) have each lost the function of one vibrating wire channel. The loads that are now reported for these three load cells are based on the average of the two functional channels and projecting a reading for the now malfunctioning channel based on the last reading taken for that channel and the changes observed in the two functional channels since that time.</p> <p>Since the end of construction, the load cells have generally shown an overall trend of increasing load, with the highest seasonal loads measured towards the end of each winter. The current loads measured in the upper two anchor rows at all three piles, as well as the lower row at P022, are above the design loads. However, the recent readings for P060 and P097 appear to show that the anchor loads in the upper two anchor rows in P060 and P097 are starting to level off.</p>

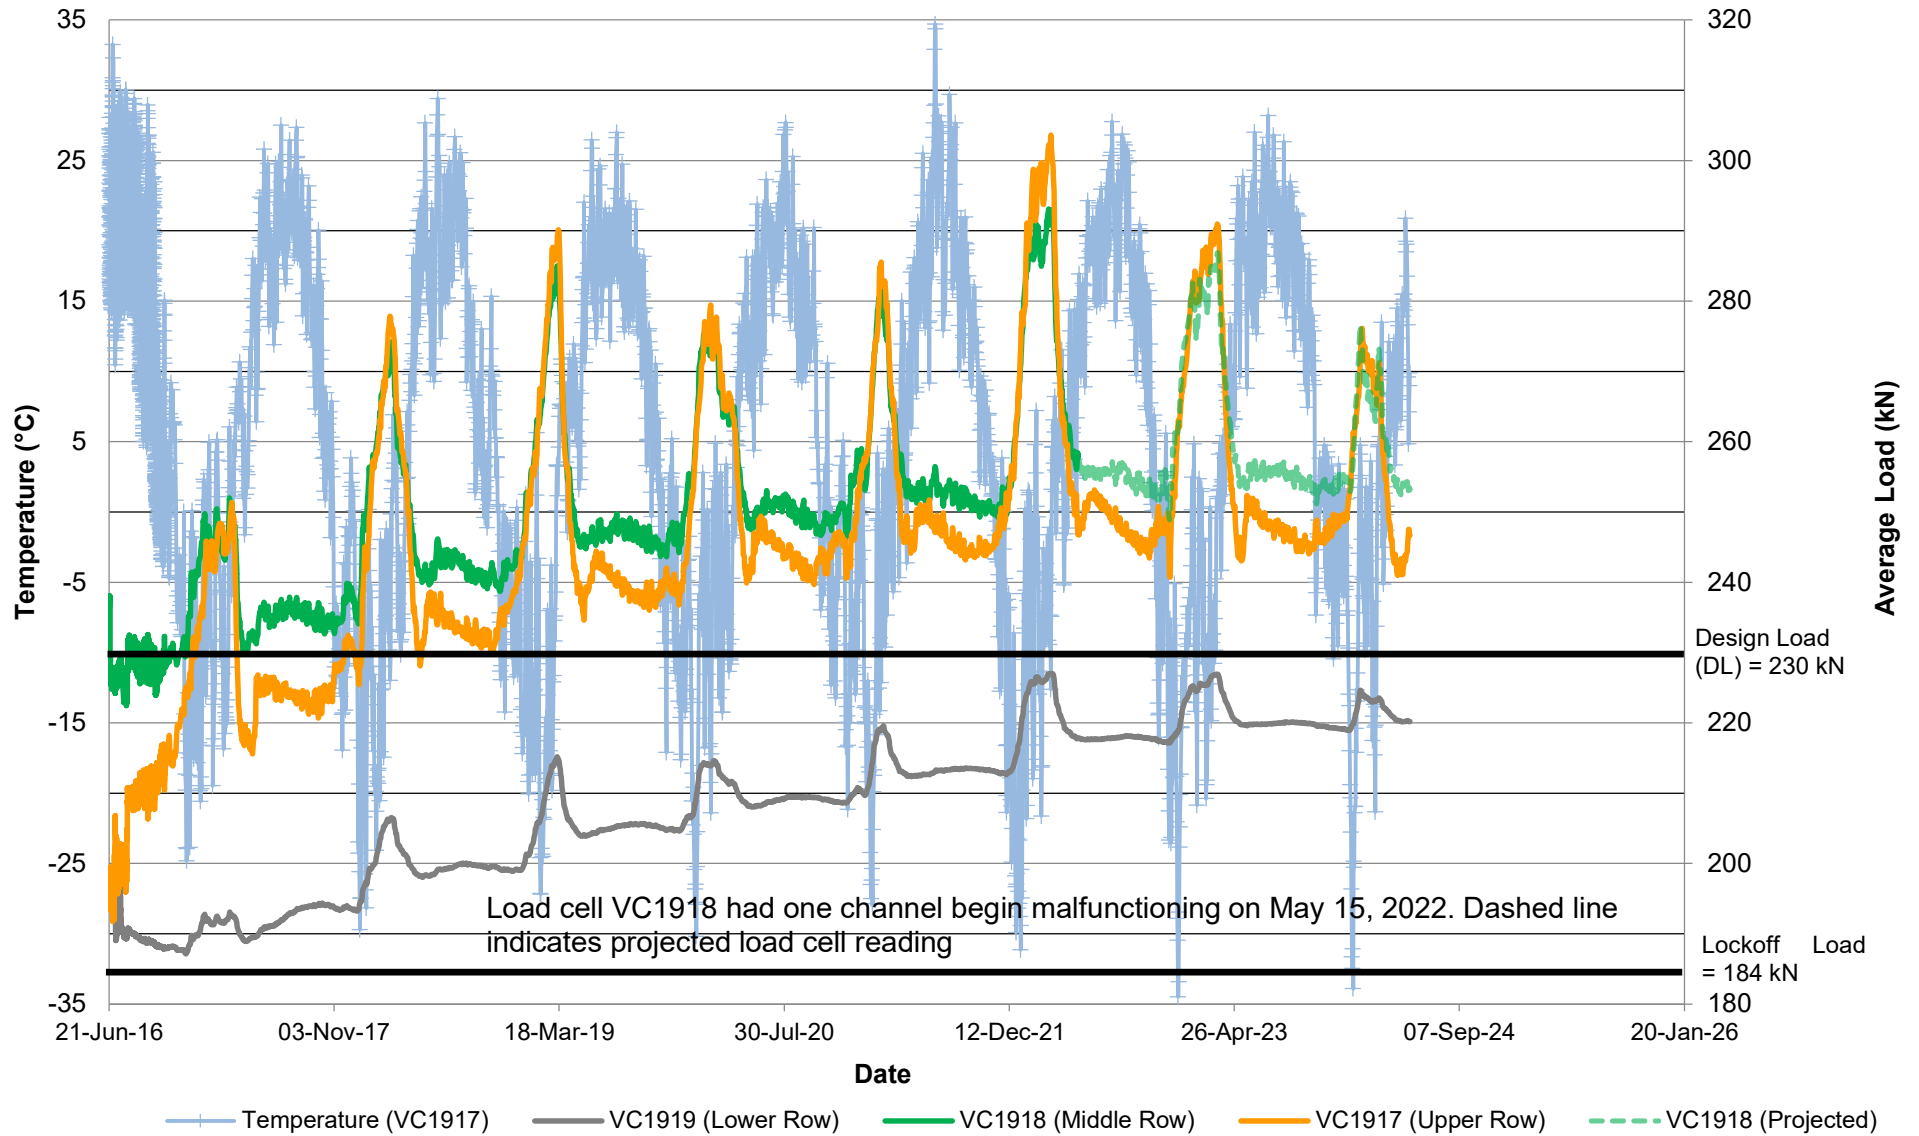
**FIGURE PH071-5
LOAD CELL DATA FOR HWY 986:01, DAISHOWA WEST (PILE P097)**

- 4) As of May 15, 2022, only two wire channels are functional on load cell VC1918. The reported loads after this date are based on the average of the two functional channels and a projected reading for the now malfunctioning channel.

- 5) As of December 5, 2023, only two wire channels are functional on load cell VC1922. The reported loads after this date are based on the average of the two functional channels and a projected reading for the now malfunctioning channel.
