ALBERTA TRANSPORTATION LANDSLIDE RISK ASSESSMENT

SECTION A: GEOTECHNICAL FILE REVIEW

**SITE PH64: HWY 64:02 BF79554 SIDESLOPE INSTABILITIES (KM
52.7)**

Highway Control Section: **HWY 64:02**

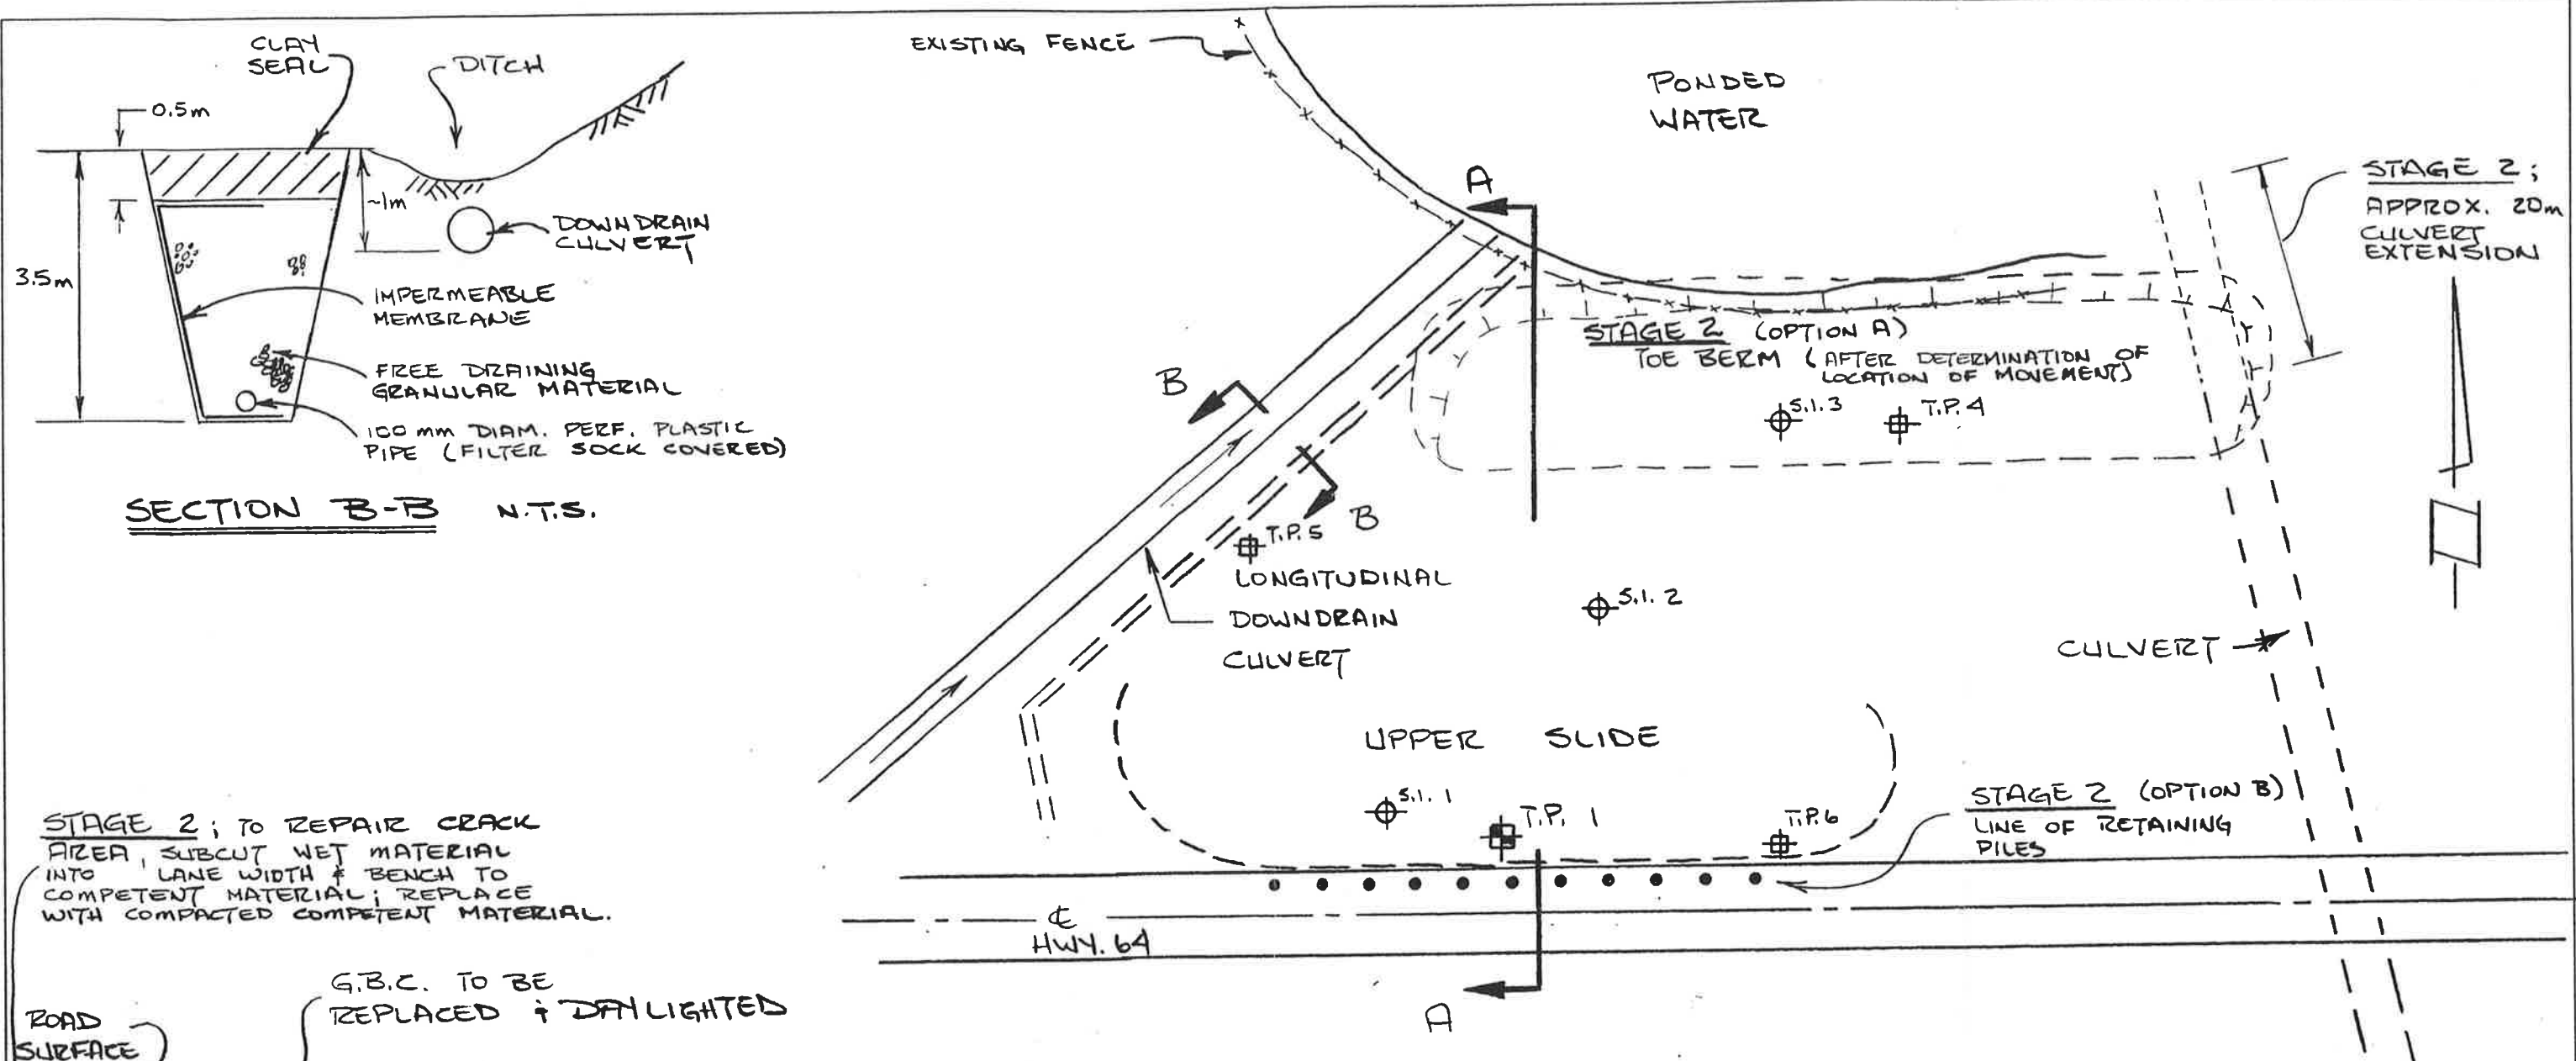
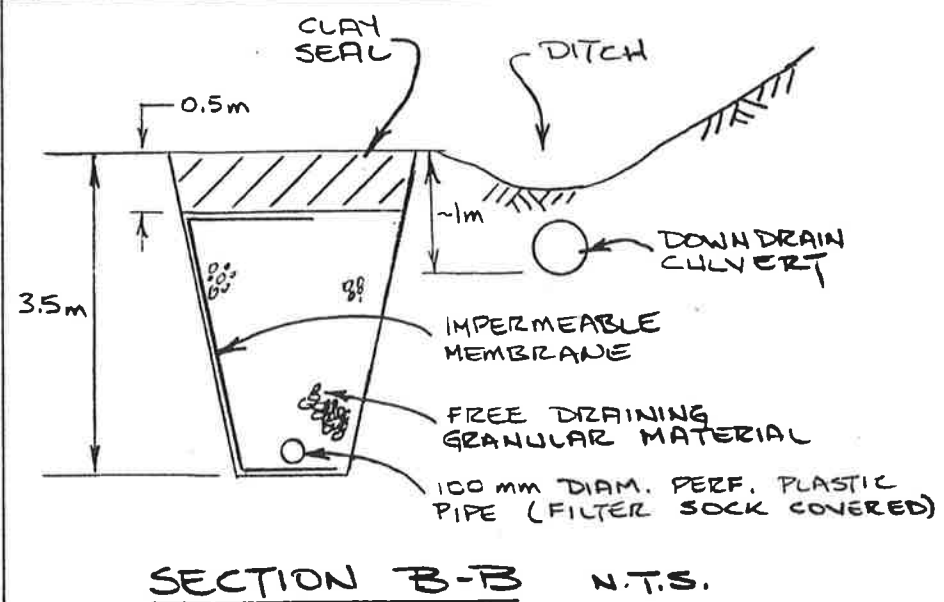
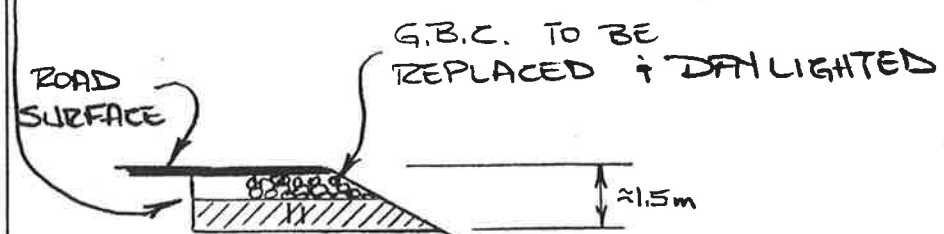
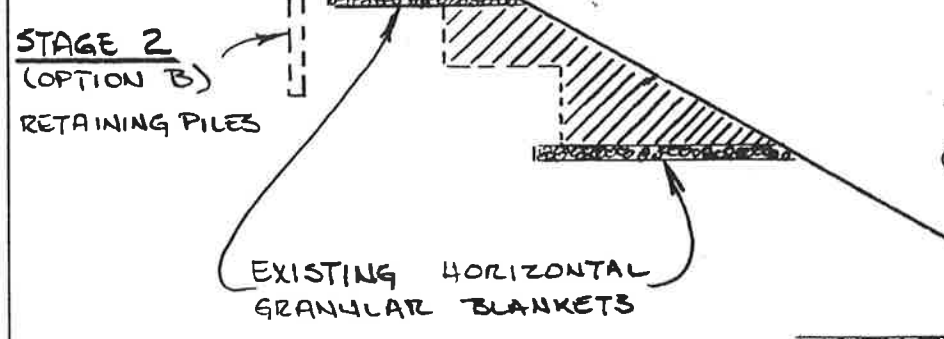
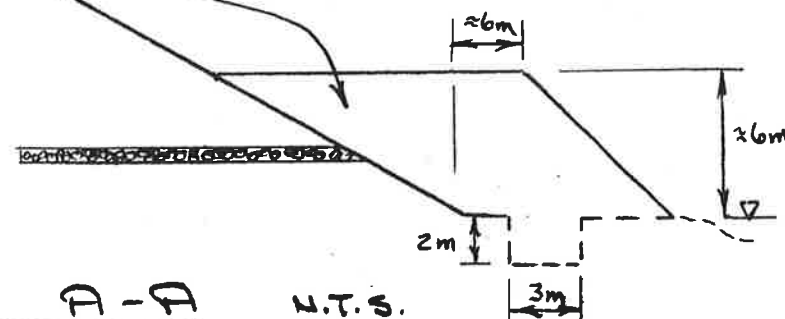
Pete van Deligt, Project Manager, informed that upon destruction of the beaver dam and after draining away approximately 1 m depth of dammed water, a portion of toe bulging of approximately 15 m width was discerned. A major portion of the toe was still submerged to inhibit detailed observation. Also, shortly after implementation of the above remedial works, a vertical drop movement of approximately 0.3 m was observed at just below the alignment level.

The last movement was apparently an adjustive movement as a result of the soft creek bottom of the creek foundation of the embankment as well as the seepage from the west backslopes. Such seepage flow served to saturate the fill and reactivate the old slip surface despite the proper weeping effect of the horizontal granular layers.

A toe berm should be constructed over the location of the true toe of the slope as determined by slope indicator monitoring. The toe berm should be found on competent ground; any top thickness of wet/soft incompetent should be excavated before construction. Existing horizontal granular layers should be connected to daylight to the side of the toe berm. Length of toe berm is estimated to be approx. 40 m. Borrow material should be available from the north backslope area. Approx. 20 m extension of culvert towards upstream is estimated. Existing ditches down the sides of the embankment slope might have to be shifted to the backslope to accommodate the end of the toe berm.

To repair crack area along shoulder line, any wet subbase beneath the GBC should be subcut and replaced with compacted competent material so that later separation at old juncture can be avoided.

STAGE 2; TO REPAIR CRACK AREA, SUBCUT WET MATERIAL INTO LANE WIDTH & BENCH TO COMPETENT MATERIAL; REPLACE WITH COMPACTED COMPETENT MATERIAL.

STAGE 2 (OPTION A) TOE BERM (AFTER DETERMINATION OF LOCATION OF MOVEMENT)

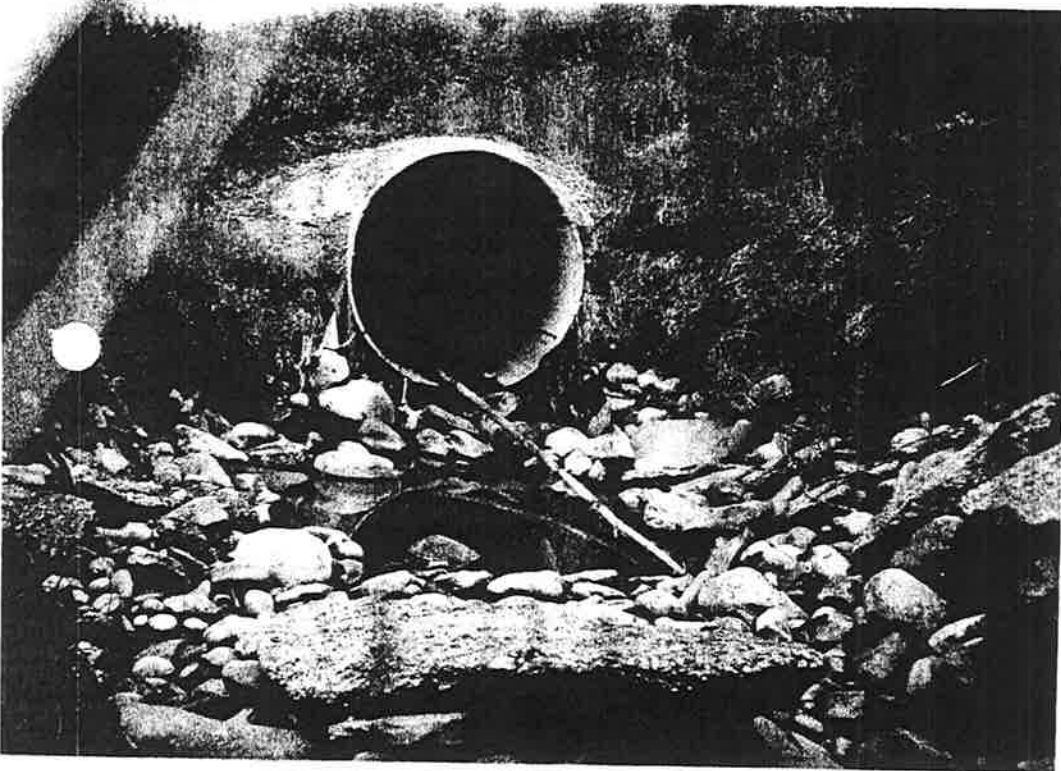
←
The outlet has been repaired in the past with ample rock (though small) in the streambed.

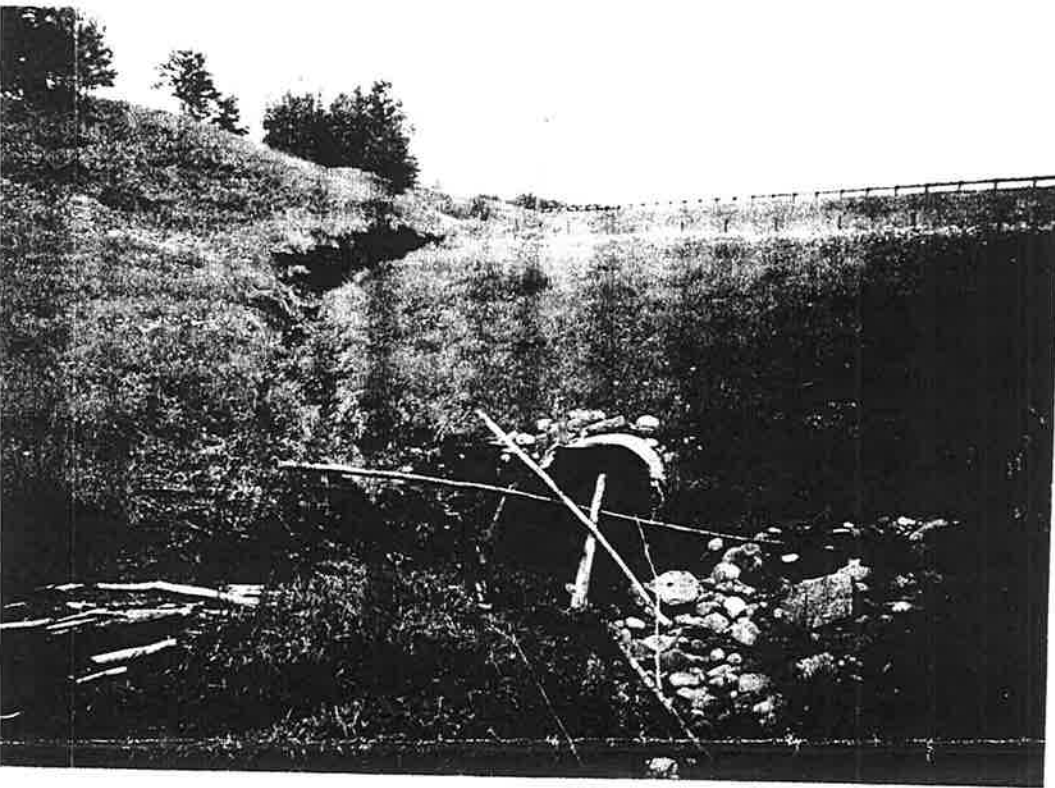
←
Ditch erosion gully at the NE corner all the way down.

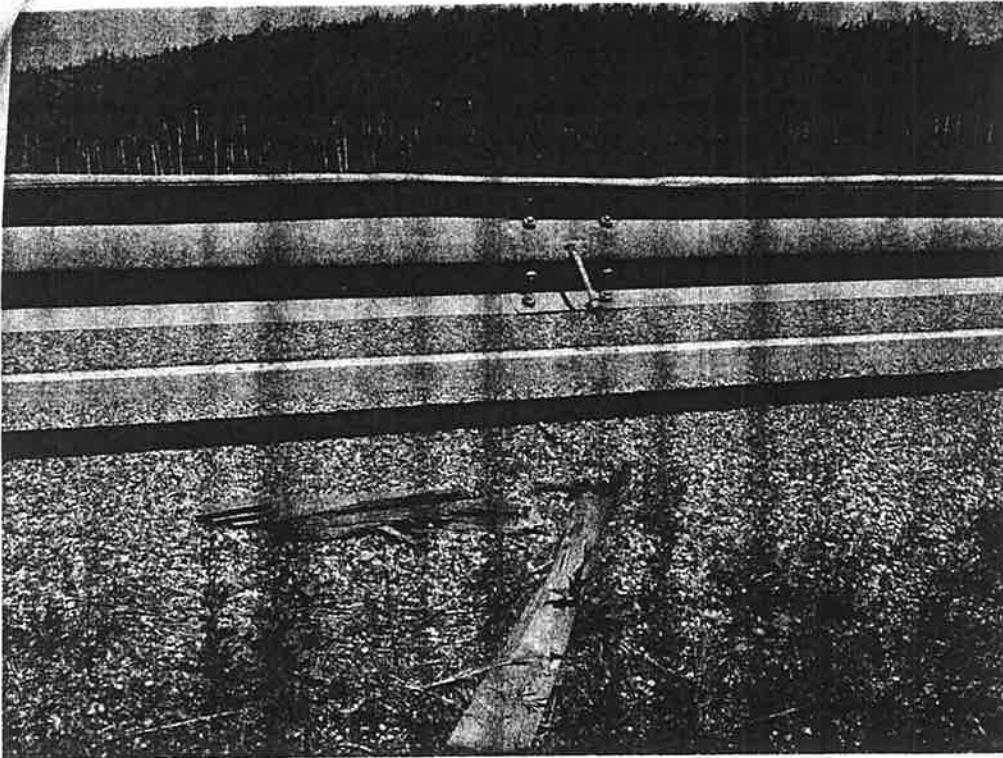
Viewing the missing post on the south side of the guardrail.

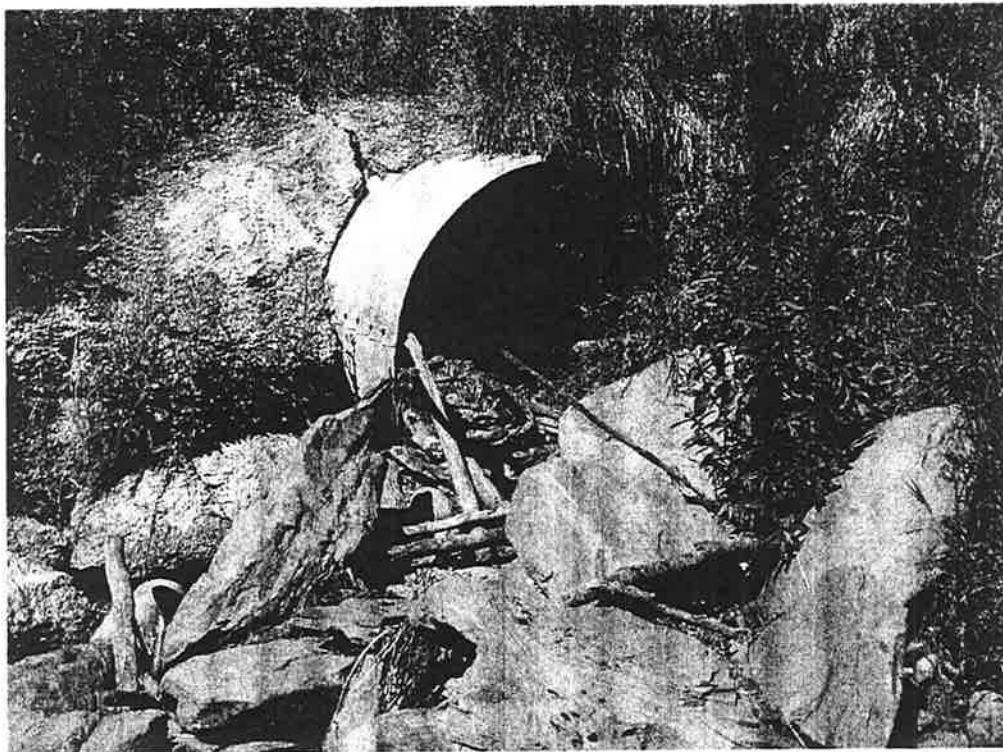
*July / 2006
Outlet*

A bridge inspection on July 20, 2006, by MPA Engineering Ltd., has a photo showing significant debris (consisting of tree branches, large riprap, and soil) partially blocking the culvert outlet.

Viewing the debris blocking the outlet.
