**SOUTHERN REGION GEOHAZARD ASSESSMENT  
ANNUAL ASSESSMENT REPORT  
2007**

**Alberta Infrastructure and Transportation**  
Calgary, Alberta

**AMEC Earth & Environmental,**  
**a division of AMEC Americas Limited**  
Calgary, Alberta

### 4.1 S1 – JUMPINGPOUND CREEK

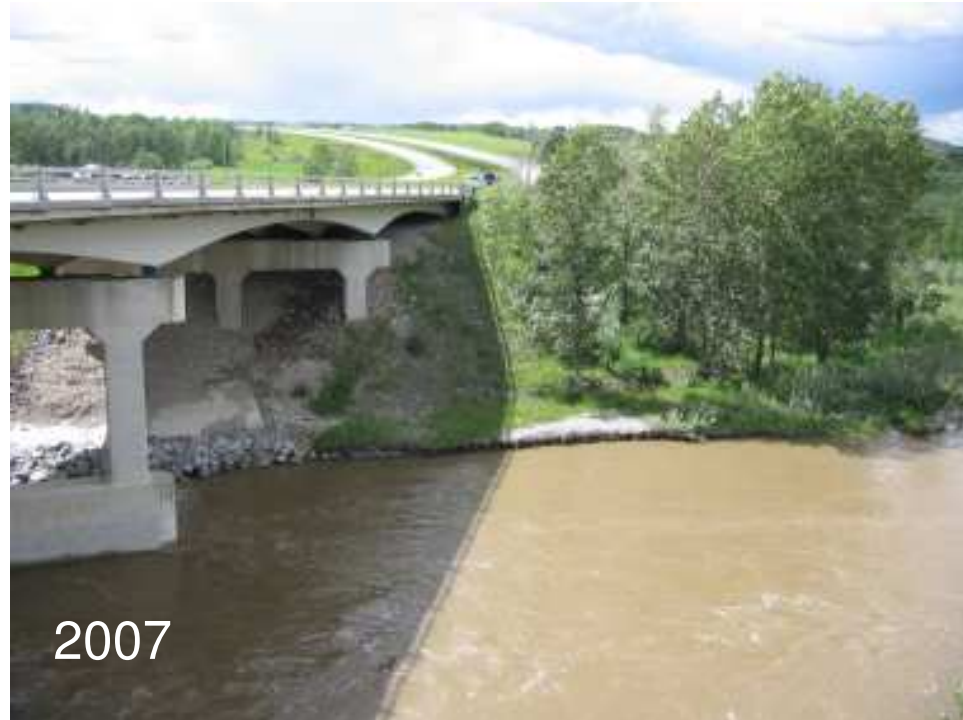
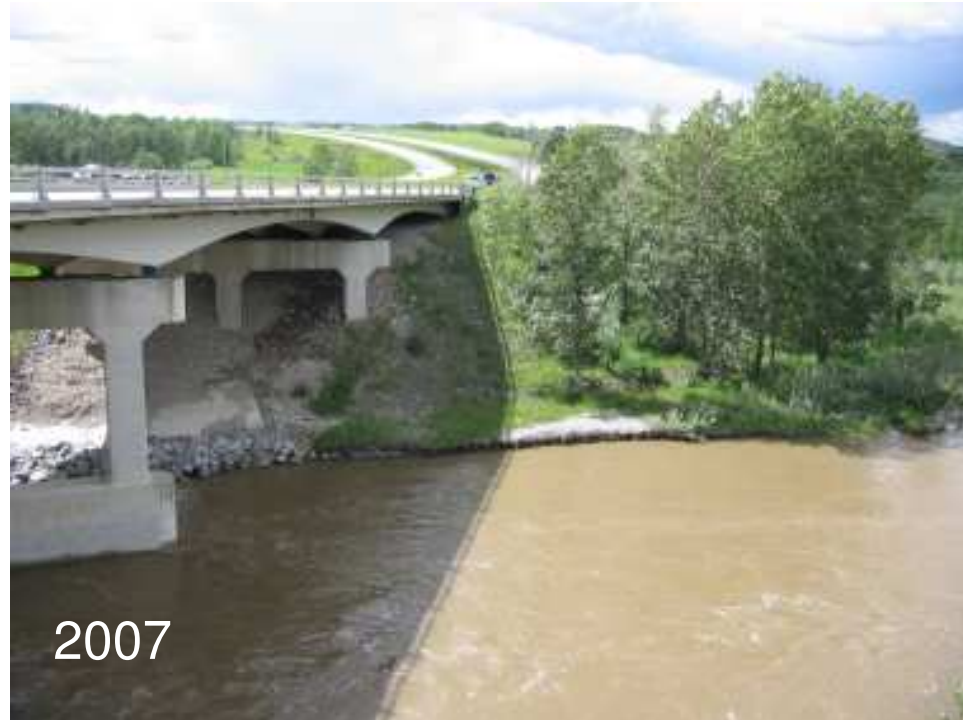
- Creek bank erosion was visible in the west creek bank, downstream of the bridges, as shown in Photo S1-1. It is hypothesized that this erosion started when the previous rip-rap armouring along the creek bank was removed during high creek flows following the heavy rains in June 2005, as shown in Photo S1-2.
- East bank, upstream of eastbound bridge – as shown in Photos S1-7, 8, 9, 10 and 11 the east bank upstream of the bridges is along the outside of a bend in the creek channel and appeared to be undergoing significant erosion at the time of the inspection.

**Photo S1-1 – June 2007** (upper left)  
West creek bank, downstream of the westbound bridge. Note the erosion visible along the unarmoured segment of the creek bank in comparison to the 2005 photo of the same area (Photo S1-2).

- a. The bank protection along the west creek bank north of the westbound lane bridge (see Photos S1-1 and S1-2) should be replaced.
  - b. The segment of the east creek bank shown in Photos S1-7, 10 and 11 should be protected from further erosion in order to prevent the development of a risk to the stability of the east abutment of the eastbound lane bridge.

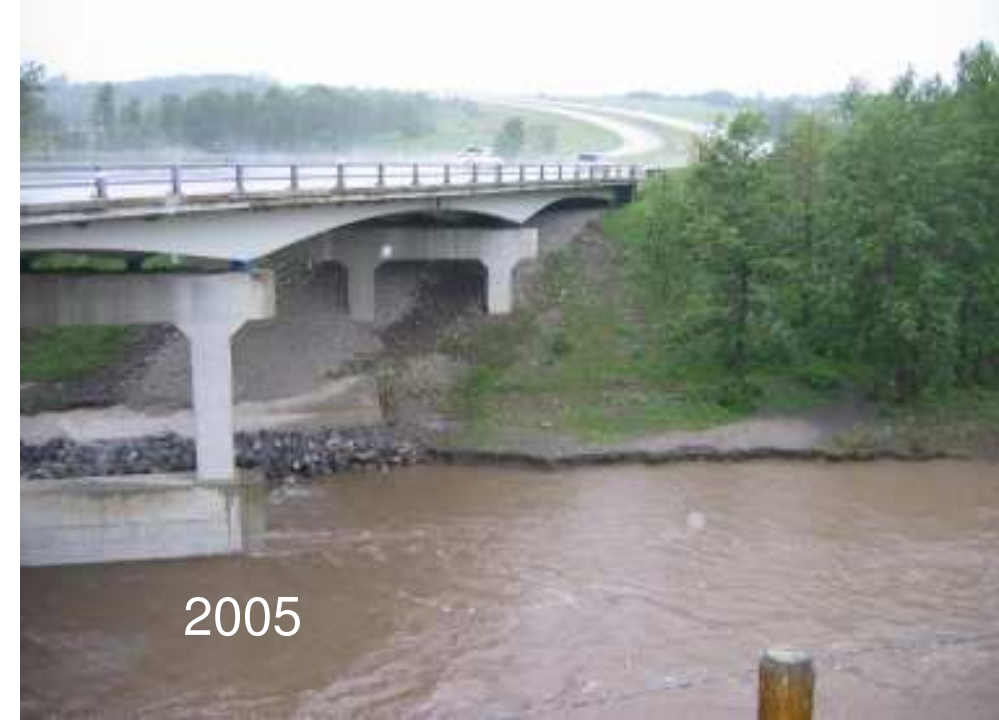
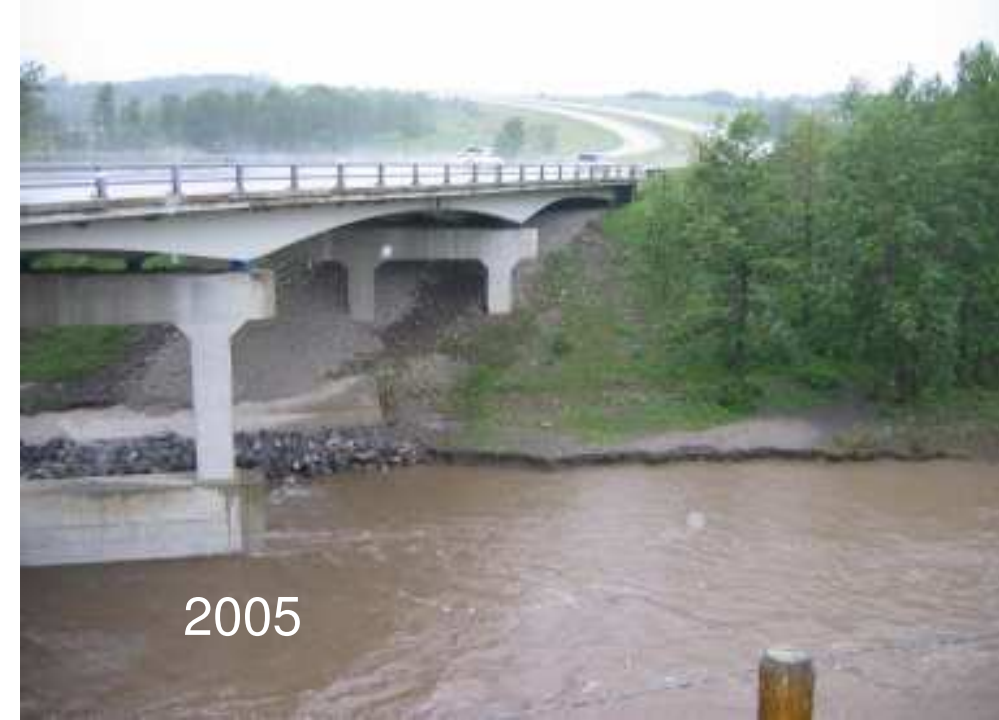
**Photo S1-2 – June 2005** (upper right)  
West creek bank, as seen during the June 2005 inspection.

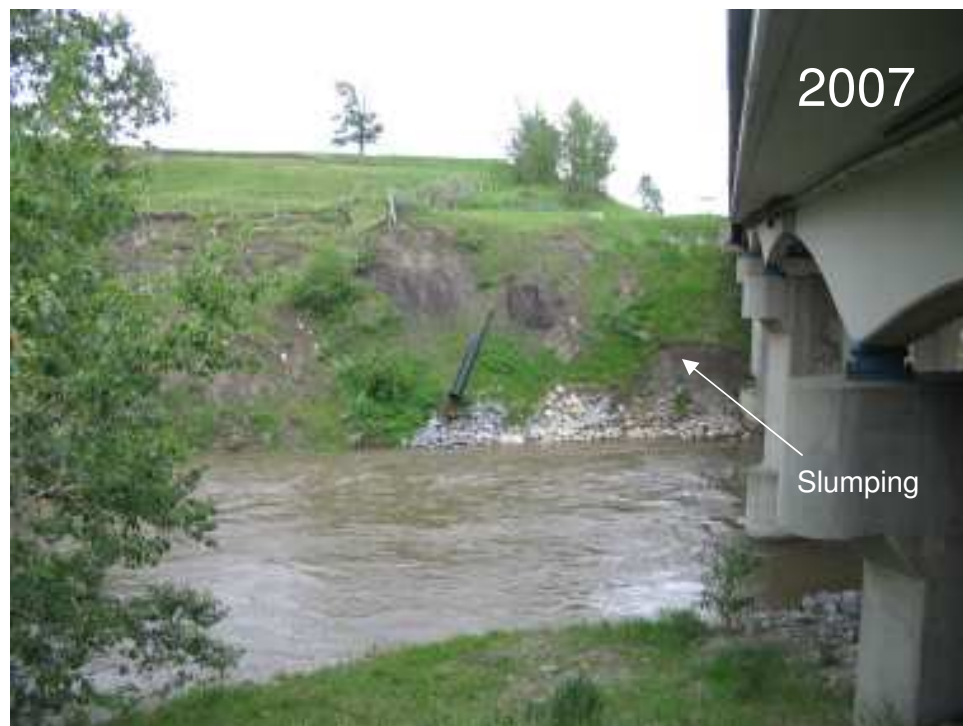
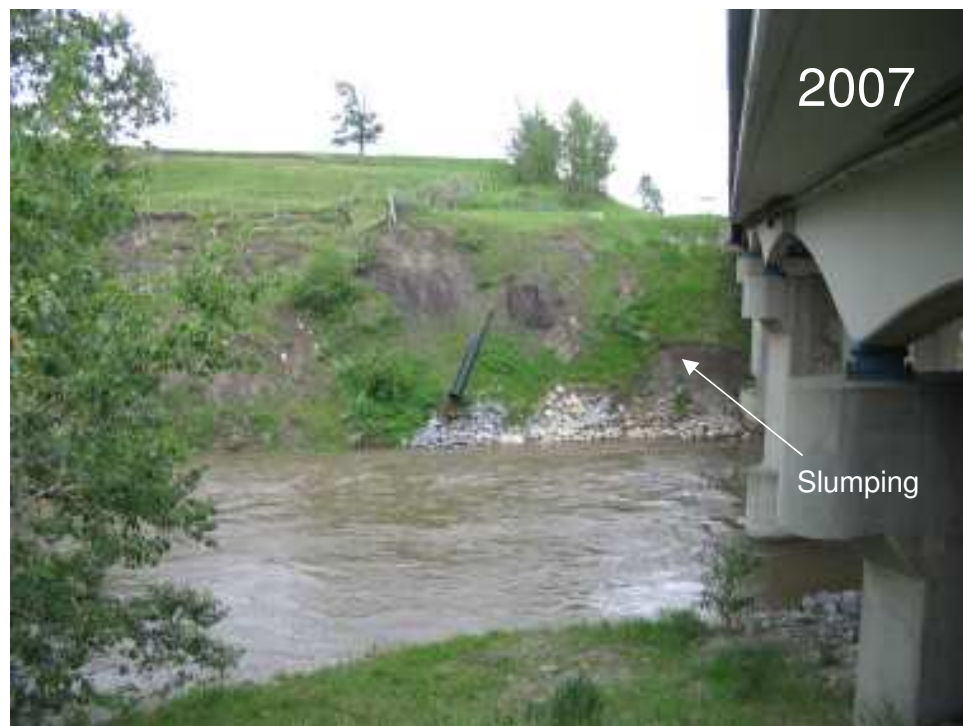
- The slump that was first noted in 2005 on the east abutment slope, just downstream of and adjacent to the pier of the westbound bridge, was still visible and appeared to have increased slightly in size since the 2005 and 2006 inspections however overall it did not appear to be developing into a risk to the bridge abutment stability to date. Photos S1-3 and S1-4 show comparative views of this area from the 2005 and 2007 inspections. This slump appears to be shallow instability that occurred as a result of a concentration

of surface runoff from the north side of the westbound bridge area and possibly also due to toe erosion following the loss of rip-rap armouring along the creek bank during the peak flows in 2005.

**Photo S1-3 – June 2007** (lower left)  
East creek bank, downstream of the westbound bridge. The slumping just above the upslope limit of the rip-rap armouring appears to have increased slightly in size since the 2006 inspection (see Photo S1-4) however it does not appear to have developed into a significant risk to the bridge abutment stability to date.

- c. Install a flume or pipe to intercept the surface runoff from the area that currently drains into the slump on the east abutment slope, below the north side of the westbound bridge (Photo S1-3), and carry it to a discharge point at the toe of the slope. Also, repair/replace the rip-rap armouring along the toe of the slope below this slump.

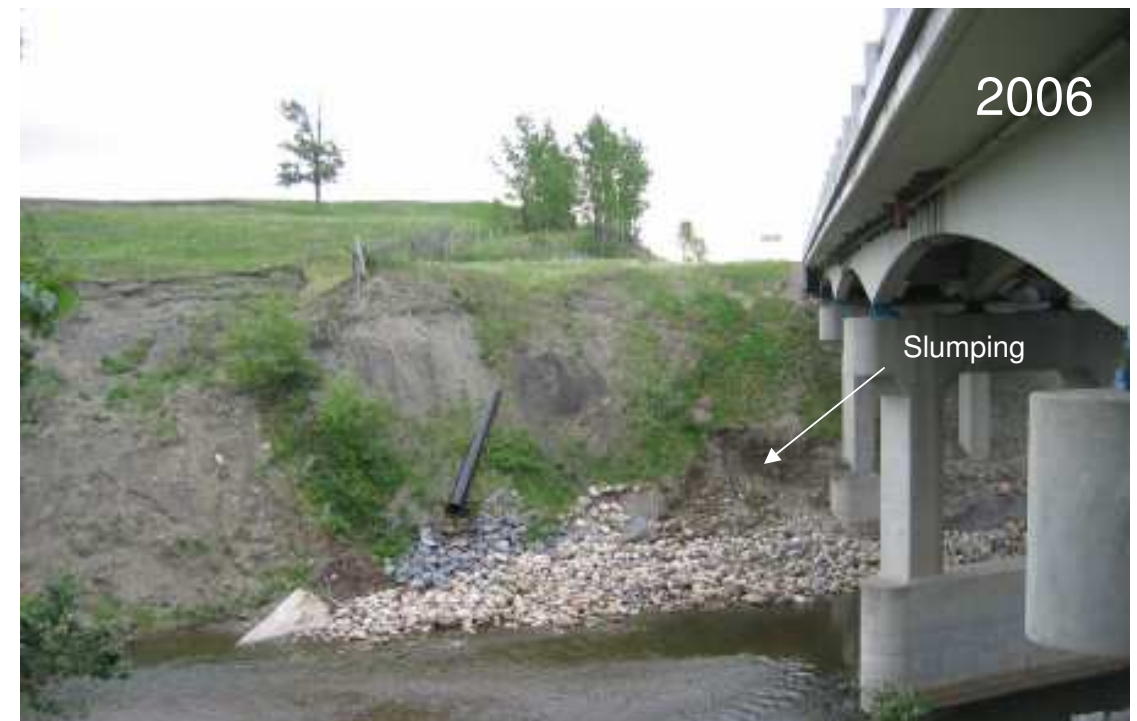
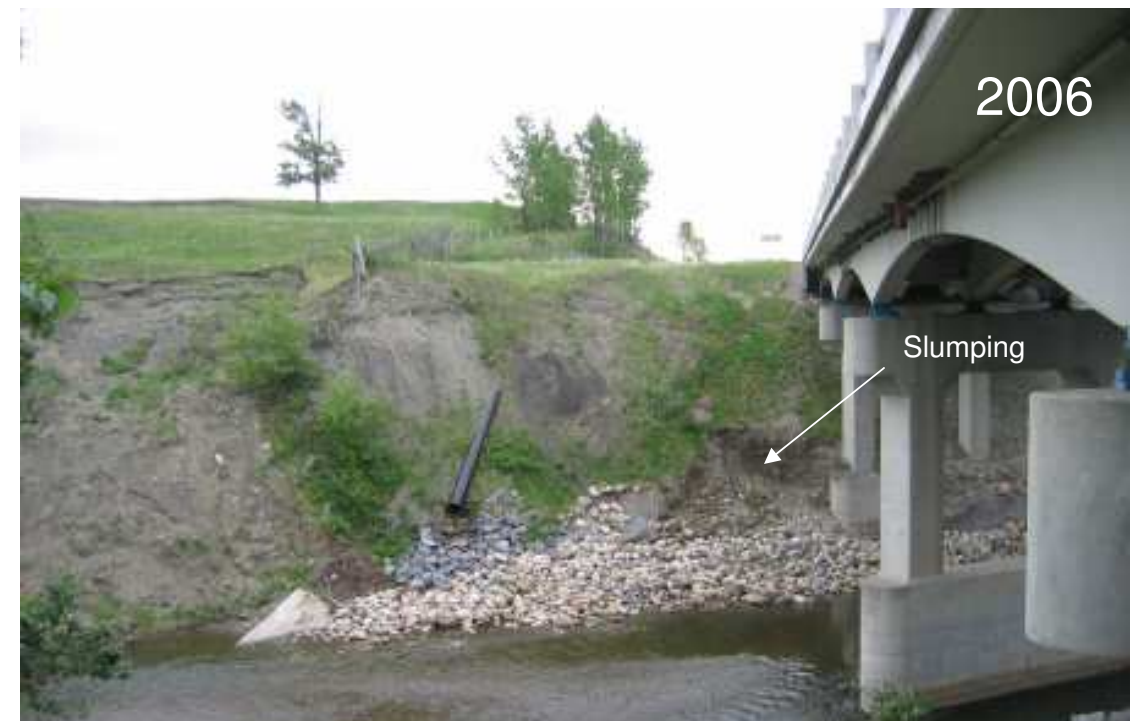
**Photo S1-4 – June 2006** (lower right)  
East creek bank, as seen during the 2006 inspection.

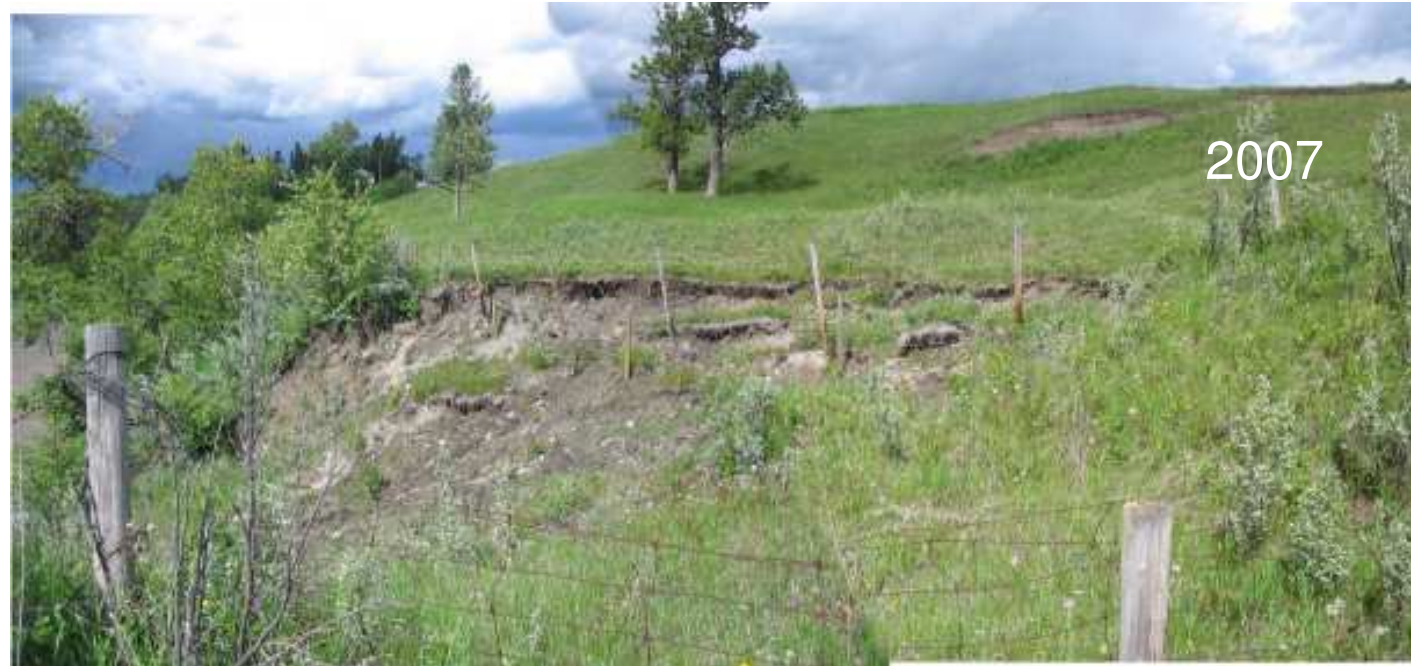
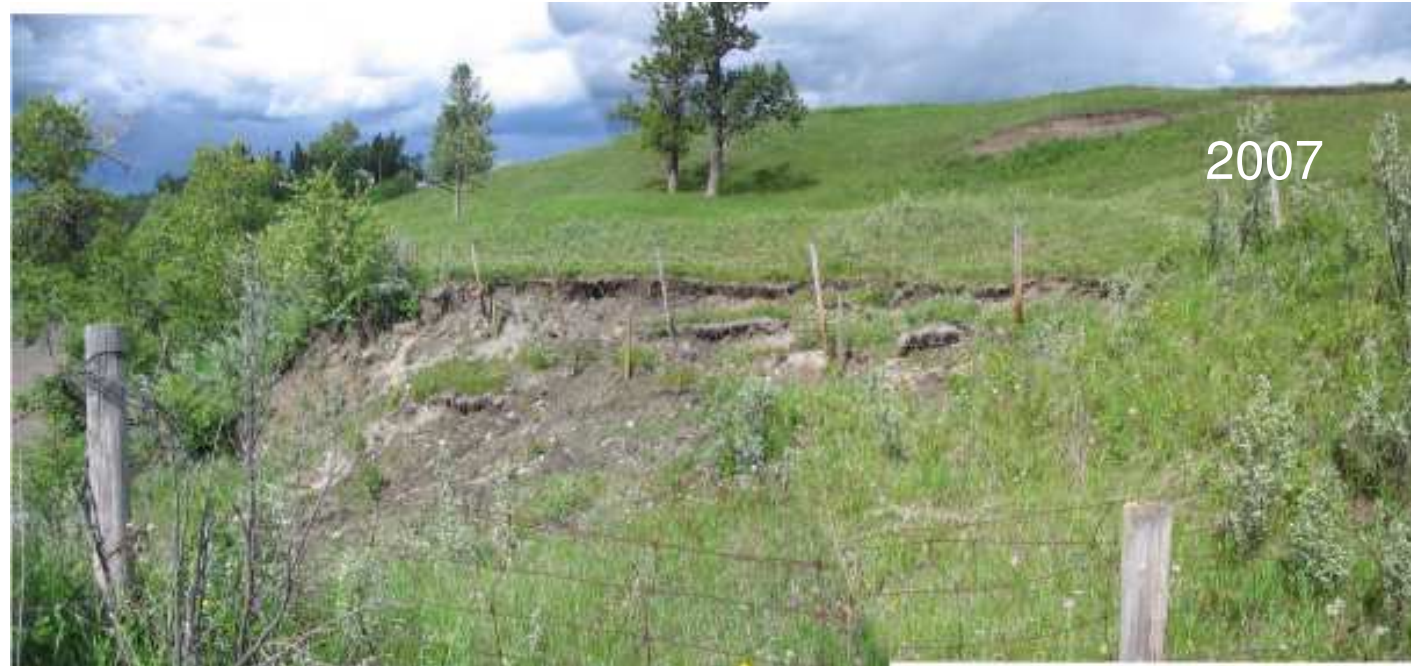
**Photo S1-5 – June 2007** (top)

- The slope instability at the crest of the east creek valley slope, downstream of the westbound lane bridge, that has been noted in each annual inspection since 2000 did not appear to have worsened significantly since the previous assessments. Photos S1-5 and S1-6 show comparative views of this area from the June 2007 and June 2005 assessments.

Slope instability along the crest of the east creek valley slope, downstream of the westbound lane bridge. This instability has been noted since the first annual inspection in 2000, however it does not appear to have worsened significantly since that time nor retrogressed towards the highway. Compare with the view of the same area from the 2005 inspection, as shown in Photo S1-6.

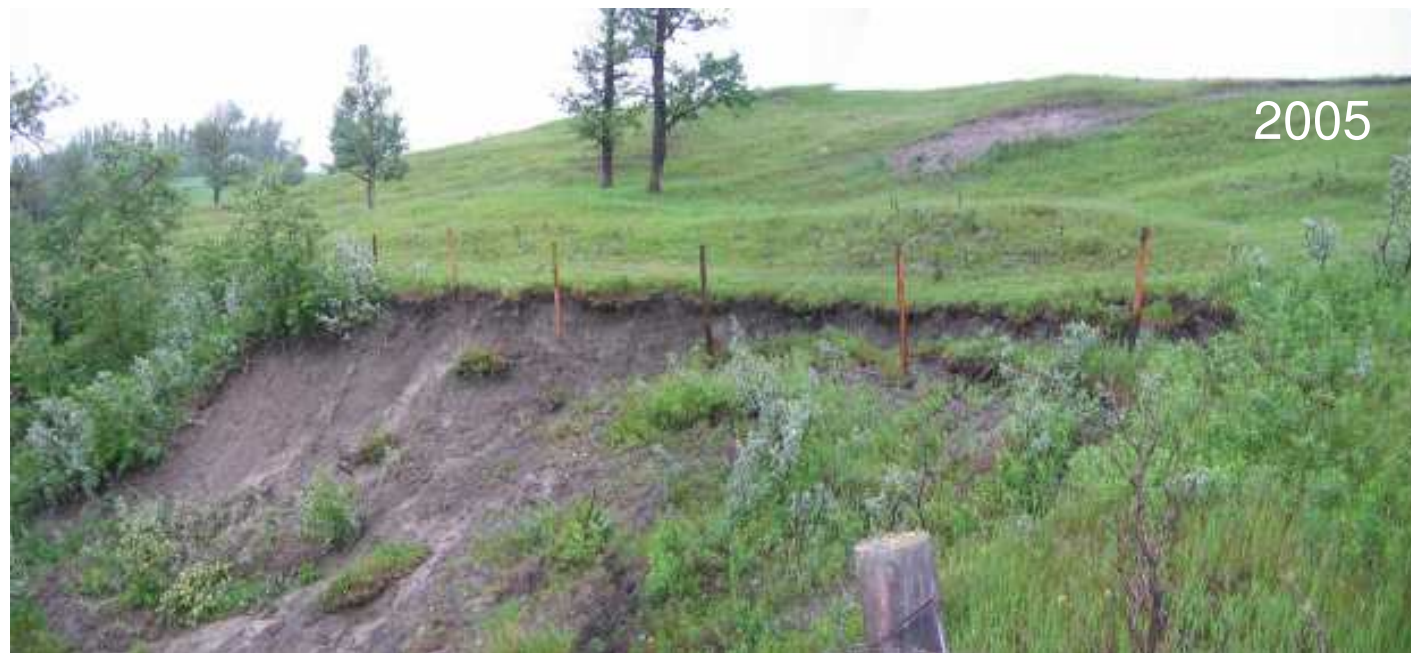
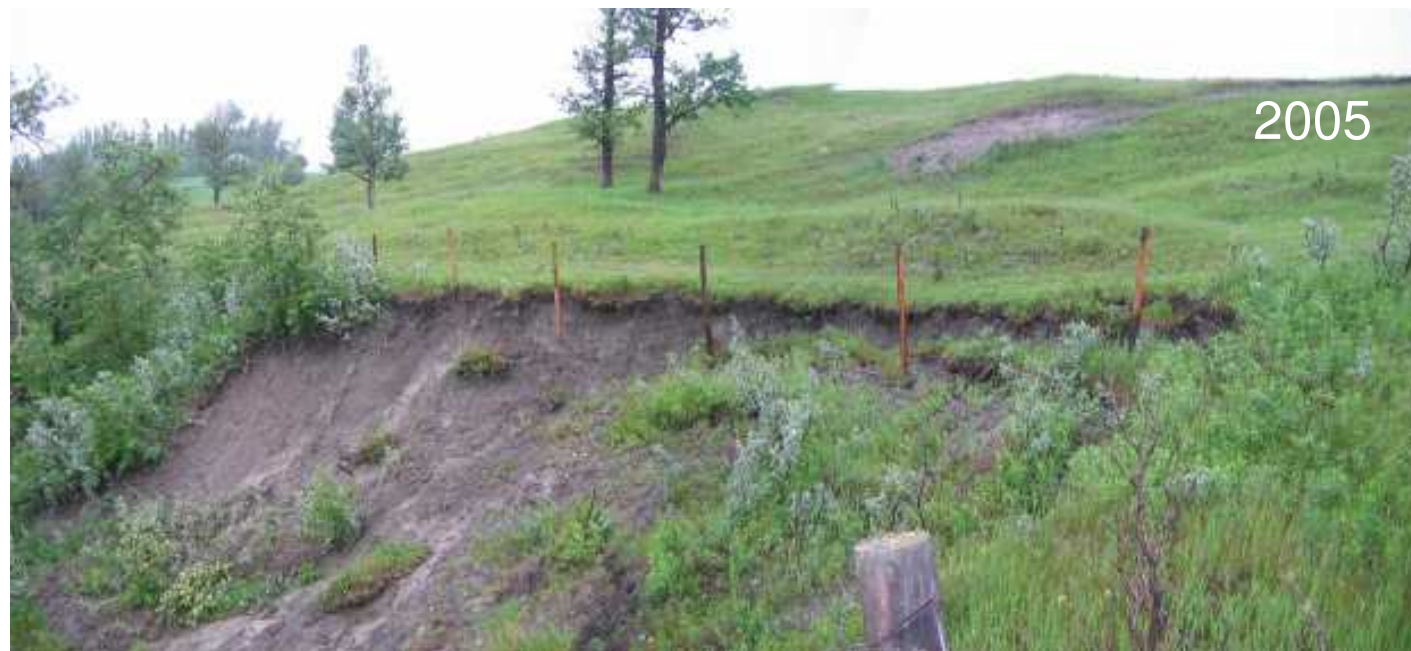
**Photo S1-6 – June 2005** (bottom)

Slope instability along the crest of the east creek valley slope, downstream of the westbound lane bridge – as seen during the 2005 inspection.

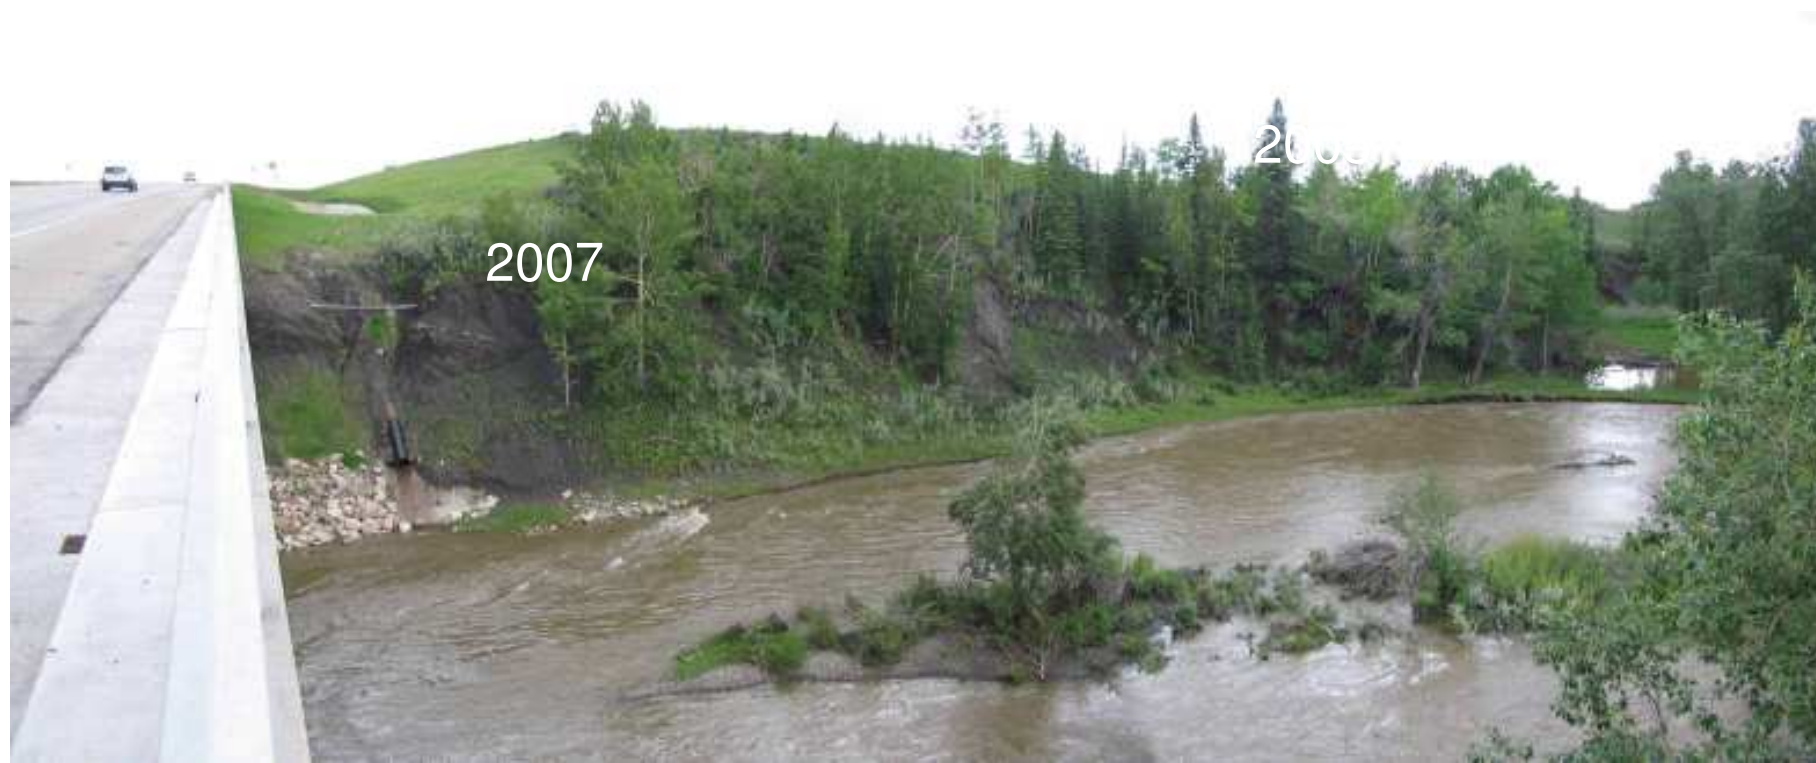
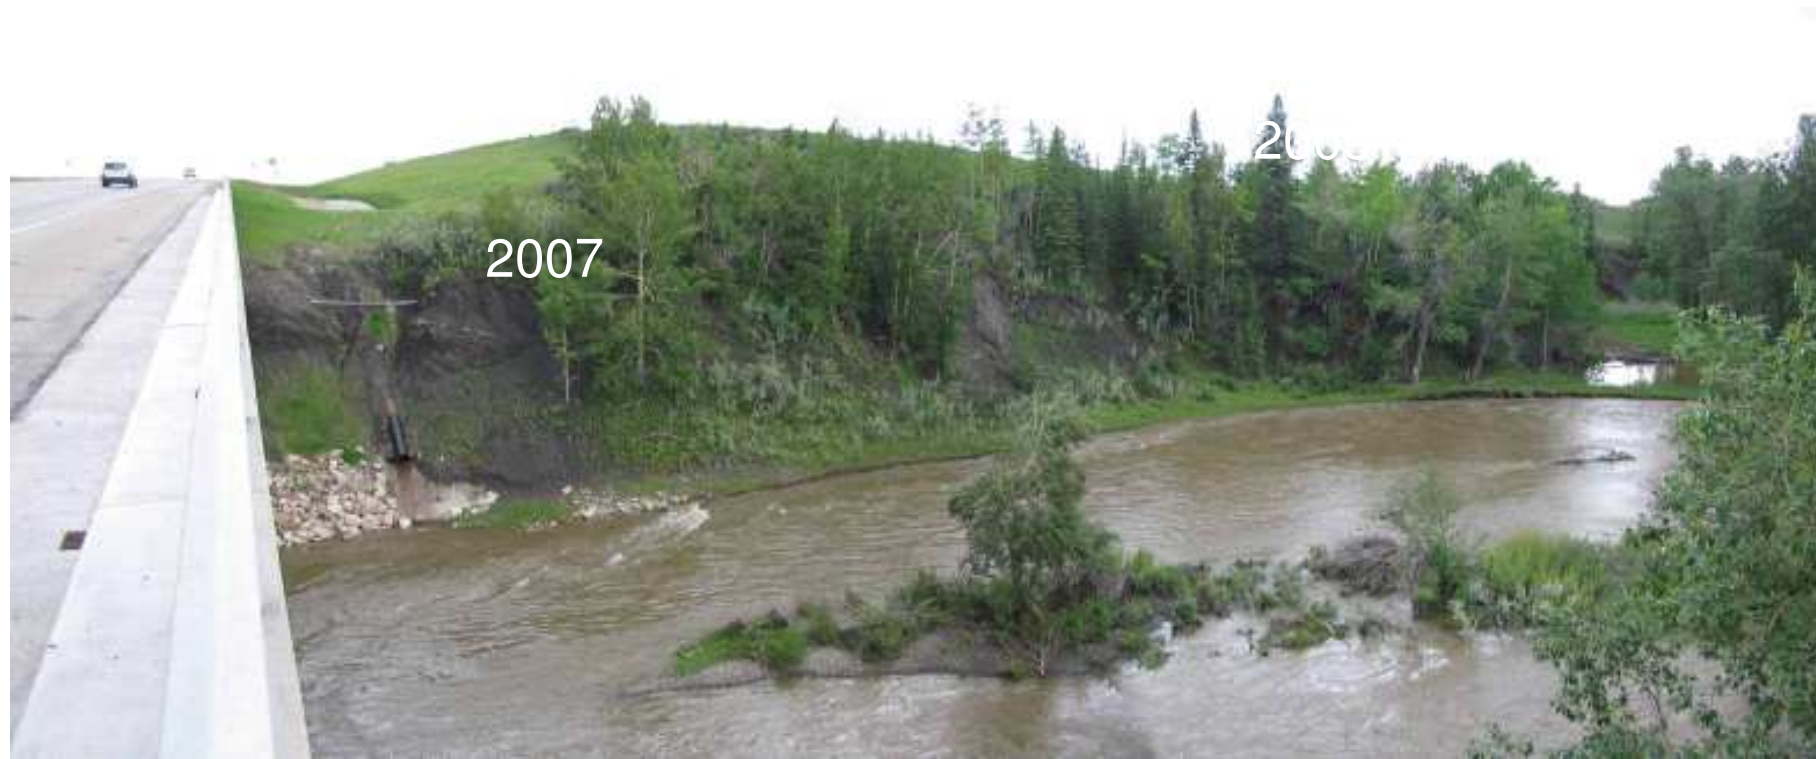
**Photo S1-7 – June 2007** (top)

East creek bank, upstream of the eastbound lane bridge. Compare with views of the same area from the 2005 and 2004 inspections in Photos S1-8 and S1-9. See also Photos S1-10 and S1-11 for other views of this area from 2007.

It appeared that this bank has been eroded by high flows in recent years. There is a chance that continued bank erosion could eventually develop into a risk to the stability of the east bridge abutment.

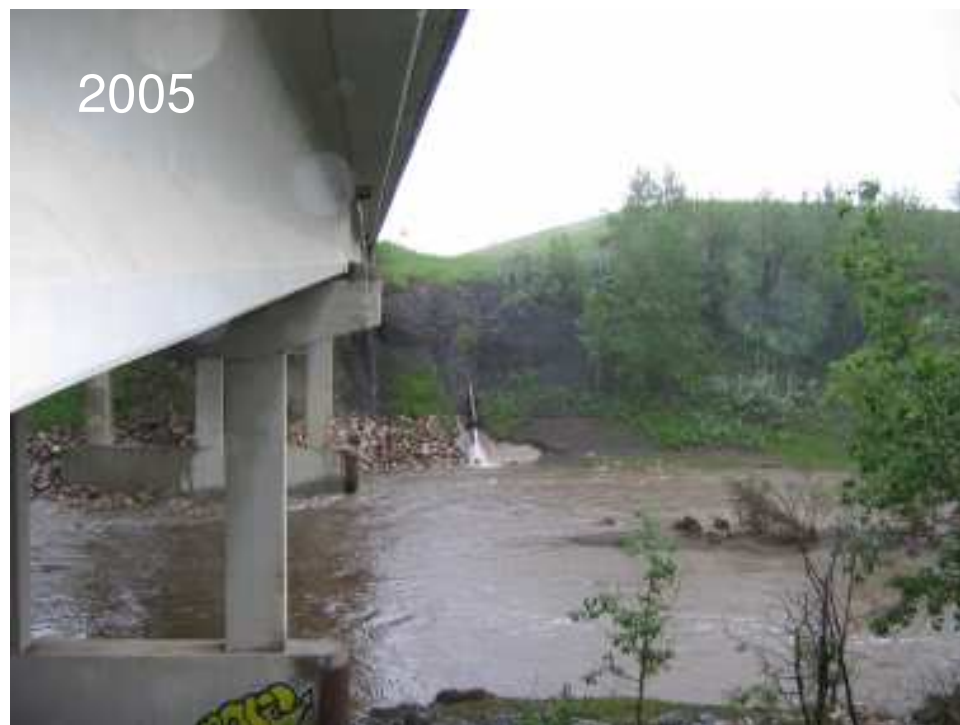
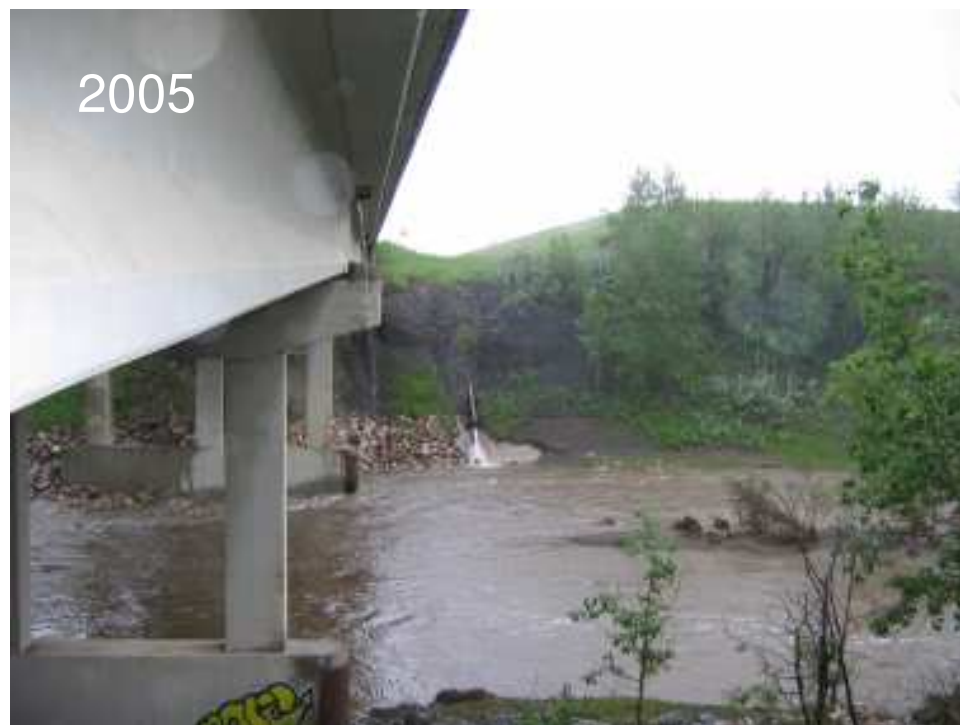
**Photo S1-8 – June 2005** (lower left)

East creek bank, upstream of the eastbound lane bridge, as seen during the 2005 inspection.

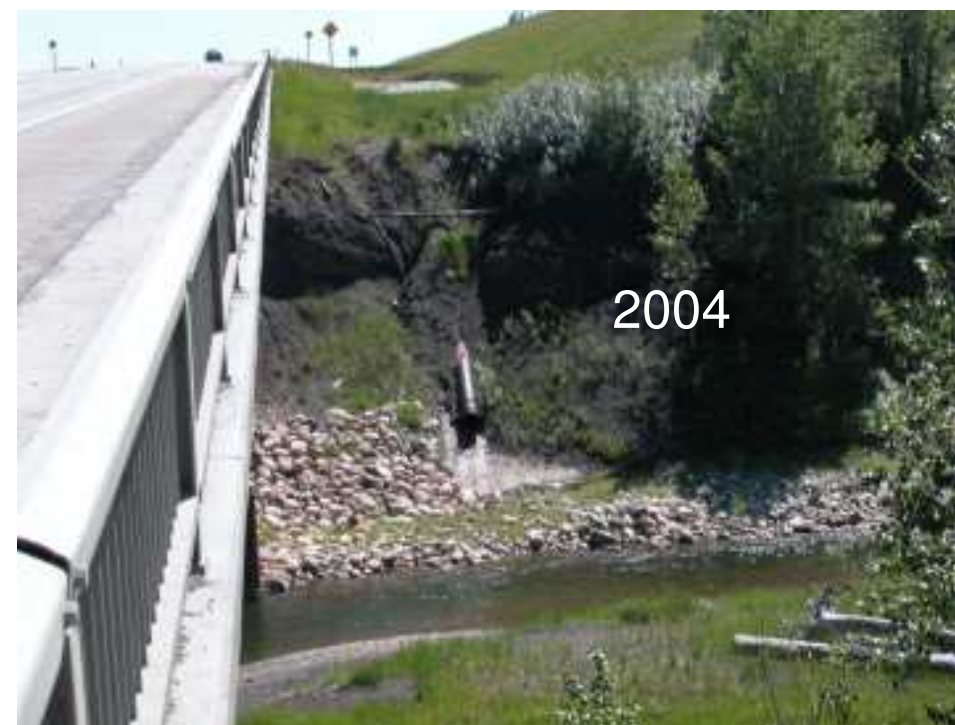
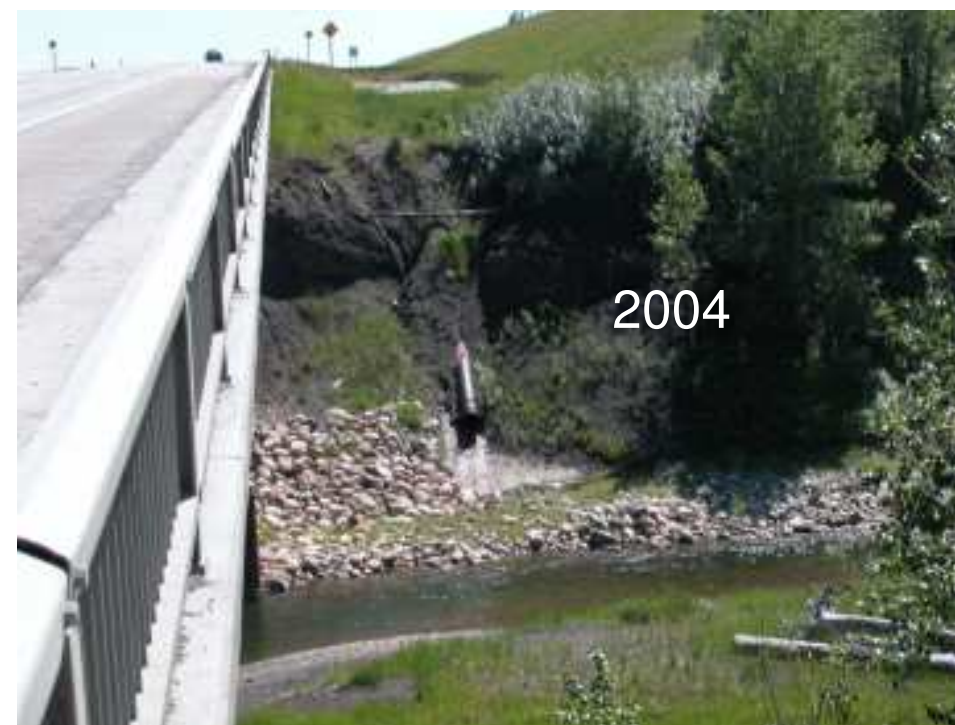
**Photo S1-9 – May 2004** (lower right)

East creek bank, upstream of the eastbound lane bridge, as seen during the 2004 inspection.

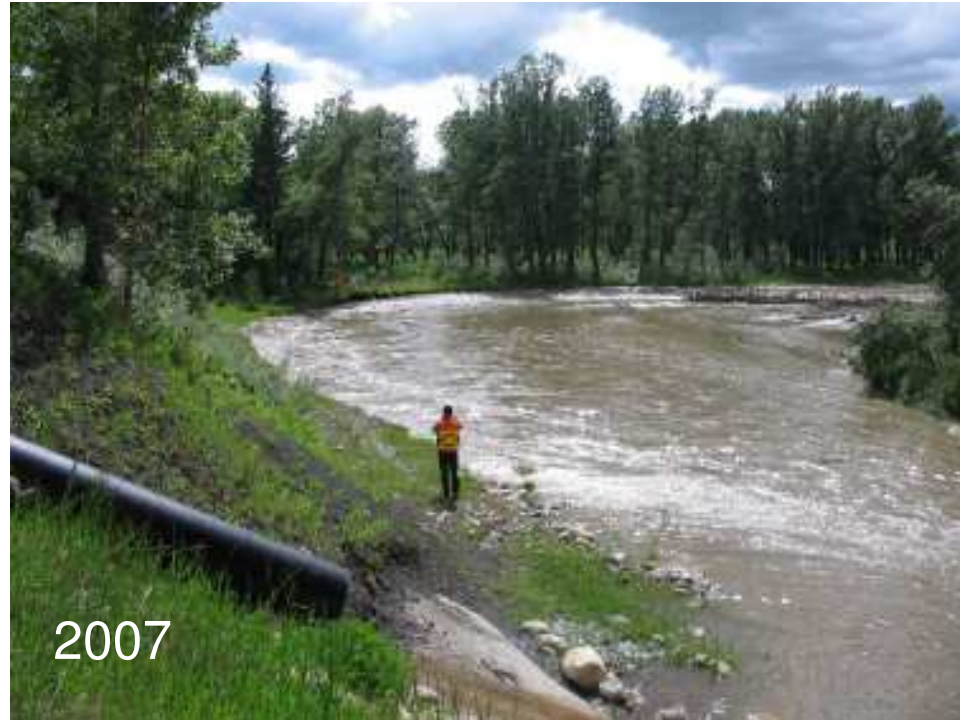
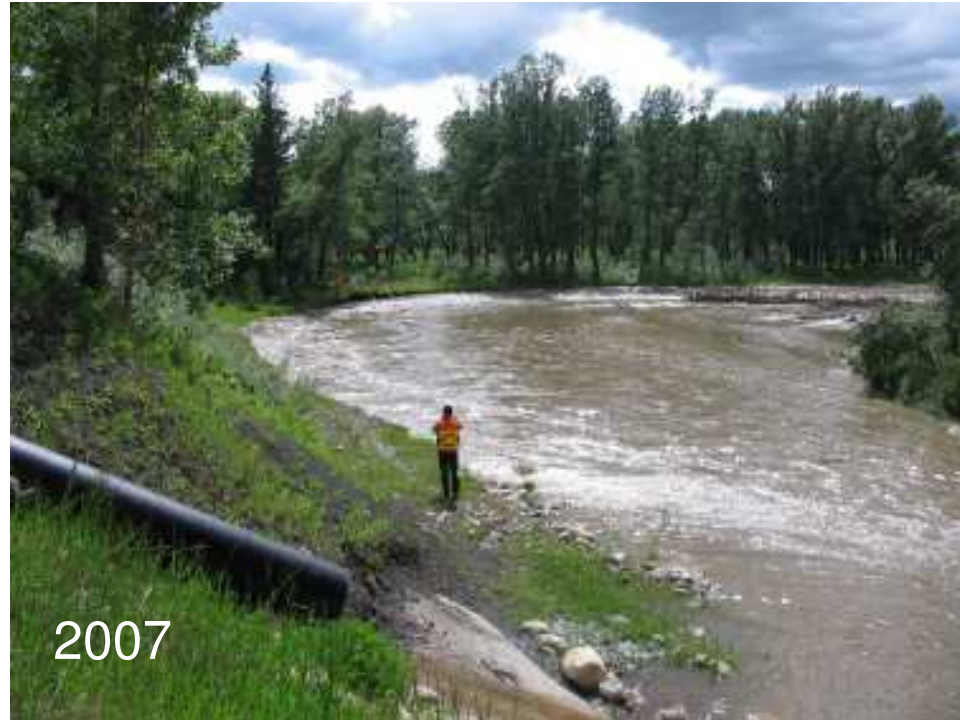
**Photo S1-10 – June 2007** (upper left)  
Facing upstream along the east creek bank, upstream of the eastbound lane bridge. The high creek flows are eroding into the unprotected east bank.

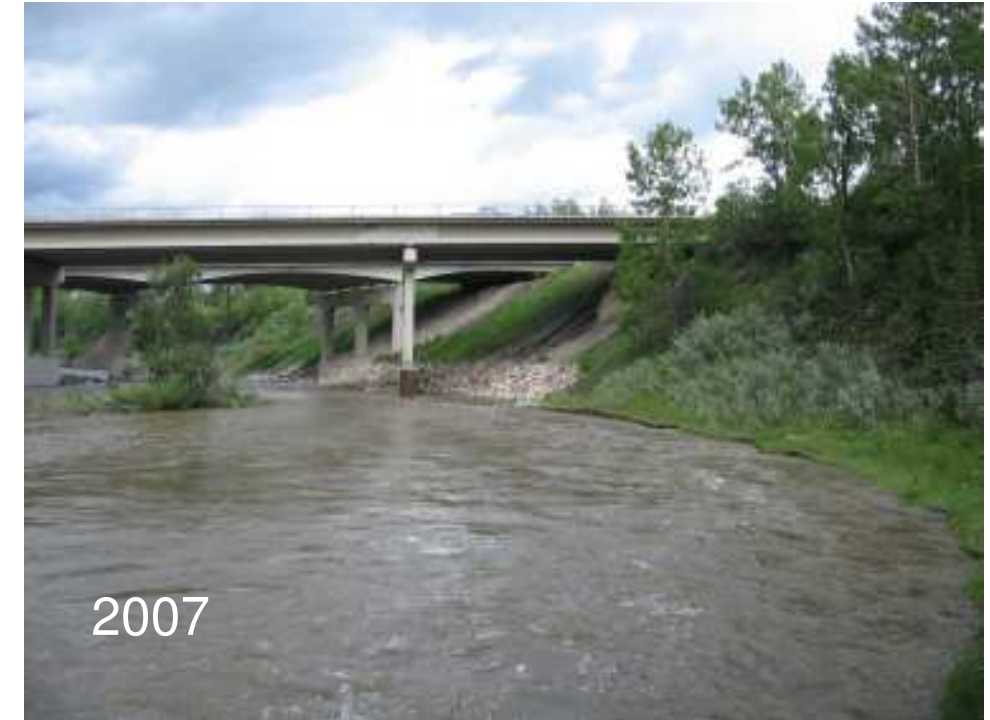
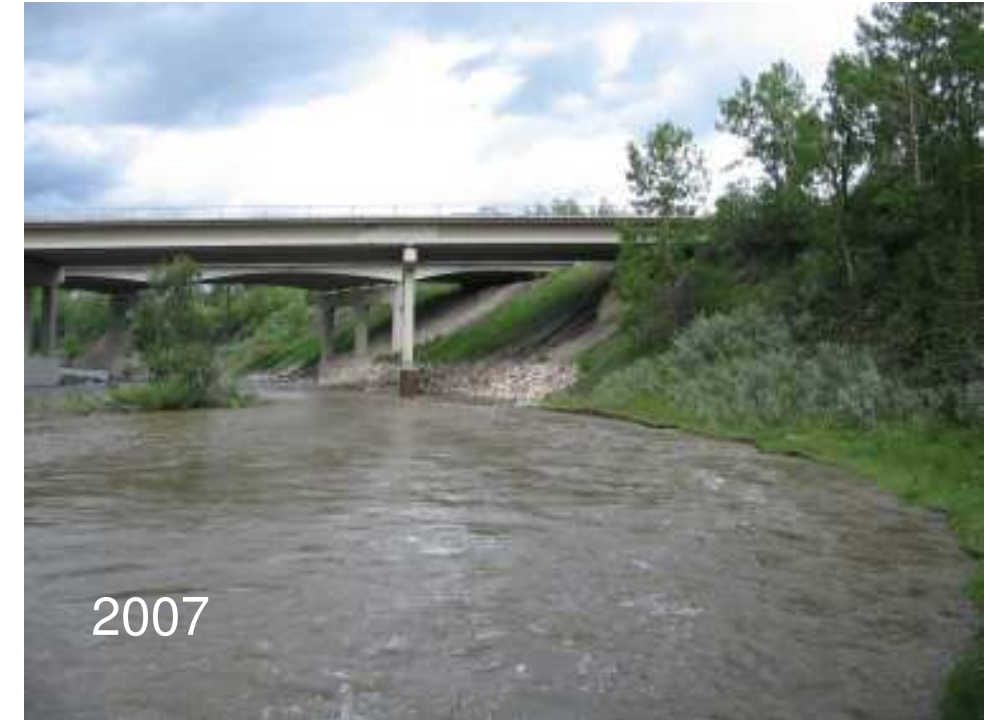
**Photo S1-11 – June 2007** (upper right)  
Facing downstream along the east creek bank, towards the eastbound lane bridge. The high creek flows are eroding into the unprotected east bank.

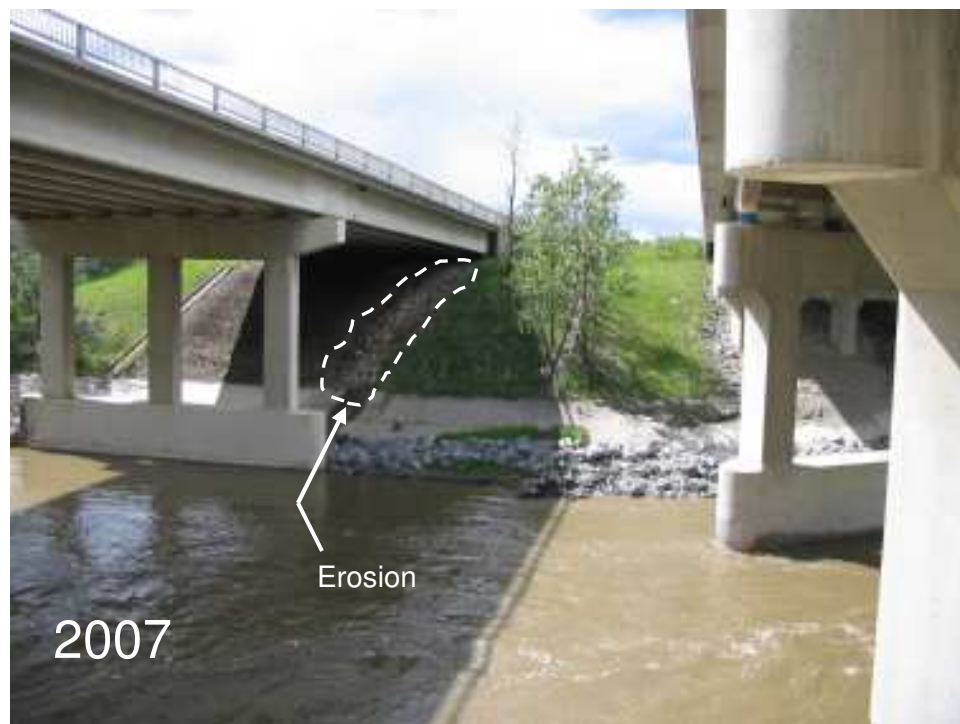
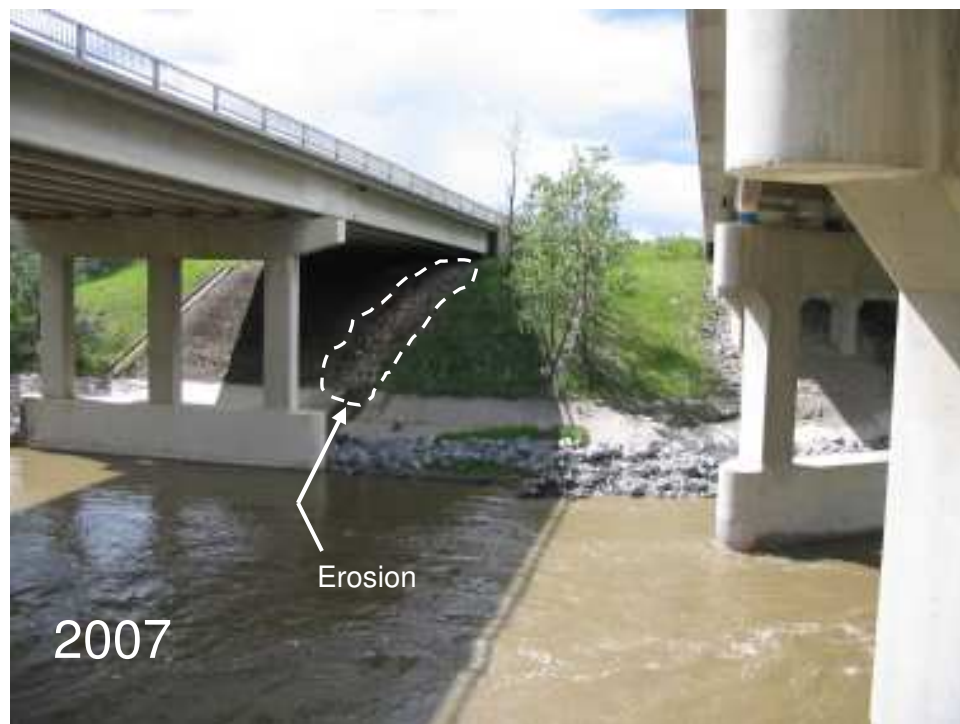
- Extensive oversteepening and erosion of the exposed shale bedrock was noted on the east abutment of the eastbound lane bridge. The cause of the erosion appears to be uncontrolled runoff from the bridge deck and surrounding areas and is fundamentally the same as noted in previous inspections dating back to 2004. However, it appears to have worsened since the 2006 inspection.
- The previously-noted erosion in the west abutment slope of the eastbound lane bridge, as shown in Photo S1-12, has not changed significantly since the previous inspections.

**Photo S1-12 – June 2007** (lower left)  
Erosion of the west abutment slope, below the north side of the eastbound lane bridge, due to surface drainage discharge onto the slope. The erosion does not appear to have worsened significantly in recent years.

- b. The west abutment of the eastbound lane bridge – the gutter outlet above the erosion shown in Photo S1-12 should be connected to either of the concrete-lined runoff channels already in place on adjacent areas of the slope face to both the north and south of the eastbound lane bridge.
