September 29, 2008

CG25277.B

**Re: Southern Region Geohazard Assessment Program
Site S1 – Jumpingpound Creek, Highway 1:04
2008 Annual Inspection Report**

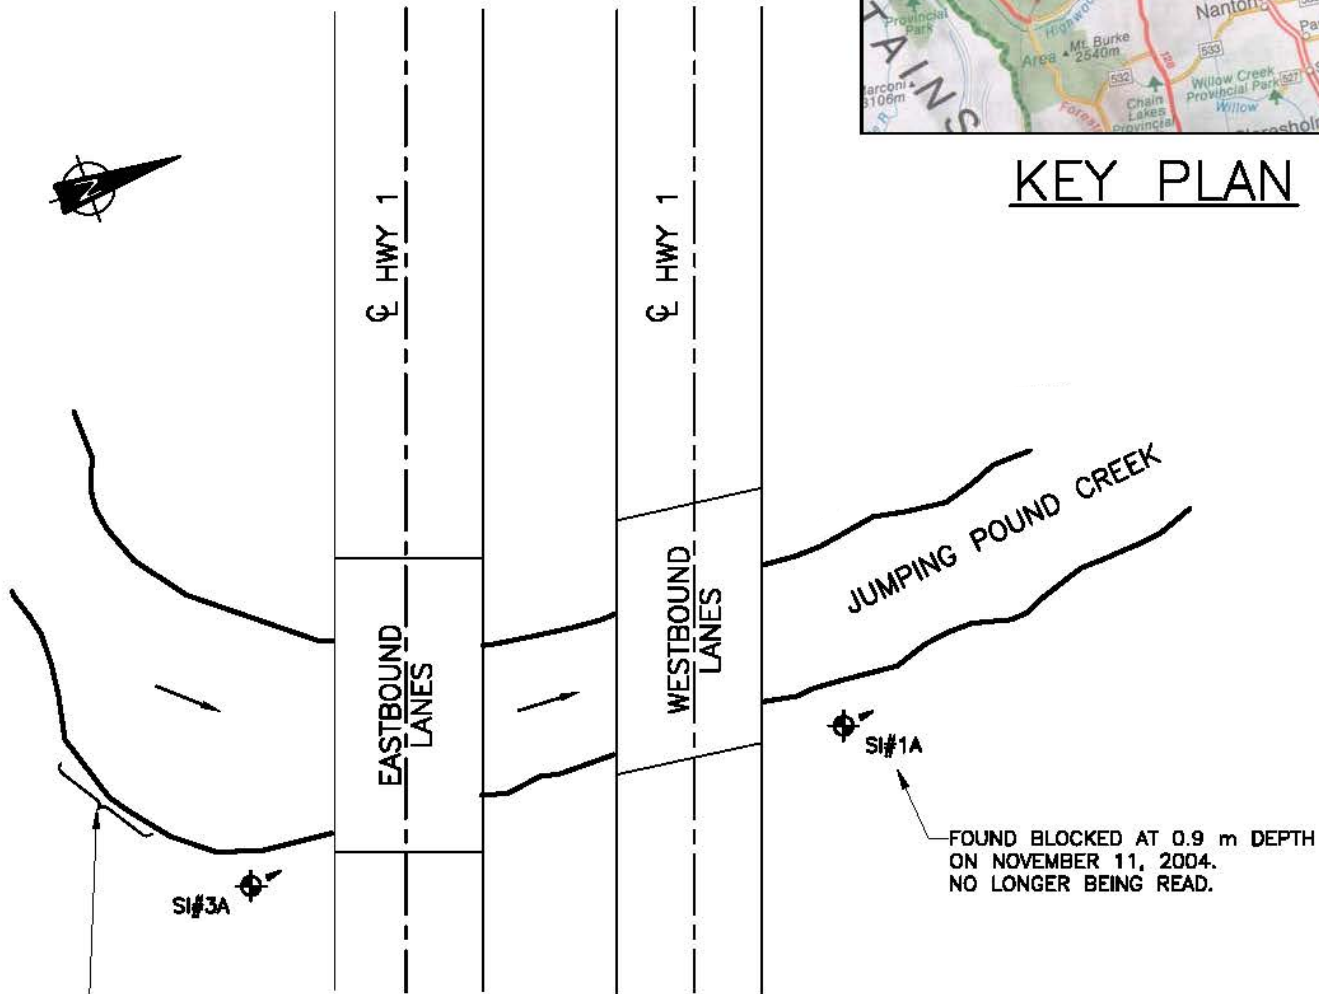
BANK EROSION
(See Photo S1-1)

FOUND BLOCKED AT 0.9 m DEPTH
ON NOVEMBER 11, 2004.
NO LONGER BEING READ.

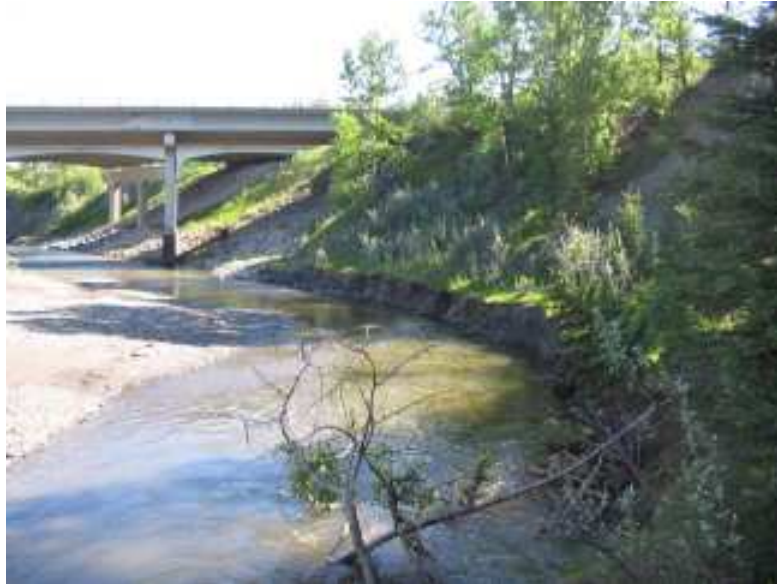
- The erosion along the east bank of the creek channel upstream of the bridges that was first noted during the 2007 site inspection was noted again in 2008. The overall appearance of the bank erosion was similar to that in 2007 with an approximately 50 m long segment of the east bank along the outside of a bend in the creek channel exposing an approximately 1 to 1.5 m near-vertical soil bank. Photos S1-1 and S1-2 show views of this area. The amount of bank erosion in the past year could not be determined quantitatively from the visual inspection, but the area had the visual appearance of the bank having shifted up to 1 to 2 m in places in recent years. At the time of the site inspection, the majority of the creek flow was within a west sub-channel away from the erosion area, however the east sub-channel across the erosion area was also carrying flow and it appeared that during peak flows the east bank in this area would be prone to bank erosion and eastwards channel shifting towards the toe of the overall east valley slope.

The apparently ongoing and possibly worsening erosion of the east (right) creek bank a short distance upstream of the bridges is of concern because if the creek channel shifts significantly the creek flow may be able to erode or outflank the armouring along the toe of the east bridge abutment slope. This could possibly lead to bank erosion and loss of ground along the east bank below the bridges themselves, in turn possibly leading to scouring around the east piers of the bridges. This could occur over the next few years, but is not expected to happen in the short term. A hydrotechnical review of the channel alignment and flow conditions would help to assess this risk.

Photo S1-1 – June 2008 (top)
Facing downstream along the right (east) creek bank, towards the east abutment of the eastbound lane bridge. Note the pronounced bank erosion visible where peak flows in the east creek sub-channel have created a 1 to 1.5 m high, near-vertical soil bank. It appears that segments of the east bank have eroded up to 1 to 2 m in the past couple of years.

A hydrotechnical review of the creek channel upstream of the bridges should be performed in order to make an initial assessment of the possibility of continued erosion along the east bank leading to erosion beneath the bridges and possible destabilization of the east abutment slopes and/or the east piers of the bridges. Such a review may determine that there is little risk to the east bridge abutments from bank erosion. However, another possible outcome could be that the east creek bank at and upstream of the bridges will need to be protected with bioengineering measures or additional conventional armouring in order to minimize future risk to the bridges.

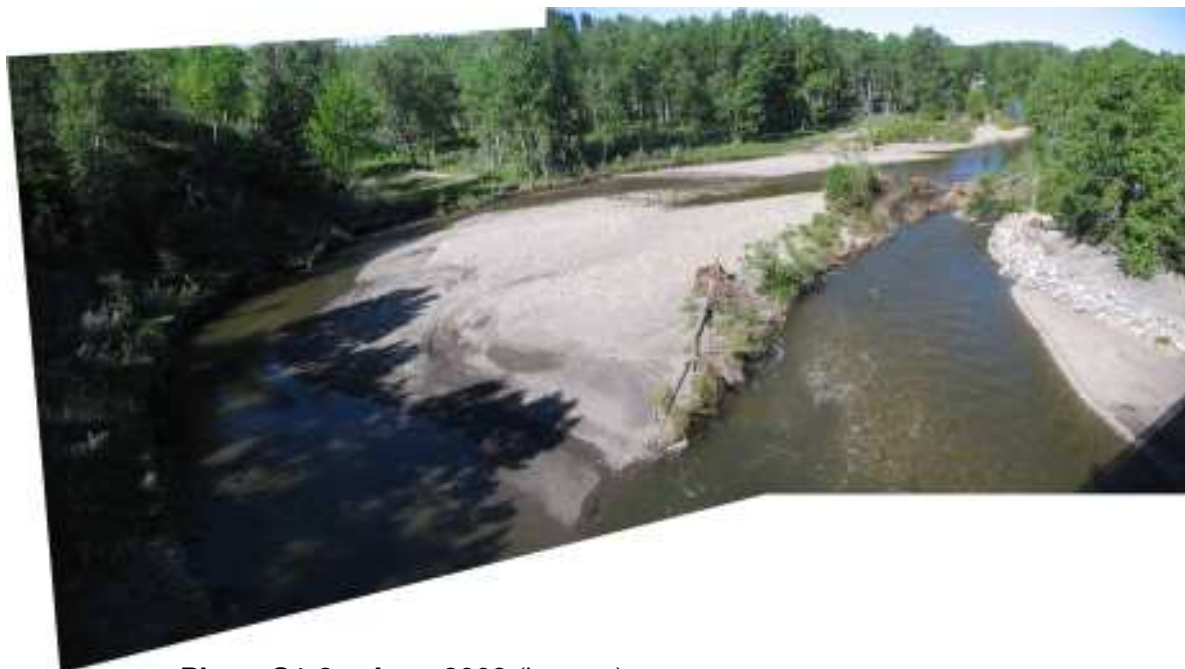
Photo S1-2 – June 2008 (bottom)
Facing upstream from the middle of the eastbound lane bridge deck. The west sub-channel (on the right hand side of the photo) appeared to be carrying the majority of the flow at the time of the inspection. It appeared that earlier peak flows in the east sub-channel (left on photo, largely in shadow) had recently eroded significant volumes of soil from the east bank, as shown in Photo S1-1.

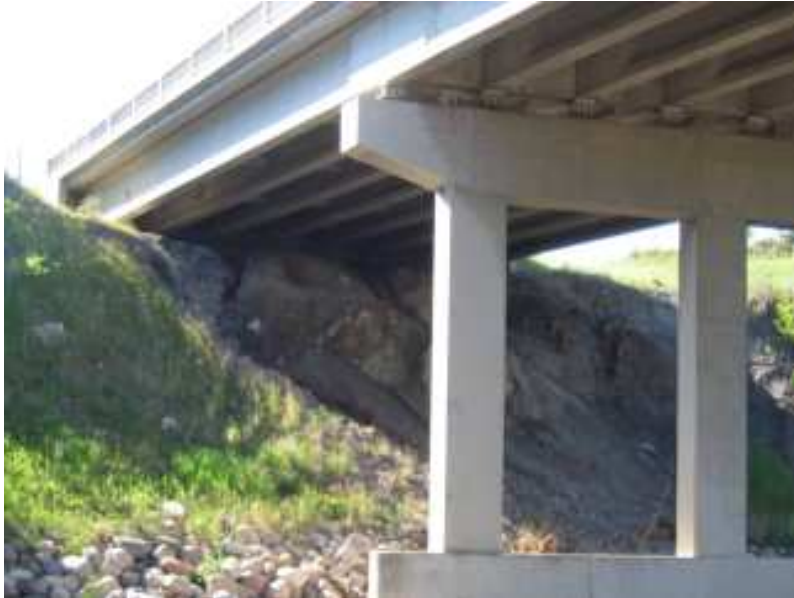
- The localized oversteepening and surface erosion of the exposed shale bedrock beneath the east bridge abutments that was noted in previous site inspections did not appear to have changed significantly since 2007. Photo S1-3 shows this area.

The geotechnical risks to the bridge abutments from the surface erosion in areas of concentrated runoff from the bridge decks and abutment slopes are still present but do not appear to have significantly changed or worsened in recent years. It may be that the ongoing maintenance of the bridges, presumably including clearing of accumulated soil and gravel debris in the drainage gutters below the bridge decks, is sufficient to ensure that surface runoff from the bridge decks is properly conveyed down to the creek elevation without ongoing erosion on the abutment slopes.

Photo S1-3 – June 2008 (top)
Surface erosion and gullying of the exposed shale bedrock in the east abutment slope of the eastbound lane bridge. It appears that the erosion is caused by overflow of bridge deck runoff from the collection gutters below the east end of the bridge. The appearance of the erosion and gullying has gradually worsened over time since the annual inspections began in 2000, but did not appear to have worsened significantly since the 2007 inspection.

The ongoing maintenance of the bridges, including cleaning of the gutters collecting the bridge deck runoff, should be continued in order to manage the amount of surface erosion on the abutment slopes from overflows from the gutters. AMEC understands that AT's operations personnel are responsible for this work and will ensure that it continues.

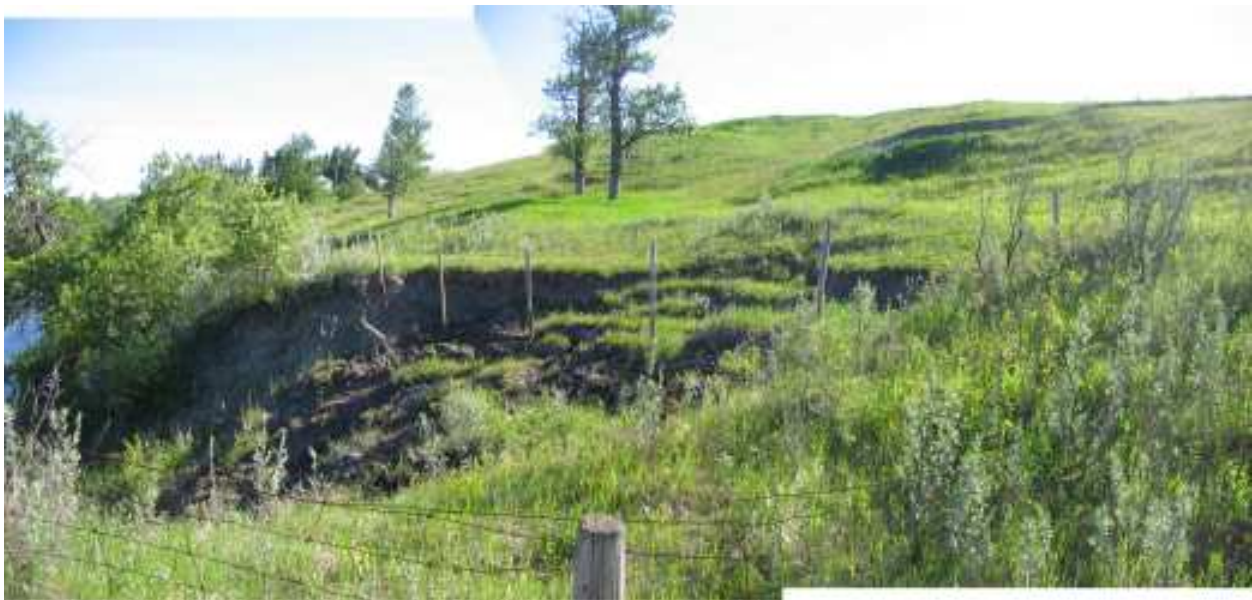
Photo S1-4 – June 2008 (bottom)

- The slumping at the crest of the east creek valley slope, downstream of the westbound lane bridge, that has been noted in each annual inspection since 2000 did not appear to have worsened significantly since the previous assessments. Photo S1-4 shows this area.

Slope instability along the crest of the east creek valley slope, downstream of the westbound lane bridge. This instability has been noted since the first annual inspection in 2000, however it does not appear to have worsened significantly since that time nor retrogressed towards the highway.
