November 23, 2009

CG25309.C

**Re: Southern Region Geohazard Assessment
Fall 2009 Instrumentation Monitoring Results
Site S1: Highway 1:06, Jumpingpound Creek**

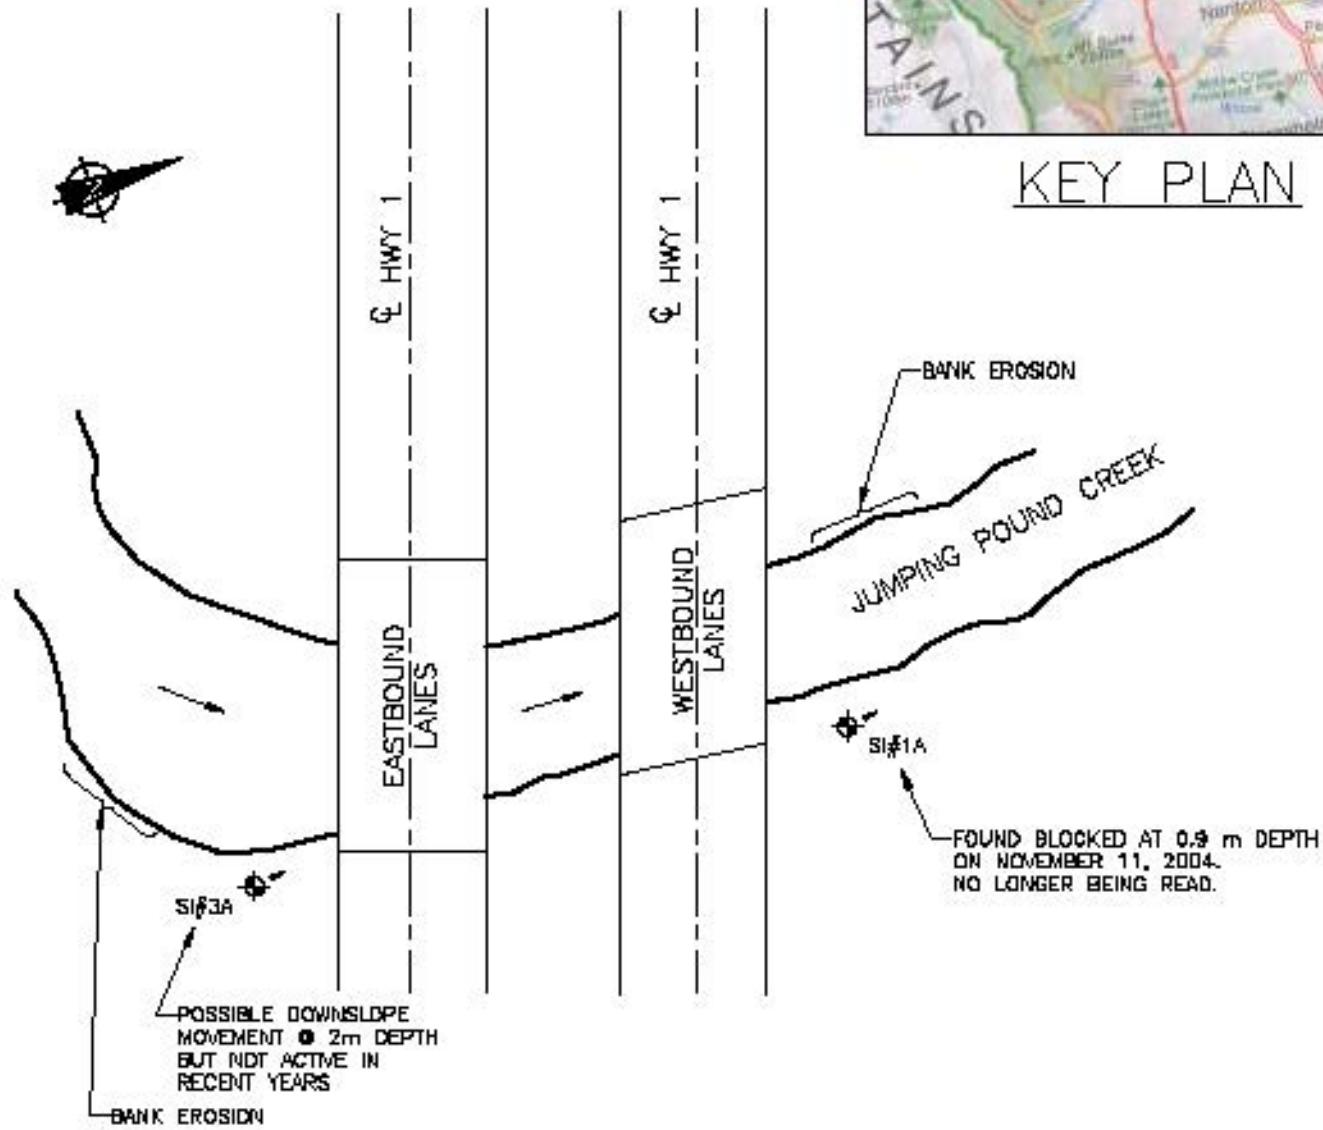
FIGURE S1-1

Please refer to Figure S1-1 attached in Section D for site layout and instrument locations.
